Inspection Photos

Operator: BP America

API: 05-067-07014

Date: 8/21/2018

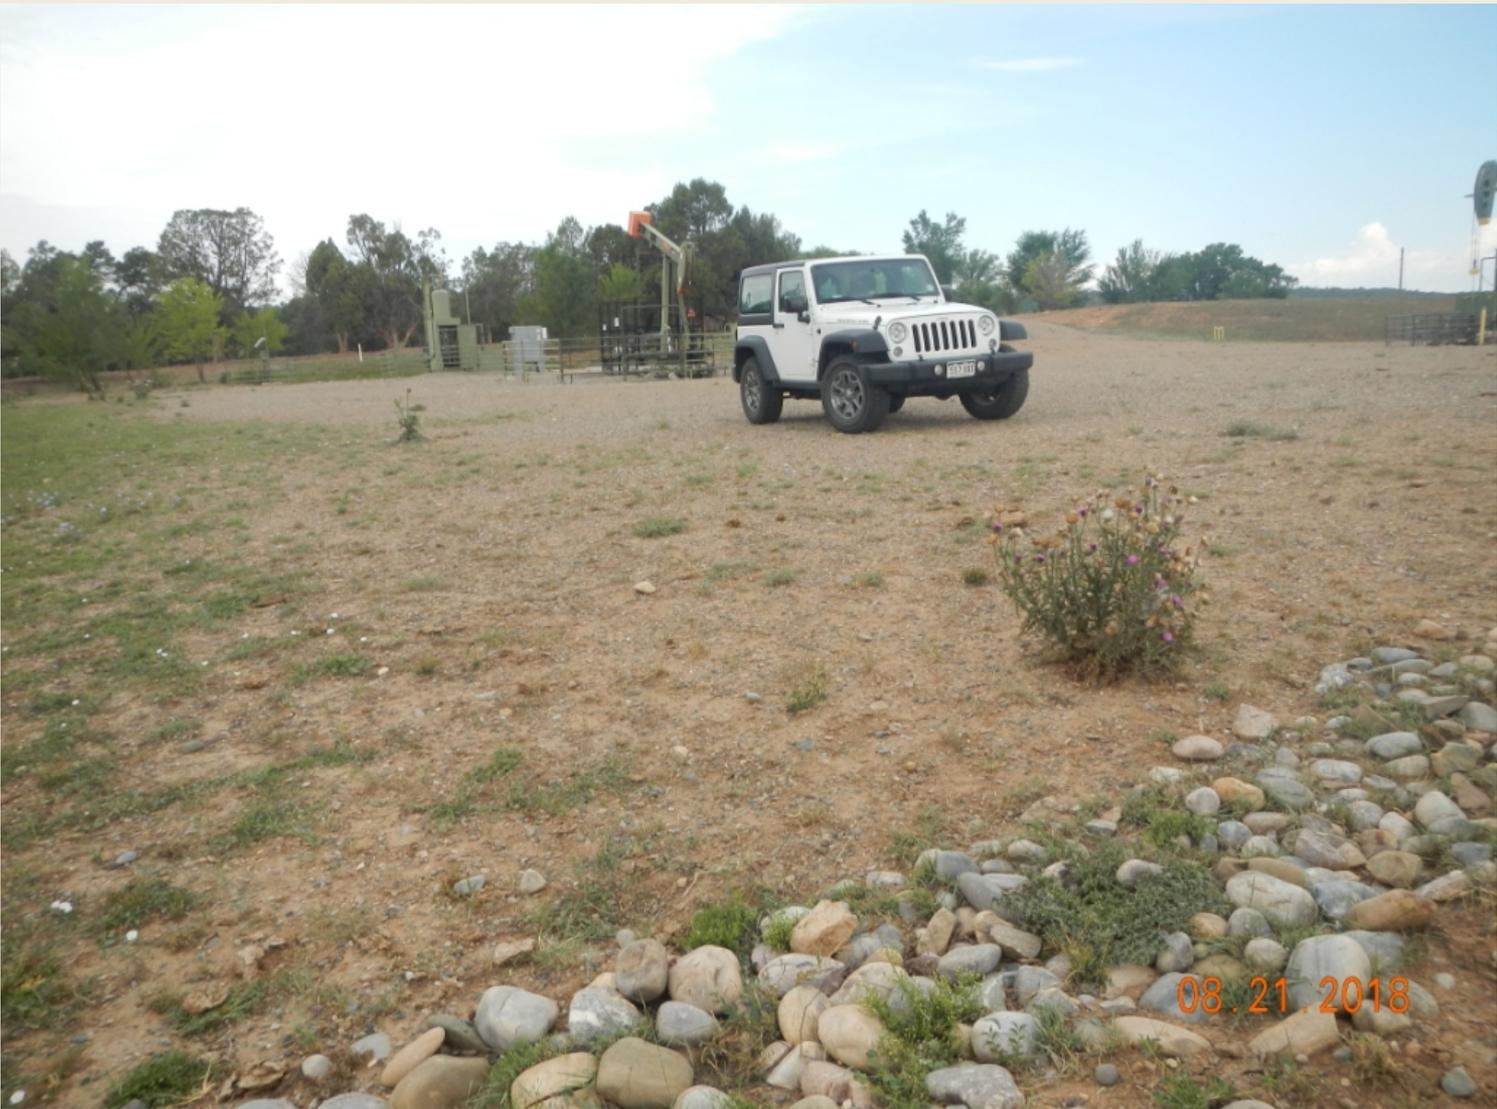
Photo 1. View of the project area from the southern edge facing center.

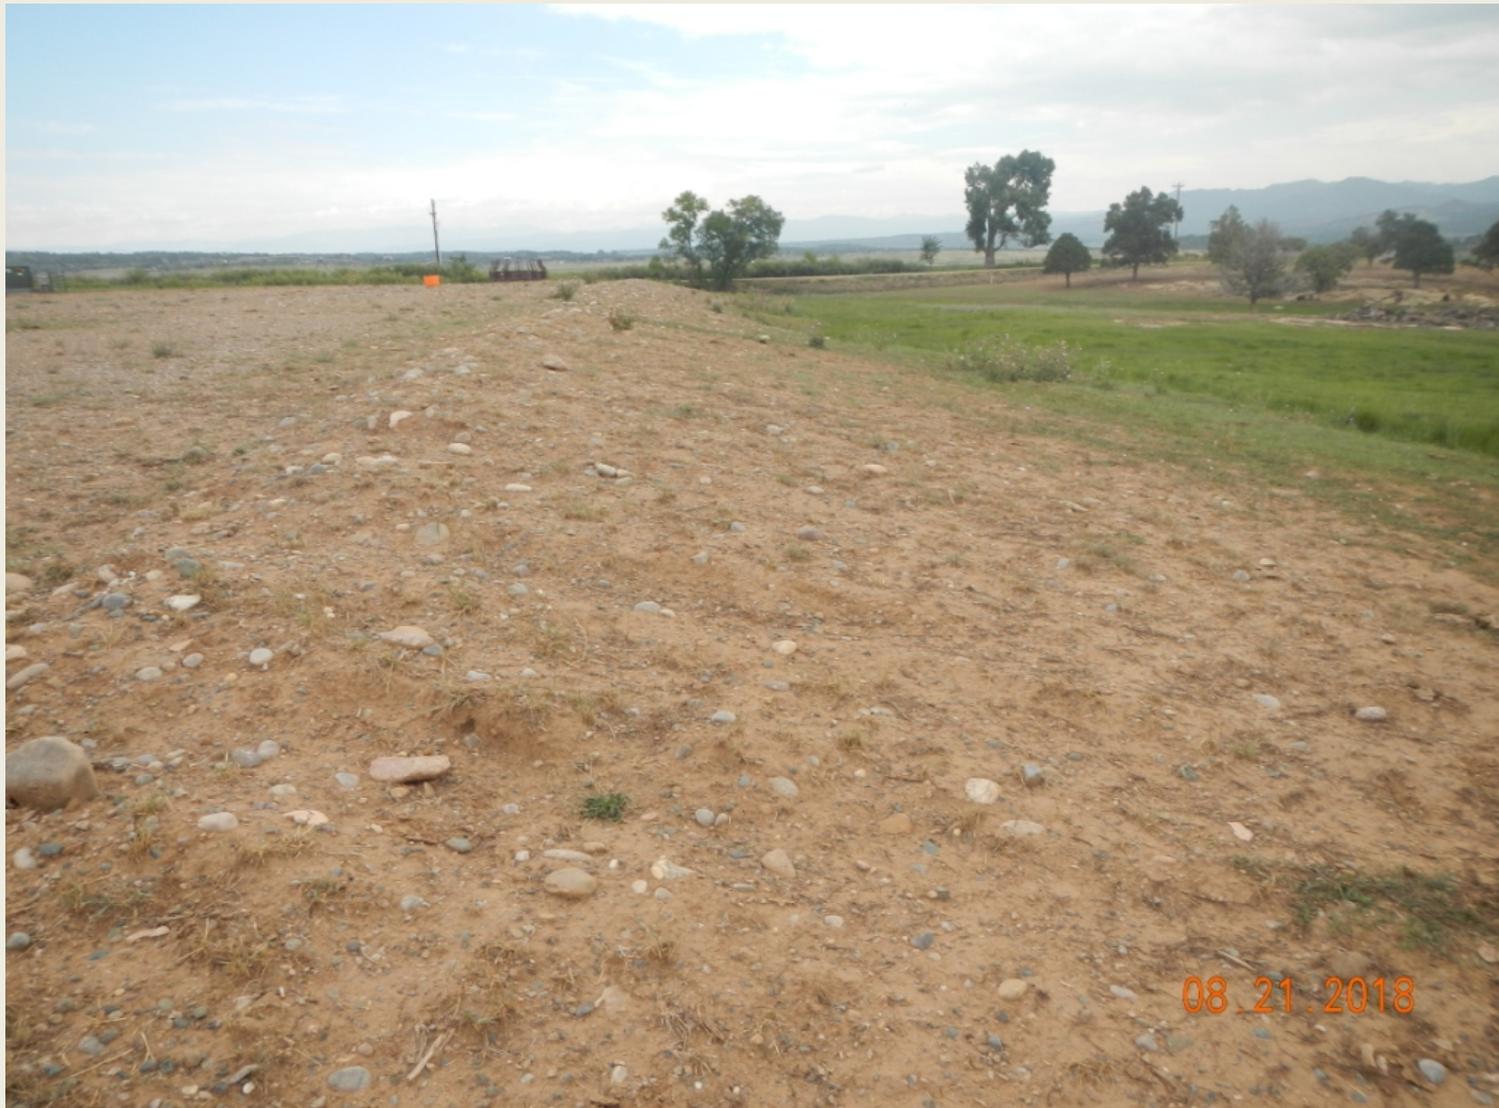
Photo 2. View of the eastern corner of the project area from the southeastern corner facing northward. Revegetation is sparse on fill slopes.

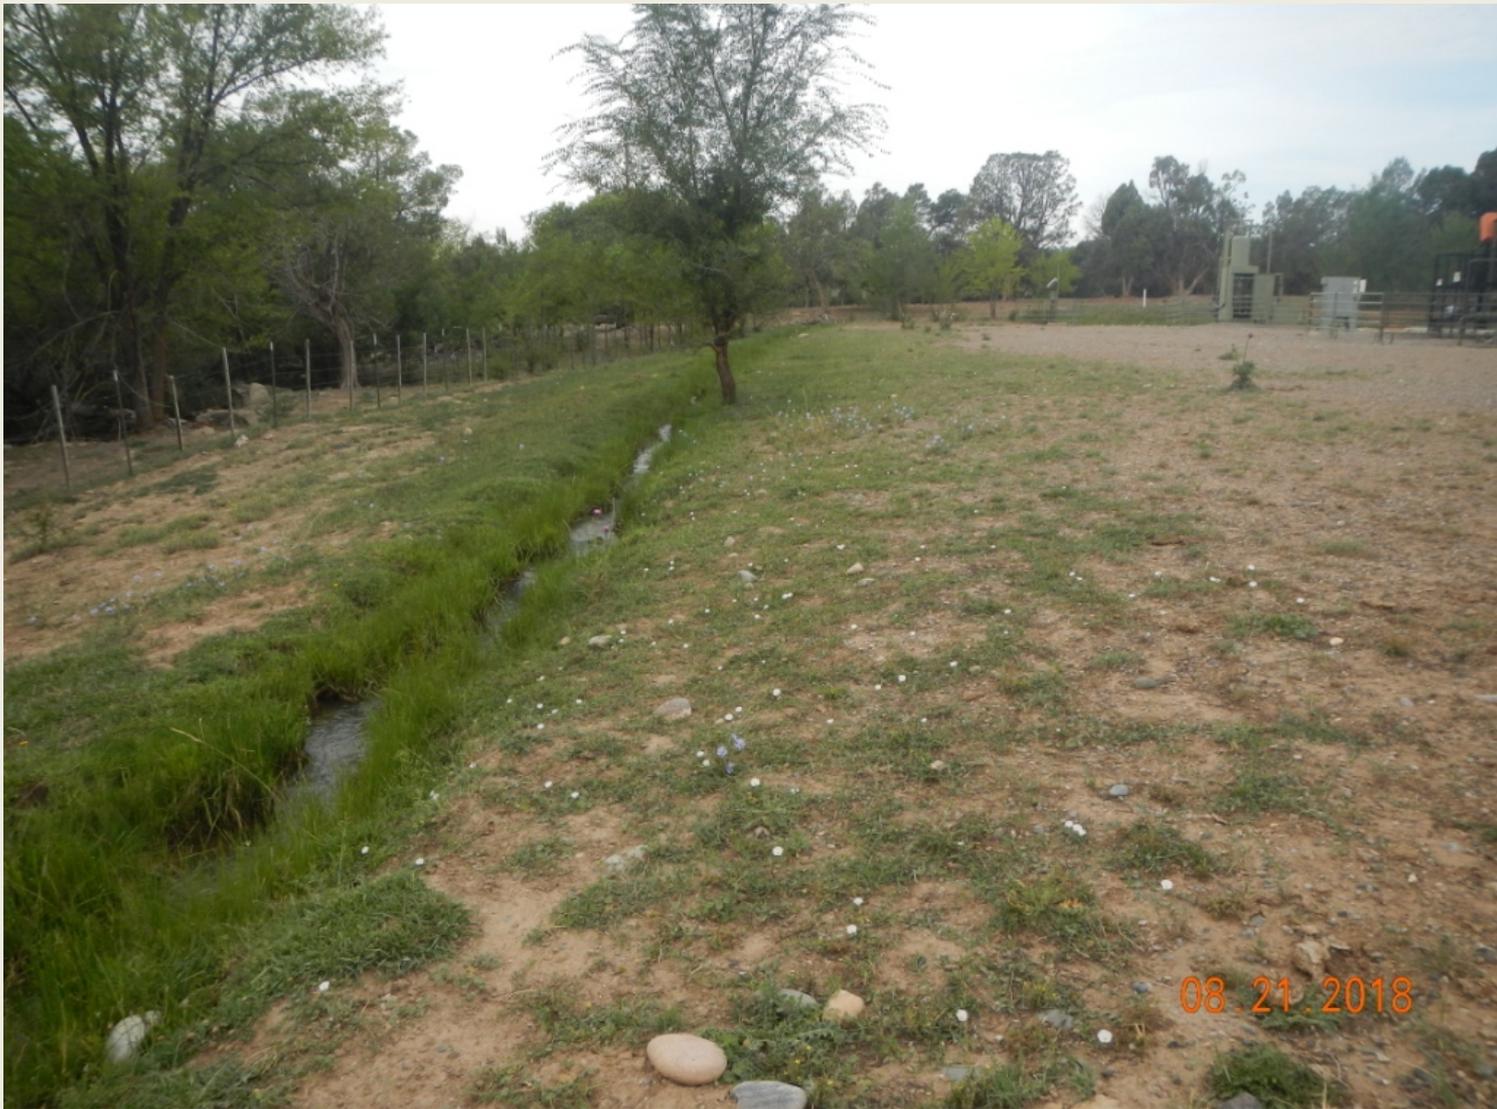
Photo 3. View of the southern project area and adjacent irrigation ditch.

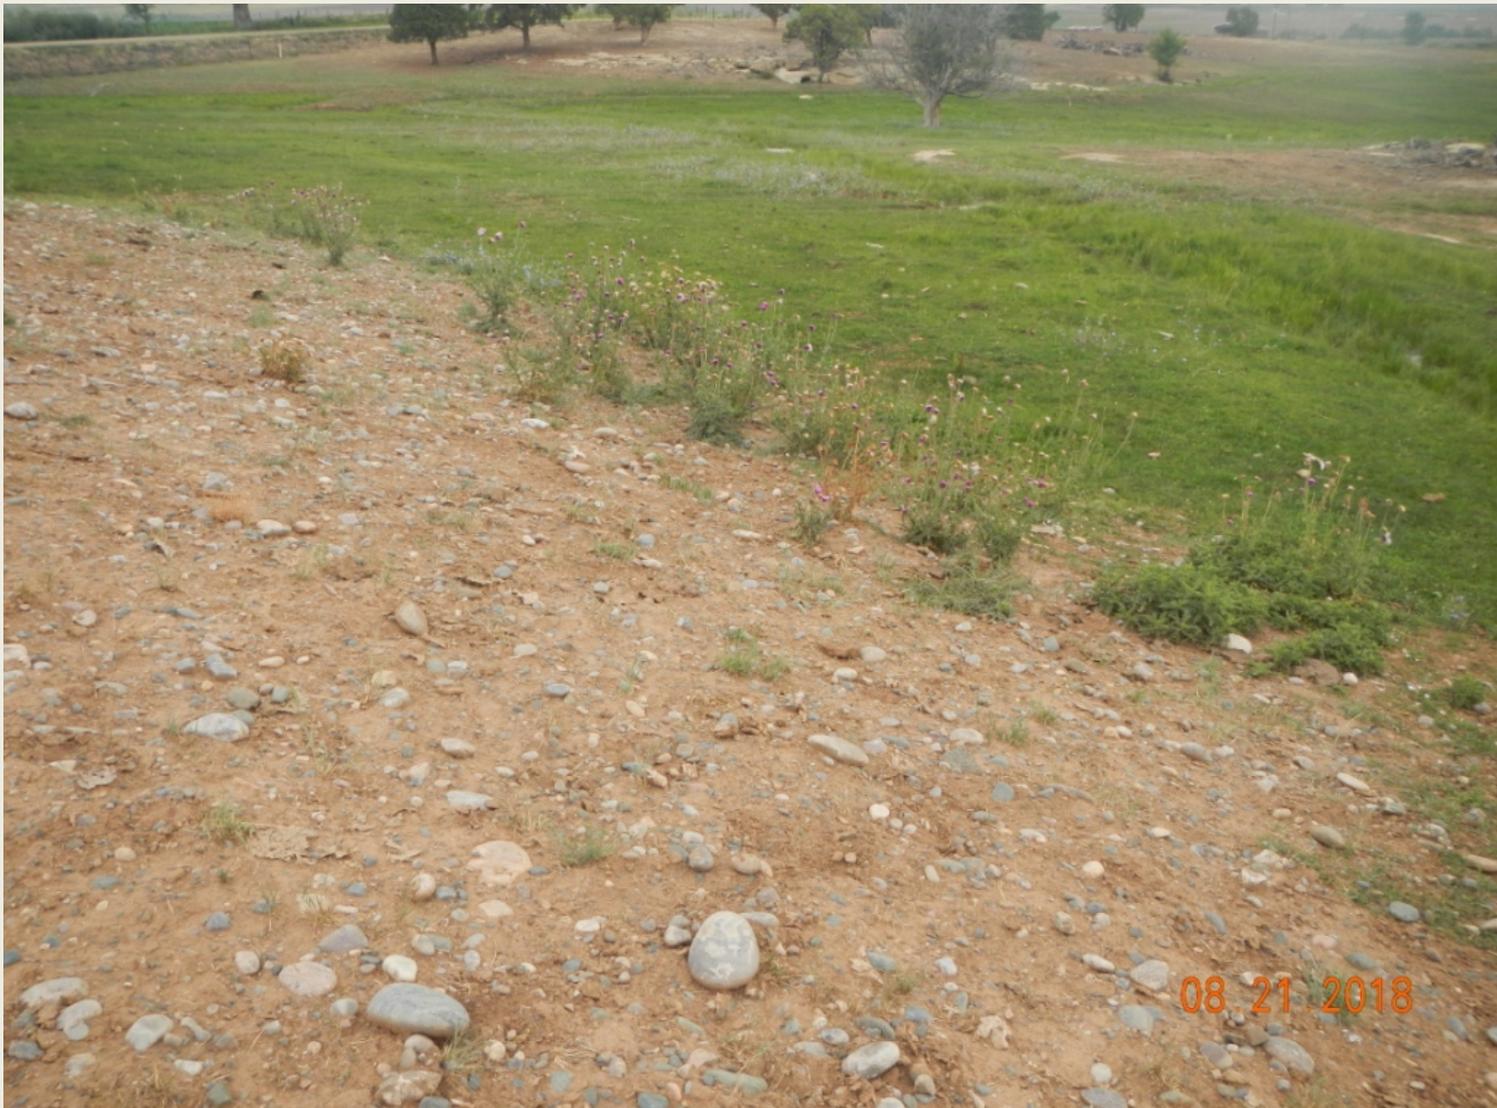
Photo 4. View of musk thistles (*Carduus nutans*) in flower and seed condition in the northeastern project area.
