Final Reclamation Inspection

Operator: TOP OPERATING COMPANY - 39560

API: 05-123-08731

Inspection Photos
Location Name: KNOX #22-23
API: 05-123-08731

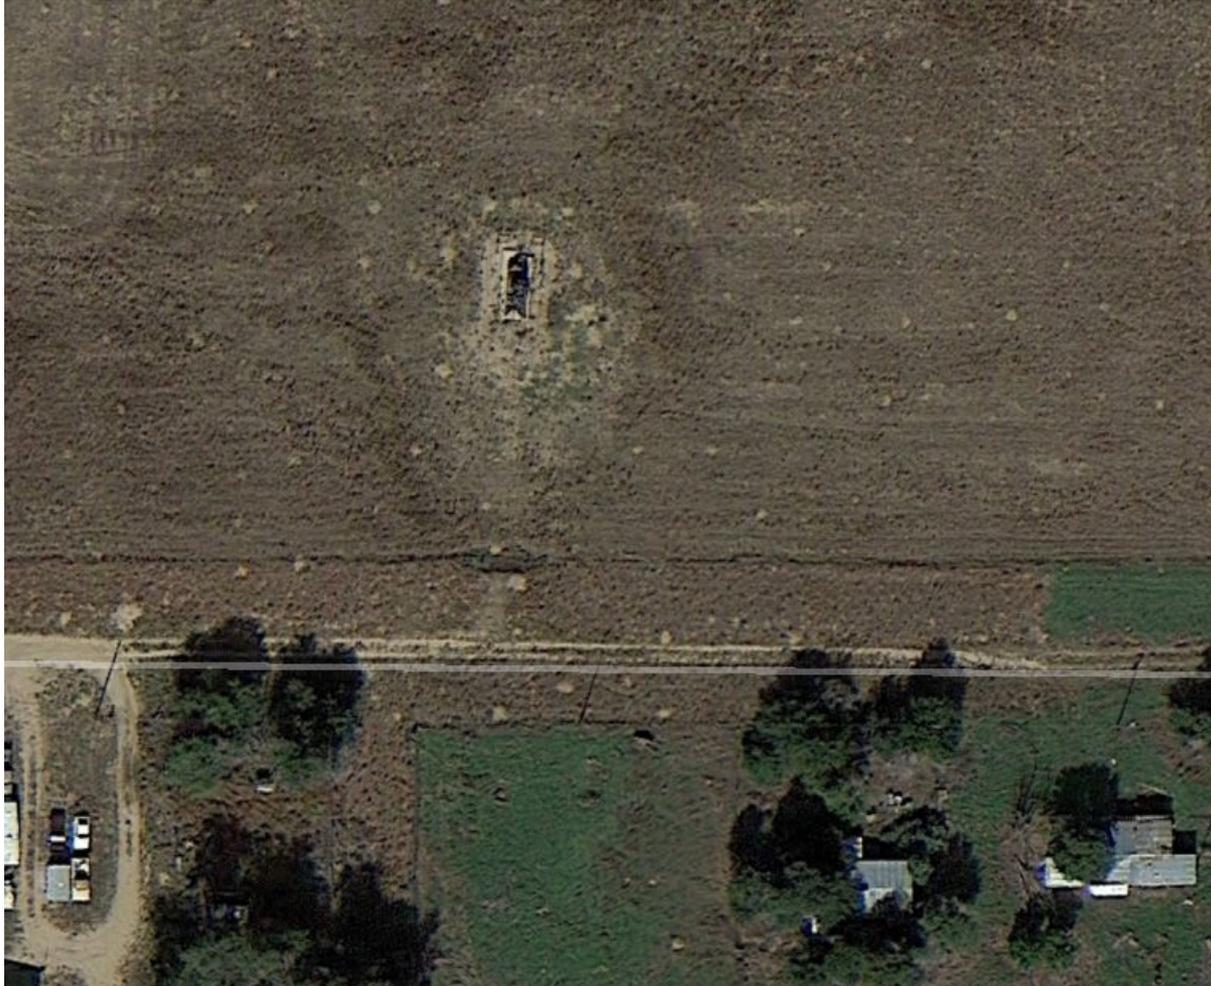
Google Earth aerial imagery taken October 6, 2014. Photo illustrates equipment had not been removed per Rule 1004.a. and remained 15 months after plugging and abandonment. Operator did respond to previous corrective actions to remove all equipment.

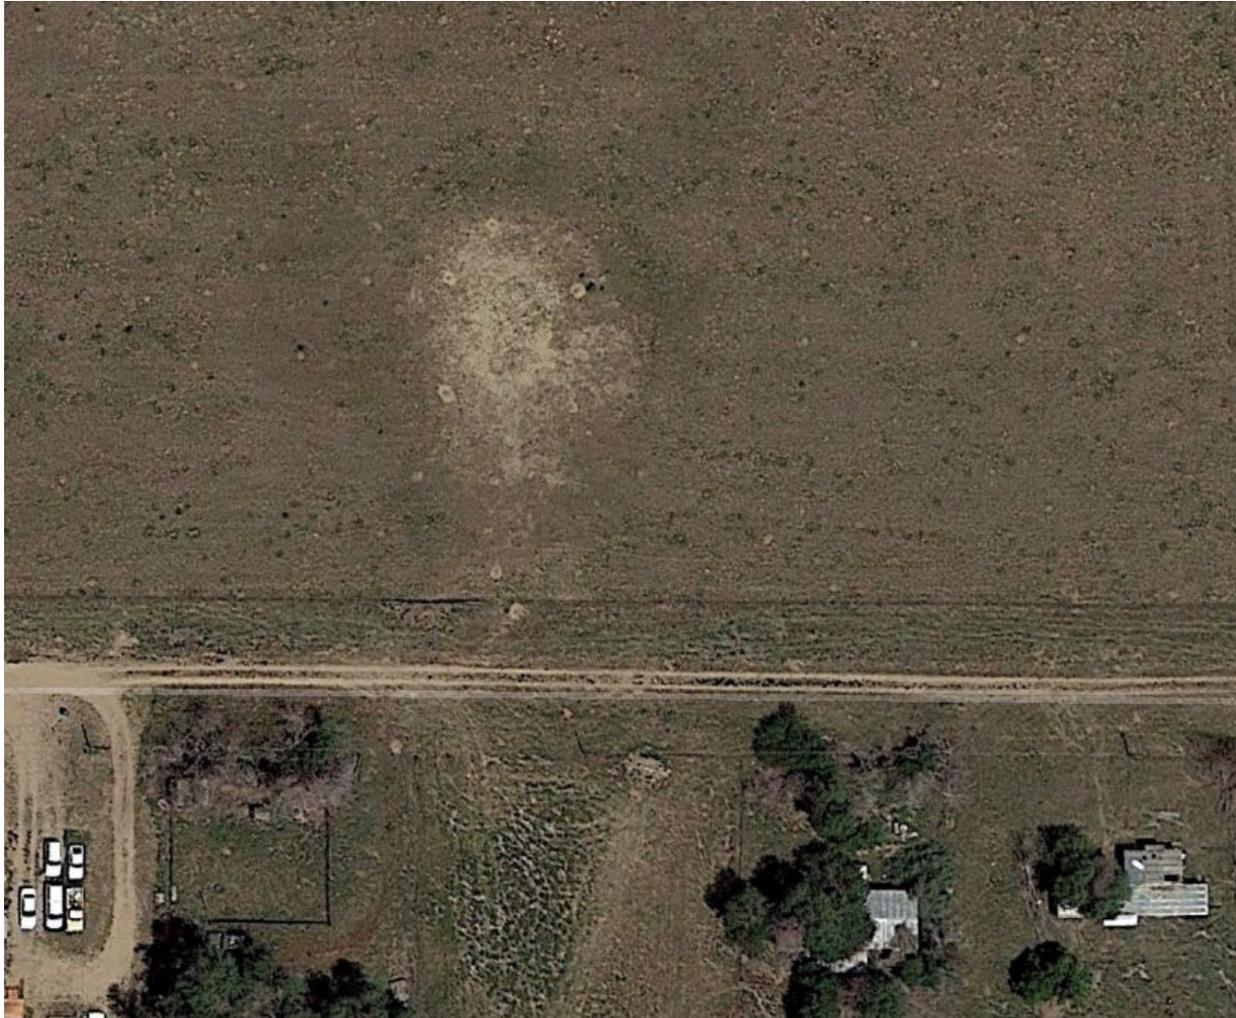
Google Earth aerial imagery taken June 9, 2017. Aerial imagery shows disturbance areas do not meet vegetative standards, even though the Operator submitted a Final Reclamation Complete Notice on January 28, 2016.

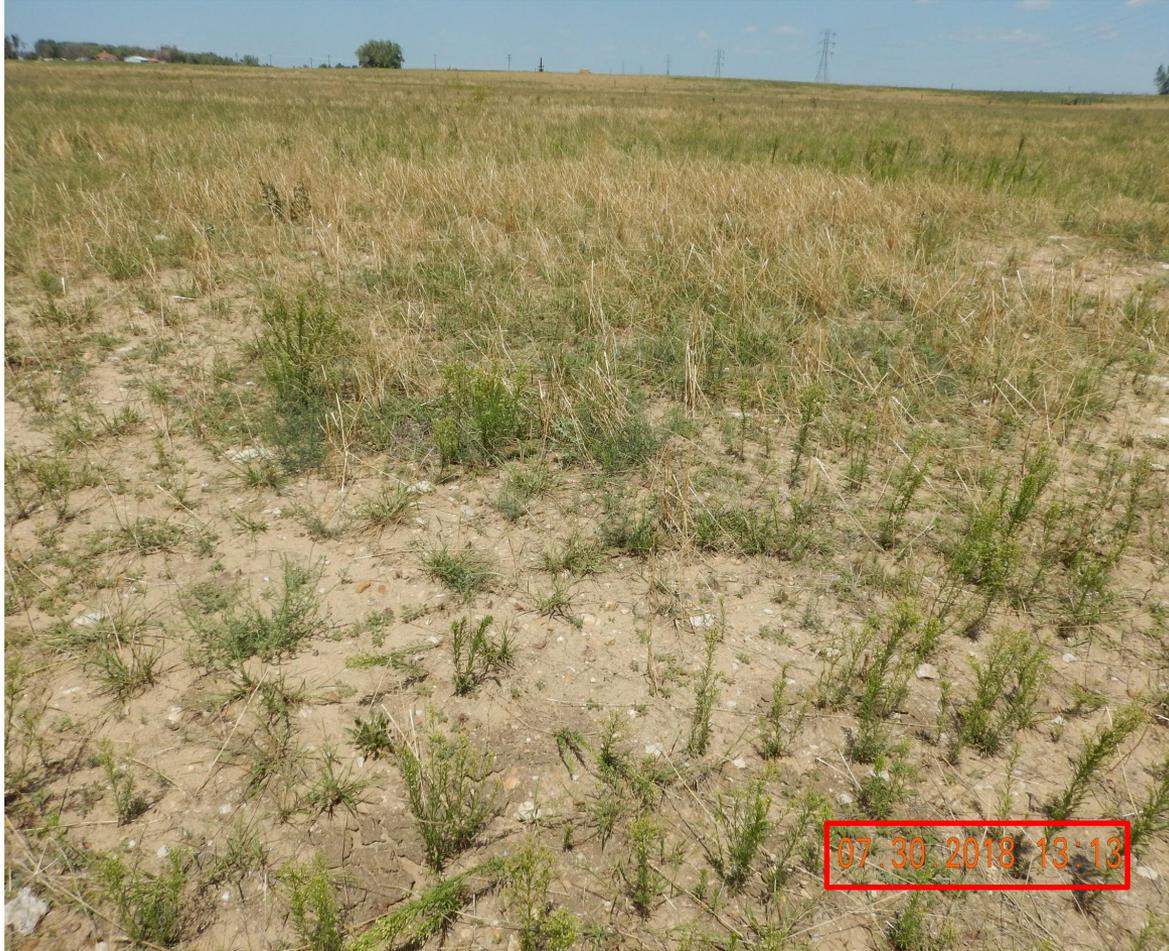
Photo 1. Photo taken from the approximate center of location on July 30, 2018, facing North. Disturbance areas are evident with the lack of perennial vegetative growth and bare soil. Vegetative cover is not uniform or reflective of reference area vegetative growth. Does not appear the Operator has removed gravel from the location.

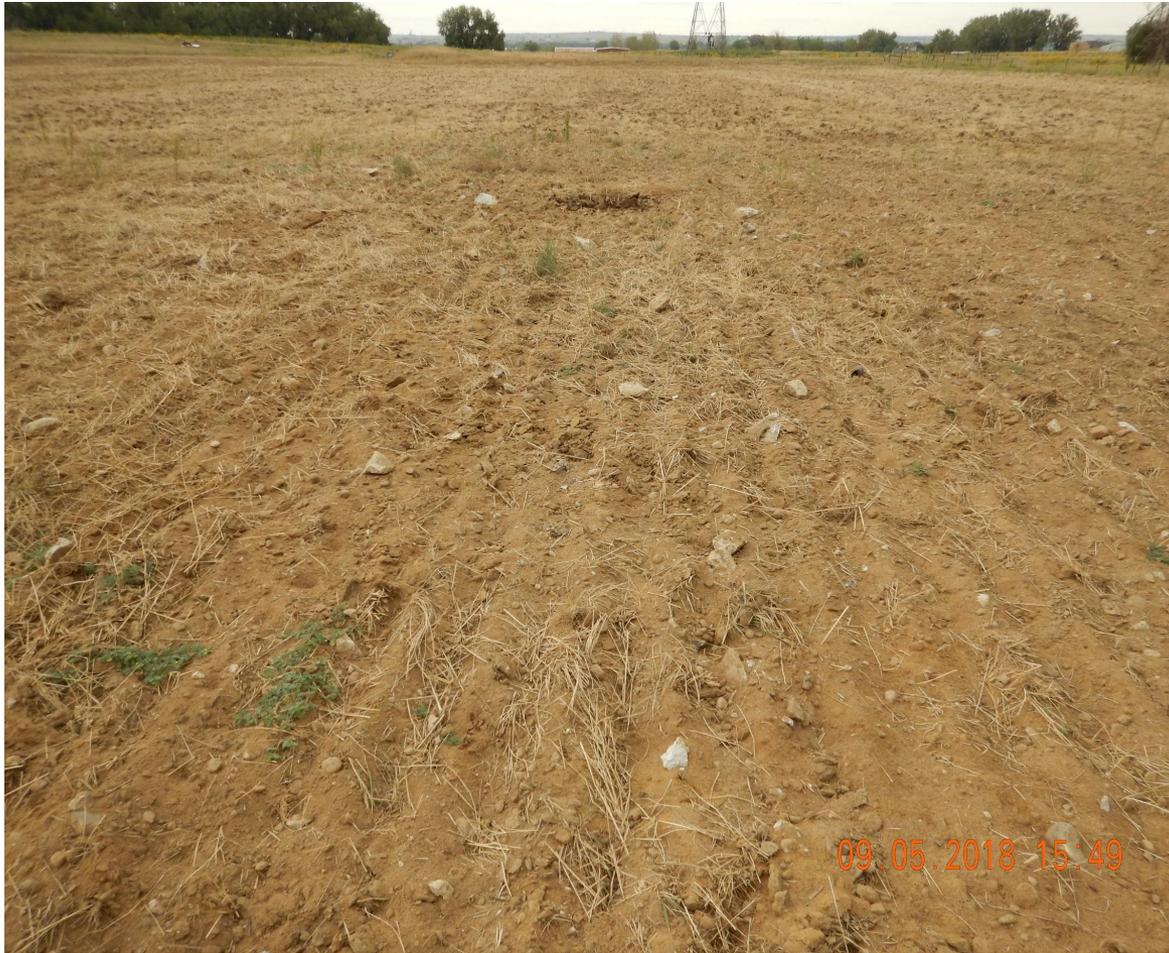
Photo 2. Photo taken from the approximate center of location on September 5, 2018, facing East. Surface owner has recently cultivated the ~30 acre parcel, including this P&A location. This photo illustrates the Operator has failed to remove gravel as large rock fragments and concrete material were observed.

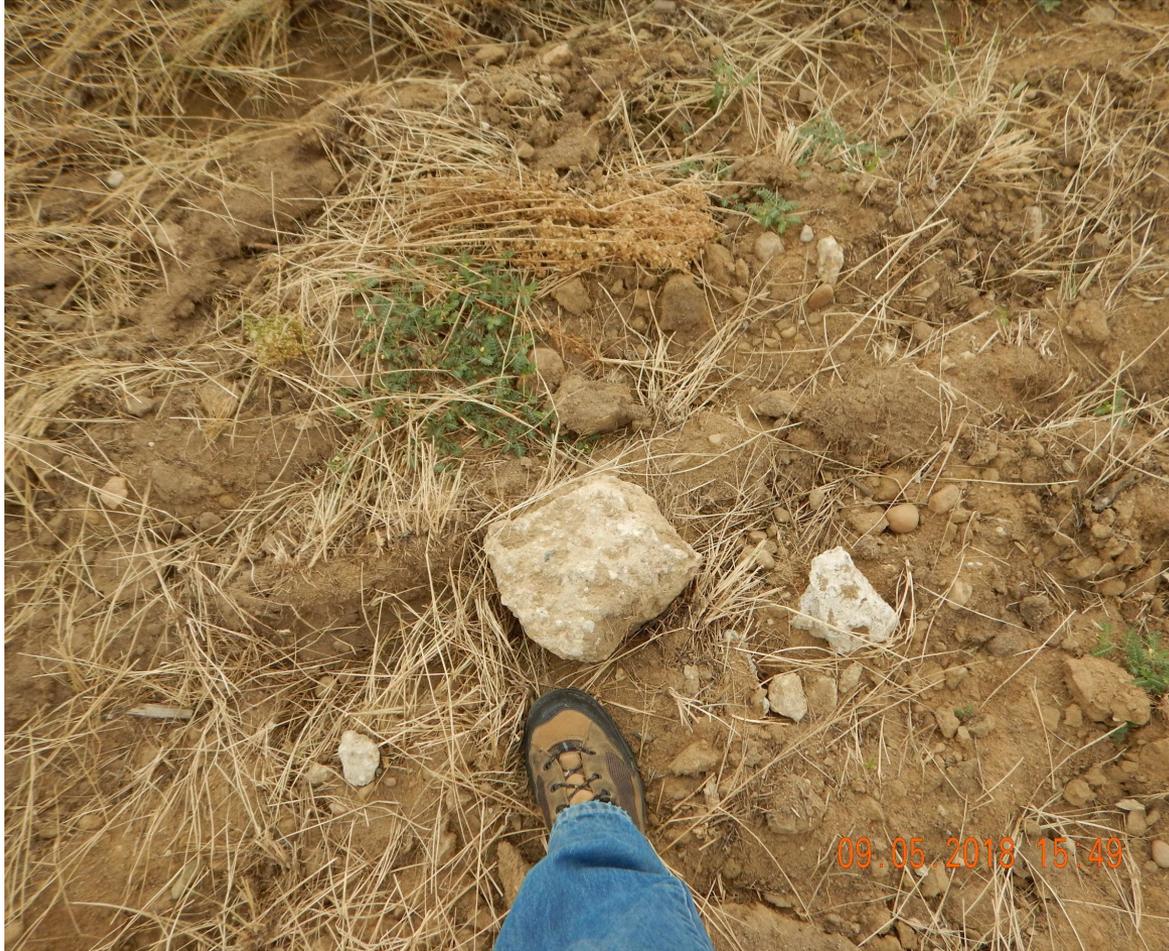
Photo 3. Photo taken from the approximate center of location on September 5, 2018. This photo illustrates the Operator has failed to remove gravel as large rock fragments were observed.

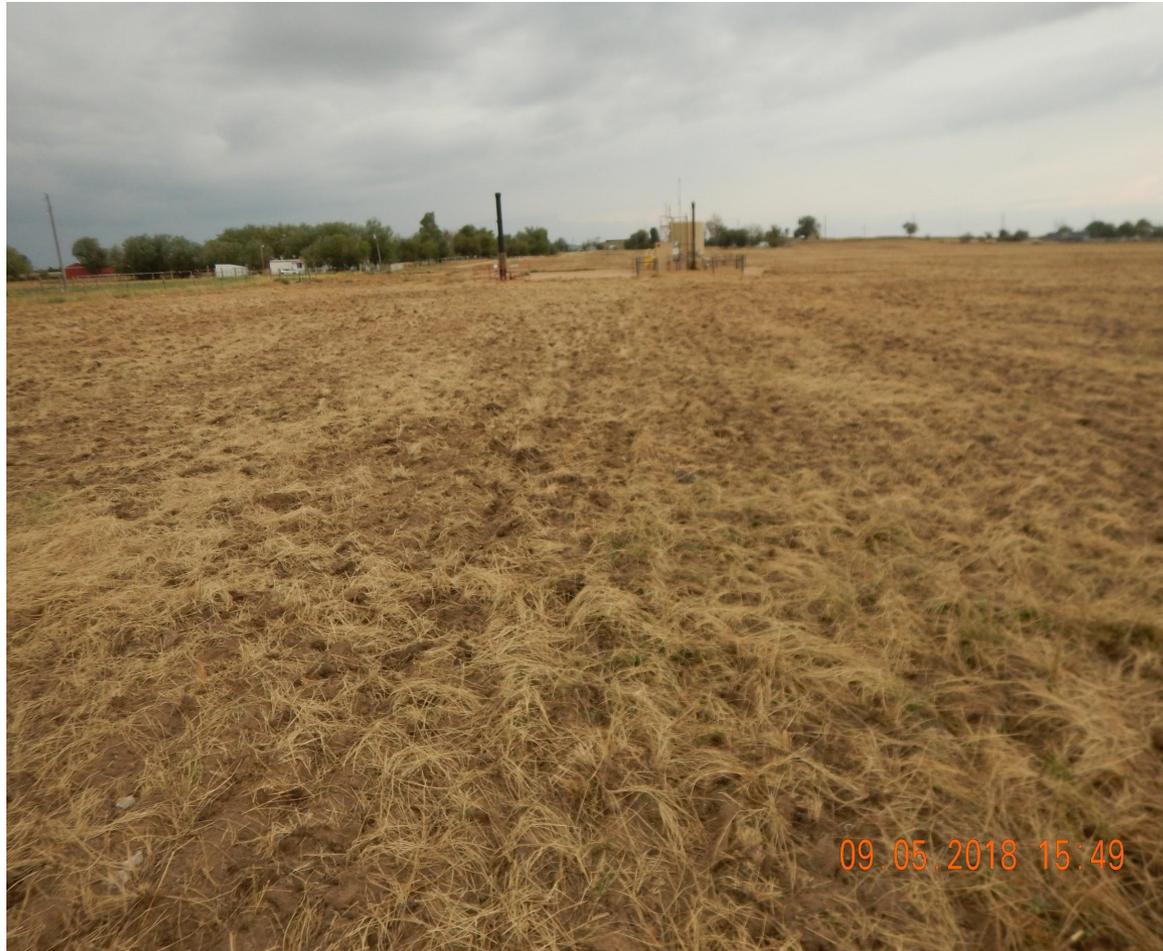
Photo 4. Reference photo taken west of the location, facing West. Photo illustrates little to no rock fragments of similar size or density were observed in reference areas. This indicates the Operator failed to remove gravel and perform compaction alleviation.

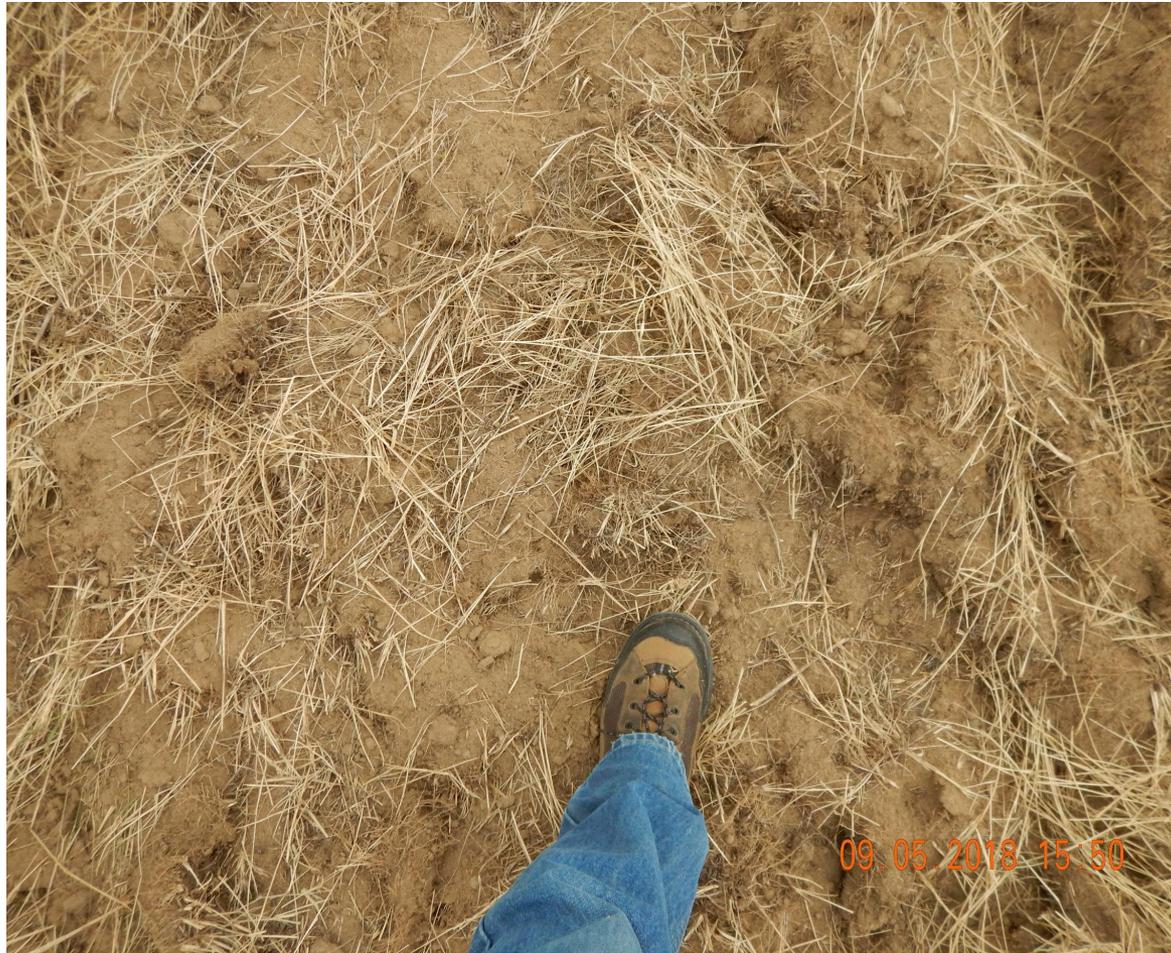
Photo 5. Reference photo taken west of the location. See comments under Photo 4.
