Inspection Photos
Location Name: Ellgen 11-10-1
API: 05-081-07666

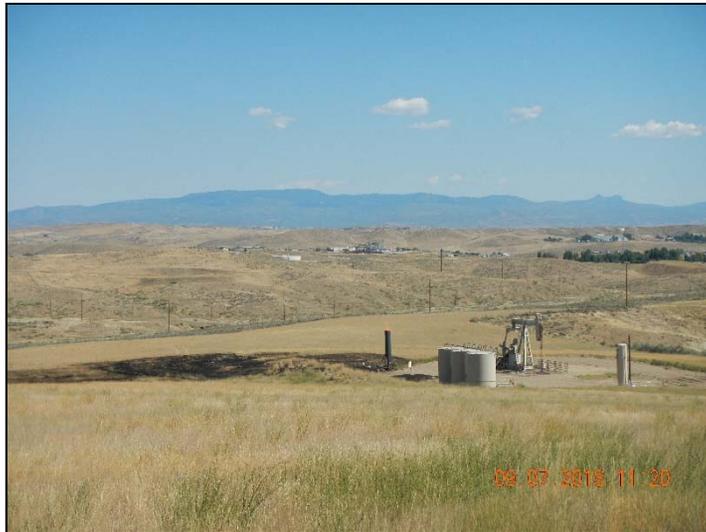
Photo 1. Long distance overview of location taken from lease road facing northeast.

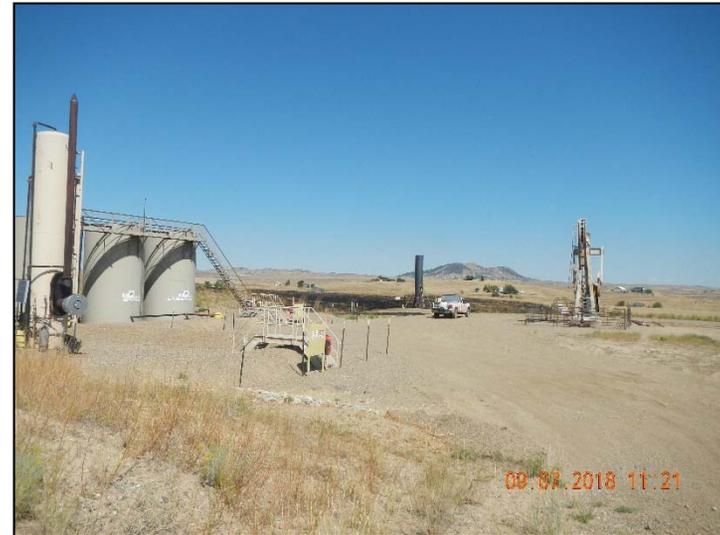
Photo 2. Overview of location taken at entrance facing north.

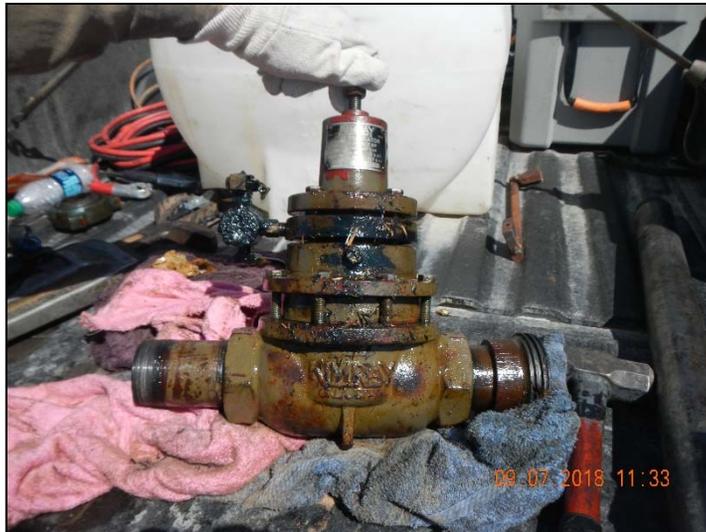
Photo 3. Photo of back pressure control valve. Area of failure is in top gasket/seal where black staining is.

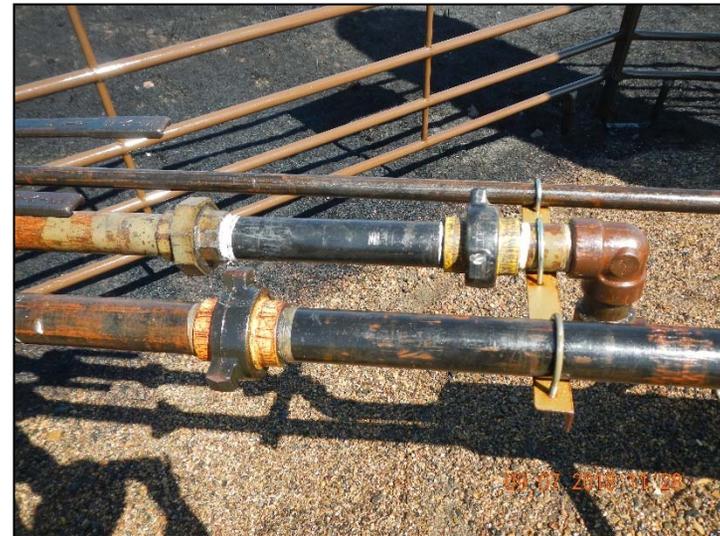
Photo 4. Photo of line valve was removed from, black line in back flowline has been added since valve was removed.

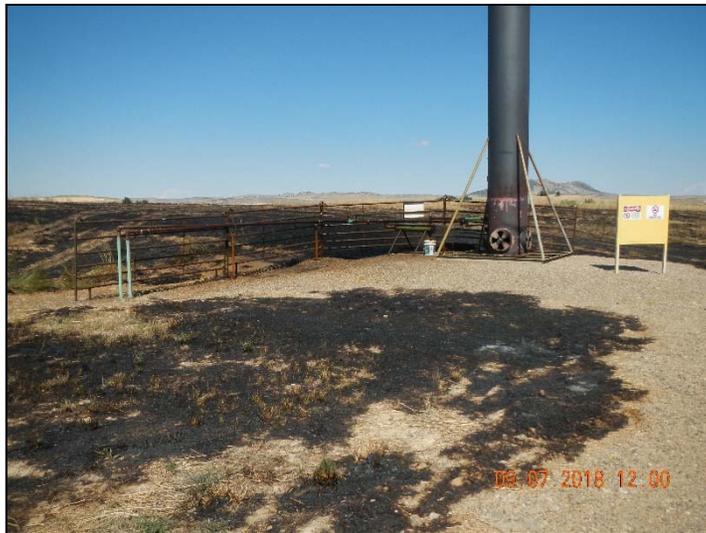
Photo 5. Area of ignition and spread of fire.

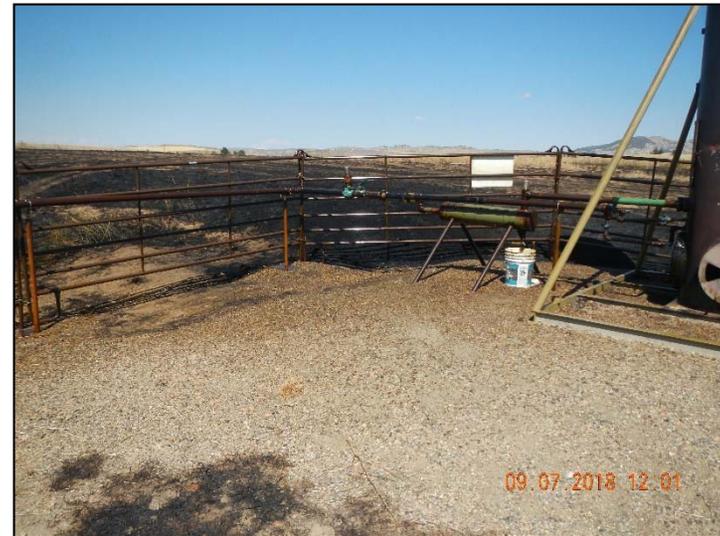
Photo 6. Stained soil and gravel at base of combustor/flowlines where fire was ignited.
