Inspection Photos

Operator: Merrion Oil and Gas

API: 05-067-09391

Date: 8/21/2018

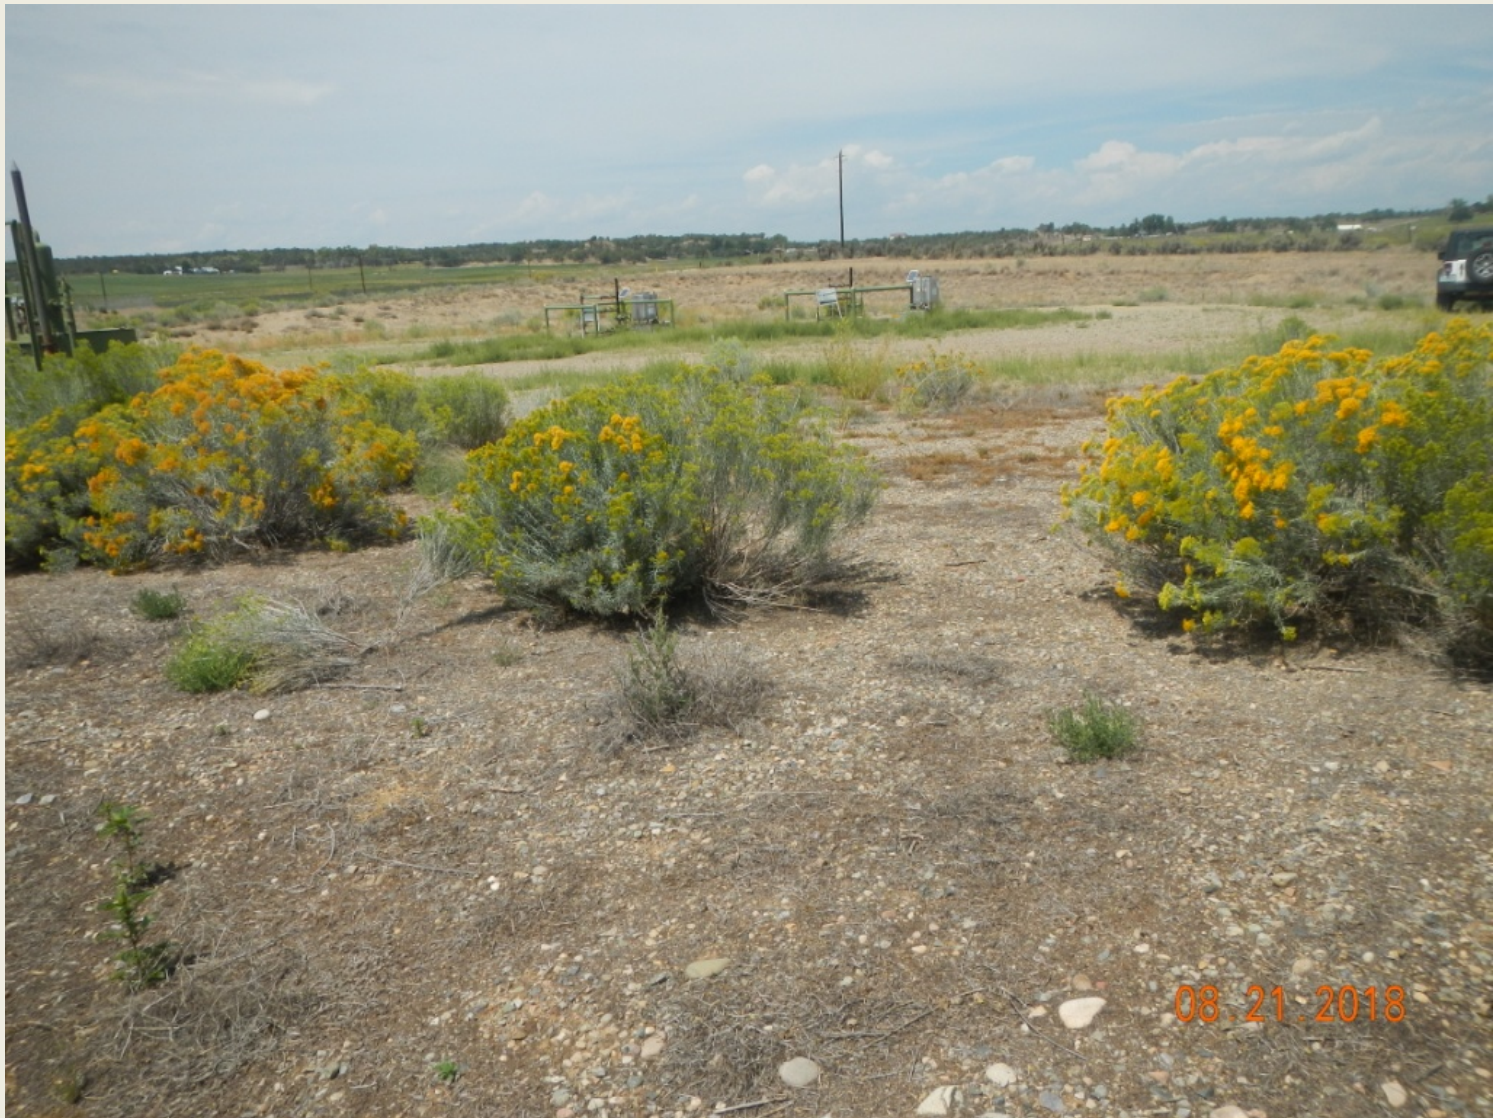
Photo 1. View of the project area from the southeastern corner facing center.

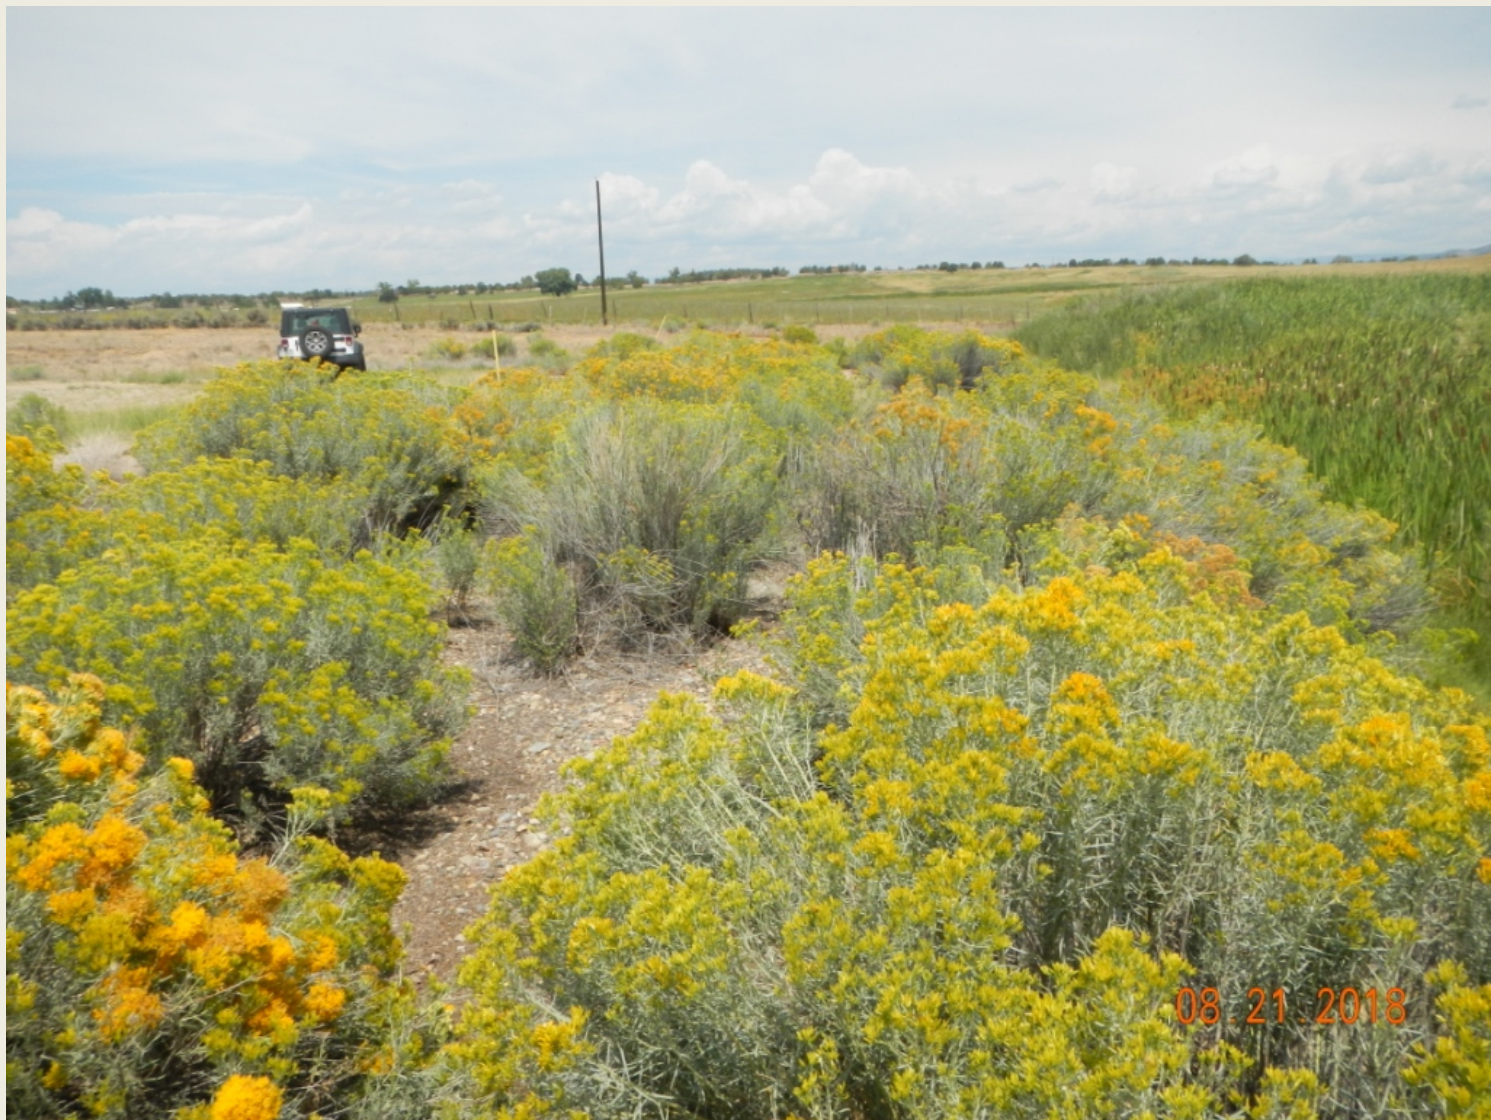
Photo 2. View of the eastern portion of the project area from the southeastern corner facing northward.

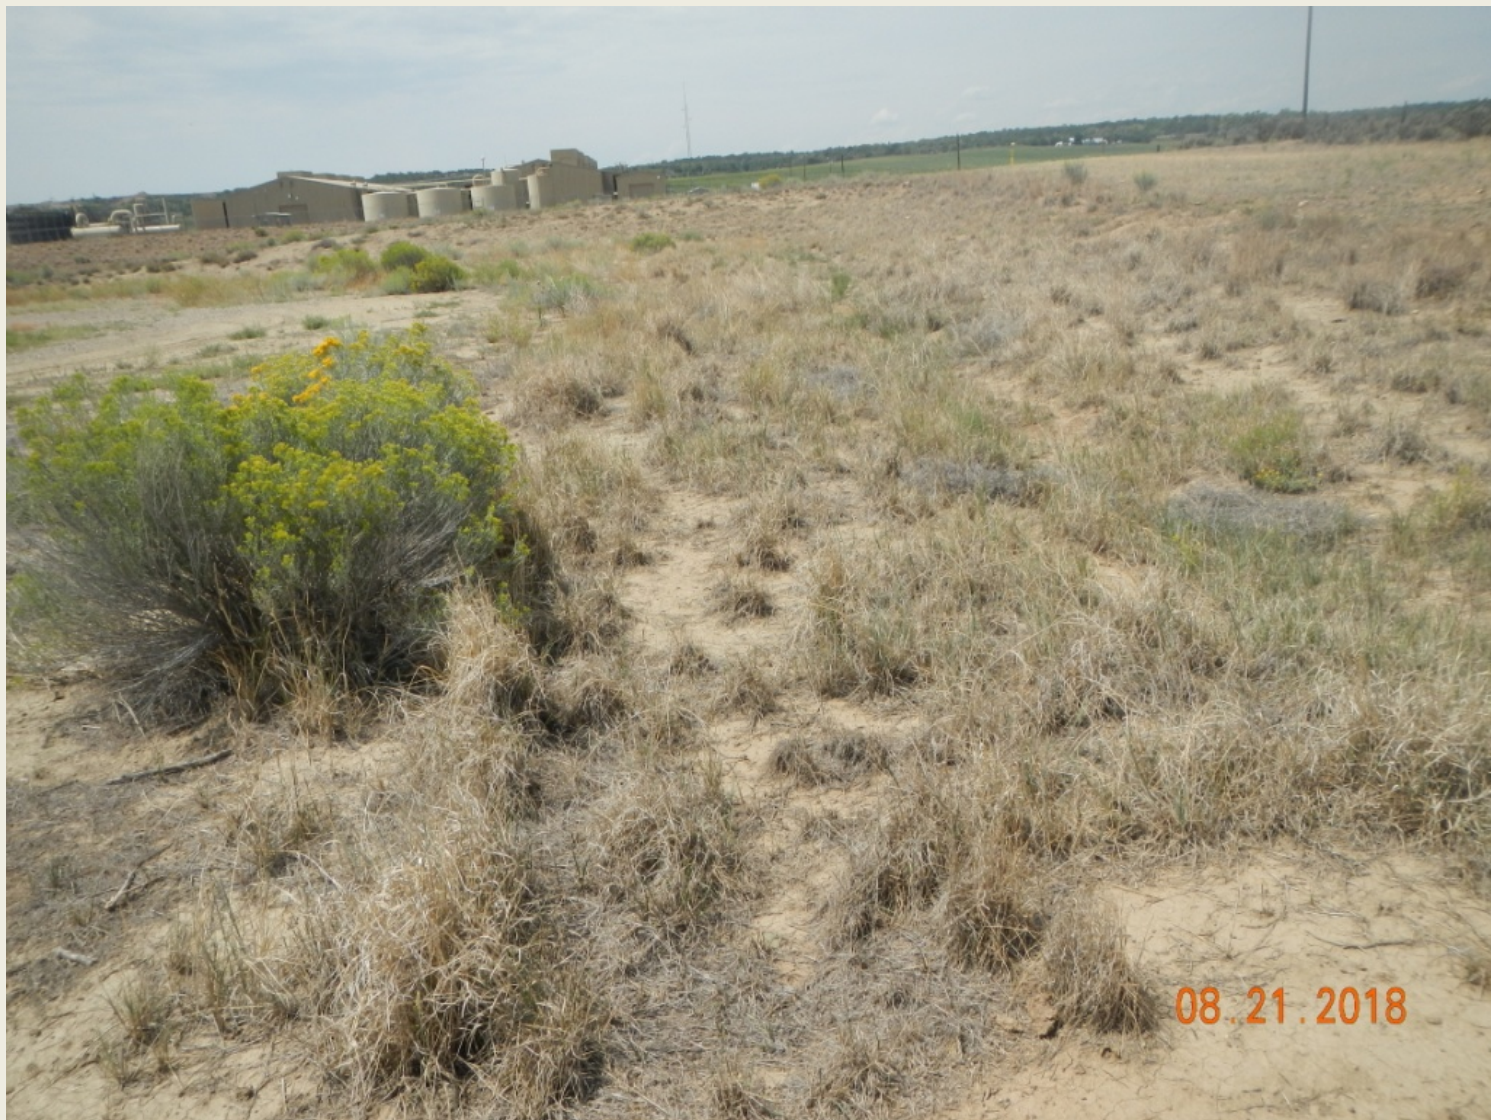
Photo 3. View of the northern portion of the project area from the northeastern corner facing westward. Revegetation is progressing within the interim reclamation areas.

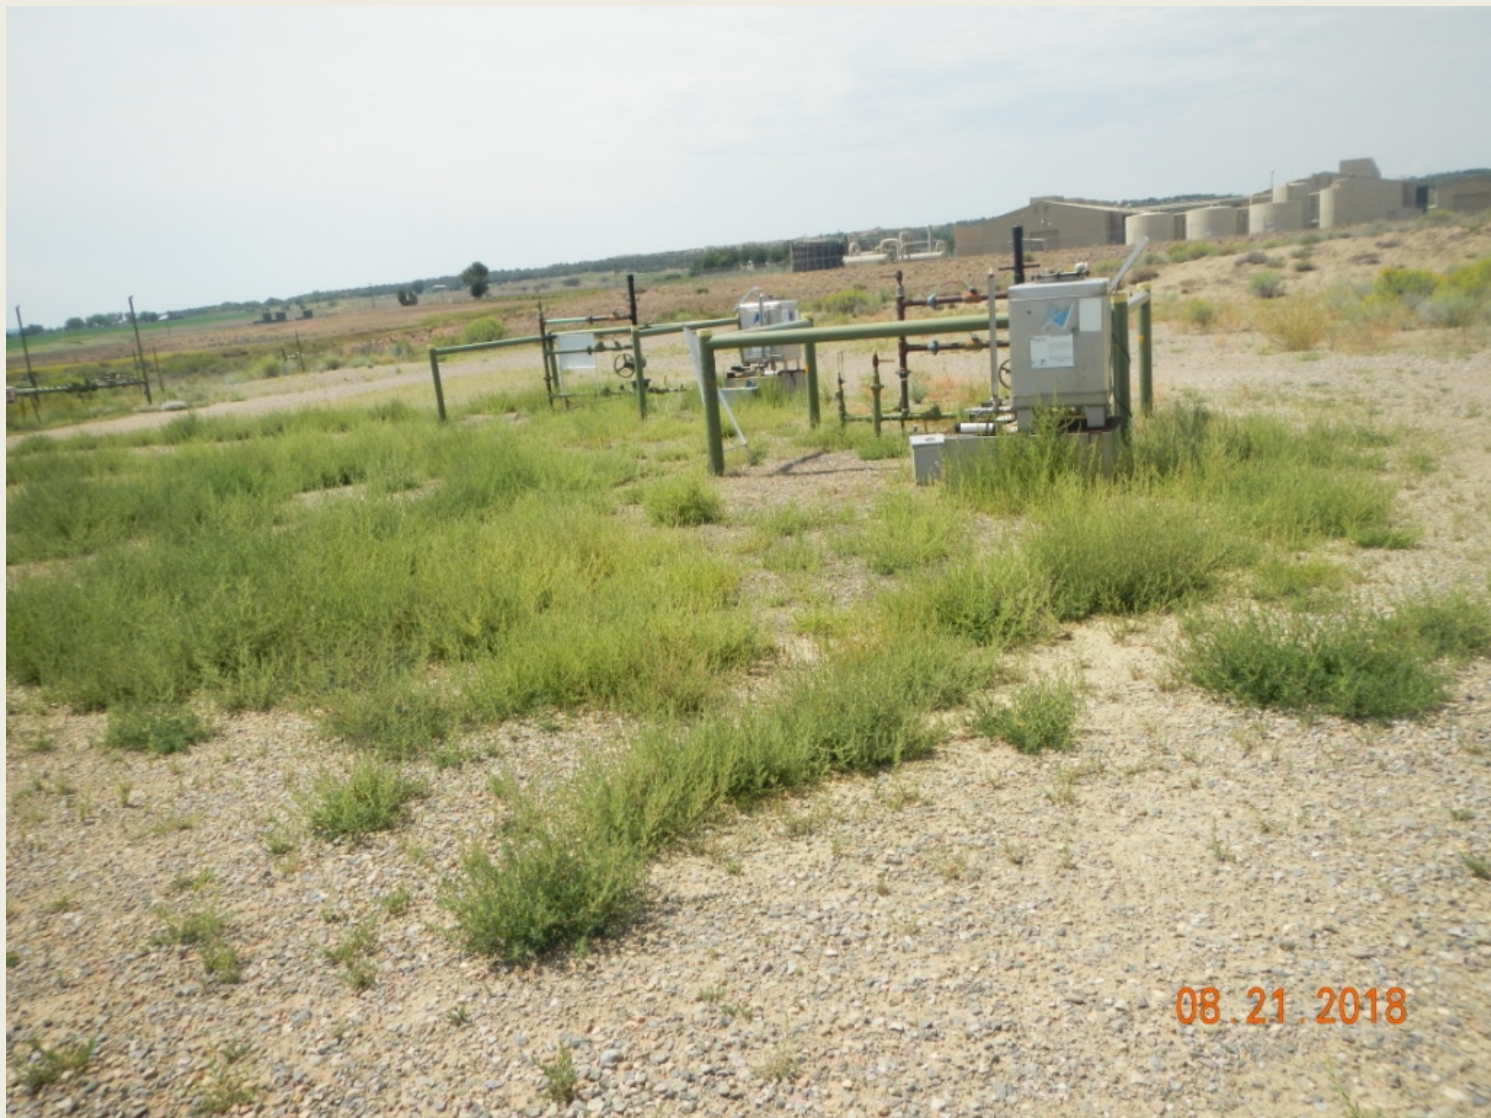
Photo 4. View of kochia (*Kochia scoparia*) weeds growing around fired equipment that need management.

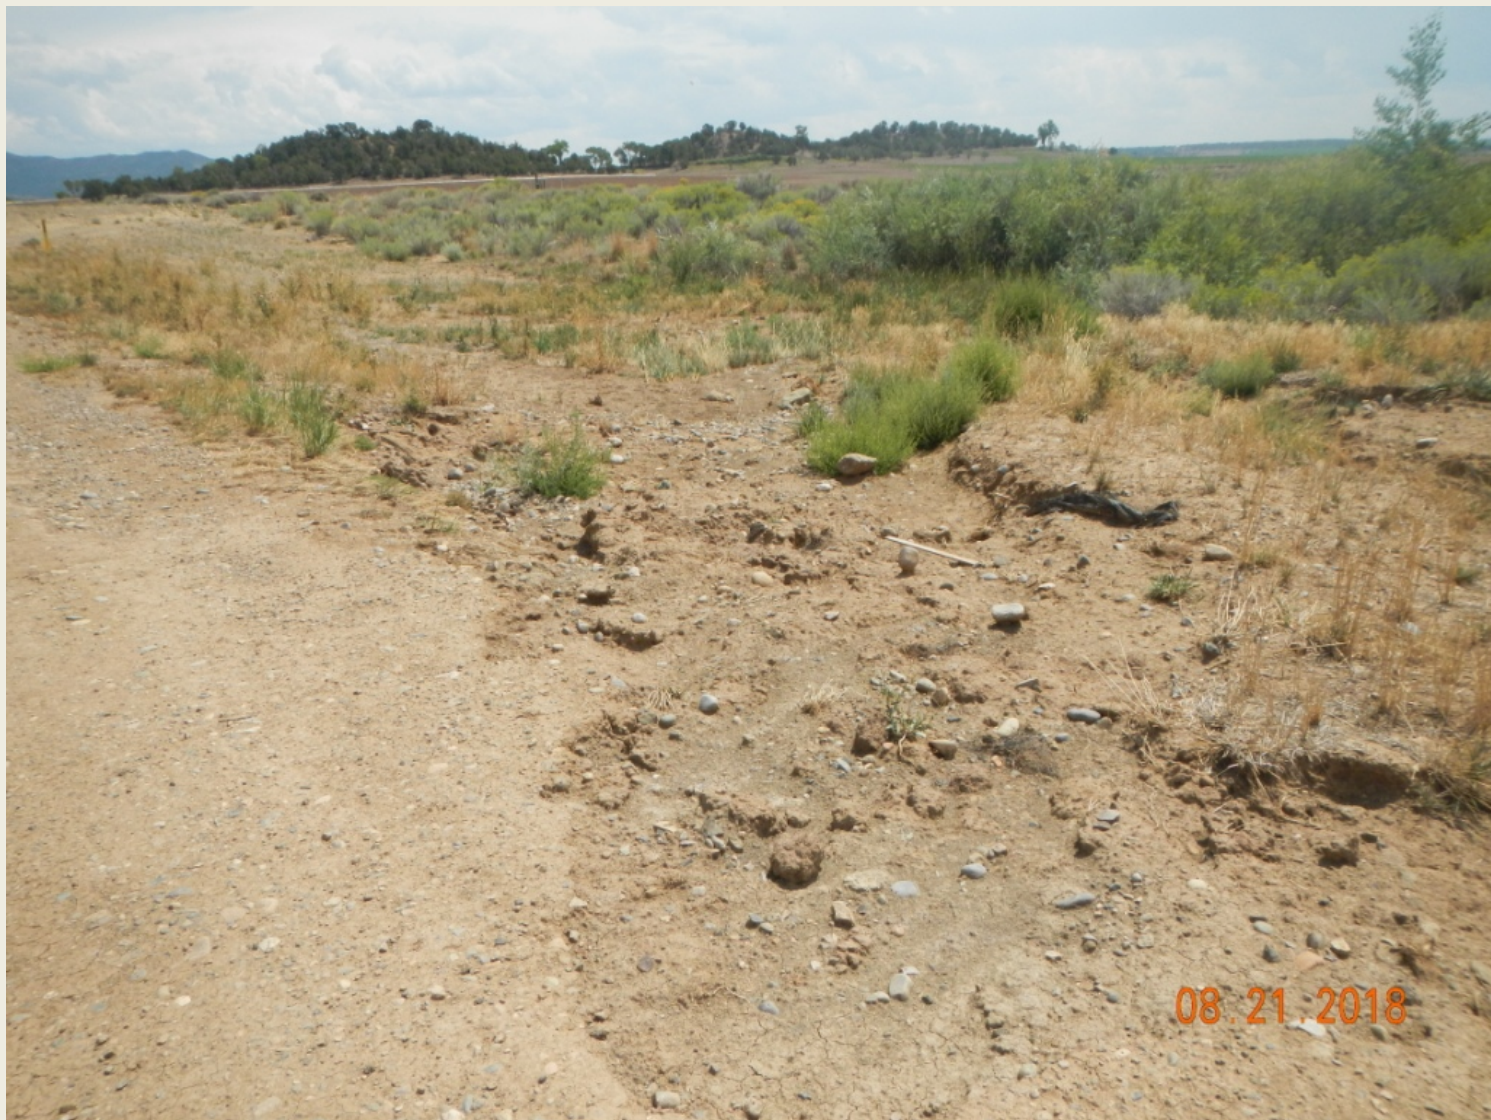
Photo 5. View of erosion and sediment deposition along the access road that needs to be repaired, facing southeastward.
