Inspection Photos
Location Name: Keating #2
API: 05-067-09001

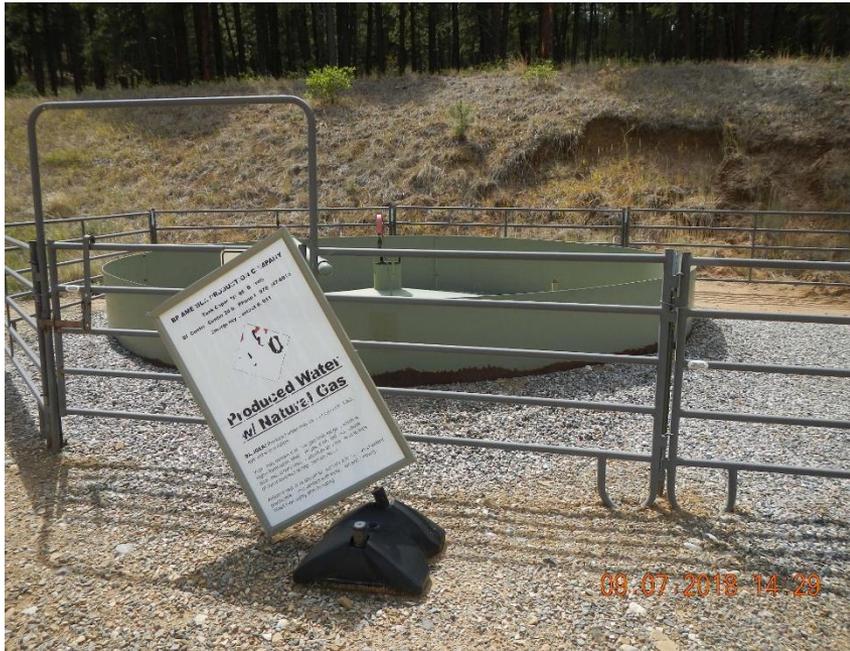
Sign holder is broken, sign is becoming illegible.

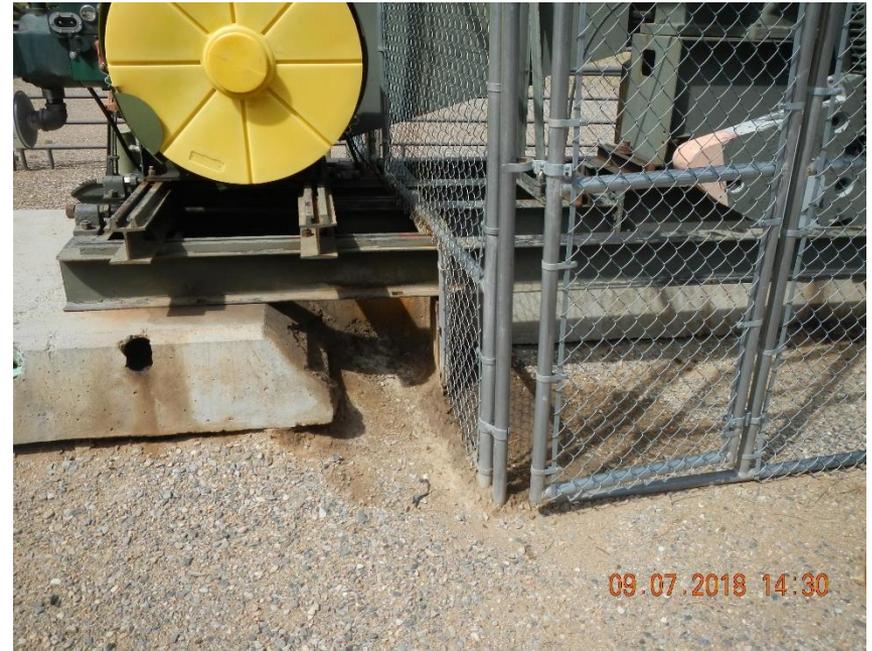
Stained soil near pump jack.

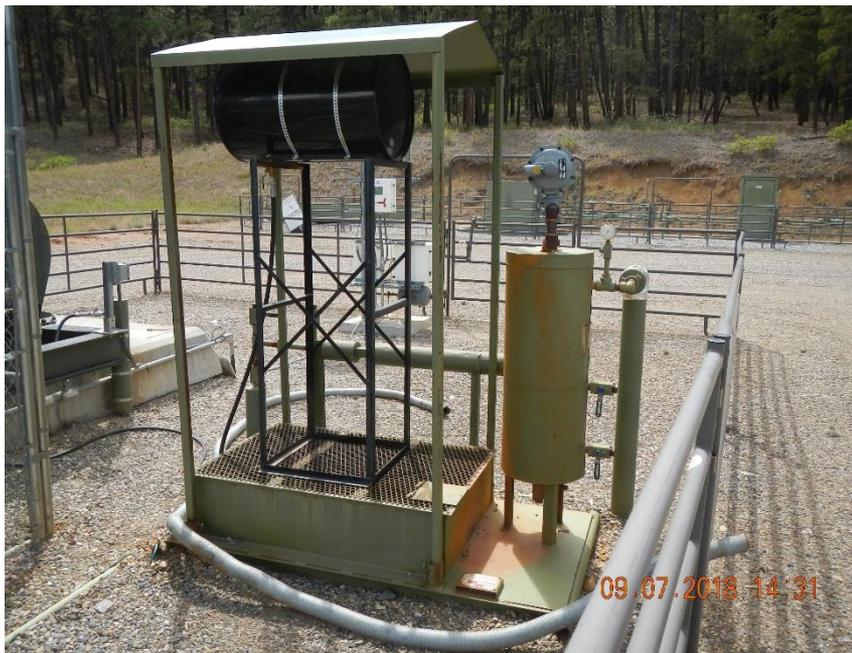
Lube oil container on secondary containment.
