Inspection Photos

Operator: NOBLE ENERGY INC - 100322

Location ID: 456690

Inspection Doc. Number: 682503854

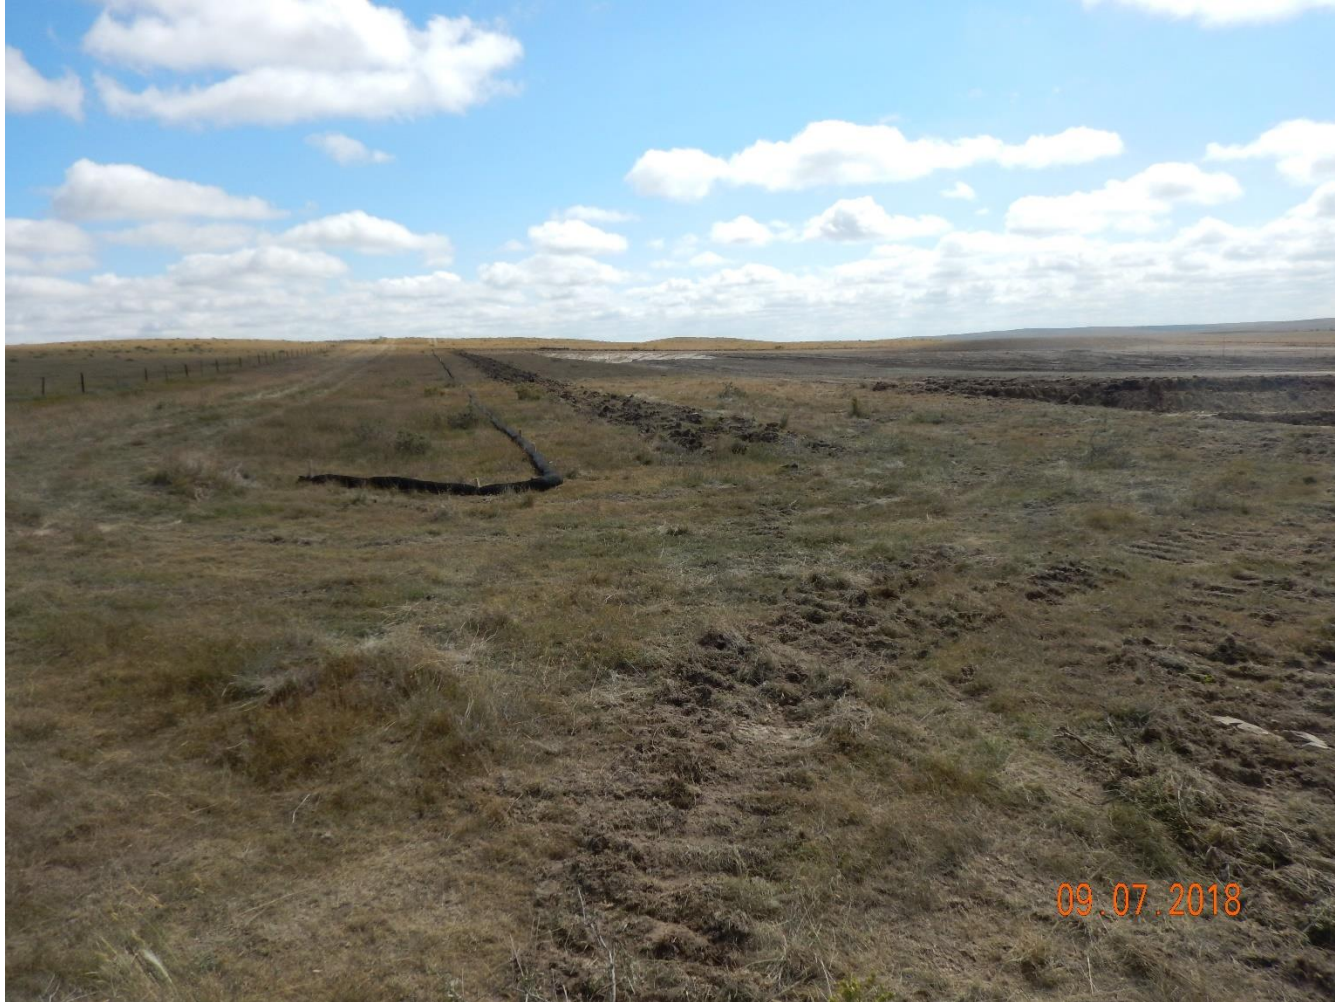
Photo 1: Photo taken from the northwest corner of the location, facing east. Photos 1-3 provide an overview of the location from east to south.

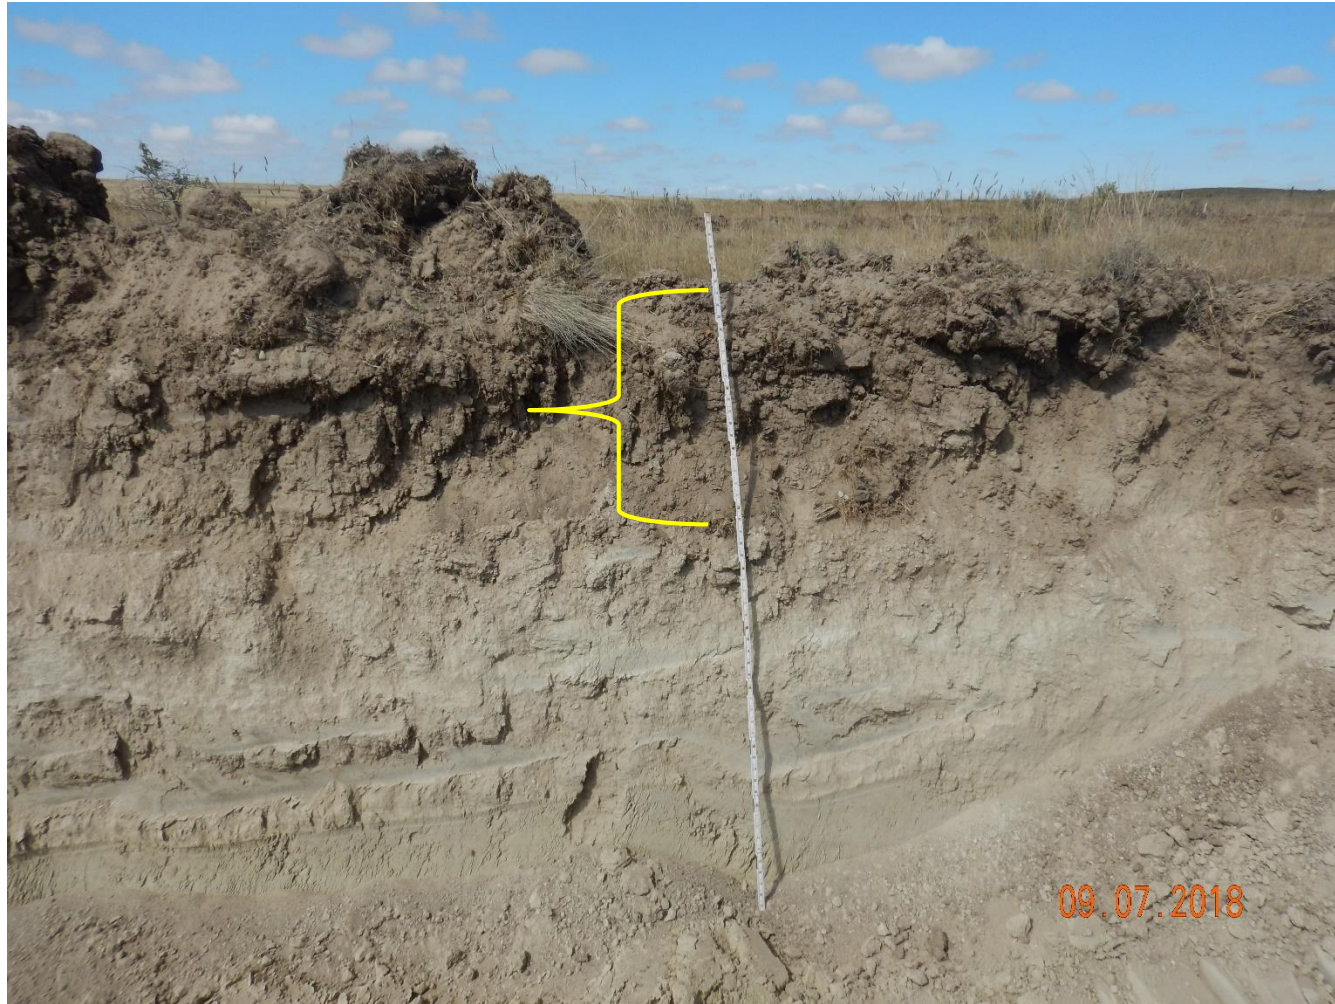
Photo 4: Photo taken from the northwest corner of the pad. Photo shows the topsoil horizon. Topsoil horizon appears to be ~2 feet in depth. 6 foot measuring stick for reference.

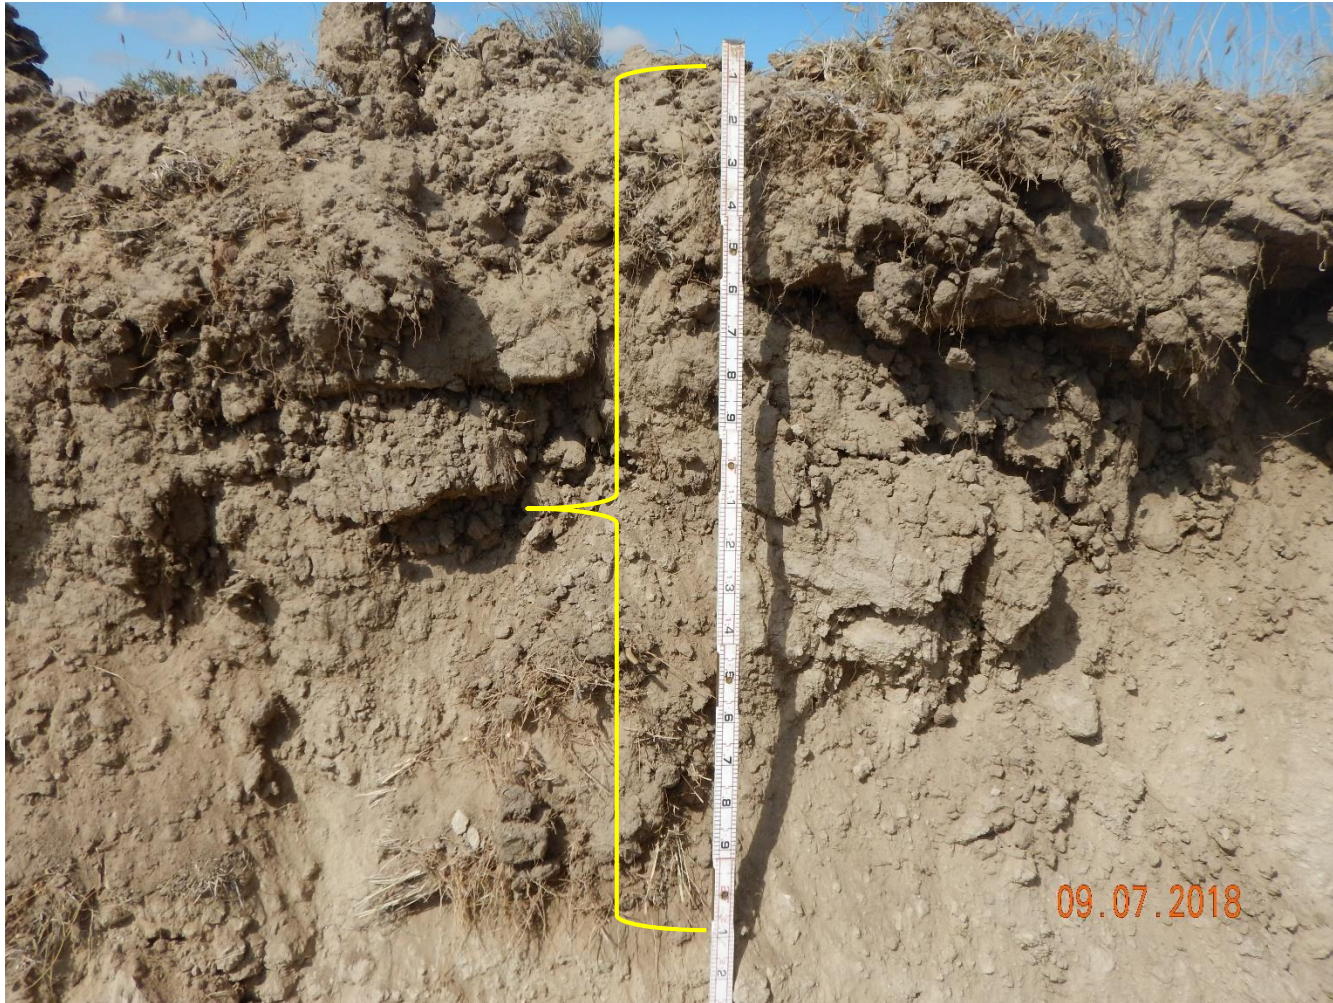
Photo 5: Continued from photo 4. Photo shows the topsoil horizon. Topsoil horizon appears to be ~2 feet in depth. 6 foot measuring stick for reference.

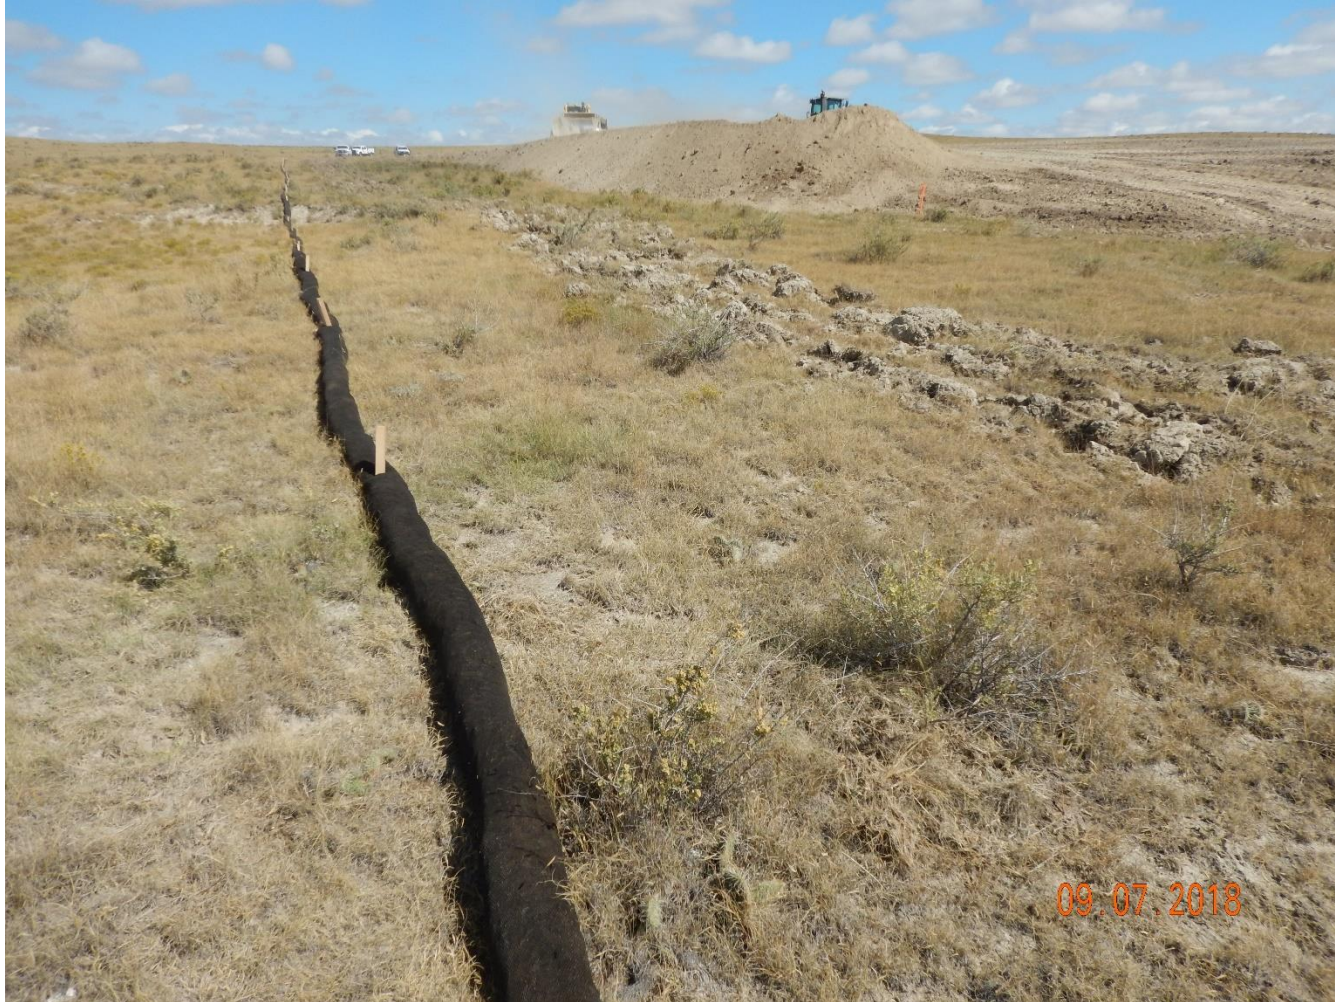
Photo 6: Photo taken from the southwest corner of the location, facing north. Photo shows operator appears to have implemented wattles and surface roughening as stormwater and erosion control BMPs

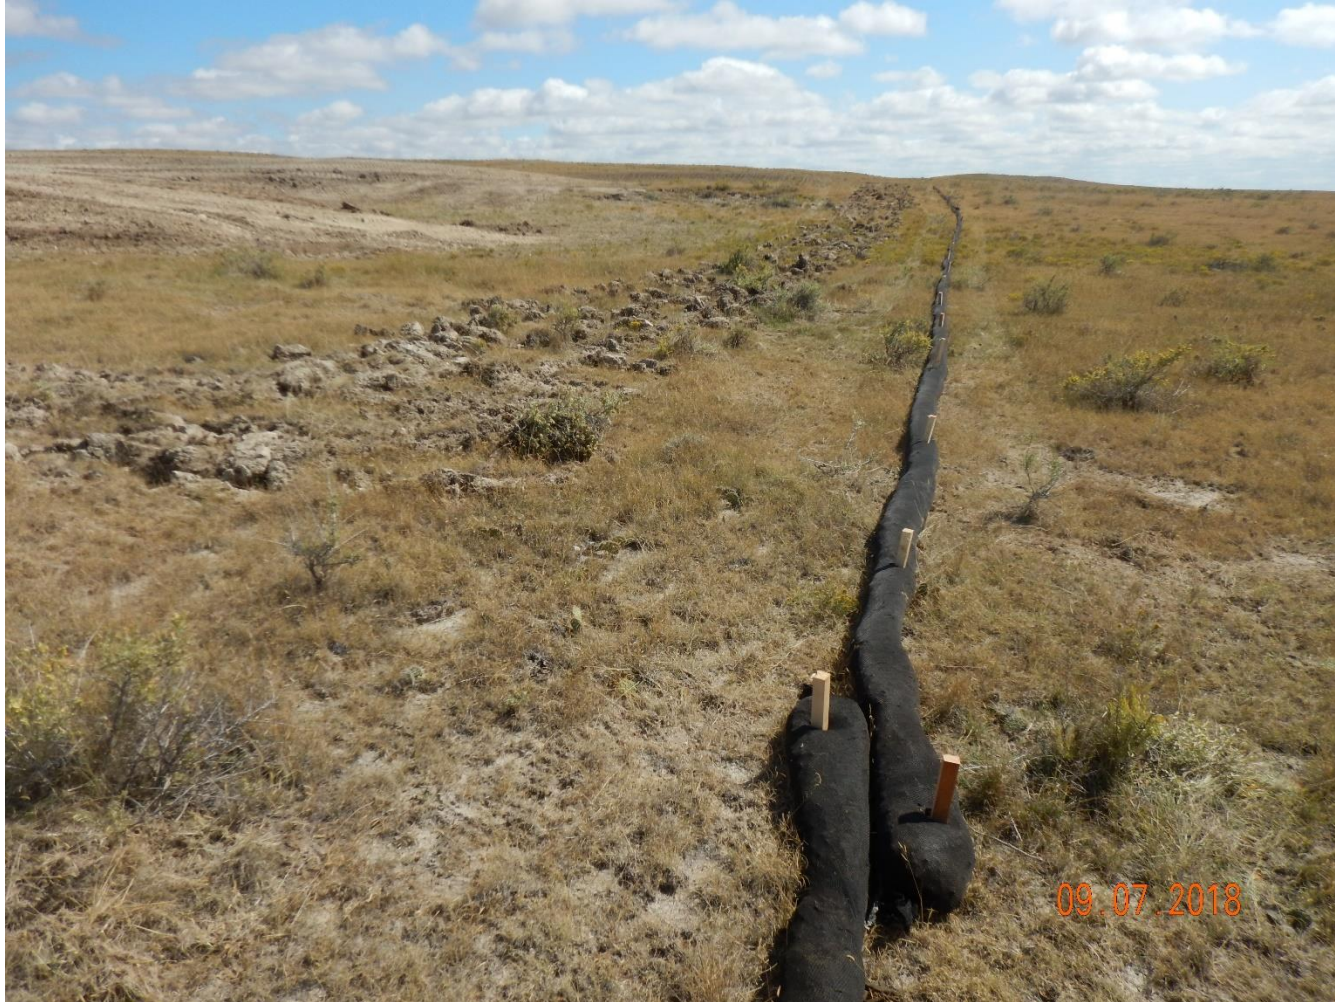
Photo 7: Photo taken from the southwest corner of the location, facing east. See comments under photo 6

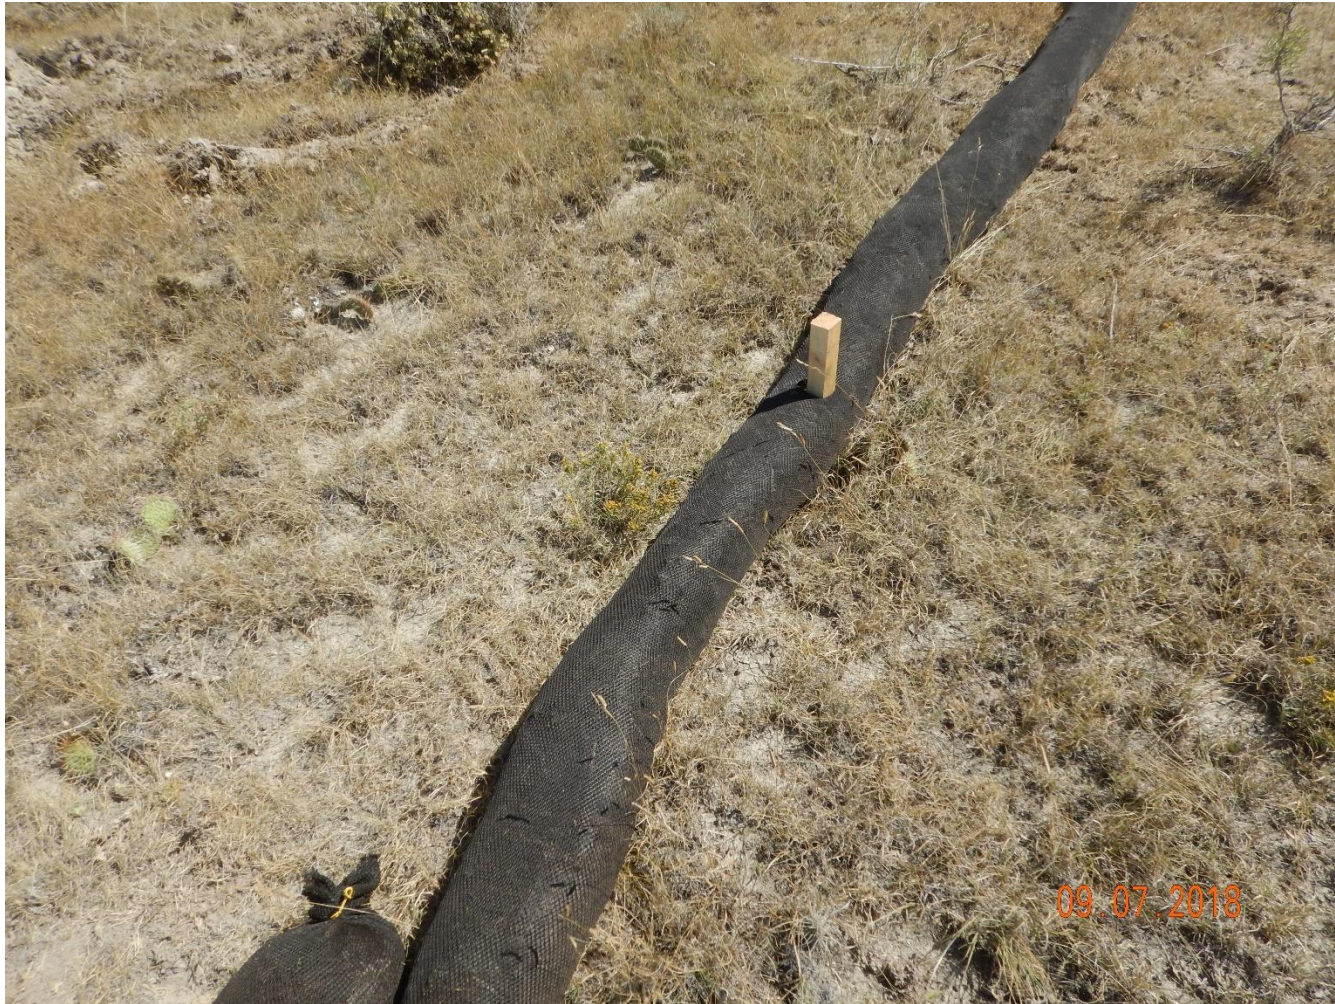
Photo 8: Photo taken from the south end of the location. Photo shows wattle. Wattles have been laid directly upon the soil surface and have not been trenched and back-filled in accordance with good engineering practices; BMP is not in proper functioning condition.

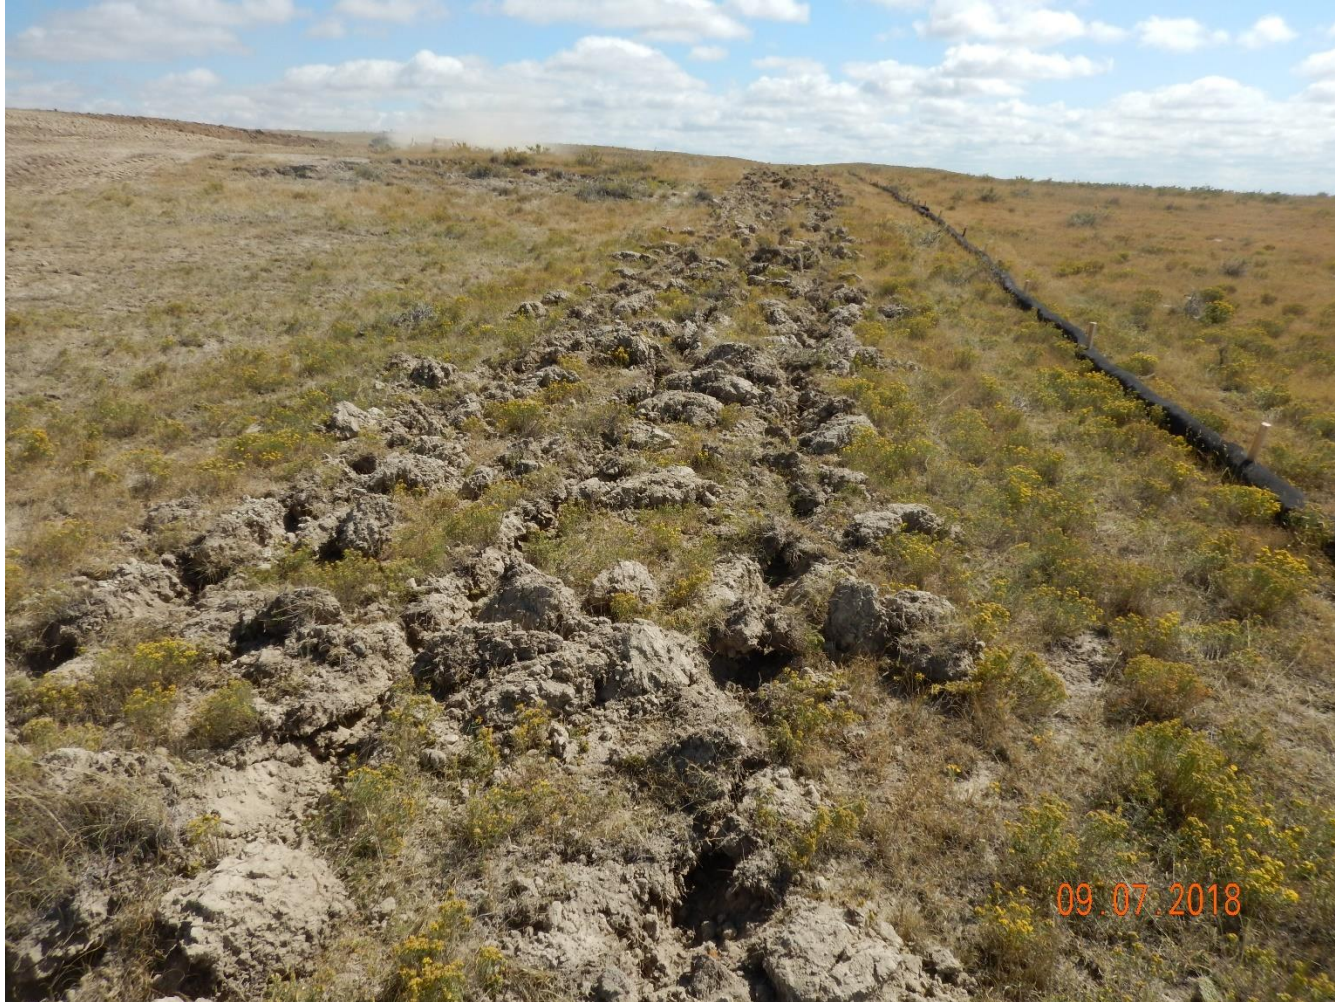
Photo 9: Photo taken from the south end of the location. Photo shows surface roughening BMP along perimeter.

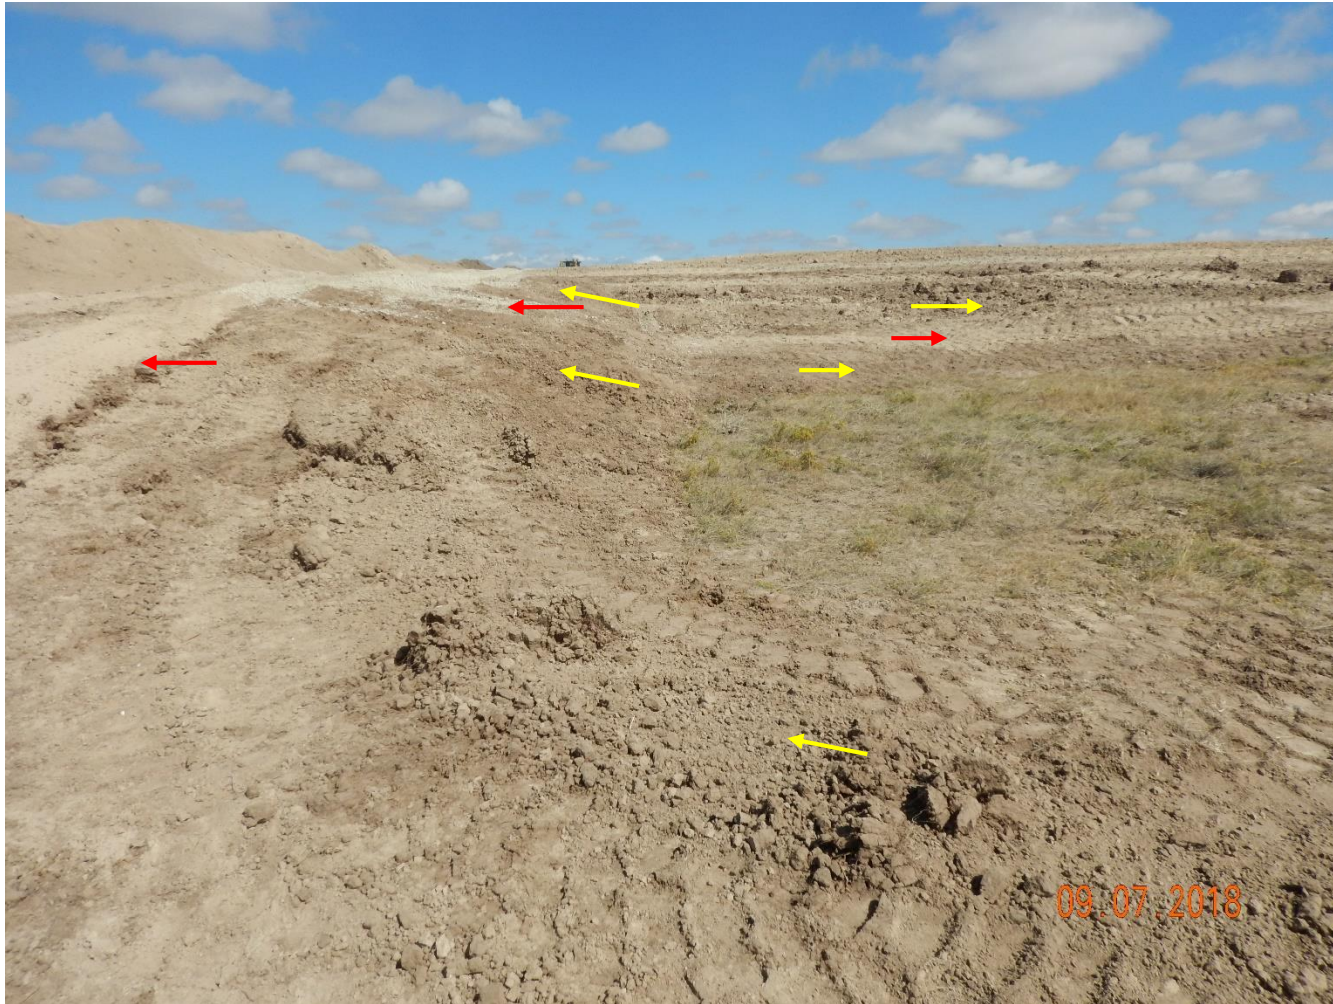
Photo 10: Photo taken from the southwest end of the pad. Photo shows construction in process. It does not appear as though soil salvage has been conducted on this section of the location. Additionally, It is unclear how the horizons are being separated as topsoil (dark soils, yellow arrow) appears to be mixing with subsoils (Light, red arrow). TOPSOIL APPEARS TO BE BEING USED AND INCORPORATED AS FILL MATERIAL.

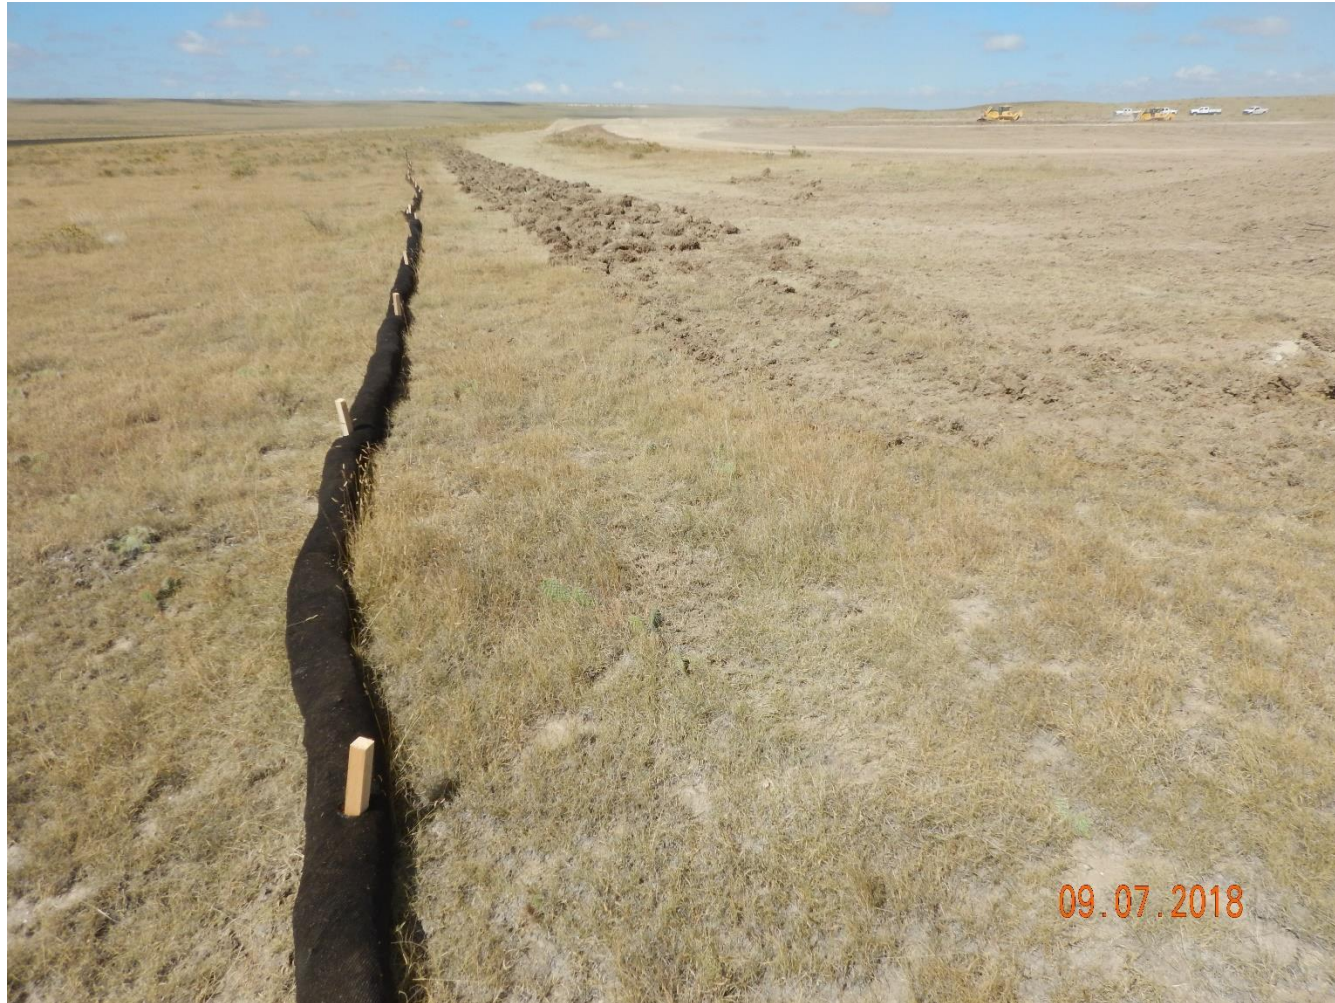
Photo 11: Photo taken from the northeast corner of the location, facing west.

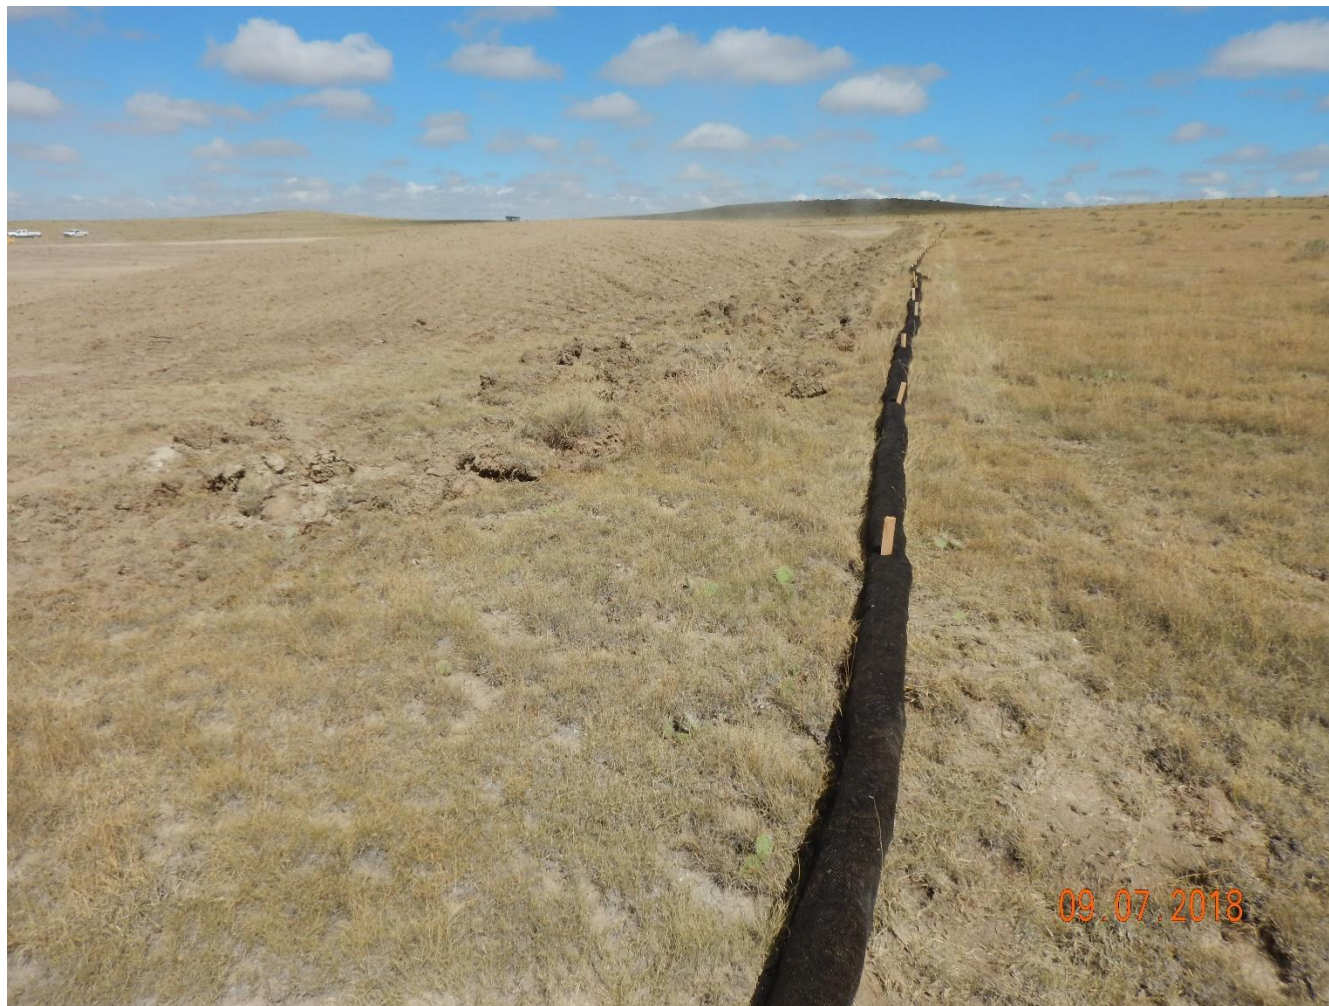
Photo 12: Photo taken from the northeast corner of the location, facing north. Photo shows topsoil stockpile for the location. Contractors performing soil salvage and construction indicate that "~4-6 inches of topsoil" was salvaged and stored on the southeast end of the location. It does not appear as though sufficient topsoil salvage has been conducted on the location.

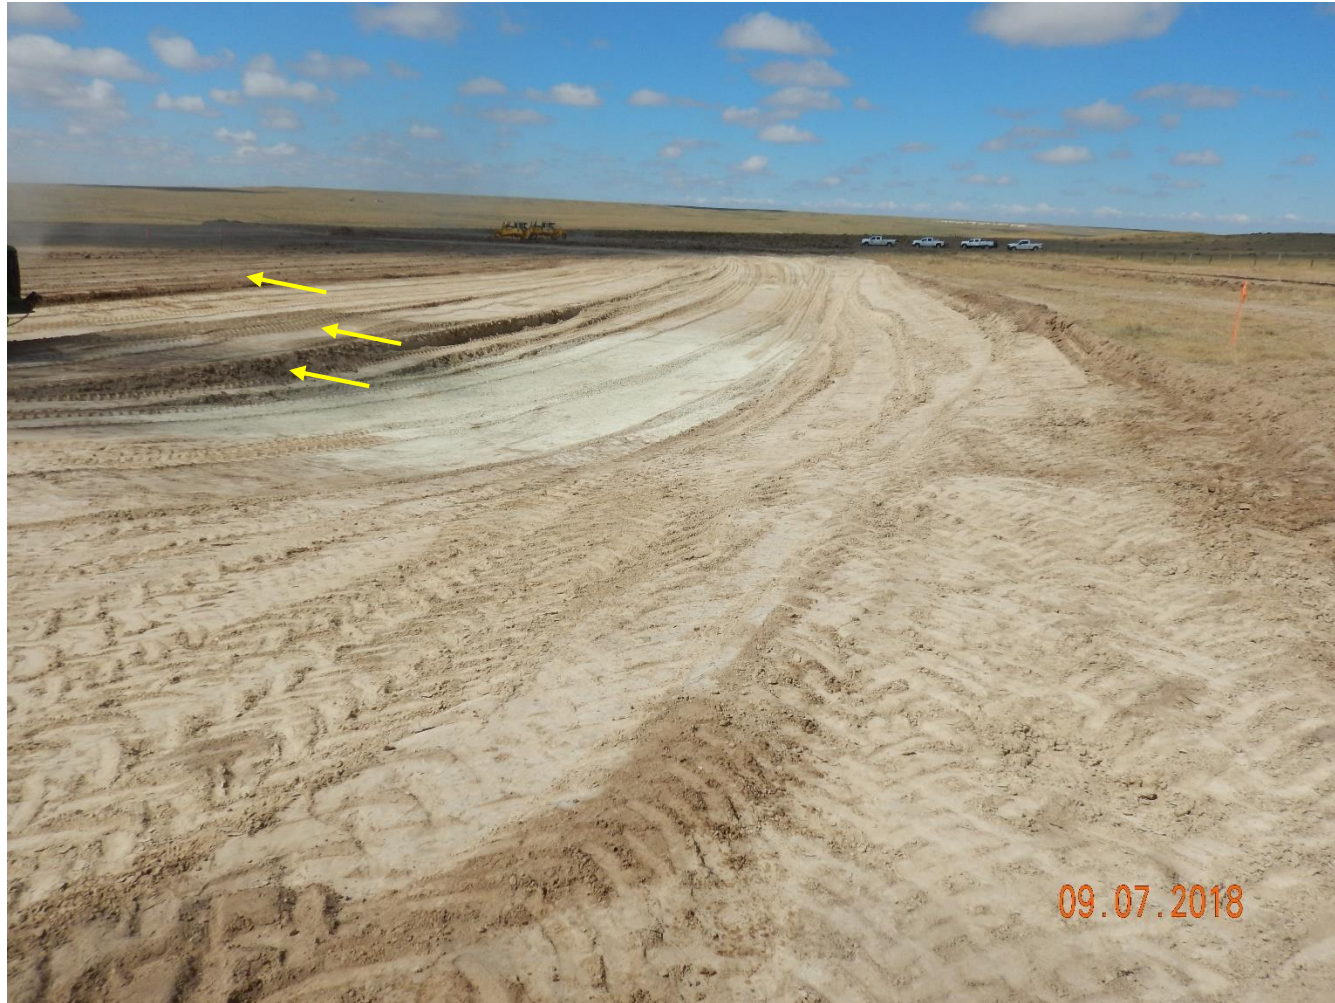
Photo 13: Photo taken from the southeast corner of the pad, facing west. Photo shows unsalvaged topsoil appears to remain on the pad.

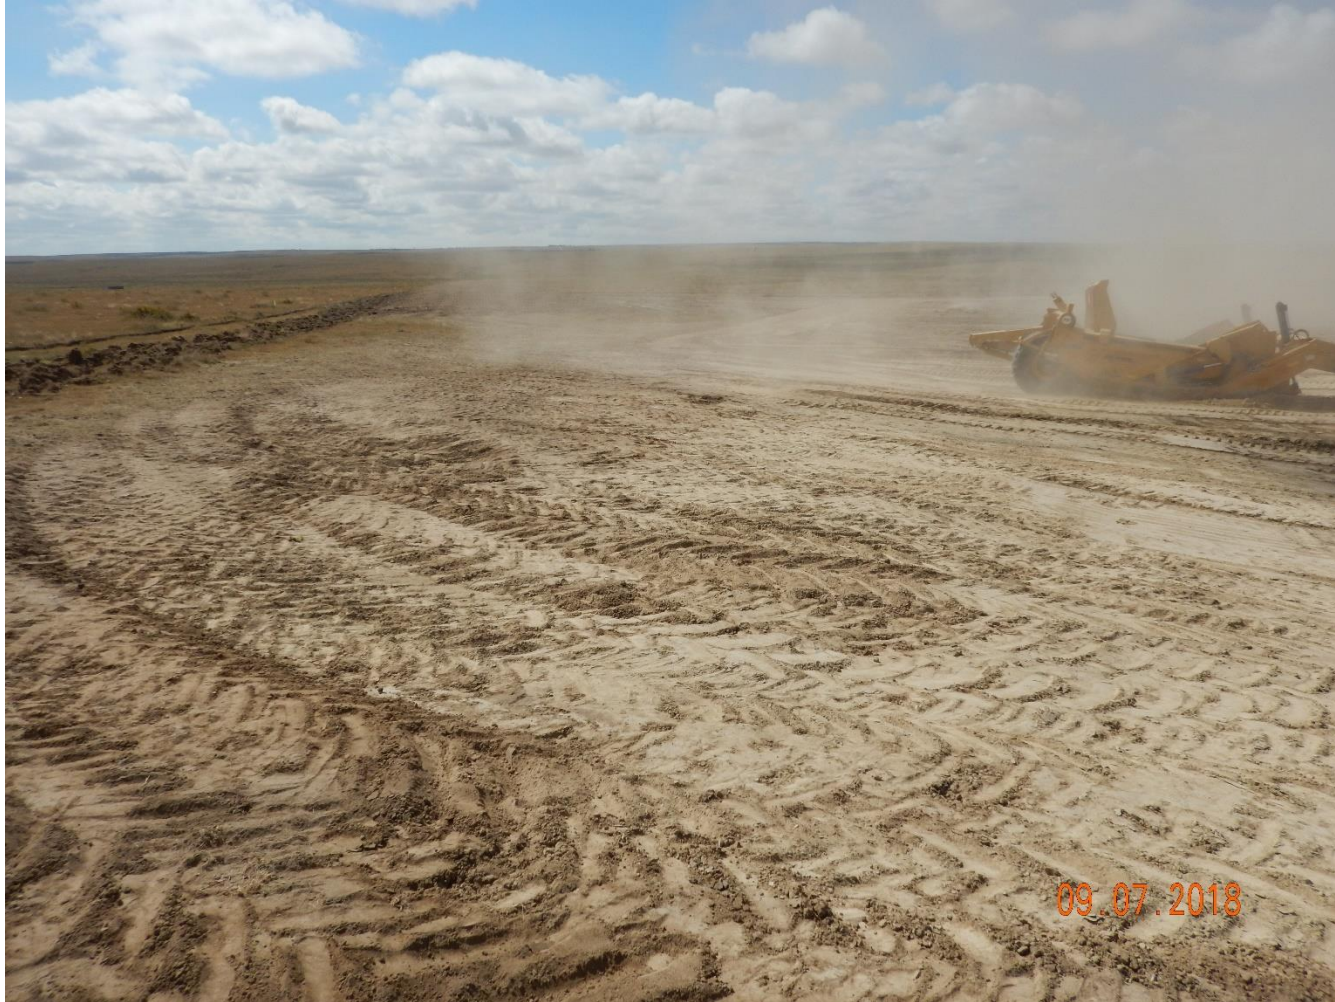
Photo 14: Photo taken from the southeast corner of the pad, facing south. Photo shows contractor scraping soil. Un-salvaged topsoil appears to remain on the pad. Upon contacting contractor operator scraper, inspector was told that topsoil salvage activities have been completed, and that no additional topsoil salvage was planned. Contractor was currently scraping soils to be used as fill material; IT APPEARS AS THOUGH TOPSOIL IS BEING USED AND INCORPORATED AS FILL MATERIAL. SEE PHOTO 10

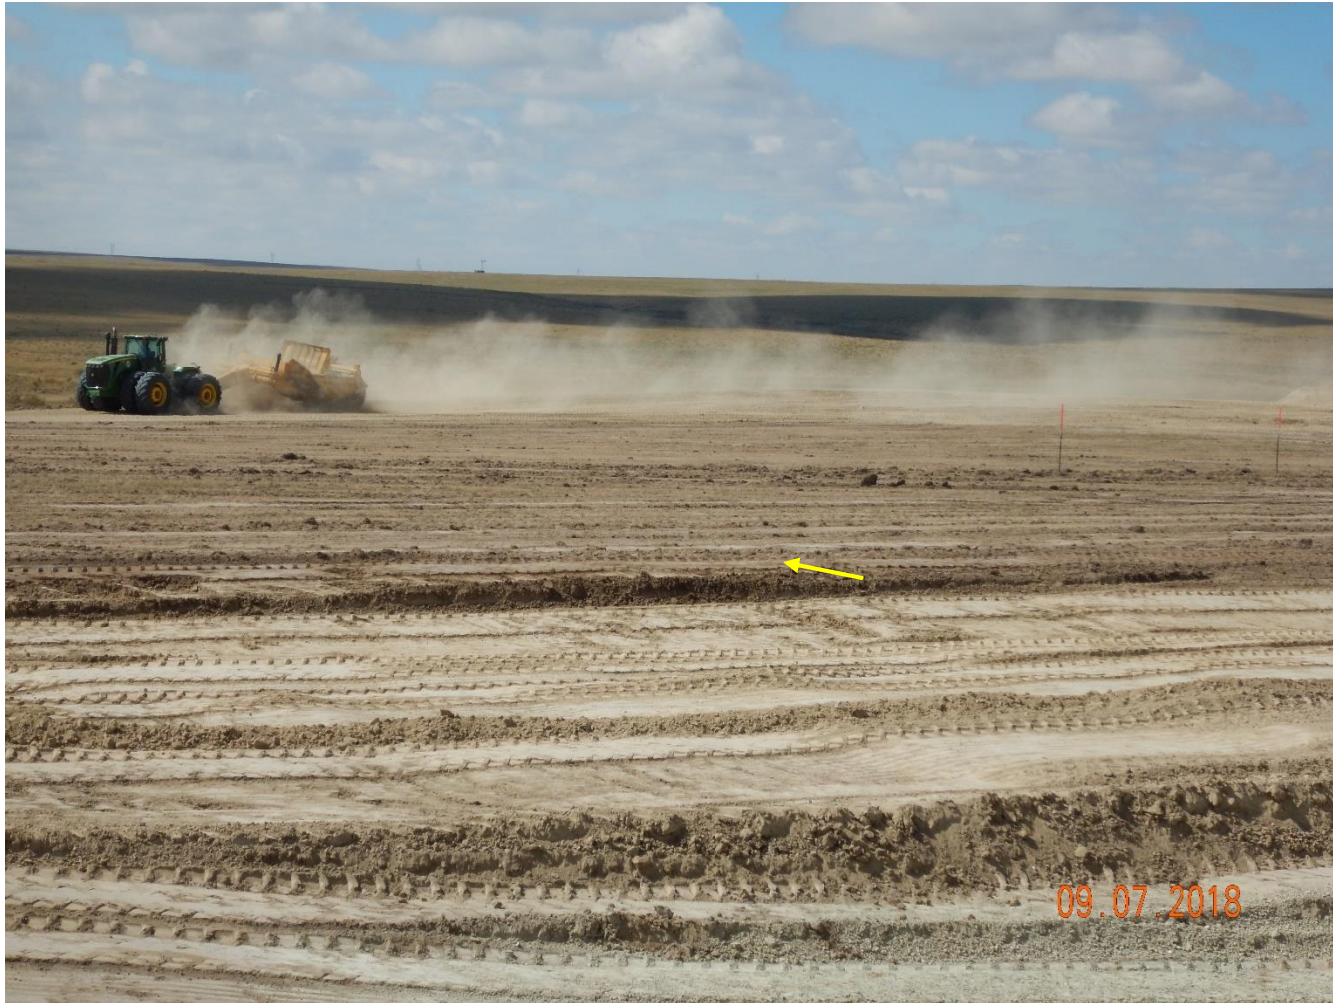
Photo 15: Photo taken from the northern area of the pad, facing south. Photo shows unsalvaged topsoil appears to remain on the pad.. It was observed that the scraper collected soils (photo 14) from areas of the pad for fill material on the southern end of the location; it appears as though topsoil is being incorporated with subsoils as fill material. See comments under photo 13 and 14

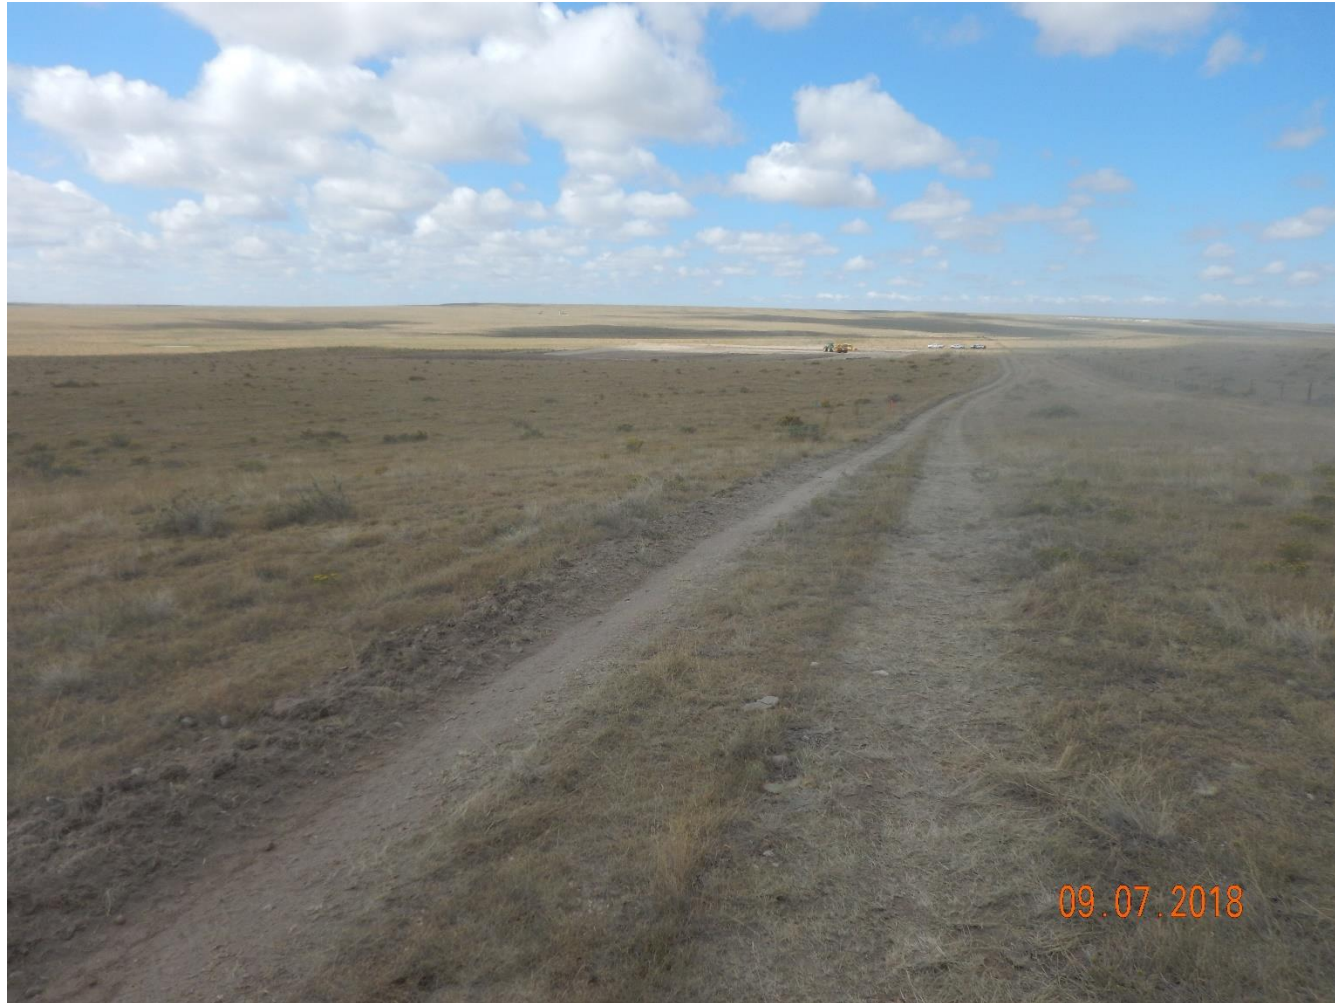
Photo 16: Photo taken from the east of the location, facing west. Photo shows access road.

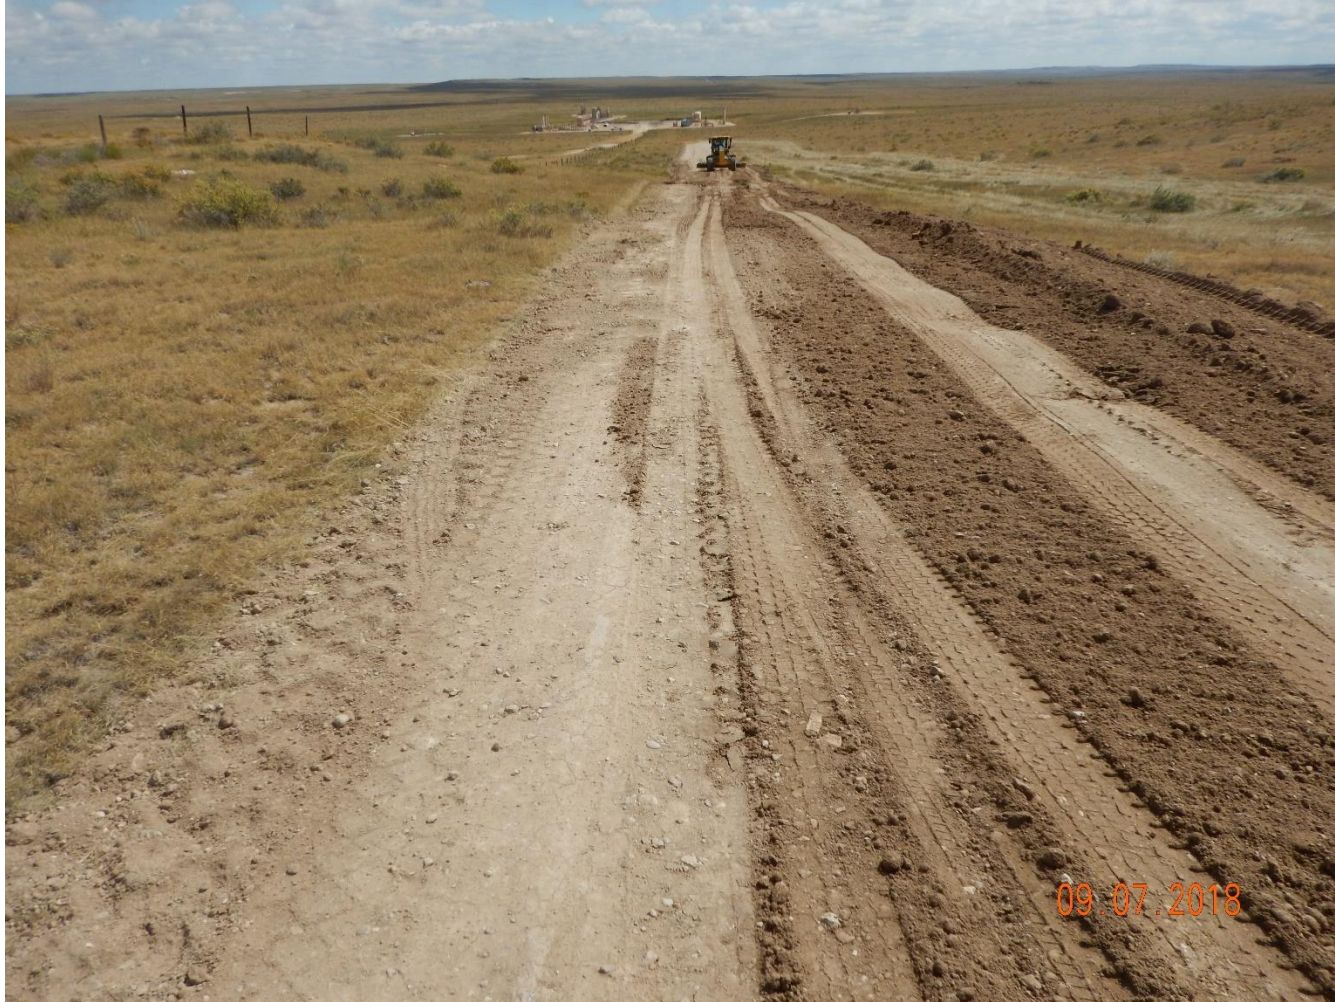
Photo 17: Photo taken from the east of the location, facing east. Photo shows access road construction in process.
