Final Reclamation Inspection

Operator: Blue Chip Oil Inc- 8840

API: 05-123-13536

Inspection Photos
Location Name: SLOAN #1
API: 05-123-13536

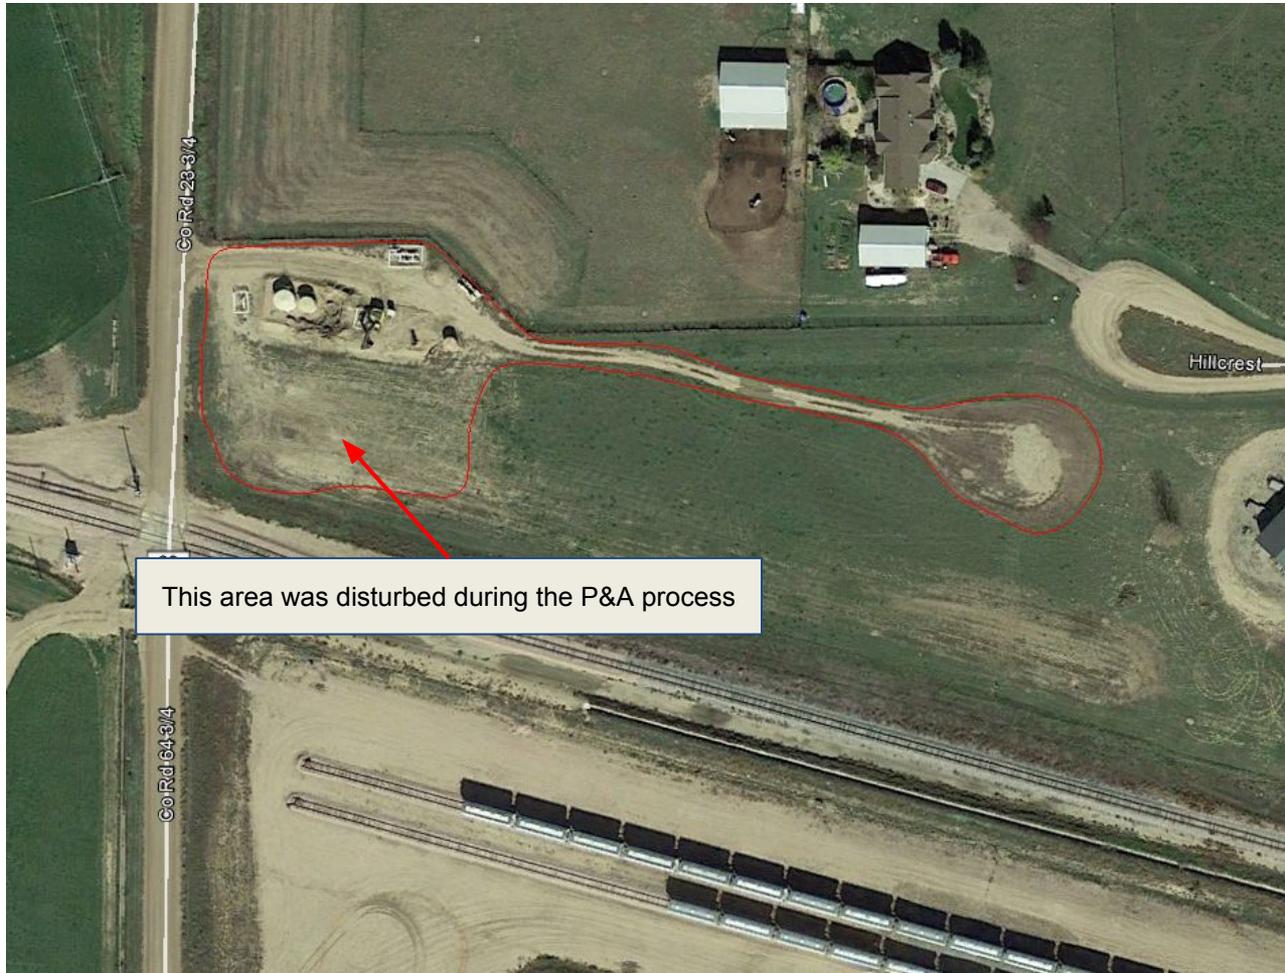
Google Earth aerial imagery taken October 14, 2017, approximately 4 months after plugging and abandoning (P&A) the well. Photo illustrates the disturbance area (red line) that was mapped on September 10, 2018 using a Trimble Juno 3B handheld device that indicates an approximate disturbance of 1.23 acres. Note: Rule 1004.a. requires all surface equipment to be removed within 3 months of P&Aing a well.

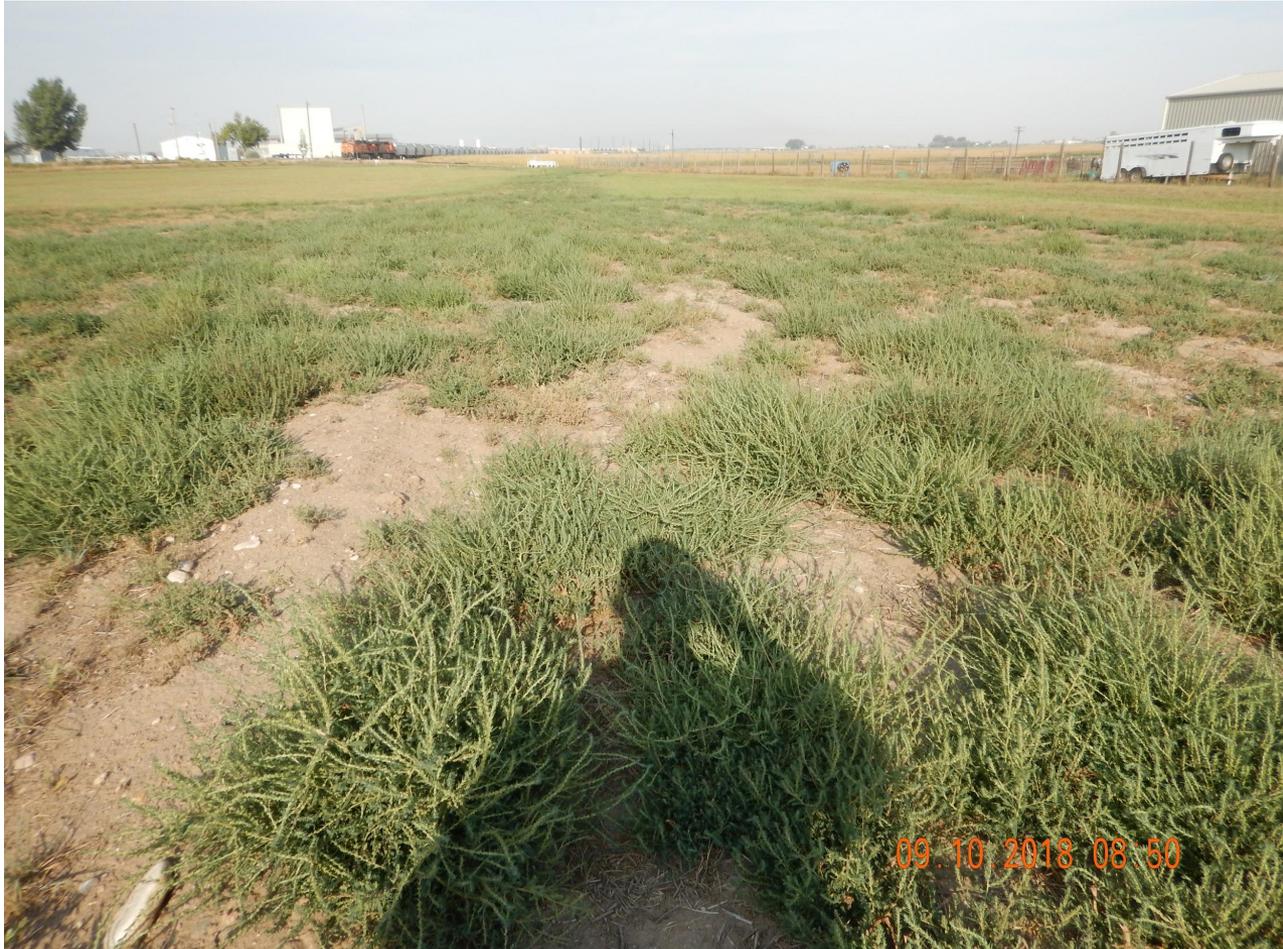
Photo 1. Photo taken from the well location, facing West. Photo illustrates the Operator performed final reclamation activities but did not contour disturbance areas or use the appropriate seed mix. Note: Most of the green foliage illustrated in the photo is Kochia, a weedy annual.

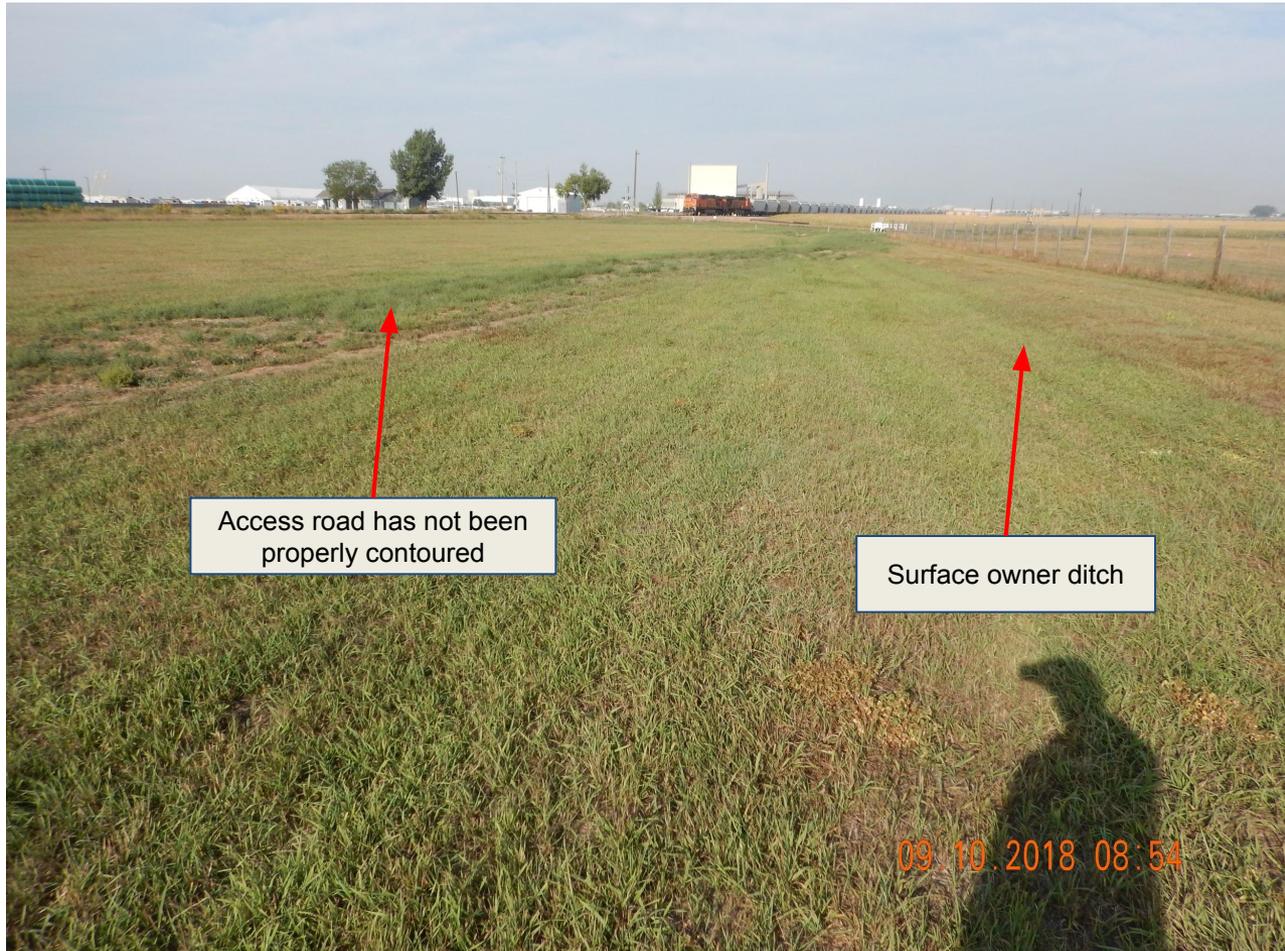
Photo 2. Photo taken along a portion of the access road, facing West. Photo illustrates the access road which has not been properly contoured to along for proper drainage. Access road still remains elevated above the surrounding landscape.

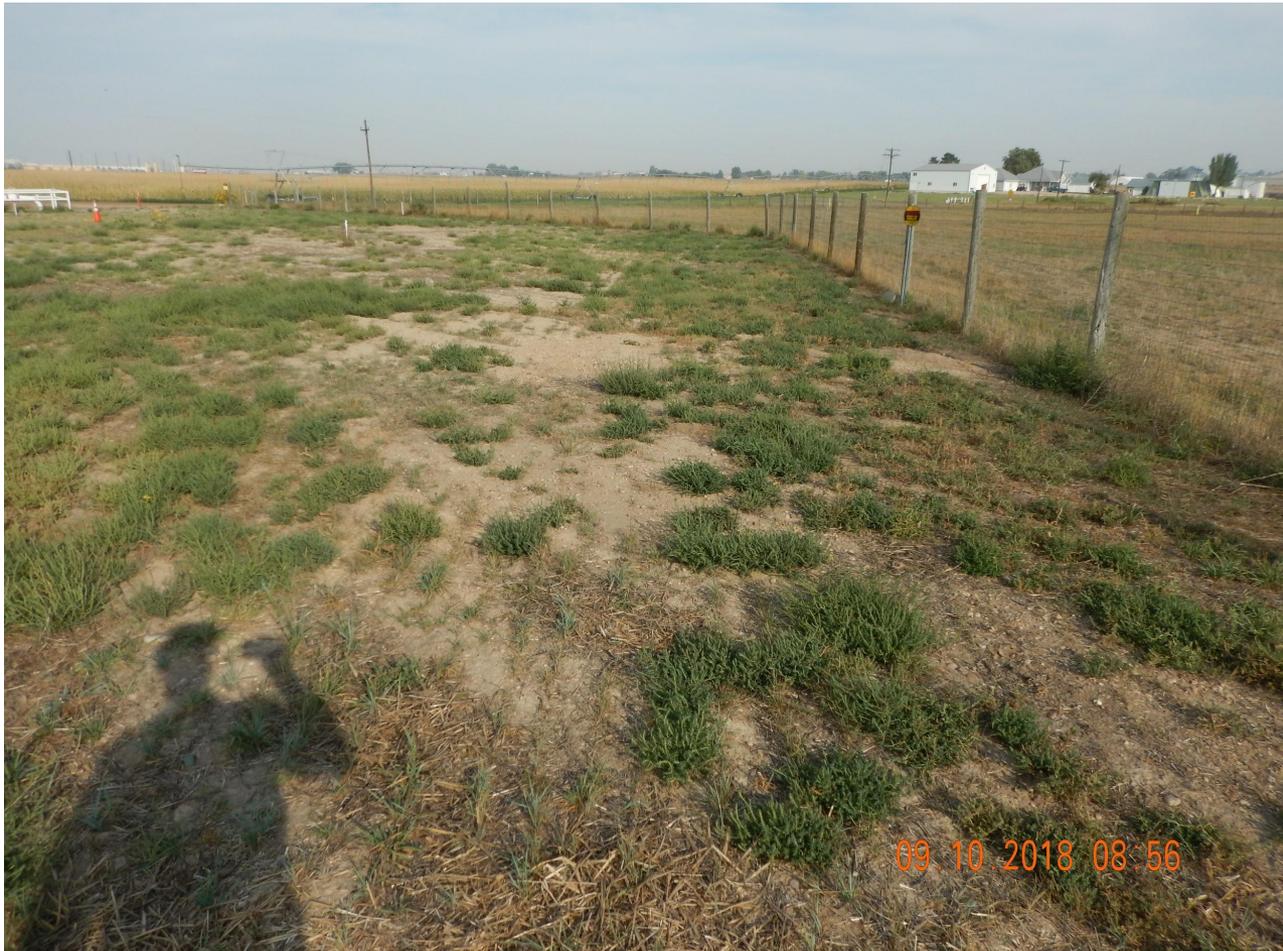
Photo 3. Photo taken from the western tank battery, facing Northwest. See comments under Photo 1. Note: Remediation Project #8315 has not been resolved and remains open until it complies with 900 series rules and regulations. Also, there was little to no germination of grass species throughout portions of the tank battery. Operator should consider taking soil samples to determine soil fertility.

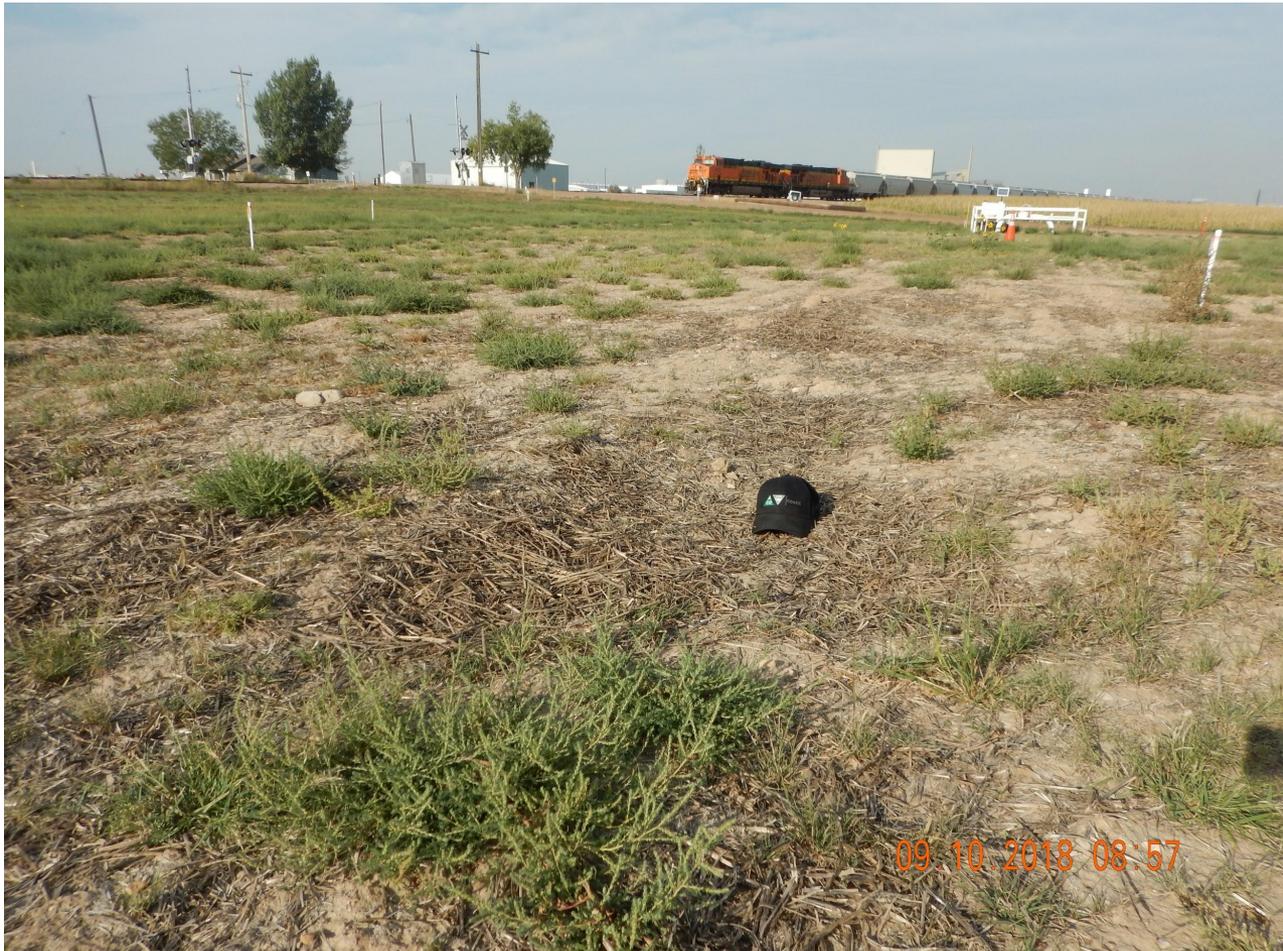
Photo 4. Photo taken from the central tank battery, facing West. Photo is attempting to illustrate subsidence or an area that has not been properly contoured.

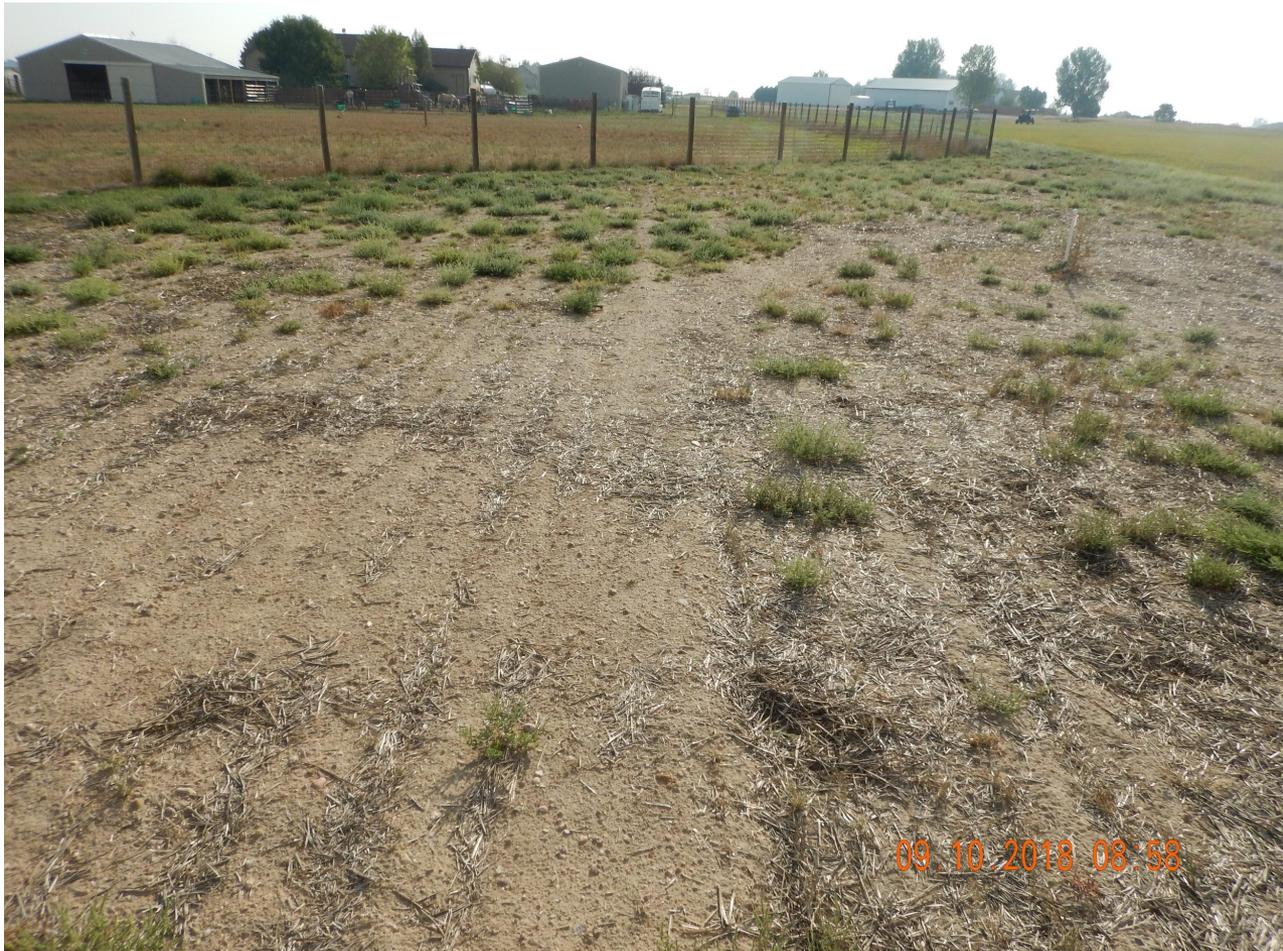
Photo 5. Photo taken from the northern tank battery, facing East. Photo illustrates an area that lacks germination which indicates unsuitable soil conditions.

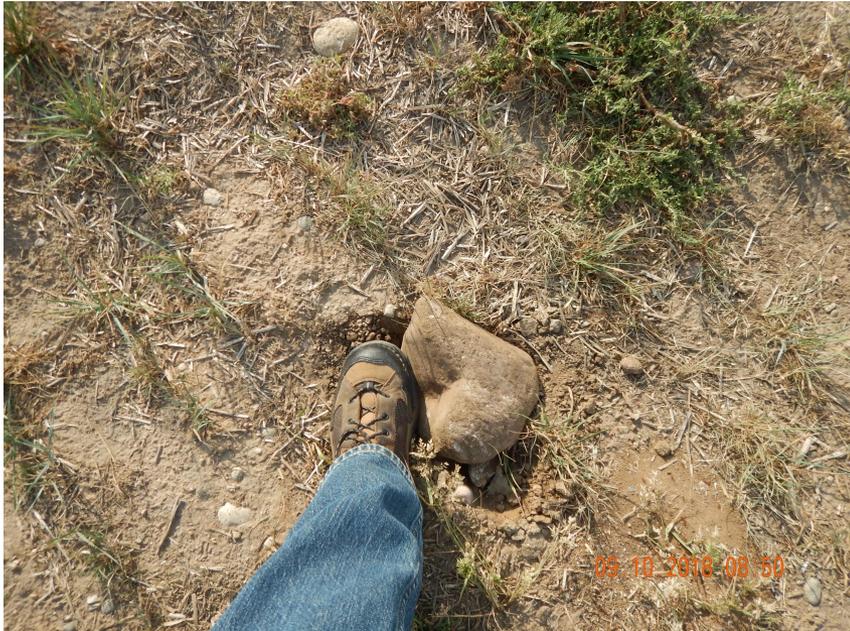
Photo 6. Photo taken from the well location. Photo illustrates a large cobble and others were observed throughout the disturbance area. Operator indicated large cobble surfaced during compaction alleviation operations. Operator shall remove large cobble as this is a cultivated field with mowing operations.

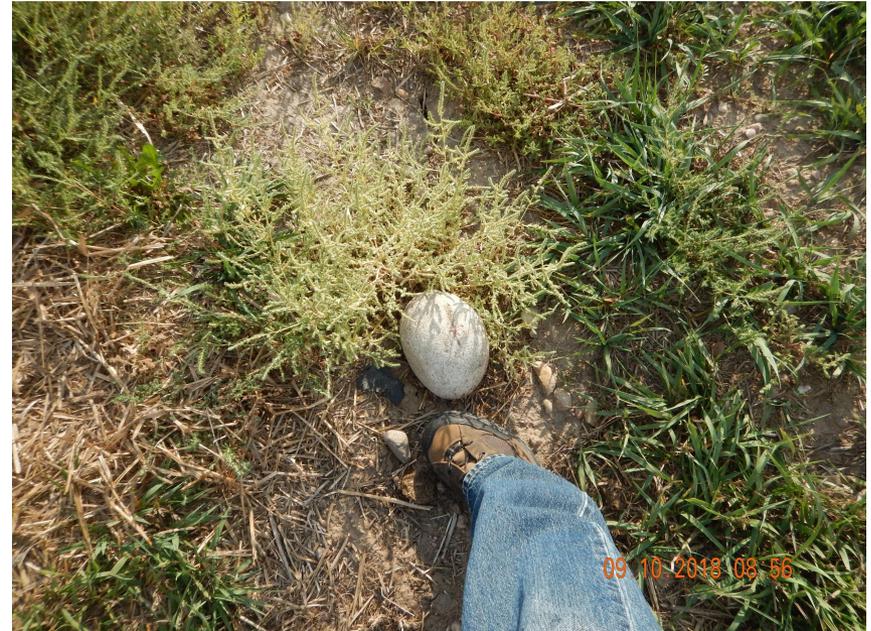
Photo 7. Photo taken from the battery location. See comments under Photo 6.

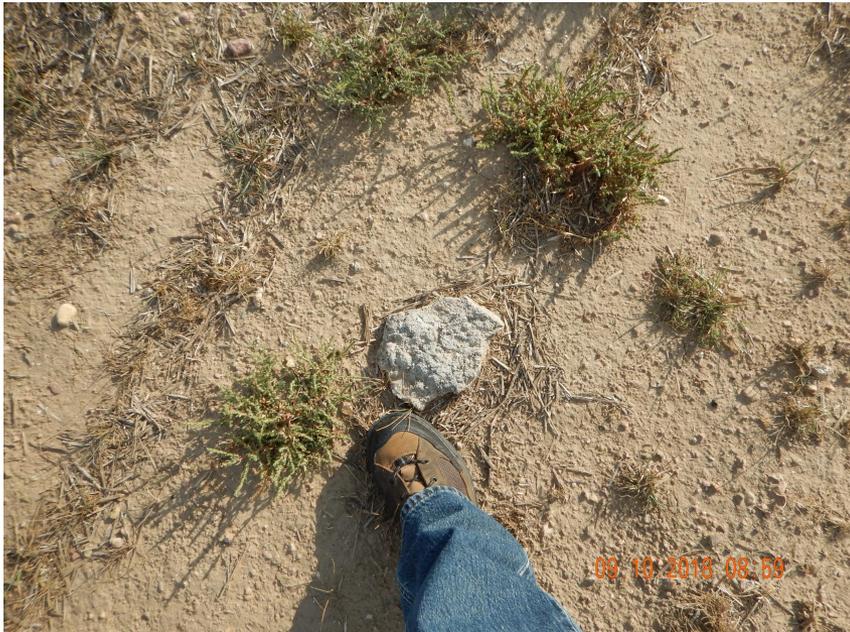
Photo 8. Photo taken from the battery location. Photo illustrates a large piece of concrete and others were observed throughout the battery location.

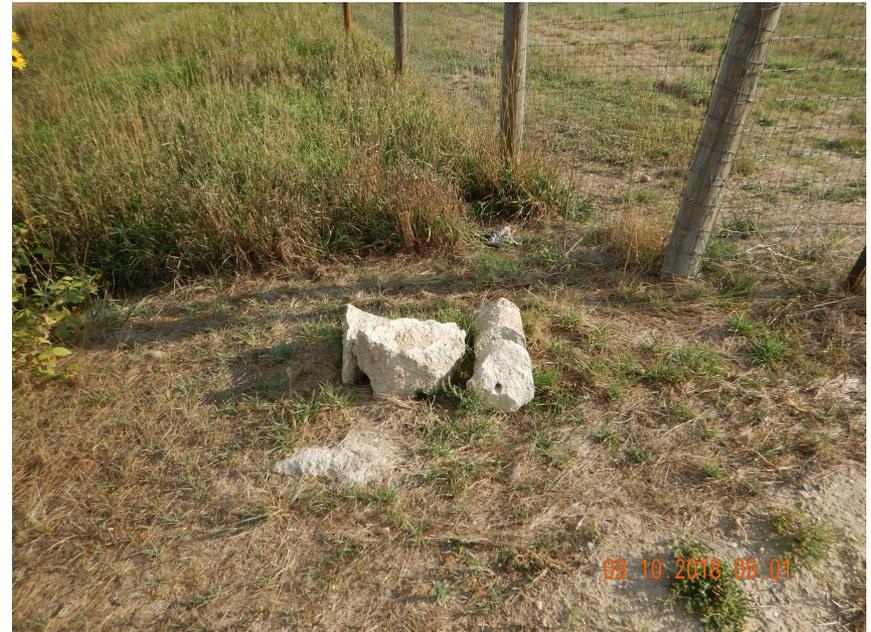
Photo 9. Photo taken from the battery location. See comments under Photo 8.
