Inspection Photos

Operator: Logos Operating

API: 05-067-09055

Date: 9/10/2018

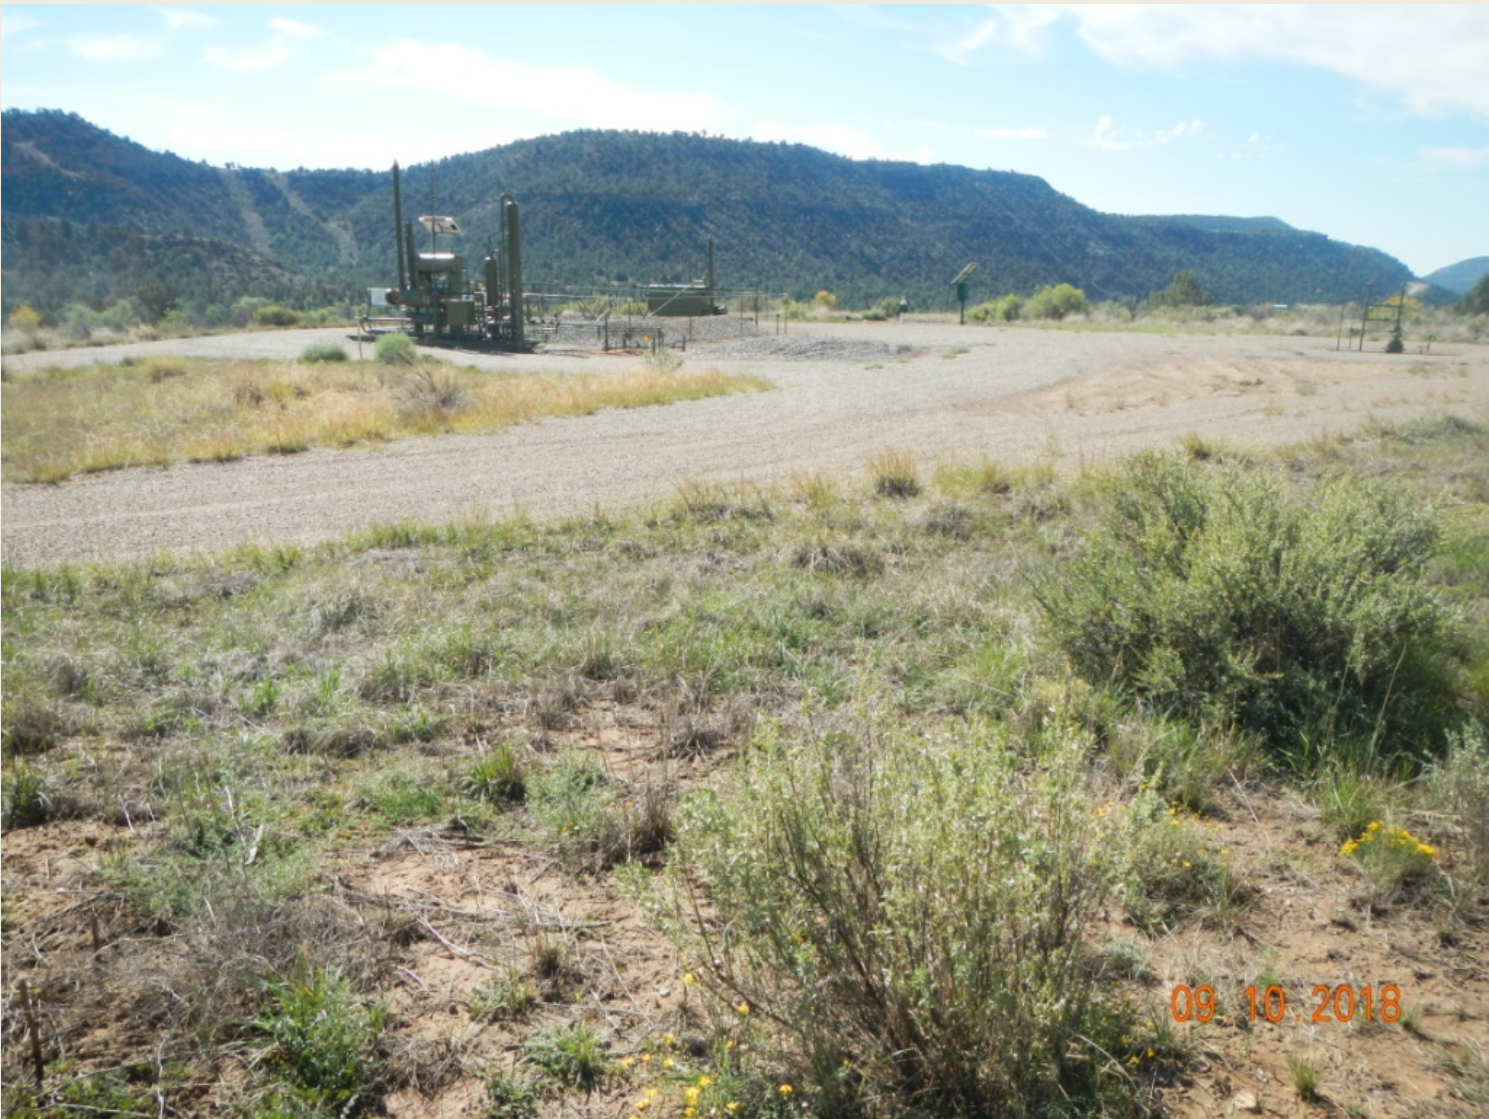
Photo 1. View of the project area from the northwestern corner of the working area facing center.

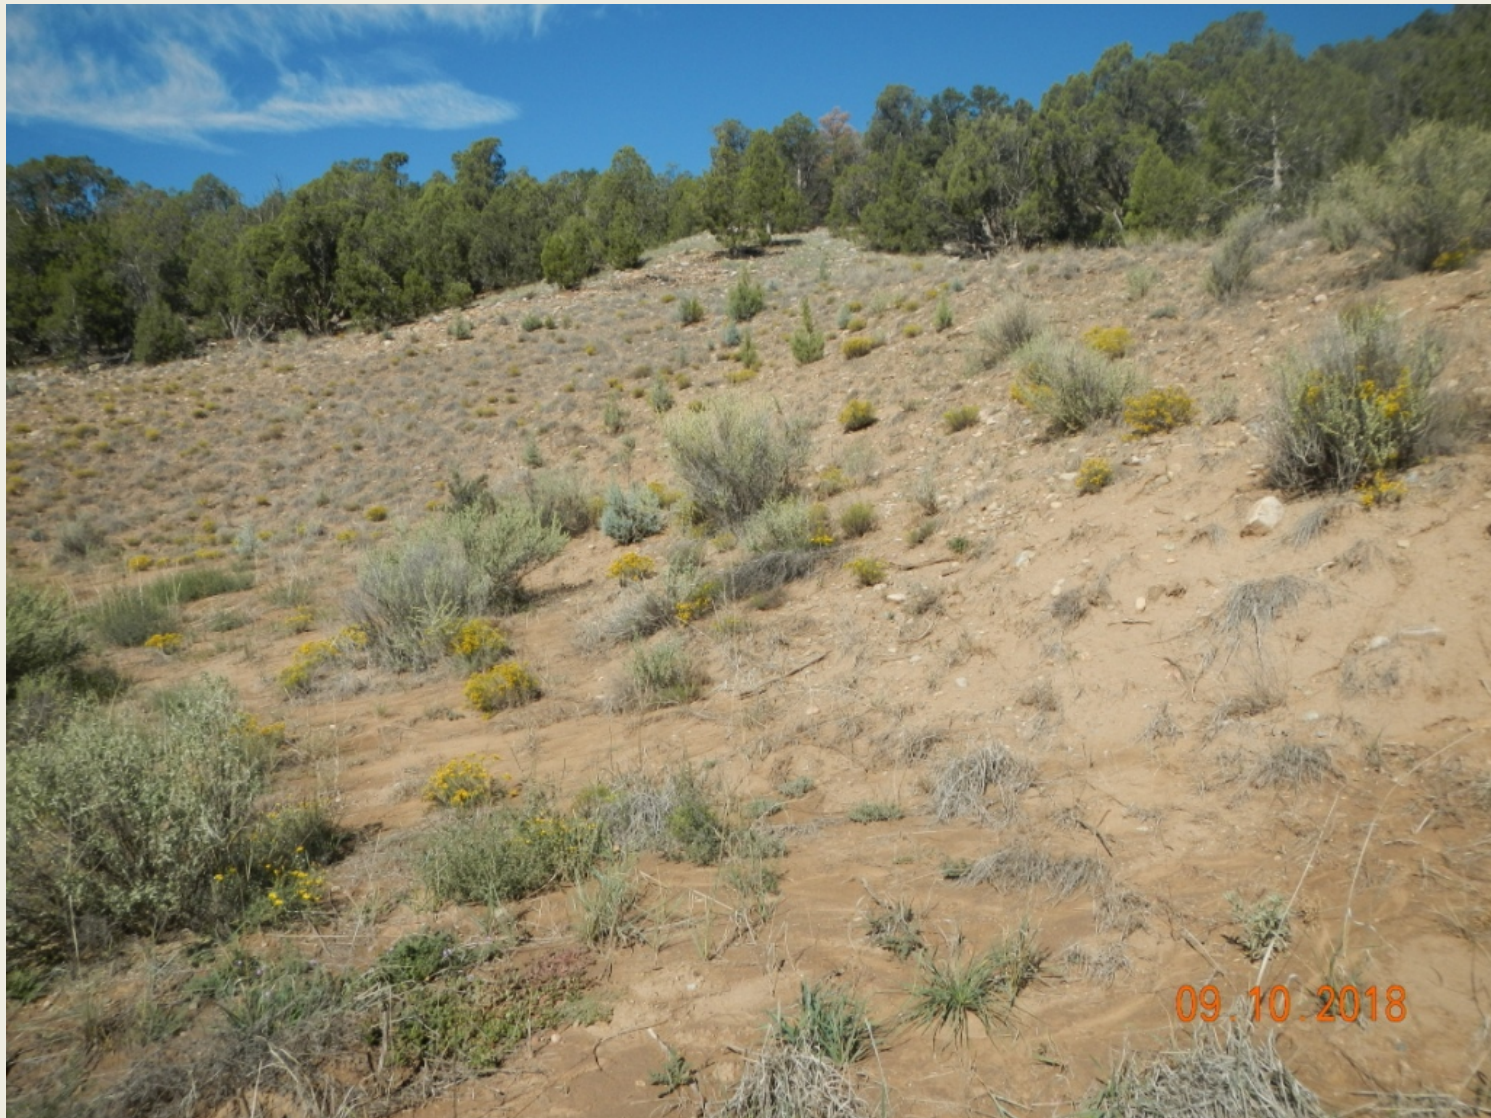
Photo 2. View of the northwestern portion of the project area from the northern edge facing westward. Revegetation is progressing with grasses, forbs, and shrubs such as blue grama (*Bouteloua gracilis*), snakeweed (*Gutierrezia sarothrae*), and fourwing saltbush (*Atriplex canescens*).

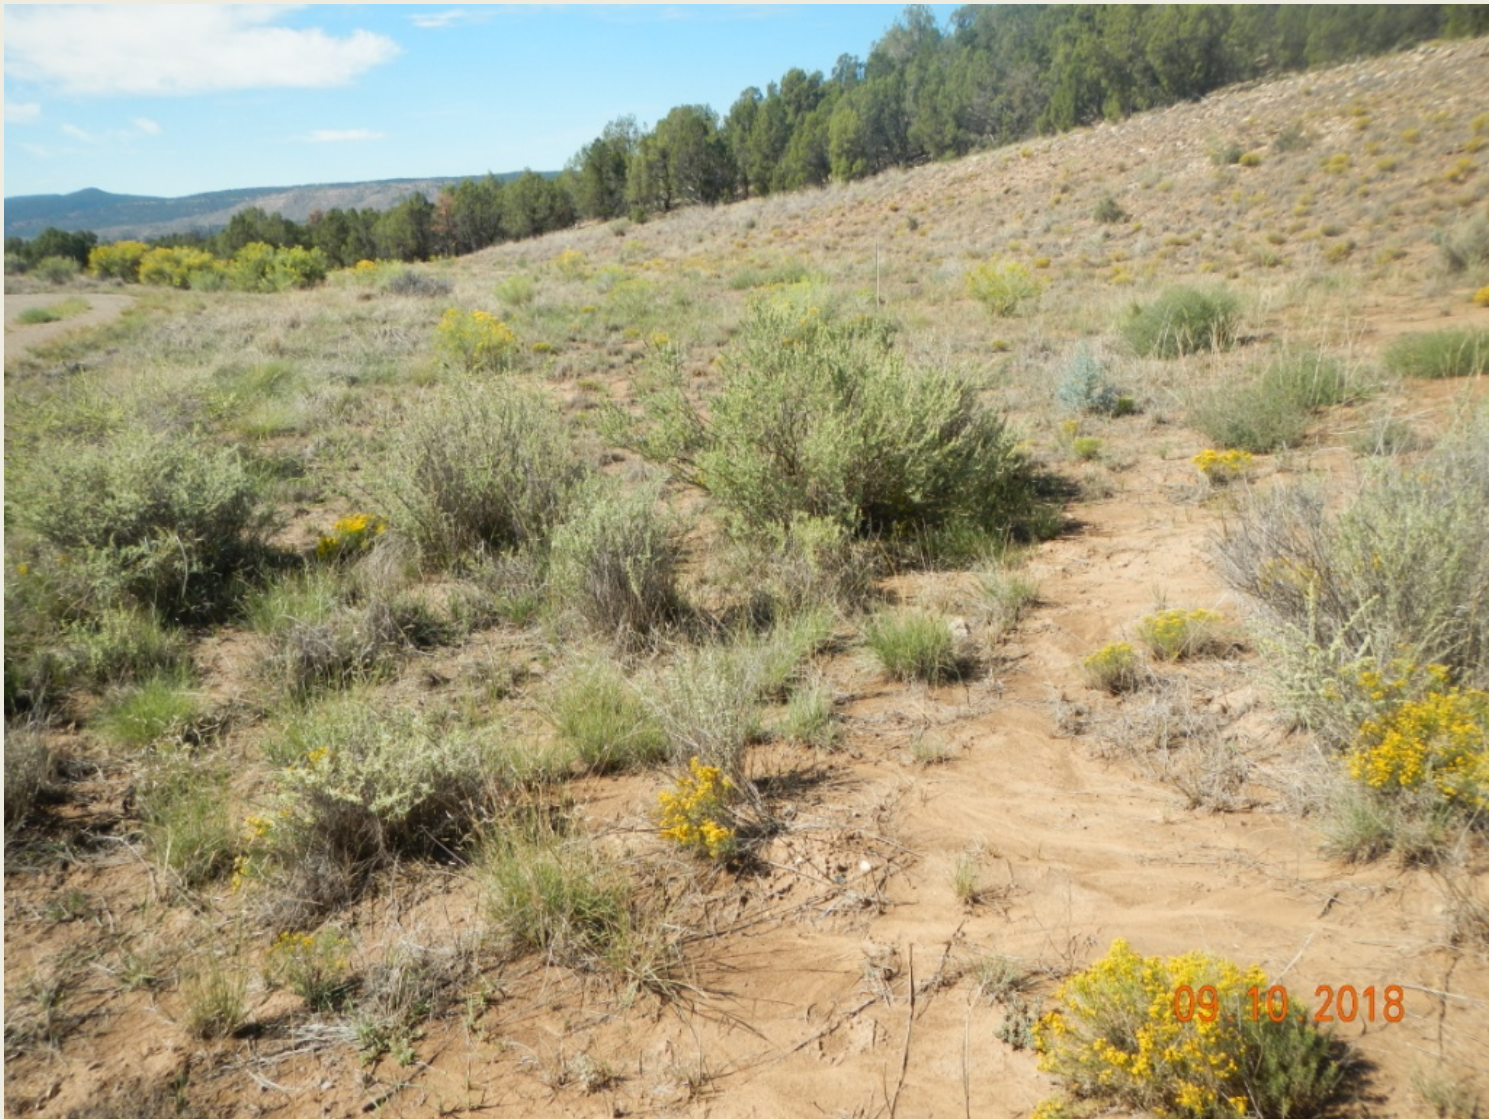
Photo 3. View of the western portion of the project area from the northern edge facing southward.

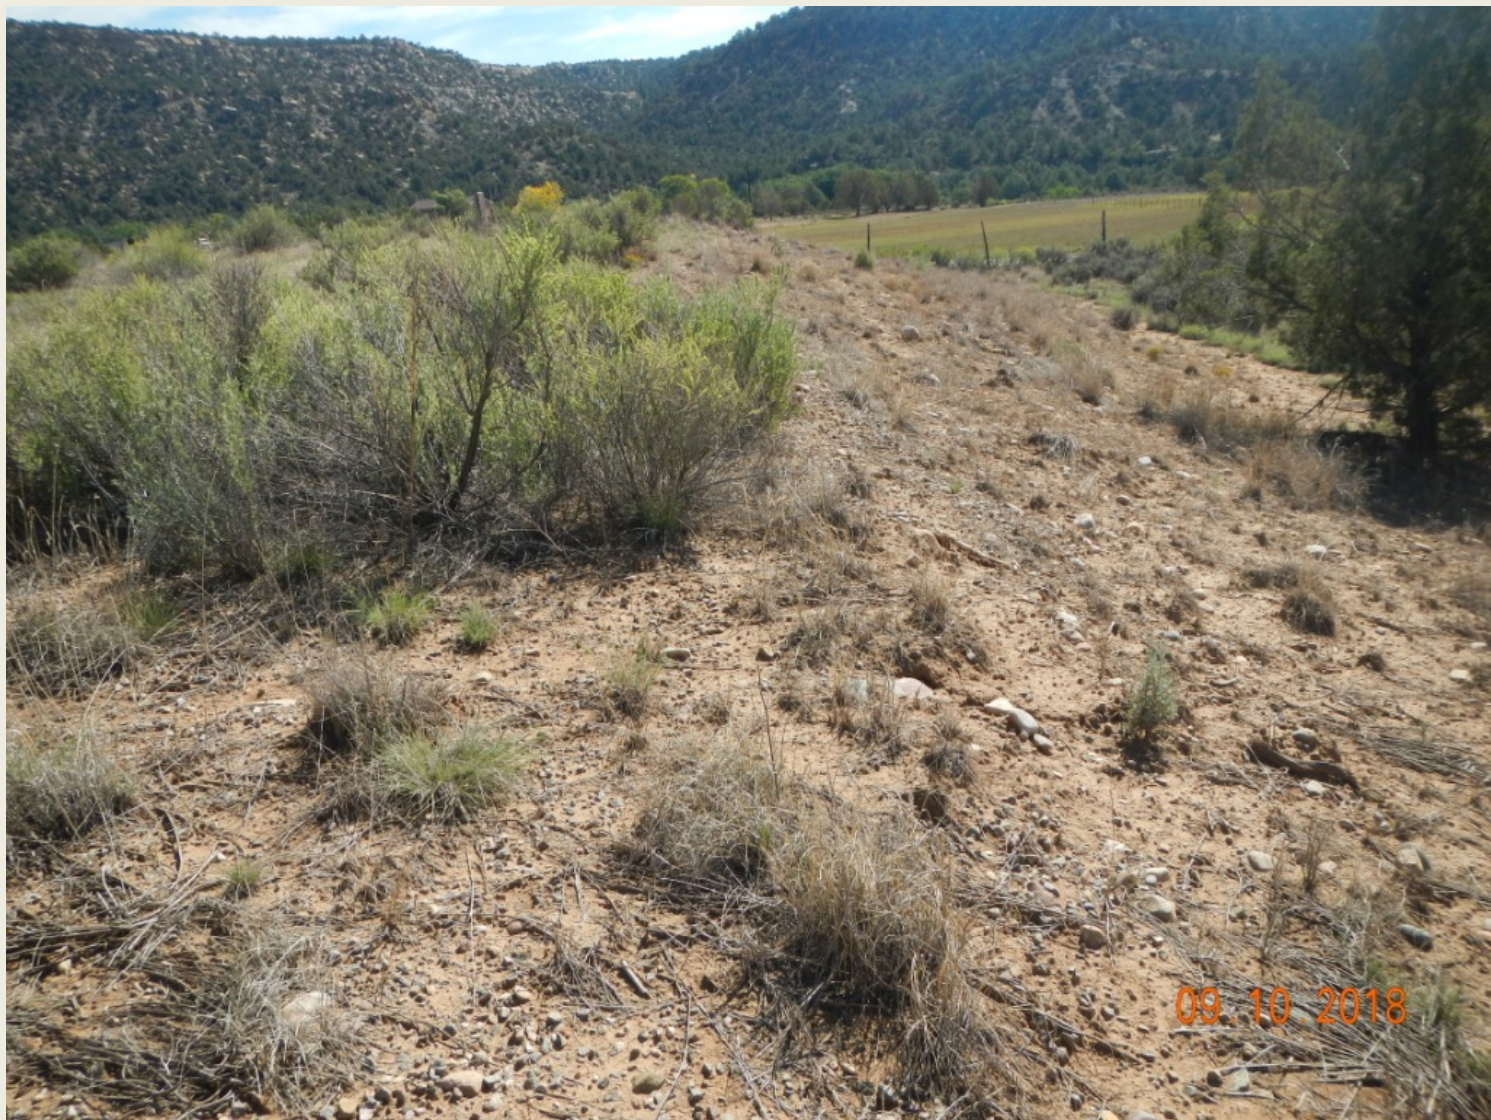
Photo 4. View of the southern fill slope from the southwestern edge facing eastward. Some rilling is occurring here as vegetation is more sparse on the slope.

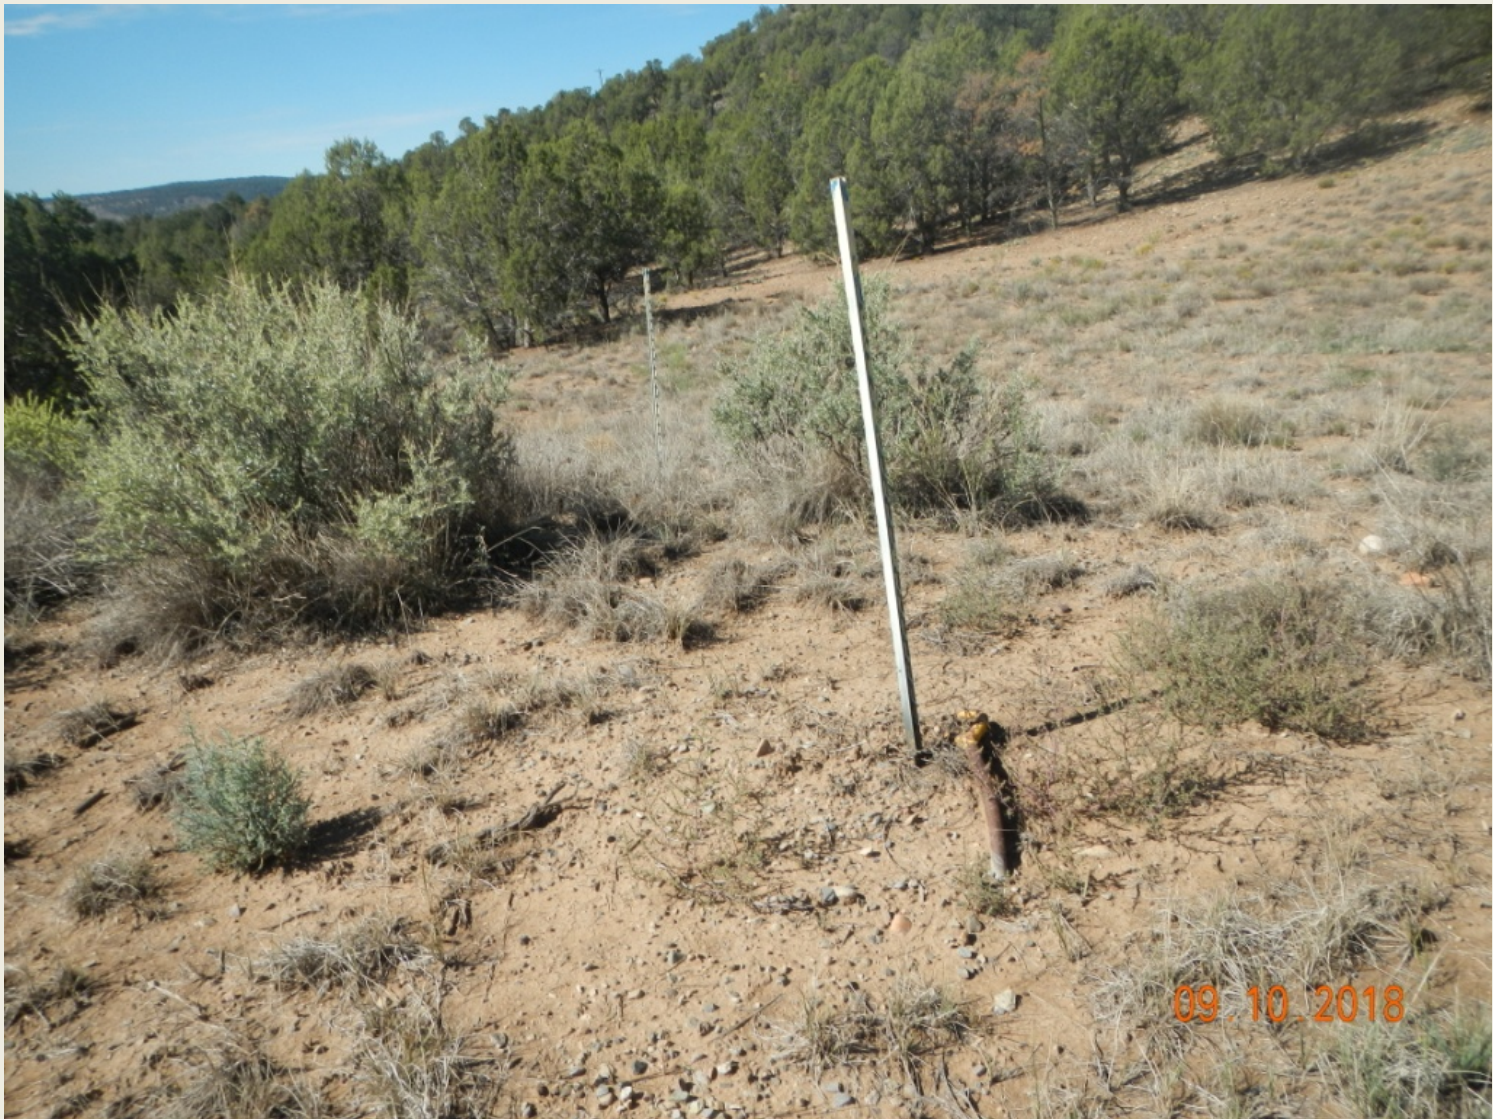
Photo 5. View of marked rig anchor within the southern project area.
