Inspection Photos

Operator: BP Production

API: 05-067-07589

Date: 9/10/2018

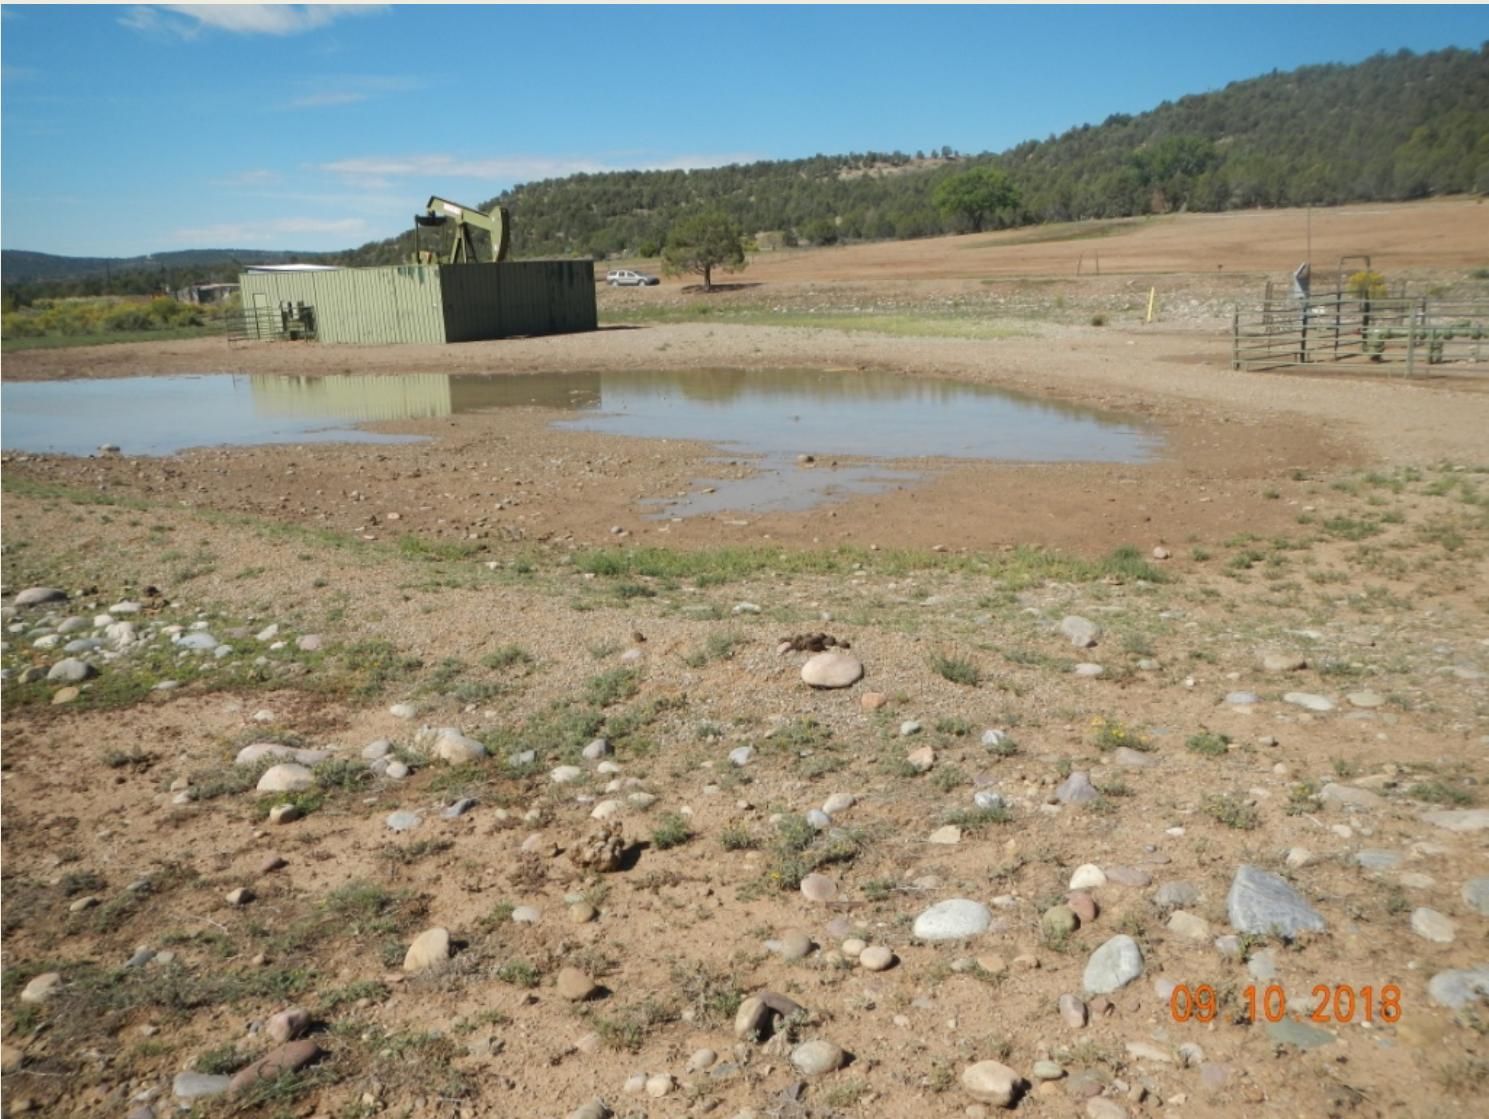
Photo 1. View of the project area from the northeastern corner facing center.

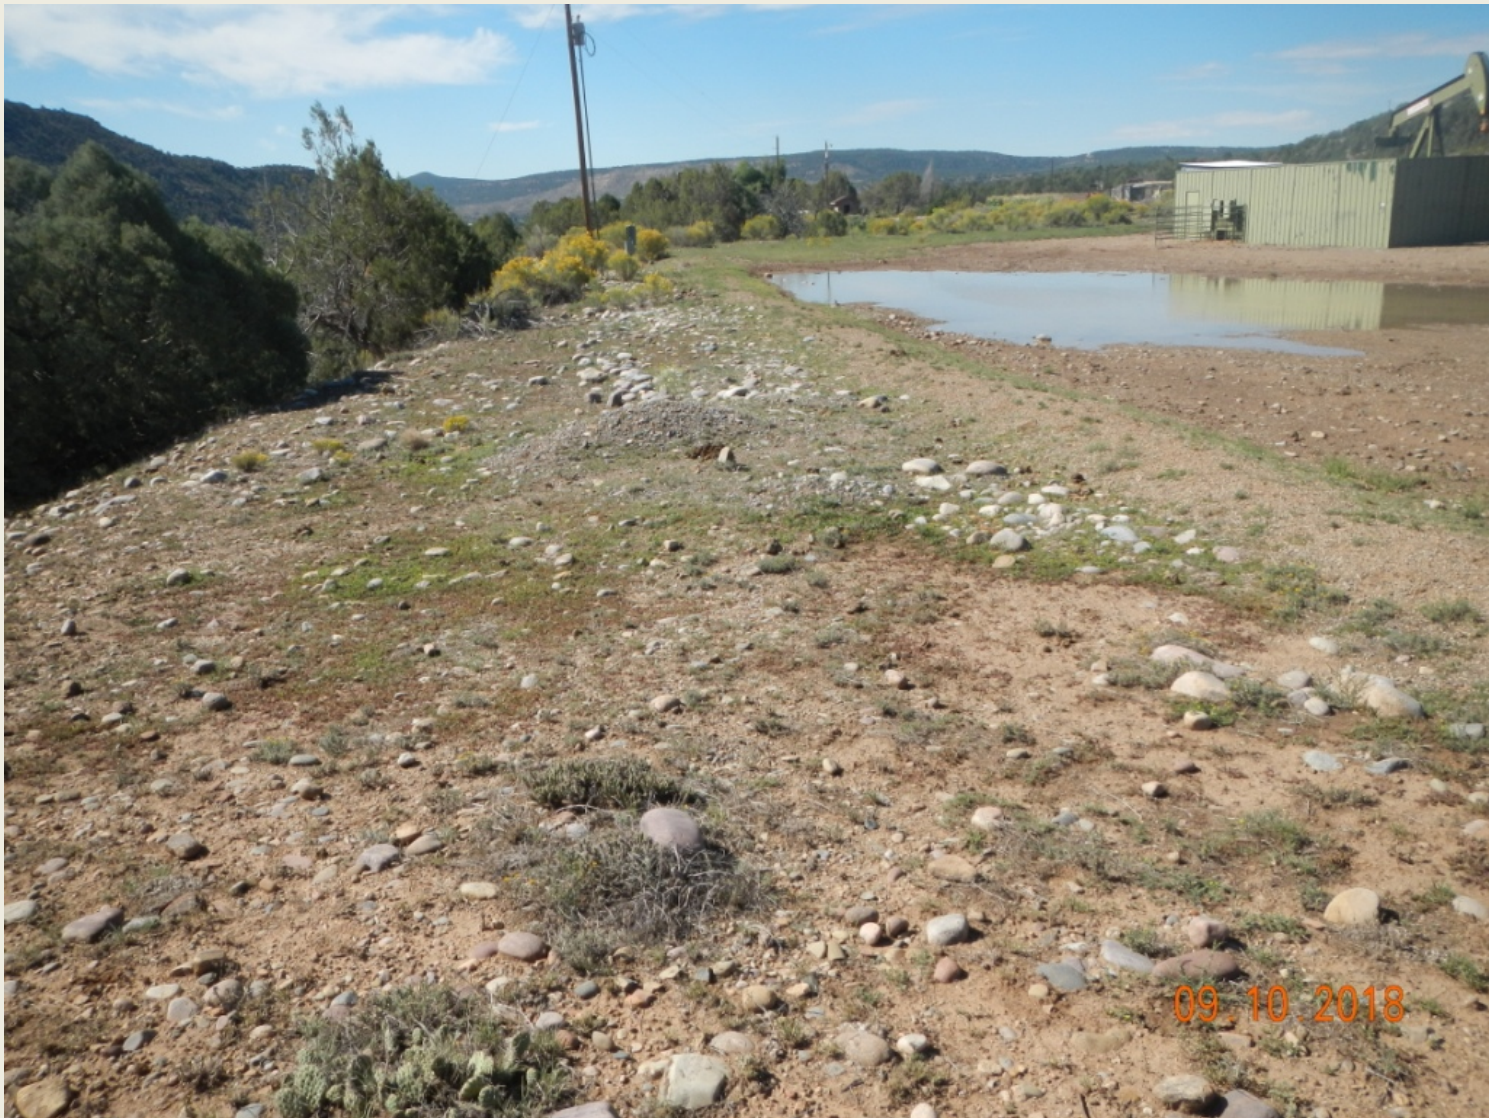
Photo 2. View of the eastern portion of the project area from the northeastern corner facing southward. Revegetation is sparse, but appears to be progressing in portions of the project area. This should be monitored.

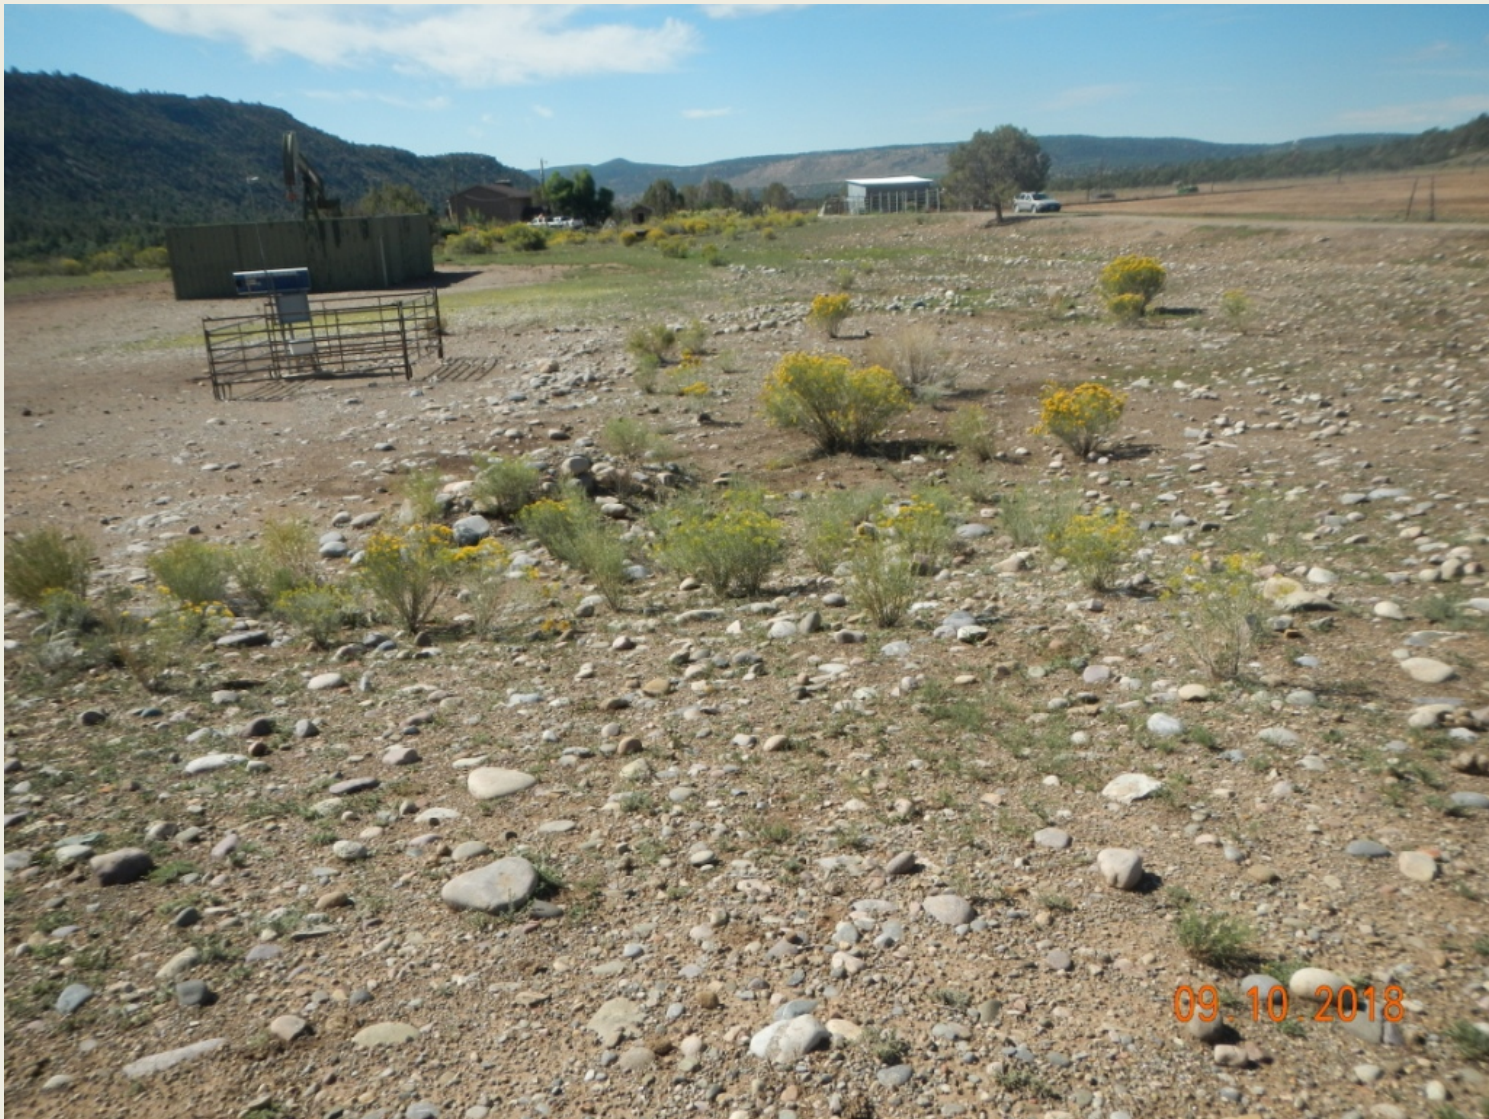
Photo 3. View of the western portion of the project area from the northwestern corner facing southward.
