# Inspection Photos

Operator: BP Production

API: 05-067-08689

Date: 9/10/2018

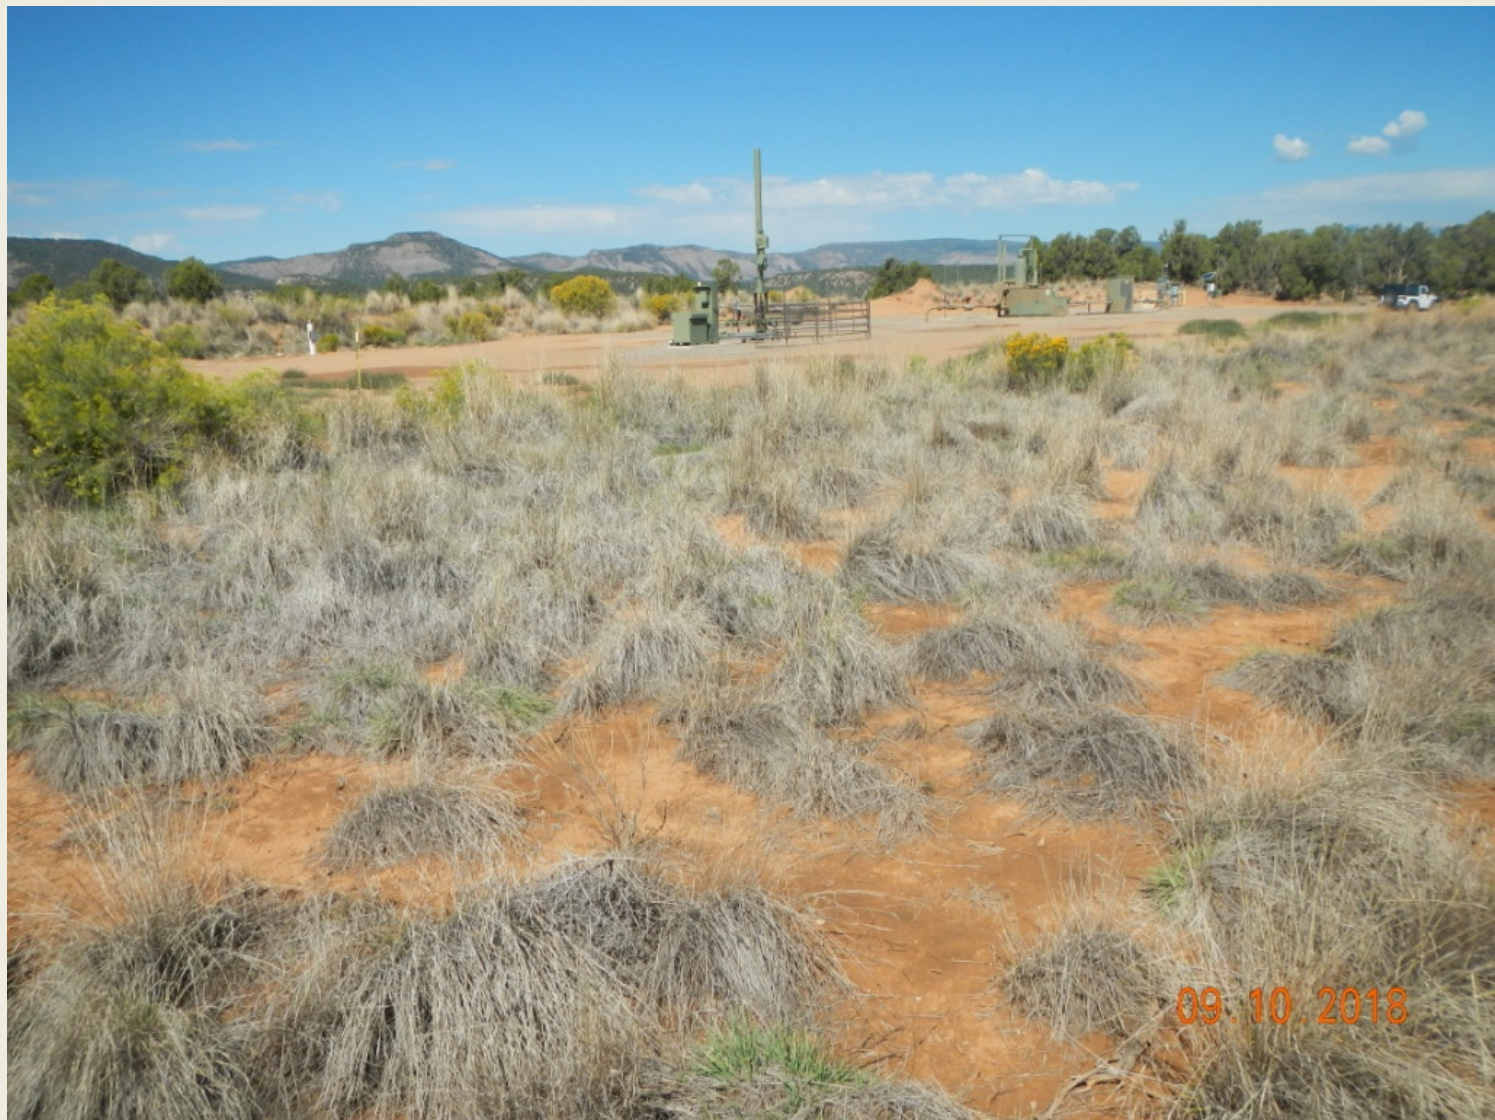
**Photo 1. View of the project area from the southeastern corner facing center.**

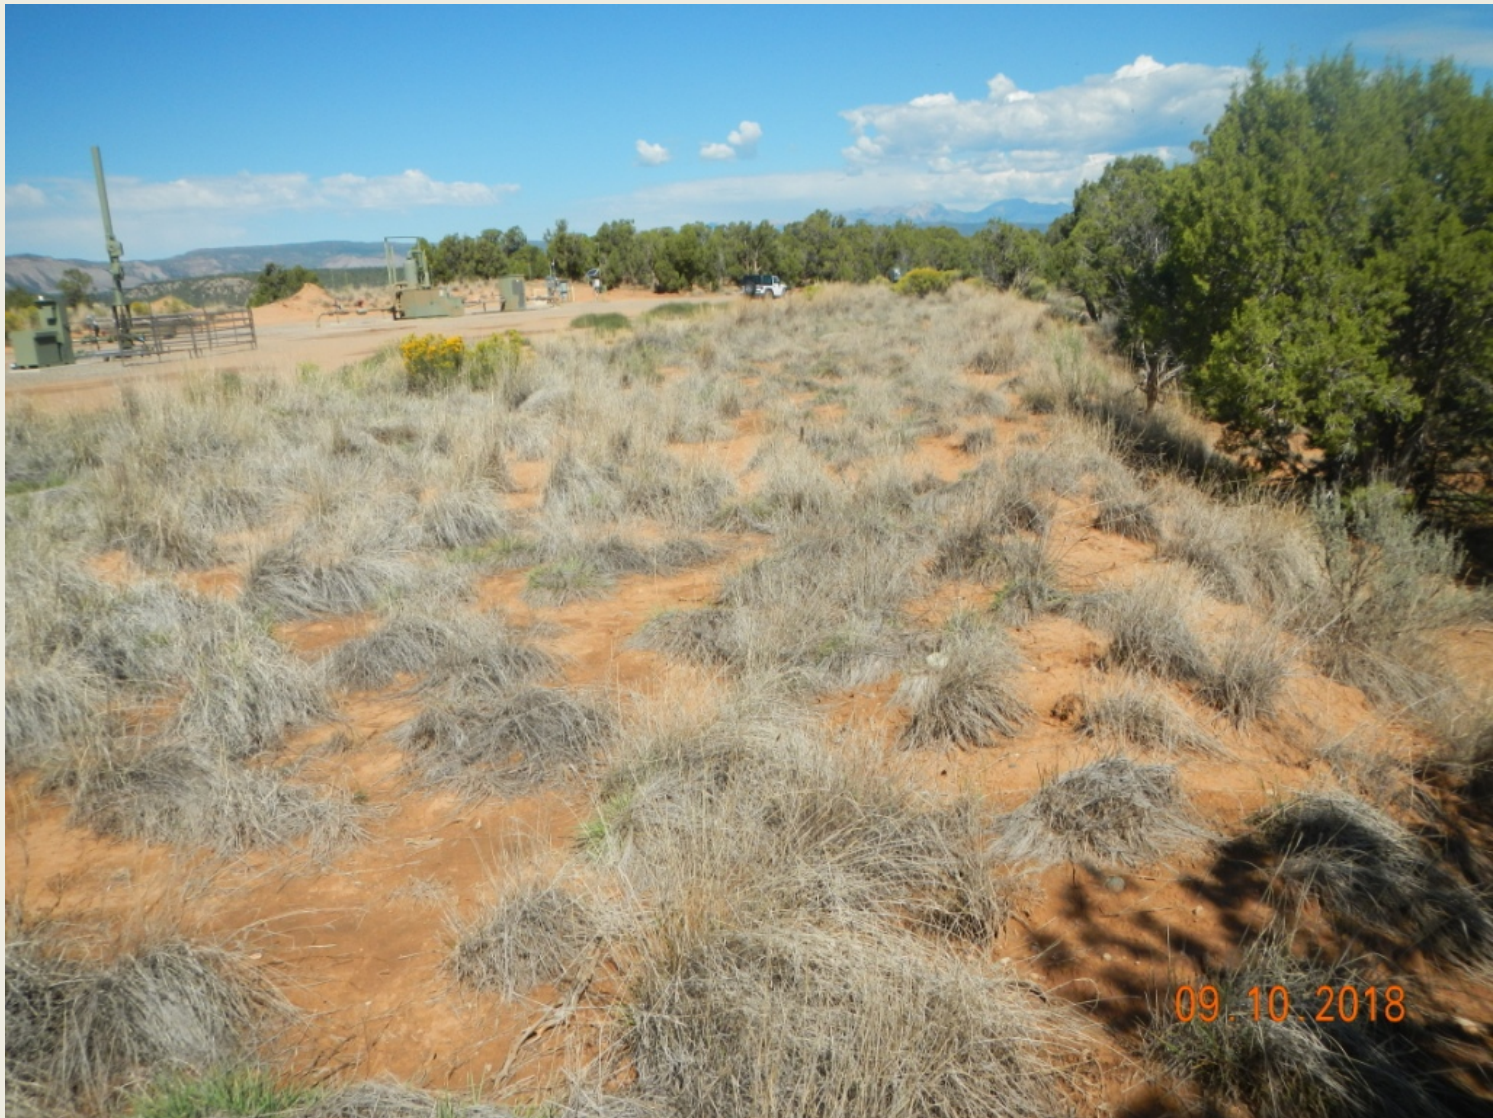
**Photo 2. View of the eastern portion of the project area from the southeastern corner facing northward. Revegetation is comprised of grasses and shrubs such as crested wheatgrass (*Agropyron cristatum*), intermediate wheatgrass (*Thinopyron intermedium*), and rubber rabbitbrush (*Chrysothamnus nauseosus*).**

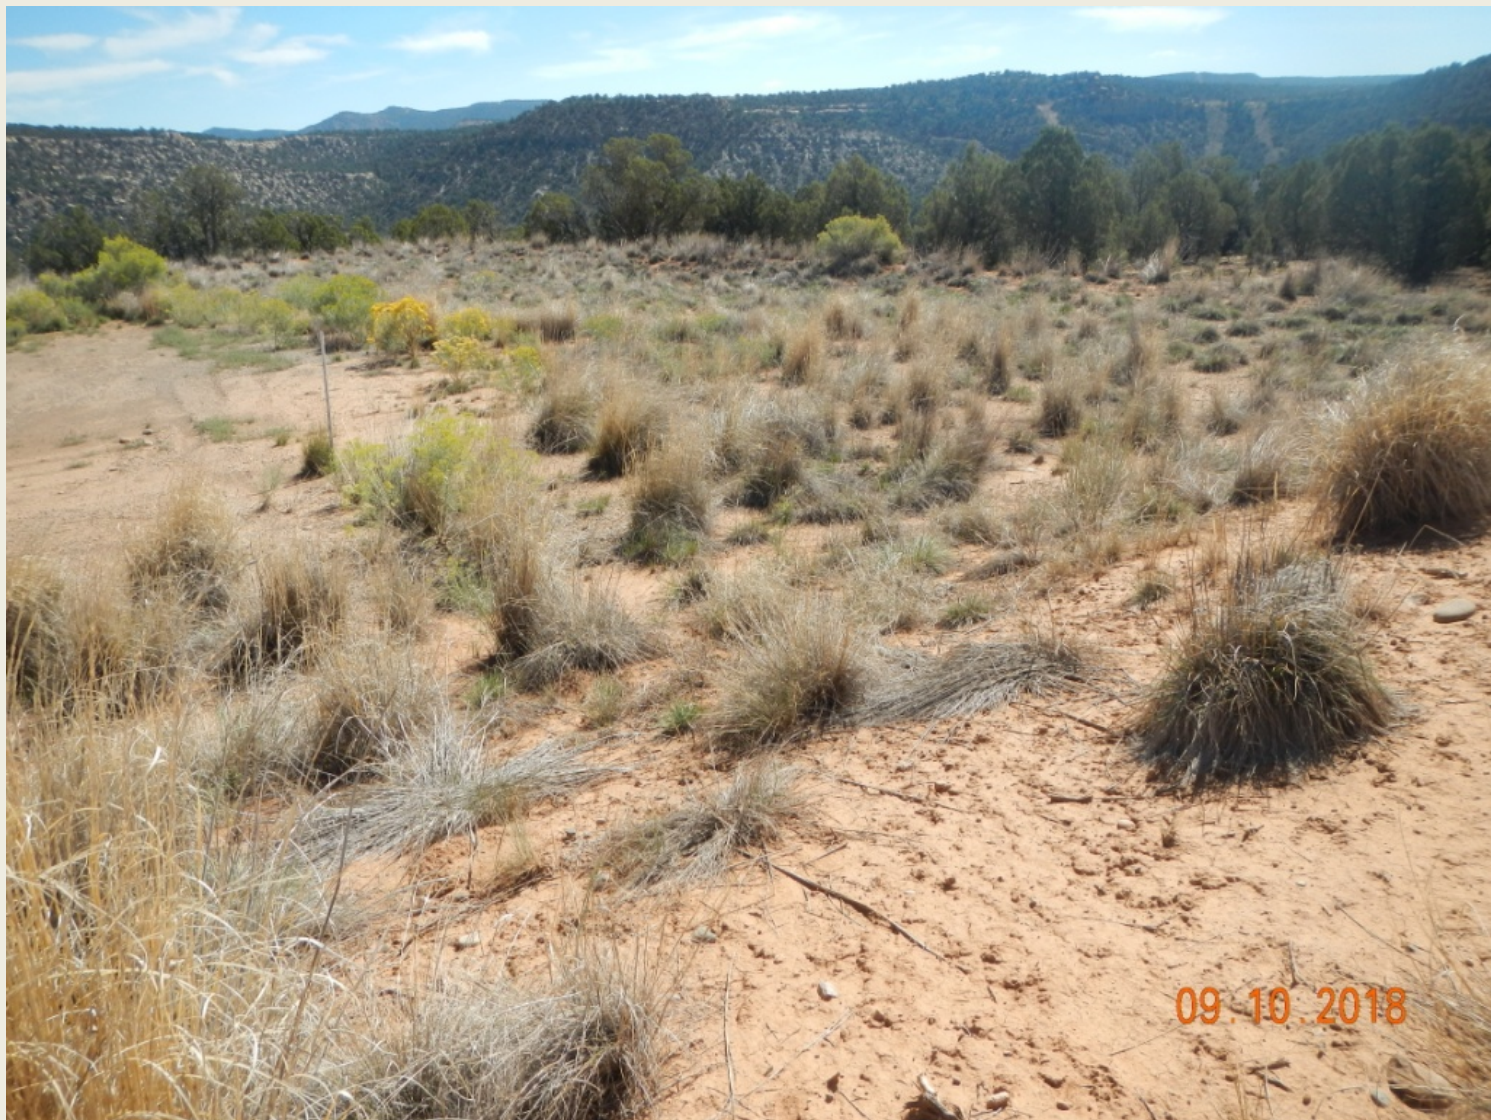
**Photo 3. View of the southern portion of the project area from the southwestern corner facing eastward.**

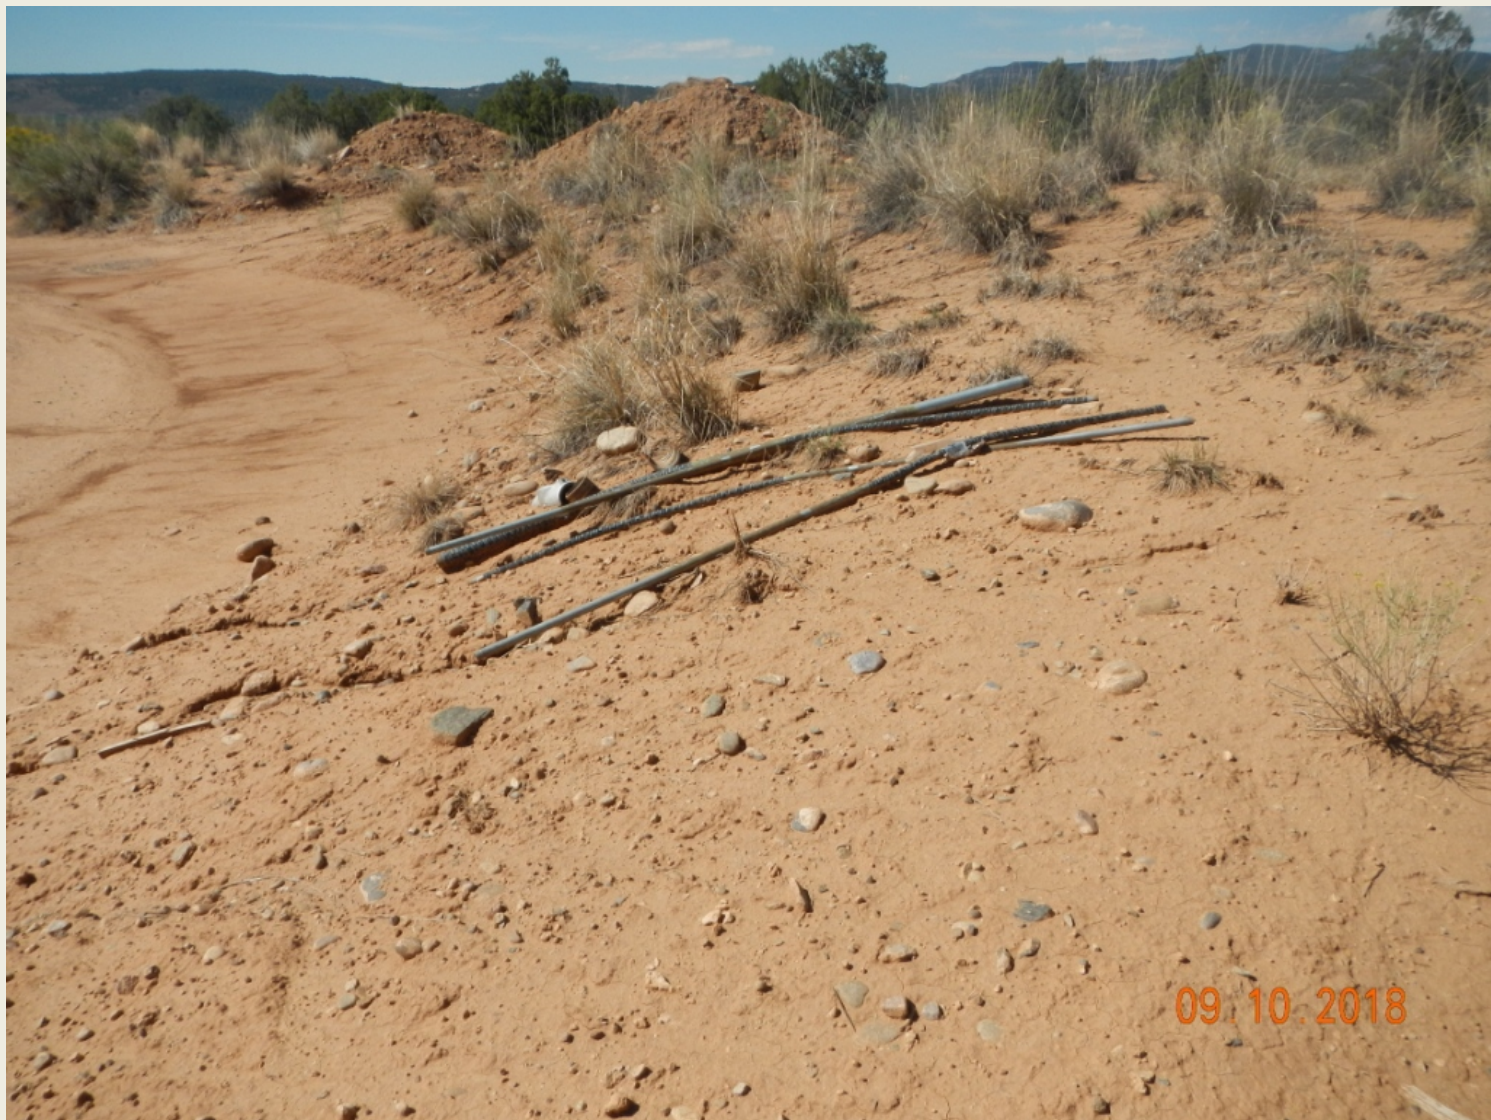
**Photo 4. View of unused pipe in the northwestern project area.**

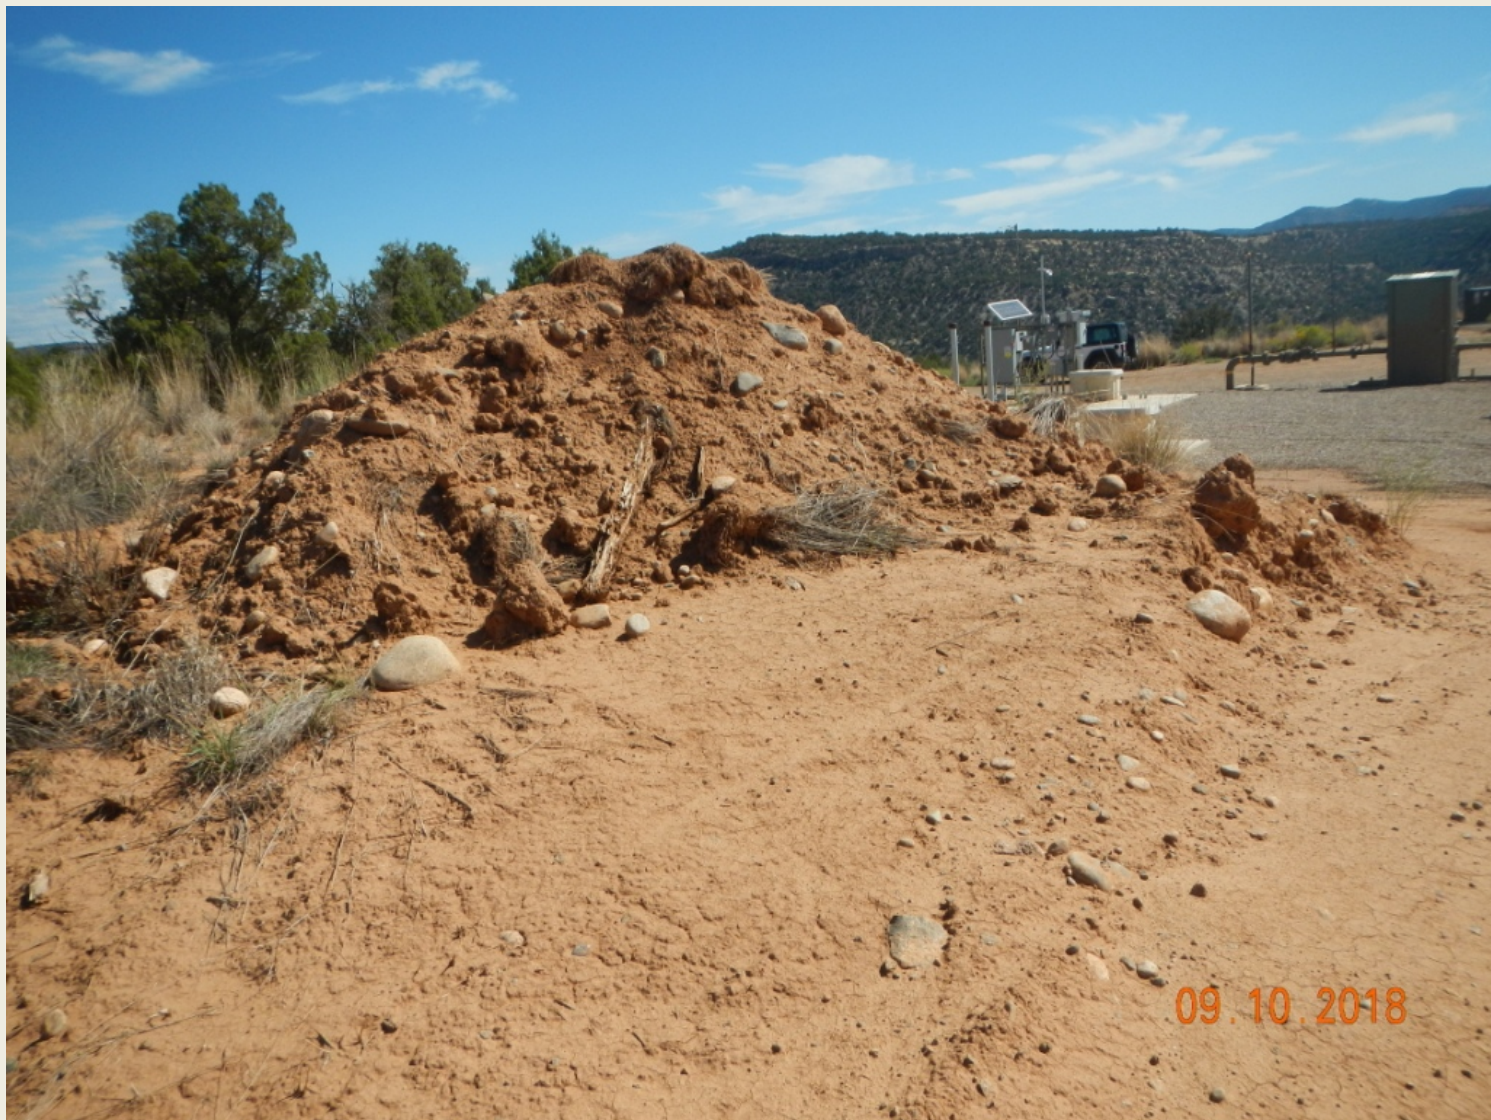
**Photo 6. View of disturbed soil in the western project area.**

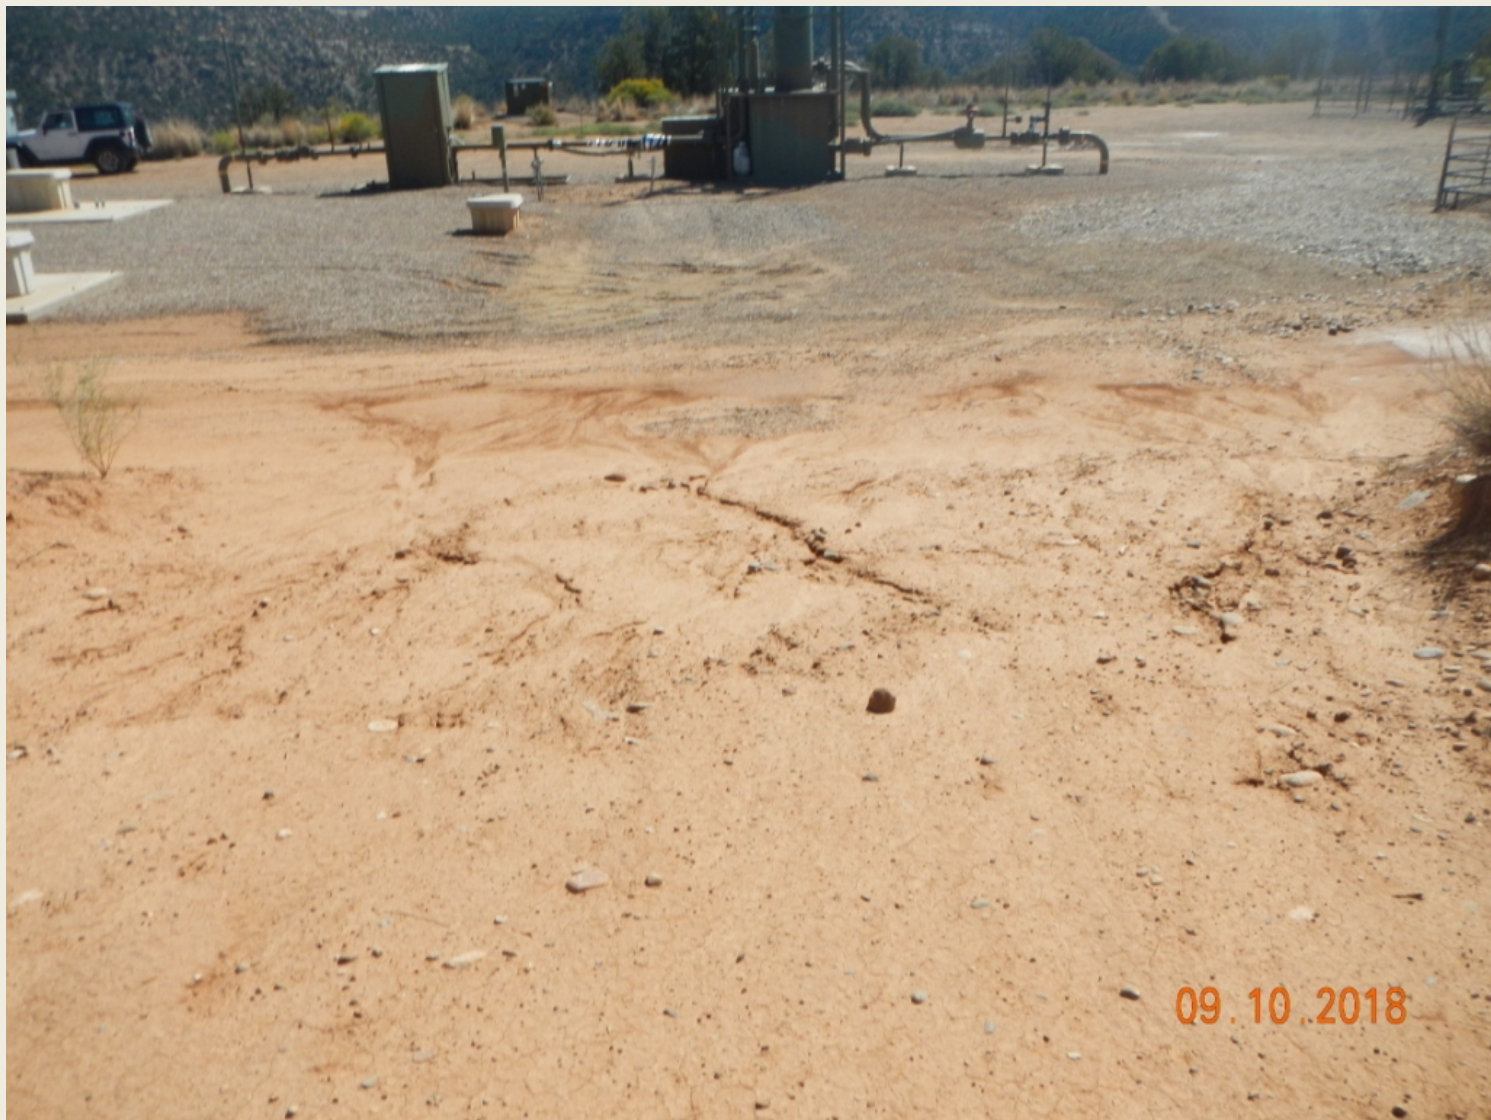
**Photo 7. View of sediment deposition on the well pad from disturbed soils within the western project area.**

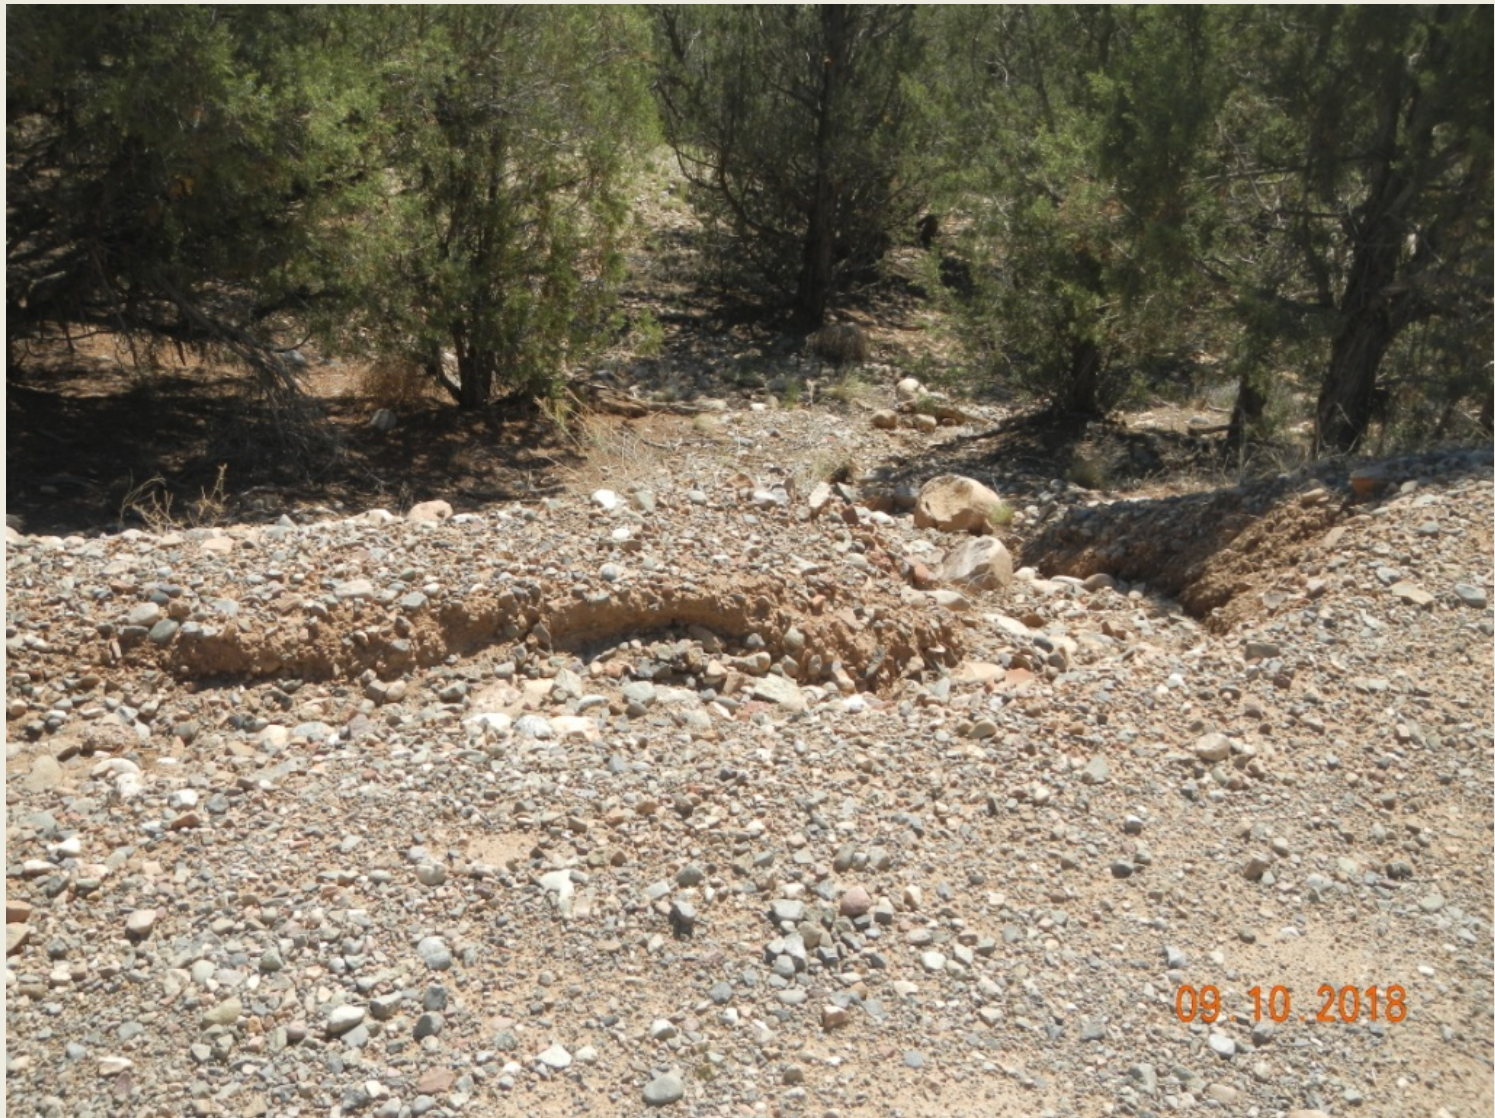
**Photo 8. View of erosional channel forming on the access road where improperly diverted stormwater is eroding the road and downslope.**

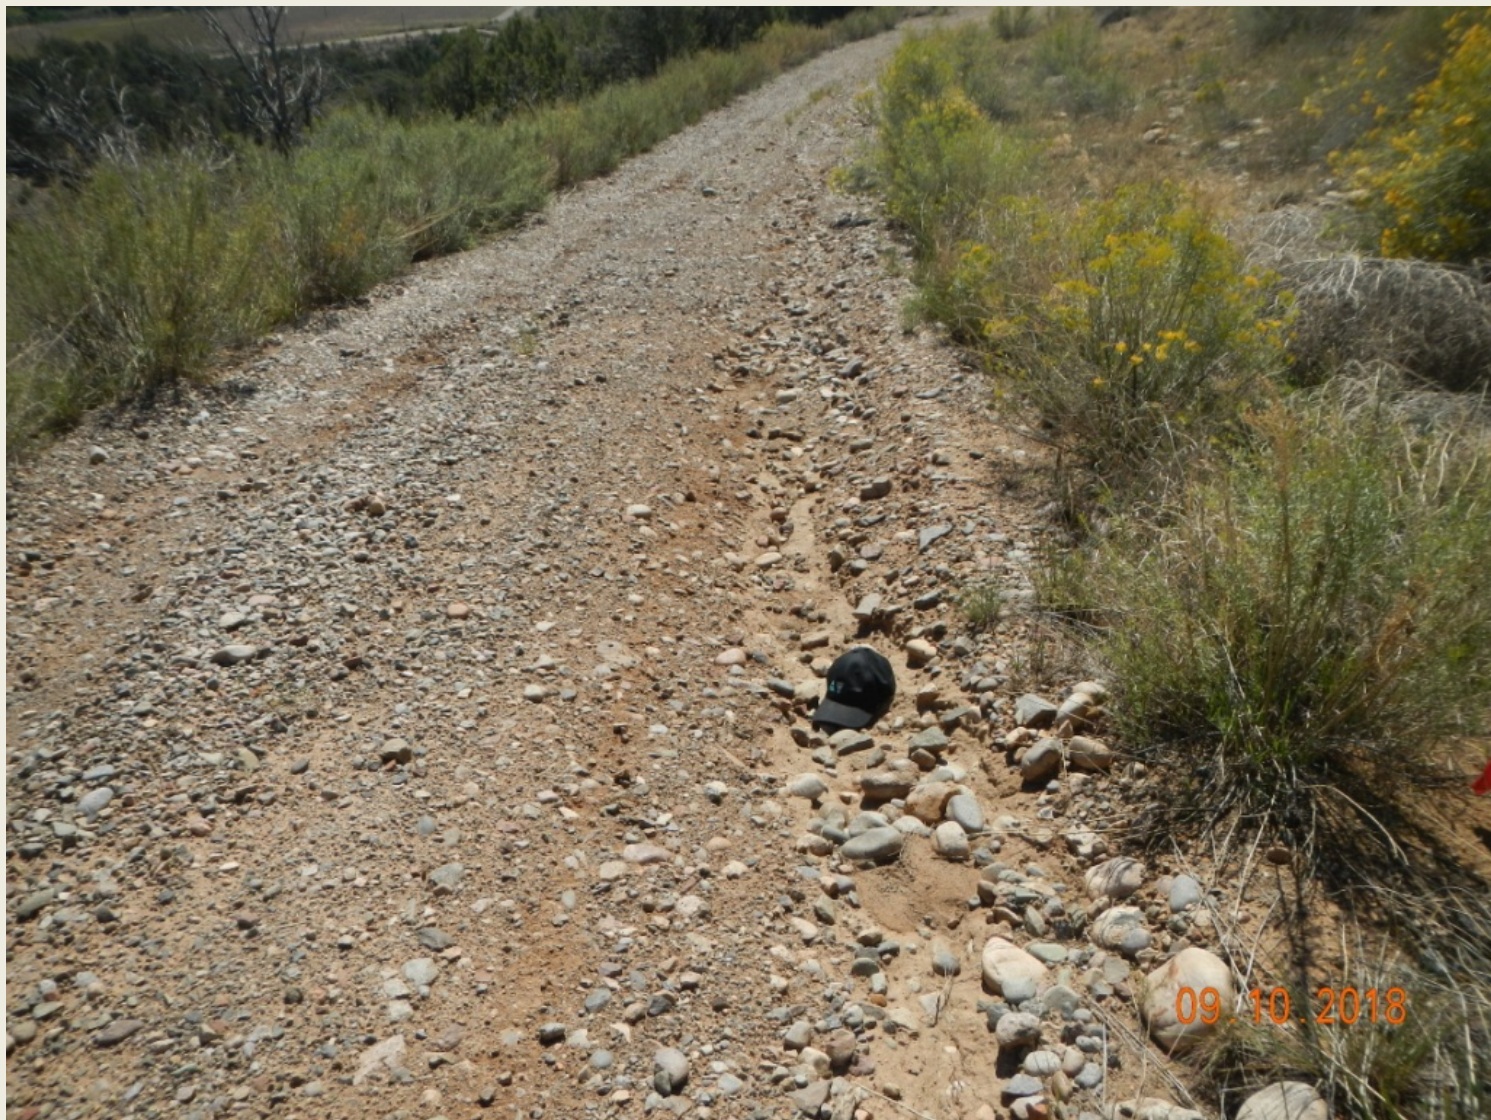
**Photo 9. View of area along the access road where roadside ditch is full of sediment and stormwater flows are diverted to the road surface, causing erosion along the road.**

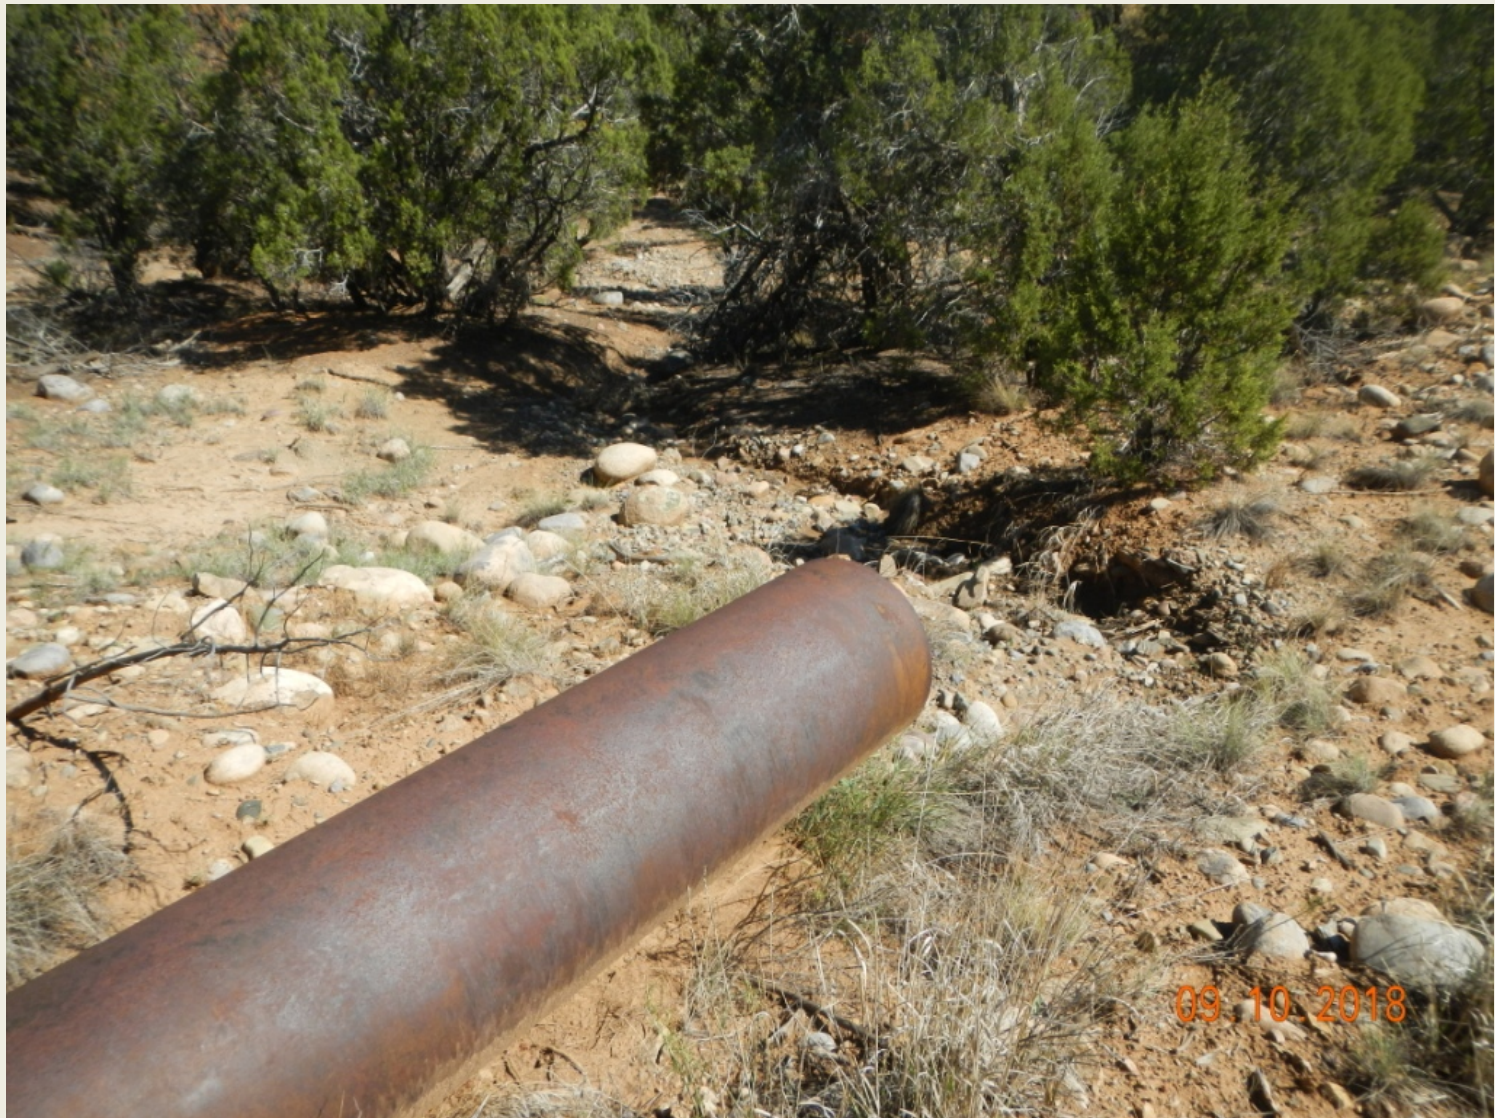
**Photo 10. View of a culvert outlet along the access road where diverted flows are not properly stabilized, energy not sufficiently dispersed, and resulting in erosional channel formation downslope from the culvert.**
