# Inspection Photos

Operator: WPX Energy

API: 05-067-08089

Date: 9/10/2018

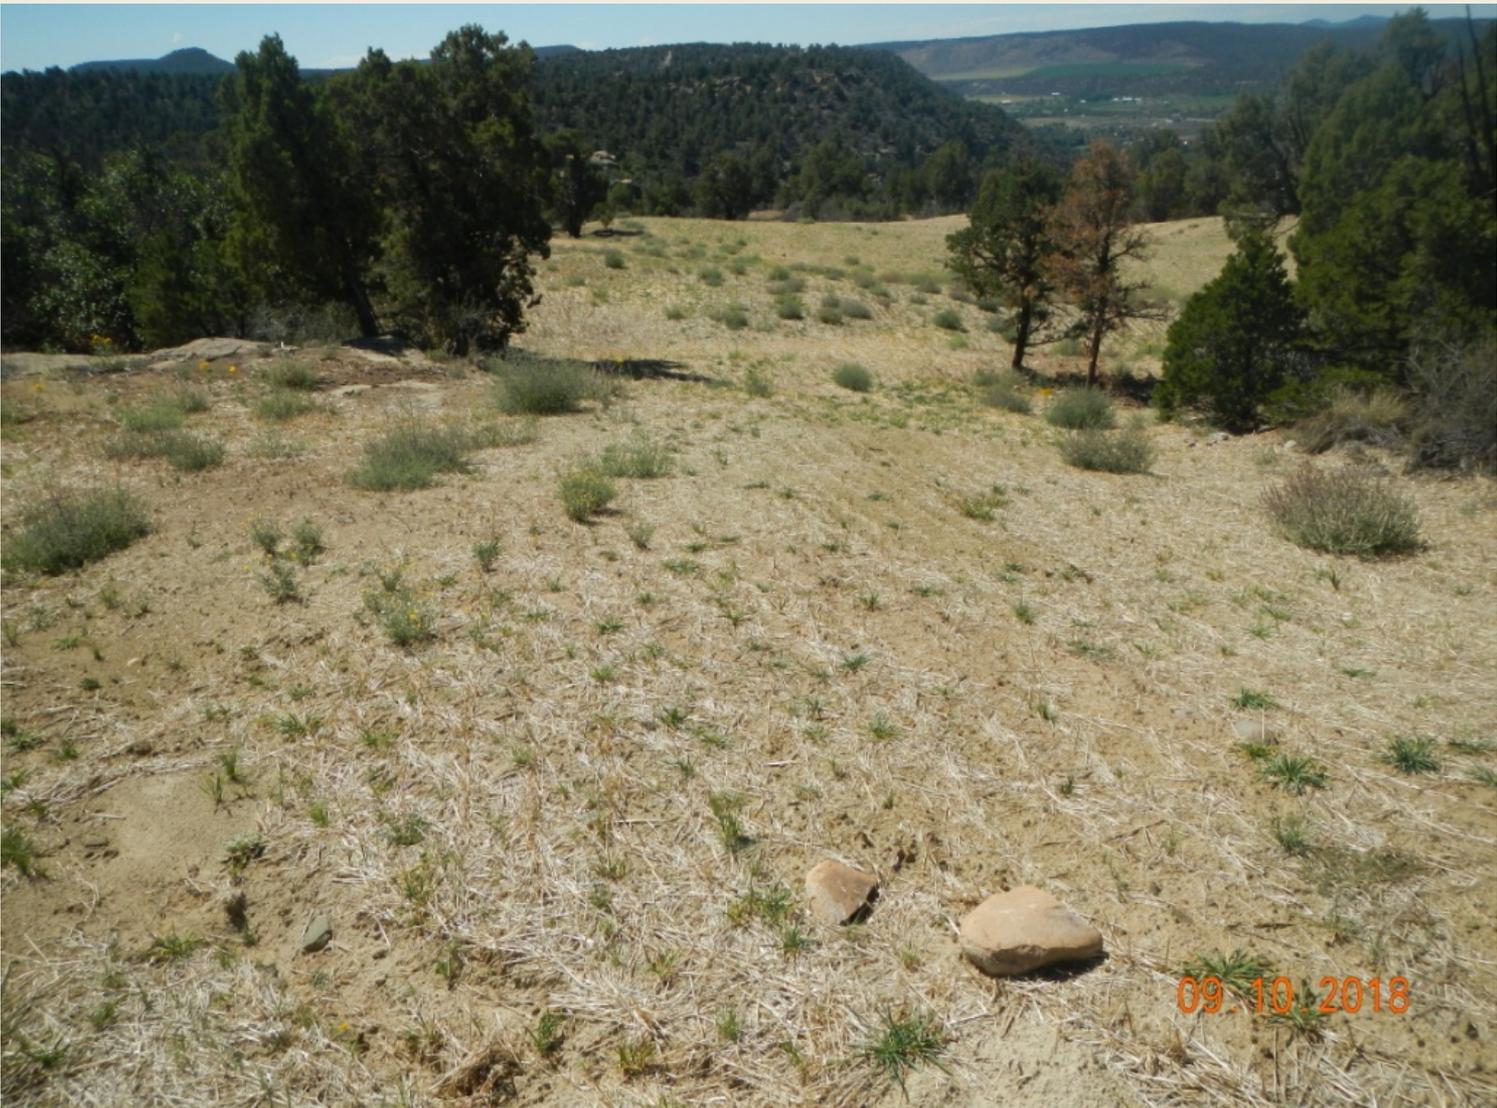
**Photo 1. View of the project area from the beginning of the access road facing southward toward the former well pad. Access road is recontoured and seeded/mulched.**

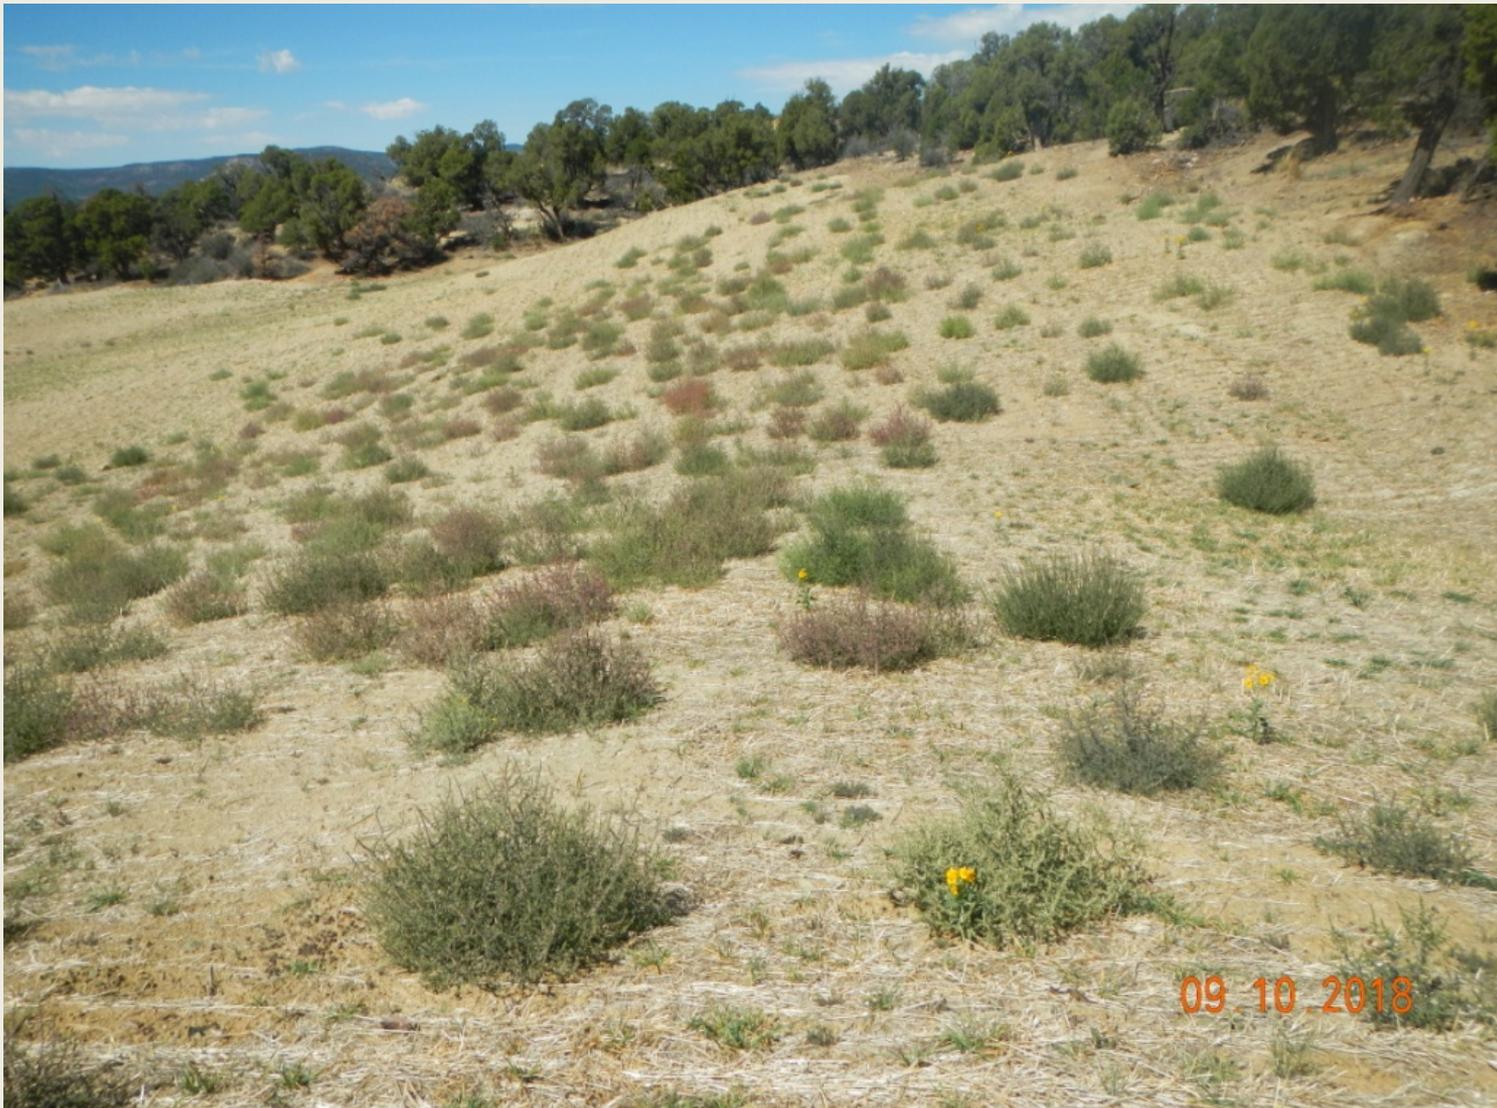
**Photo 2. View of the northern portion of the project area from the northeastern edge facing westward. Revegetation is progressing with grasses and shrubs such as blue grama (*Bouteloua gracilis*) and fourwing saltbush (*Atriplex canescens*), as well as weedy Russian thistle (*Salsola tragus*).**

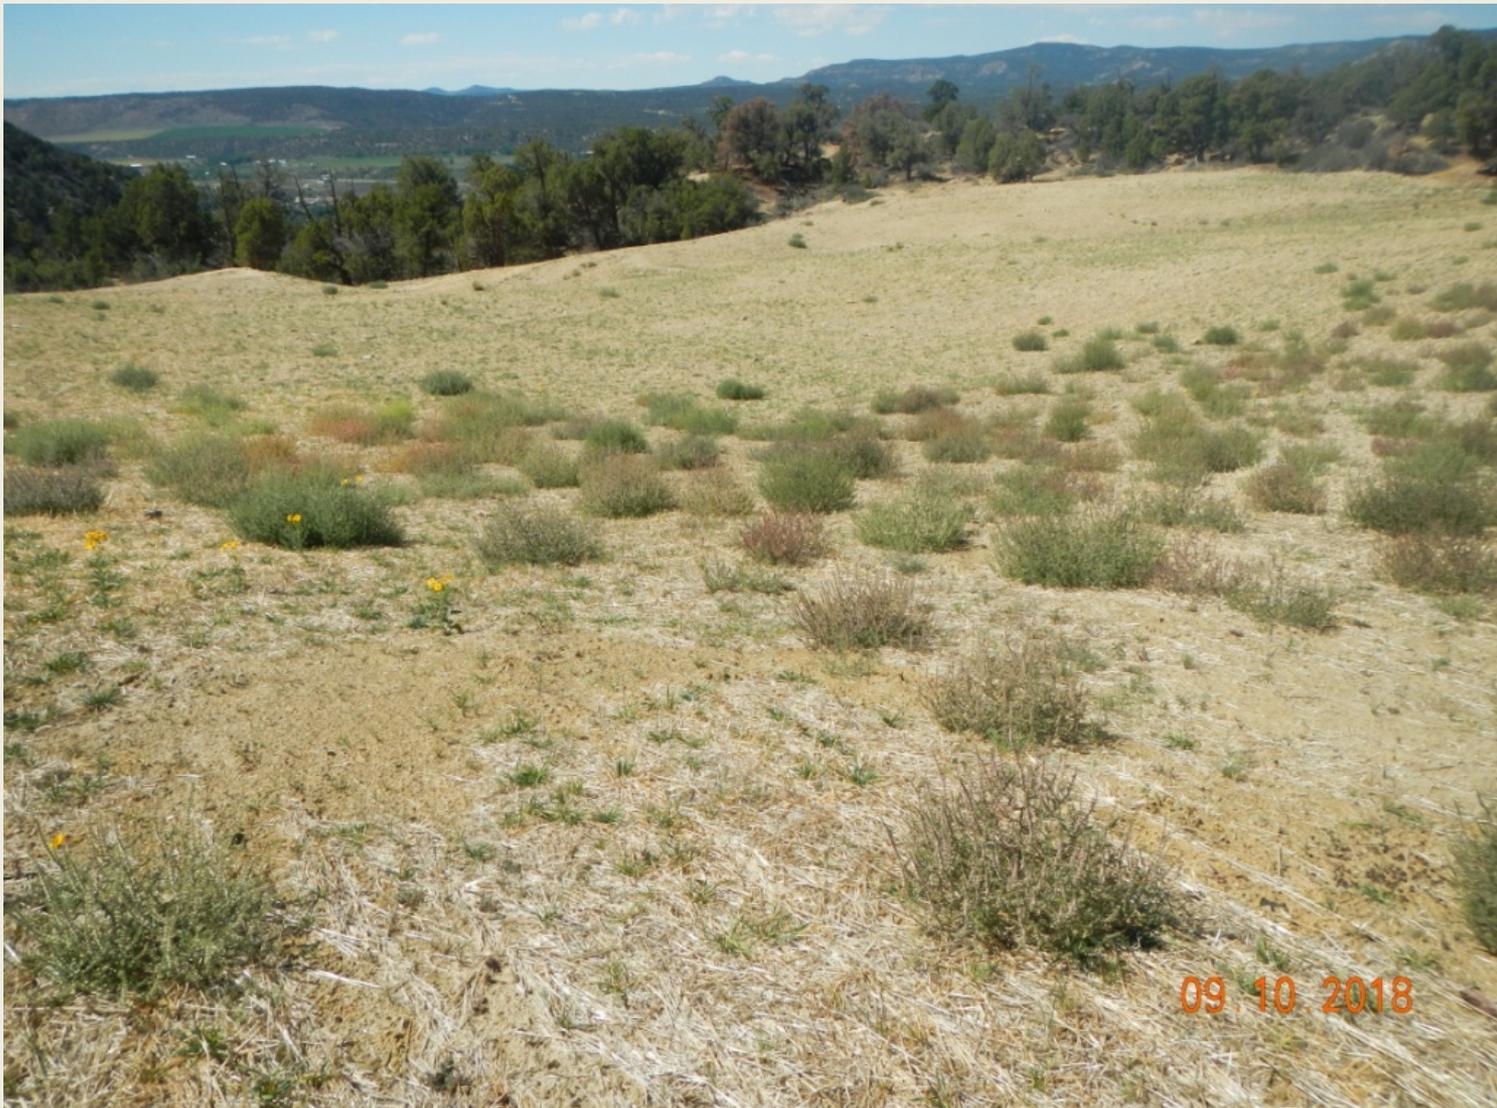
**Photo 3. View of the reclaimed well pad from the northeastern portion facing center. Location is recontoured, seeded, and mulched.**

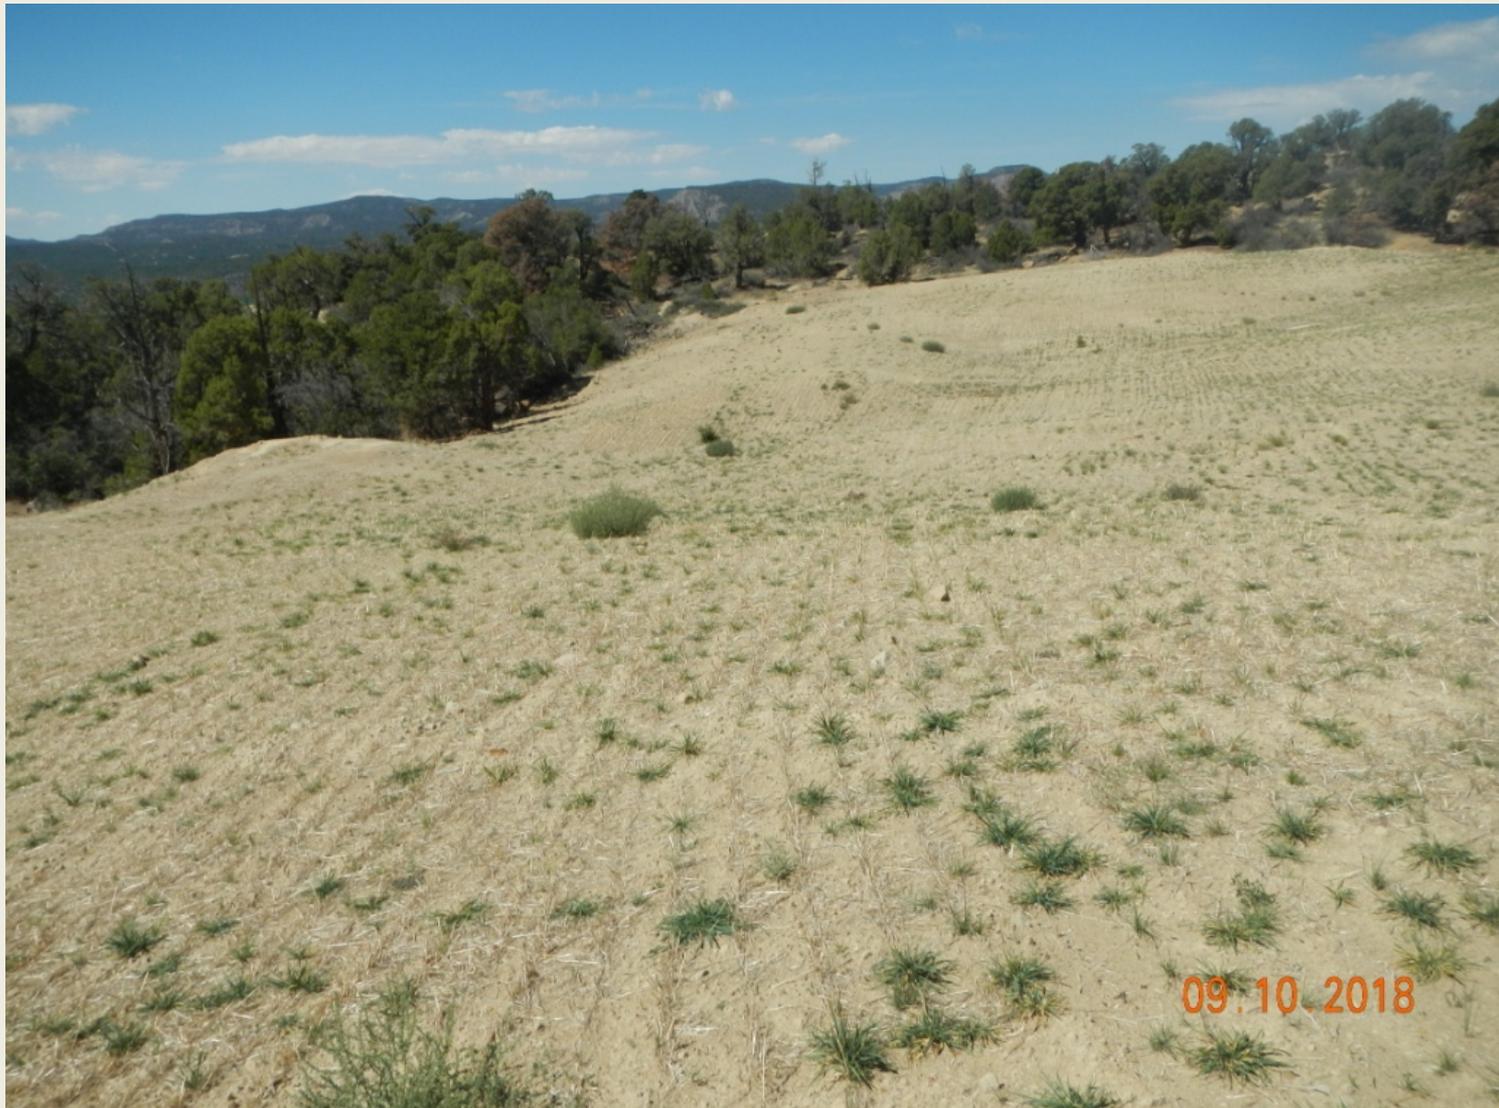
**Photo 4. View of the southern portion of the project area from the southeastern project area facing westward.**

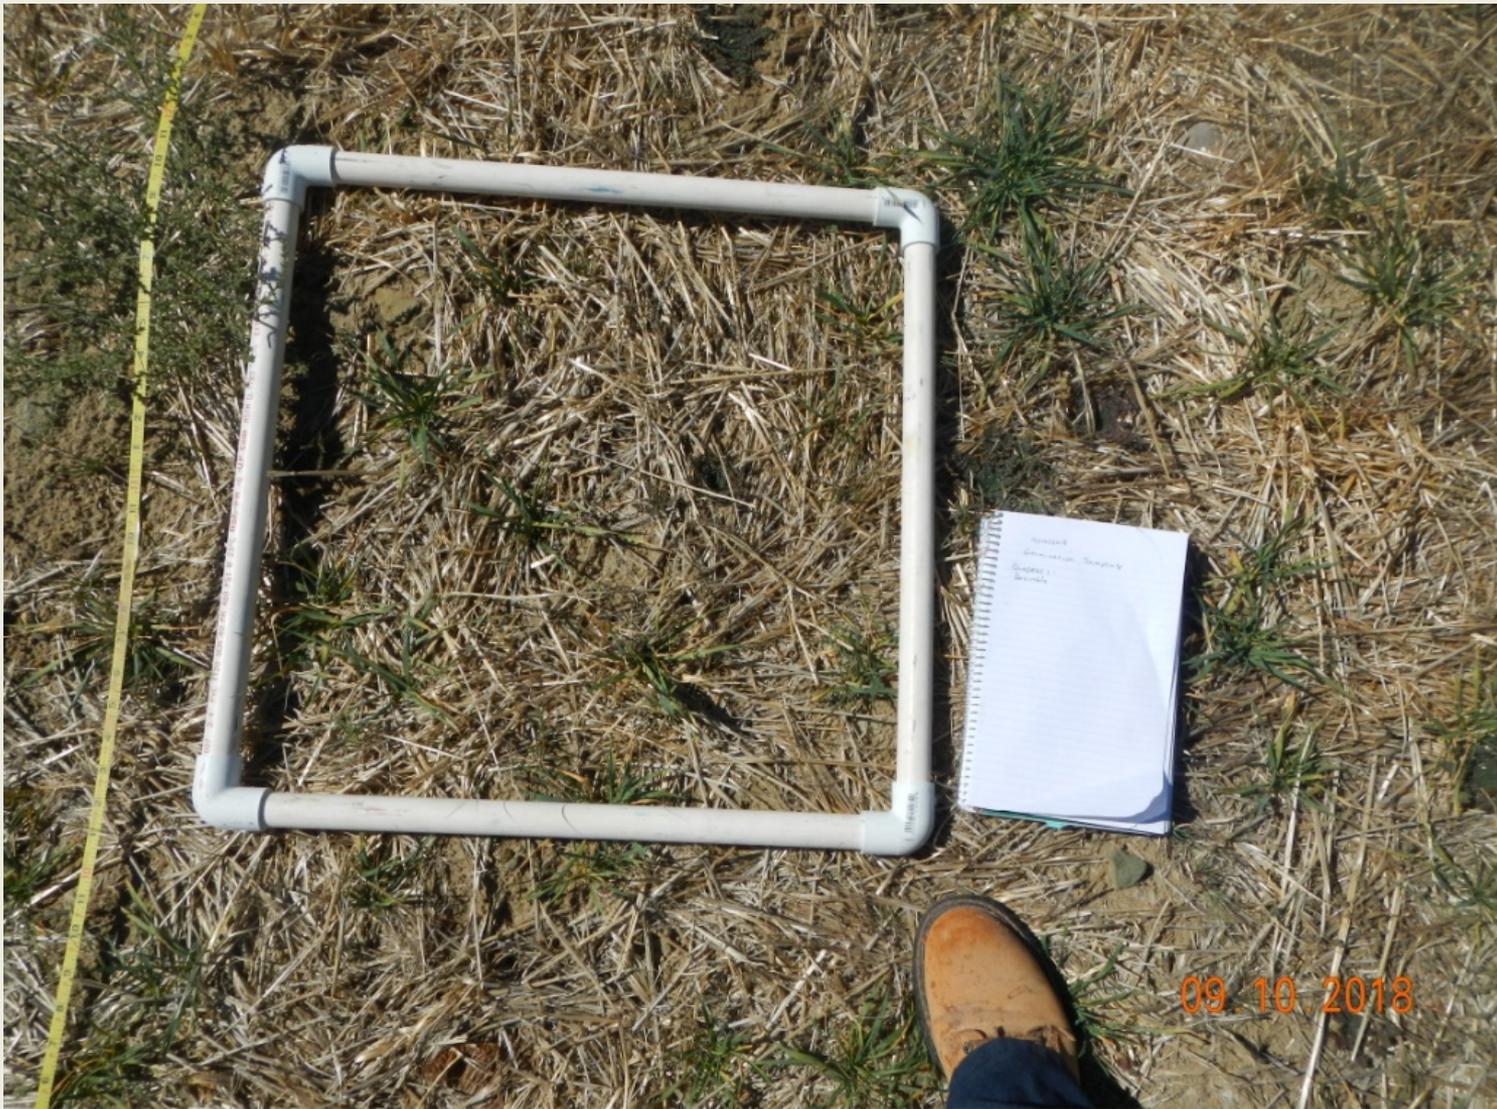
**Photo 5. View of seedling quadrat showing successful germination in quadrat sampling.**

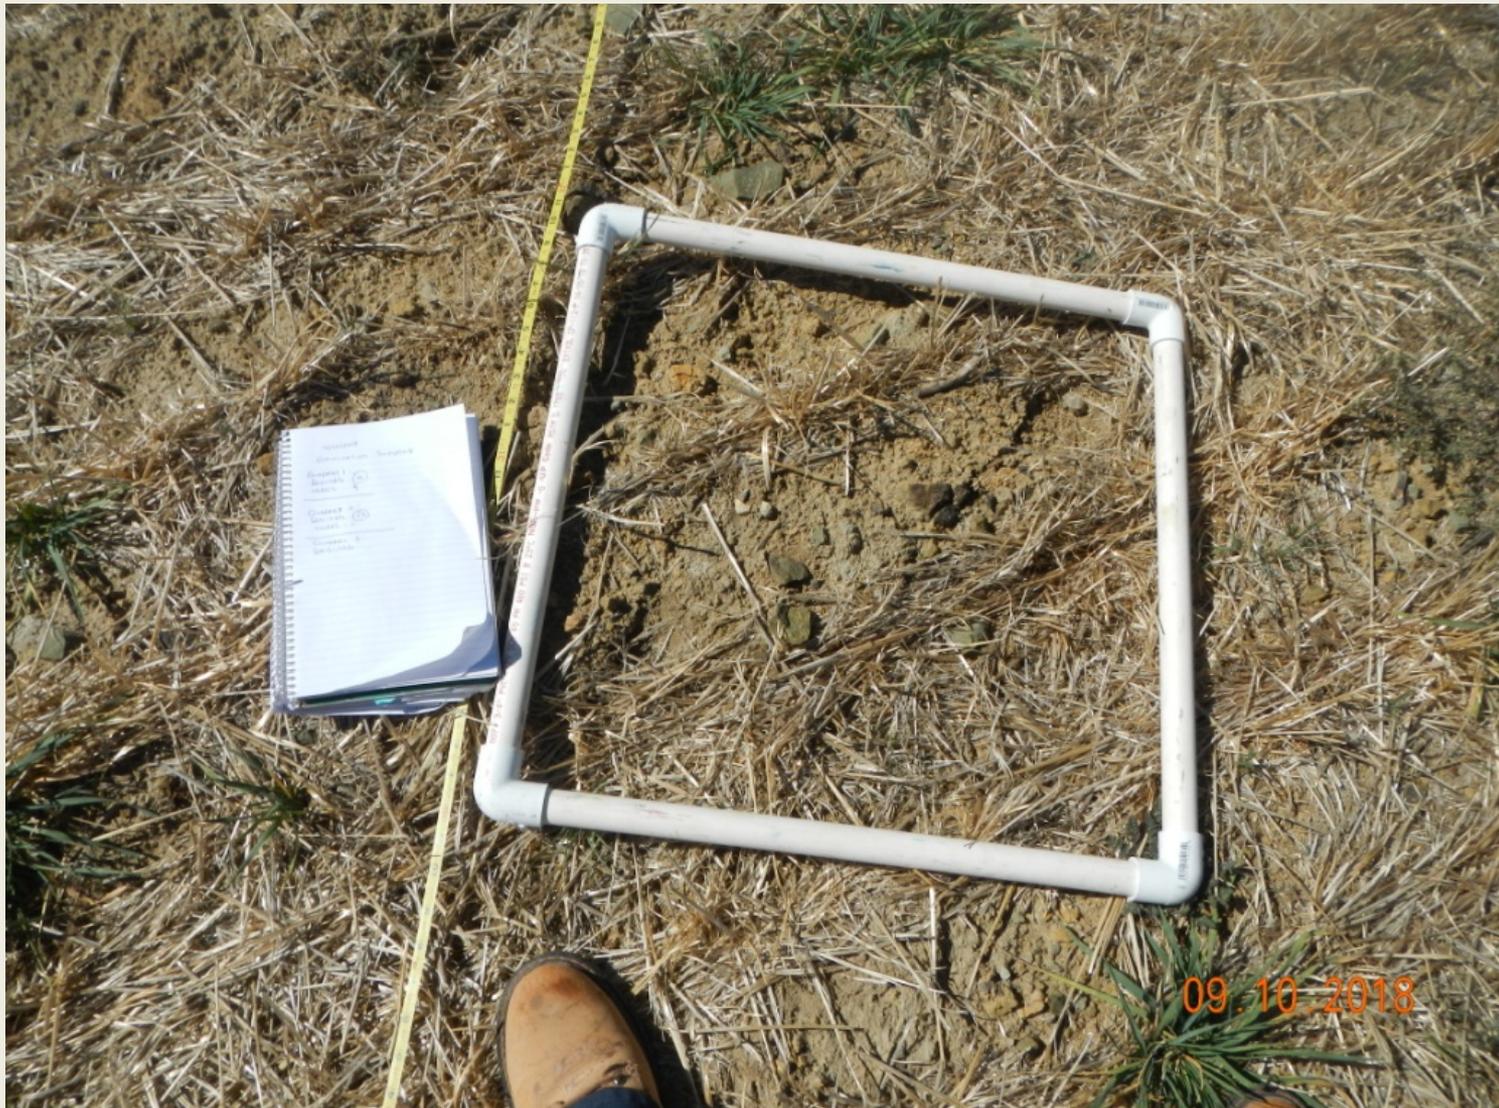
**Photo 6. View of seedling quadrat showing sparse germination in quadrat sampling.**
