Inspection Photo
Cox 33-1
API # 045-13388
Inspection # 689301909

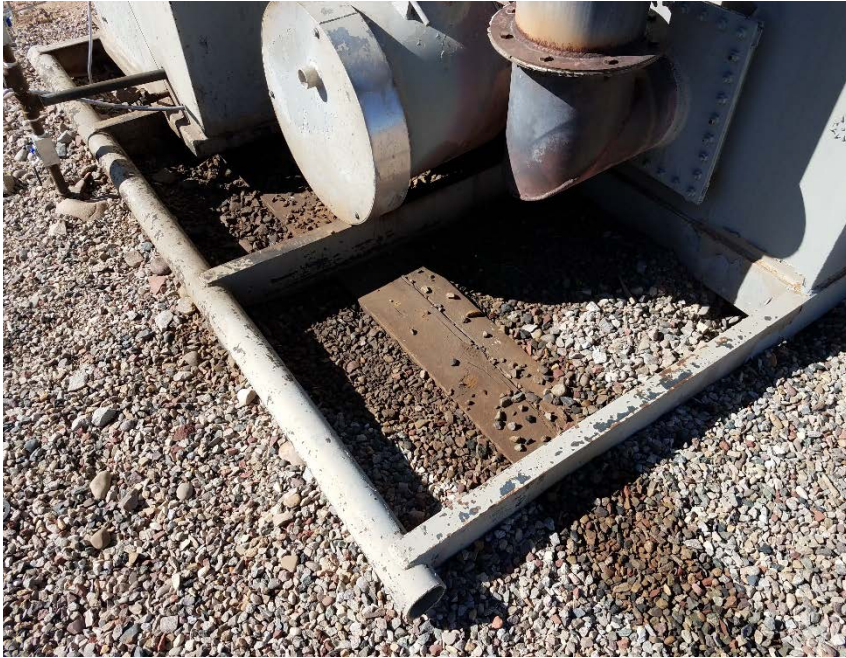
Location Photo #3, stained round near separator

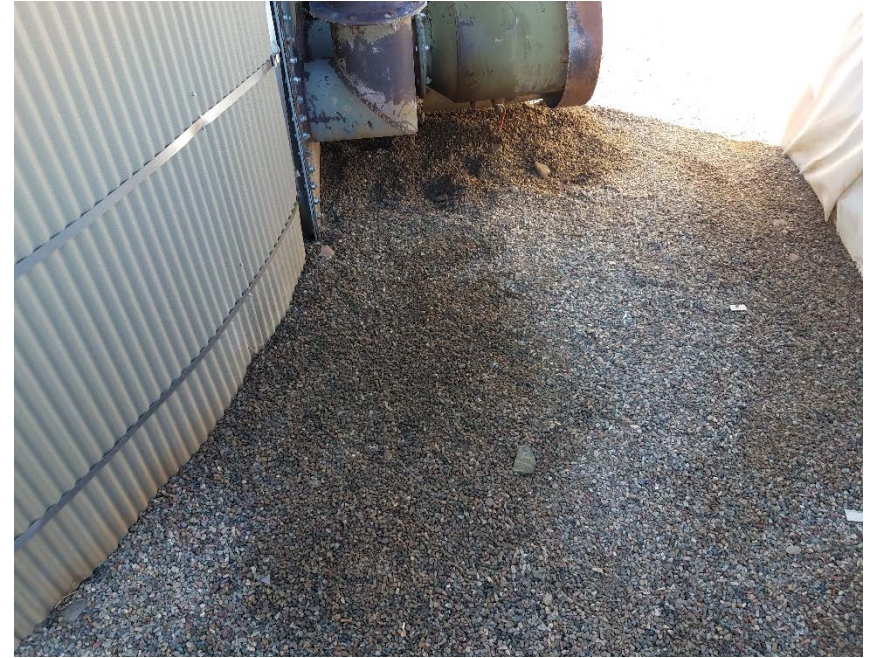
Location Photo #4, battery containment

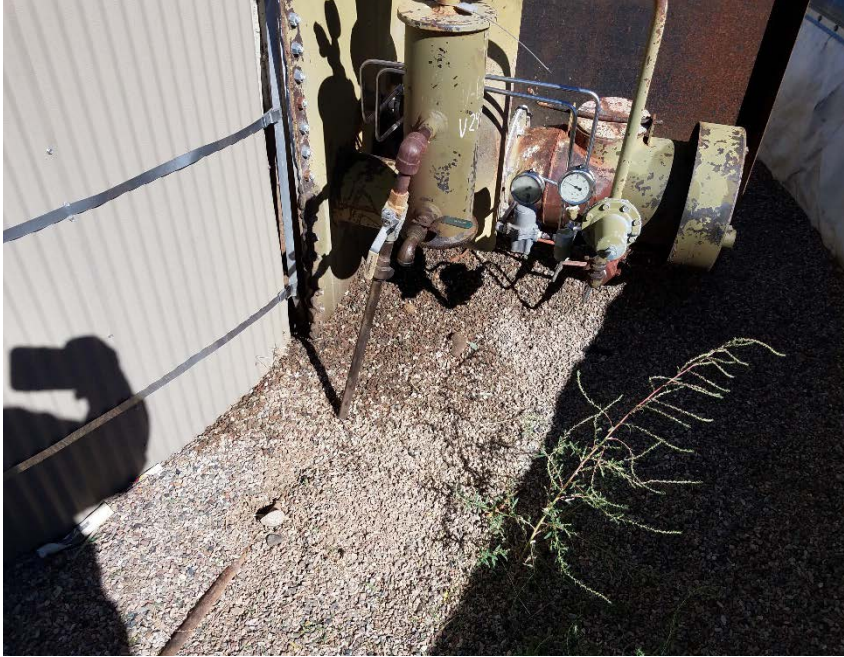
Location Photo #5, battery containment
