**Inspection Photo
Bell 34-4C
API # 045-10129
Inspection # 689301911**

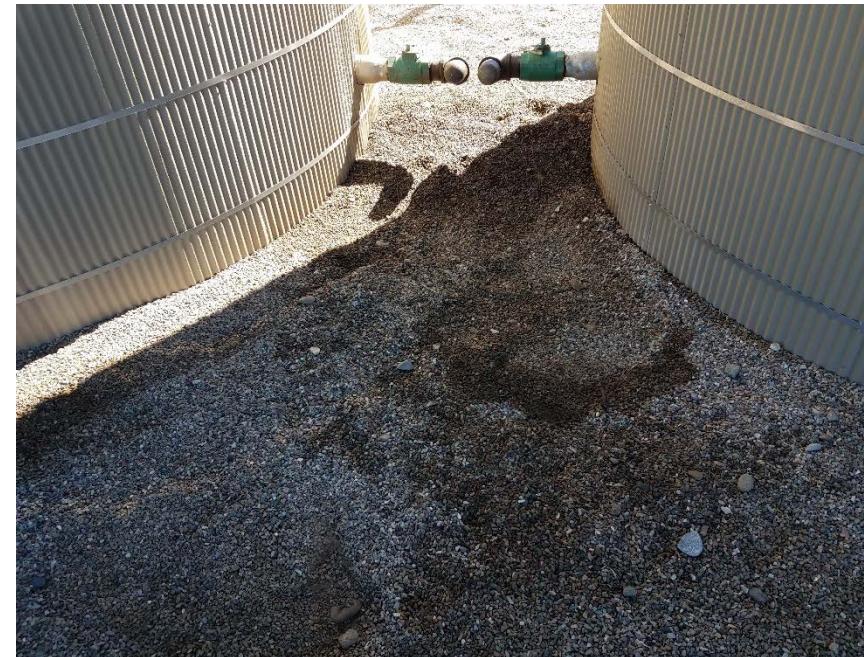
Location Photo #2, battery containment

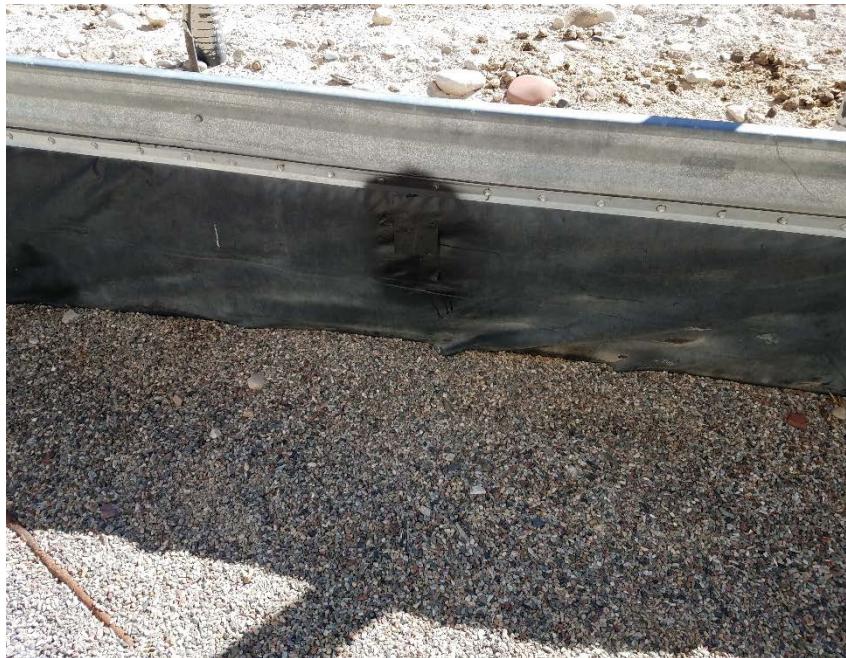
Location Photo #3 repaired holes

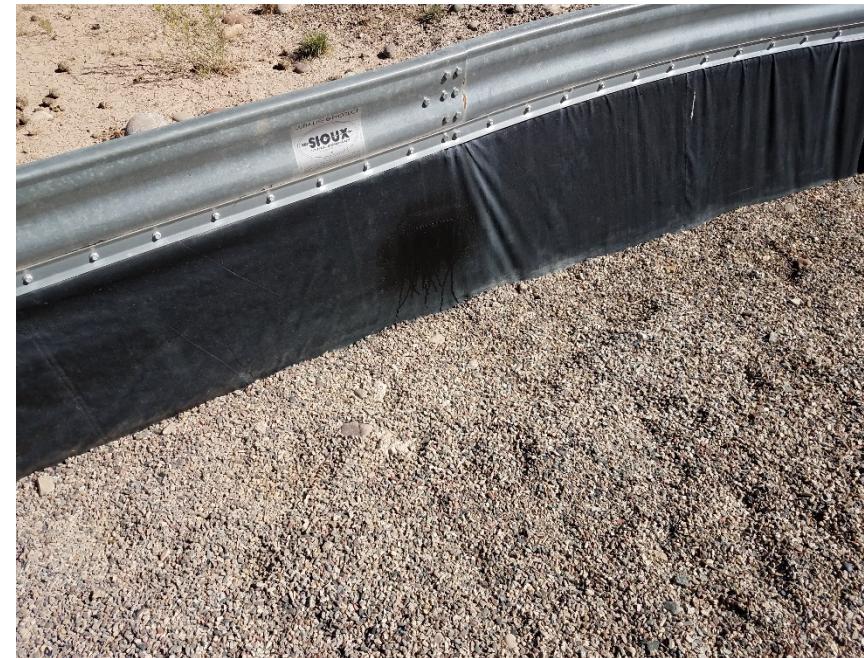
Location Photo #4, repaired holes

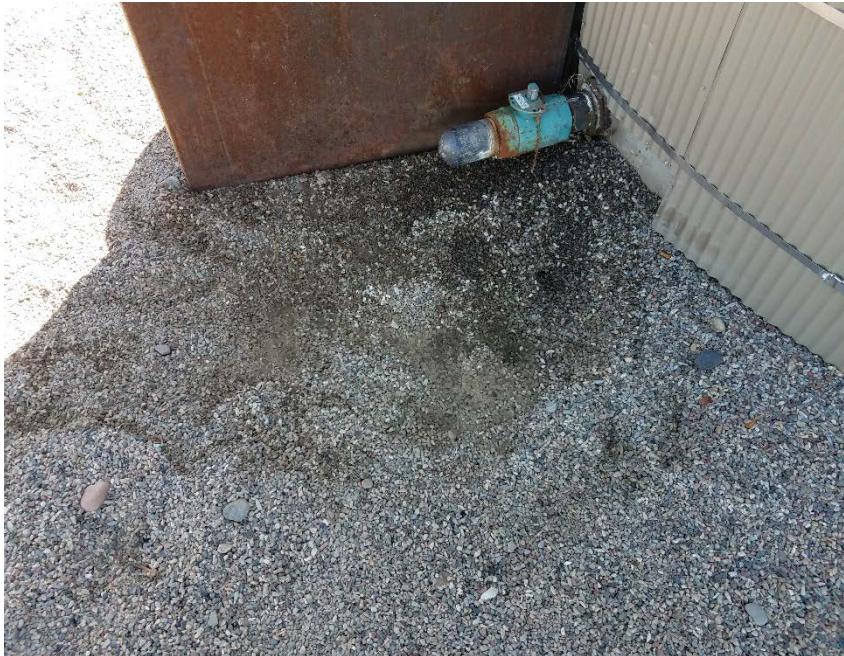
Location Photo #5, battery containment
