Inspection Photos

Operator: Hilcorp Energy

API: 05-067-08485

Date: 9/10/2018

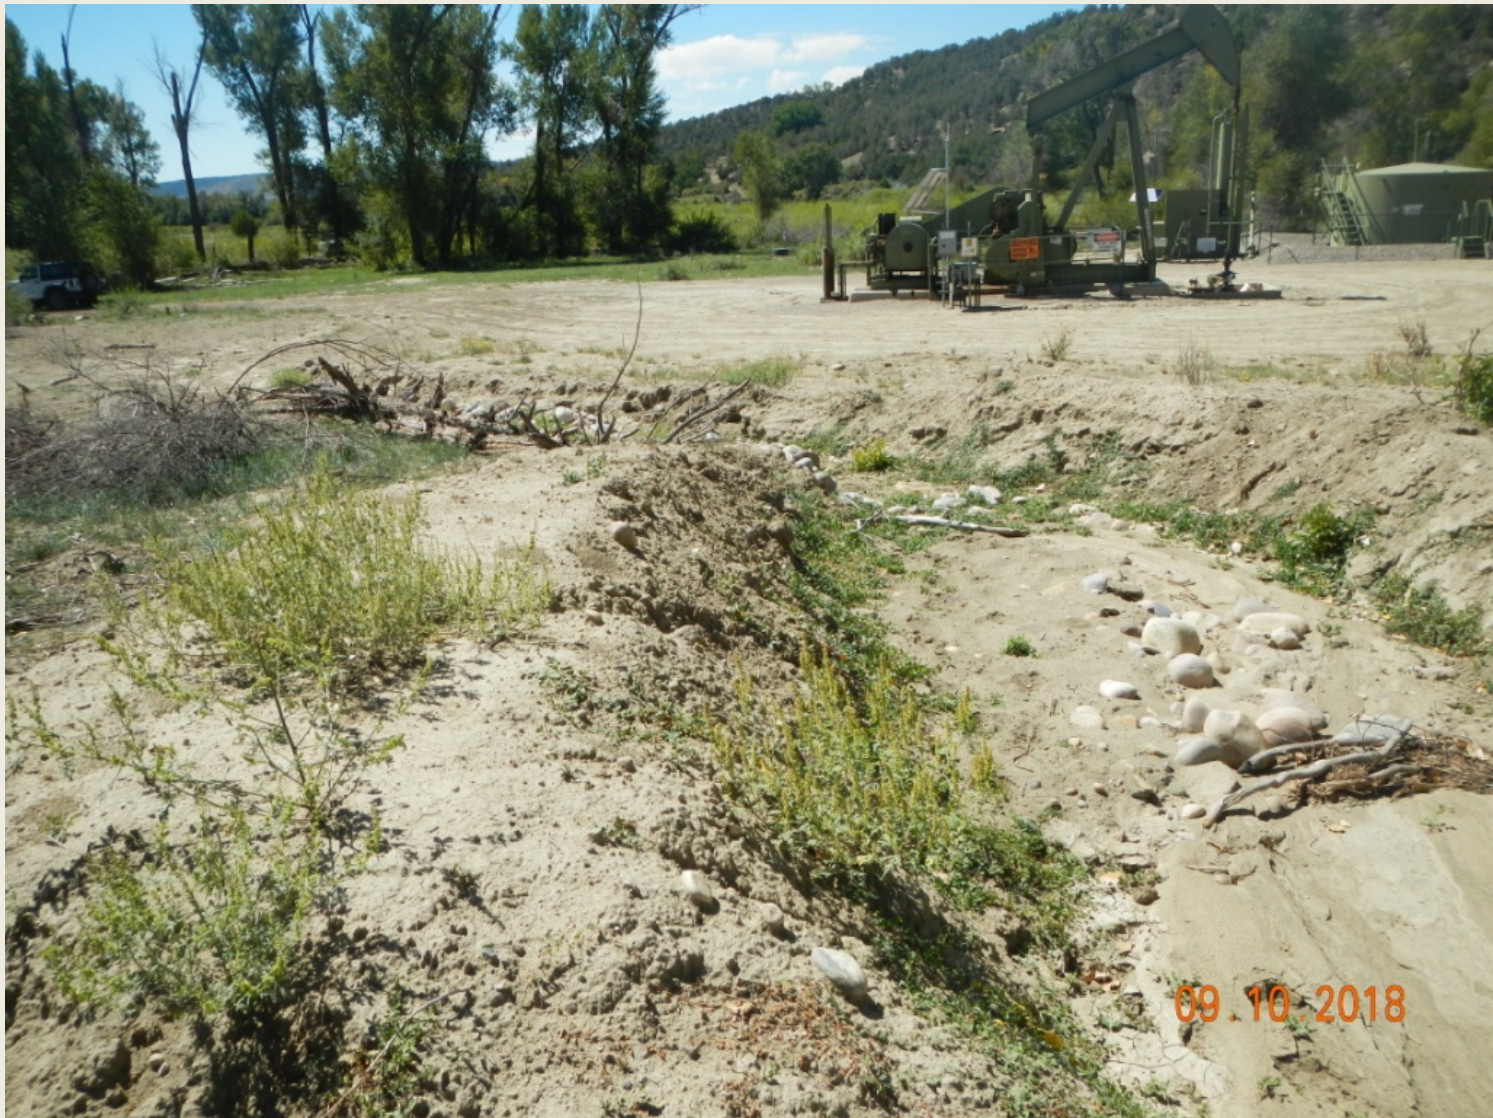
Photo 1. View of stormwater diversion with outlet on the well pad. It appears cobble was placed in the channel. Cobble is already inundated with sediment. Evidence of recent sediment deposition and stormwater flows observed on the well pad. Corrective action not addressed.

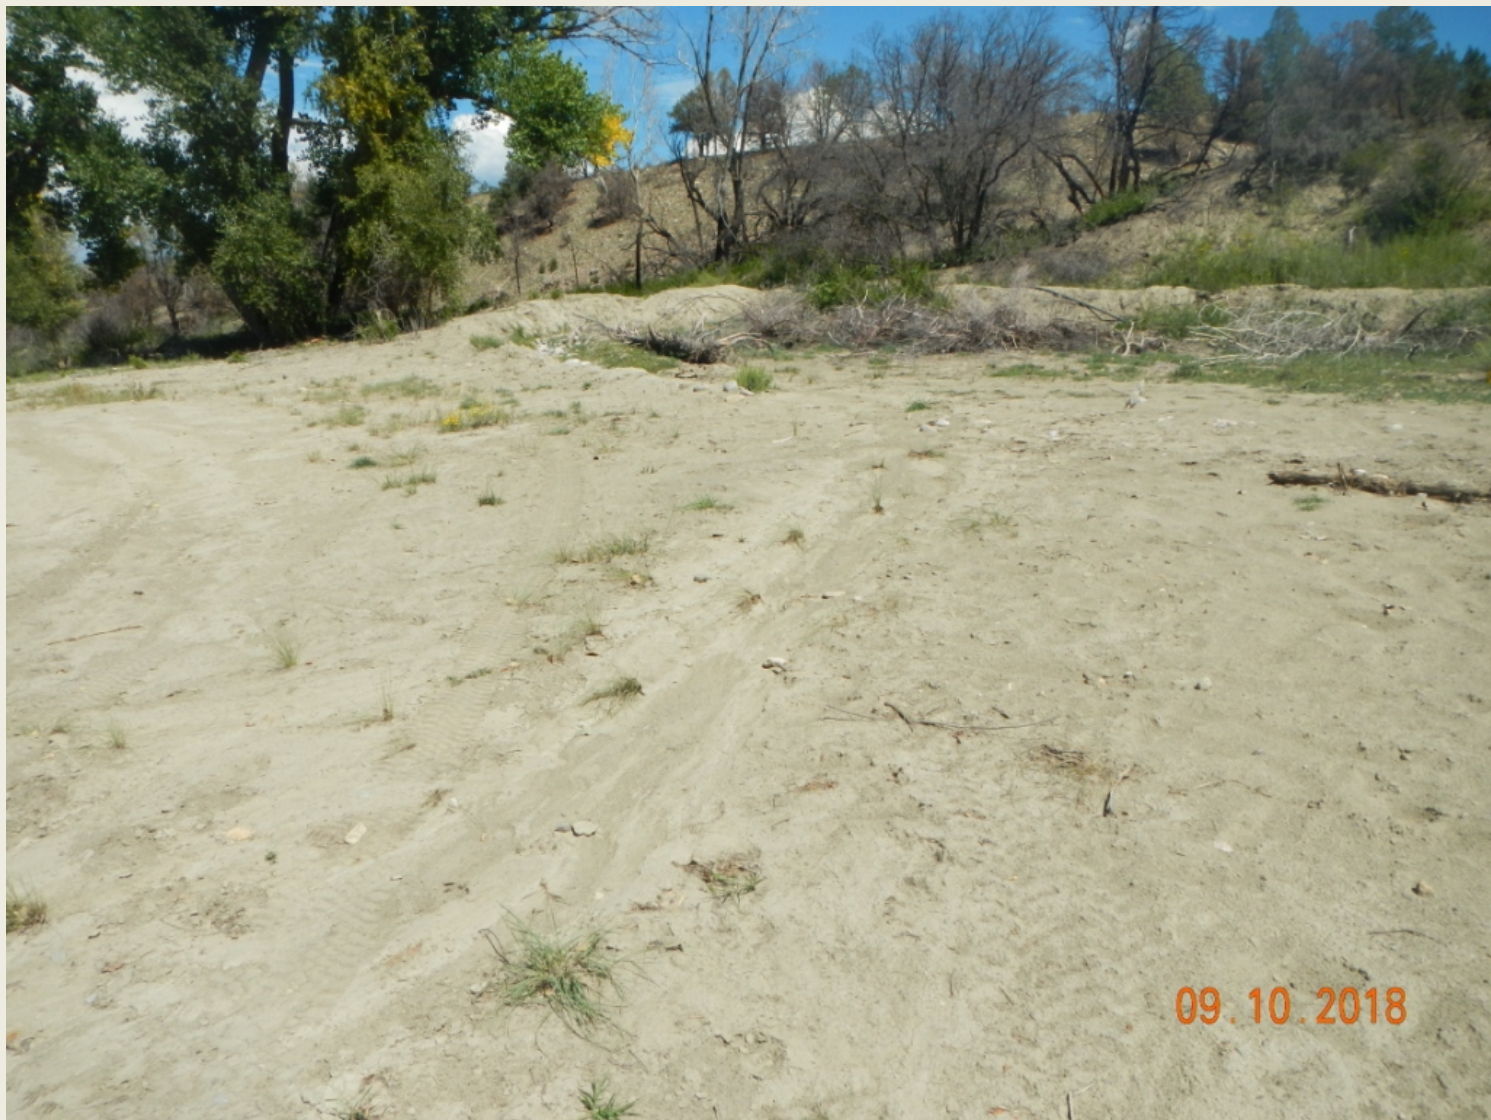
Photo 2. View of sediment deposition and evidence of recent stormwater flows on the well pad, downstream of Photo 1.

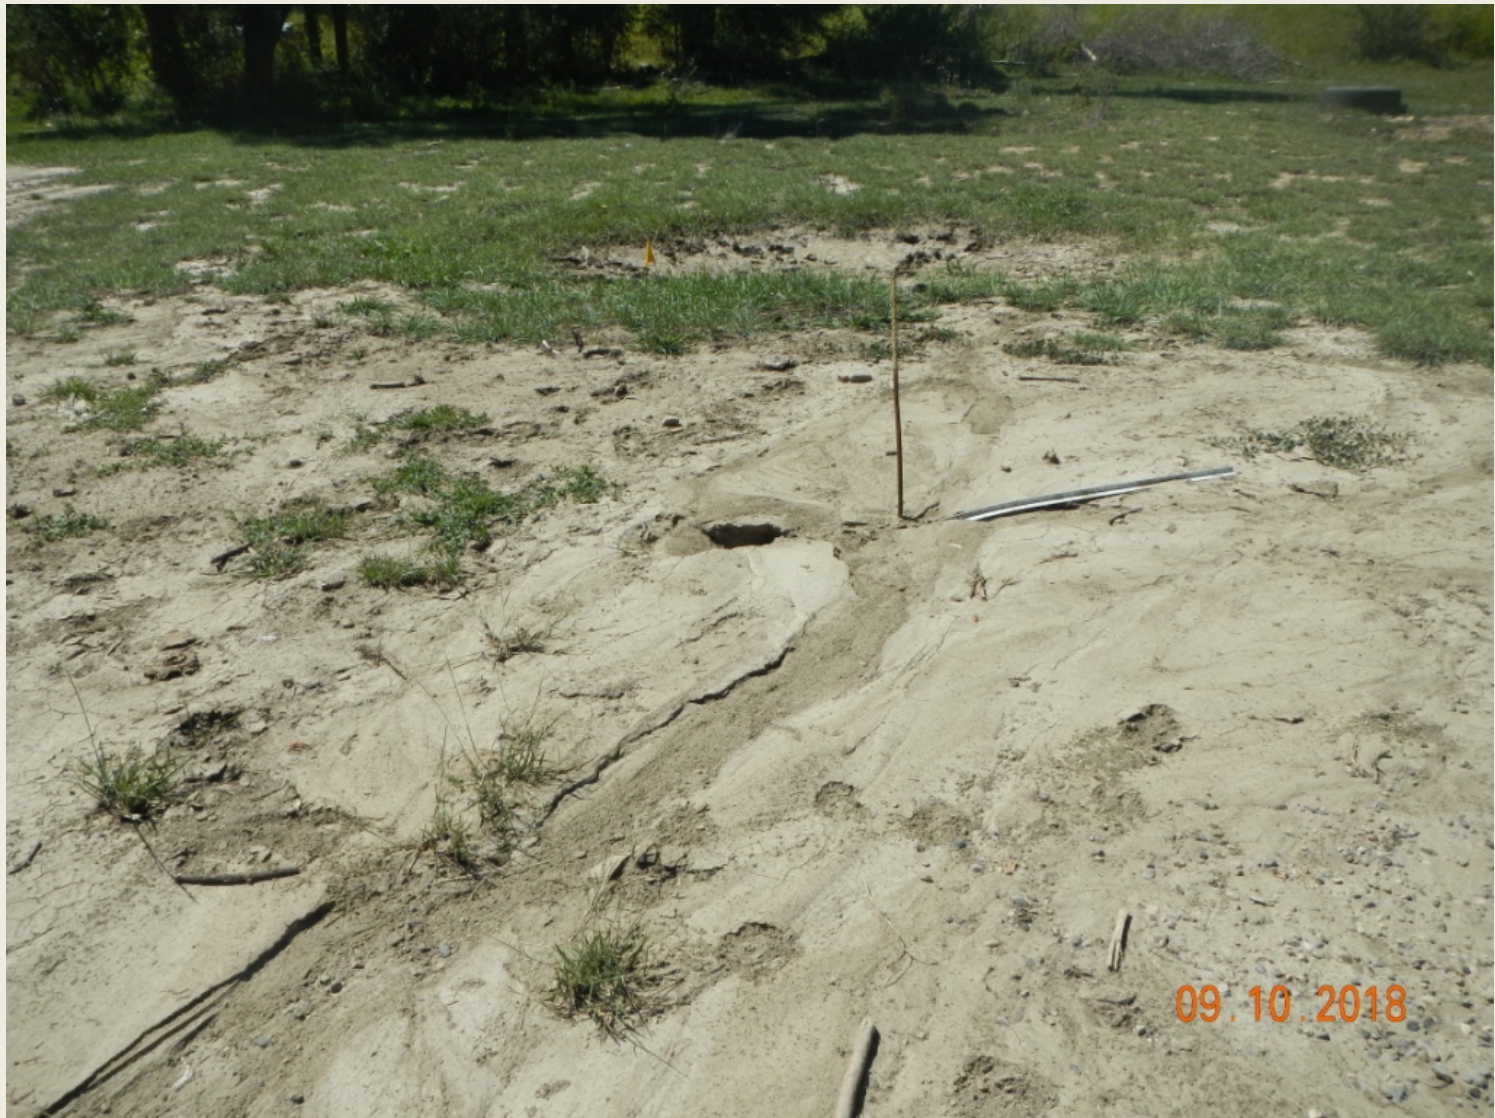
Photo 3. View of sediment deposition within the southwestern project area, downstream from photos 1 and 2. Sediment appears to be impeding desirable vegetation. Wire documented in earlier inspection is not addressed.

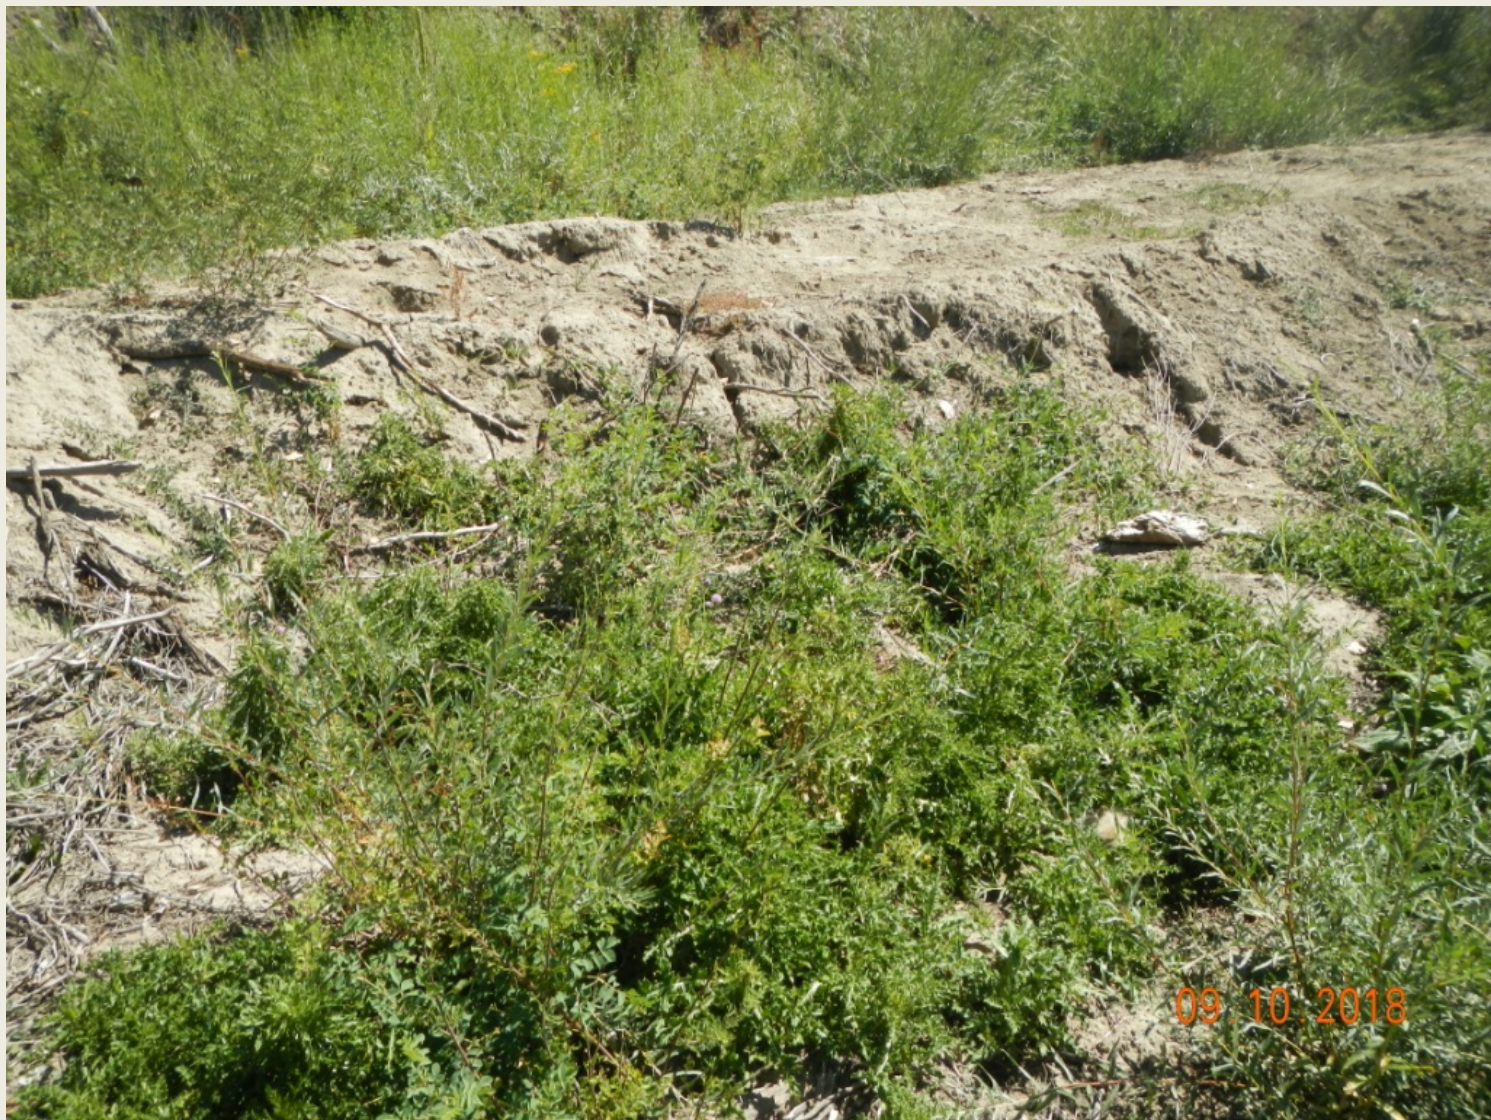
Photo 4. View of Canada thistles (*Cirsium arvense*) within the eastern project area.

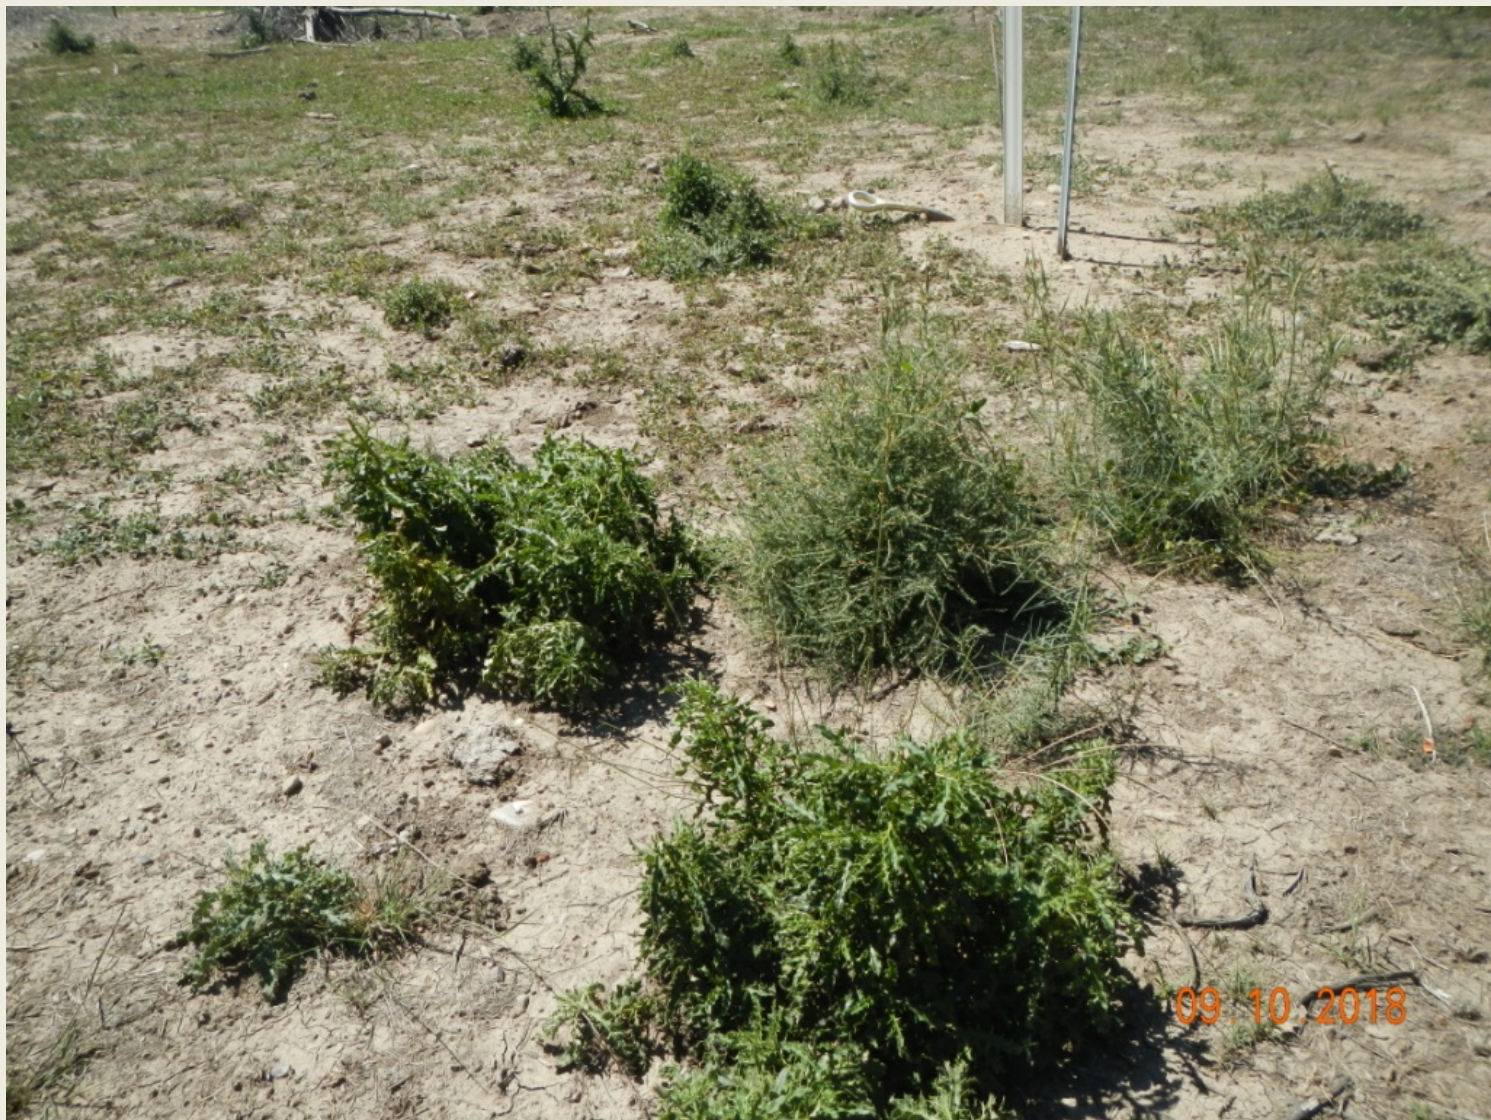
Photo 5. View of musk thistles (*Carduus nutans*) and Canada thistles within the northwestern portion of the project area.
