# Inspection Photos

Operator: Logos Operating

API: 05-067-06443

Date: 9/10/2018

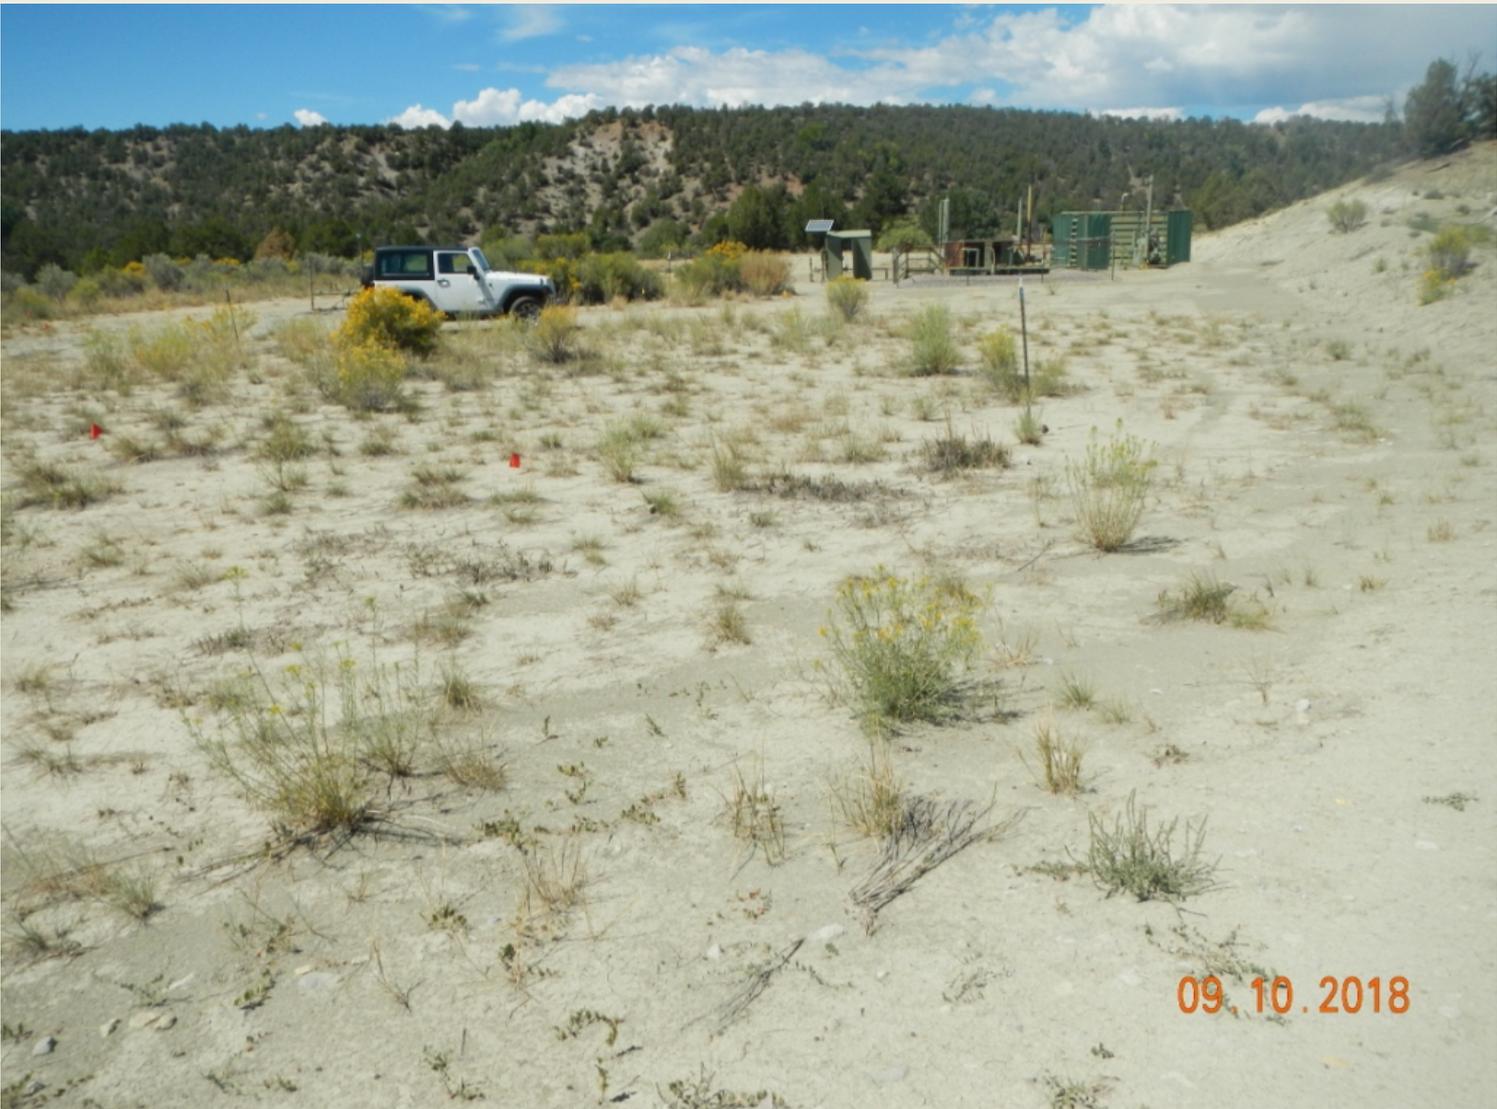
**Photo 1. View of the project area from the northeastern corner facing center.**

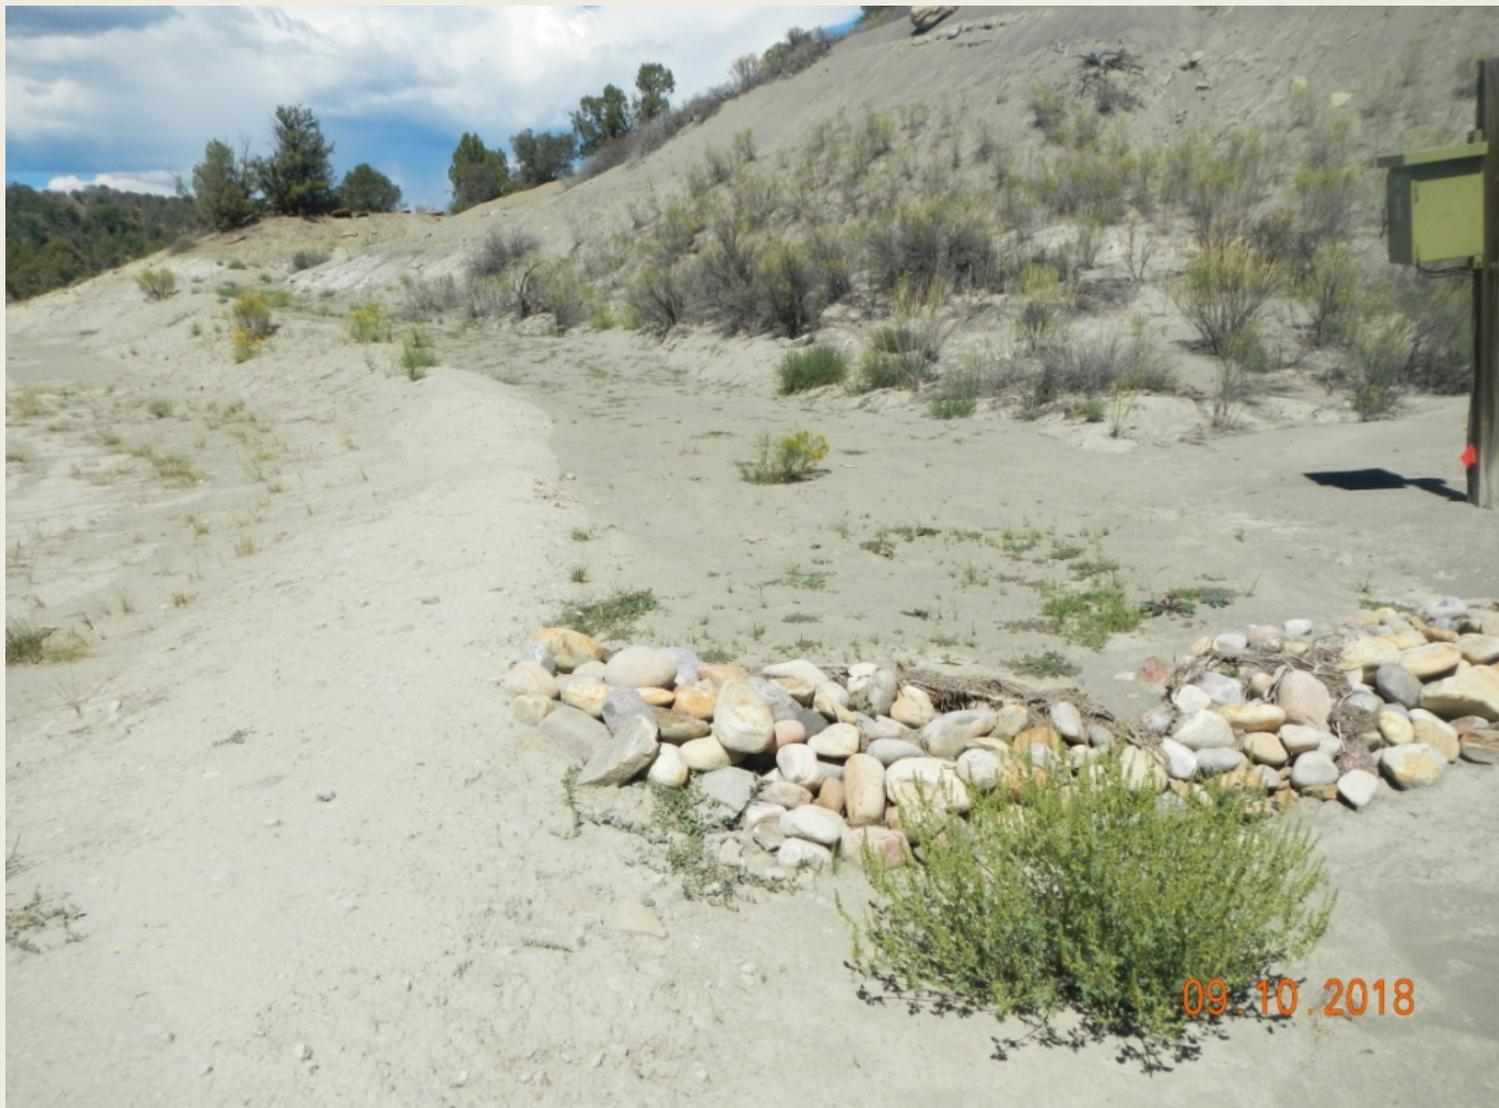
**Photo 2. View of the northern project area. Cobble sediment trap is recently installed and appears to be functioning, but is full of sediment and needs maintenance. Revegetation of northern berms and cleaning sediment from diversion will help control erosion.**

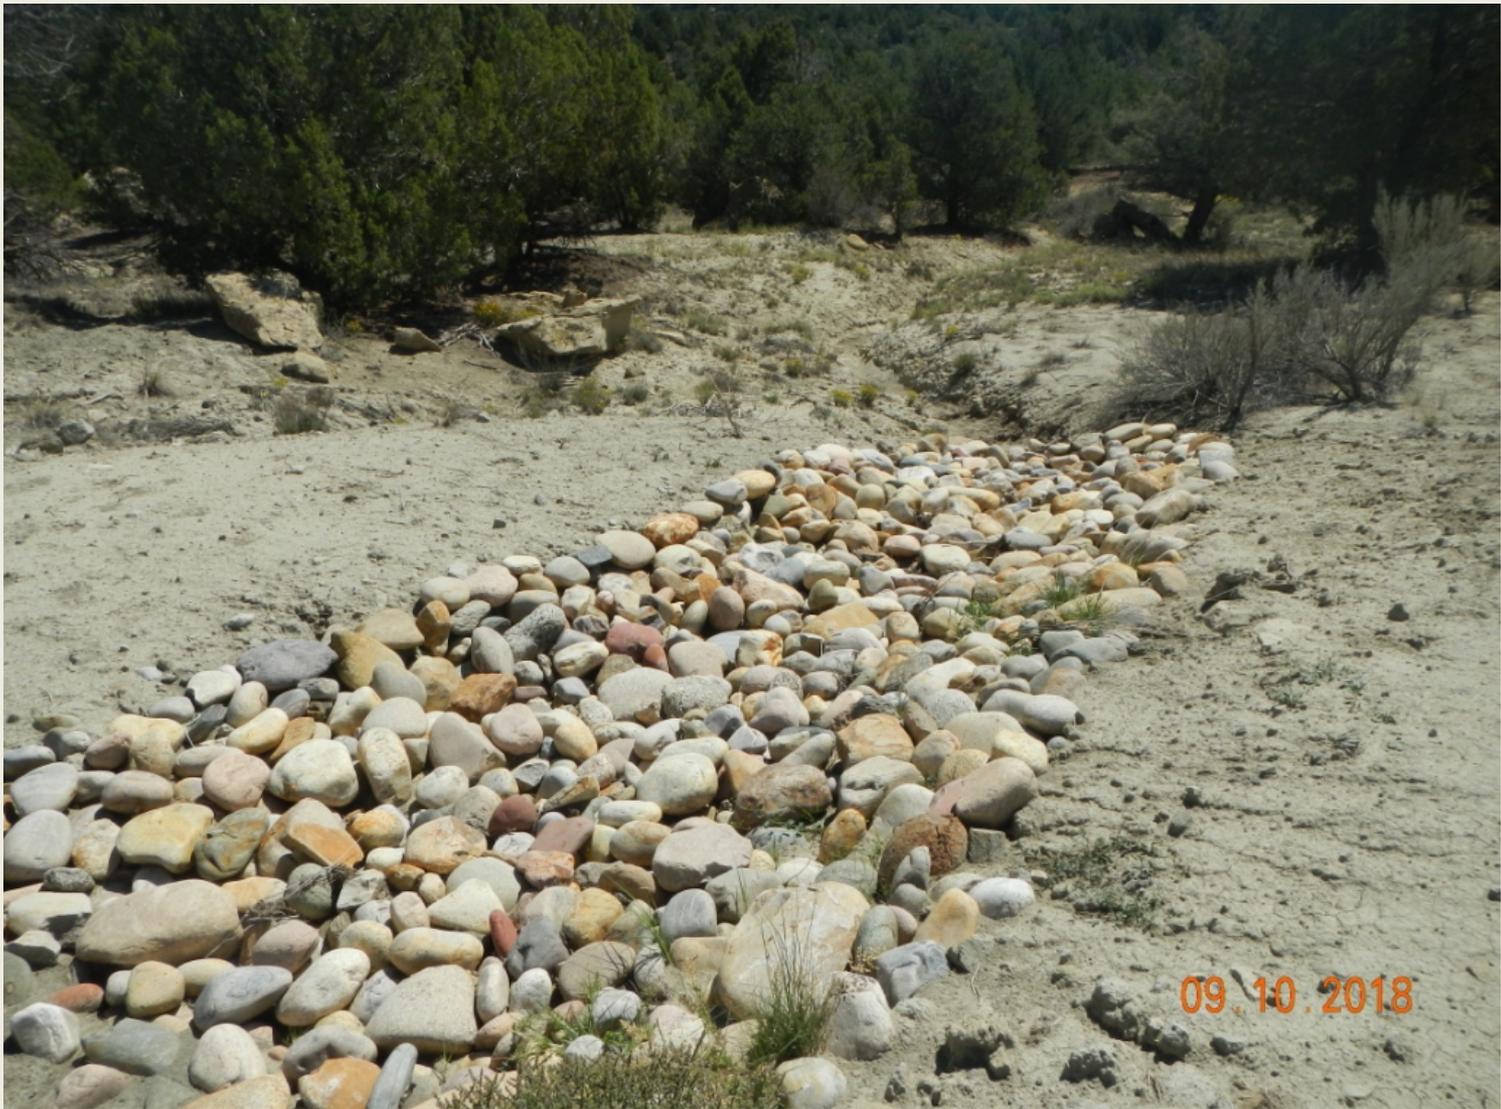
**Photo 3. View of cobble run-down in the northeastern project area in good condition.**

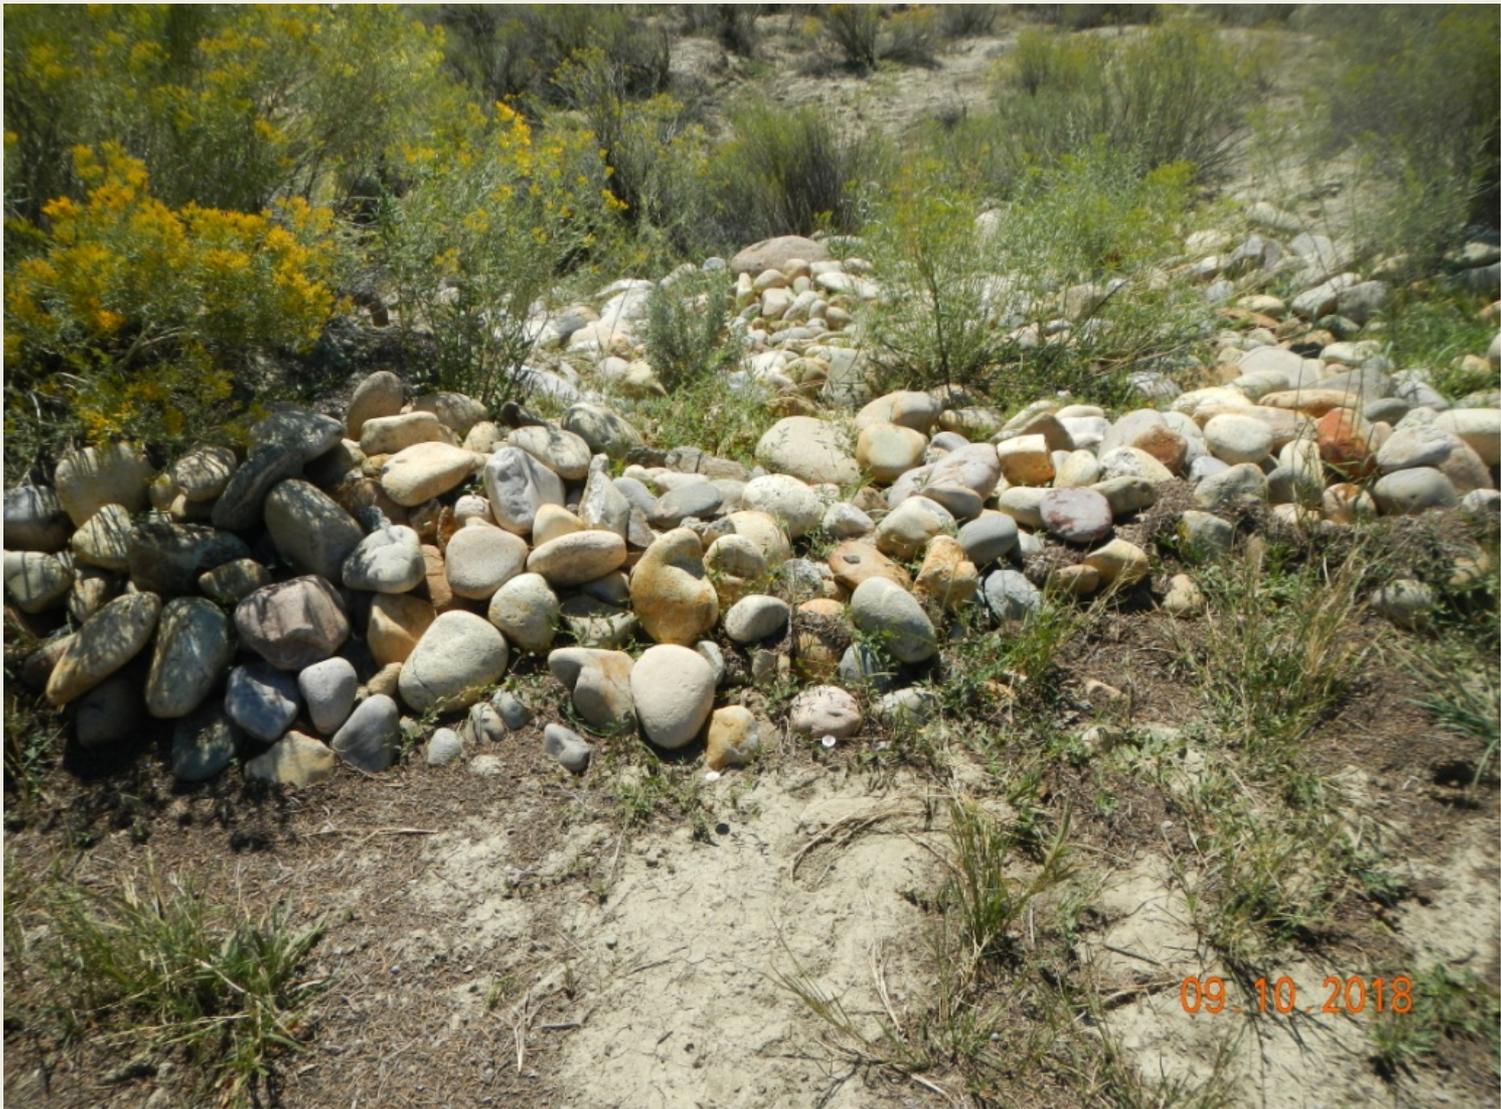
**Photo 4. View of cobble run-down in the southern project area in good working condition.**
