Inspection Photo
Clough RWF 512-11
API # 045-12668
Inspection # 689301925

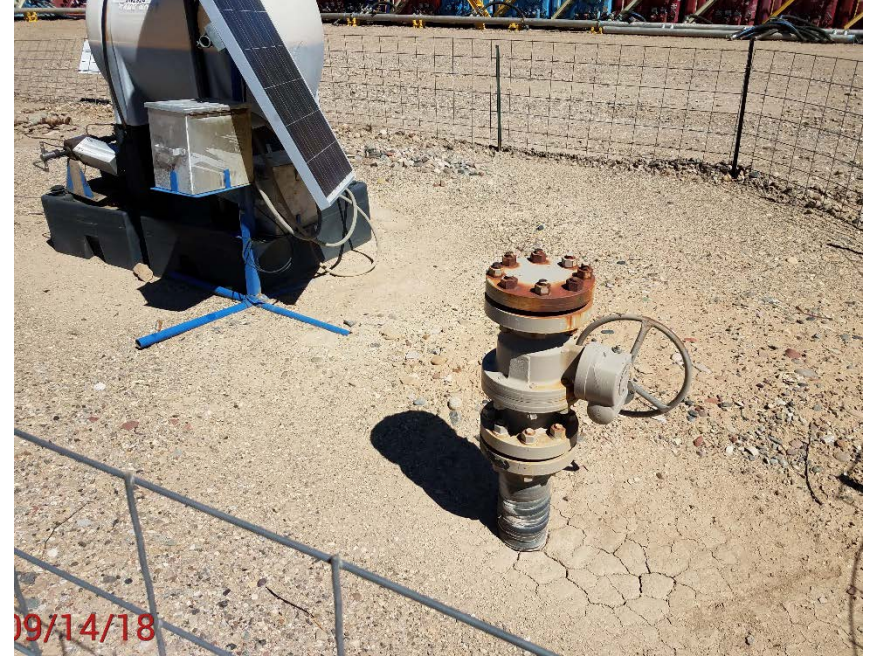
Location Photo #4, unmarked flowline riser

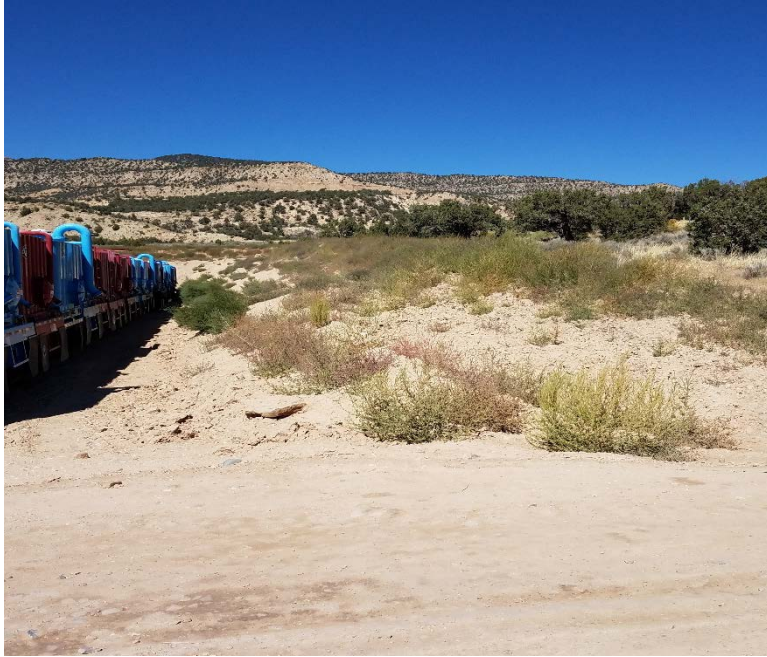
Location Photo #5, uncontrolled weeds on berm

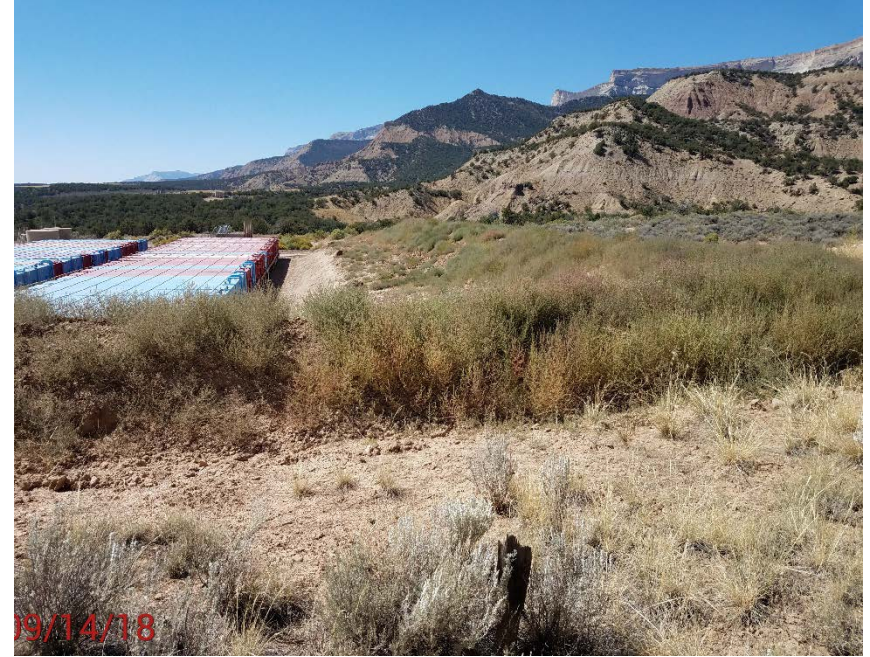
Location Photo #6, uncontrolled weeds on berm.

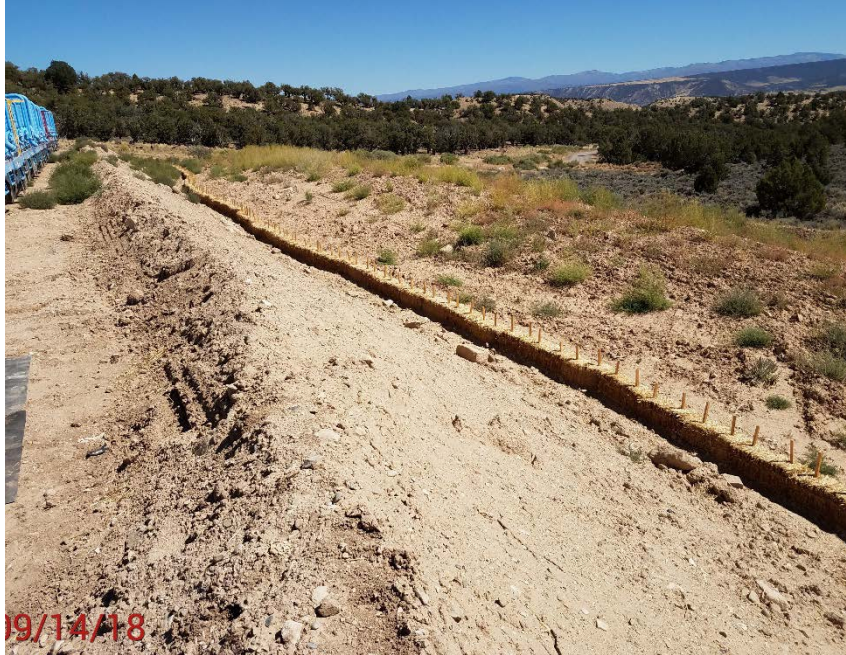
Location Photo #7, uncontrolled weeds on berm.

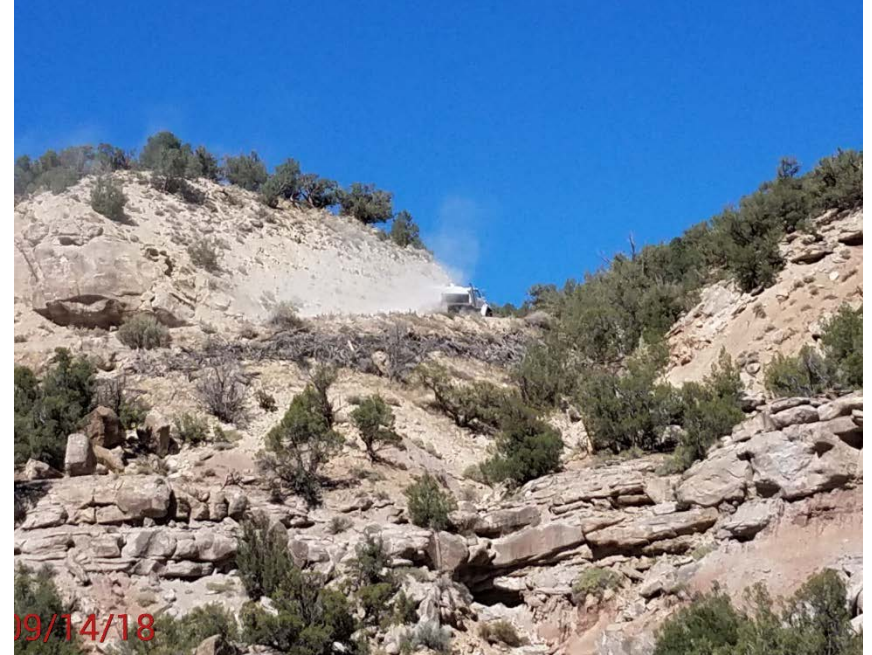
Location Photo #8, fugitive dust on access road .

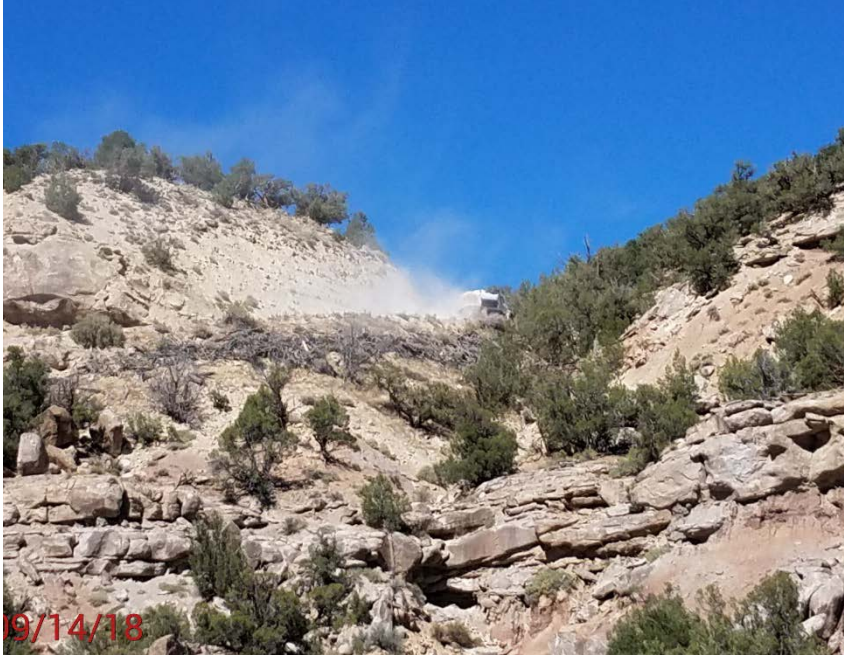
Location Photo #9, fugitive dust on access road .

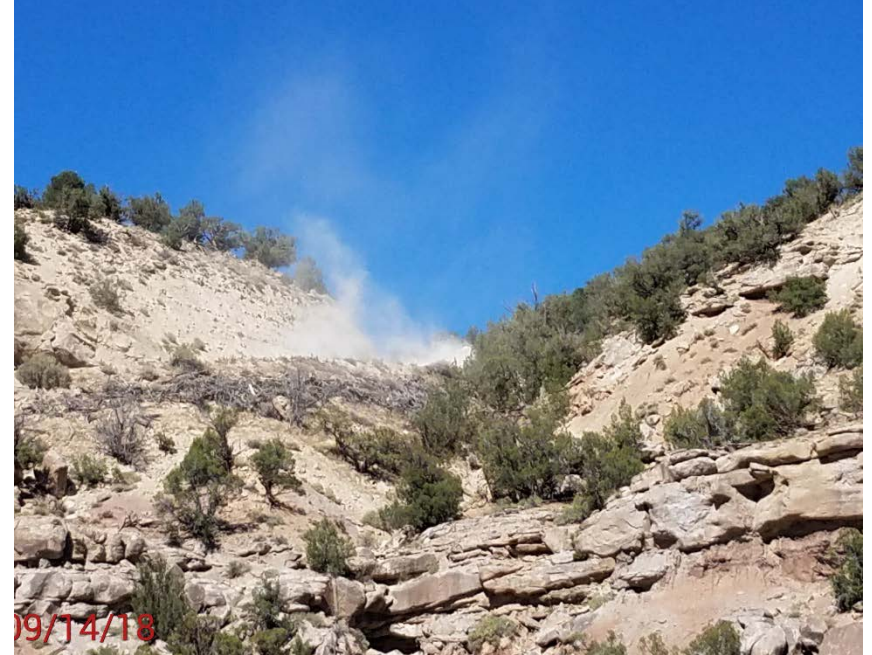
Location Photo #10, fugitive dust on access road .

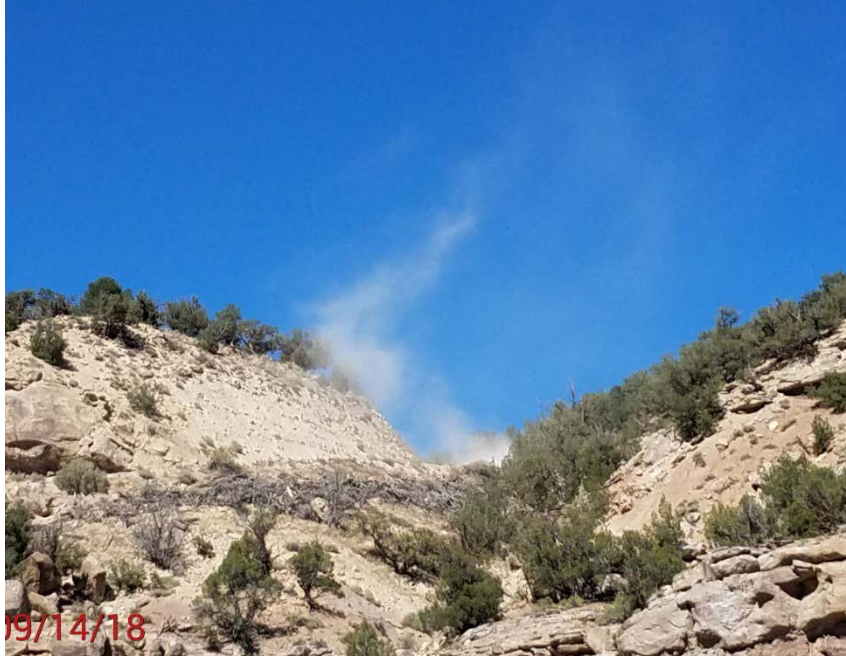
Location Photo #11, fugitive dust on access road .

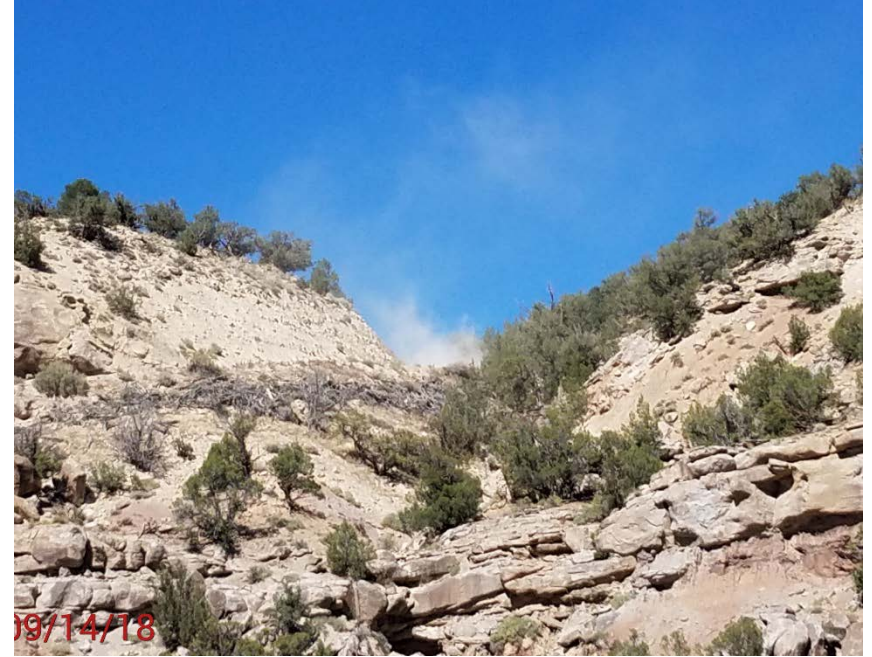
Location Photo #12, fugitive dust on access road .
