Inspection Photos

Operator: BP Production

API: 05-067-08833

Date: 9/13/2018

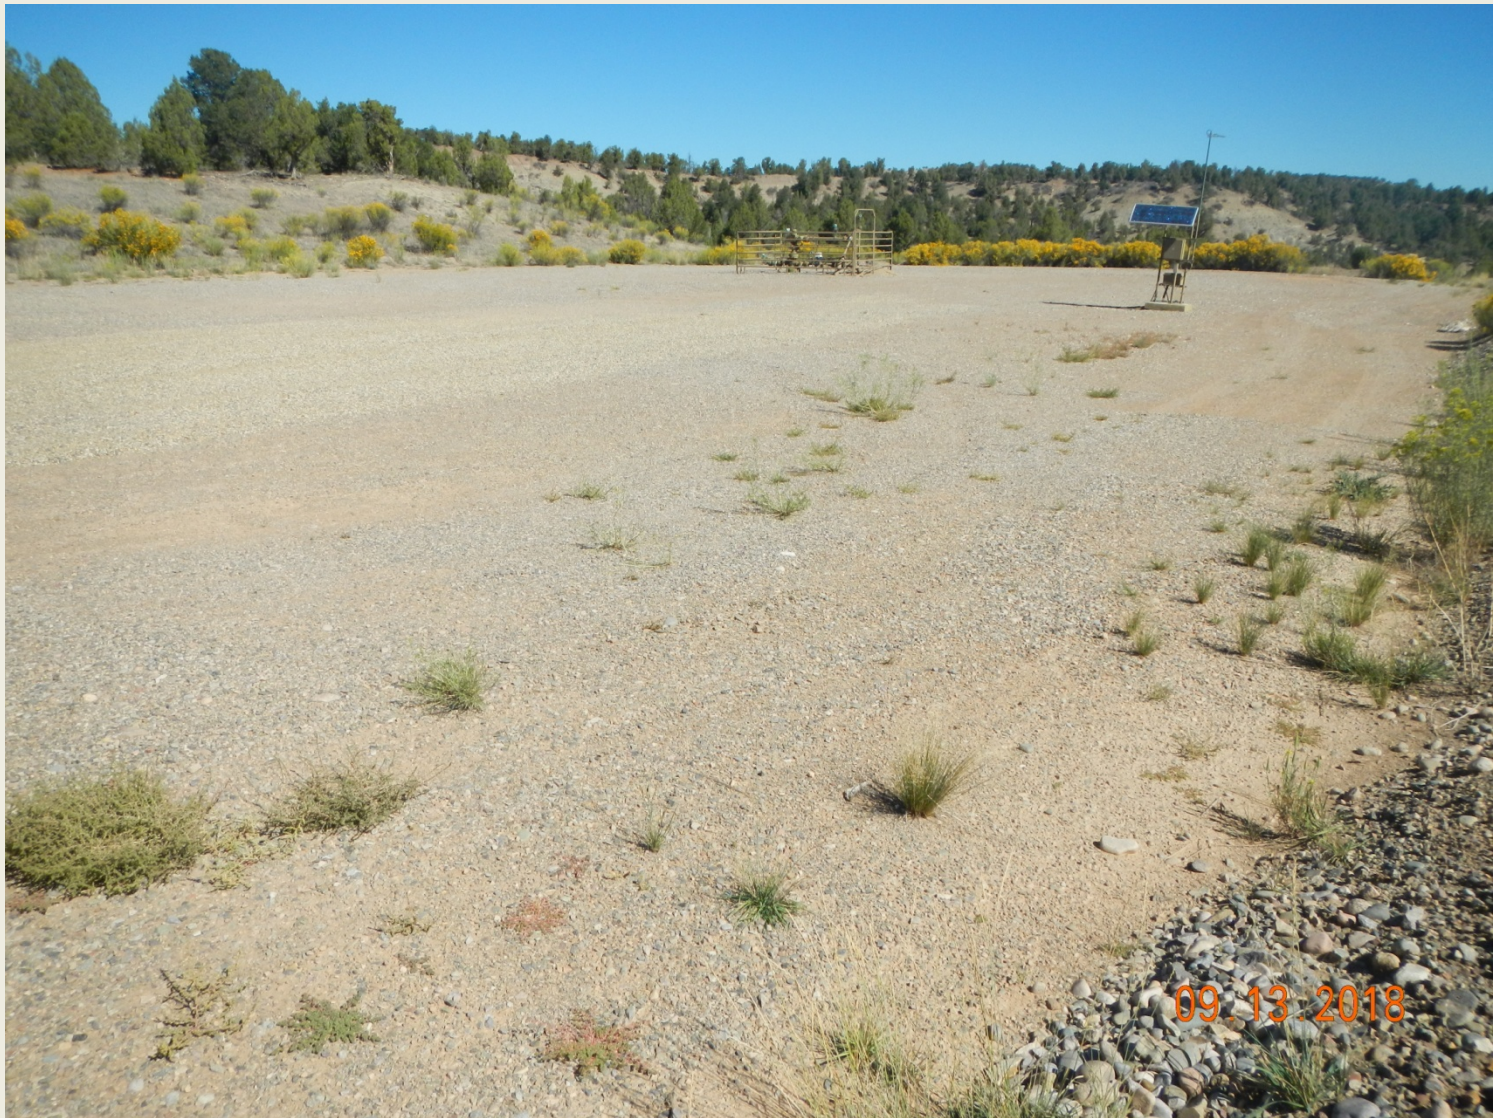
Photo 1. View of the project area from the southeastern corner facing center.

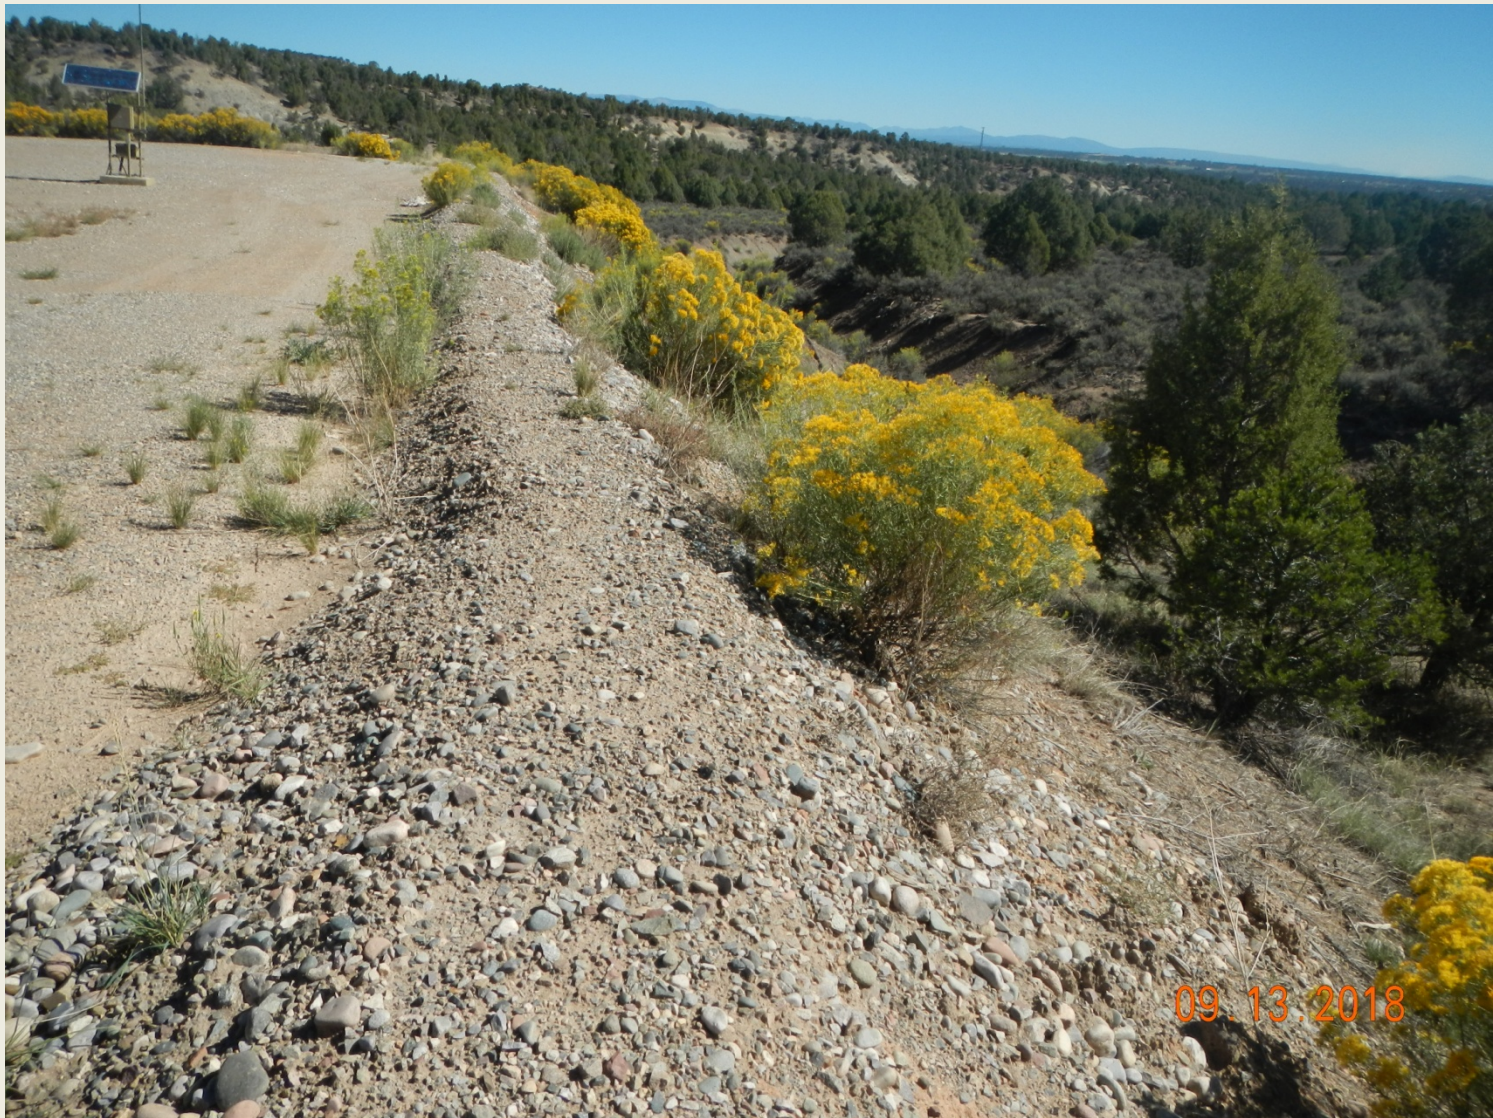
Photo 2. View of the eastern portion of the project area from the southeastern corner facing northward. Revegetation is comprised of grasses and shrubs such as smooth brome (*Bromus inermis*), intermediate wheatgrass (*Thinopyron intermedium*), and rubber rabbitbrush (*Chrysothamnus nauseosus*).

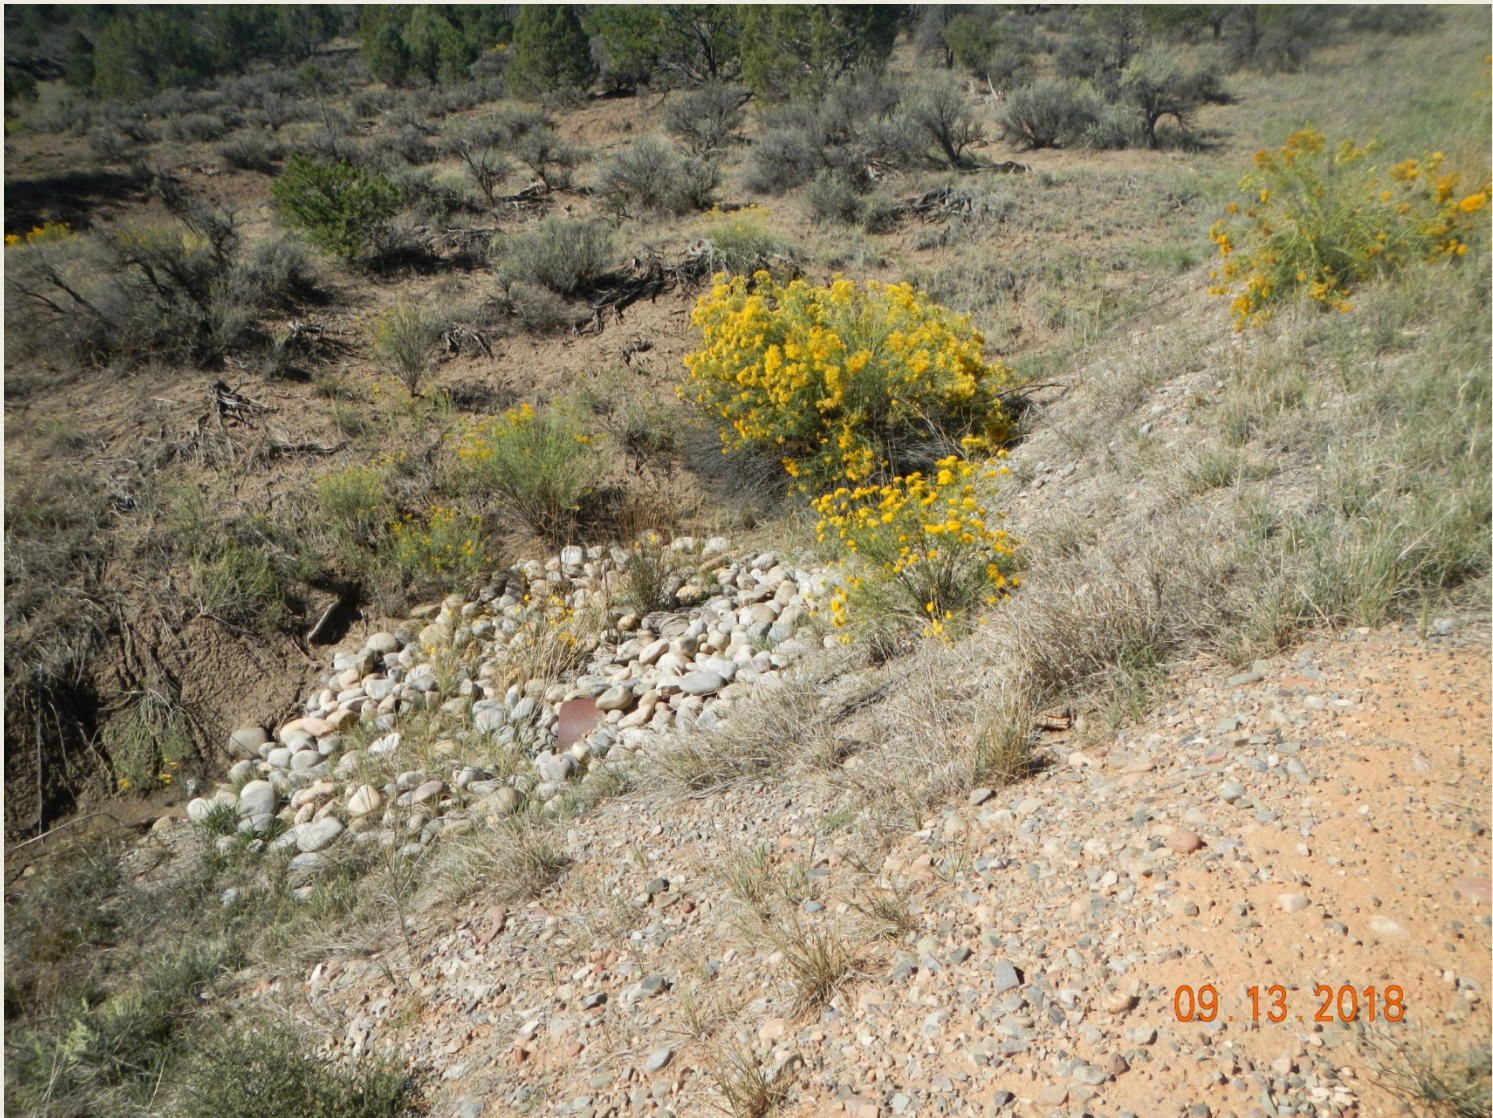
Photo 3. View of culvert outlet in the southern project area near the well pad entrance. Erosion controls appear to be functioning.

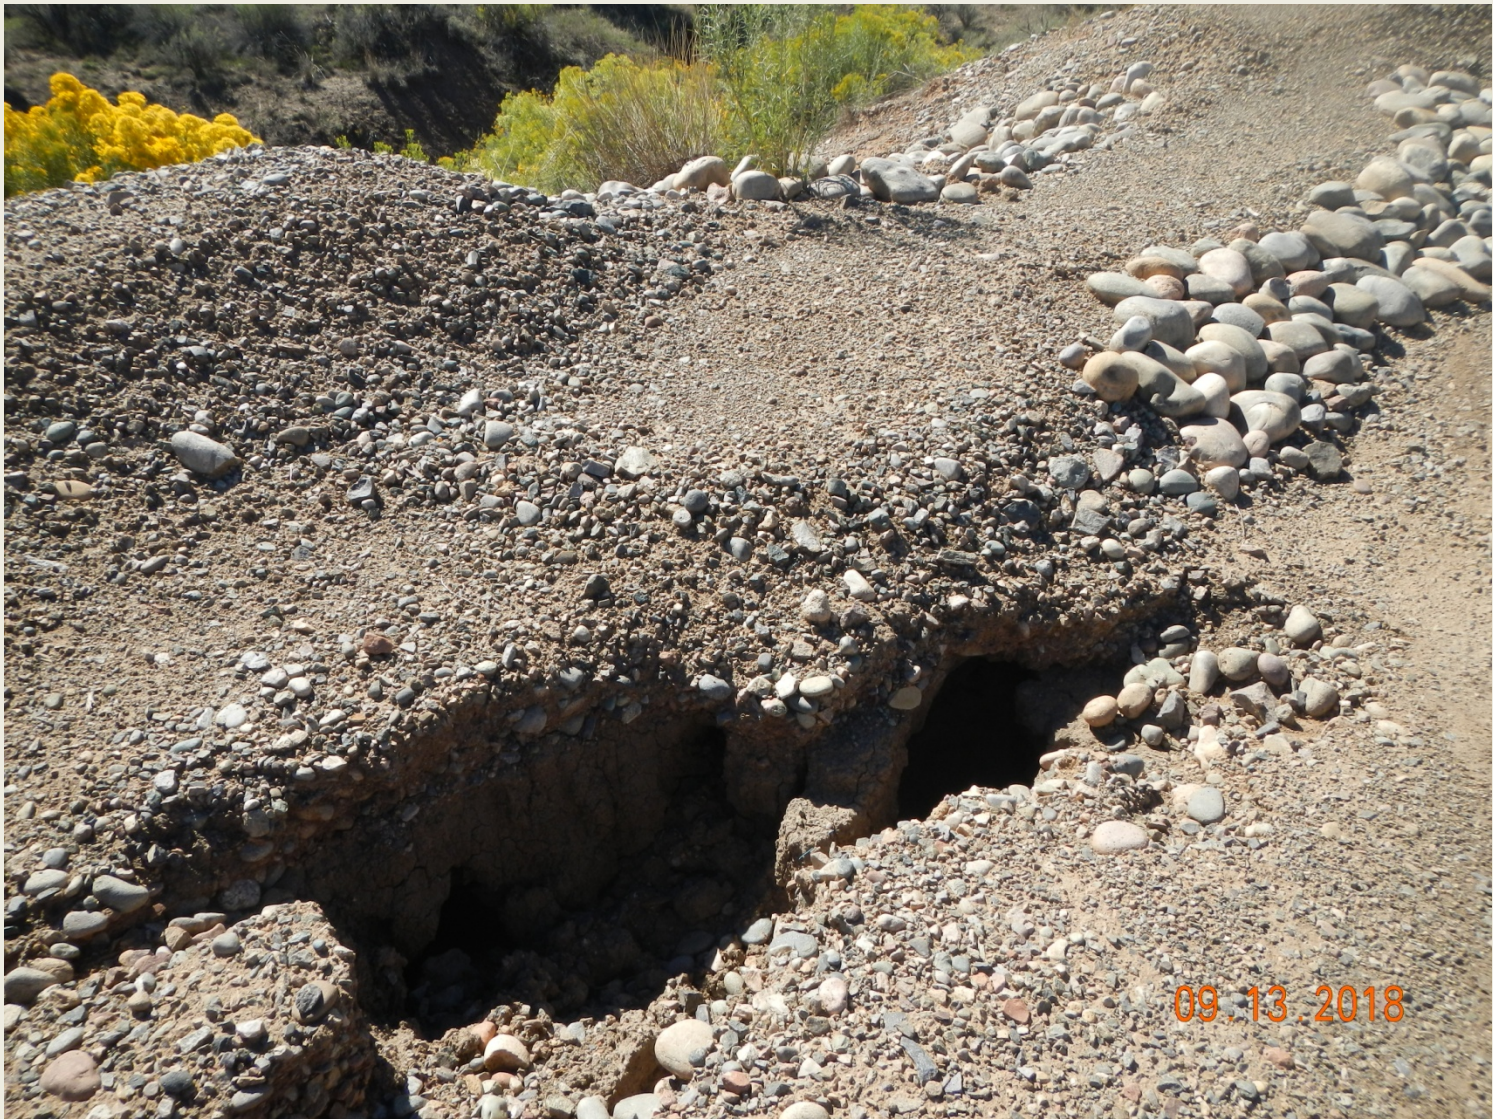
Photo 4. View of erosional tunneling in the eastern project area that needs repair.

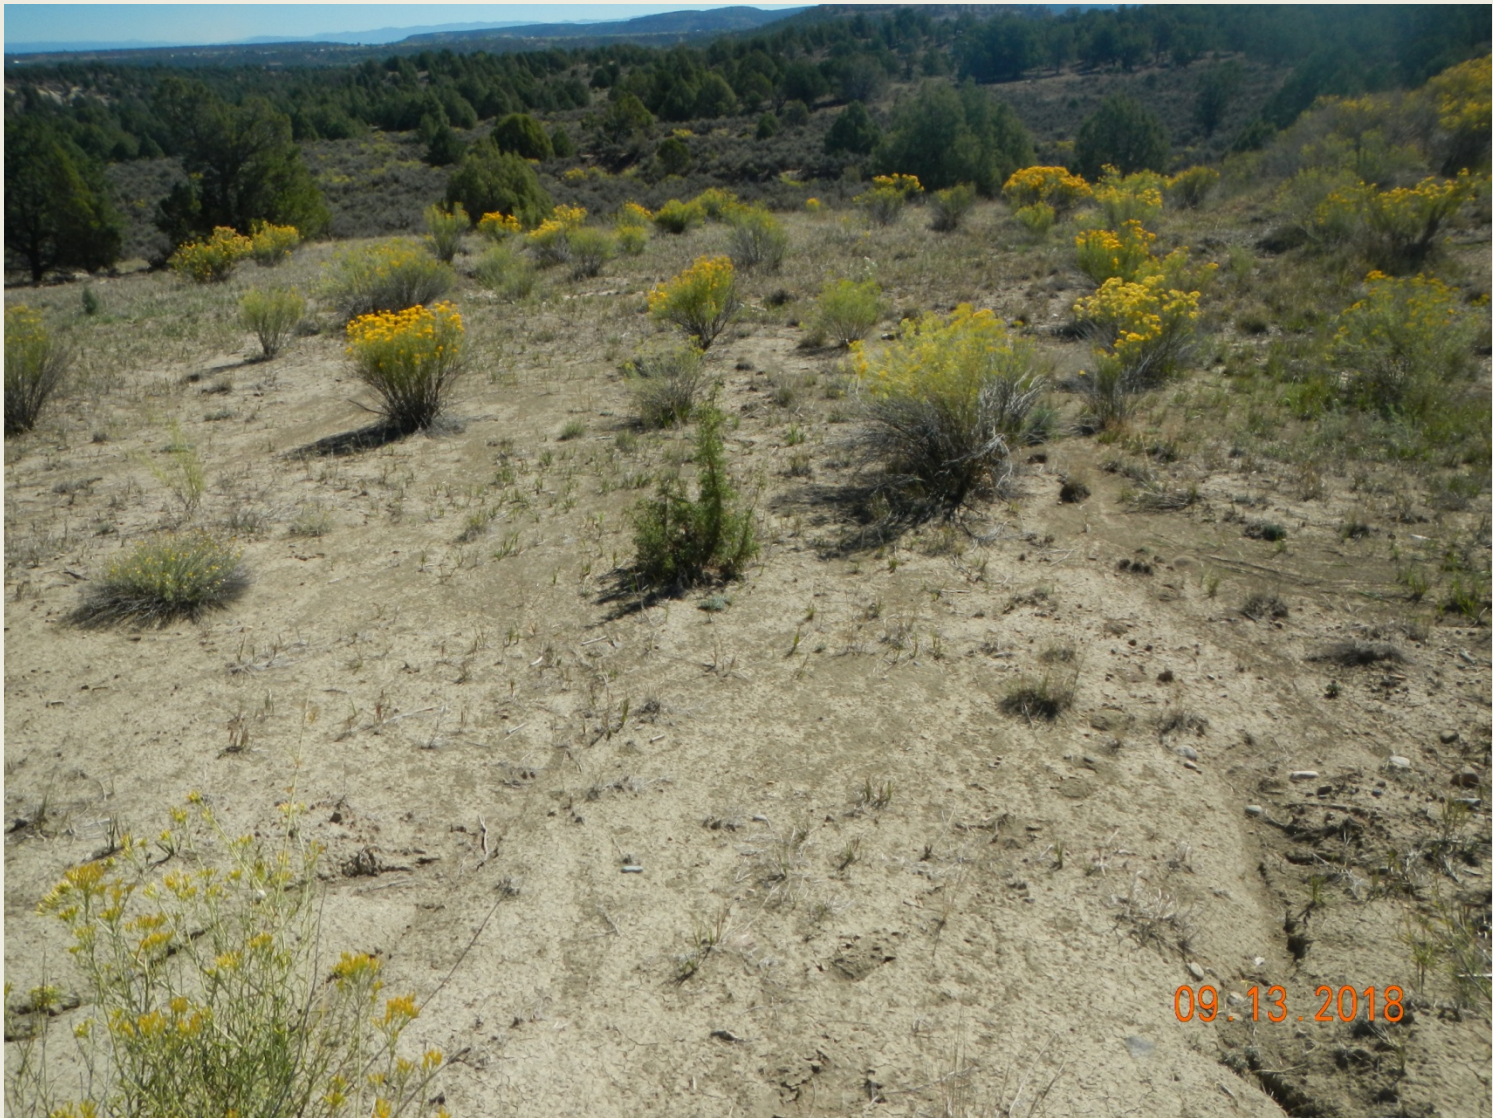
Photo 5. View of sediment deposition from erosion on the northwestern portion of the well pad cut-slope. Sediment controls are needed here.
