Inspection Photos

Operator: BP Production

API: 05-067-09562

Date: 9/13/2018

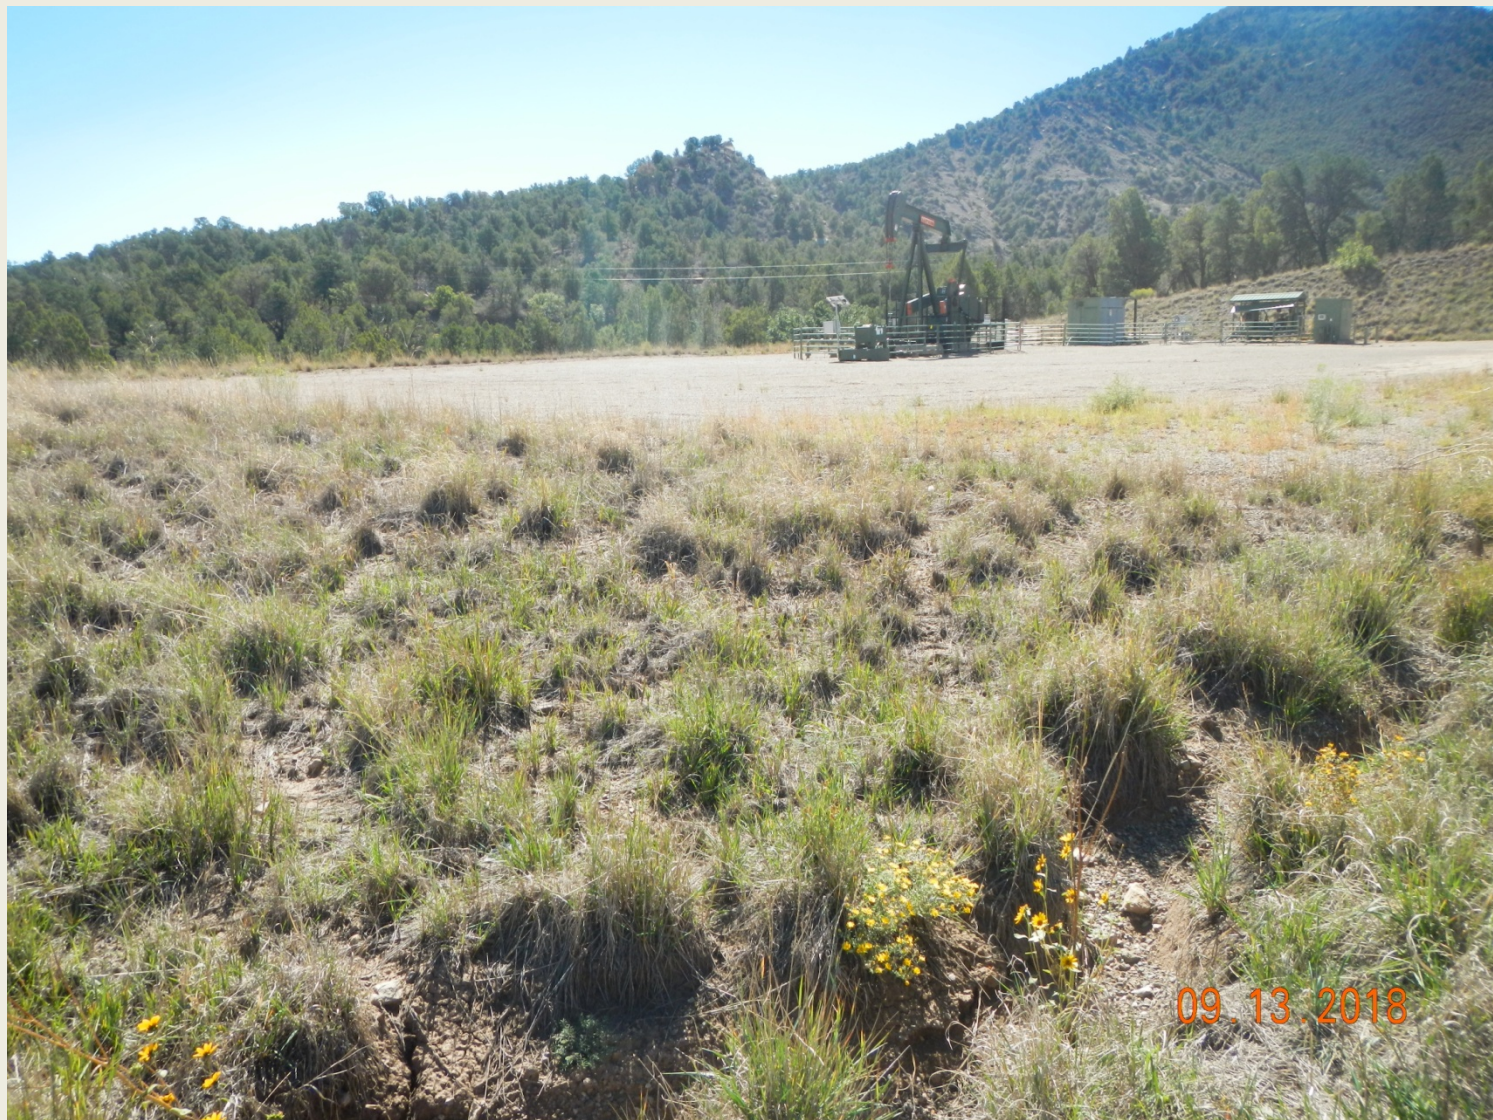
Photo 1. View of the project area from the northwestern corner facing center.

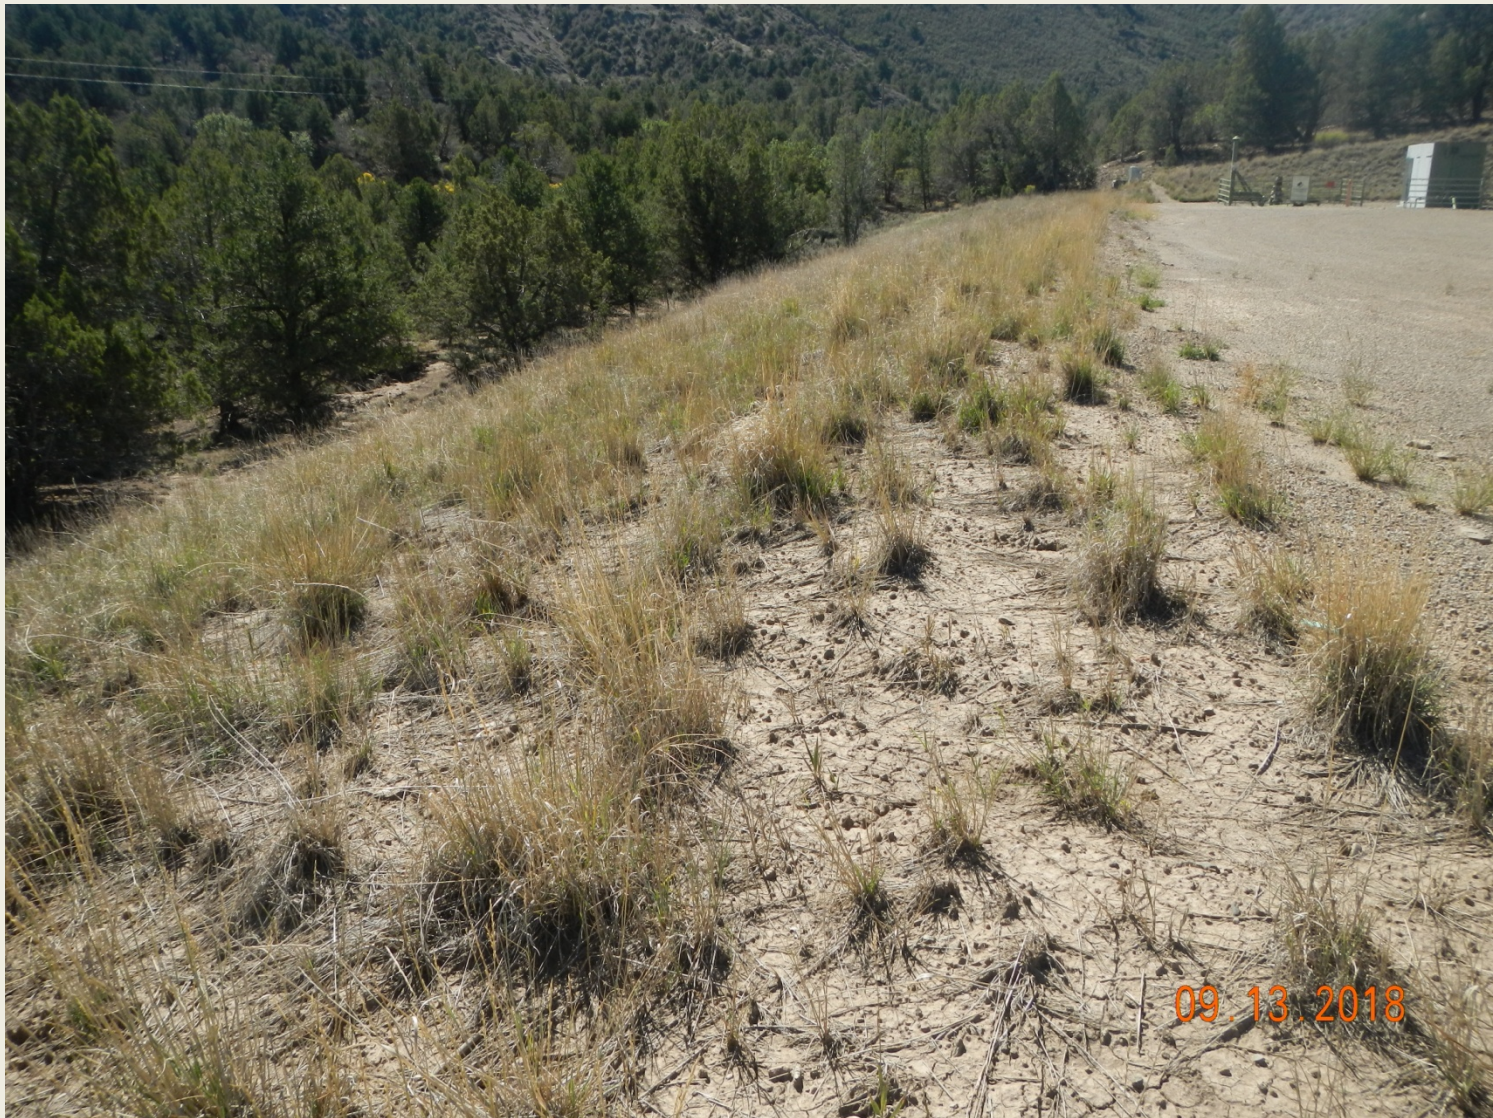
Photo 2. View of the eastern project area from the northeastern corner facing southward.

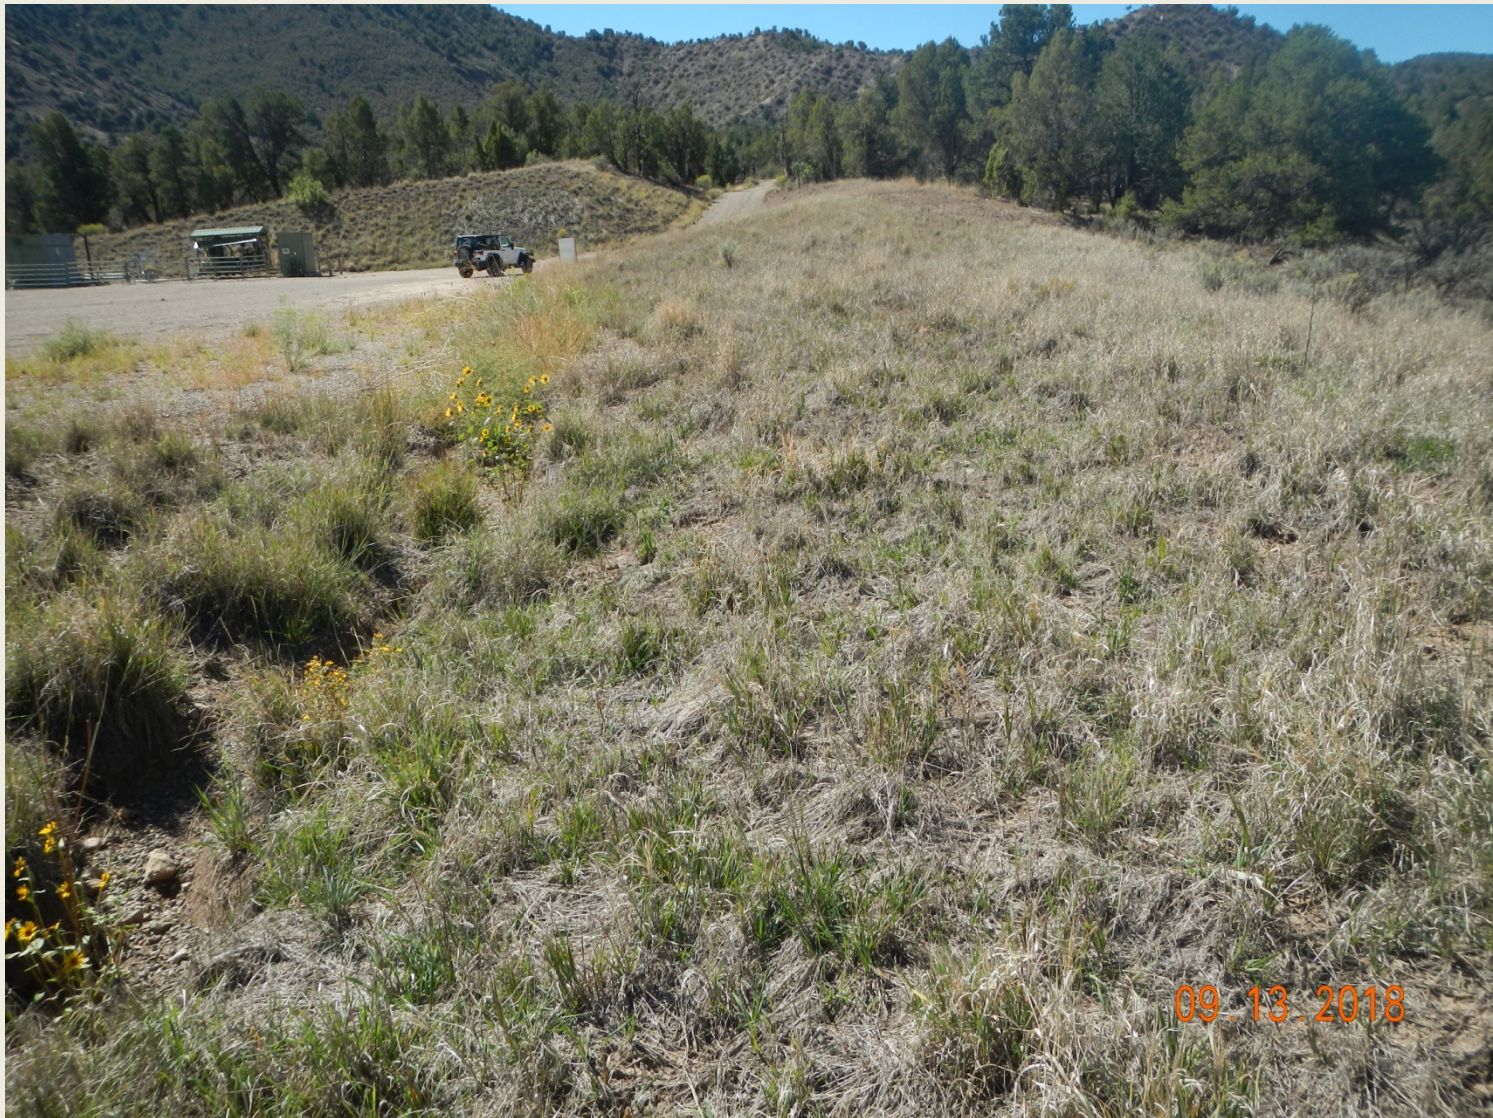
Photo 3. View of the western portion of the project area from the northwestern corner facing southward. Revegetation is comprised of grasses such as smooth brome (*Bromus inermis*) and intermediate wheatgrass (*Thinopyron intermedium*).

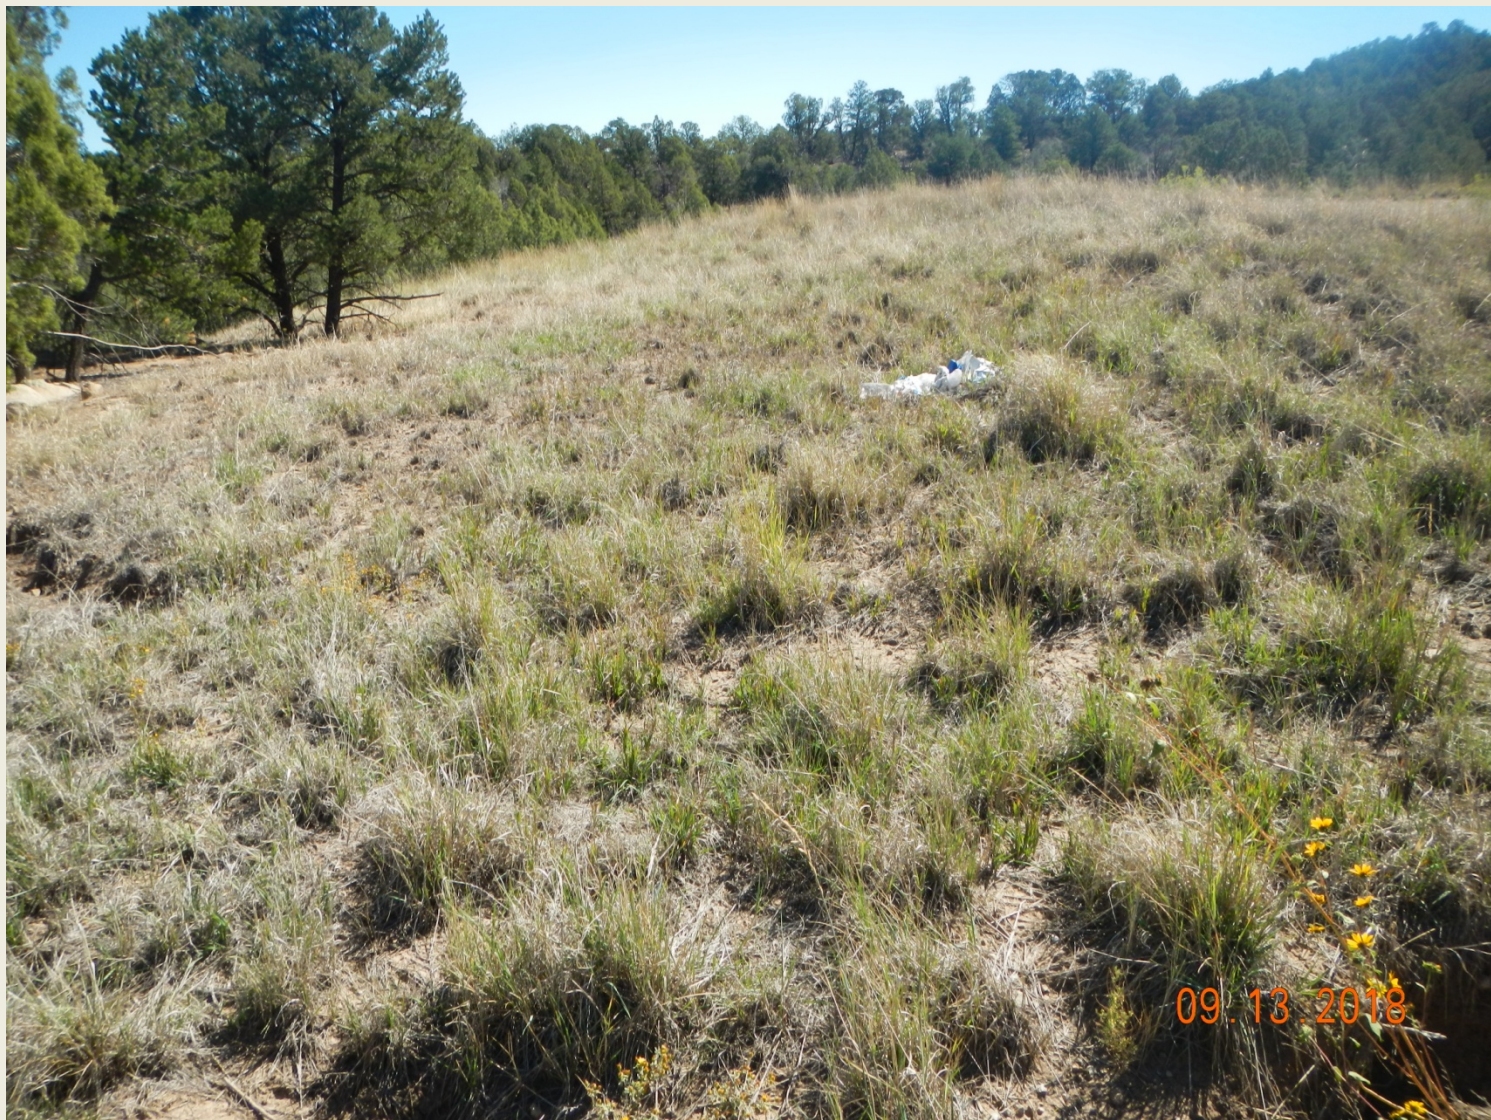
Photo 4. View of the northern project area from the northwestern corner facing eastward.

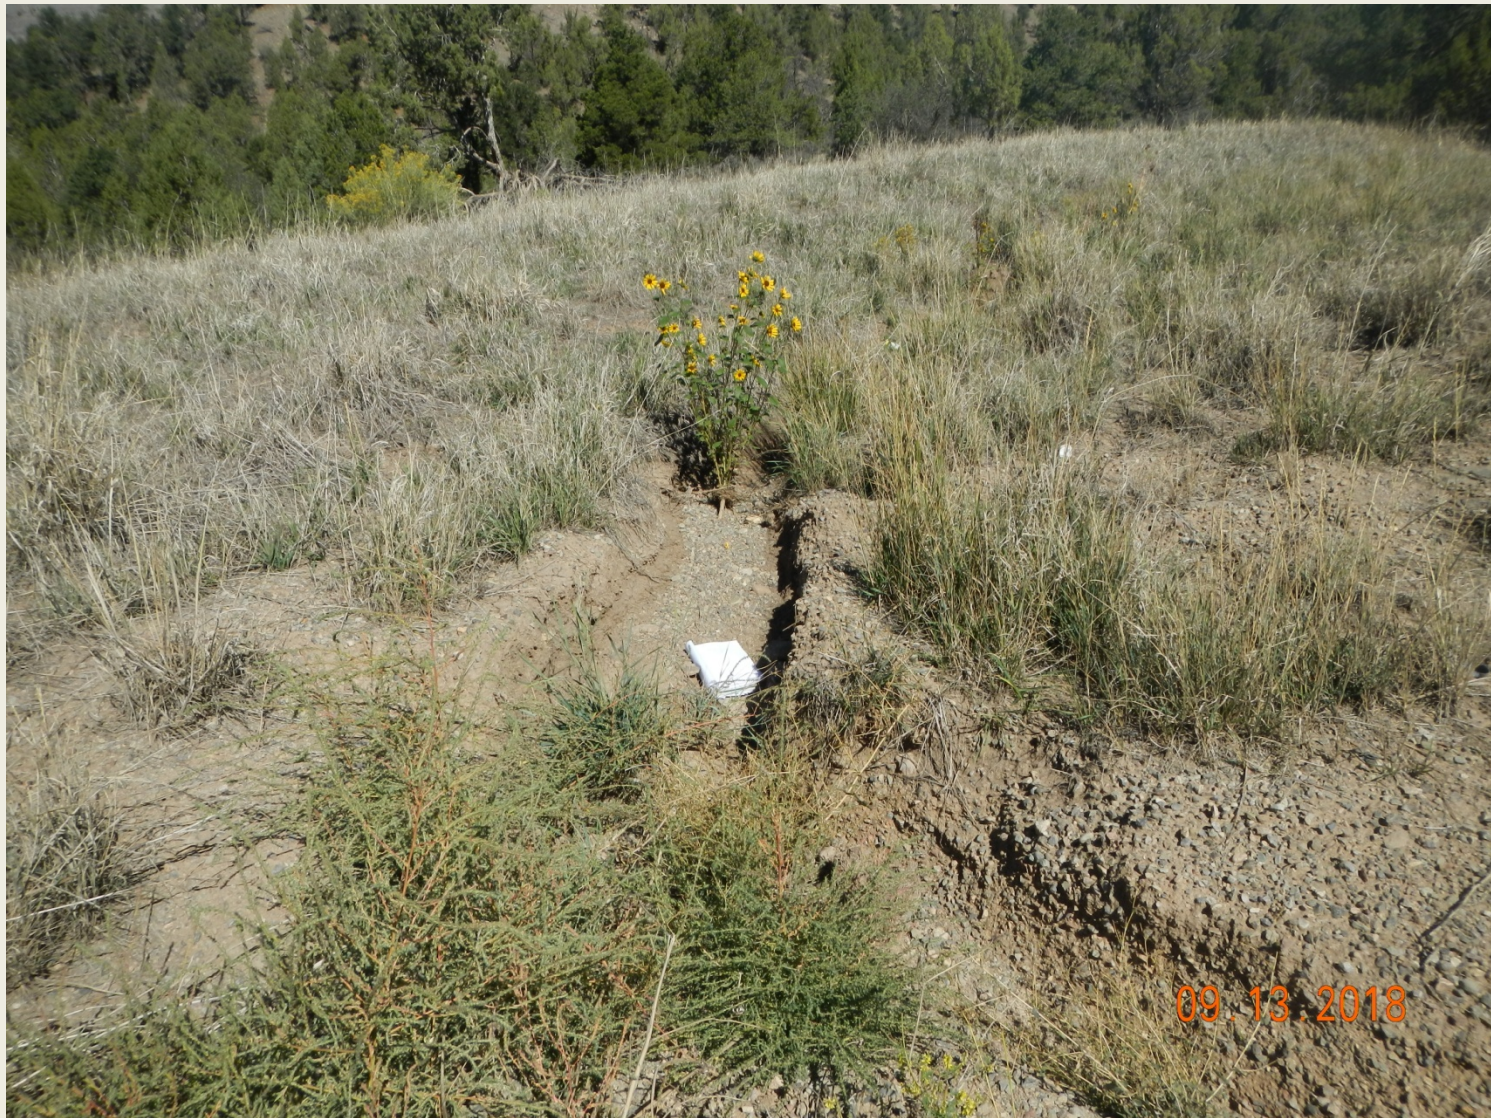
Photo 5. View of erosional channel approximately 2 feet wide and deep in the northwestern corner of the project area.

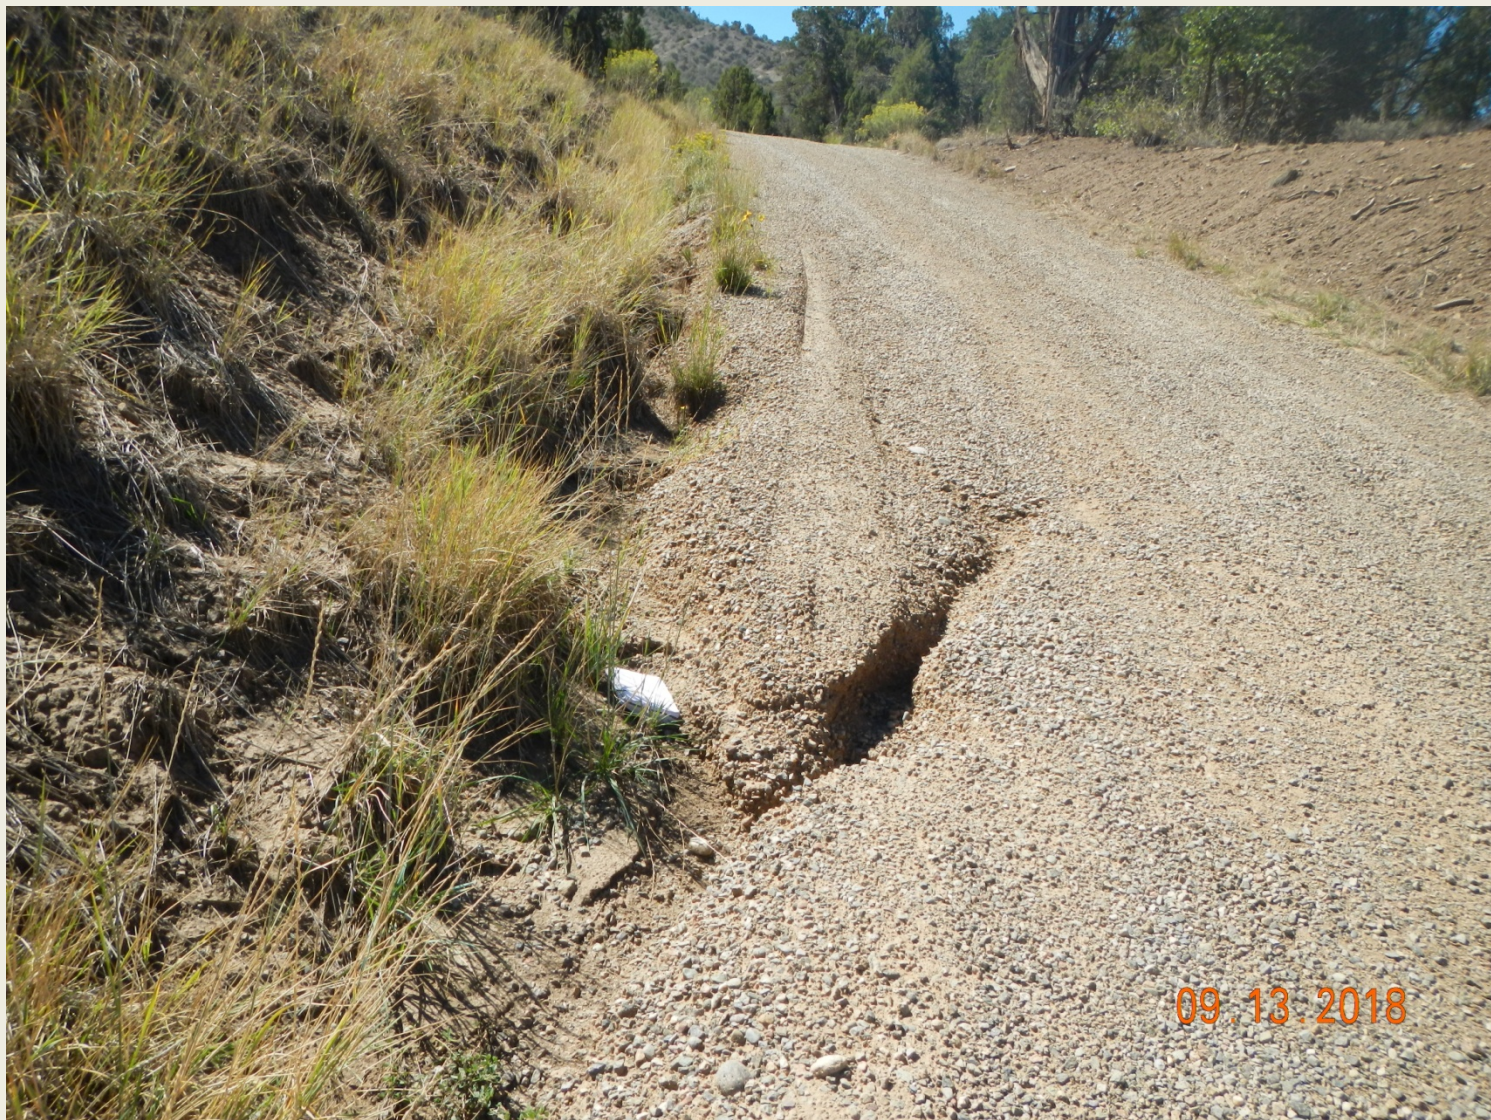
Photo 6. View of area along the access, near the well pad entrance, where stormwater flows converge and form an erosional channel that carries sediment down stream toward the well pad.

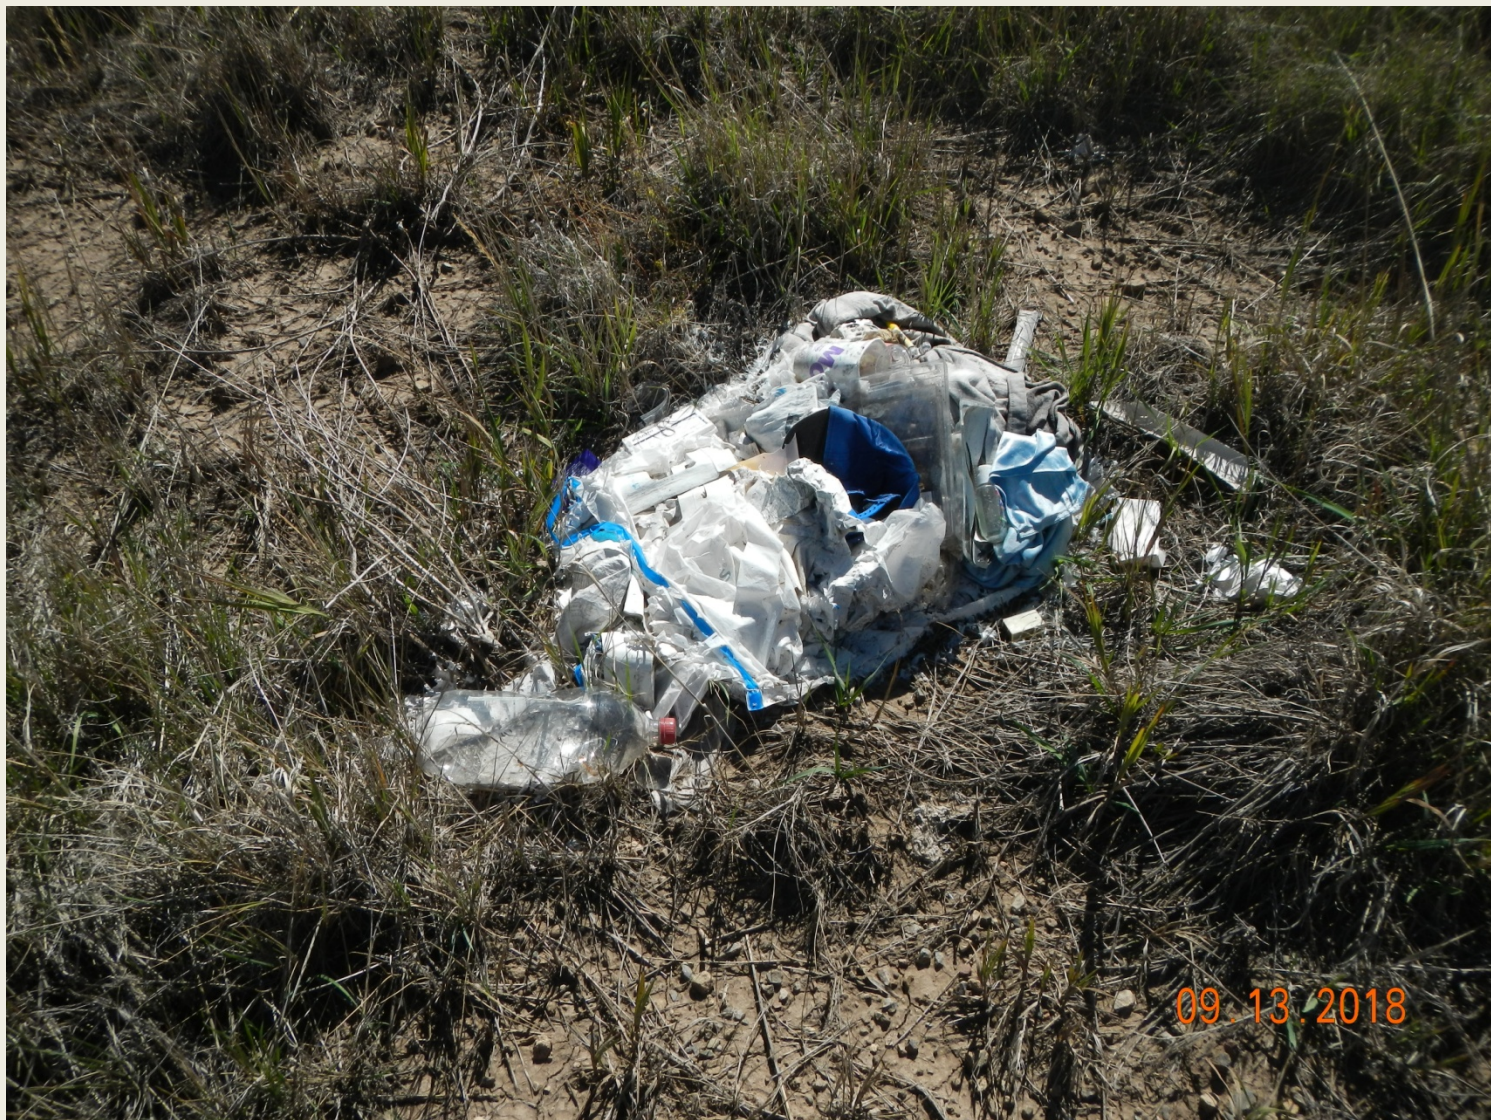
Photo 7. View of trash in the northern portion of the interim reclamation area.
