Inspection Photos

09/05/2018

Operator: FOUNDATION ENERGY
MANAGEMENT LLC - 10112

Inspection Doc. Number: 682503851
Weld County, CO

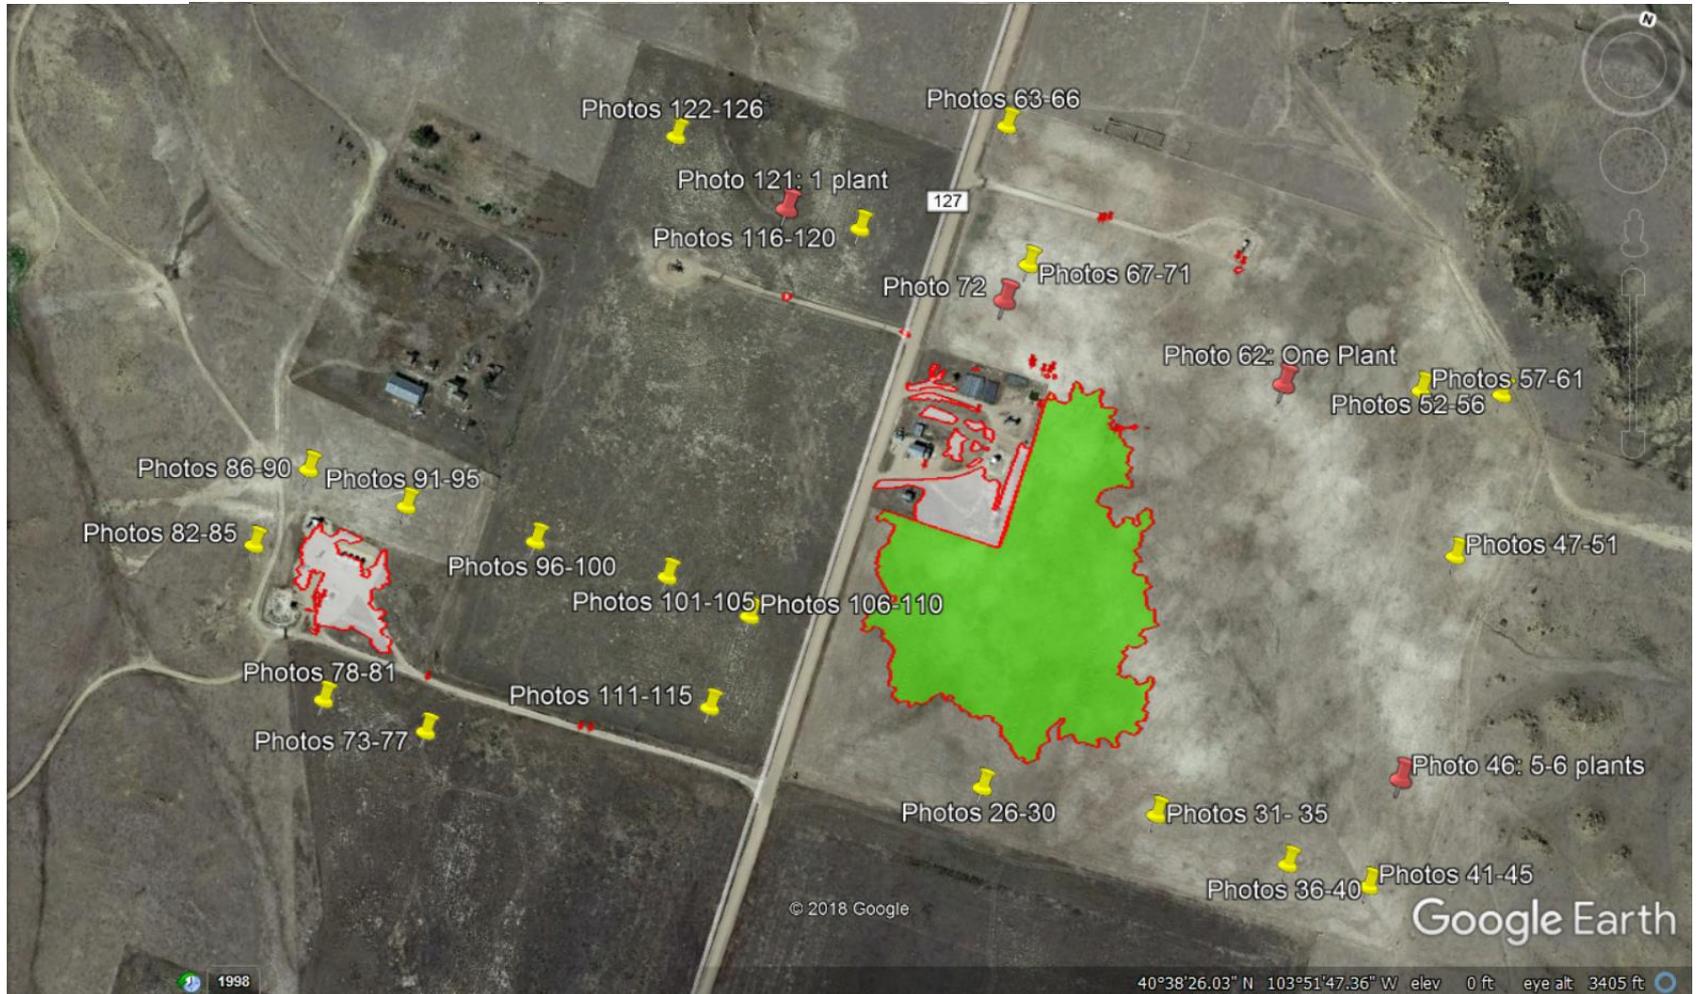
Aerial imagery of photos that have been taken for documentation purposes. Not all photo documents are included within this report. Red polygons (green/white fill) where Noxious weeds were mapped on and off location using a GPS during the 6/15/2018 inspection; White polygon is diffuse knapweed concentration on location, green is the high density knapweed off the location. Point ("thumb-tacs") represent GPS points and the related photos within the report. Photo shows adjacent lands do not have the population densities of noxious weeds compared to areas within the locations and its immediate surrounding; noxious weed population densities decrease as the distance away from the locations increase.

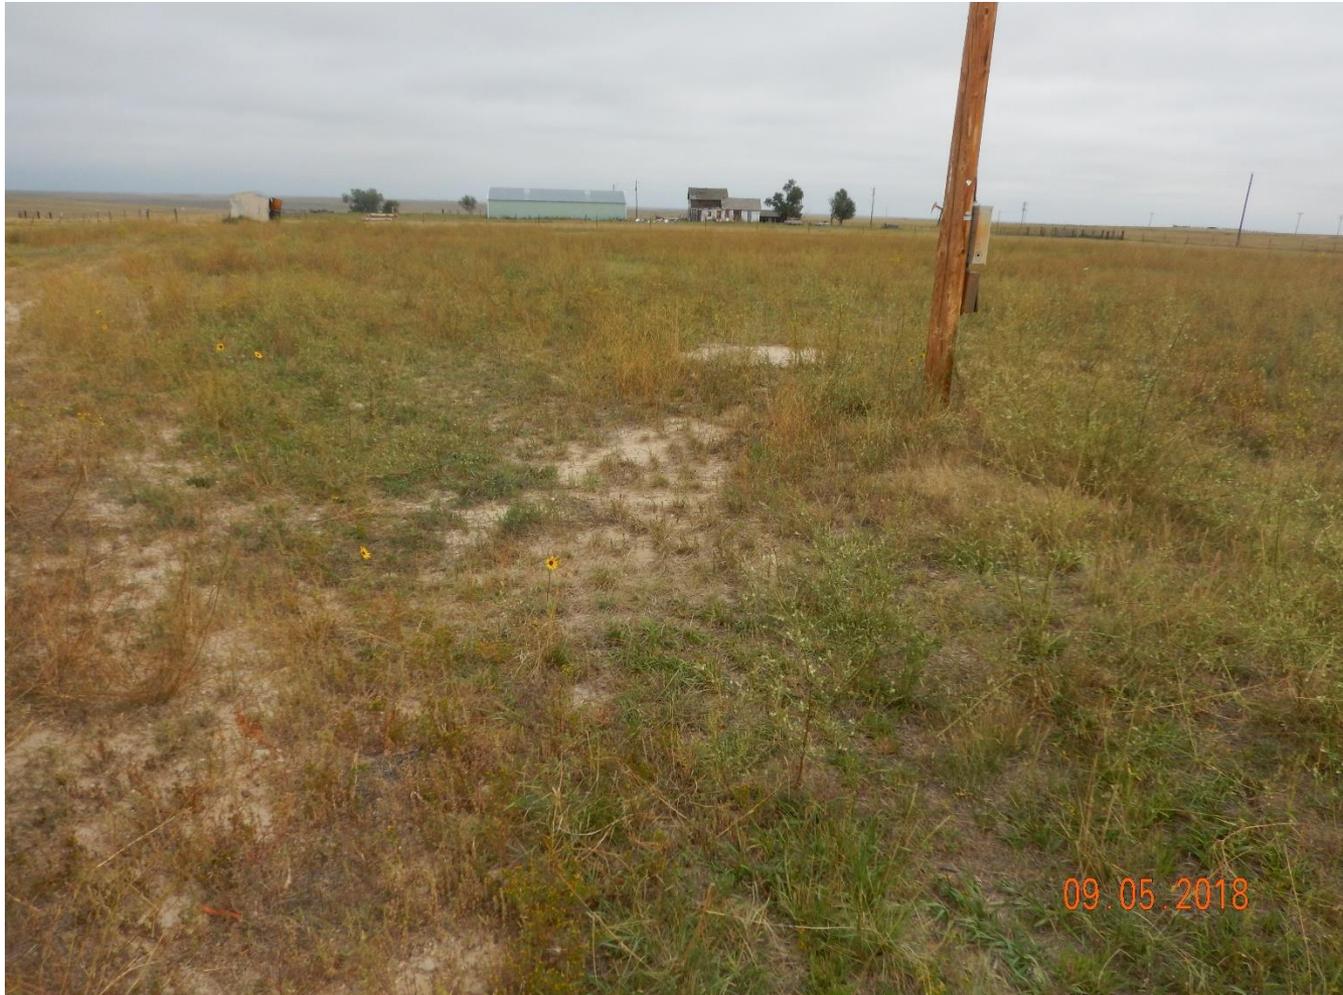
Photo 1: Photo taken from the southwest end of the location, facing north. Photo 1-2 shows overview of location.

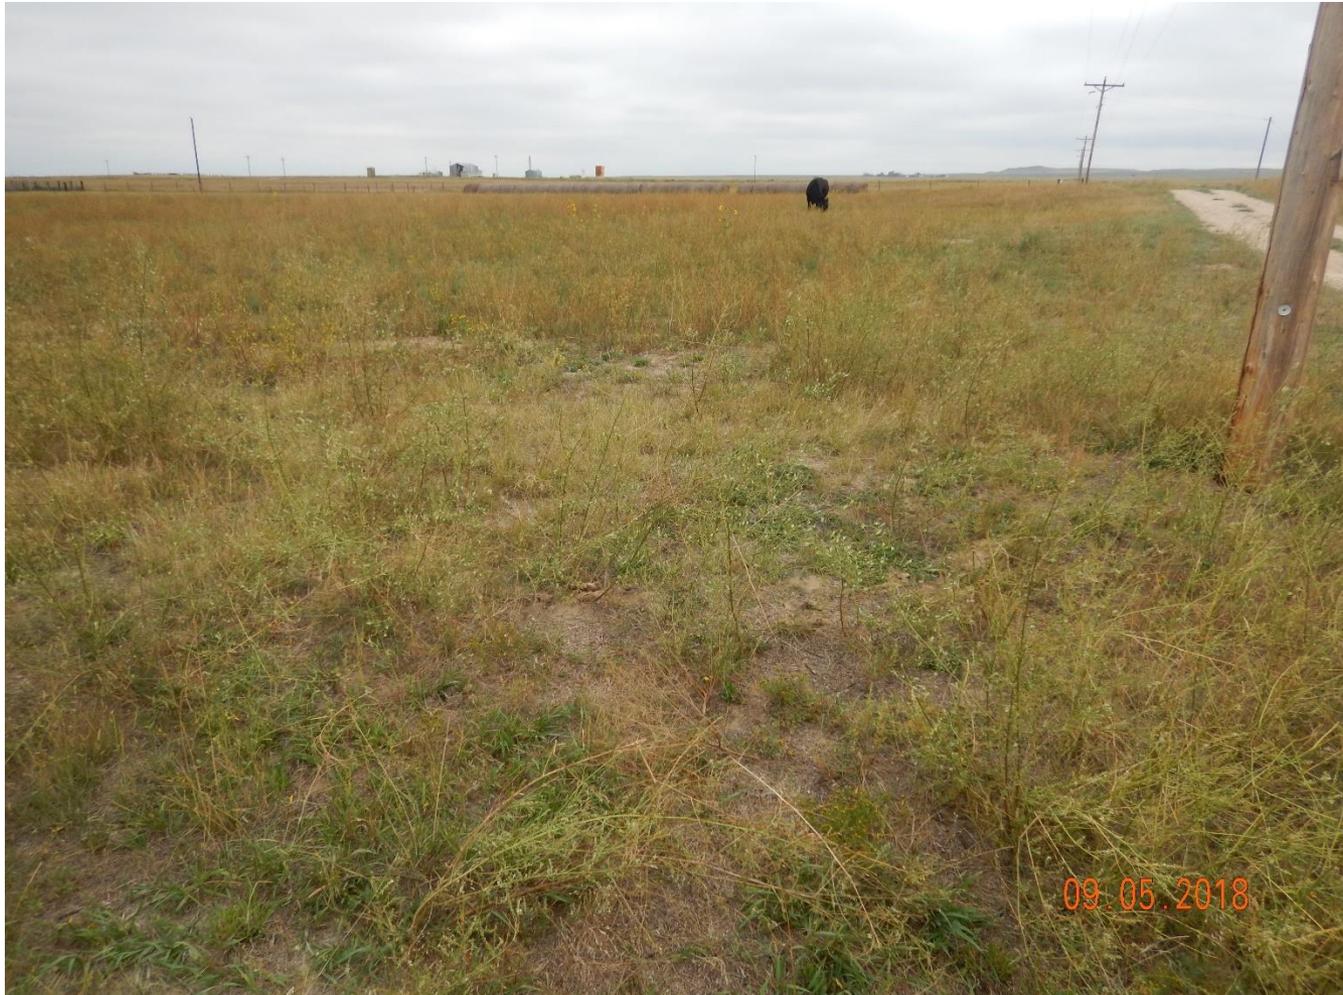
Photo 2: Photo taken from the southwest end of the location, facing north. Photo 1-2 shows overview of location.

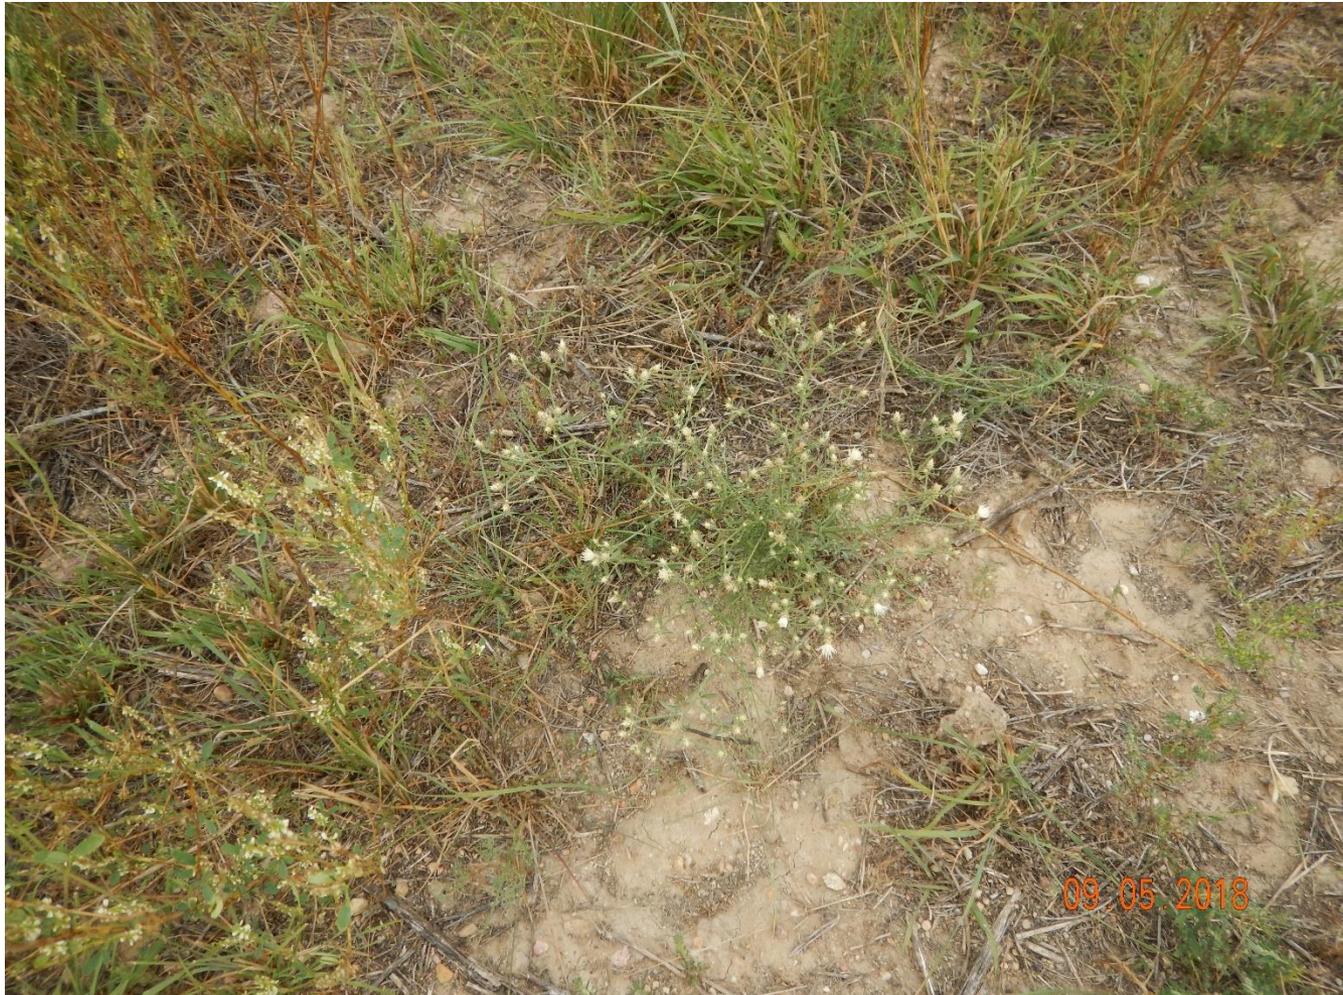
Photo 3: Photo taken from the location. Photo shows Diffuse Knapweed still remains on the location. Photo shows weed is currently mature and flowering.

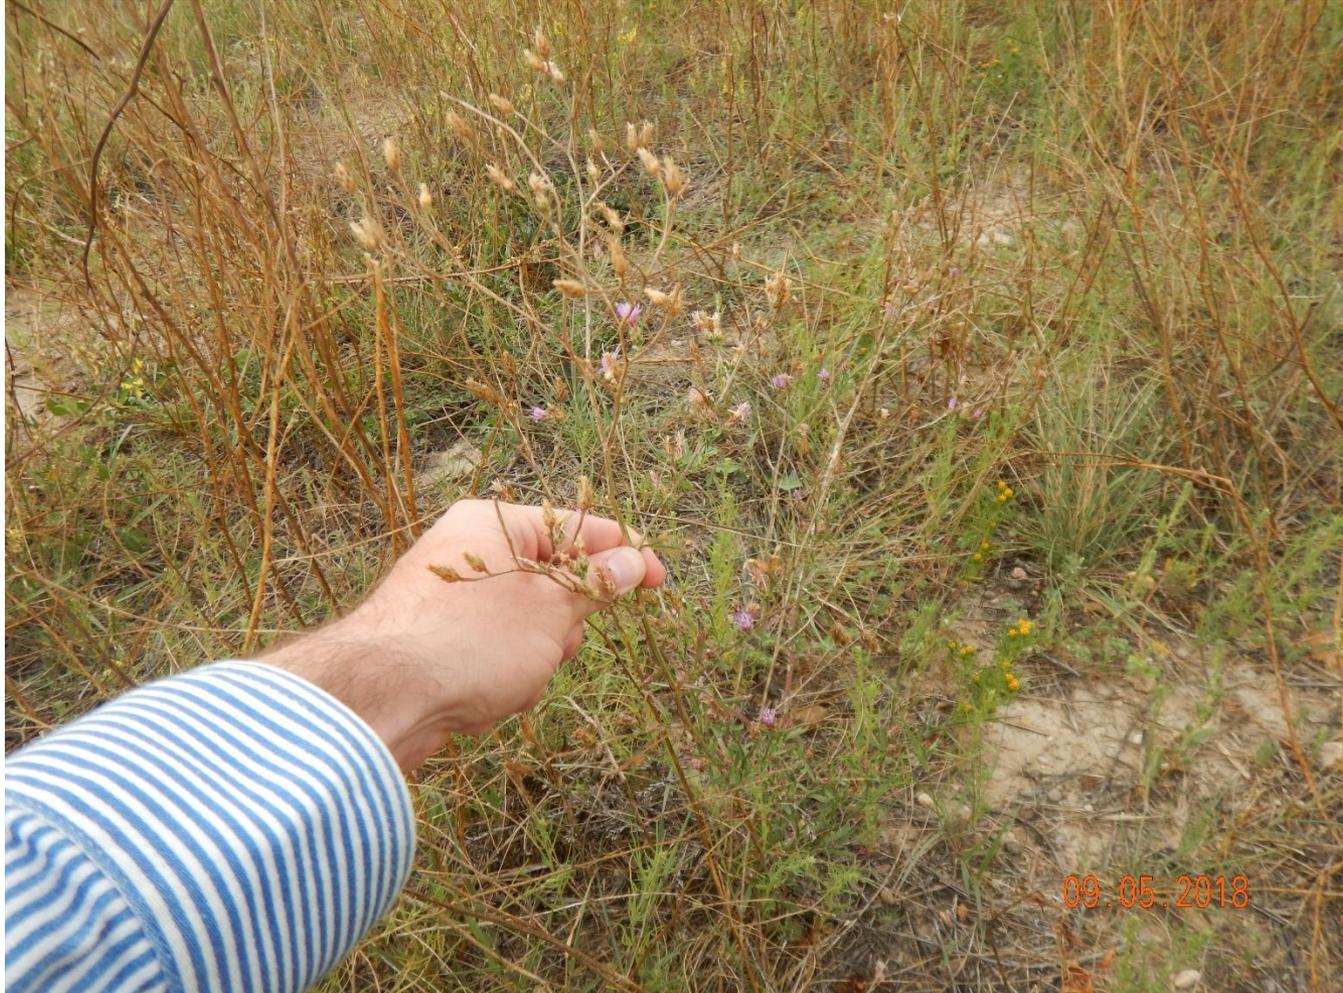
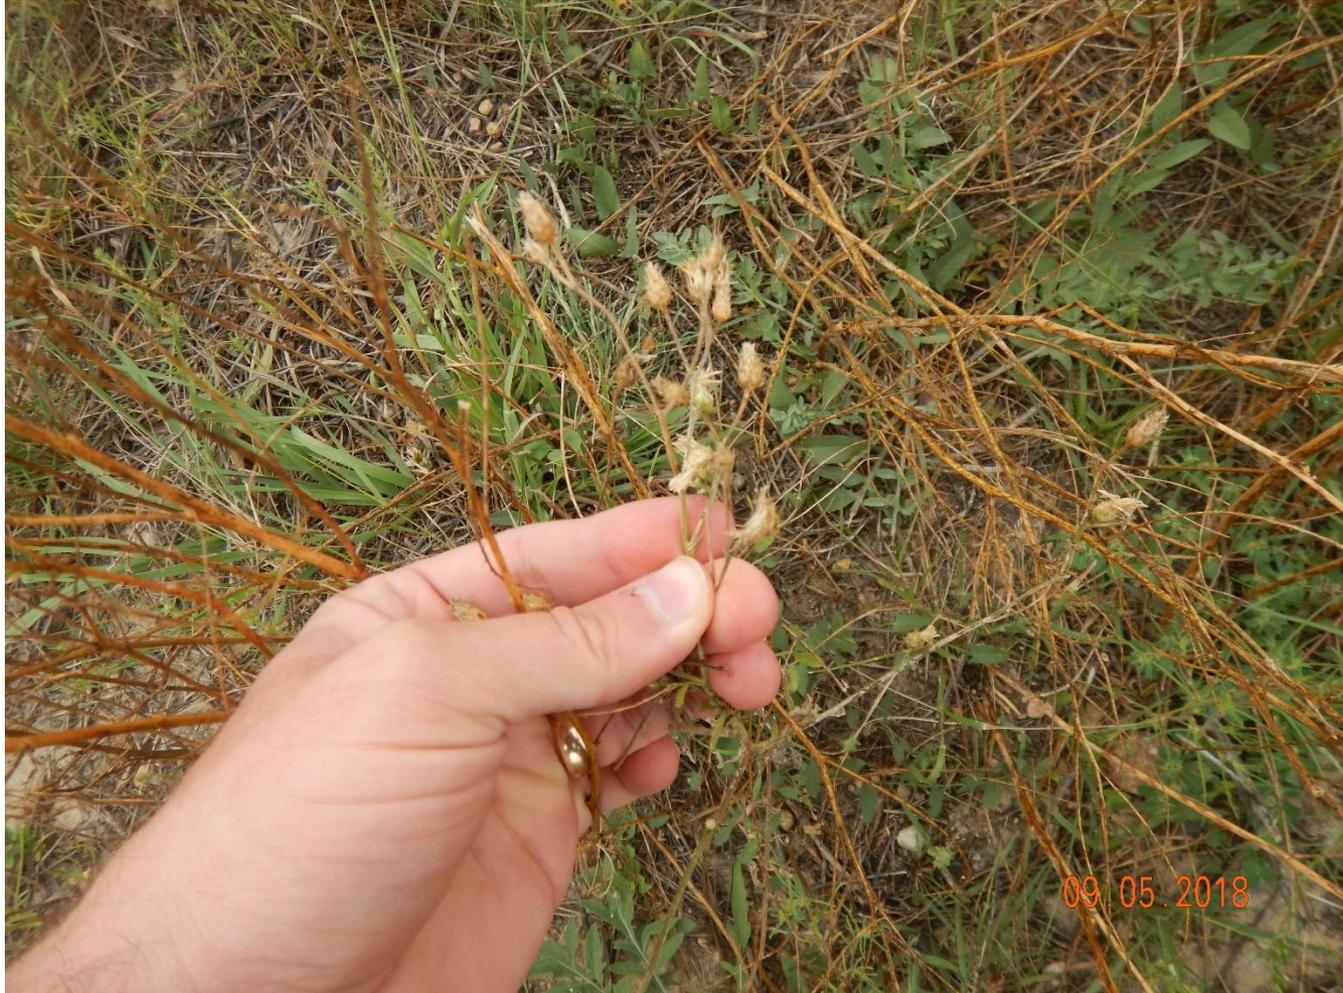
Photo 4: Photo taken from the location. Photo shows Diffuse Knapweed that appears to have been previously sprayed, however, herbicide does not appear to have been sufficient as portions of the plant was able to continue growth and is currently flowering.

Photo 5: See comments under photo 4.

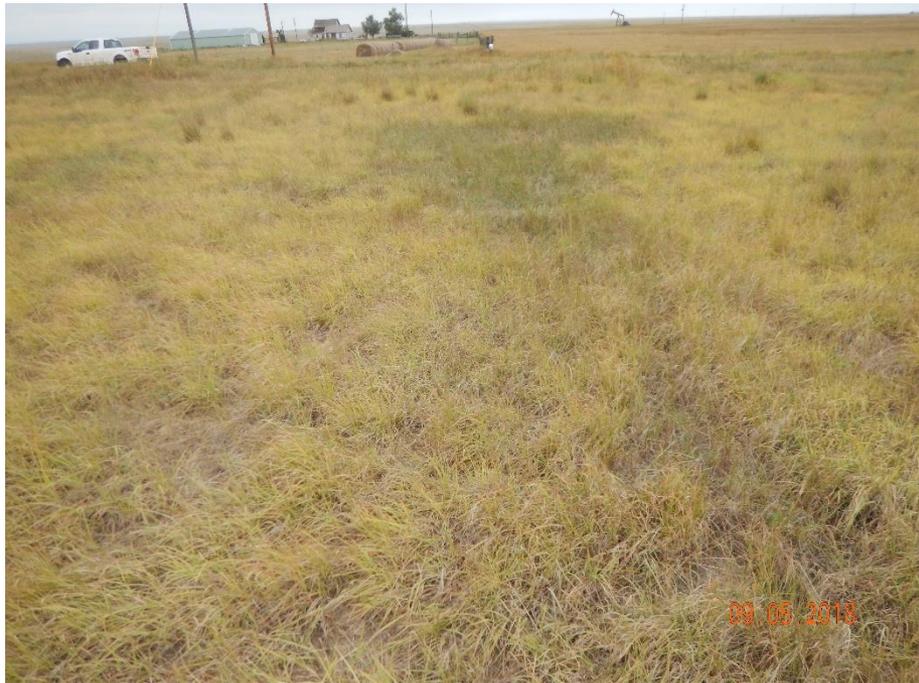
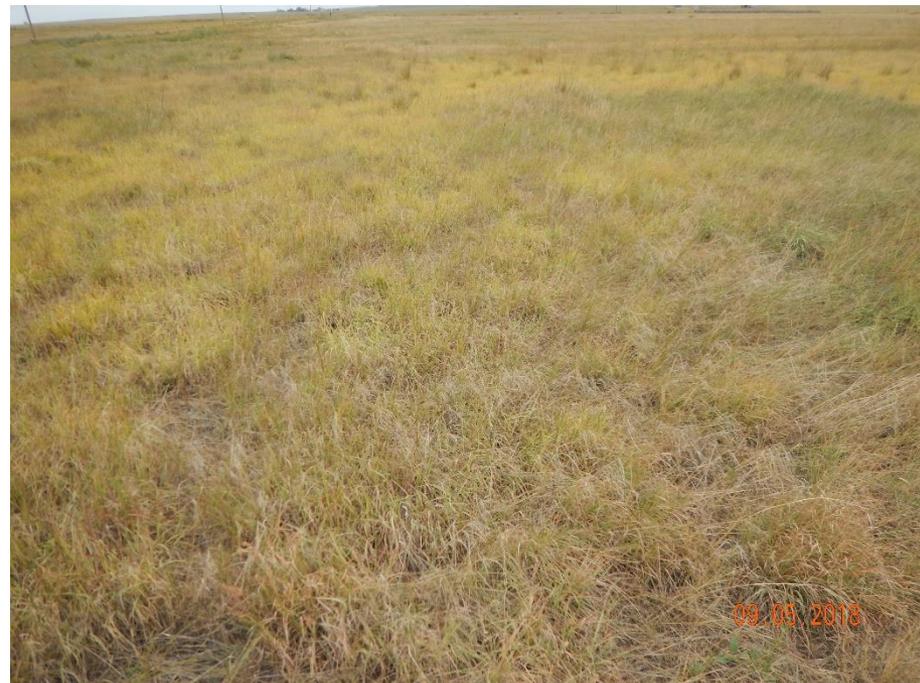
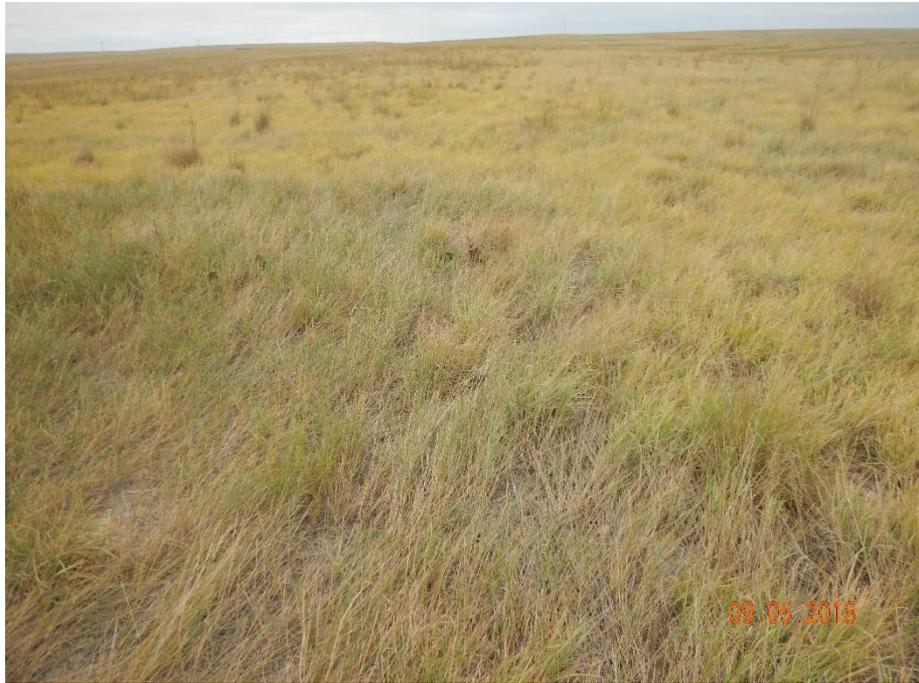
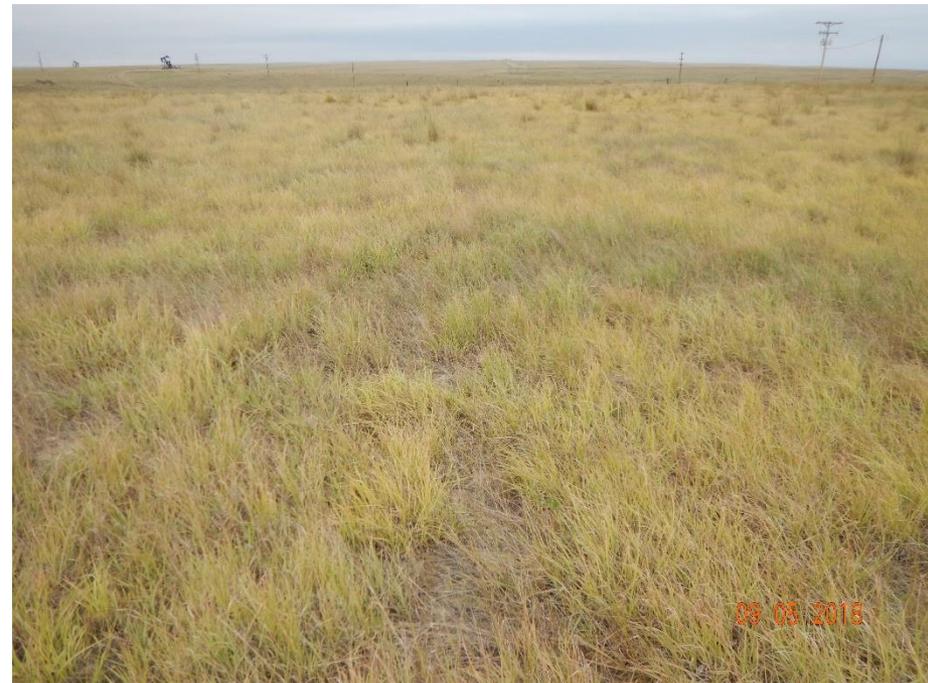
Photo 73: Photo taken from the adjacent lands, facing north. See photo 127 for additional details. Diffuse Knapweed **was not** observed in this area. Photo shows adjacent lands do not have the population densities of noxious weeds compared to areas within the locations and its immediate surrounding; noxious weed population densities decrease as the distance away from the locations increase.

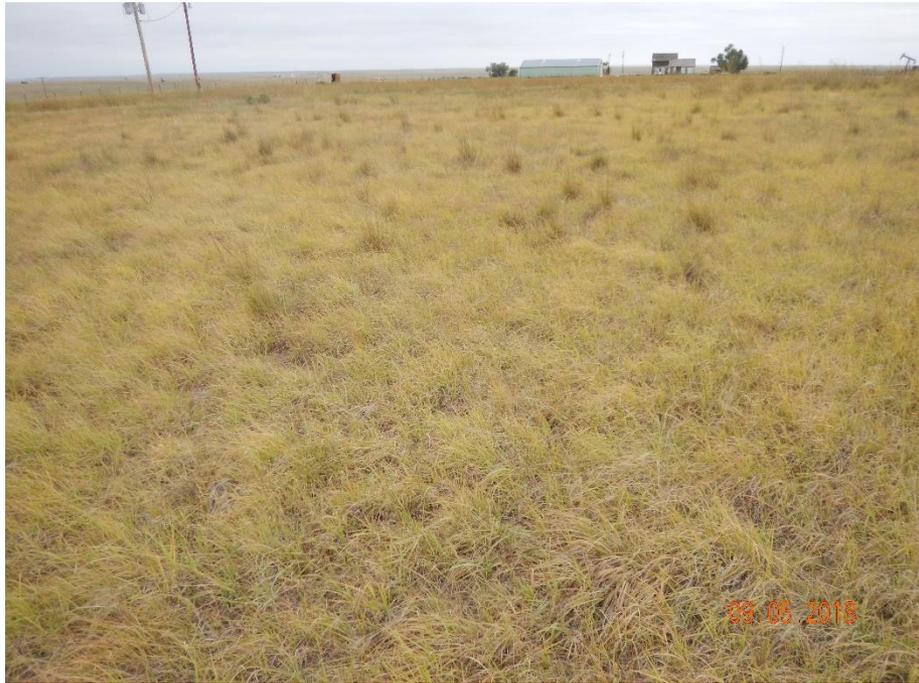
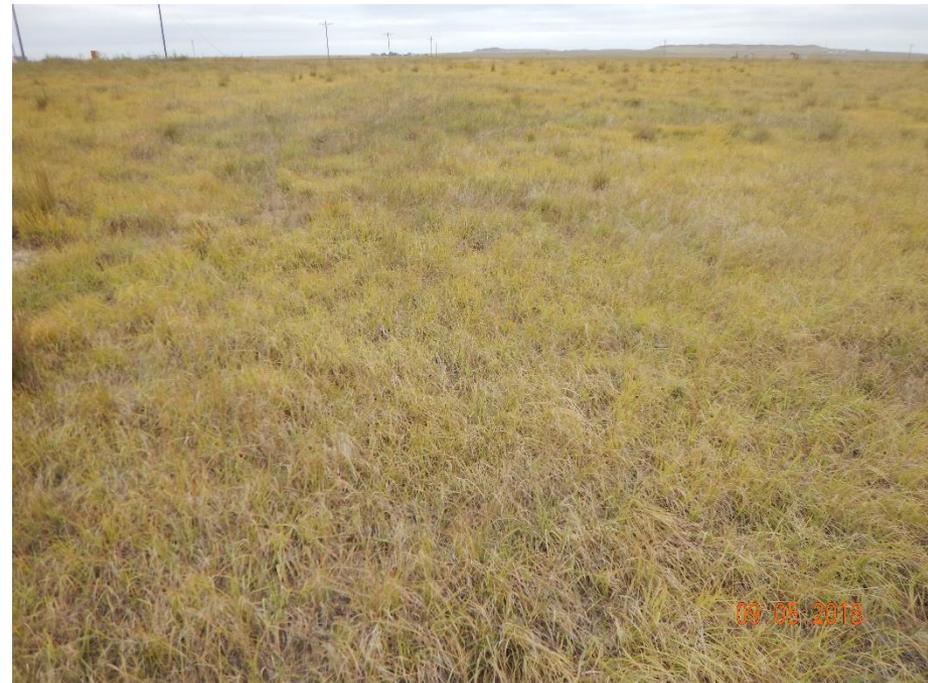
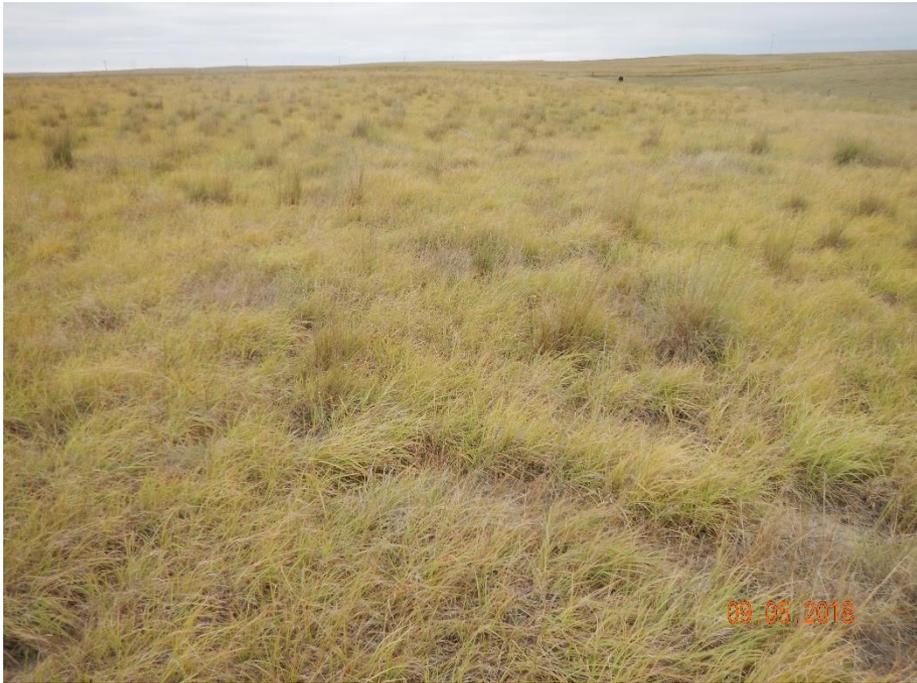
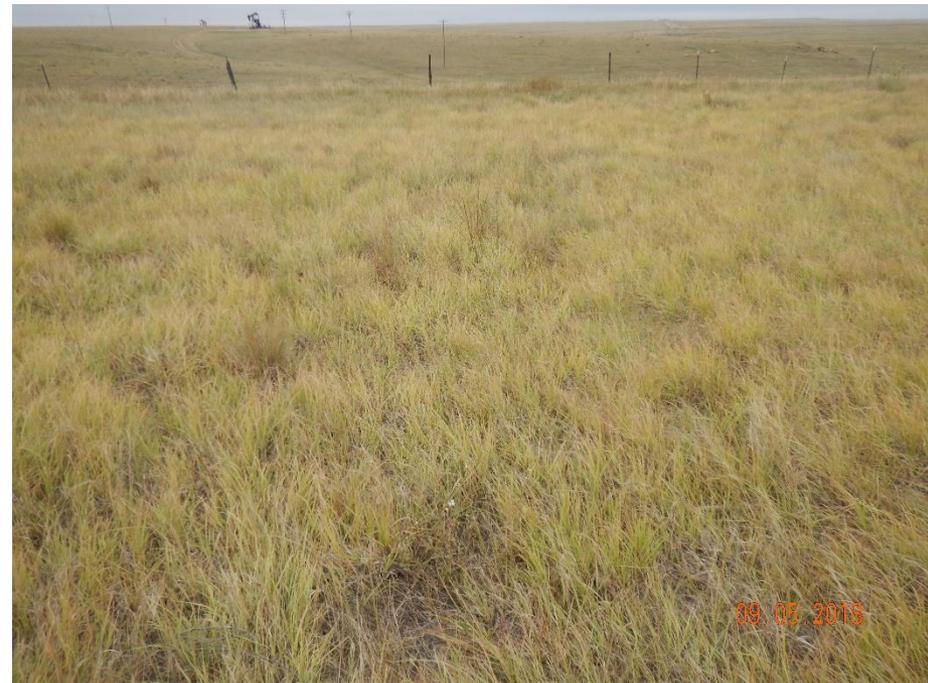
Photo 78: Photo taken from the adjacent lands, facing north. See photo 127 for additional details. Diffuse Knapweed **was not** observed in this area. Photo shows adjacent lands do not have the population densities of noxious weeds compared to areas within the locations and its immediate surrounding; noxious weed population densities decrease as the distance away from the locations increase.

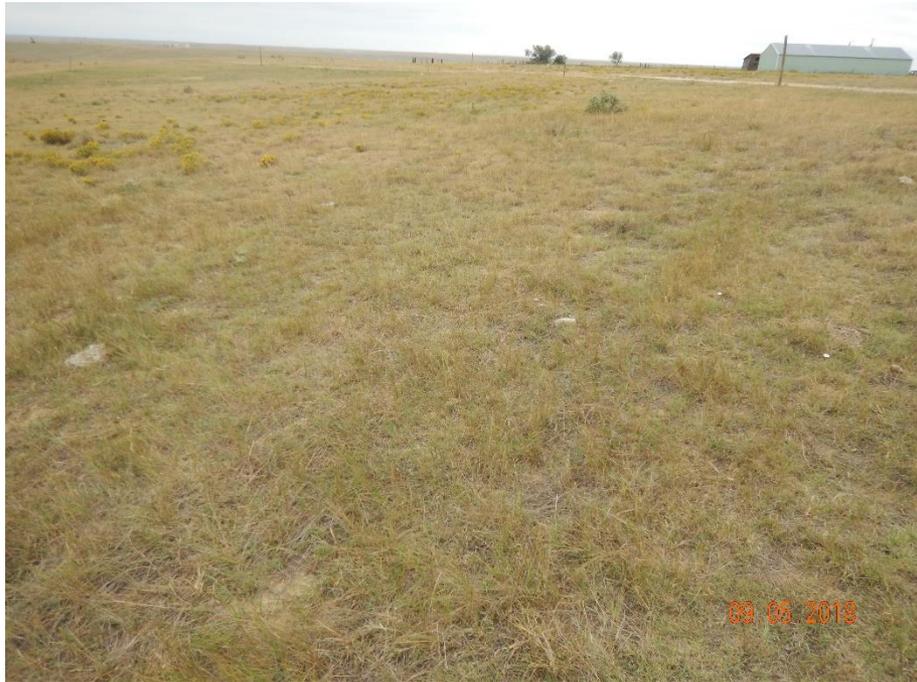
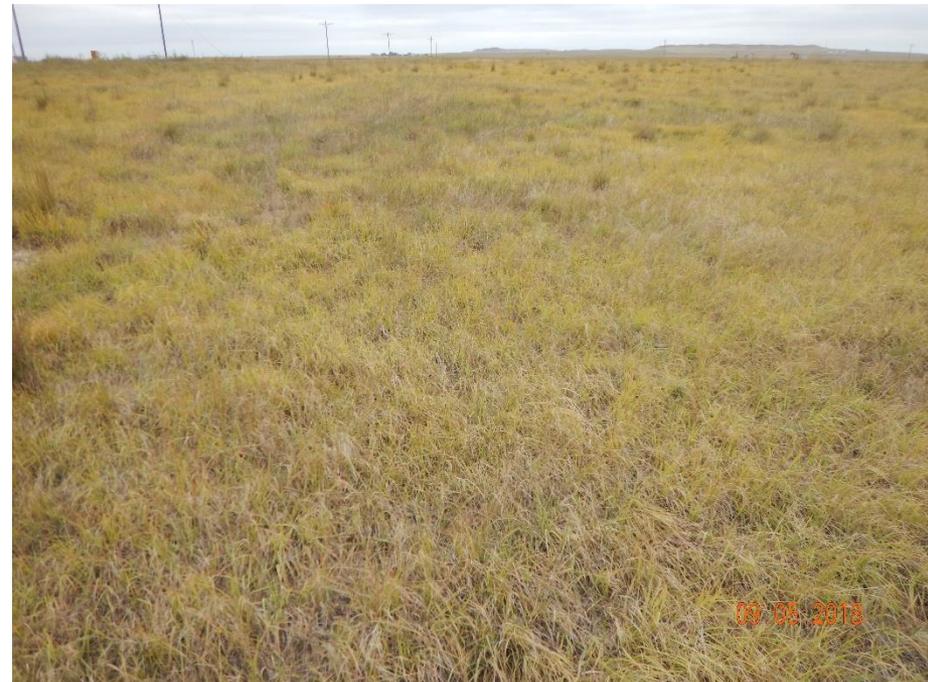
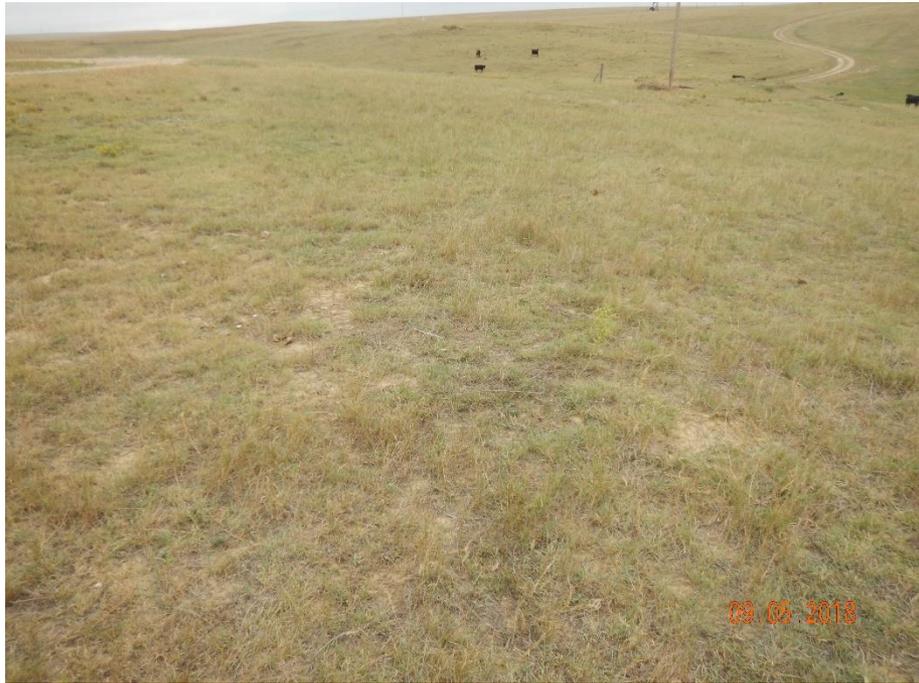
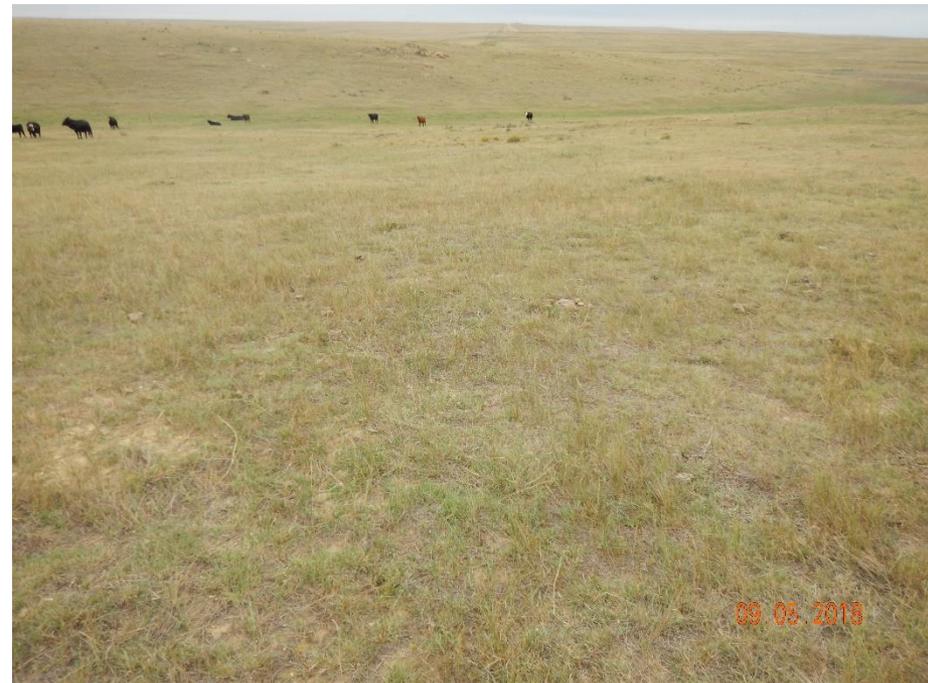
Photo 82: Photo taken from the adjacent lands, facing north. See photo 127 for additional details. Diffuse Knapweed **was not** observed in this area. Photo shows adjacent lands do not have the population densities of noxious weeds compared to areas within the locations and its immediate surrounding; noxious weed population densities decrease as the distance away from the locations increase.

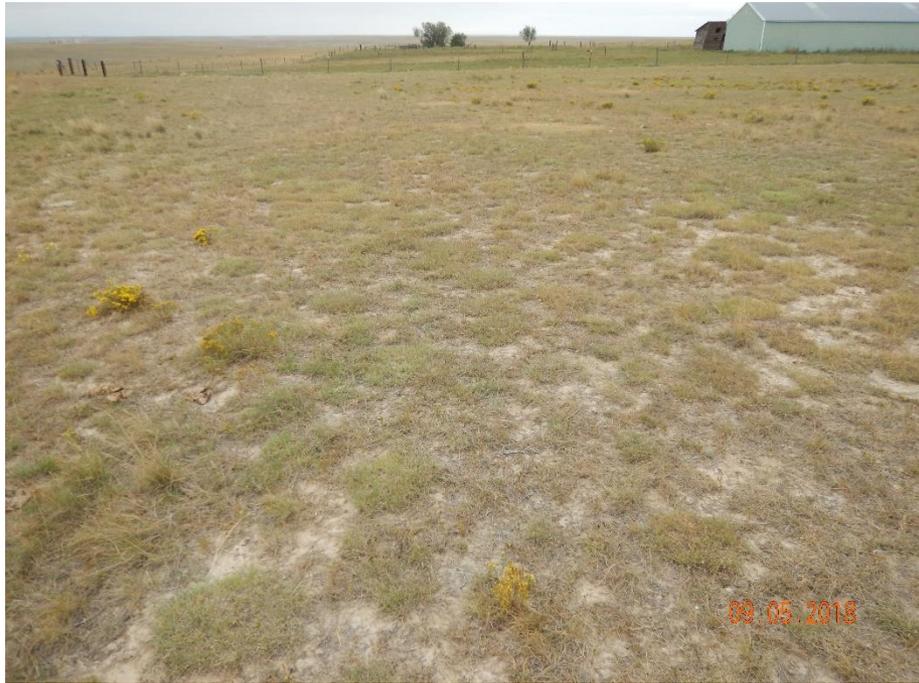
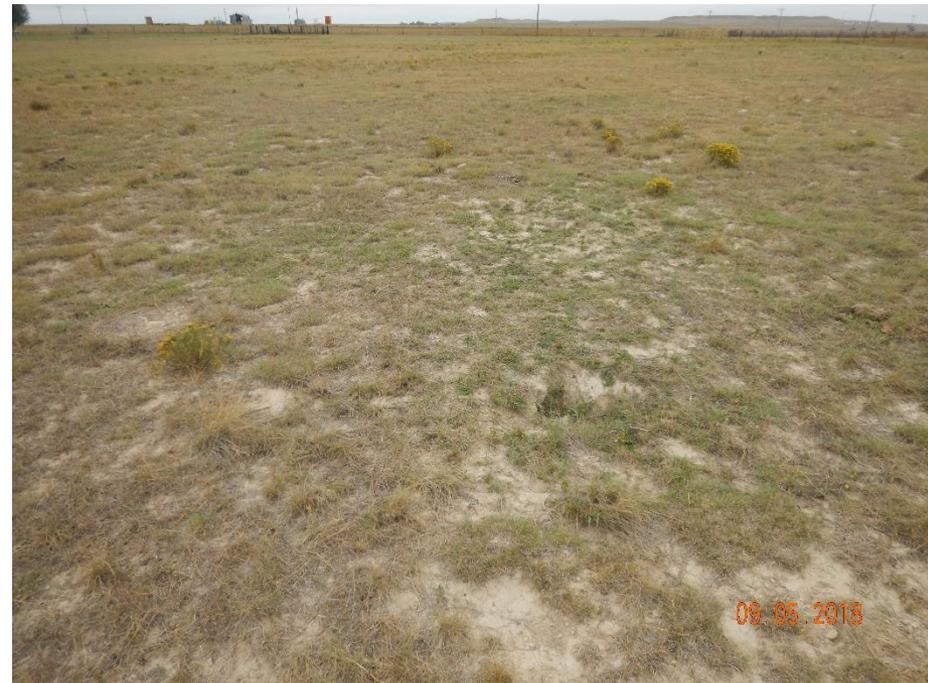
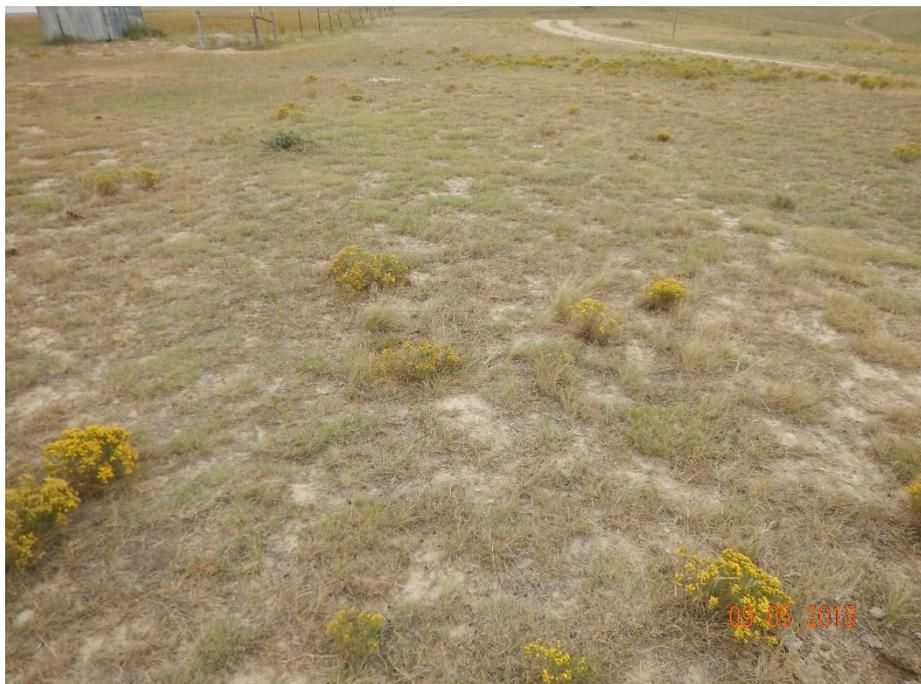
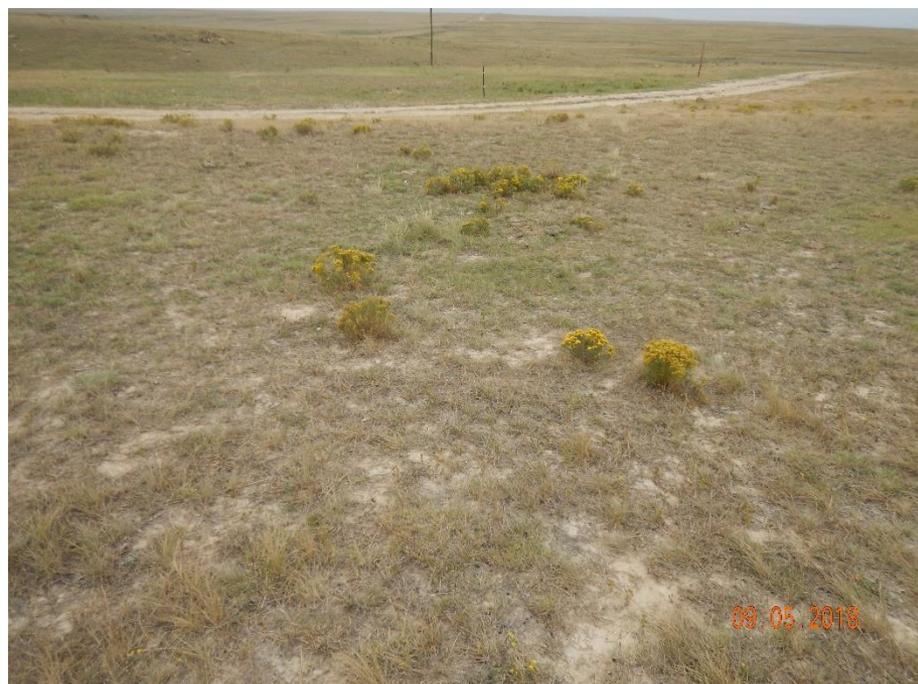
Photo 86: Photo taken from the adjacent lands, facing north. See photo 127 for additional details. Diffuse Knapweed **was not** observed in this area. Photo shows adjacent lands do not have the population densities of noxious weeds compared to areas within the locations and its immediate surrounding; noxious weed population densities decrease as the distance away from the locations increase.

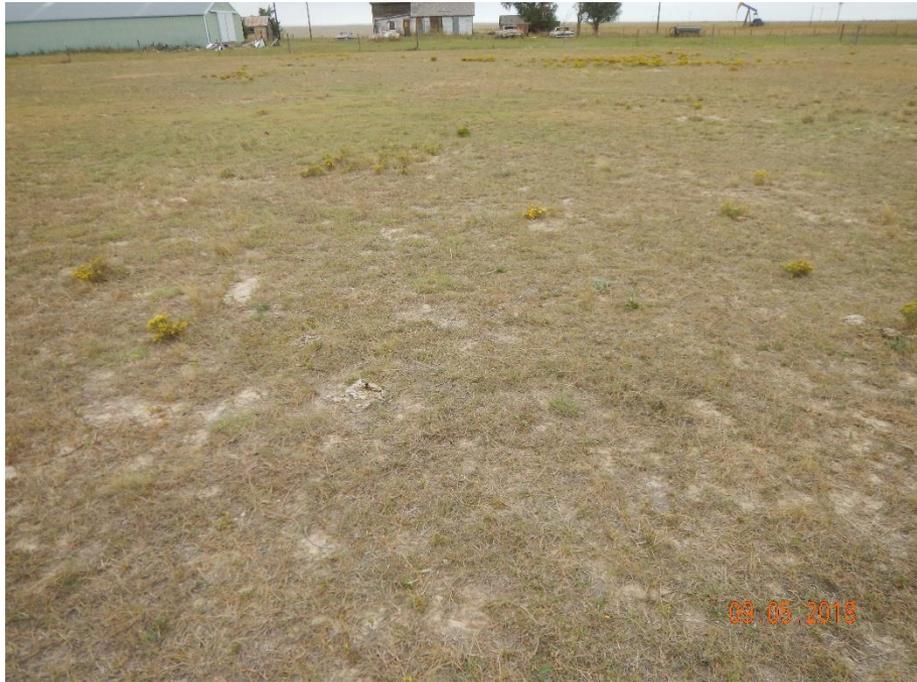
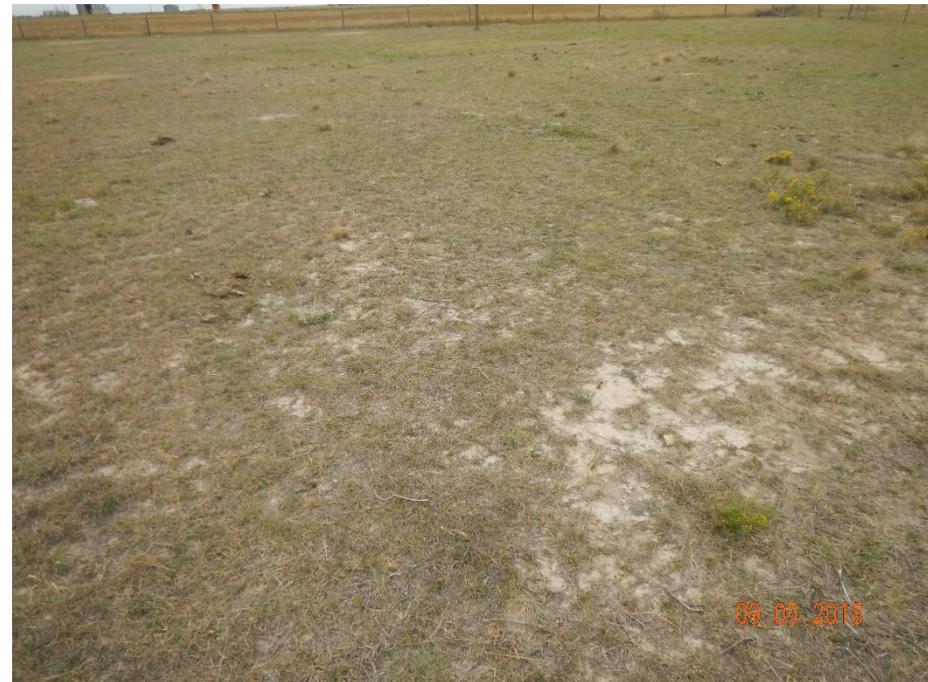
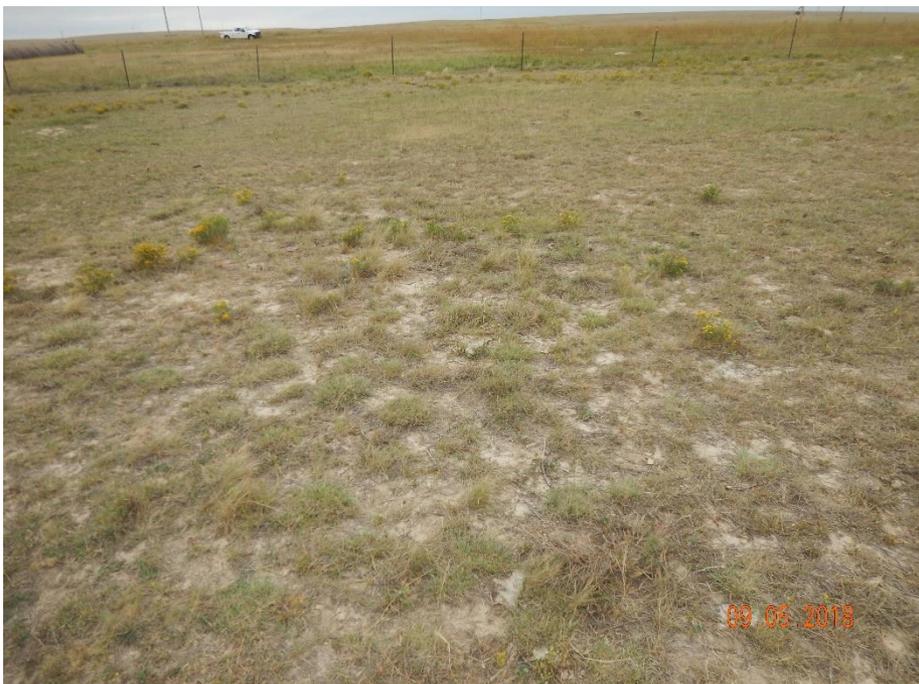
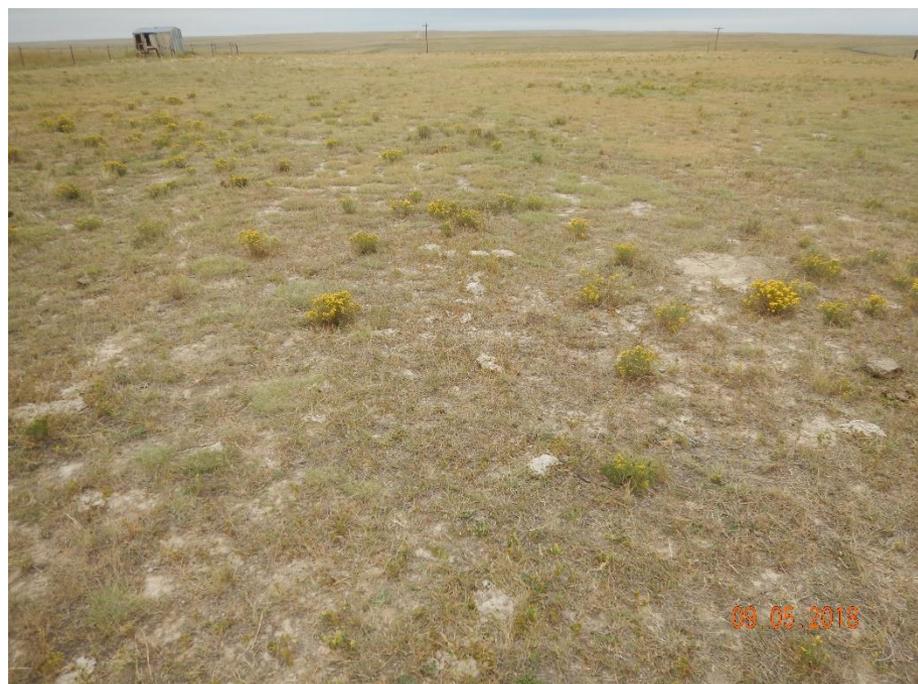
Photo 91: Photo taken from the adjacent lands, facing north. See photo 127 for additional details. Diffuse Knapweed **was not** observed in this area. Photo shows adjacent lands do not have the population densities of noxious weeds compared to areas within the locations and its immediate surrounding; noxious weed population densities decrease as the distance away from the locations increase.
