Inspection Photos

09/05/2018

Operator: FOUNDATION ENERGY
MANAGEMENT LLC - 10112

Inspection Doc. Number: 682503851
Weld County, CO

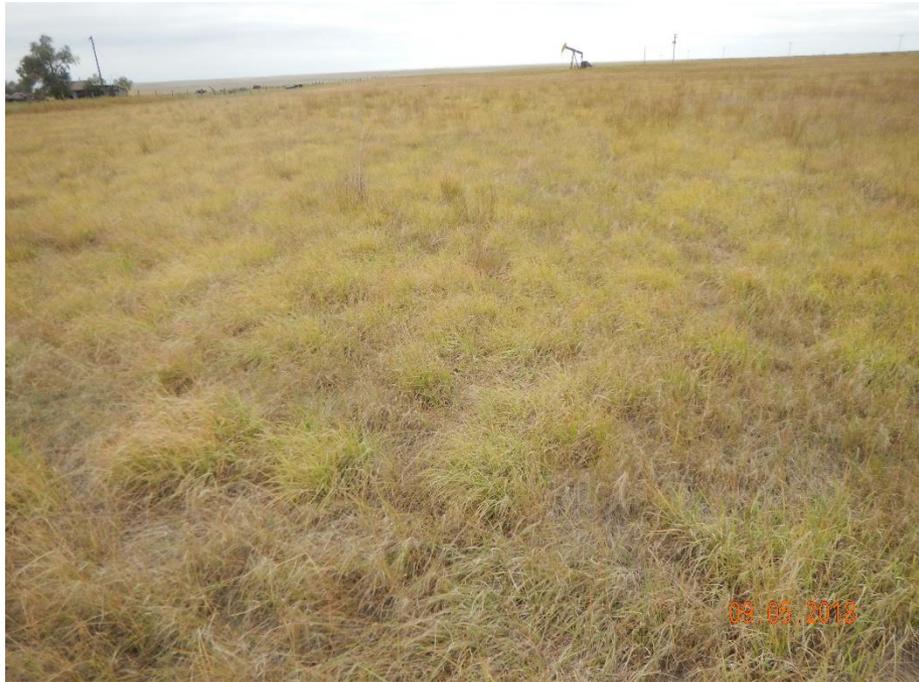
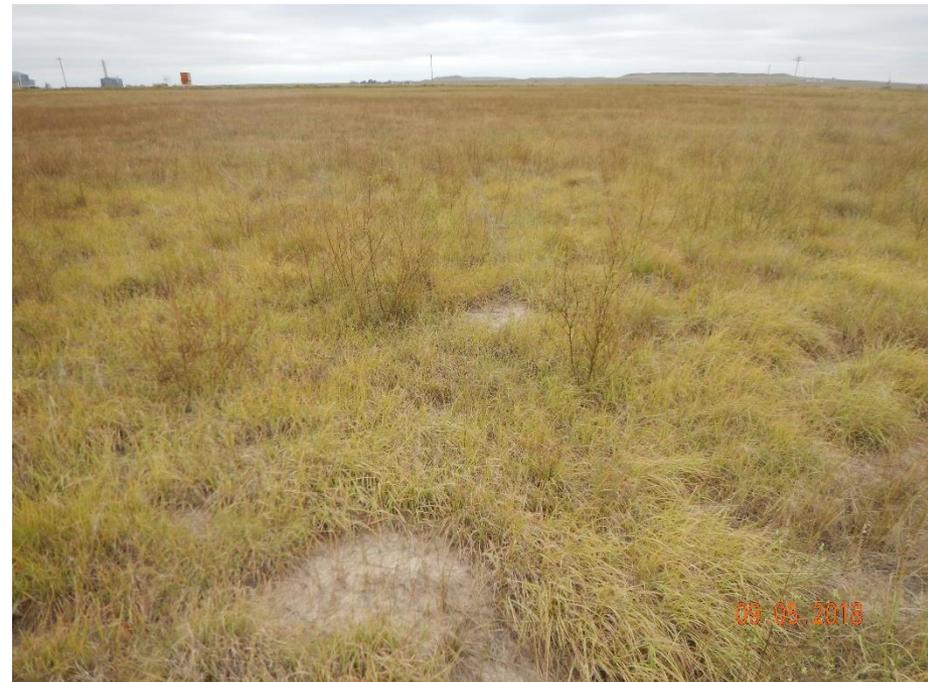
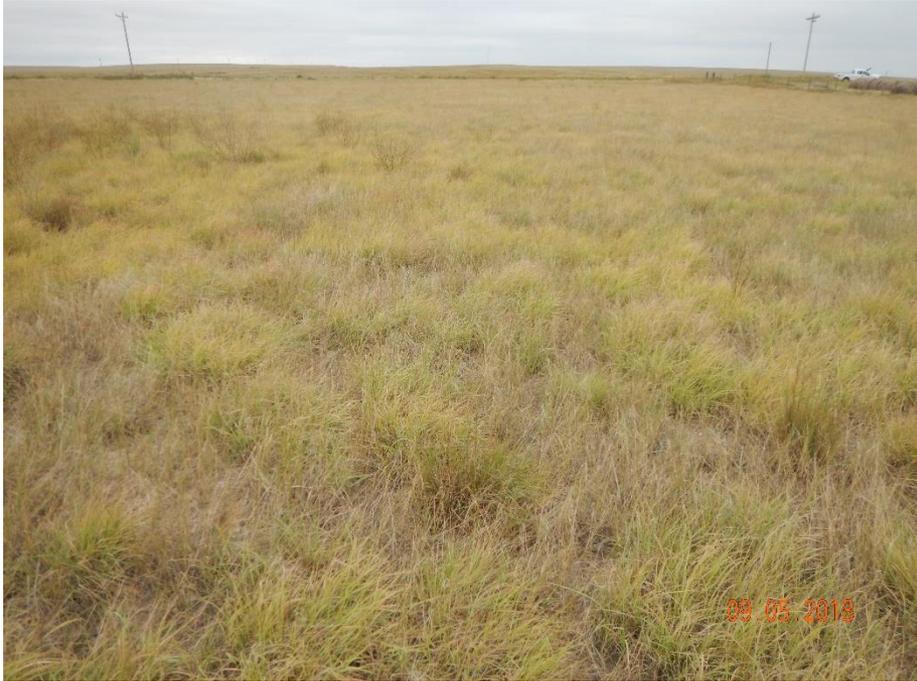
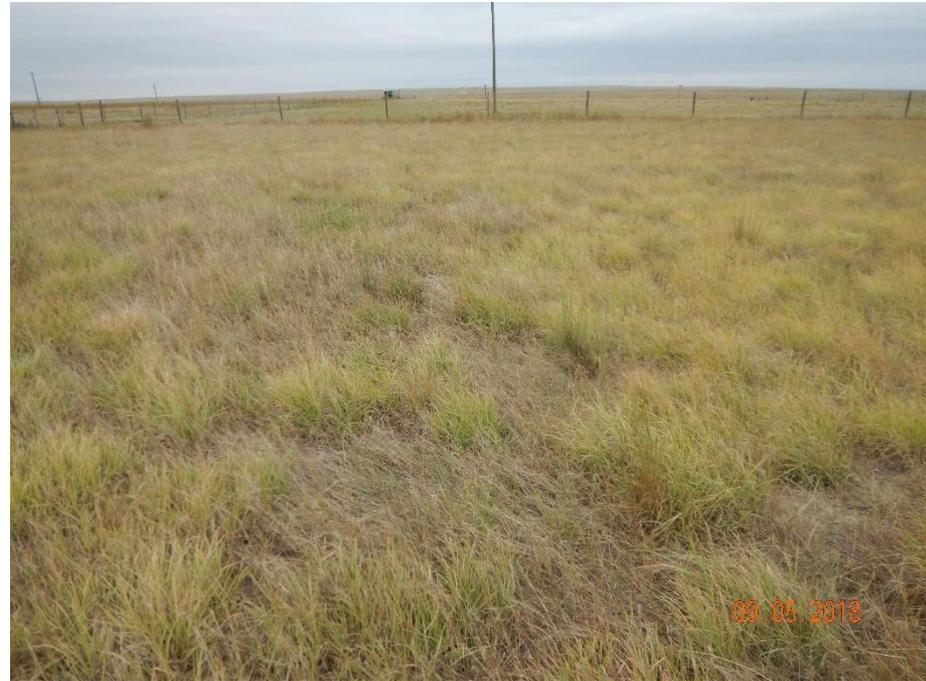
Photo 96: Photo taken from the adjacent lands, facing north. See photo 127 for additional details. Diffuse Knapweed **was not** observed in this area. Photo shows adjacent lands do not have the population densities of noxious weeds compared to areas within the locations and its immediate surrounding; noxious weed population densities decrease as the distance away from the locations increase.

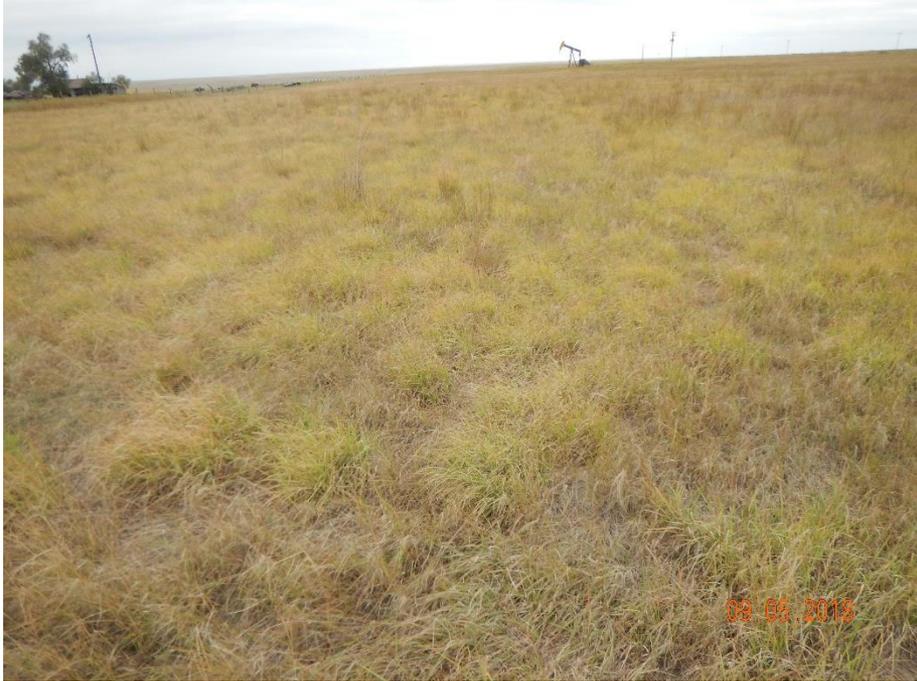
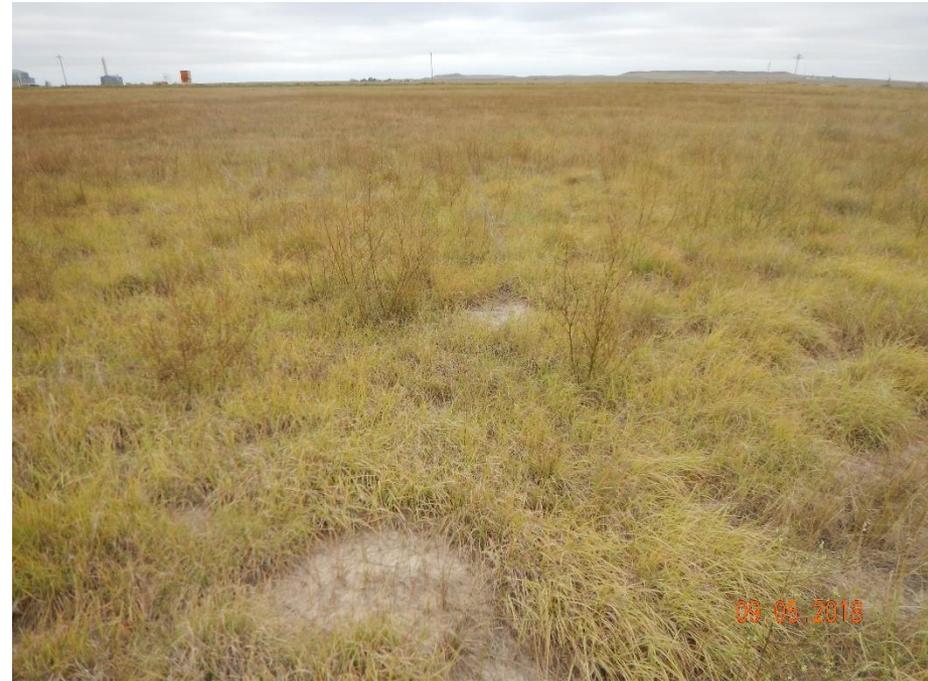
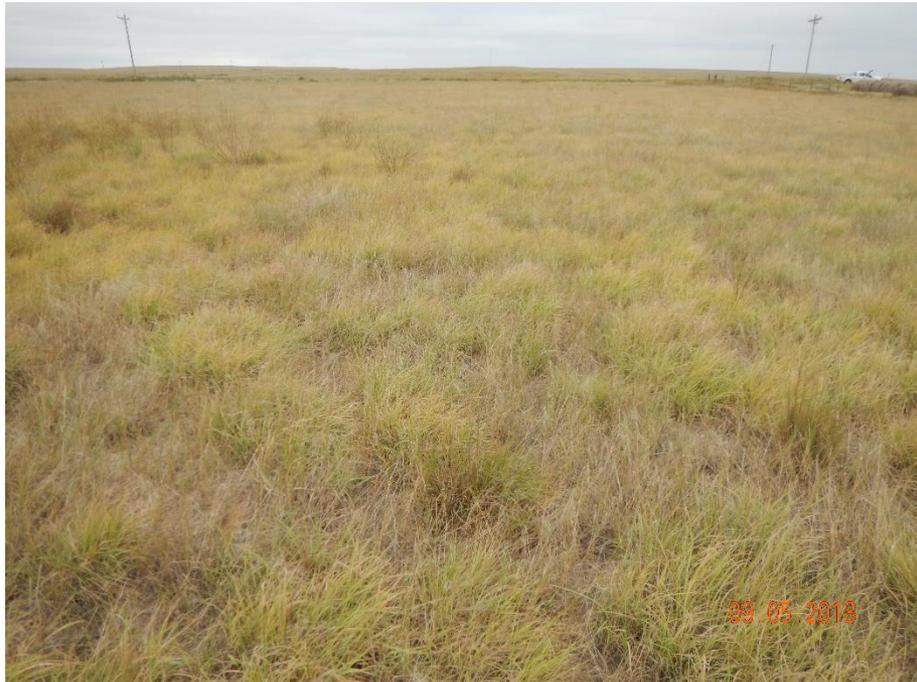
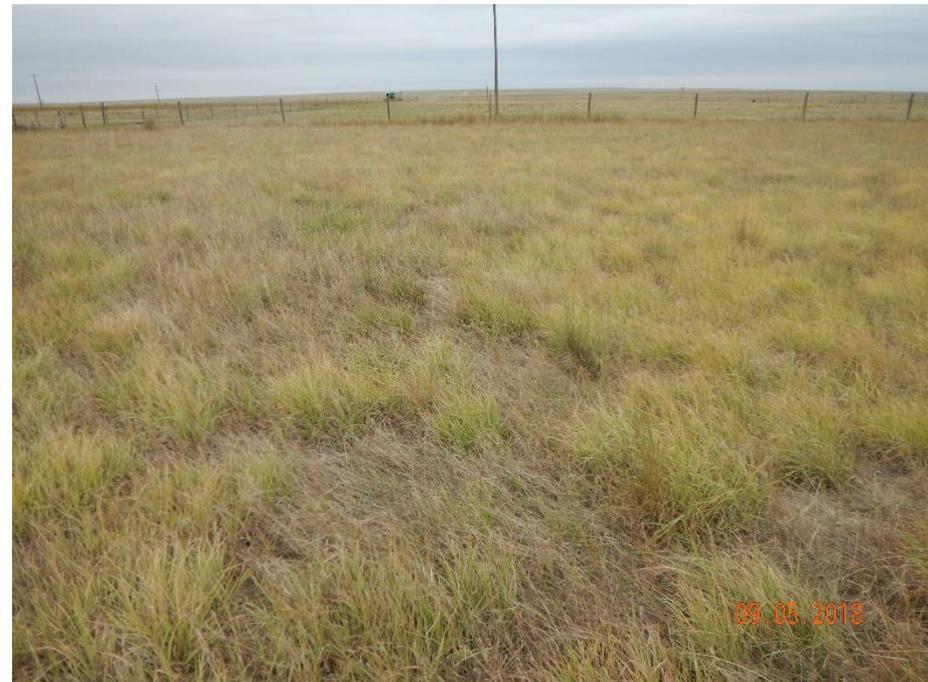
Photo 101: Photo taken from the adjacent lands, facing north. See photo 127 for additional details. Diffuse Knapweed **was not** observed in this area. Photo shows adjacent lands do not have the population densities of noxious weeds compared to areas within the locations and its immediate surrounding; noxious weed population densities decrease as the distance away from the locations increase.

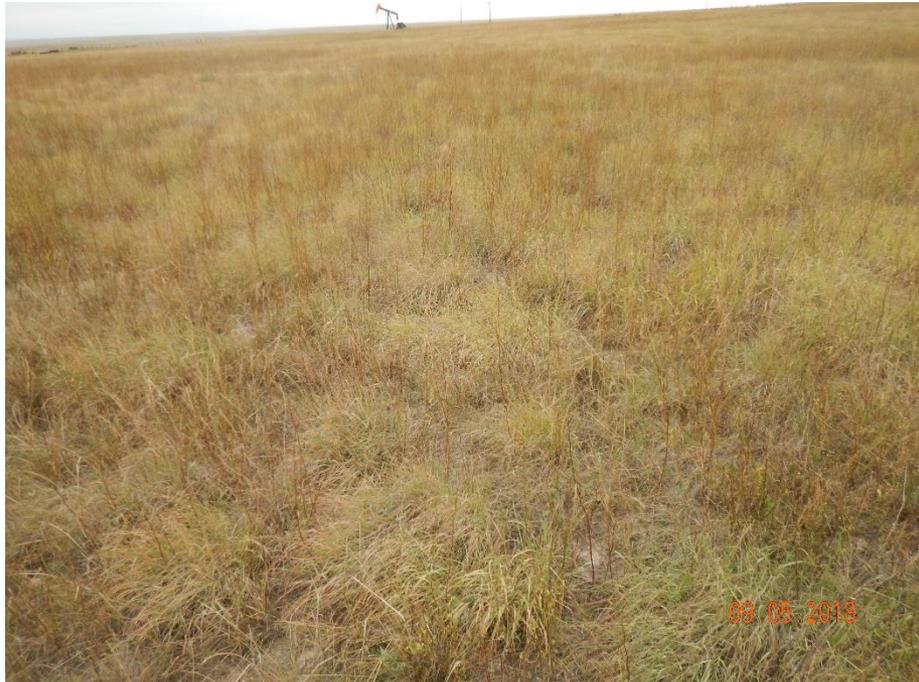
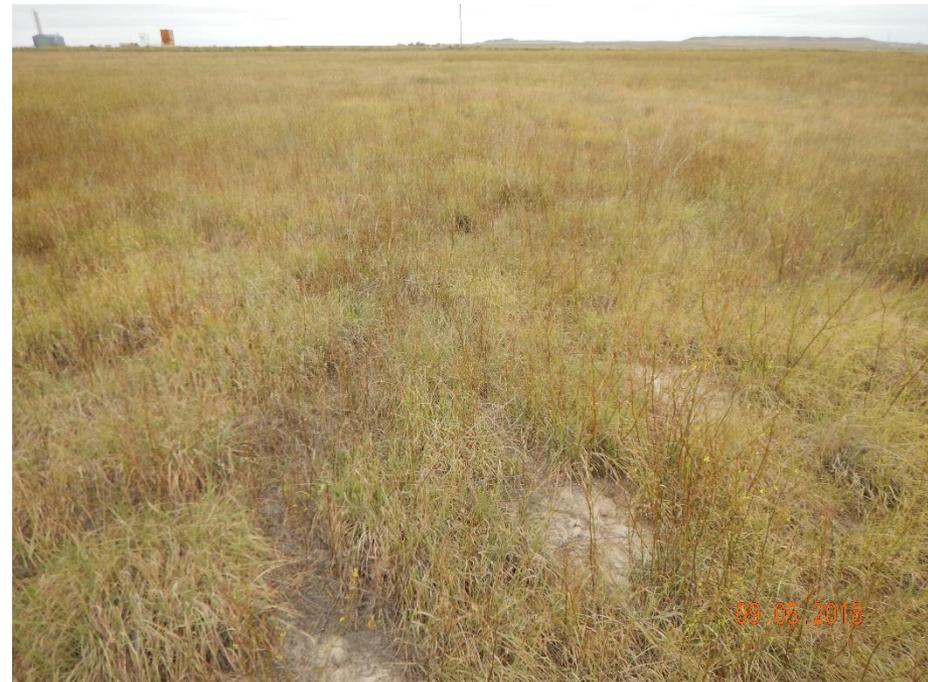
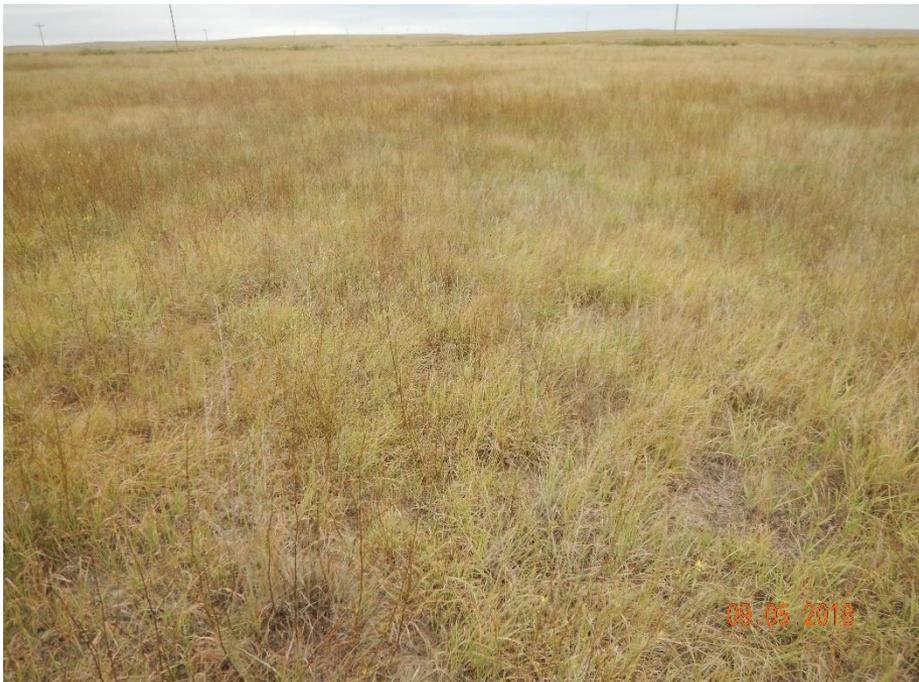
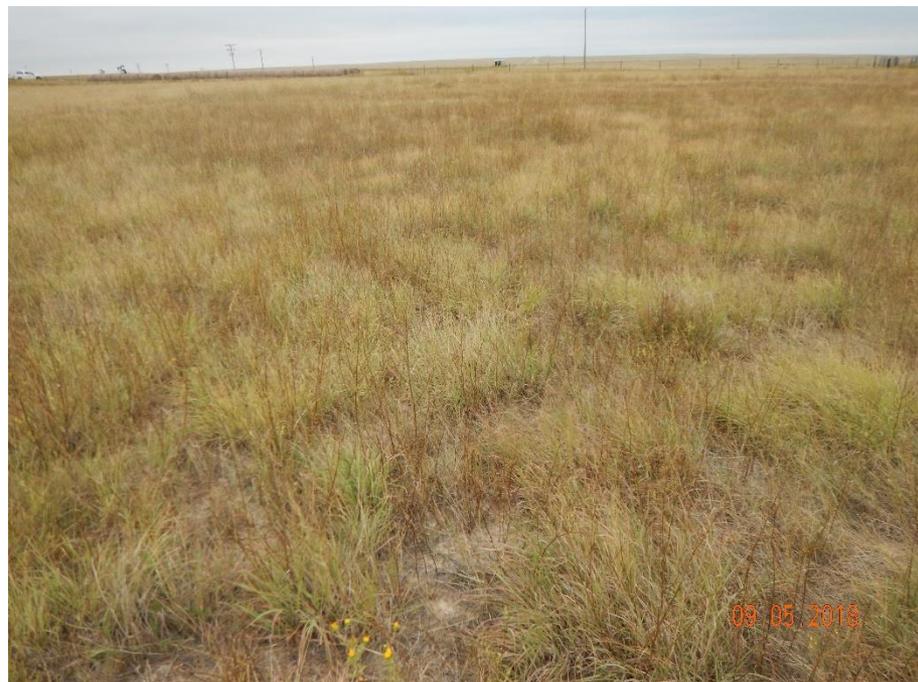
Photo 106: Photo taken from the adjacent lands, facing north. See photo 127 for additional details. Diffuse Knapweed **was not** observed in this area. Photo shows adjacent lands do not have the population densities of noxious weeds compared to areas within the locations and its immediate surrounding; noxious weed population densities decrease as the distance away from the locations increase.

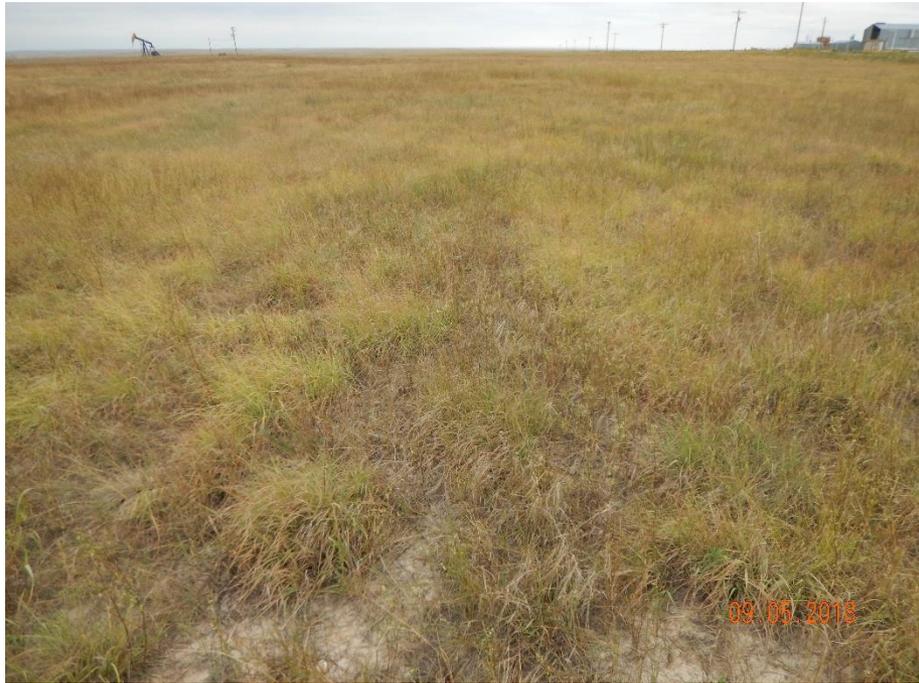
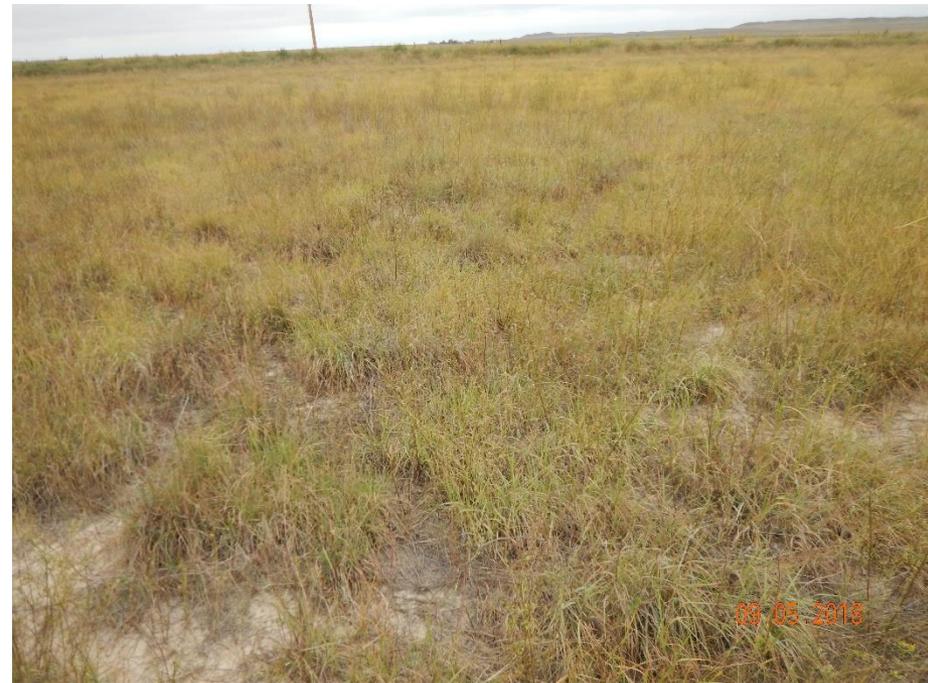
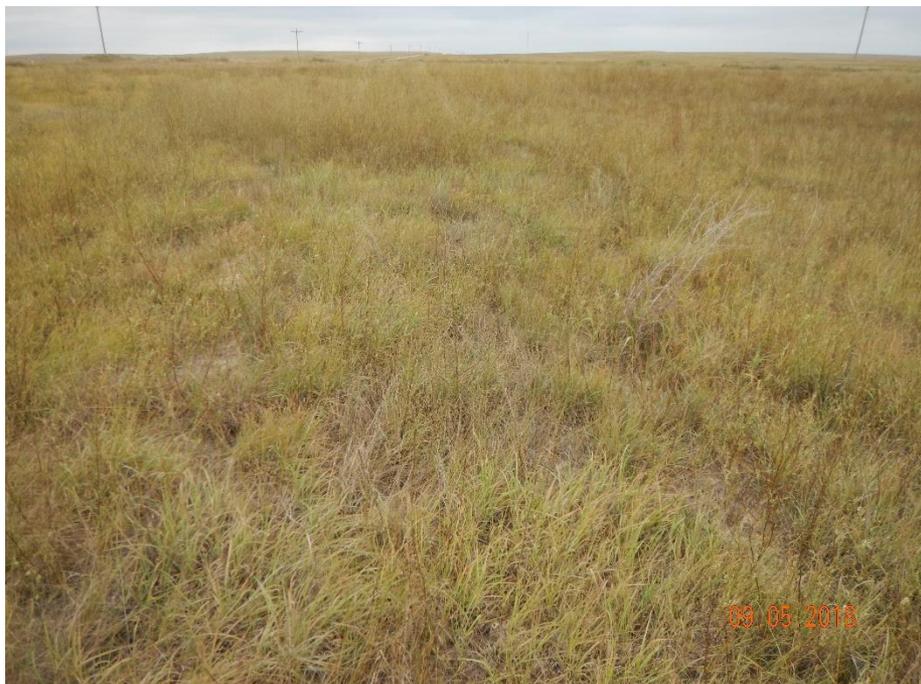
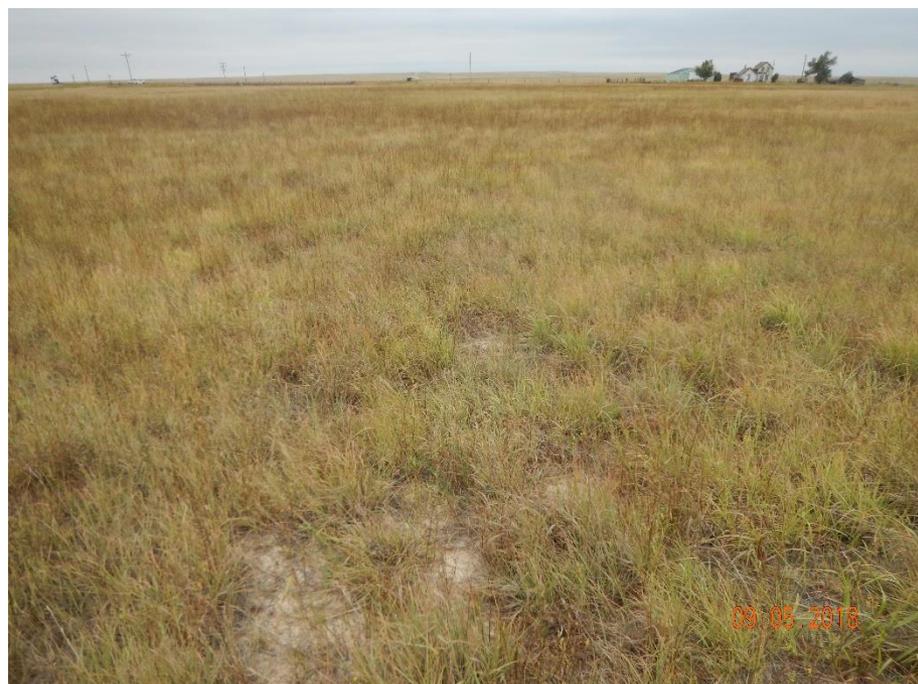
Photo 111: Photo taken from the adjacent lands, facing north. See photo 127 for additional details. Diffuse Knapweed **was not** observed in this area. Photo shows adjacent lands do not have the population densities of noxious weeds compared to areas within the locations and its immediate surrounding; noxious weed population densities decrease as the distance away from the locations increase.
