## Inspection Photos

**Location Name:** Sooner Unit - 68N58W /21SENW

**Location #:** 327361

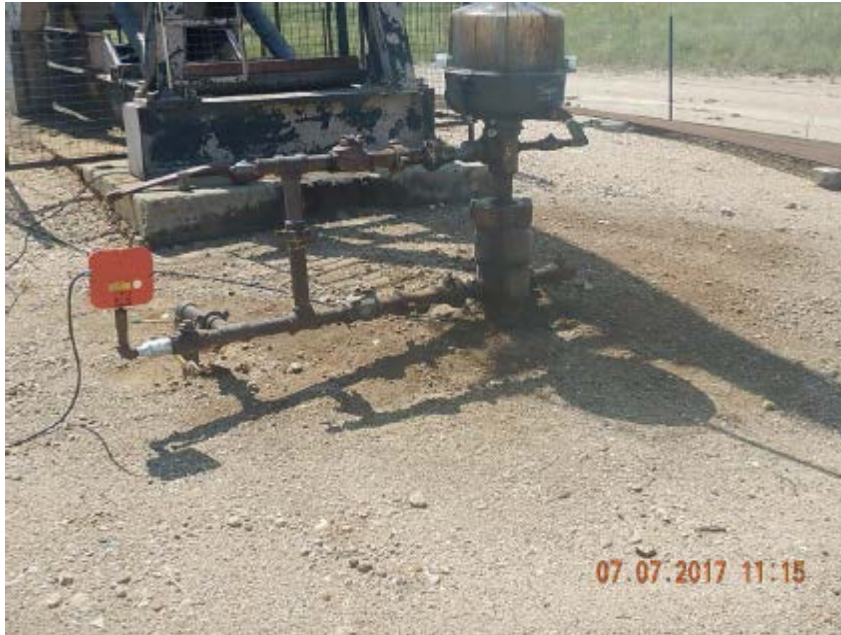
**Photo #1**

**Sooner Unit 6-21** wellhead  
Bradenhead NOT plumbed to surface  
Stained soil  
*From previous FIR*

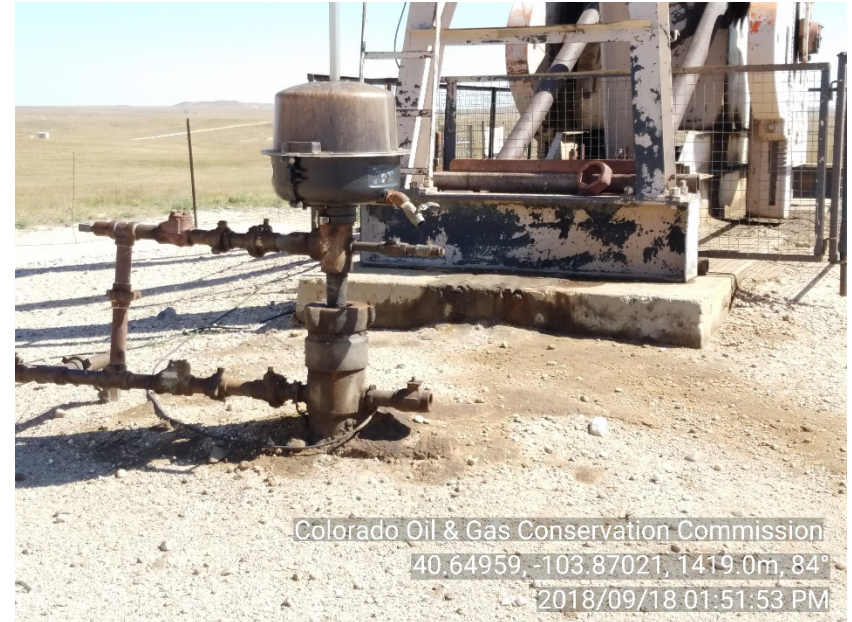
**Photo #2**

**Sooner Unit 6-21** (API # 05-123-14562) wellhead  
**Bradenhead NOT plumbed to surface**  
**Stained soil**

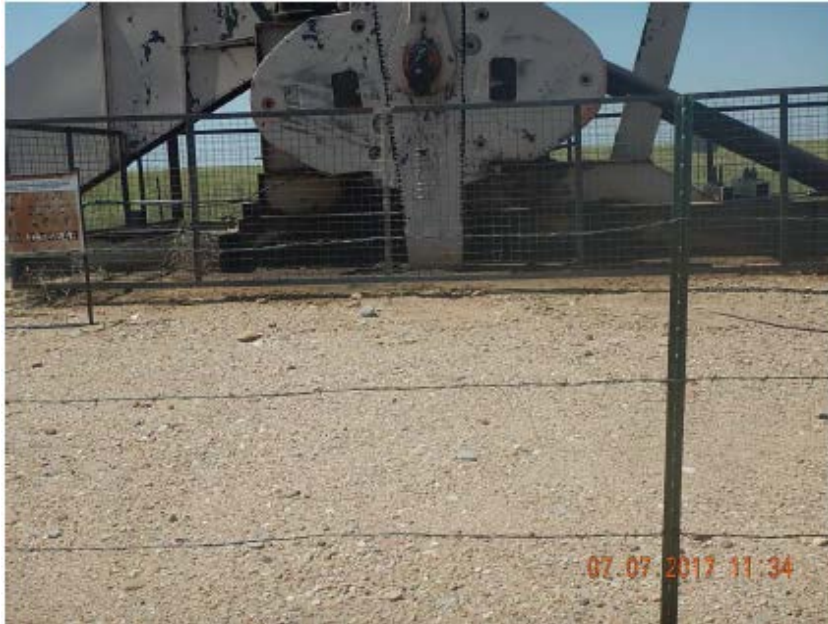
**Photo #3**

**Sooner Unit 6-21** wellsite

**Stained soil at pump jack (N & S sides)**

*From previous FIR*

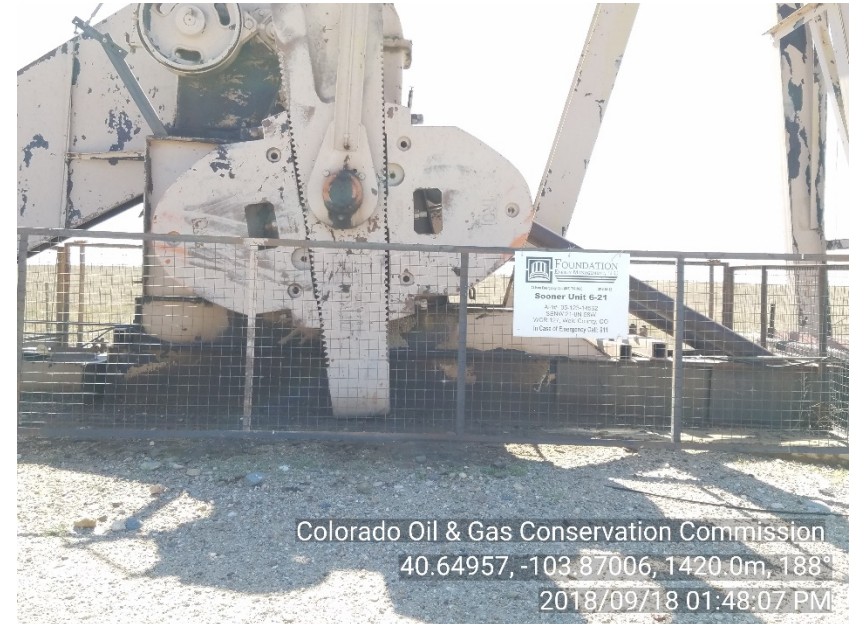
**Photo #4**

**Sooner Unit 6-21** wellsite

***New sign has been posted.***

**Stained soil at pump jack (N & S sides)**

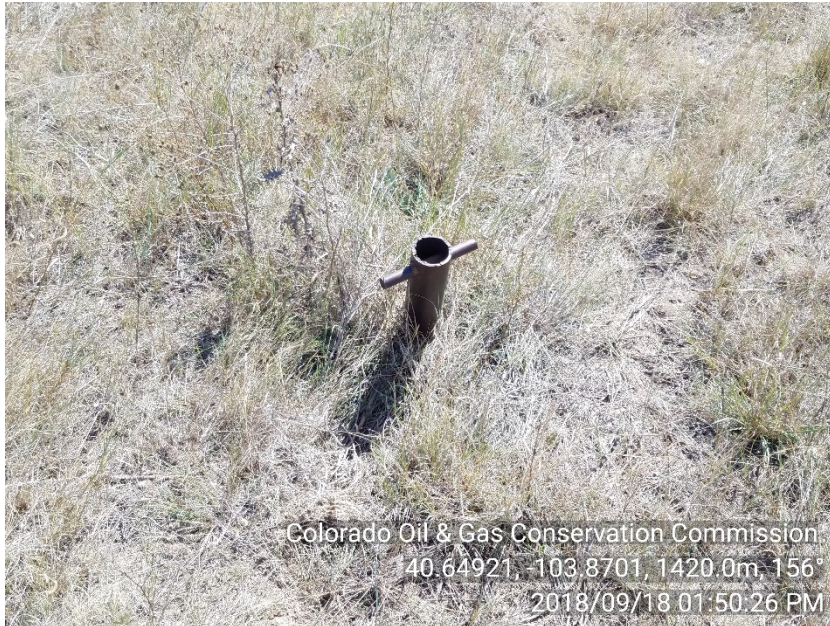
**Photo #5**

**Sooner Unit 6-21** wellsite

**Unmarked Anchors**

*2 of 4 are marked*

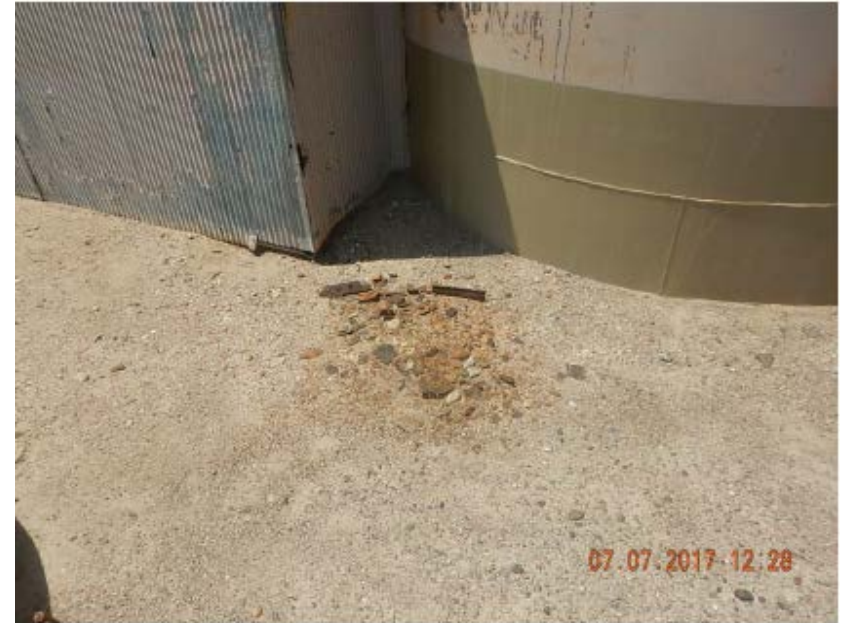
**Photo #6**

**Sooner Unit** Produced H2O tanks

**Debris near East produced H2O tanks remains**

*From previous FIR*

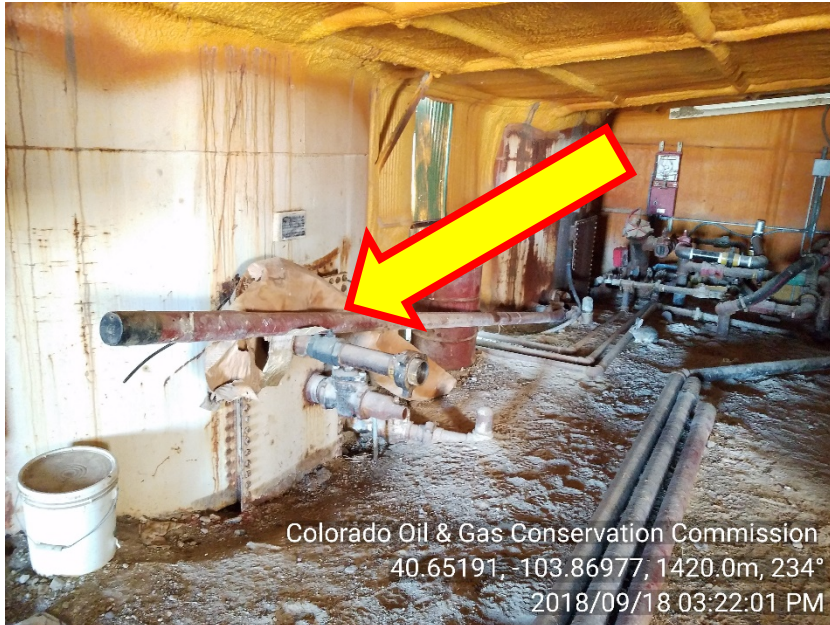
**Photo #7**

**Sooner Unit** Produced H2O tank room

**Debris near middle West produced H2O tank**

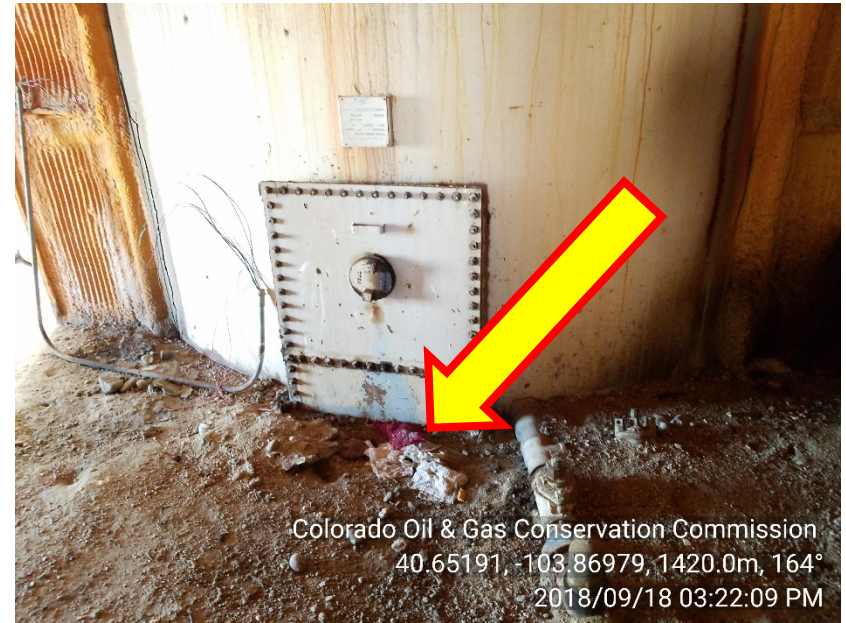
**Photo #8**

**Sooner Unit** Produced H2O tank room

**Debris near middle East produced H2O tank**

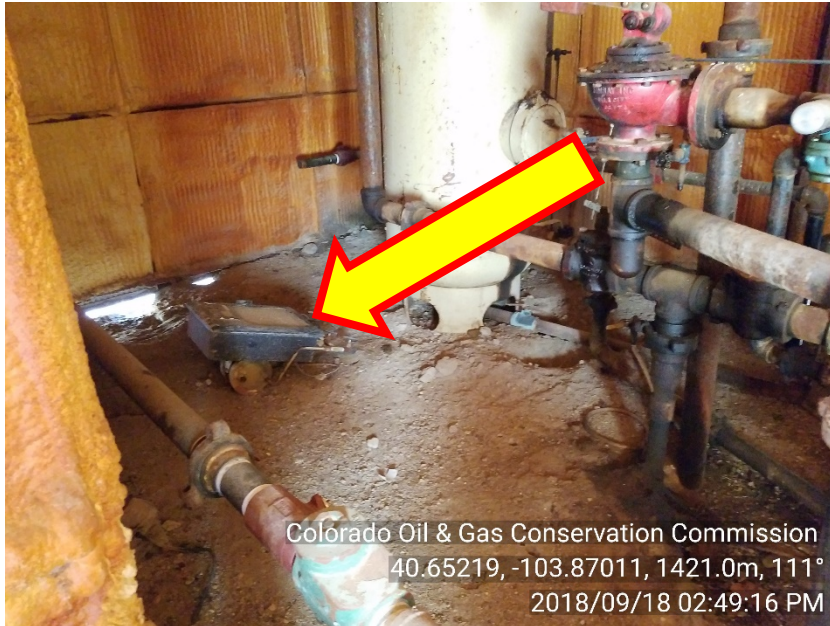
**Photo #9**

**Sooner Unit** North treater house

**Unused equipment**

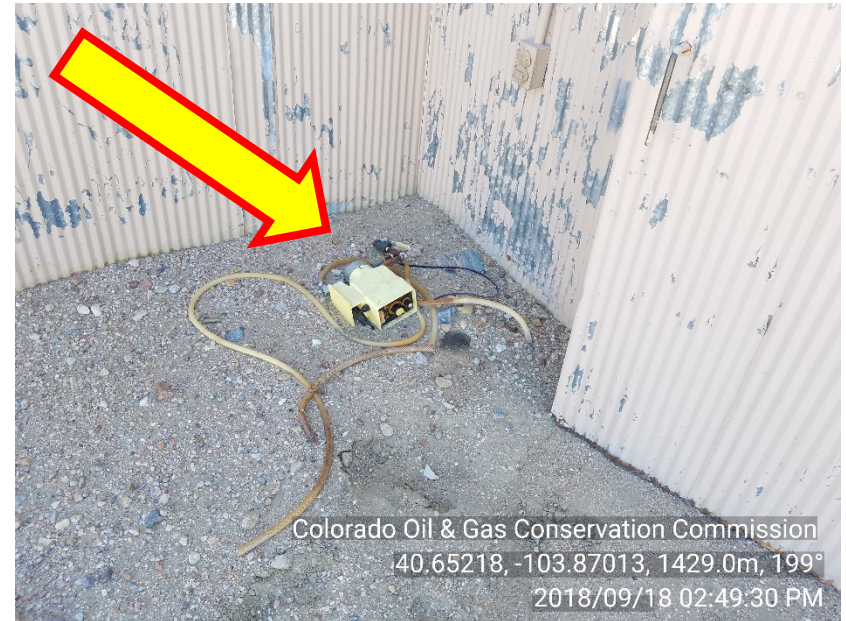
**Photo #10**

**Sooner Unit** North treater house

**Unused equipment - outside**

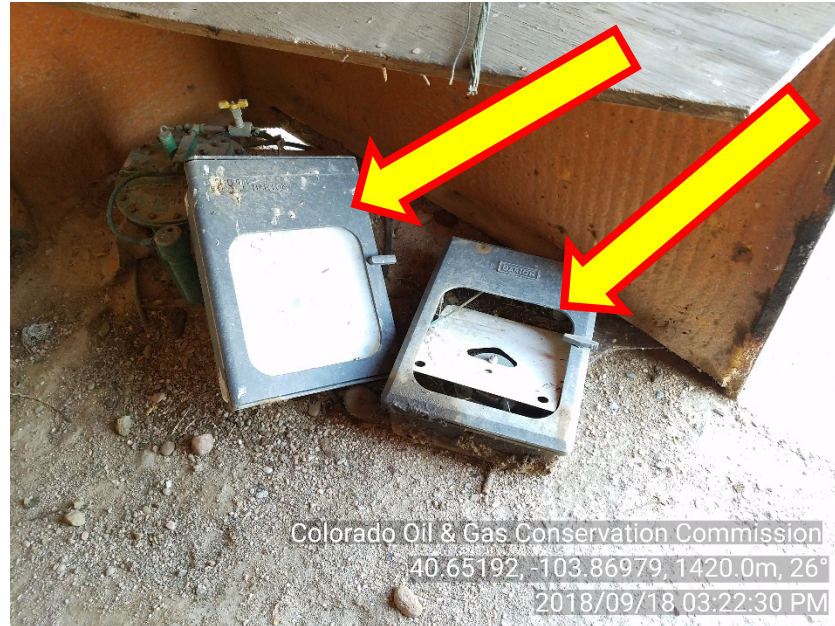
**Photo #11**

**Sooner Unit** Produced H<sub>2</sub>O tank room – E. door

***Unused equipment***

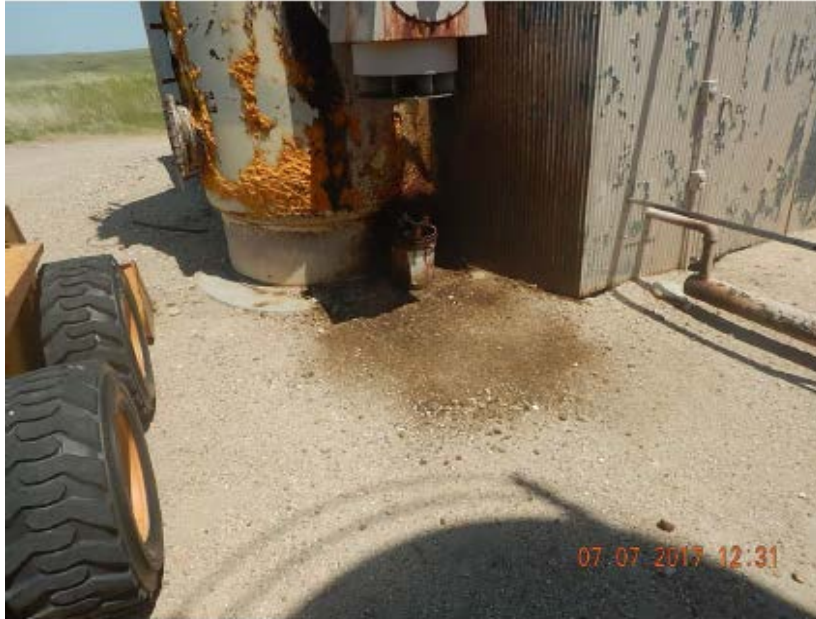
**Photo #12**

**Sooner Unit** North treater

*Stained soil and previously leaking equip.*

*From previous FIR*

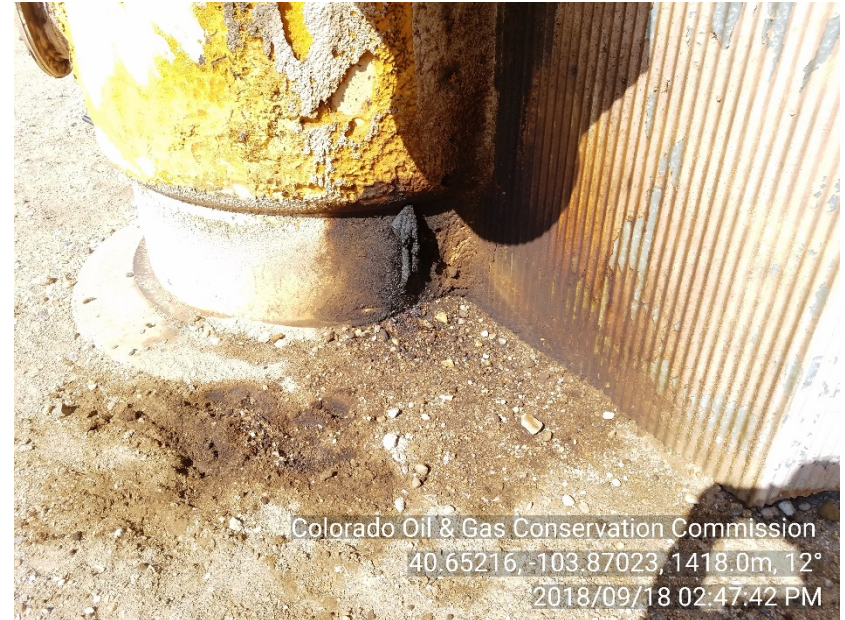
**Photo #13**

**Sooner Unit** North treater

*Stained soil and previously leaking equip.*

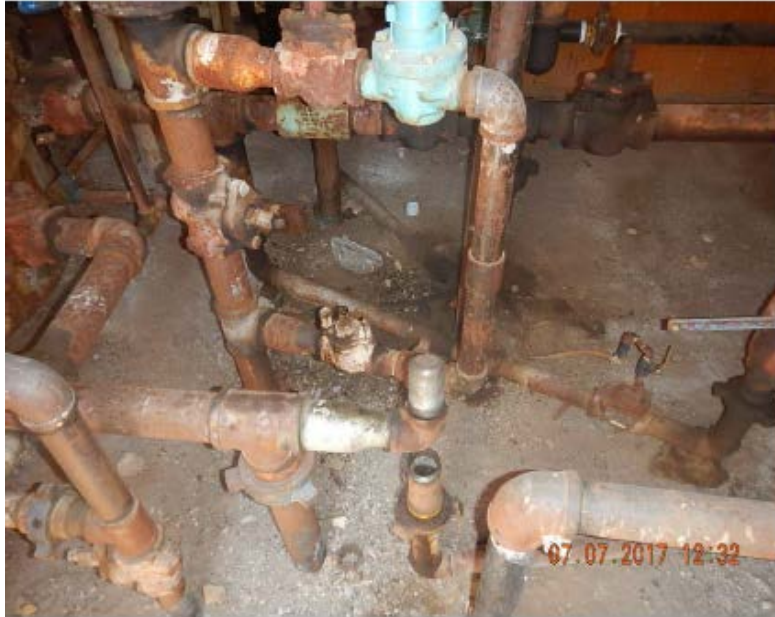
**Photo #14**

**Sooner Unit** North treater house

**Stained soil**

*From previous FIR*

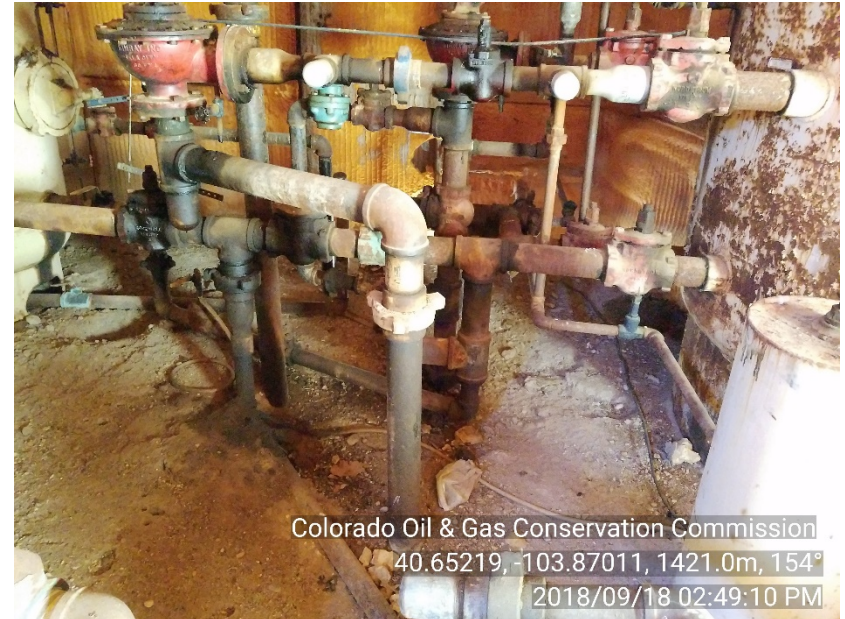
**Photo #15**

**Sooner Unit** North treater house

**Stained soil**

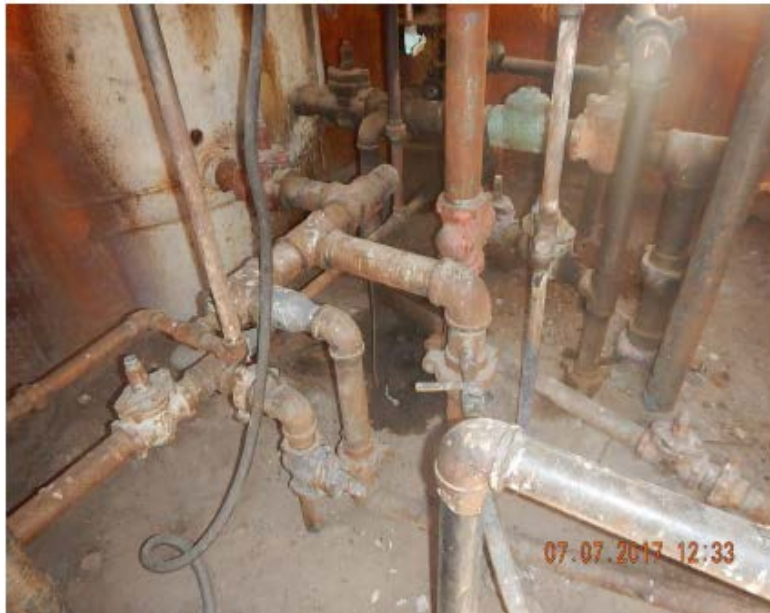
**Photo #16**

**Sooner Unit** South treater house

***Stained soil***

*From previous FIR*

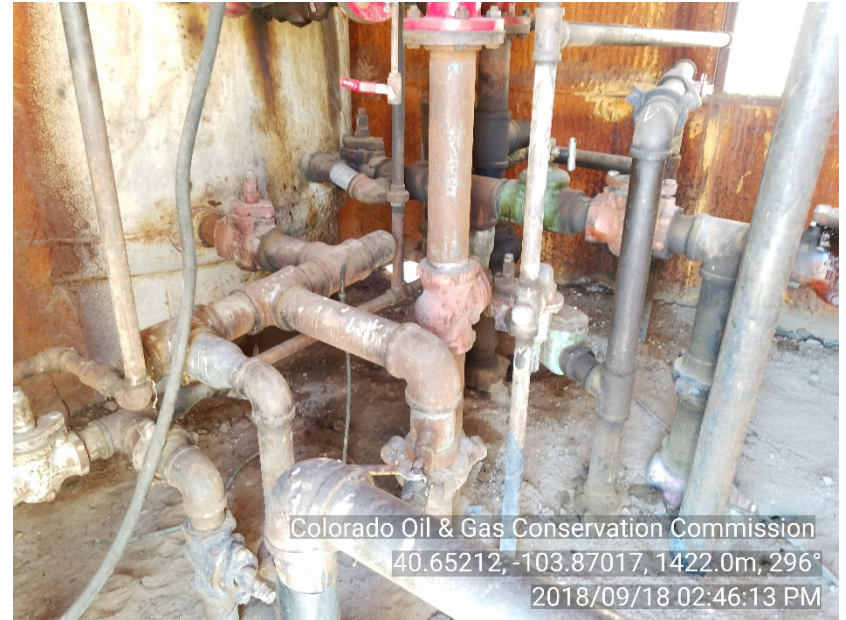
**Photo #17**

**Sooner Unit** South treater house

***Stained soil***

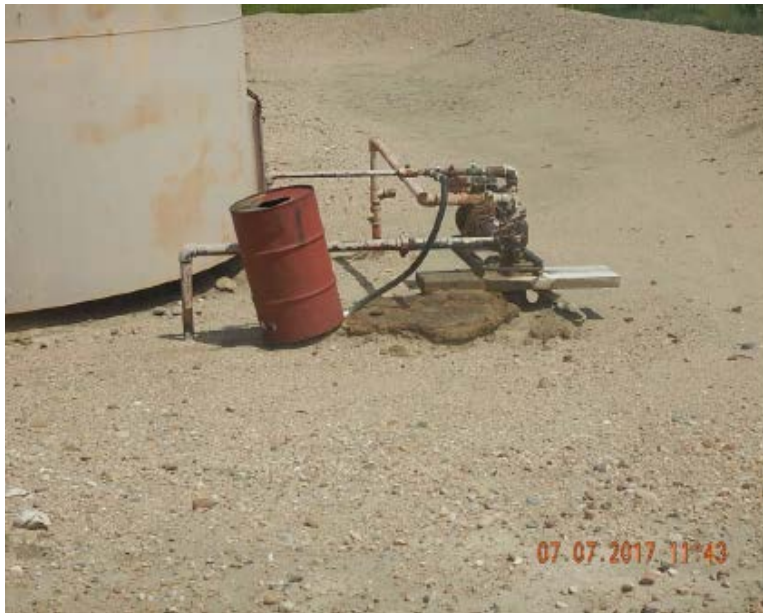
**Photo #18**

**Sooner Unit** Crude oil recycle pump

***Stained soil***

*From previous FIR*

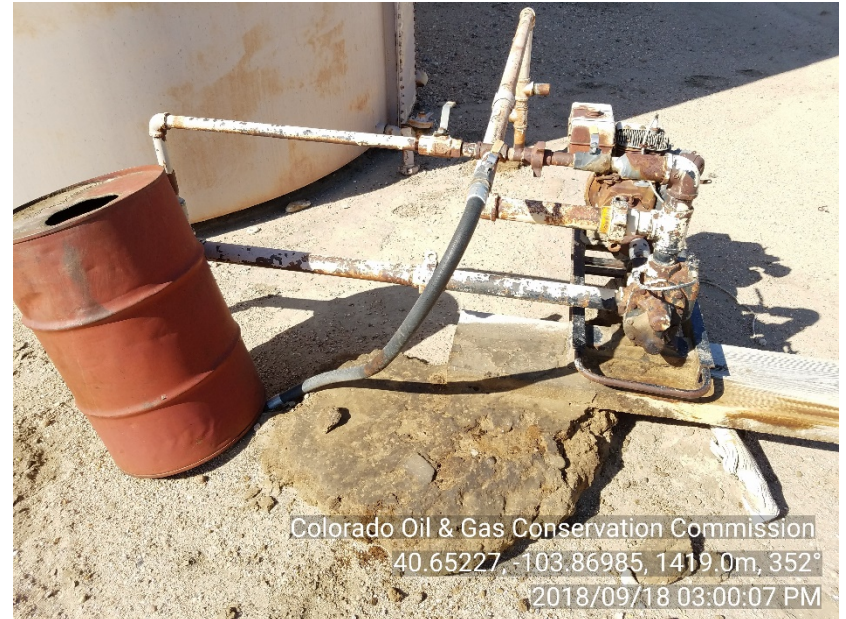
**Photo #19**

**Sooner Unit** Crude oil recycle pump

***Stained soil***

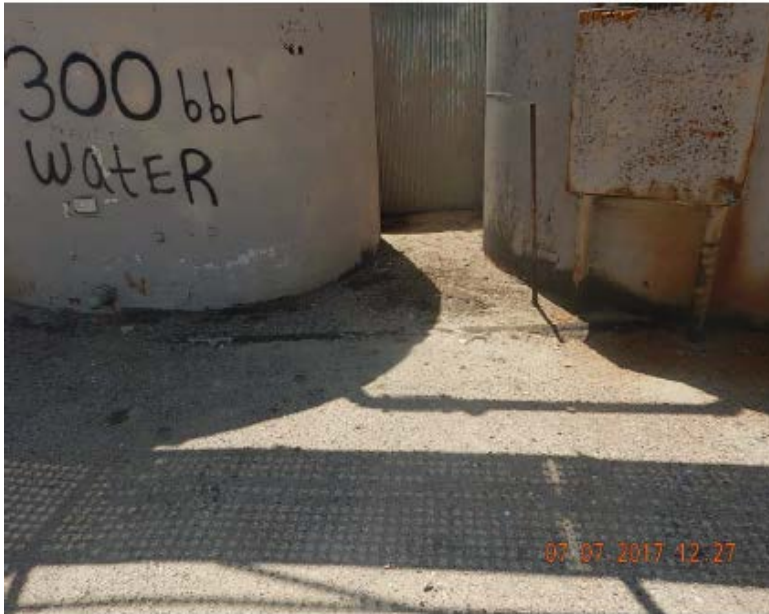
**Photo #20**

**Sooner Unit** Produced H<sub>2</sub>O tanks N side.

***Stained soil***

*From previous FIR*

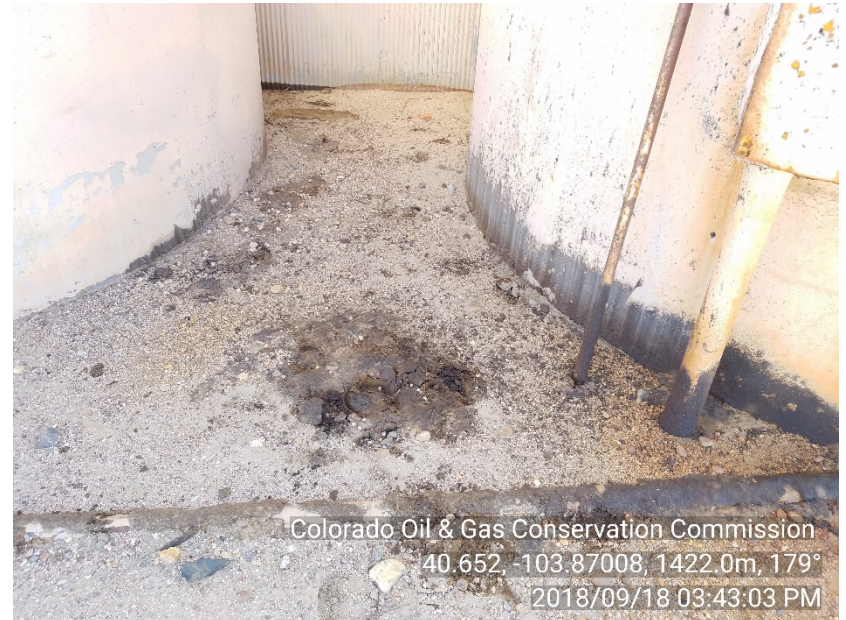
**Photo #21**

**Sooner Unit** Produced H<sub>2</sub>O tanks N side.

***Stained soil***

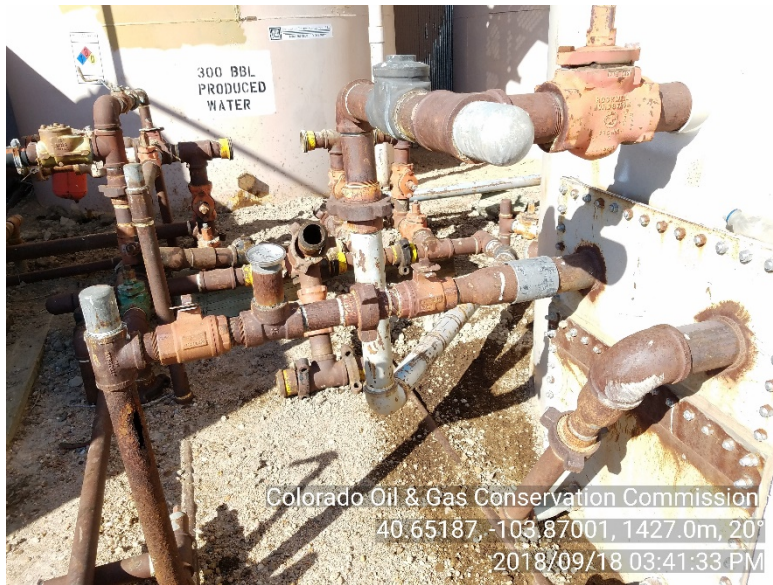
**Photo #22**

**Sooner Unit** Produced H<sub>2</sub>O transfer pumps

***Stained soil***

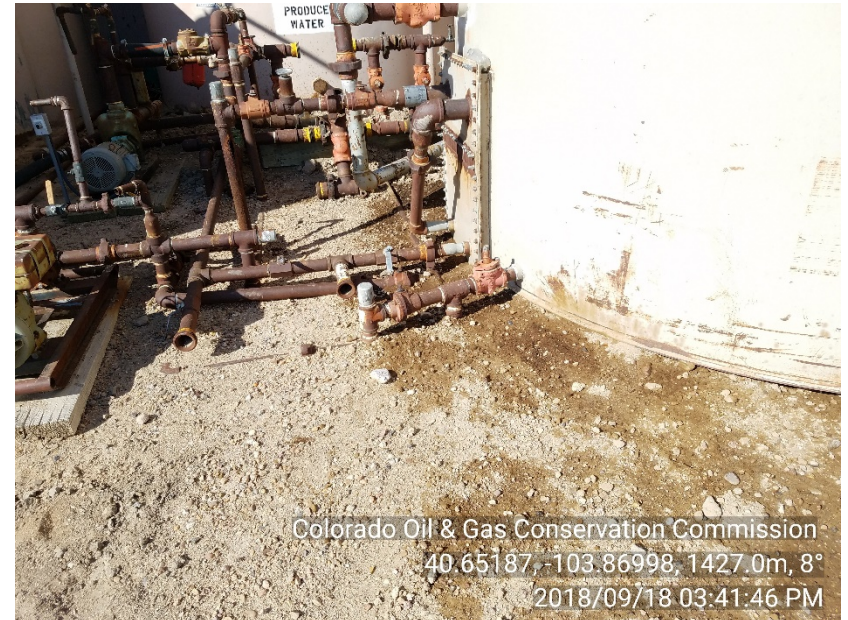
**Photo #23**

**Sooner Unit** Produced H<sub>2</sub>O transfer pumps

***Stained soil***

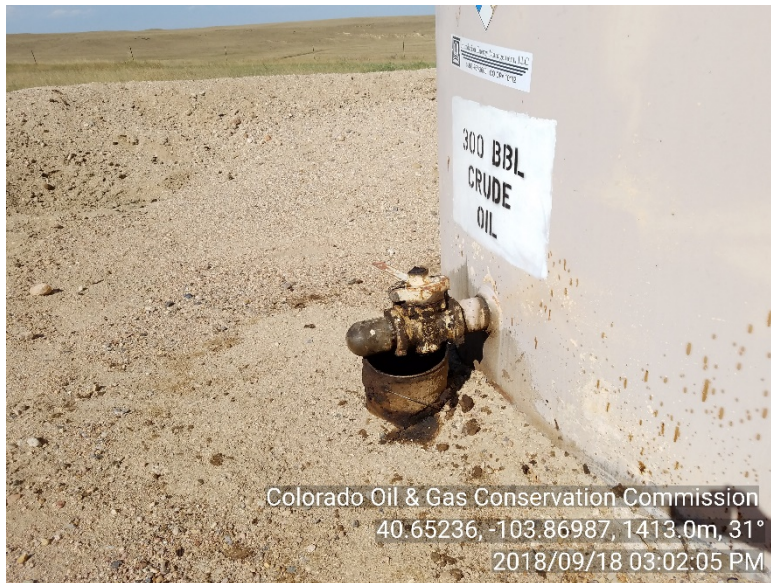
**Photo #24**

**Sooner Unit** Crude Oil tanks - loadout

***Stained soil***

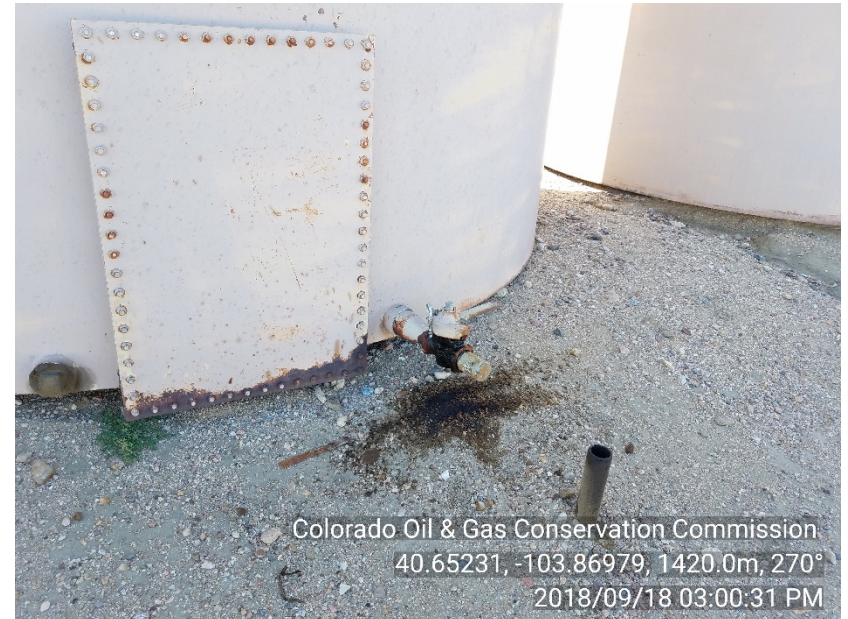
**Photo #25**

**Sooner Unit** Crude Oil tanks - drain

***Stained soil***

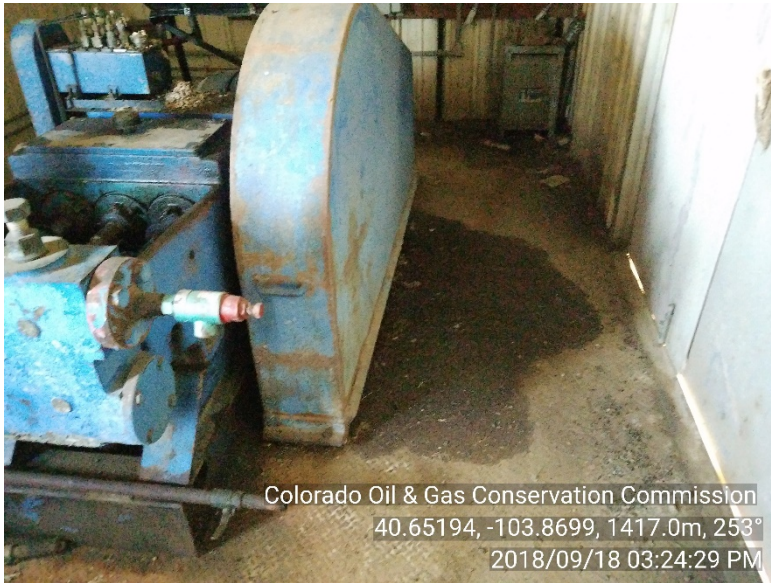
**Photo #26**

**Sooner Unit** Injection Pump – N side

**Stained floor**

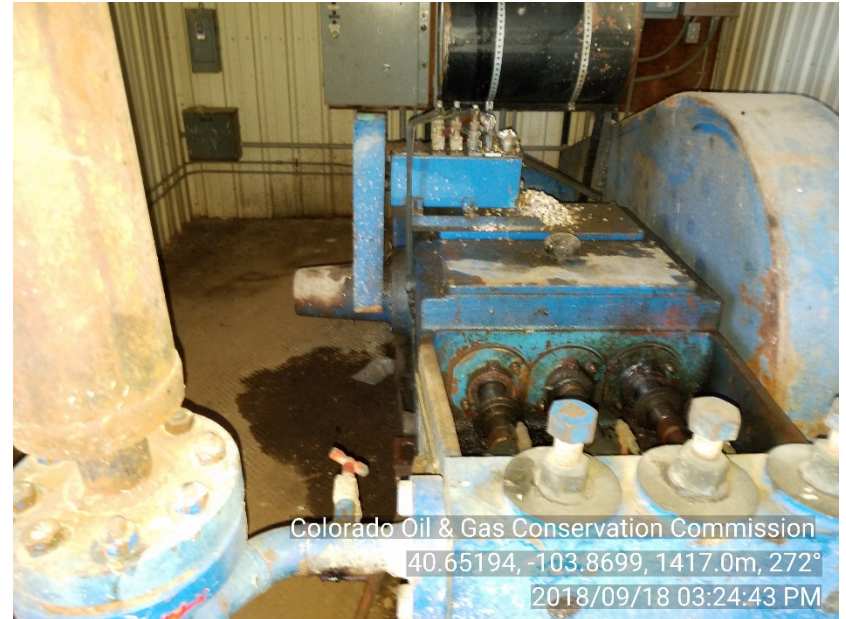
**Photo #27**

**Sooner Unit** Injection Pump – S side

**Stained floor**

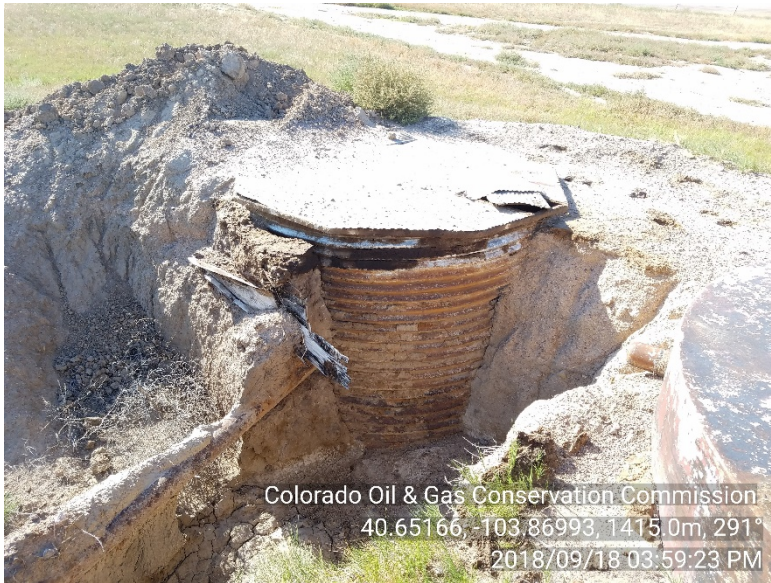
**Photo #28**

**Sooner Unit** H2O pit – skim

***Culvert Rusted***

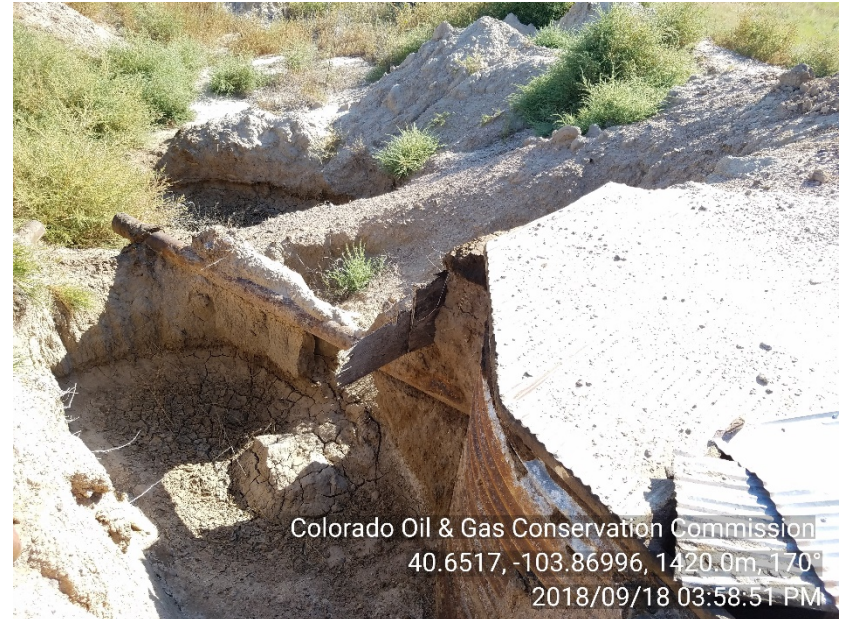
**Photo #29**

**Sooner Unit** H2O pit – skim

***Culvert rusted***
