Inspection Photos

Operator: BP Production

API: 05-067-07172

Date: 9/13/2018

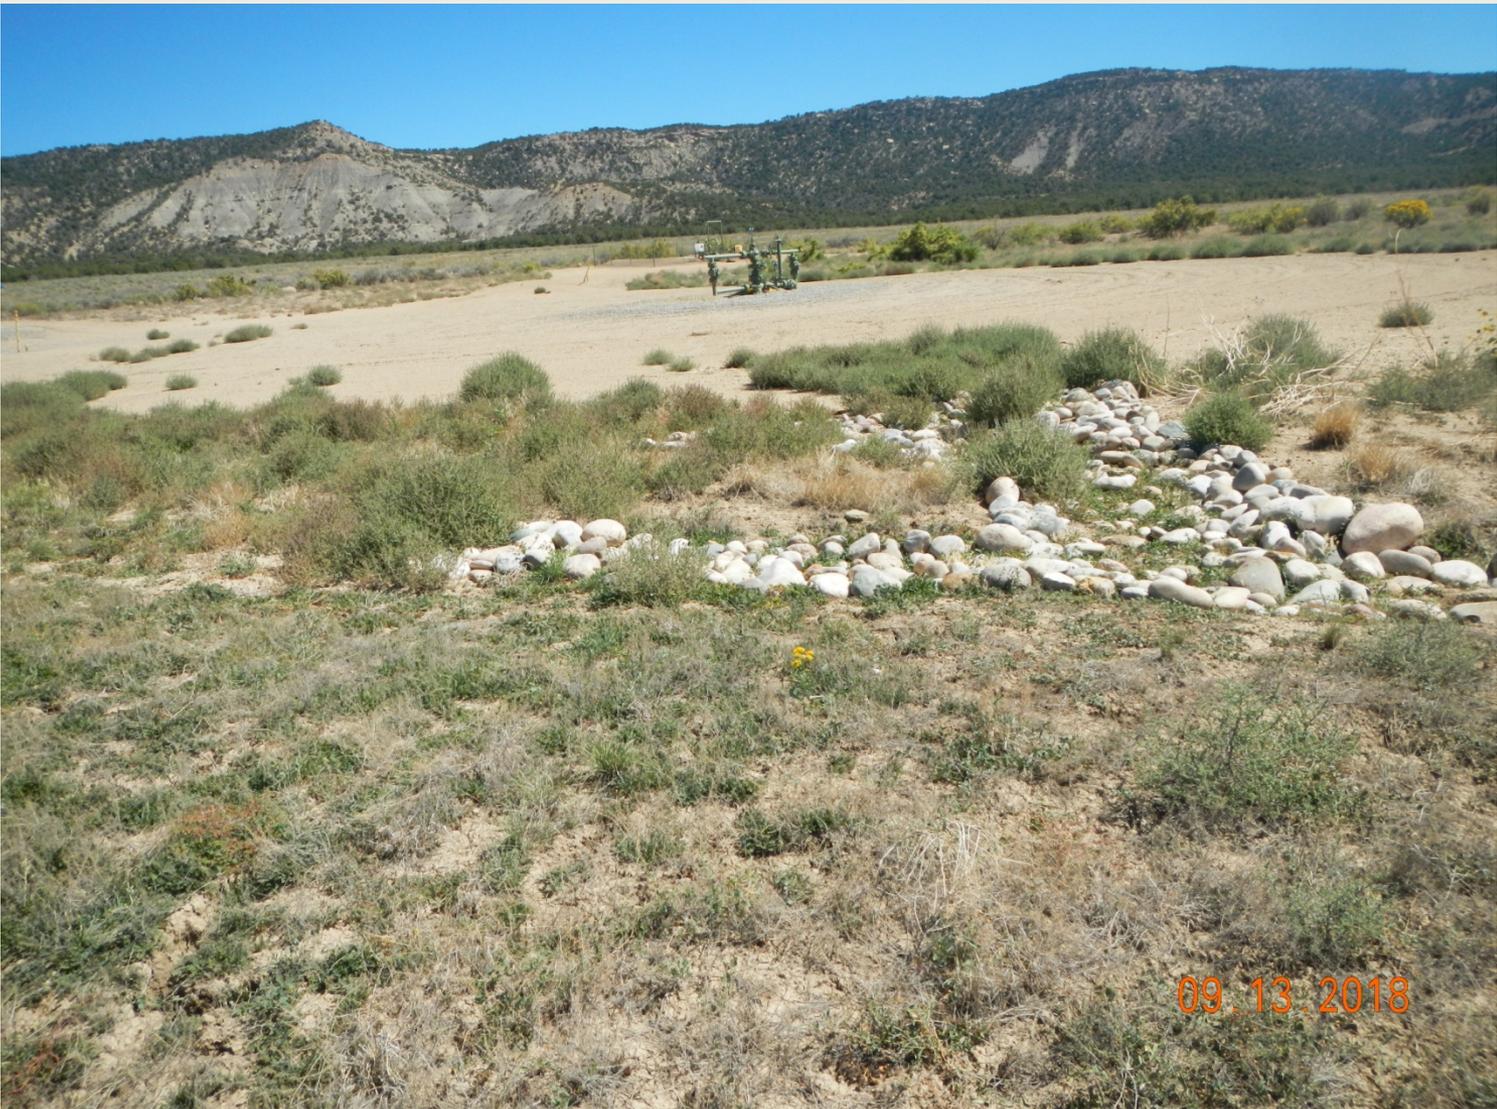
Photo 1. View of the project area from the western edge facing center.

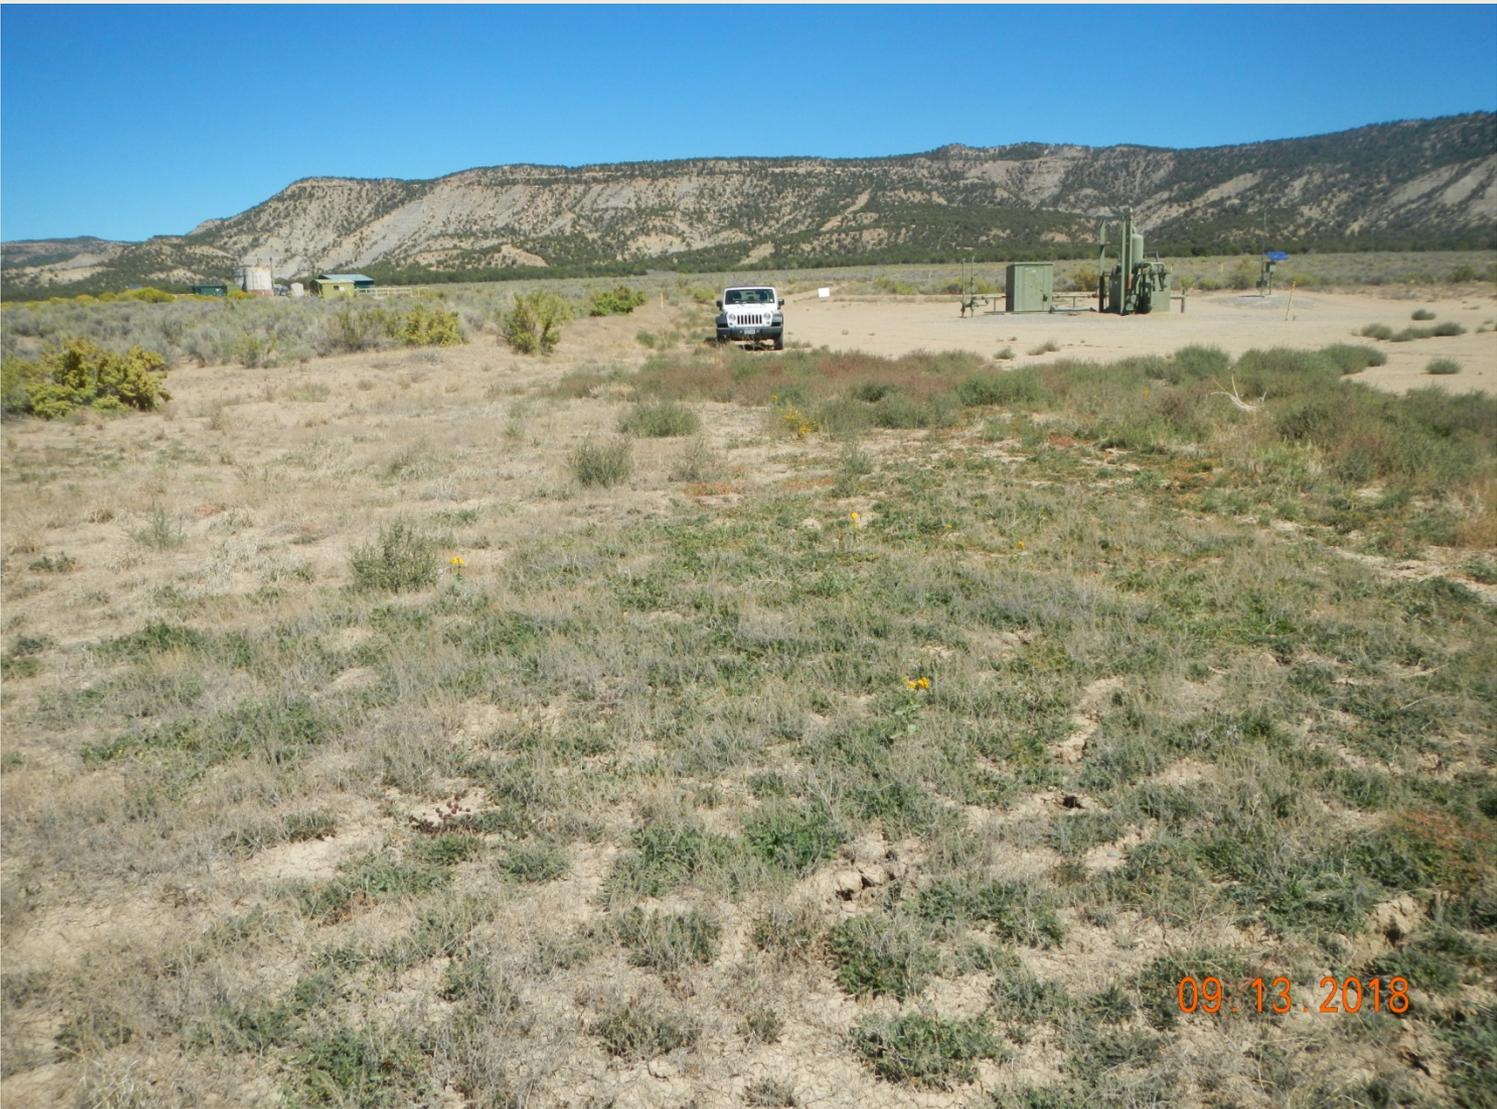
Photo 2. View of the northwestern project area from the western edge facing northeastward.

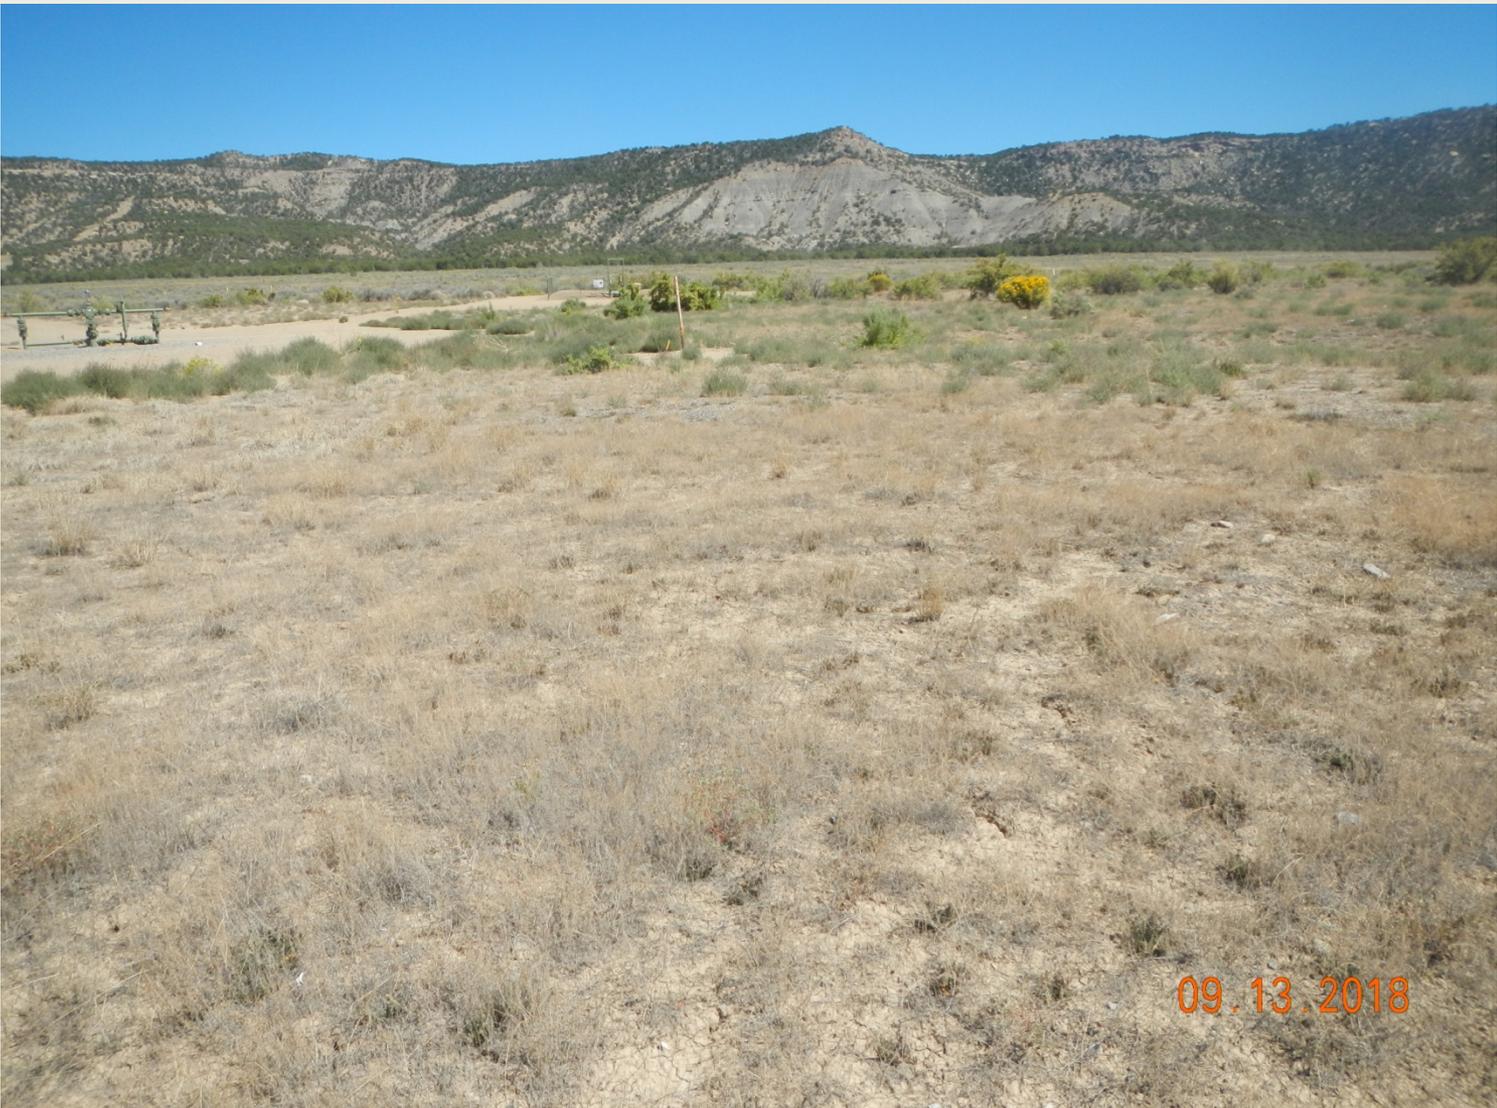
Photo 3. View of the southeastern portion of the project area from the southern corner facing northeastward. Revegetation is largely comprised of grasses such as sand dropseed (*Sporobolus cryptandrus*) and shrubs such as greasewood (*Sarcobatus vermiculatus*). Significant portions of the interim reclamation areas are vegetated with annual weeds as seen in the foreground of this photo.

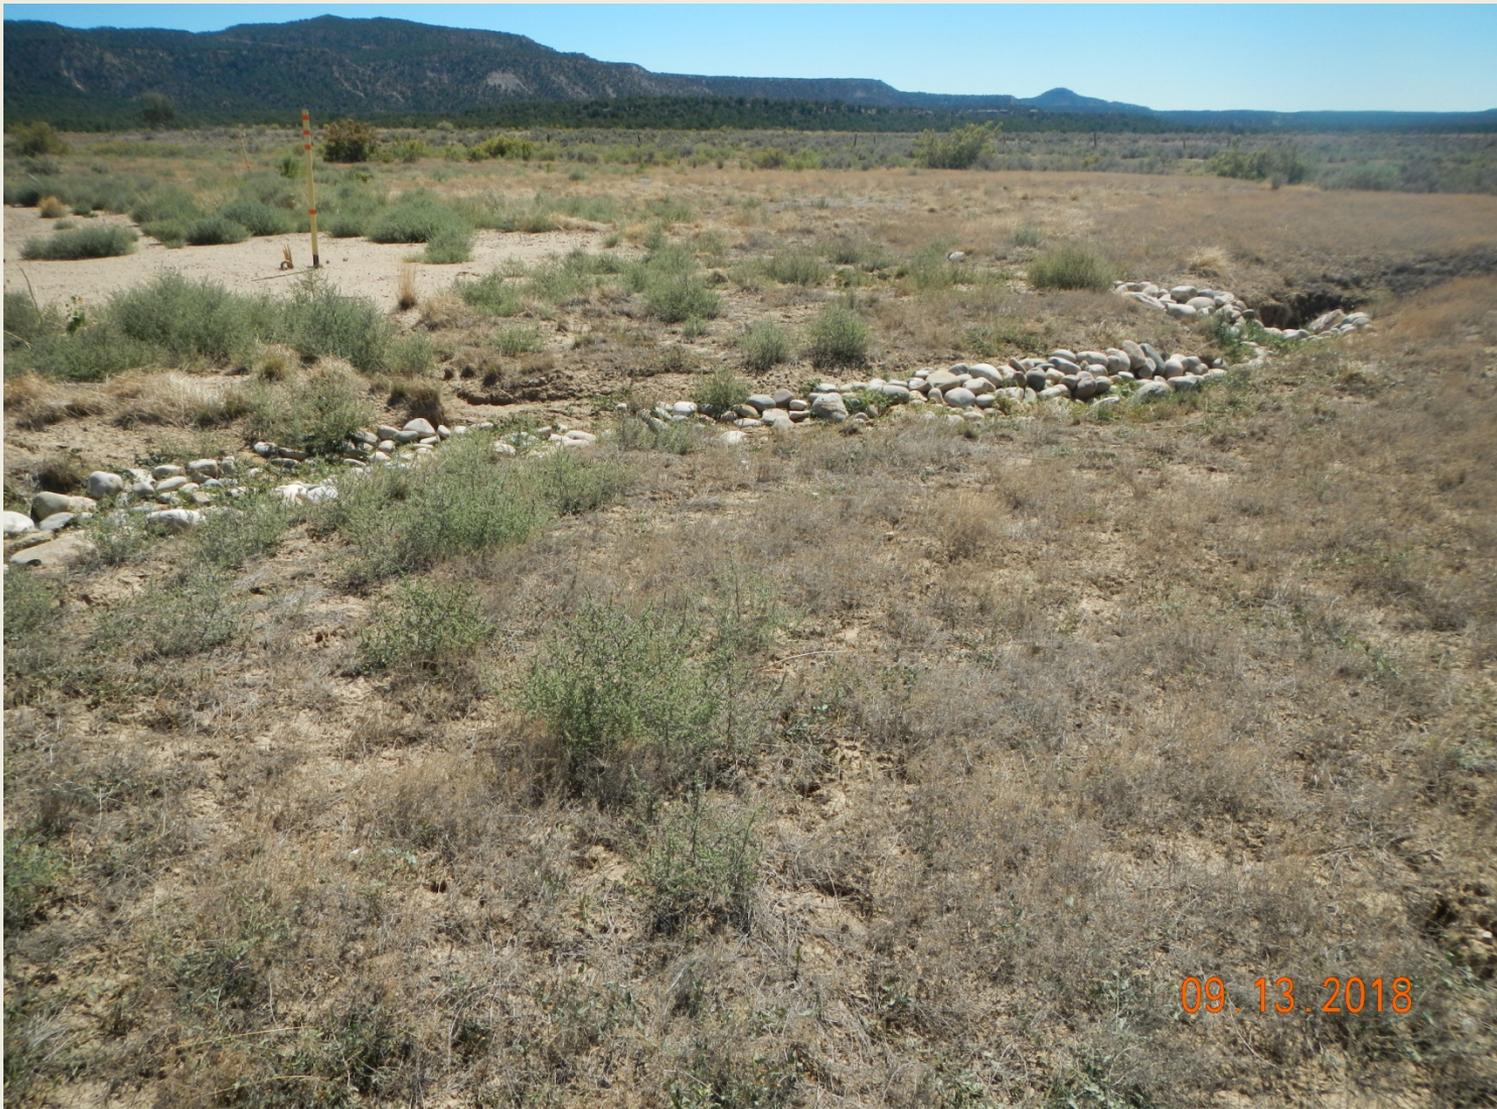
Photo 4. View of cobble run-down in gully formed in the western project area.

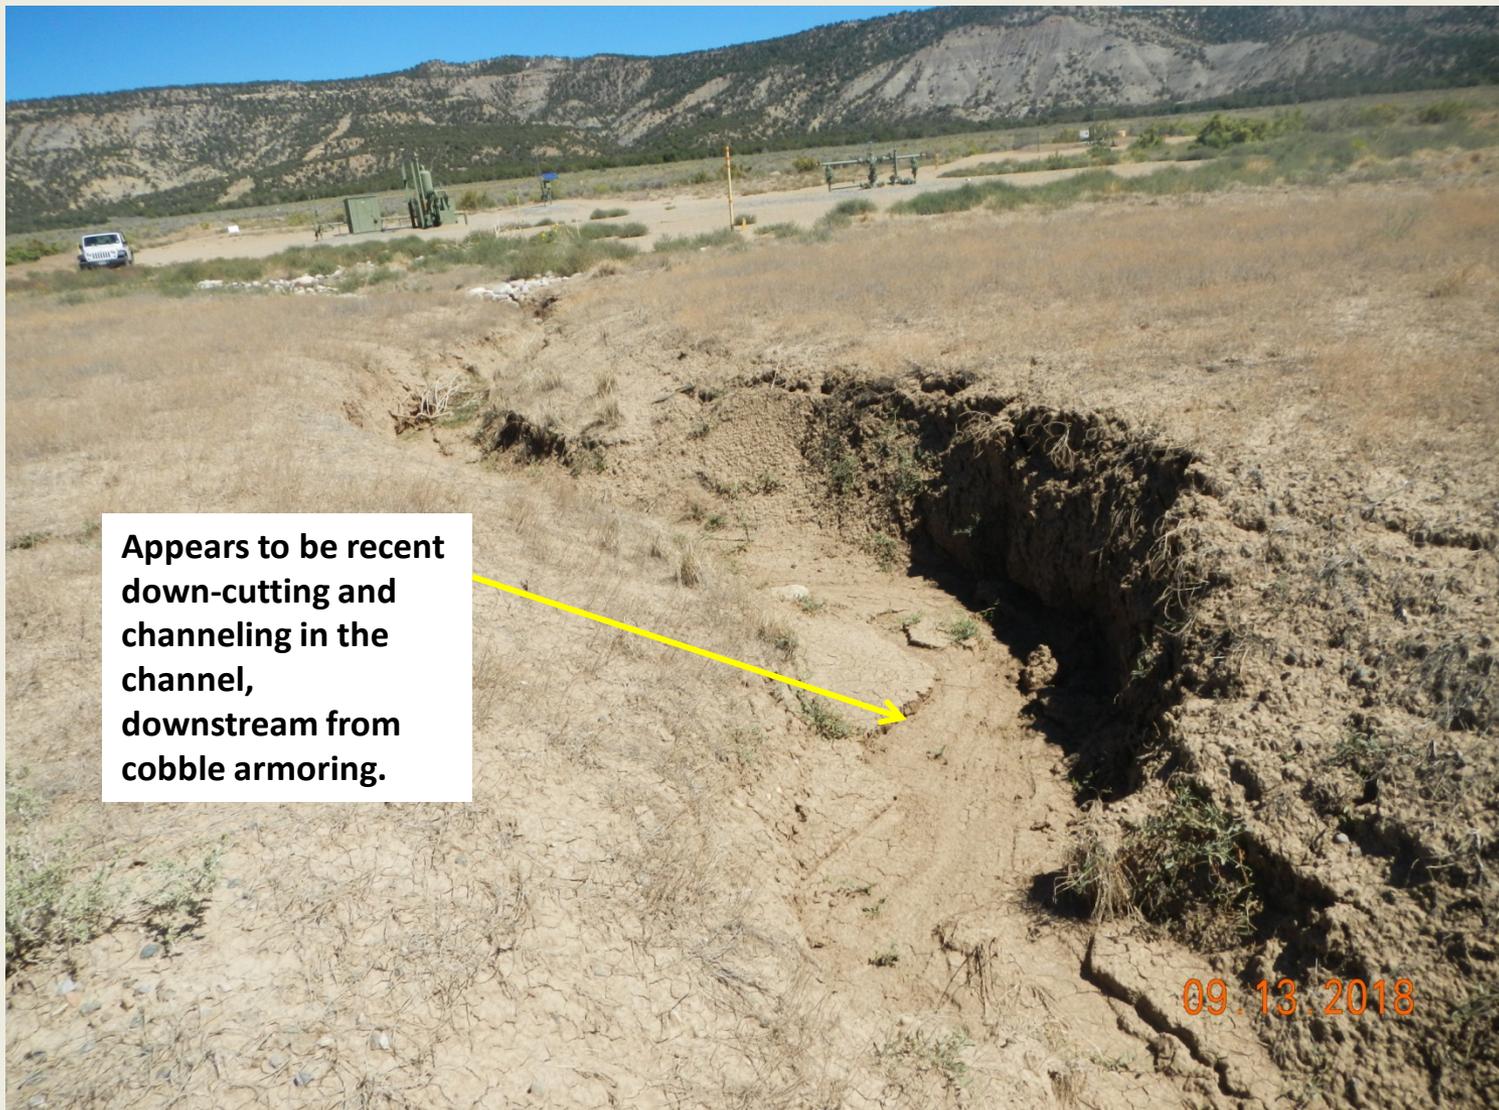
Appears to be recent down-cutting and channeling in the channel, downstream from cobble armoring.

Photo 5. View of gully with cobble armoring for a portion leading from the well pad and then no armoring. It appears that stormwater flows are continuing to erode the channel. This needs to be monitored and additional stormwater controls installed if erosion worsens.
