**Bosley SG 43-22**  
**API# 05-045-07243**  
**Inspection# 689701810**

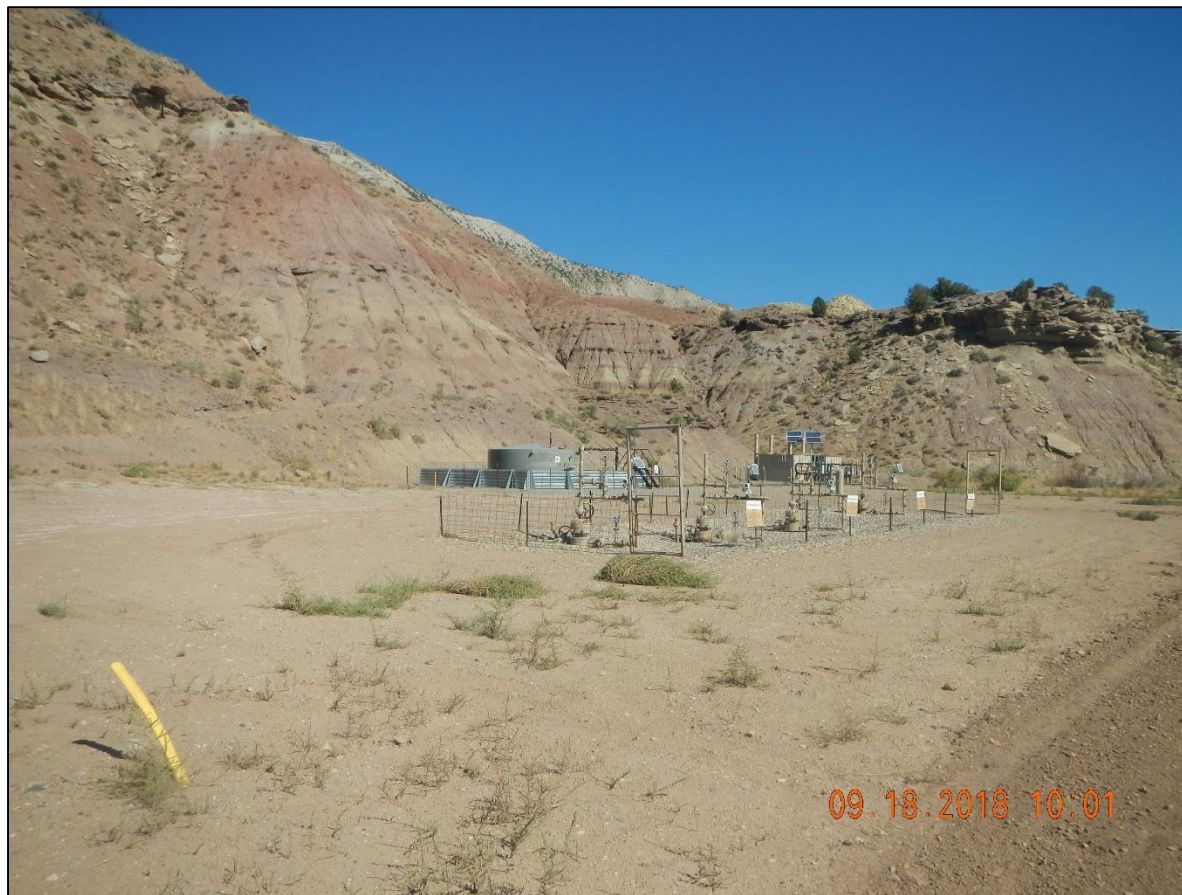
**Location photo. Dead weed debris.**

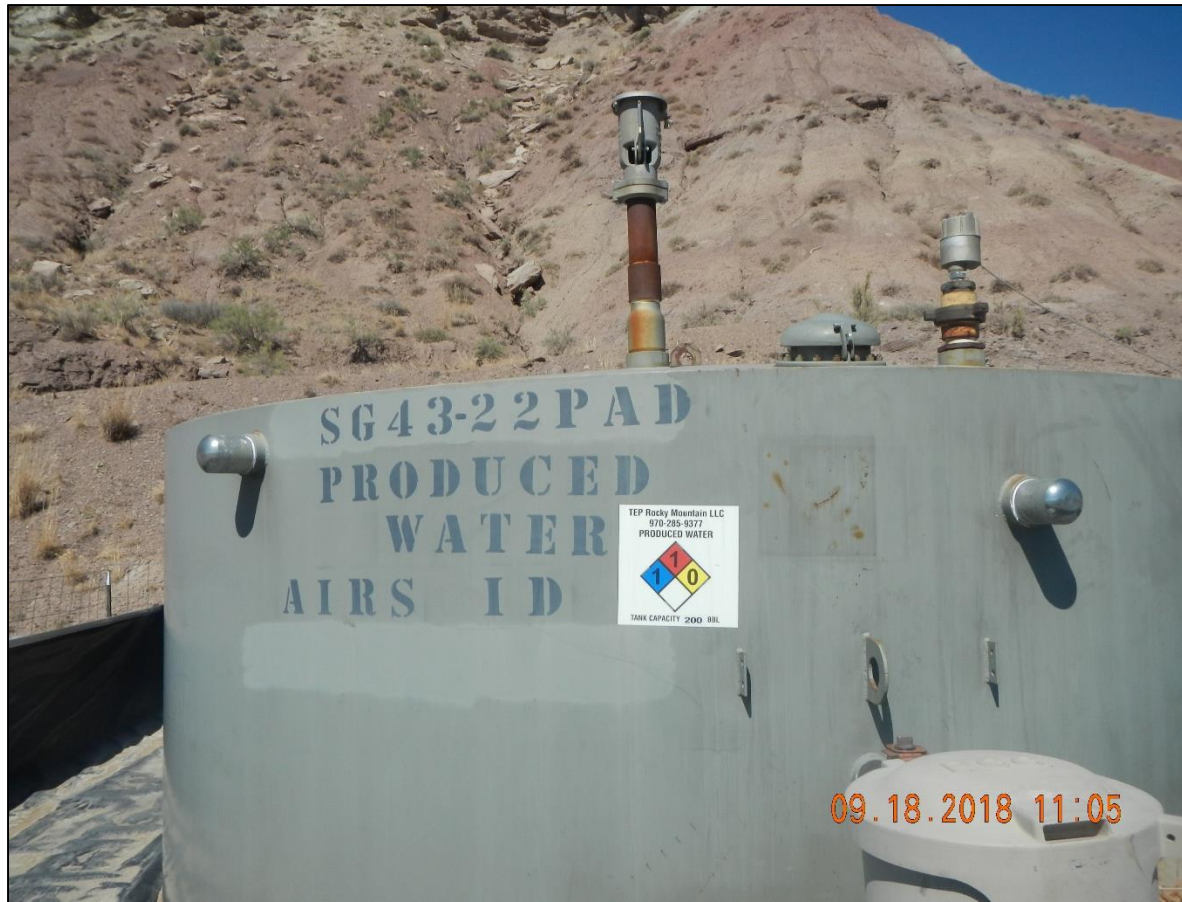
Tank volume added to label.

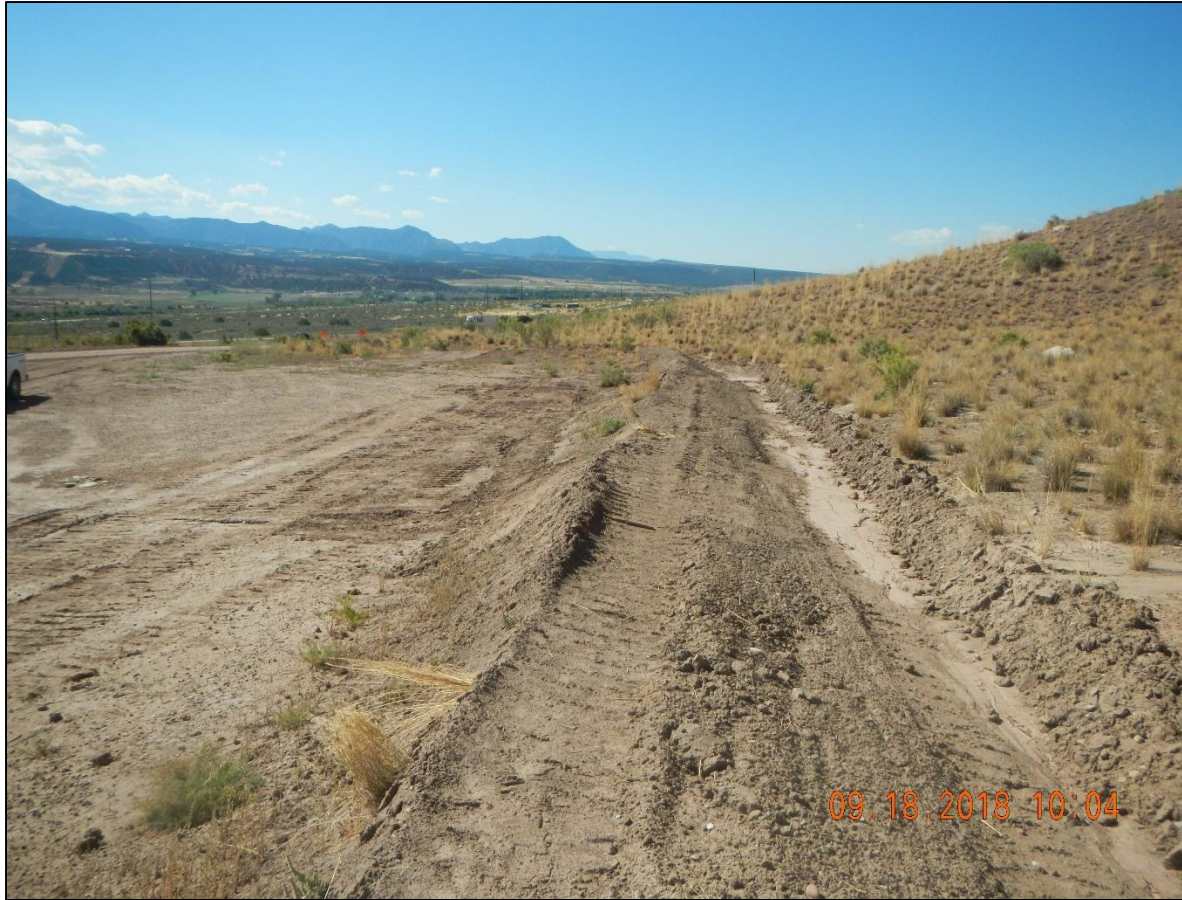
**Ditch repaired on channeling and cleared of sediment.**

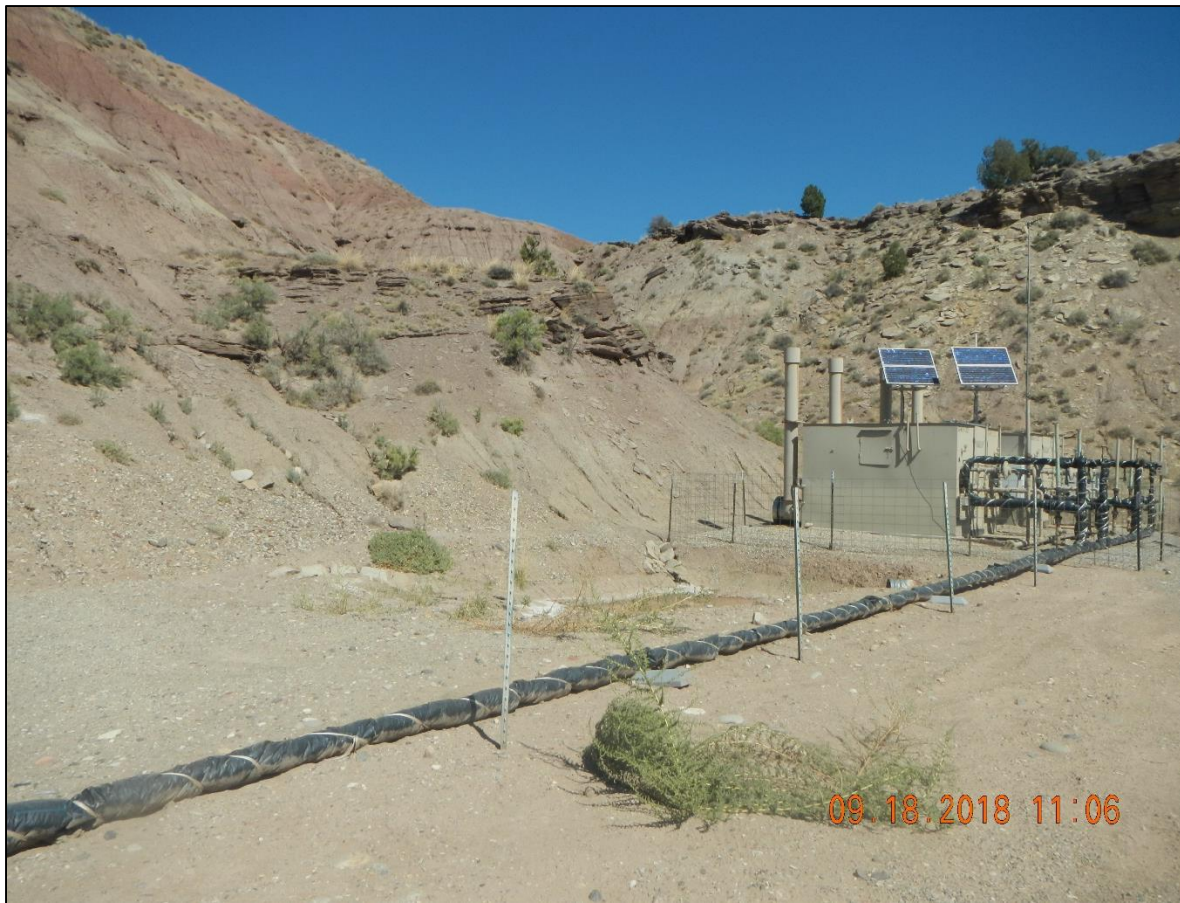
**Dead weed debris**

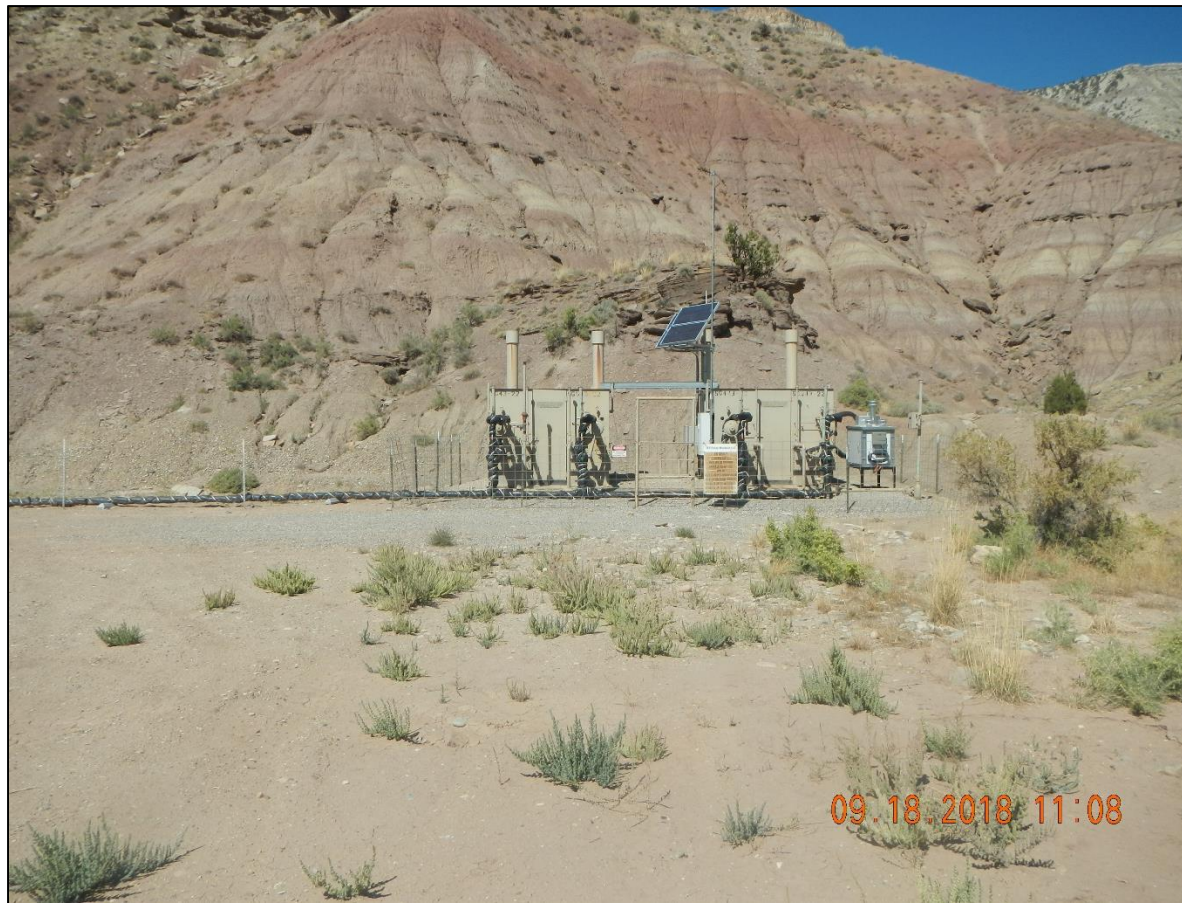
**Dead weed debris.**

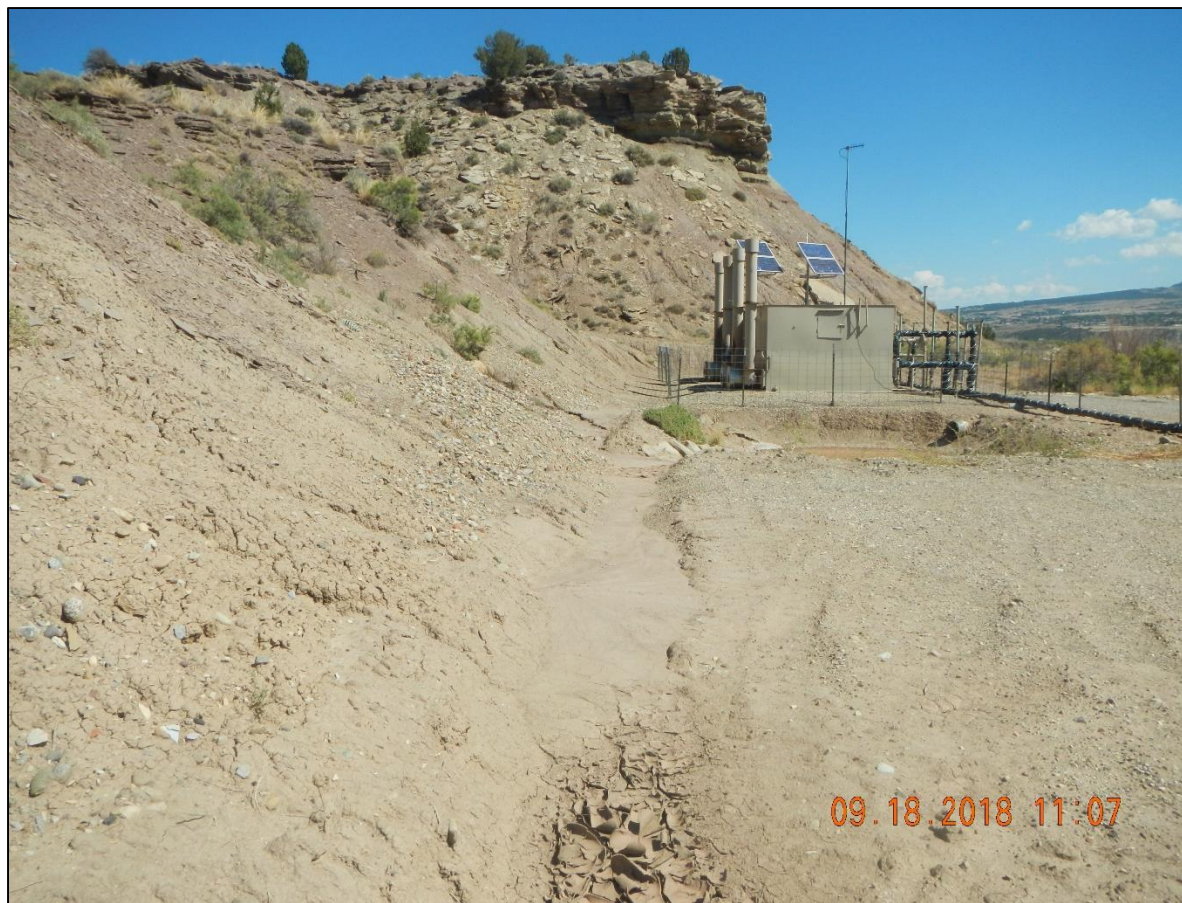
**Sediment build up in ditch between tank and separators.**

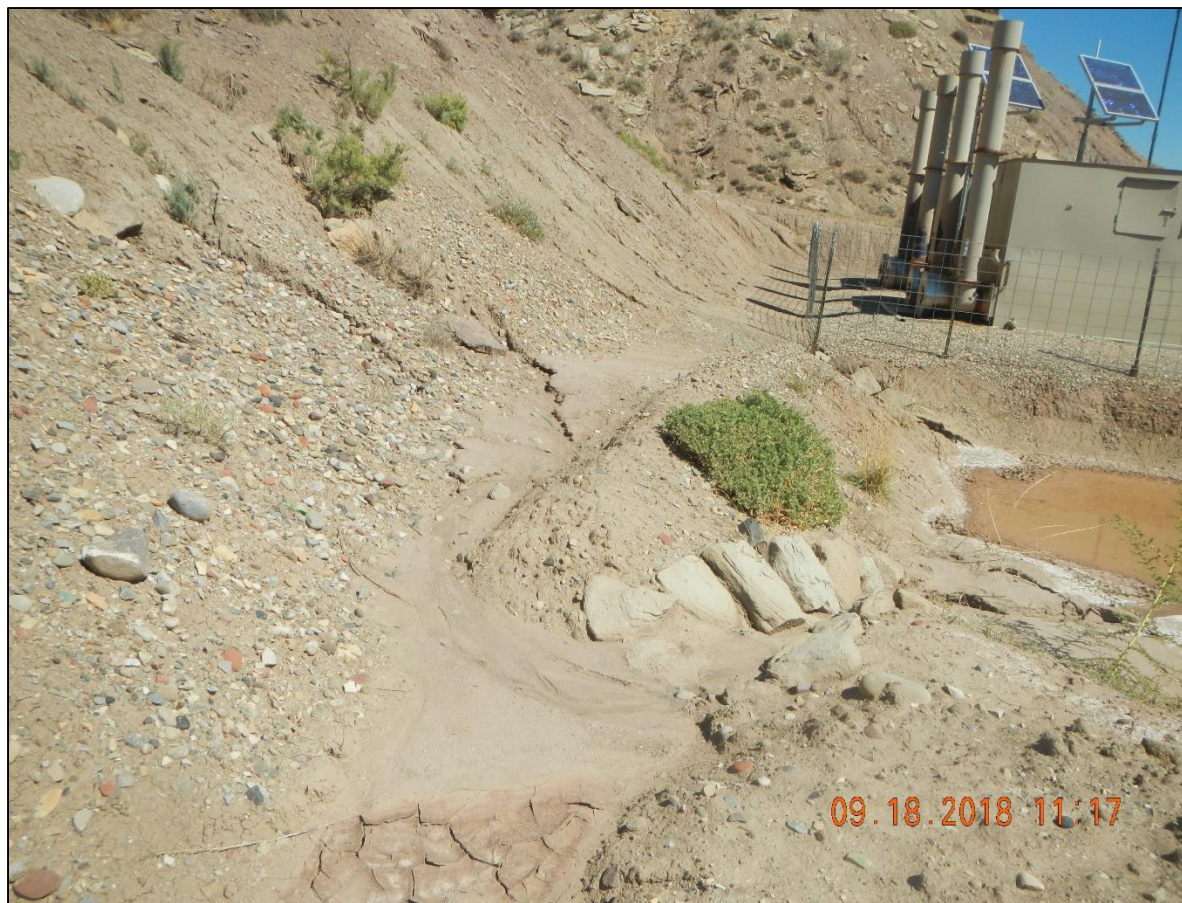
**Sediment movement and build up.**

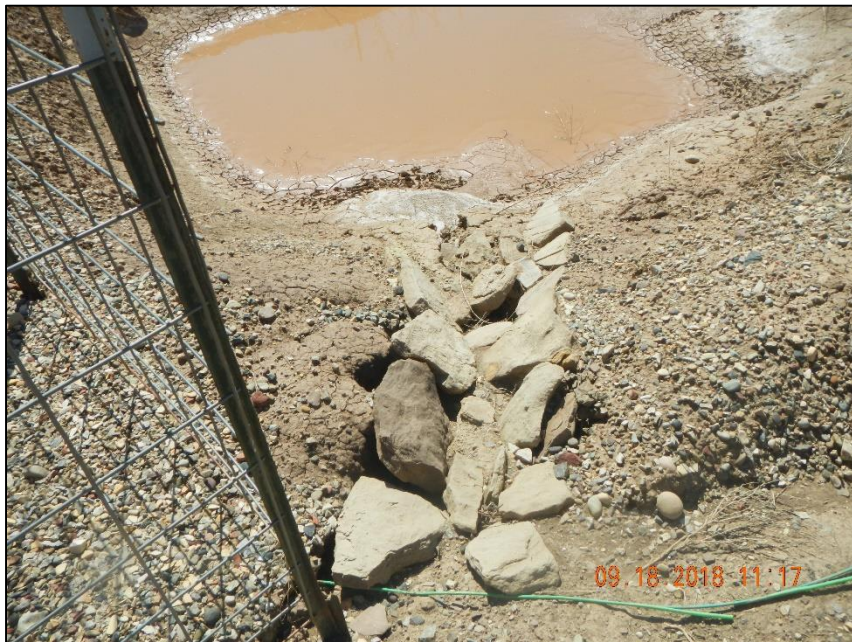
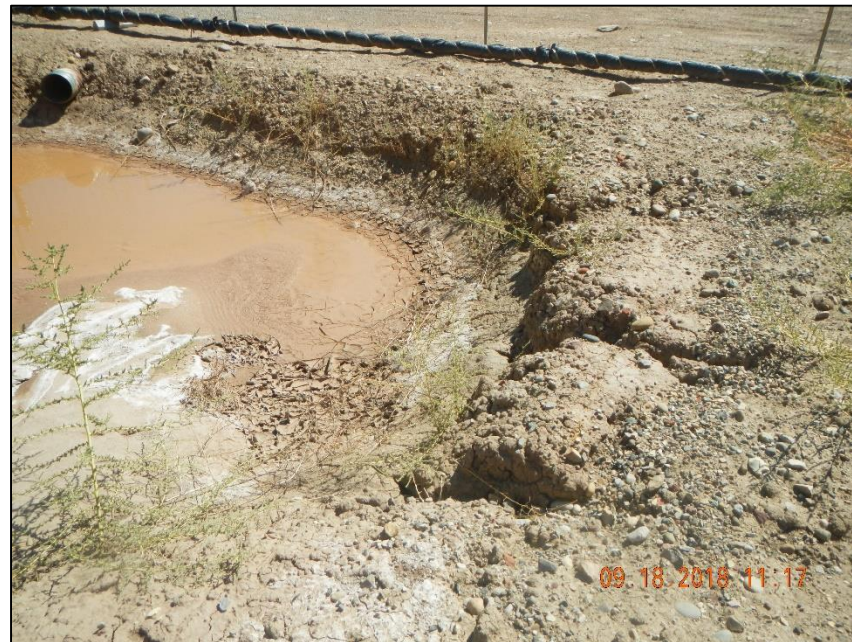
**Erosion of culvert basin by separators.**

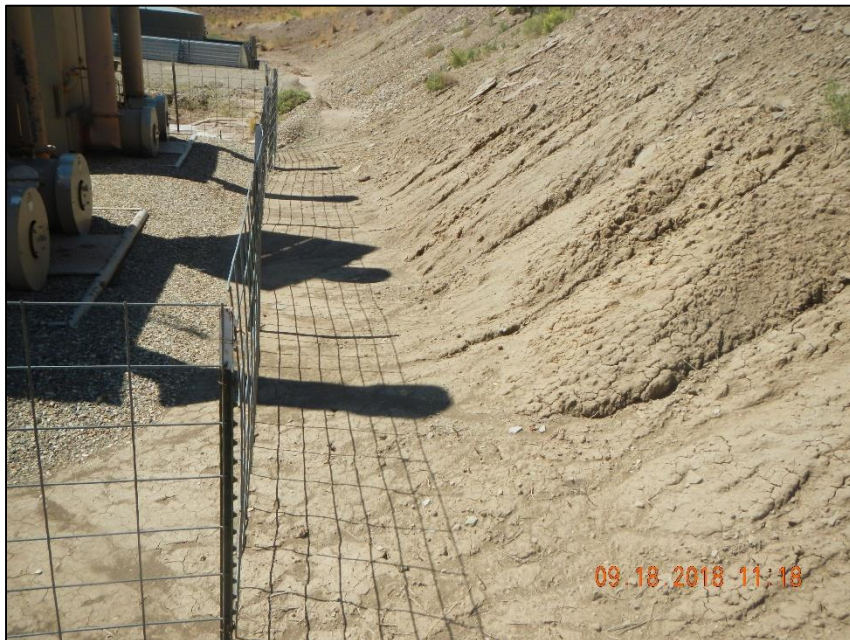
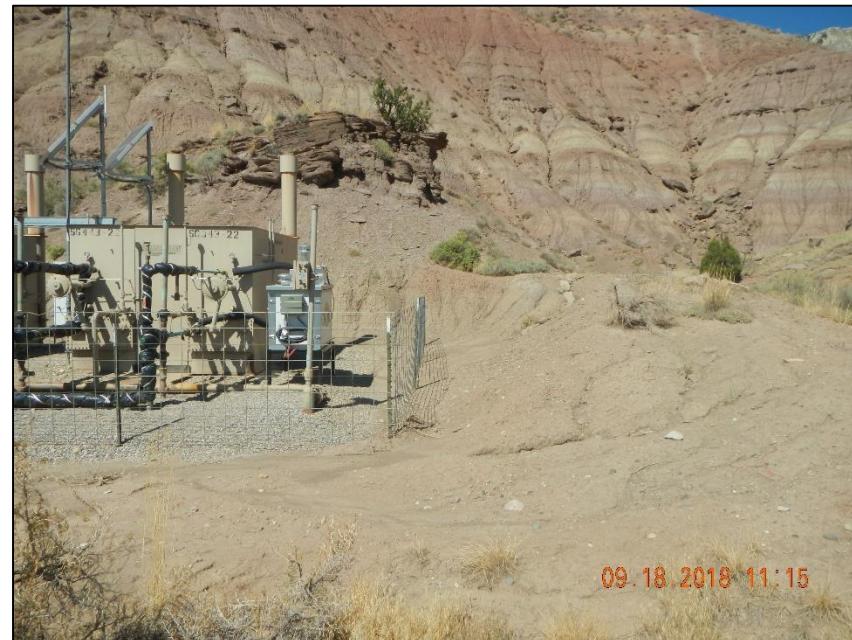
**Movement of sediment behind separators.**

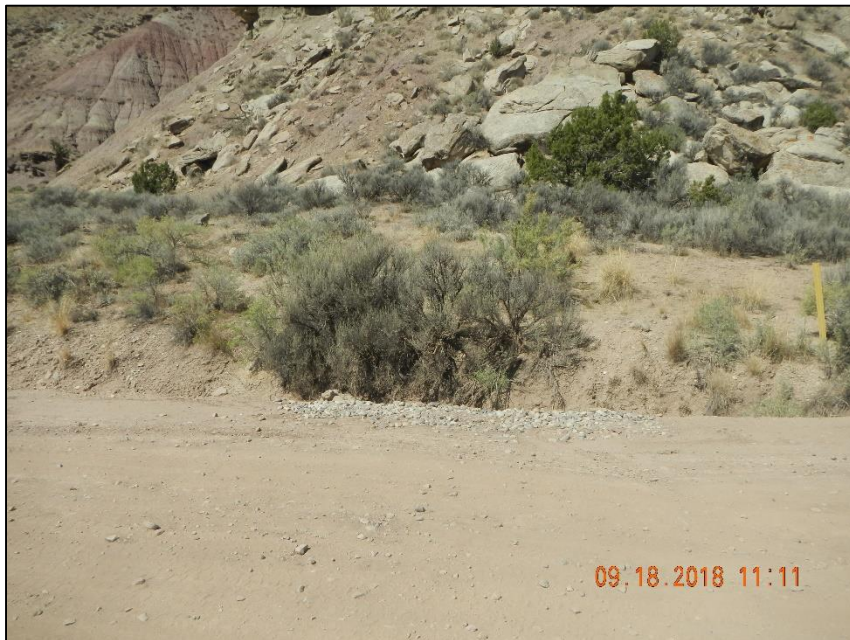
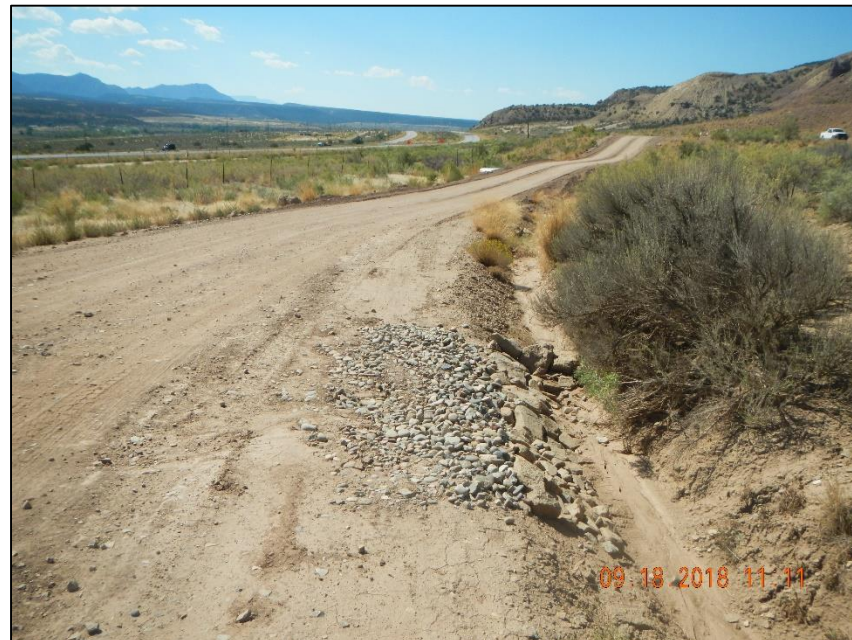
**Repair made to shoulder.**

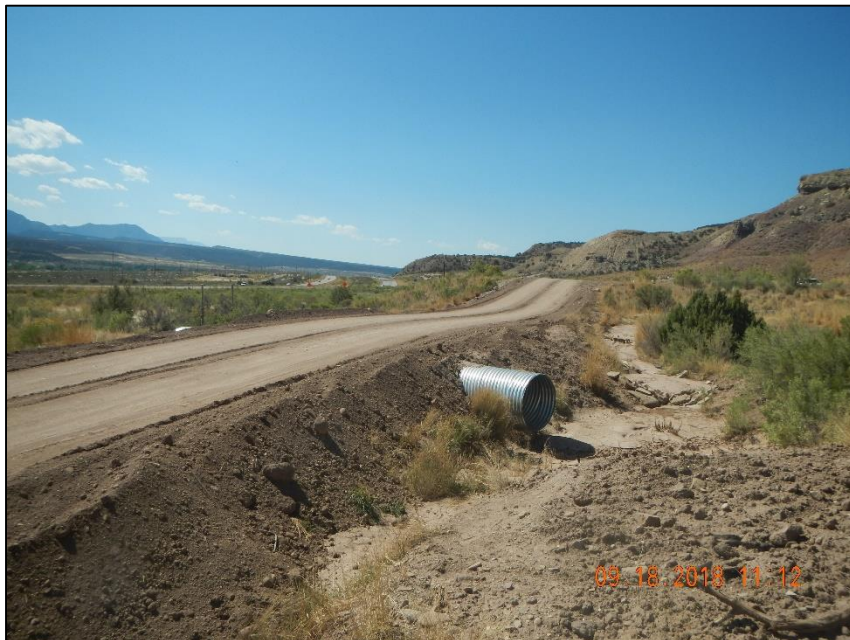
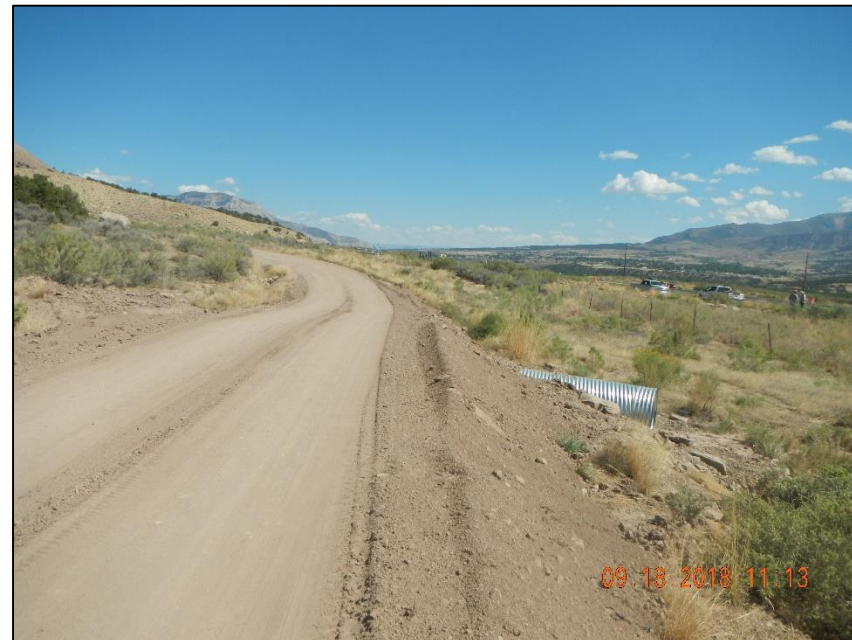
**Loose earth material along shoulders**
