# *Inspection Photos*

*Loc#413754*

*Operator: Sandridge*

*Inspection Number: 692400129*

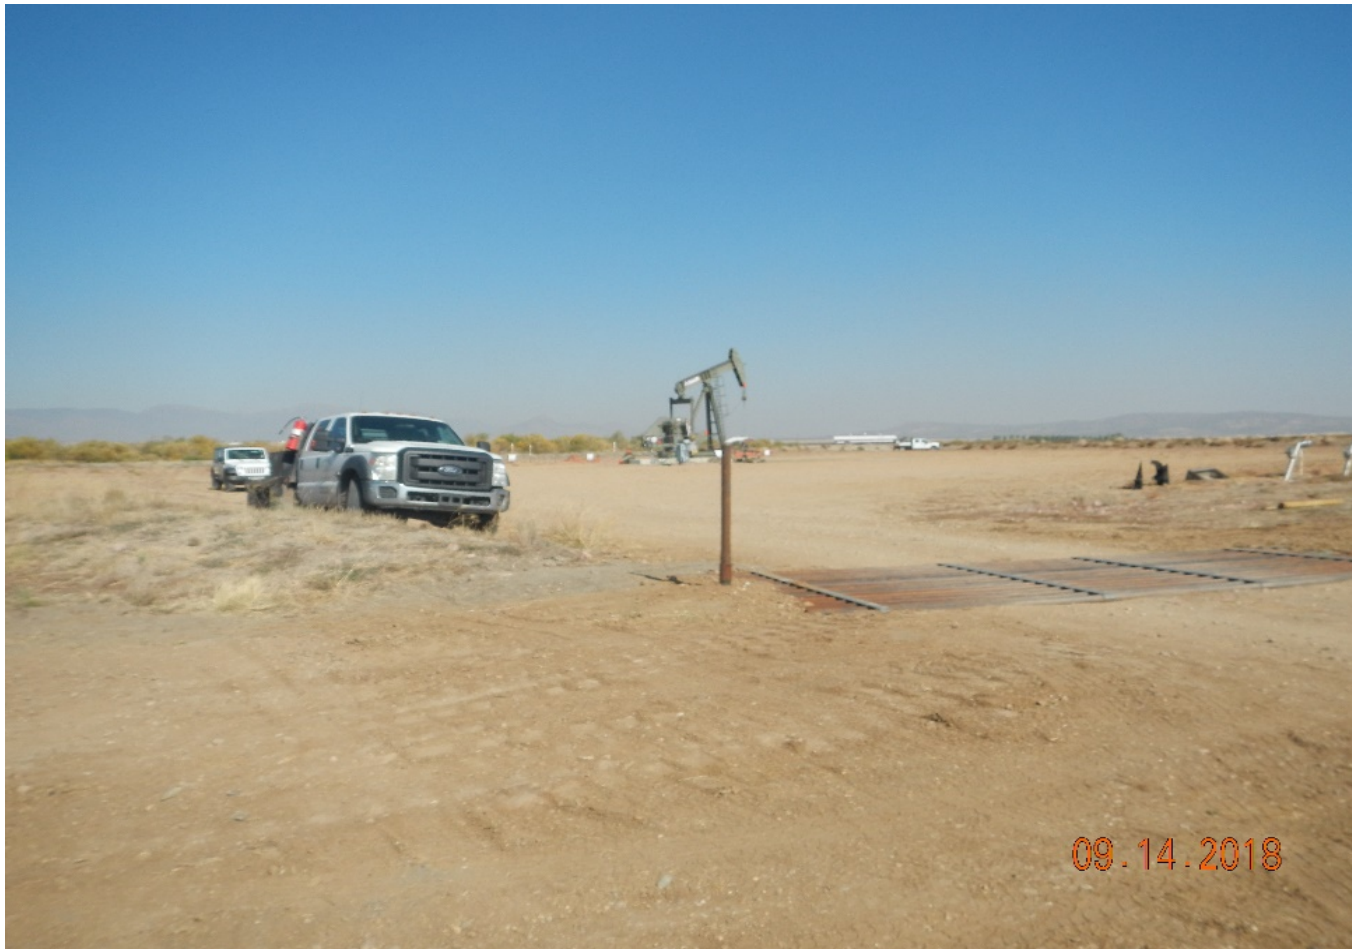
**Photo#1:**  
Overview of Location from entry to Northwest.

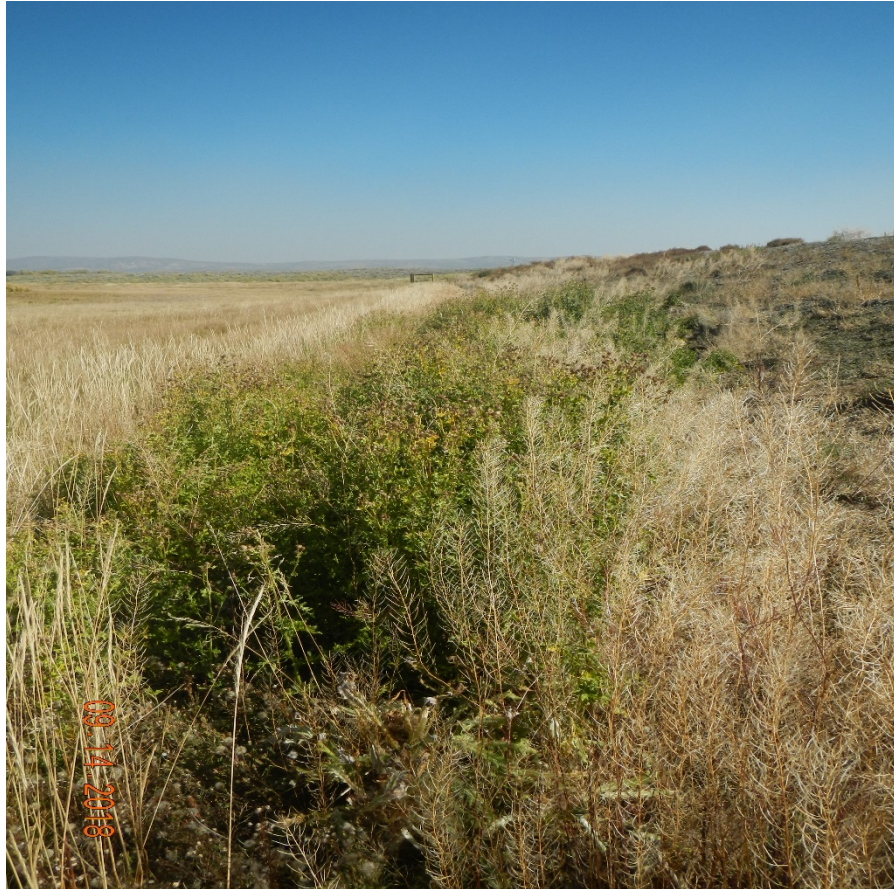
Photo#2:  
Noxious weed, Canada thistle is established on outside of West Berm.

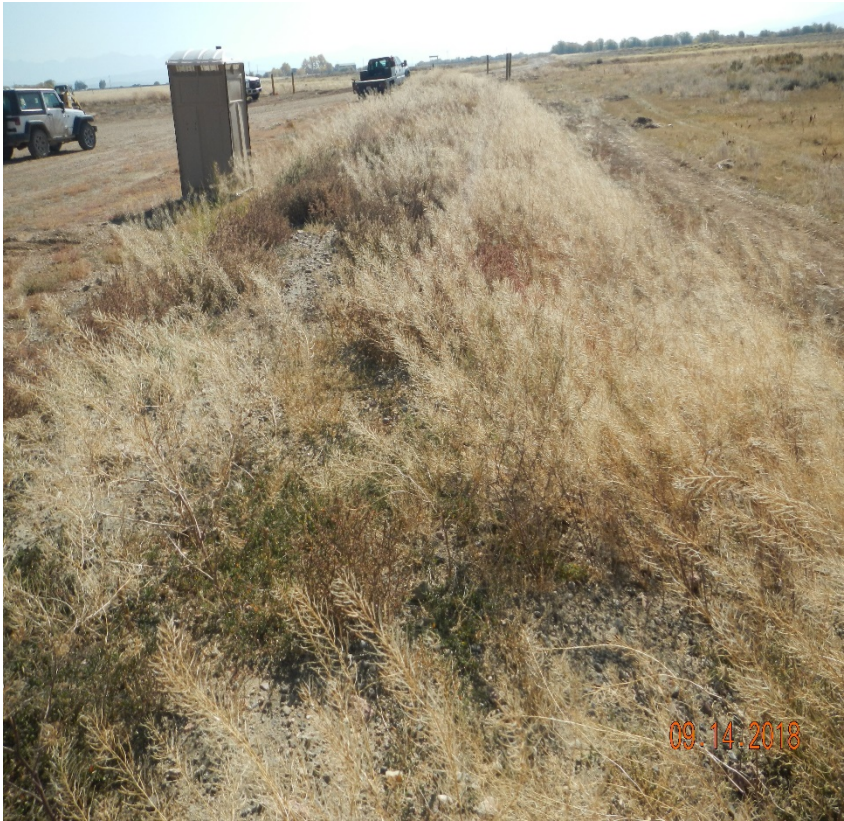
**Photo#3:**

There is evidence of heavy Annual Weed Growth on Location Berms. When these or any other vegetative material that could blow offsite or into equipment areas, are dead they are considered debris.

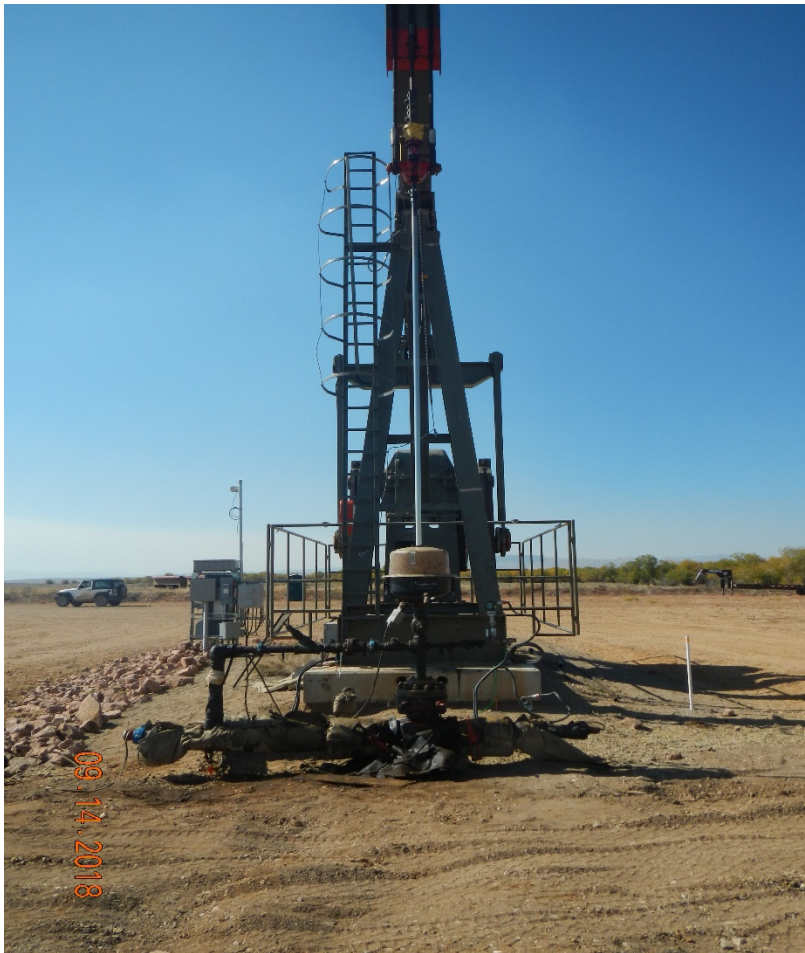
Photo#5:  
Staining of soil and Debris at Wellhead.

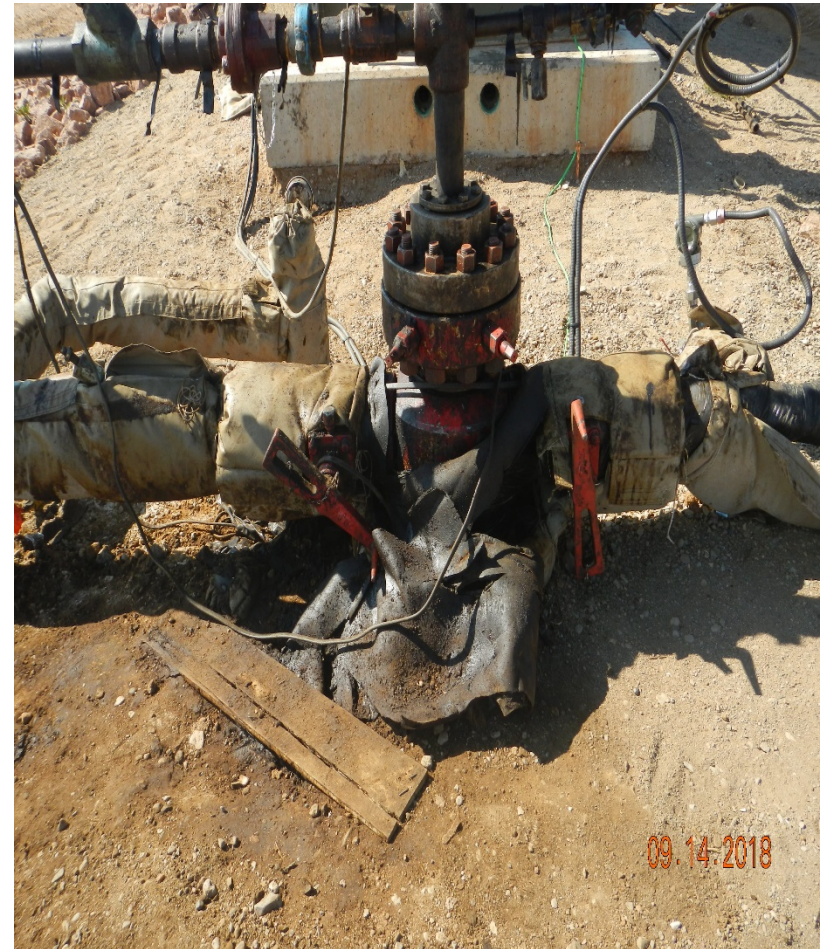
Photo#6:

Cellar of Well API#057-06556 was filled with what appears to be water topped with skim of Oily waste. No freeboard was present, stains outside of cellar showed where liquid had begun to discharge, before level subsided.
