# Inspection Photos

09/20/2018

Operator: SMITH OIL PROPERTIES INC - 79905

Location ID: 313873

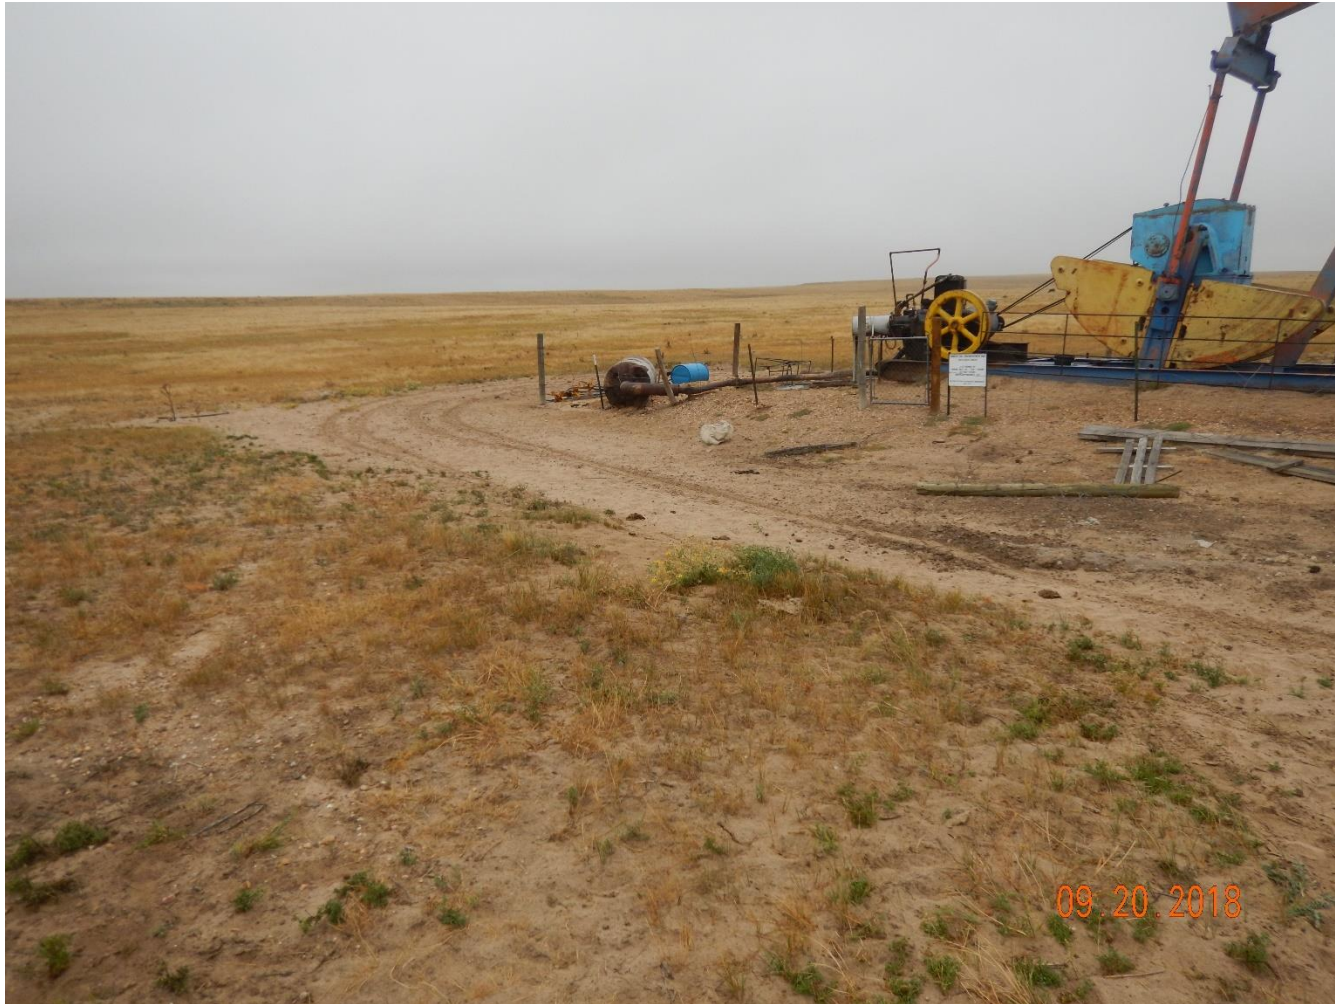
**Photo 1:** Photo taken from the south end of the well location, facing northwest. Photos 1-2 provide an overview of the well location. Photo shows various equipment and trash debris remain on site. Photo also shows no reclamation activities appear to have been conducted in accordance w/ 1004.a

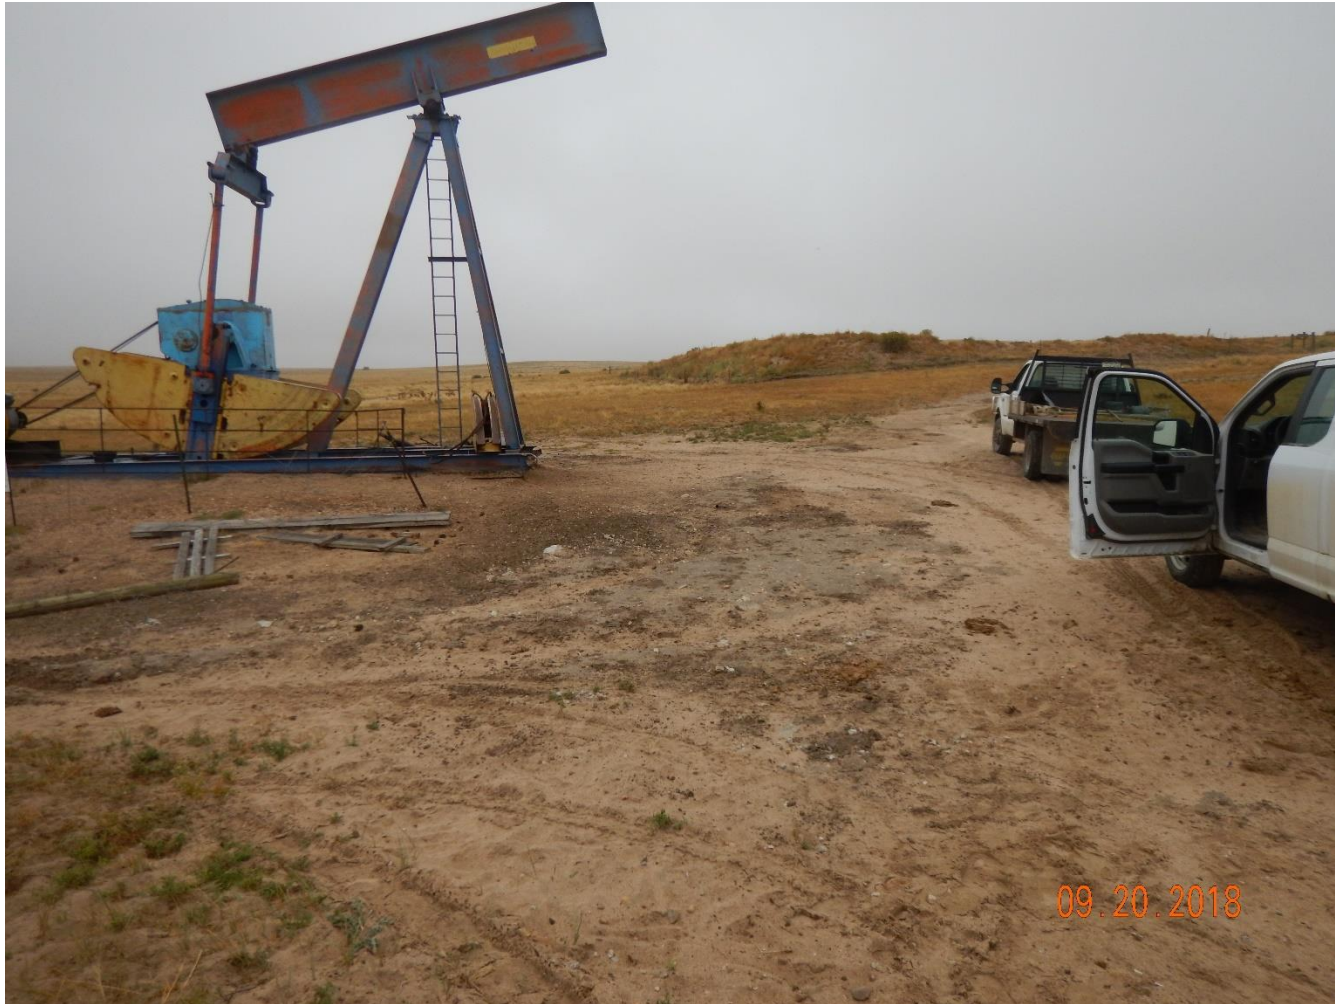
**Photo 2:** Photo taken from the south end of the well location, facing north. Photos 1-2 provide an overview of the well location. Photo shows various equipment and trash debris remain on site. Photo also shows no reclamation activities appear to have been conducted in accordance w/ 1004.a

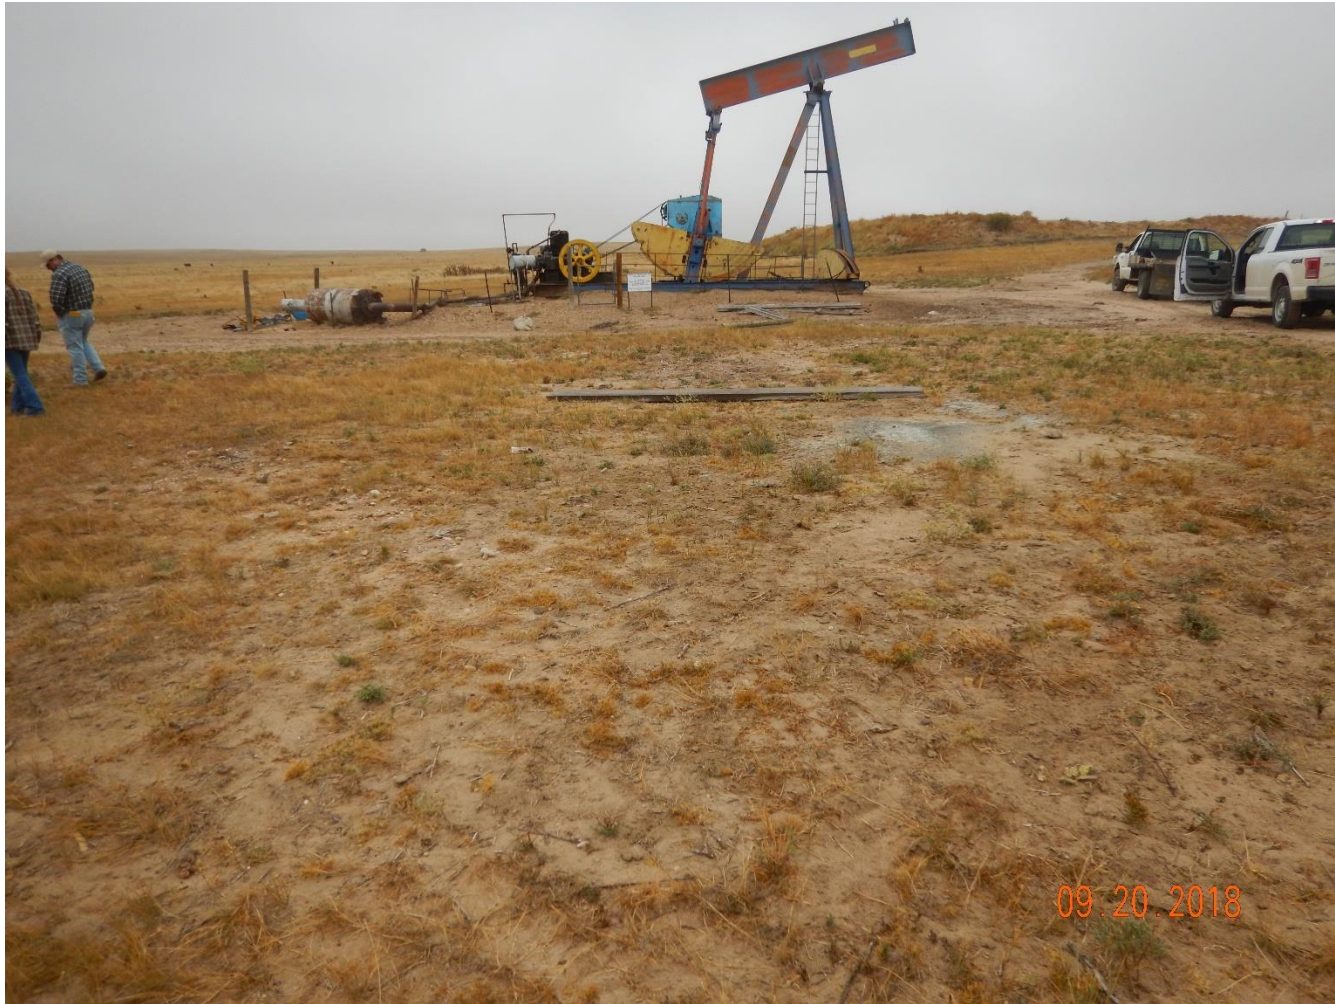
**Photo 3:** Photo taken from the south of the well location, facing north. Photo shows areas of disturbance off of the location that requires reclamation. Photo also shows various equipment and trash debris remain on site, and that no reclamation activities appear to have been conducted in accordance w/ 1004.a

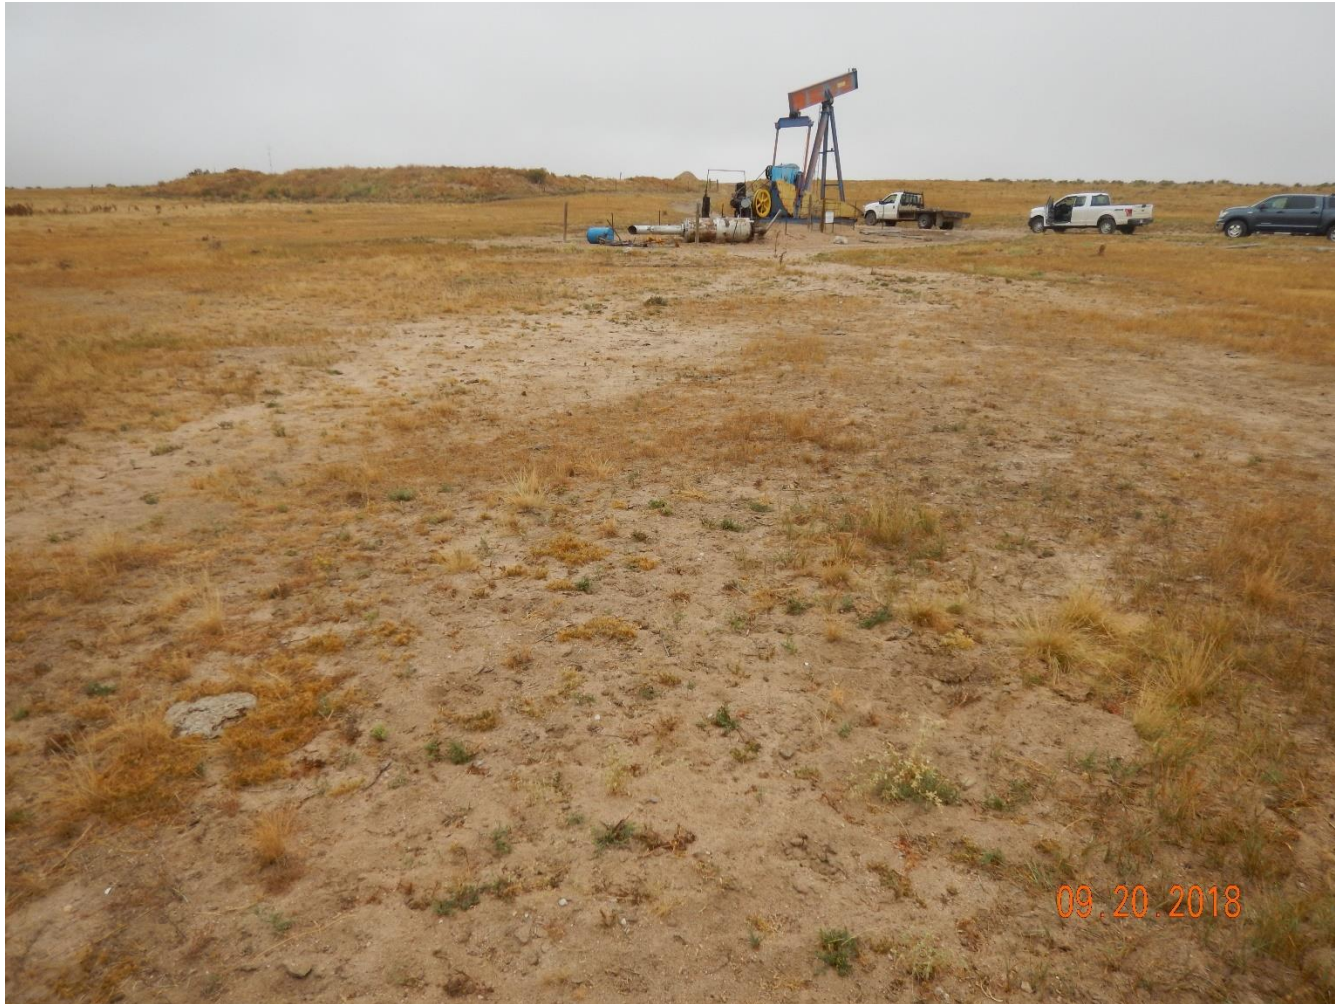
**Photo 4:** Photo taken from the southwest of the well location, facing northeast. Photo shows area of a former spill that caused degradation on the adjacent lands. These areas require reclamation.

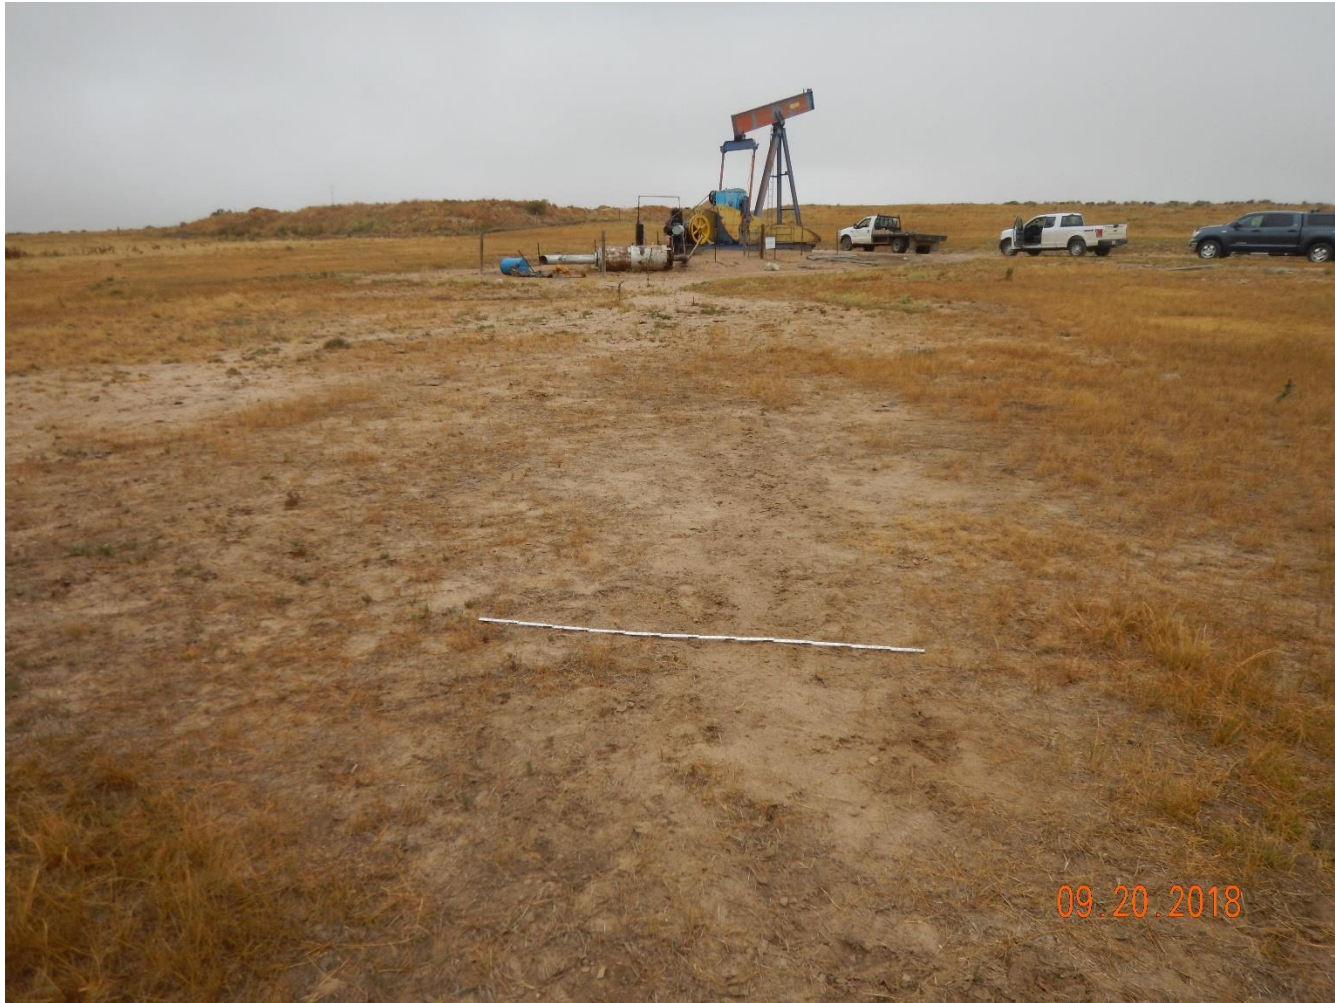
**Photo 5:** See comments under photo 4. 6 foot measuring stick for reference.

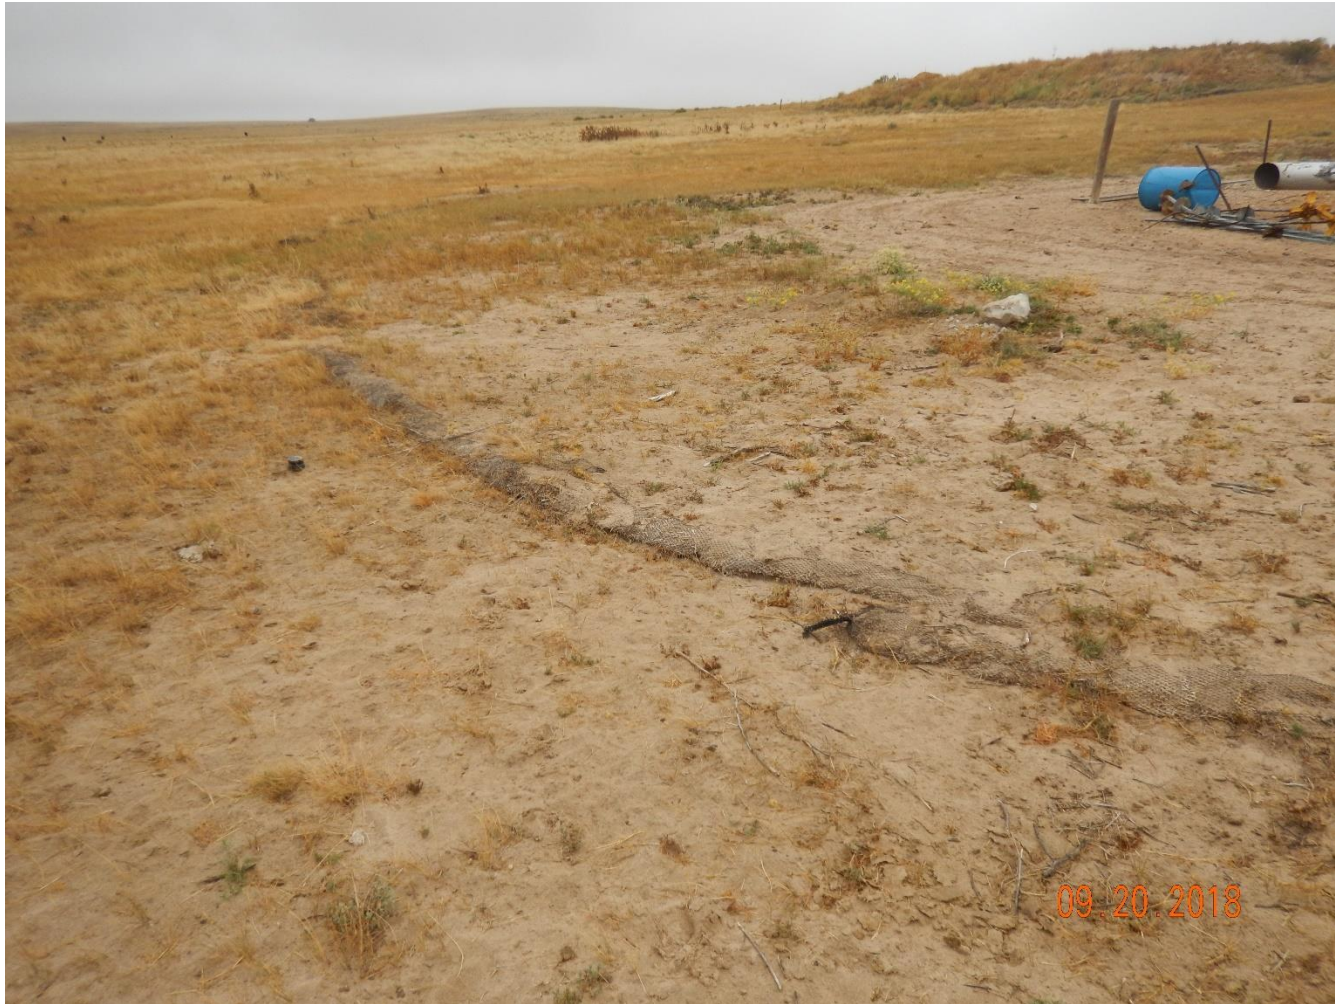
**Photo 6:** Photo taken from the west end of the well location, facing north. Operator appears to have installed straw wattles stormwater and sediment control BMPs. BMPs have not been maintained and are no longer in proper functioning conduction. Wattles are now considered debris and will need to be removed

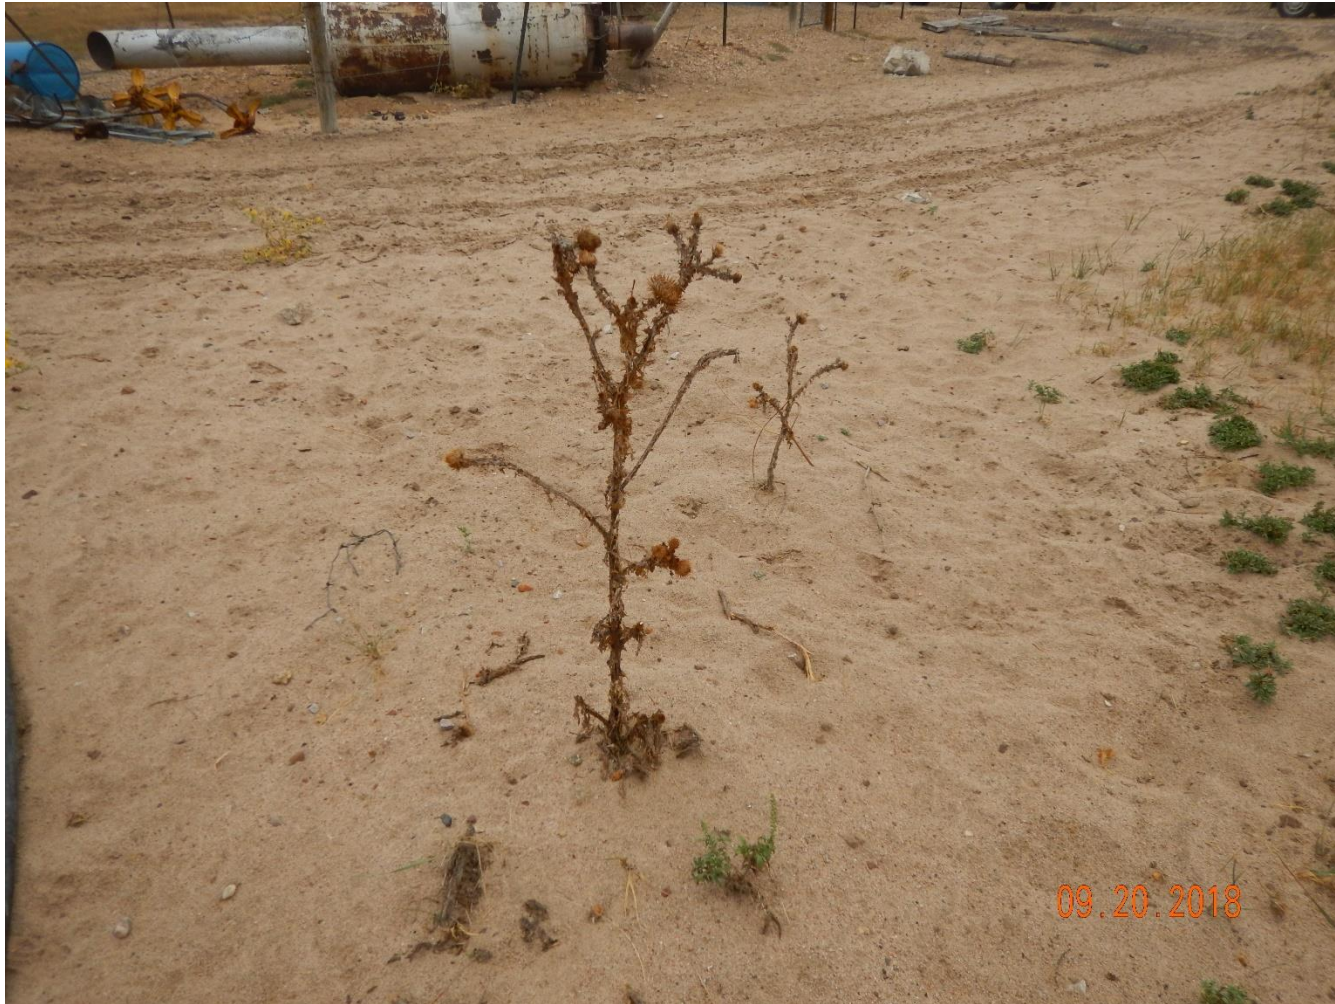
**Photo 7:** Photo taken from the west end of the well location. Photo shows Scotch Thistle. This is a Colorado State listed Noxious weed and required management.

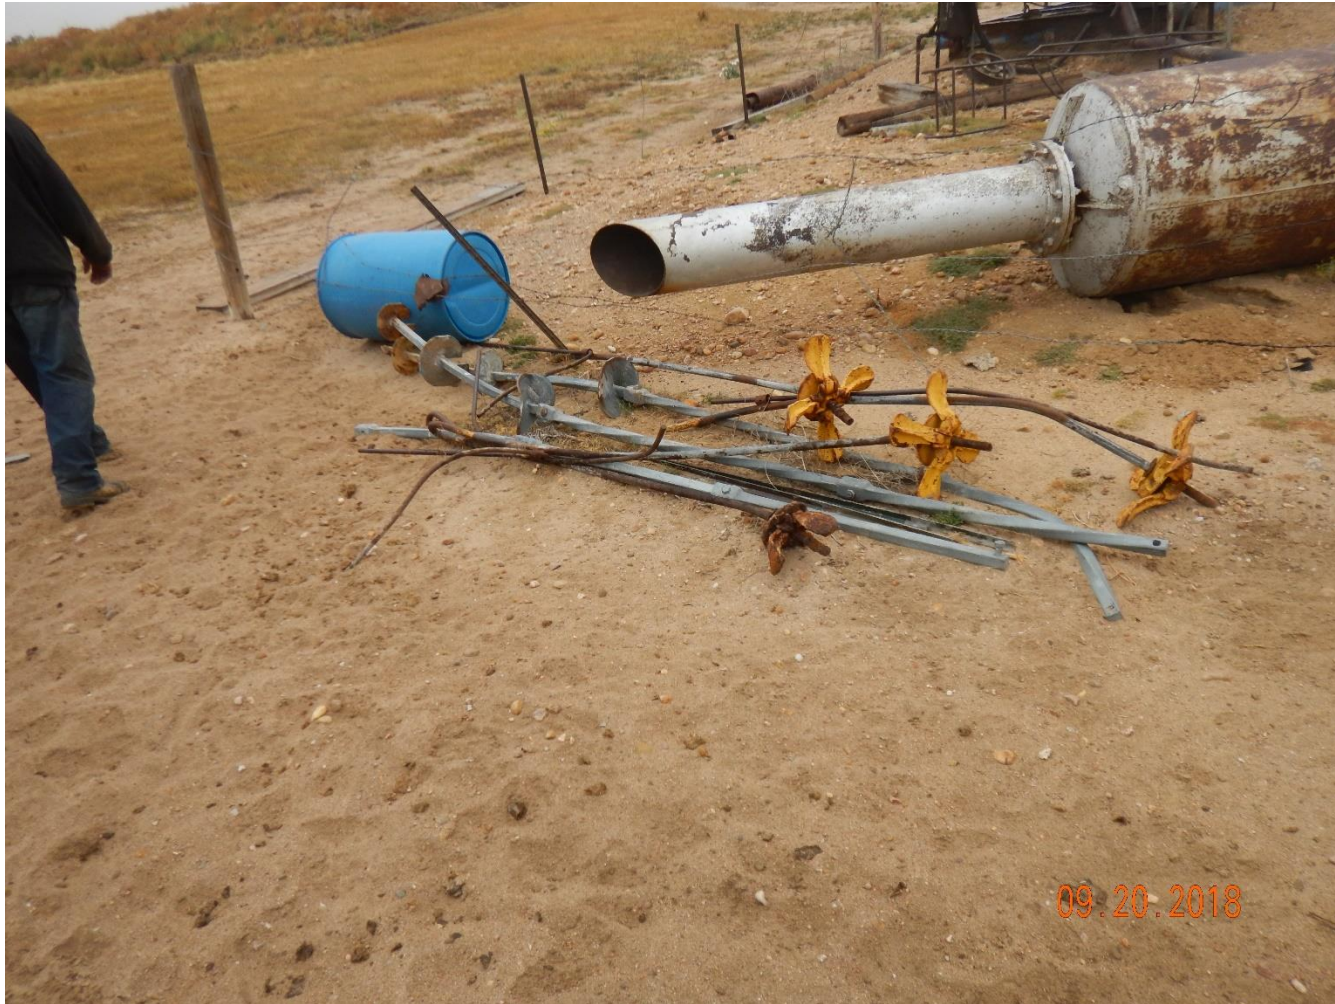
**Photo 8:** Photo taken from the west end of the well location, facing northeast. Photo shows various debris and equipment remaining on location.

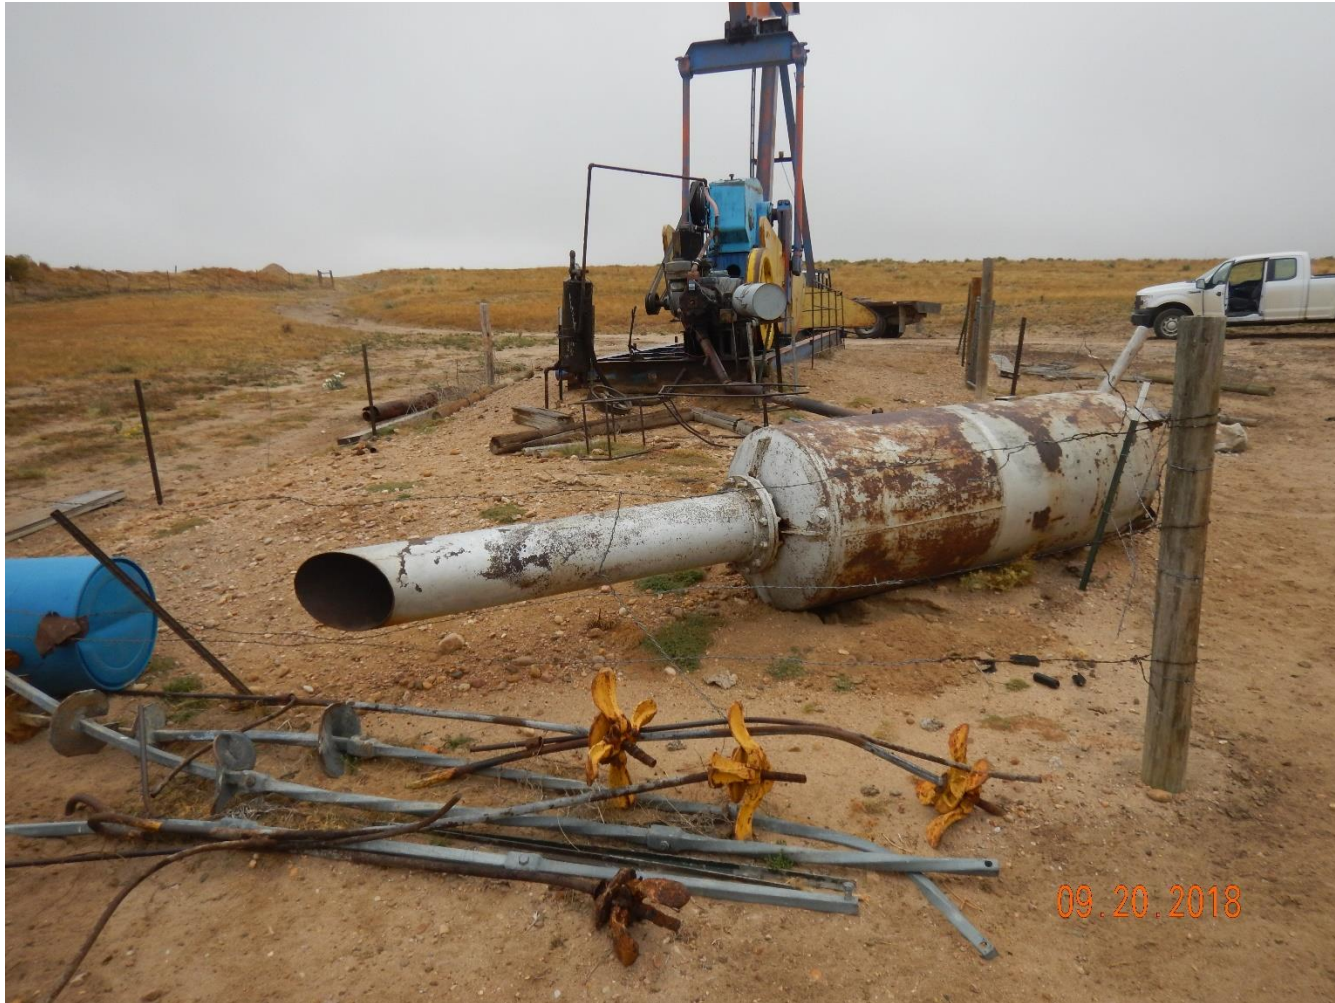
**Photo 9:** Photo taken from the west end of the well location, facing east. Photo shows various debris and equipment remaining on location. Photo also shows no reclamation activities appear to have been conducted in accordance w/ 1004.a

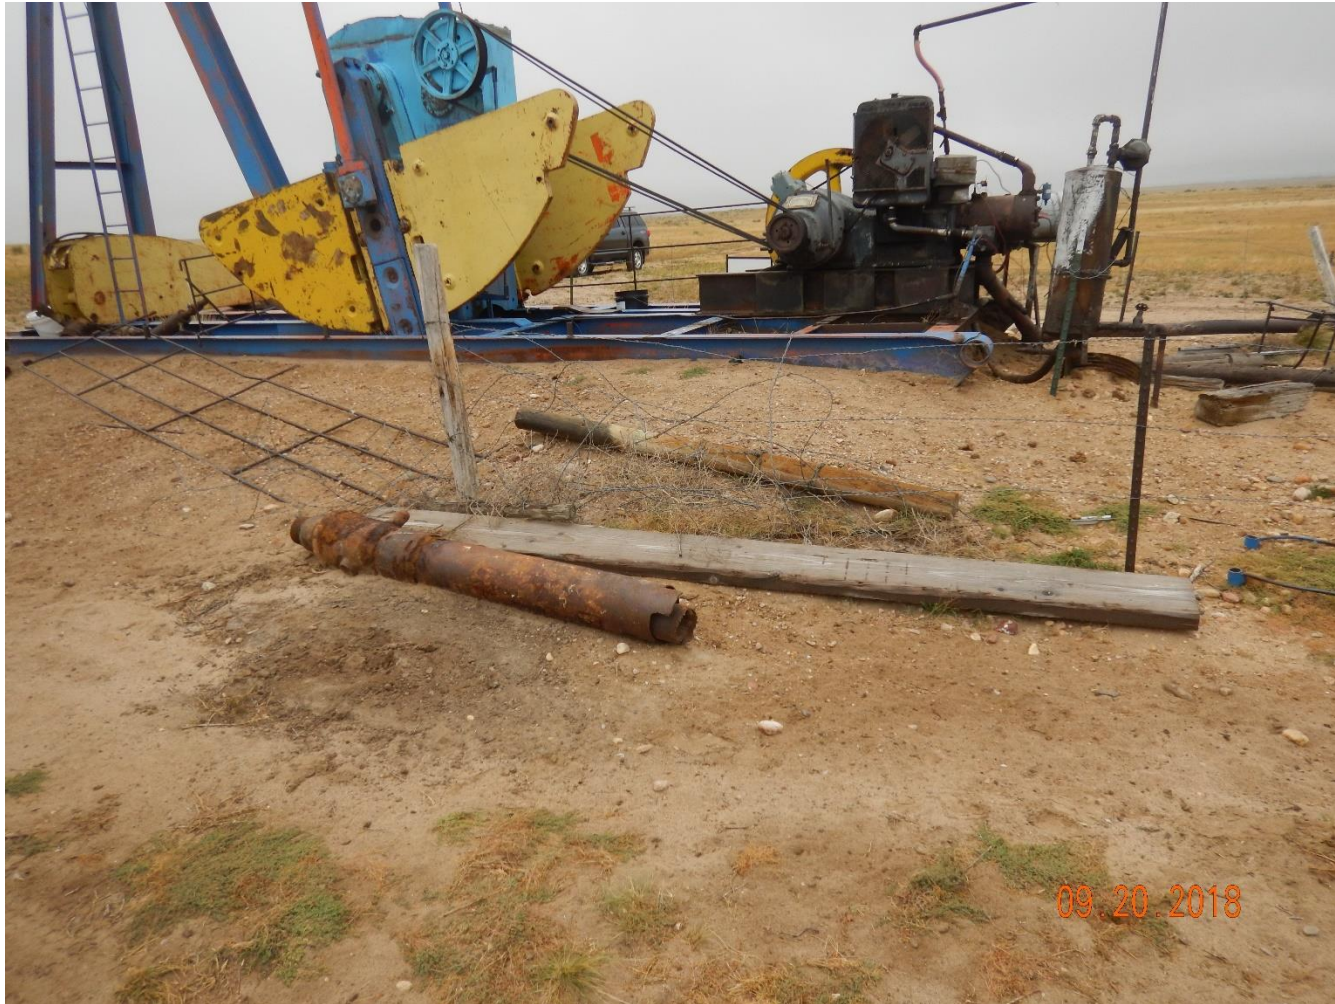
**Photo 10:** Photo taken from the north end of the well location, facing south. See comments under photo 9.

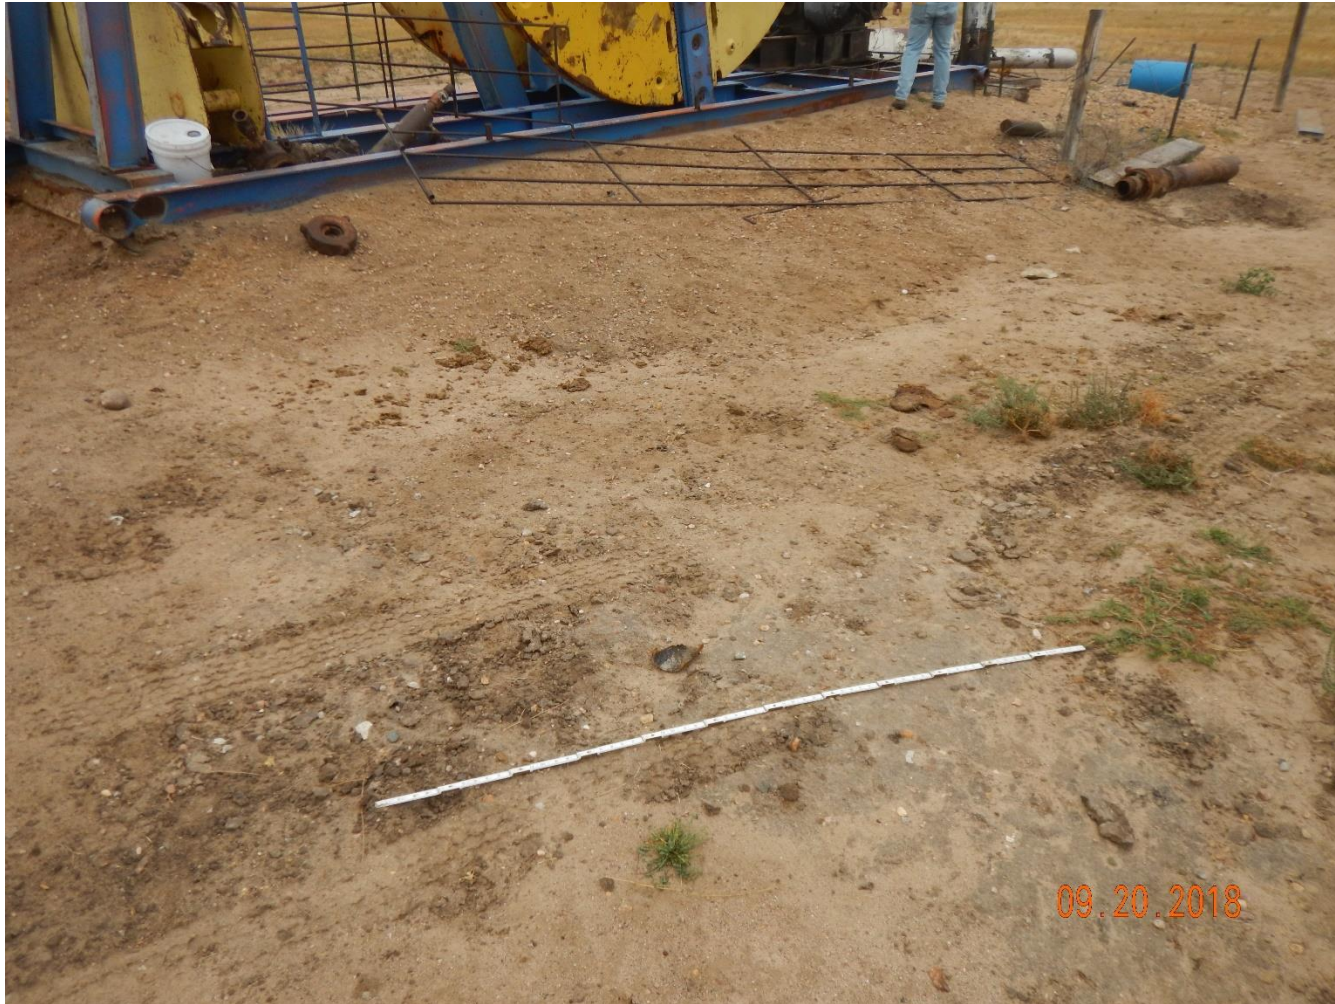
**Photo 11:** Photo taken from the north end of the well, facing southwest. Photo shows areas of contaminated soils observed on the location. 6 foot measuring stick for reference.

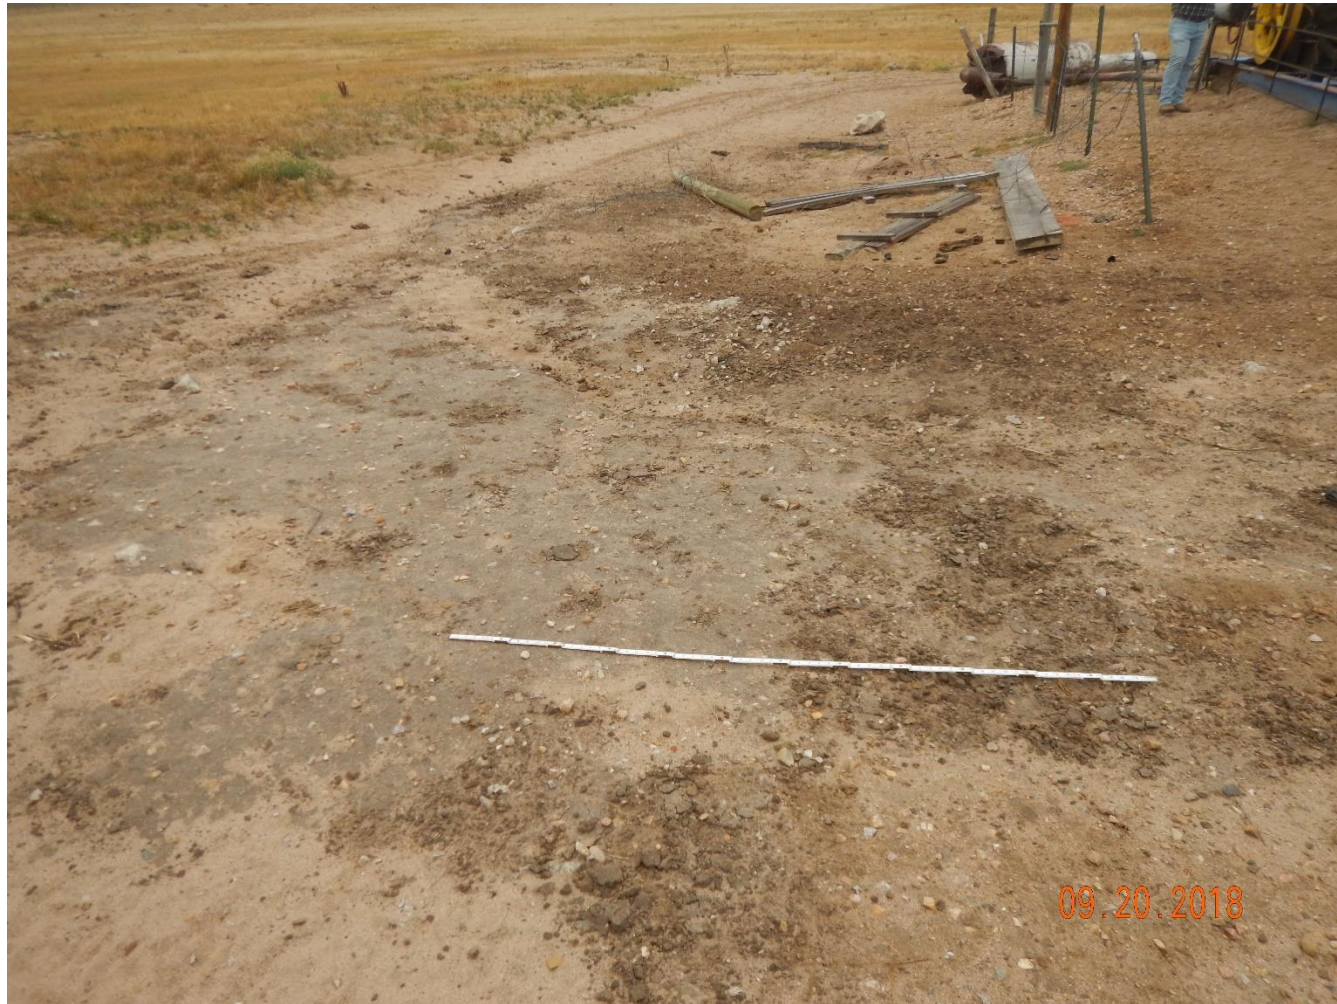
**Photo 12:** Photo taken from the south end of the well, facing west. See comments under photo 11.

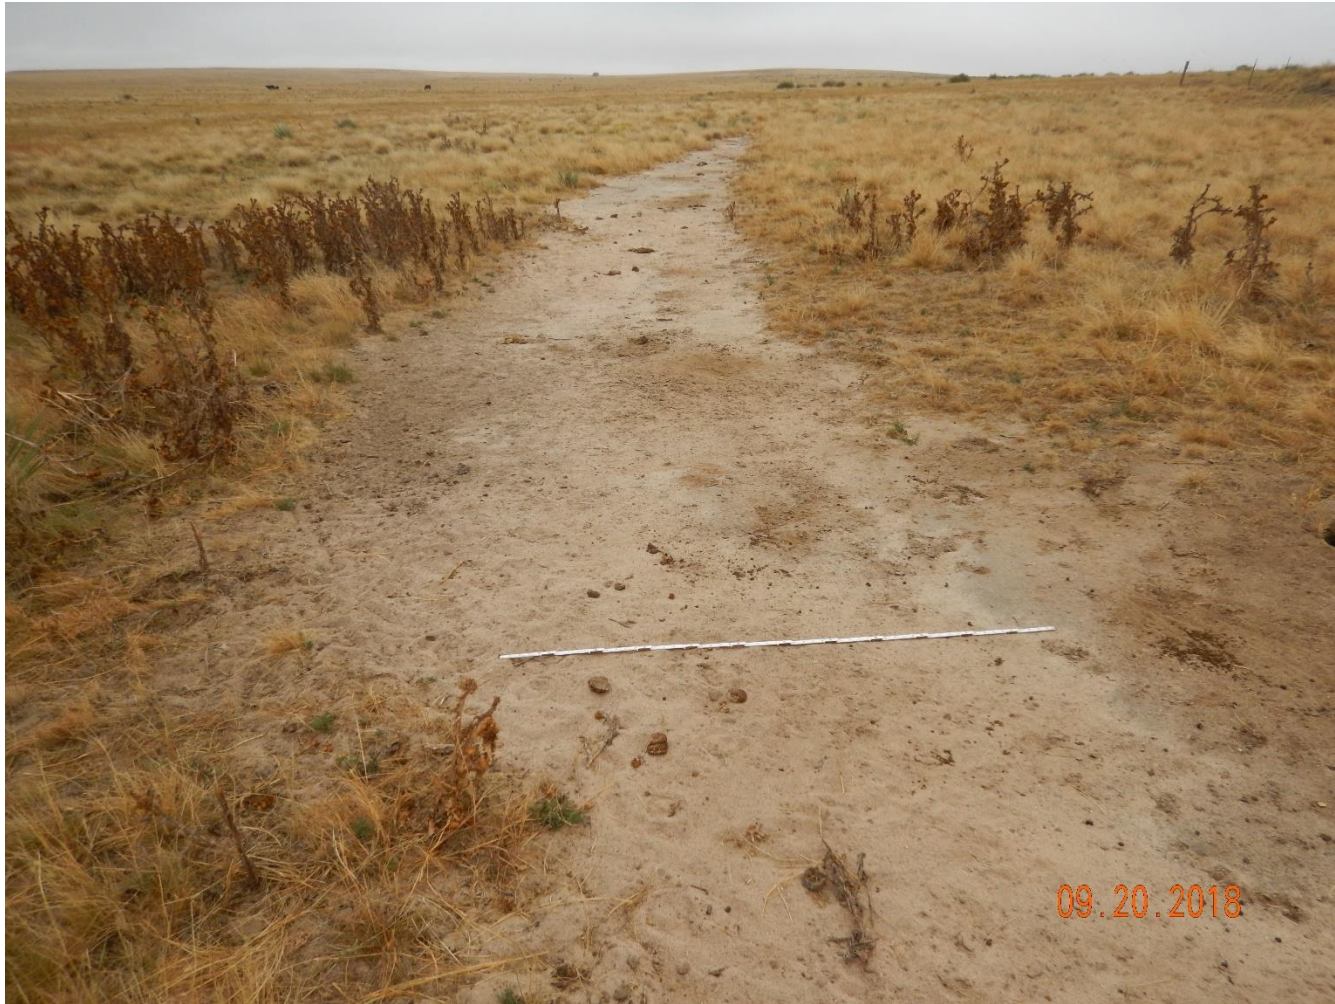
**Photo 13:** Photo taken from the west of the pit location, facing north. Photo shows areas of the closed pit that remained unvegetated. These areas require reclamation. Additional remediation may be required.

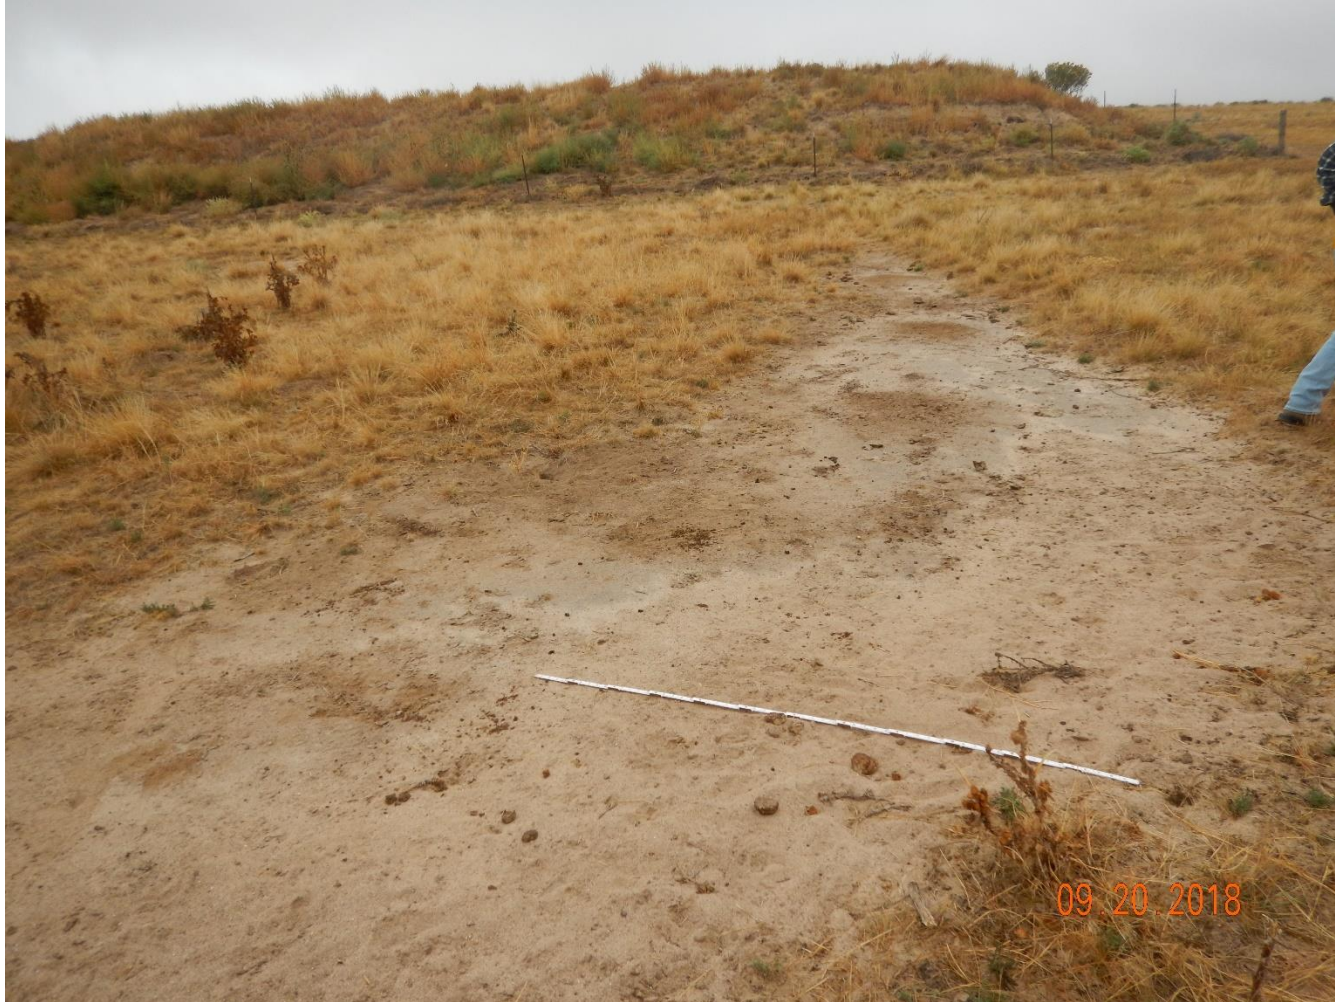
**Photo 14:** Photo taken from the west of the pit location, facing east. Photo shows areas of the closed pit that remained unvegetated. These areas require reclamation. Additional remediation may be required.

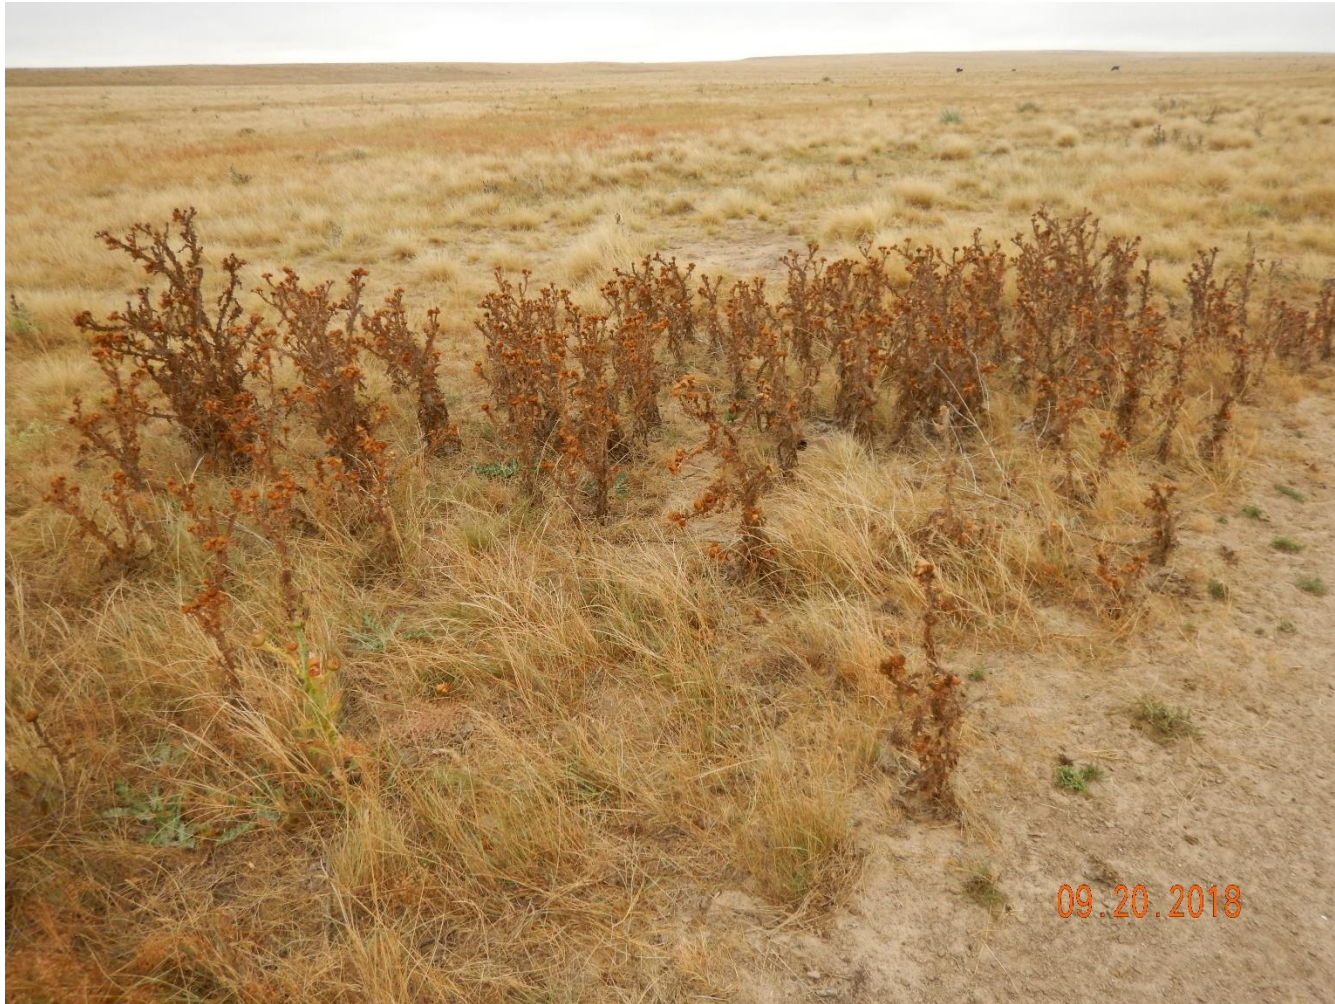
**Photo 15:** Photo taken from the west of the pit location, facing northeast. Photo shows Scotch Thistle. This is a Colorado State listed Noxious weed and required management.

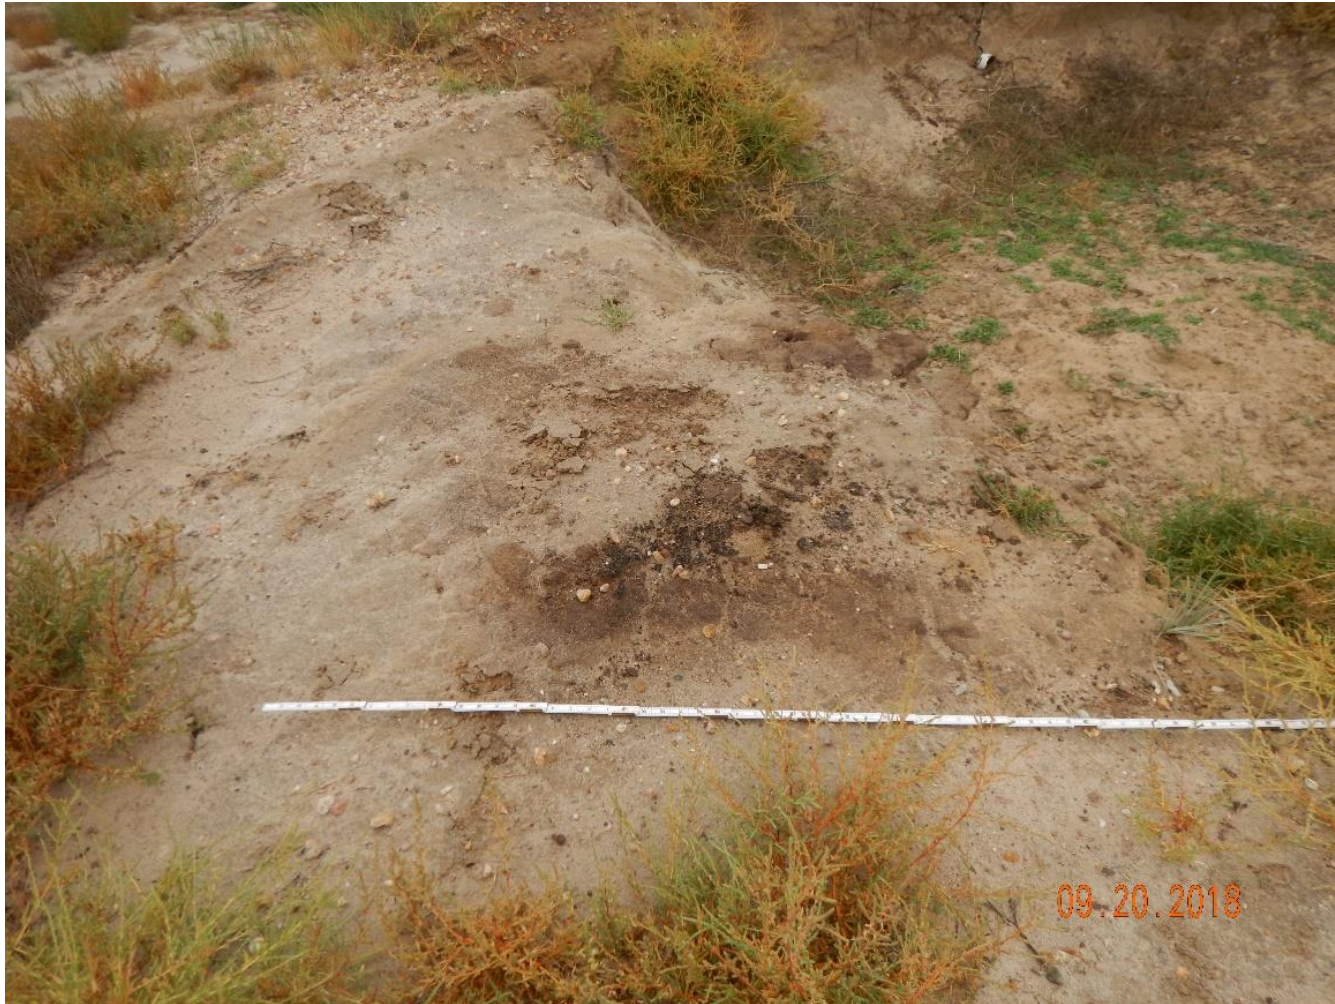
**Photo 17:** Photo taken from the skim pit. Photo of contaminated soils. 6 foot measuring stick reference.
