# Inspection Photos

09/20/2018

Operator: SMITH OIL PROPERTIES INC - 79905

Location ID: 313873

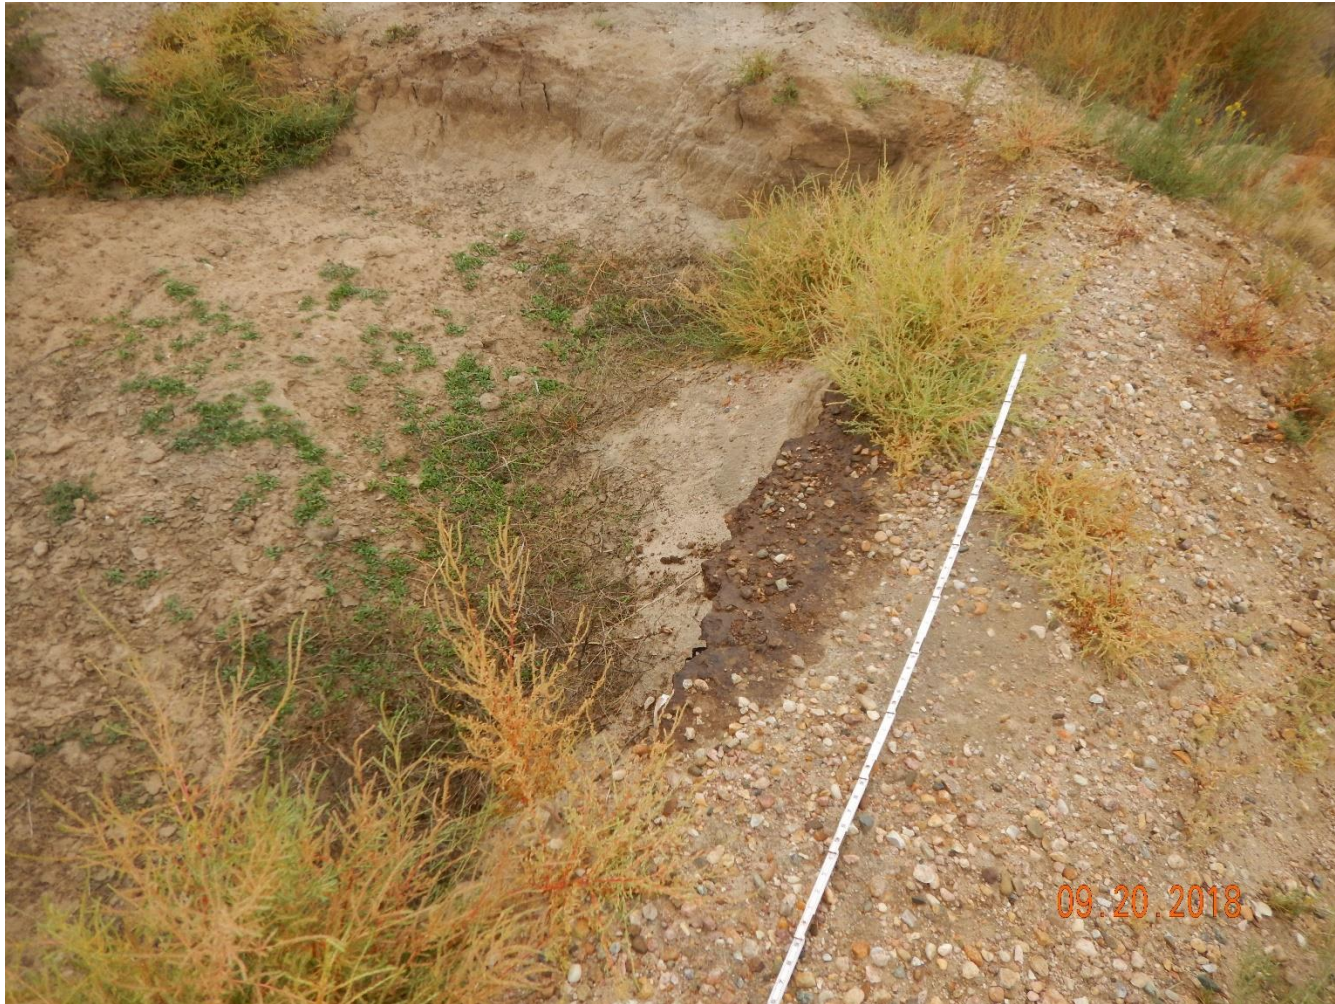
**Photo 18:** Photo taken from the skim pit. Photo of contaminated soils. 6 foot measuring stick reference.

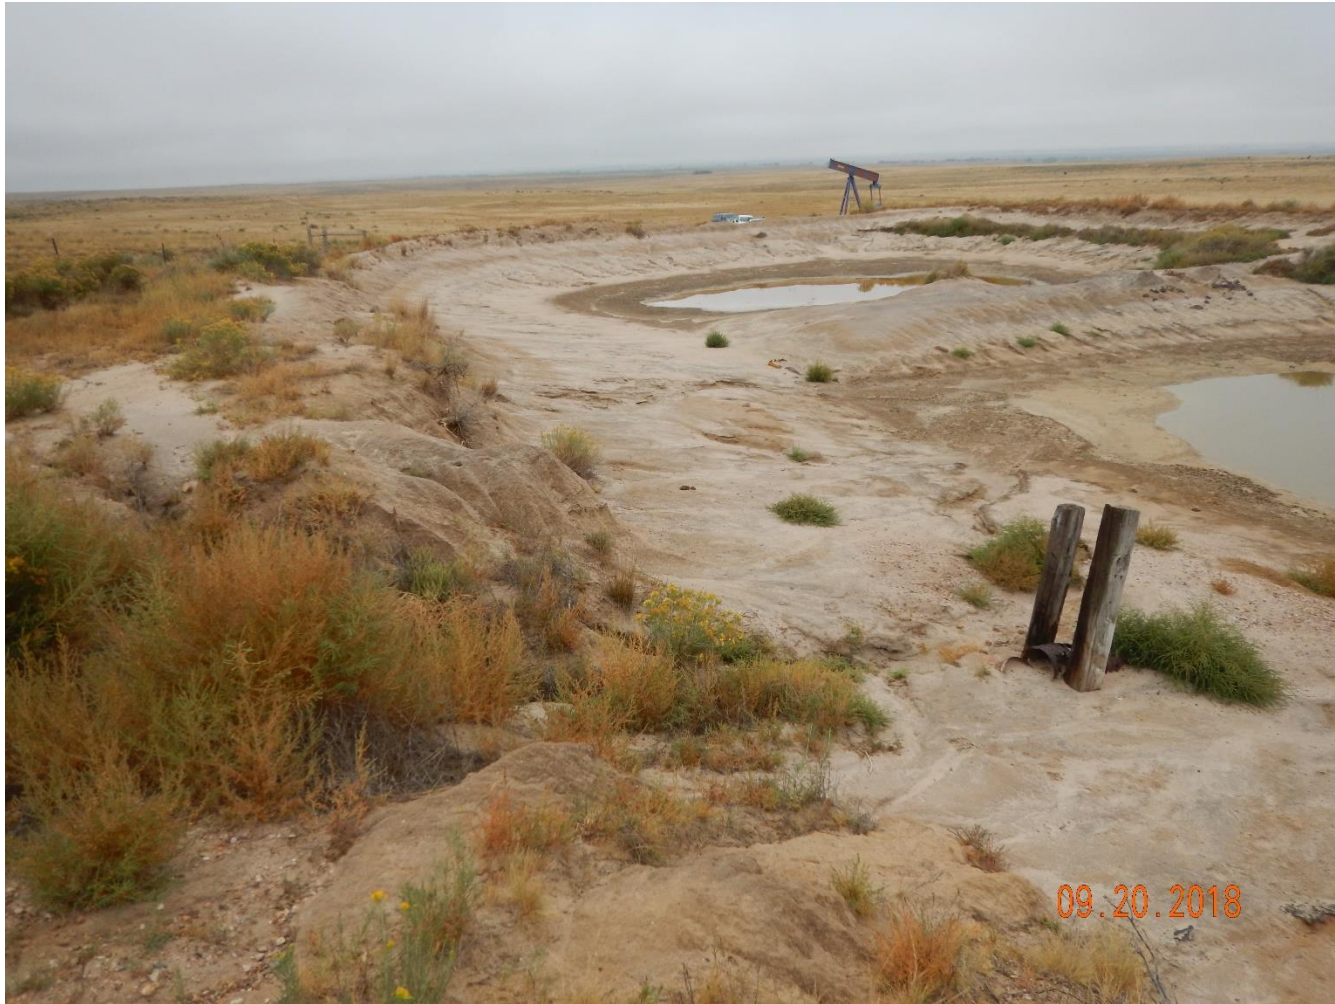
**Photo 19:** Photo taken from the northeast end of the pit, facing southwest. Photo shows overview of the pits. Pits remain open and have not been reclaimed.

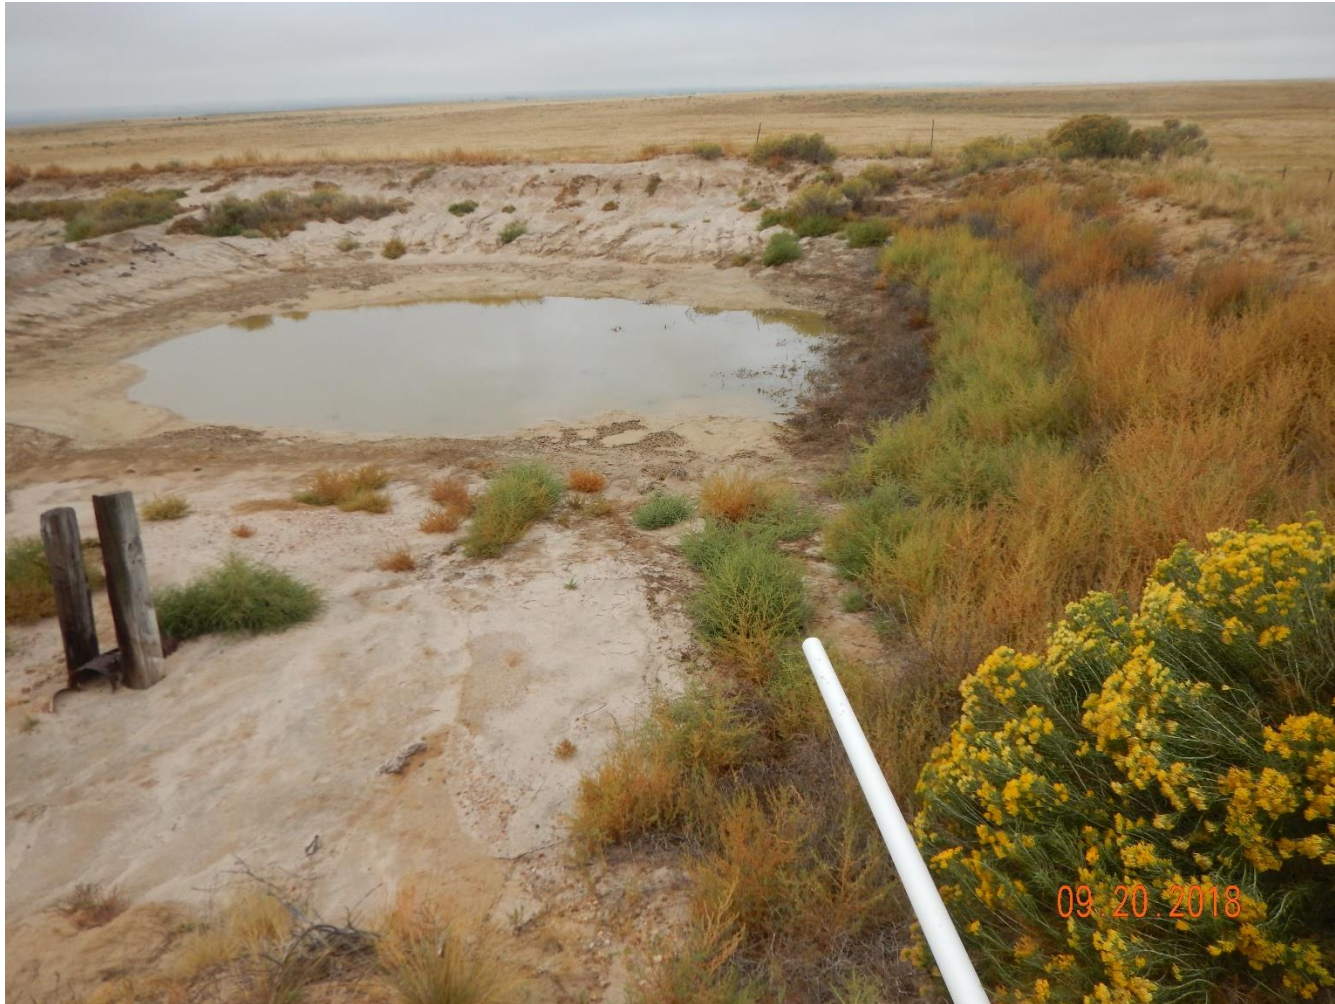
**Photo 20:** Photo taken from the northeast end of the pit, facing west. Photo shows overview of the pits. Pits remain open and have not been reclaimed. .

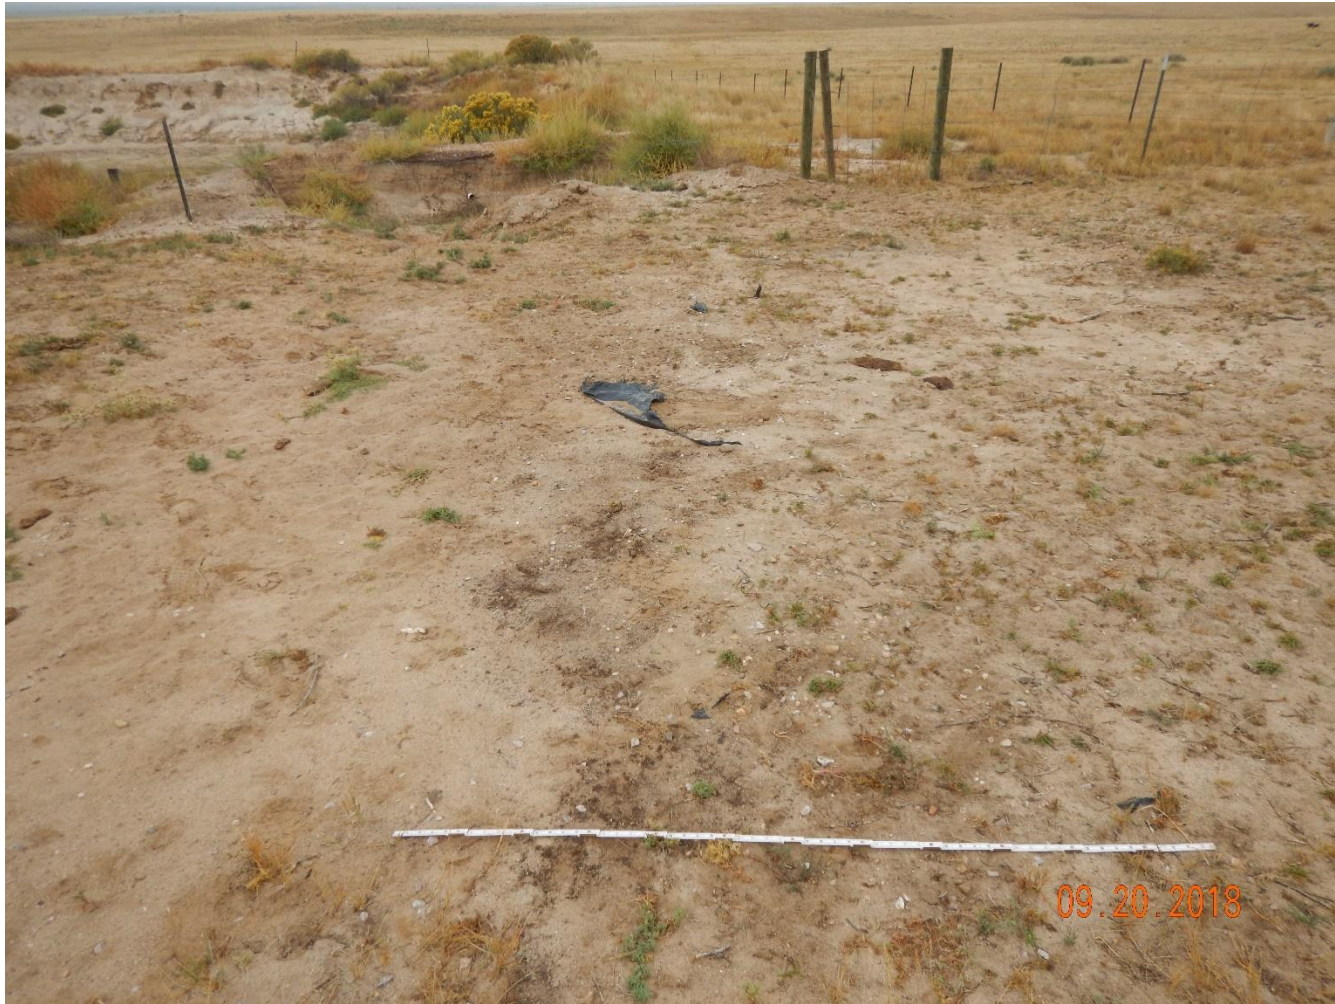
**Photo 21:** Photo taken from the north end of the battery location, facing west. Photo shows areas where contaminated soils were once stored. Tarp remains on site. 6 foot measuring stick for reference.

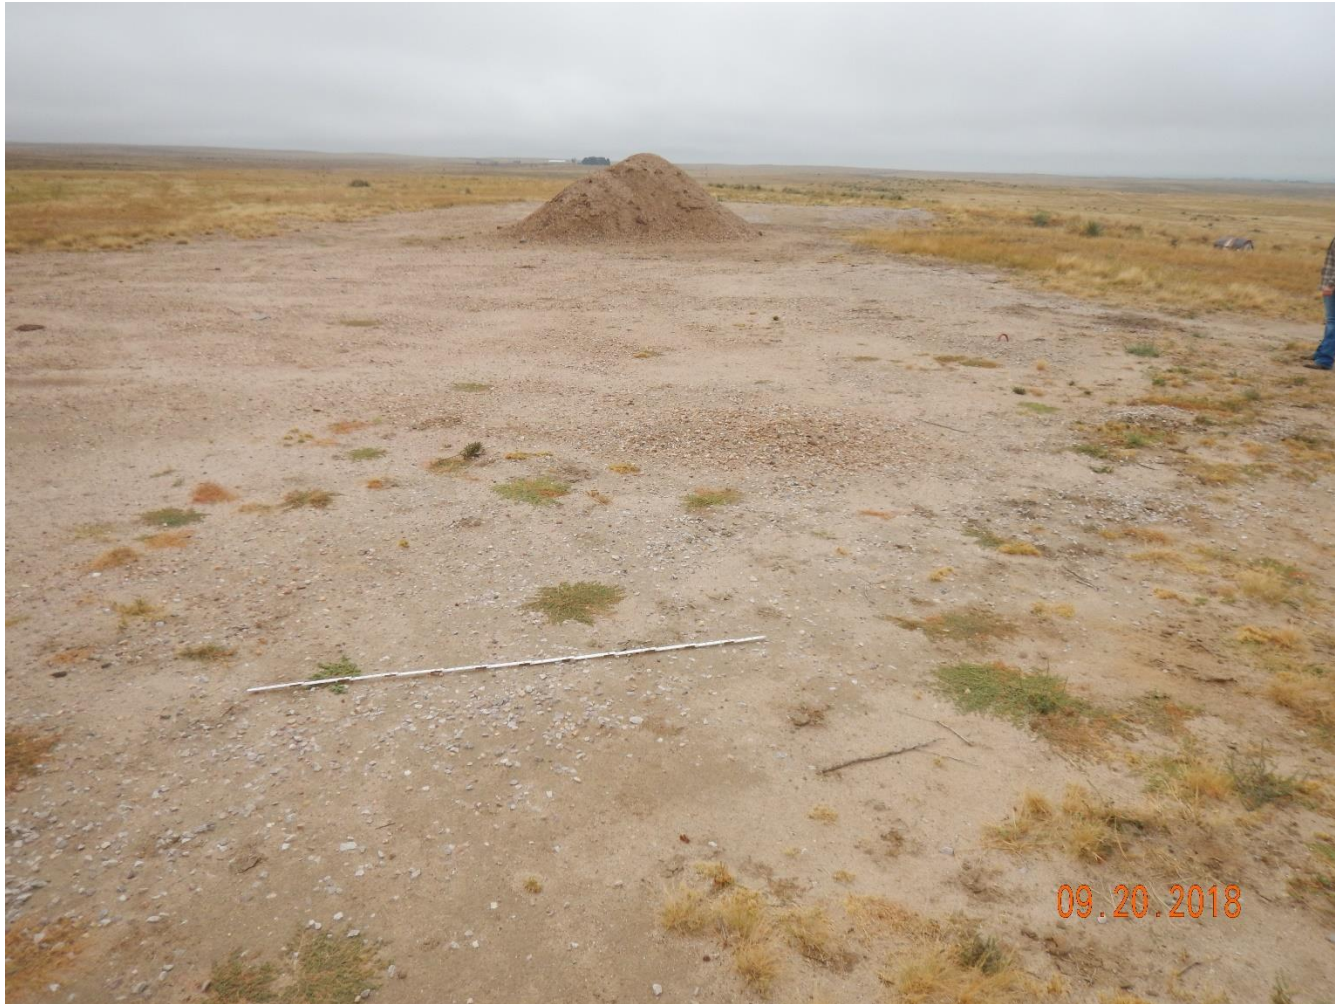
**Photo 22:** Photo taken from the northwest end of the battery location, facing south. Photo shows battery location has not been reclaimed. 6 foot measuring stick for reference.

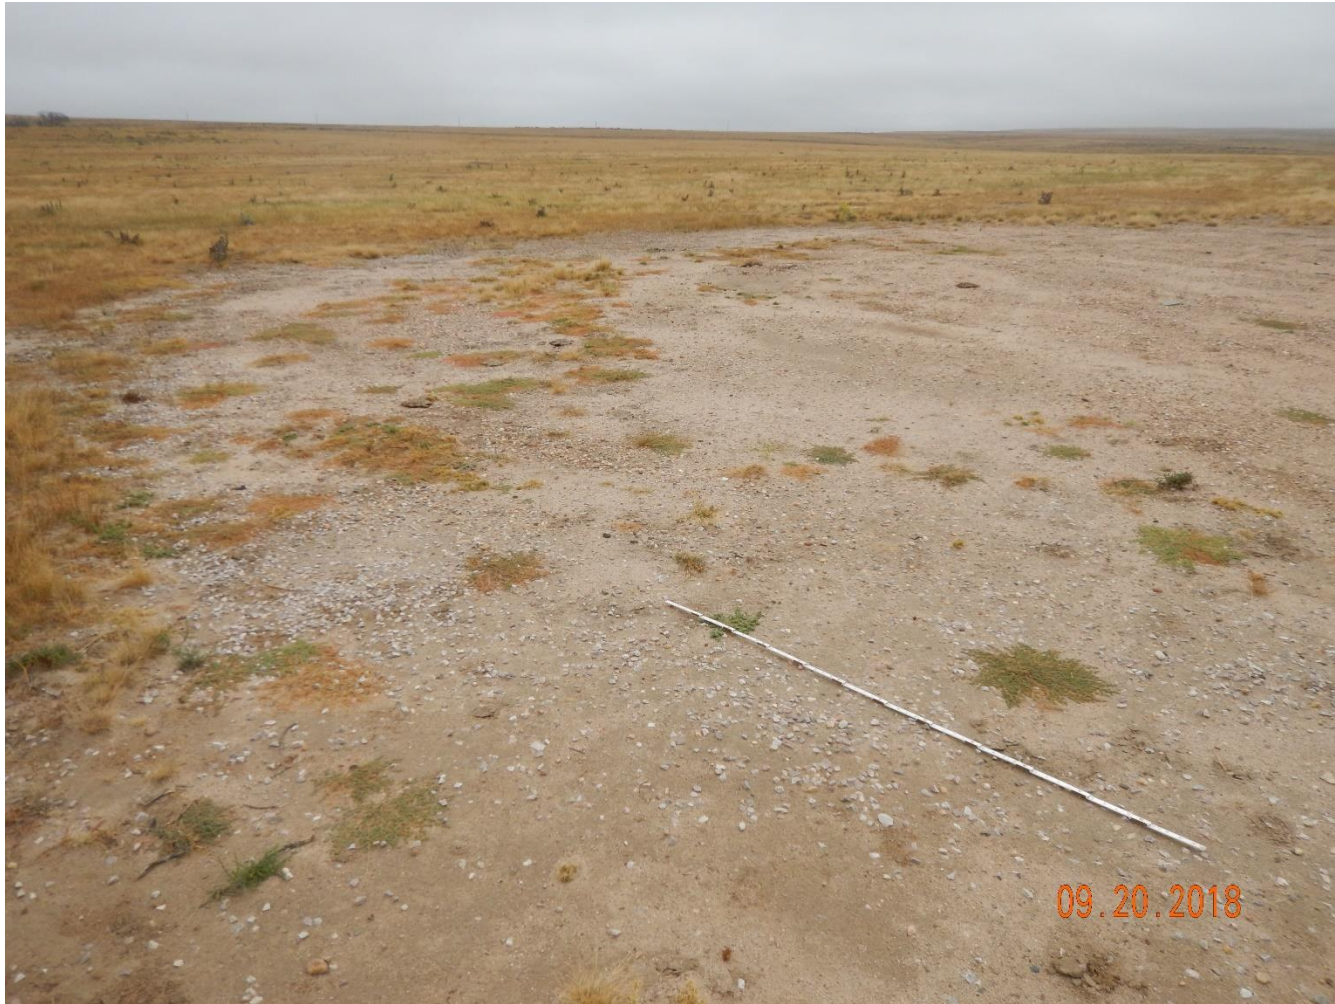
**Photo 23:** Photo taken from the northwest end of the battery location, facing east. Photo shows battery location has not been reclaimed. 6 foot measuring stick for reference.

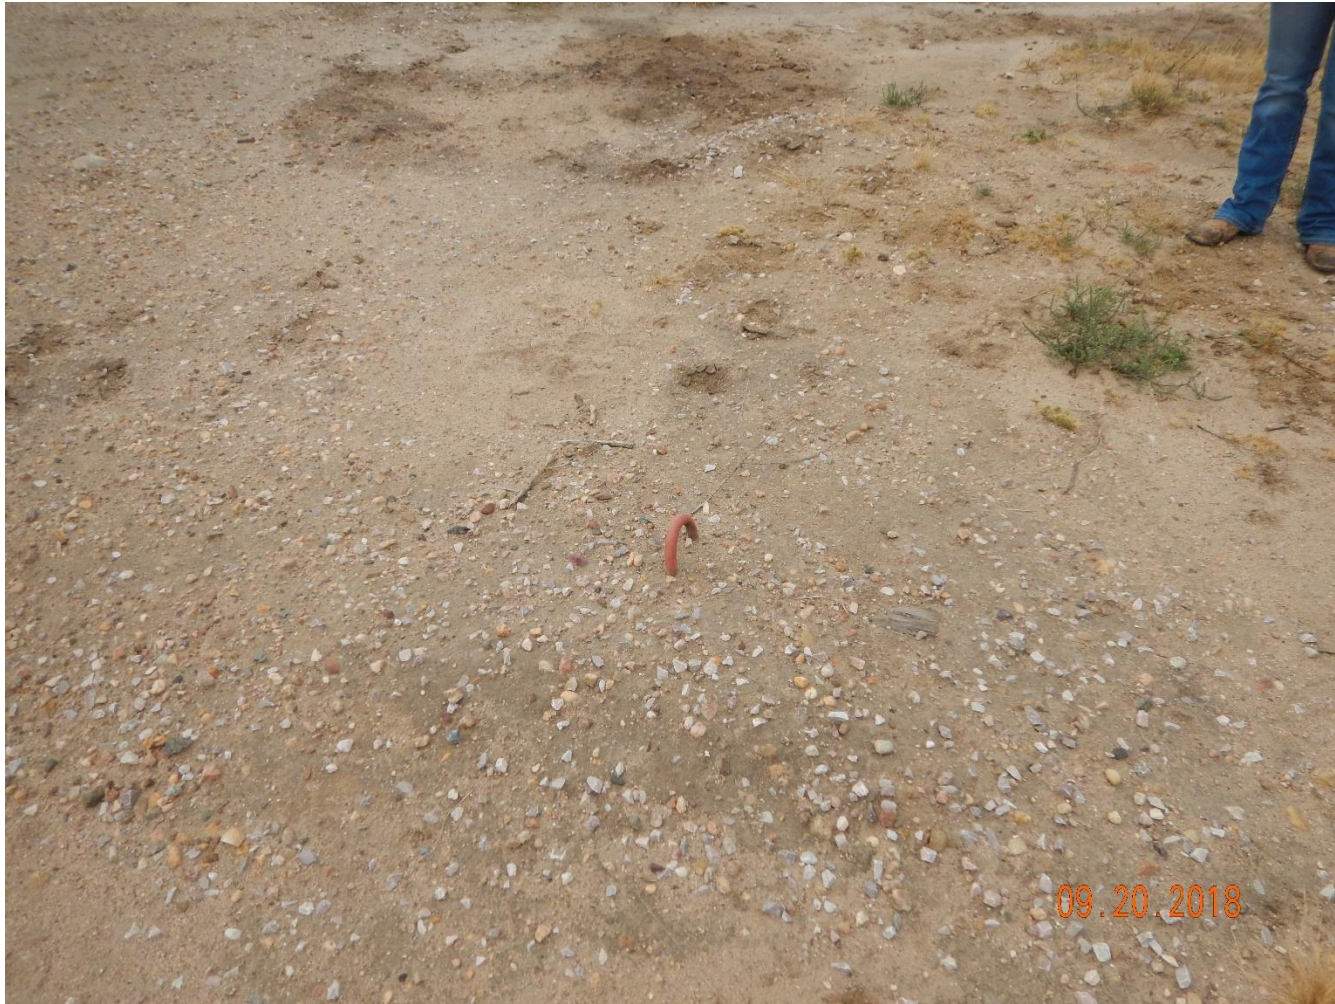
**Photo 24:** Photo taken from the northwest end of the battery. Photo shows anchor remaining on site.

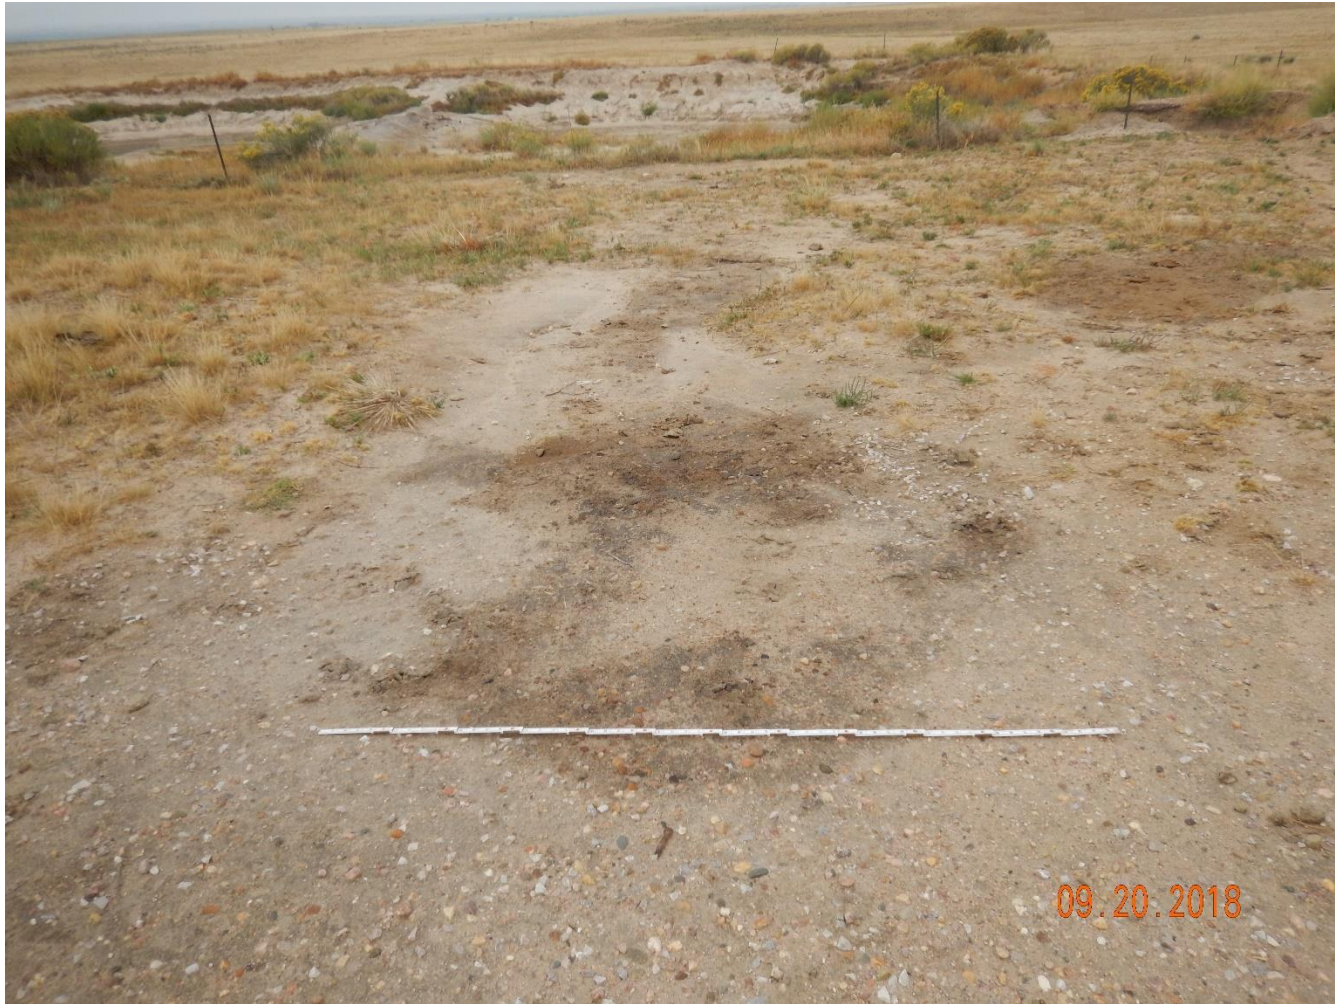
**Photo 25:** Photo taken from the west end of the battery location. Photo shows contaminated soils on the battery location. 6 foot measuring stick for reference.

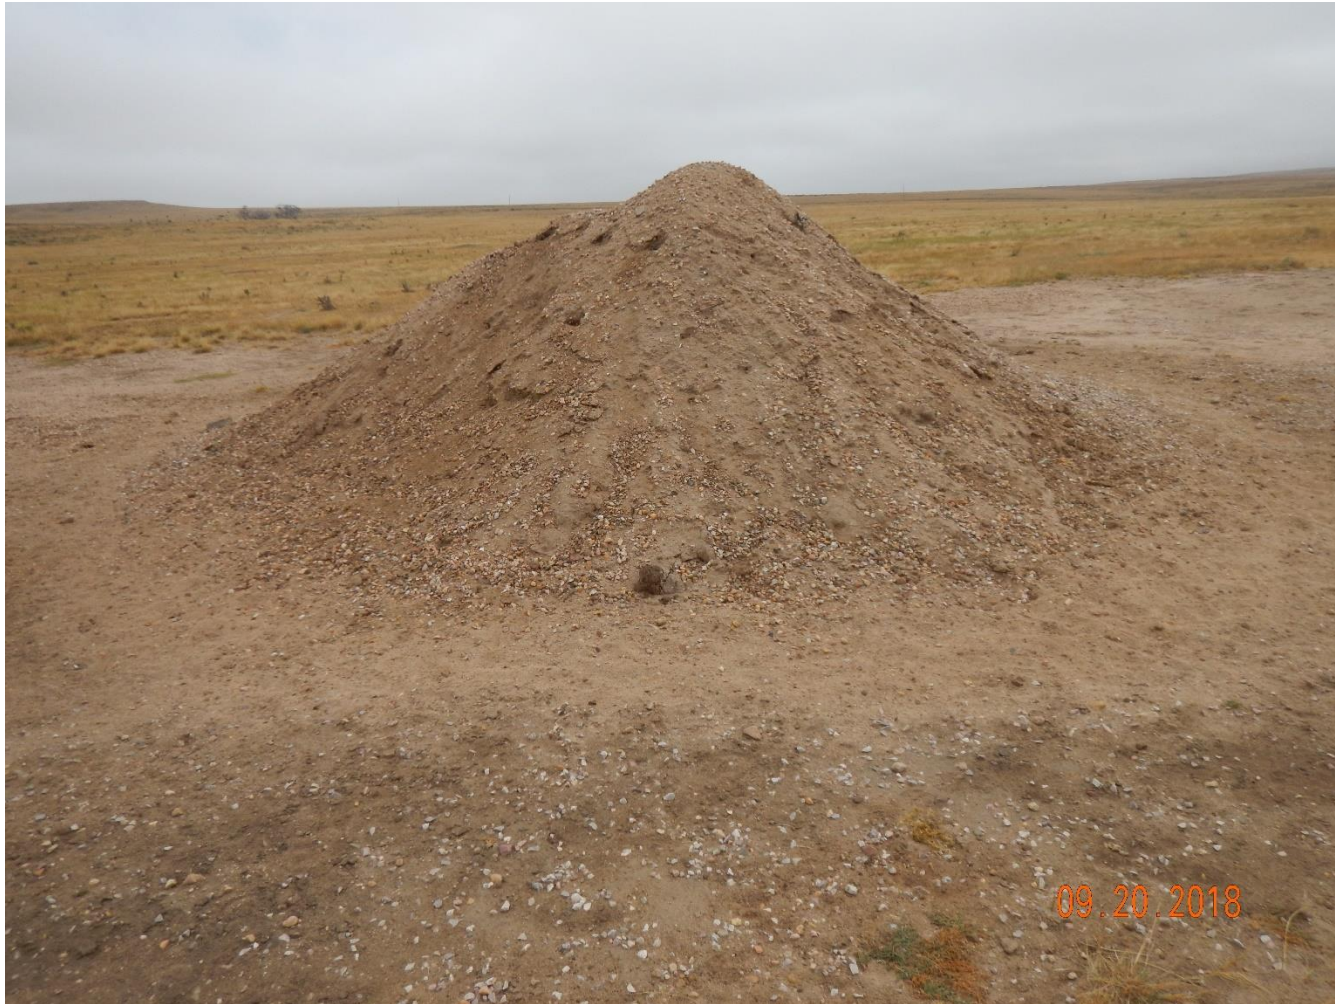
**Photo 26:** Photo taken from the southern end of the battery. Photo shows a pile of soil stored on locaiton.

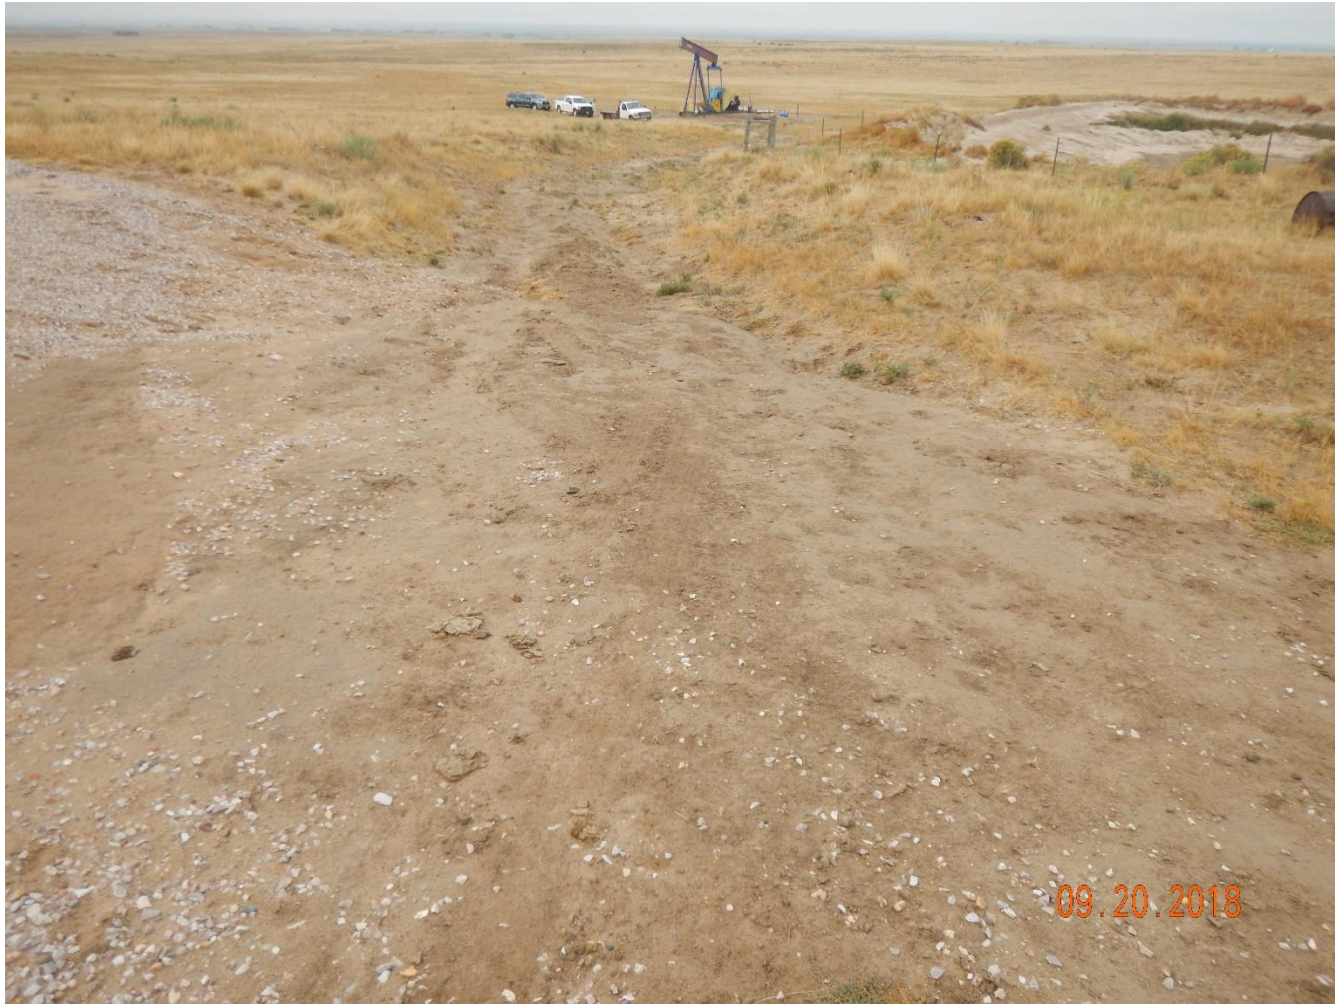
**Photo 27:** Photo taken from the west end of the battery, facing southwest. Photo shows area of access road leading from the well to the battery. Photo shows access road has not been reclaimed. Erosion degradation evident.

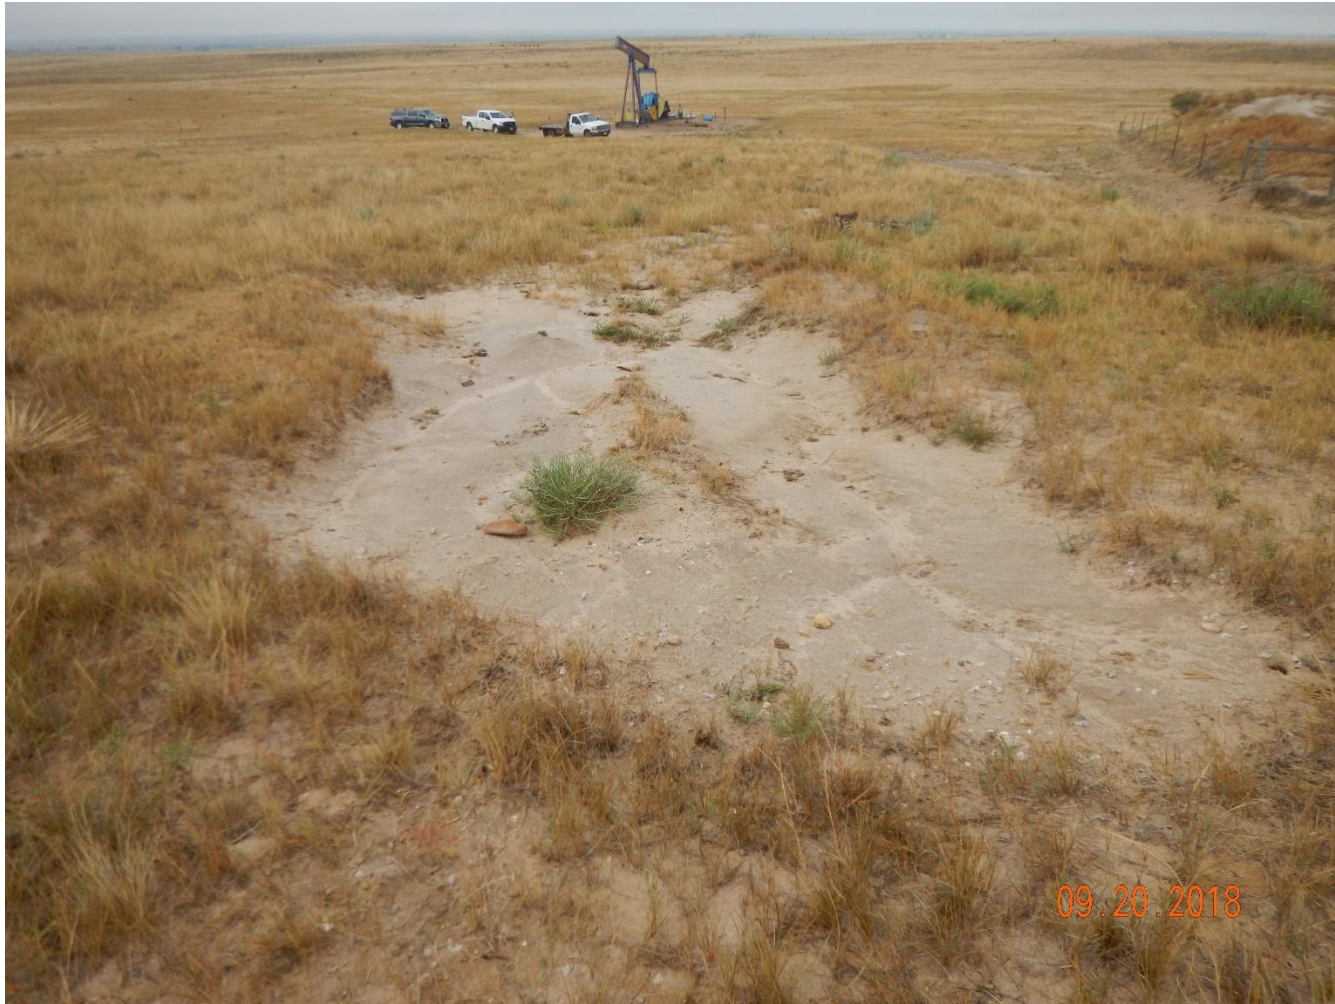
**Photo 28:** Photo taken from the southwest of the battery. Photo shows area of a previous spill. Photo shows area remains predominantly bare and exposed soil. Area requires remediation/reclamation.

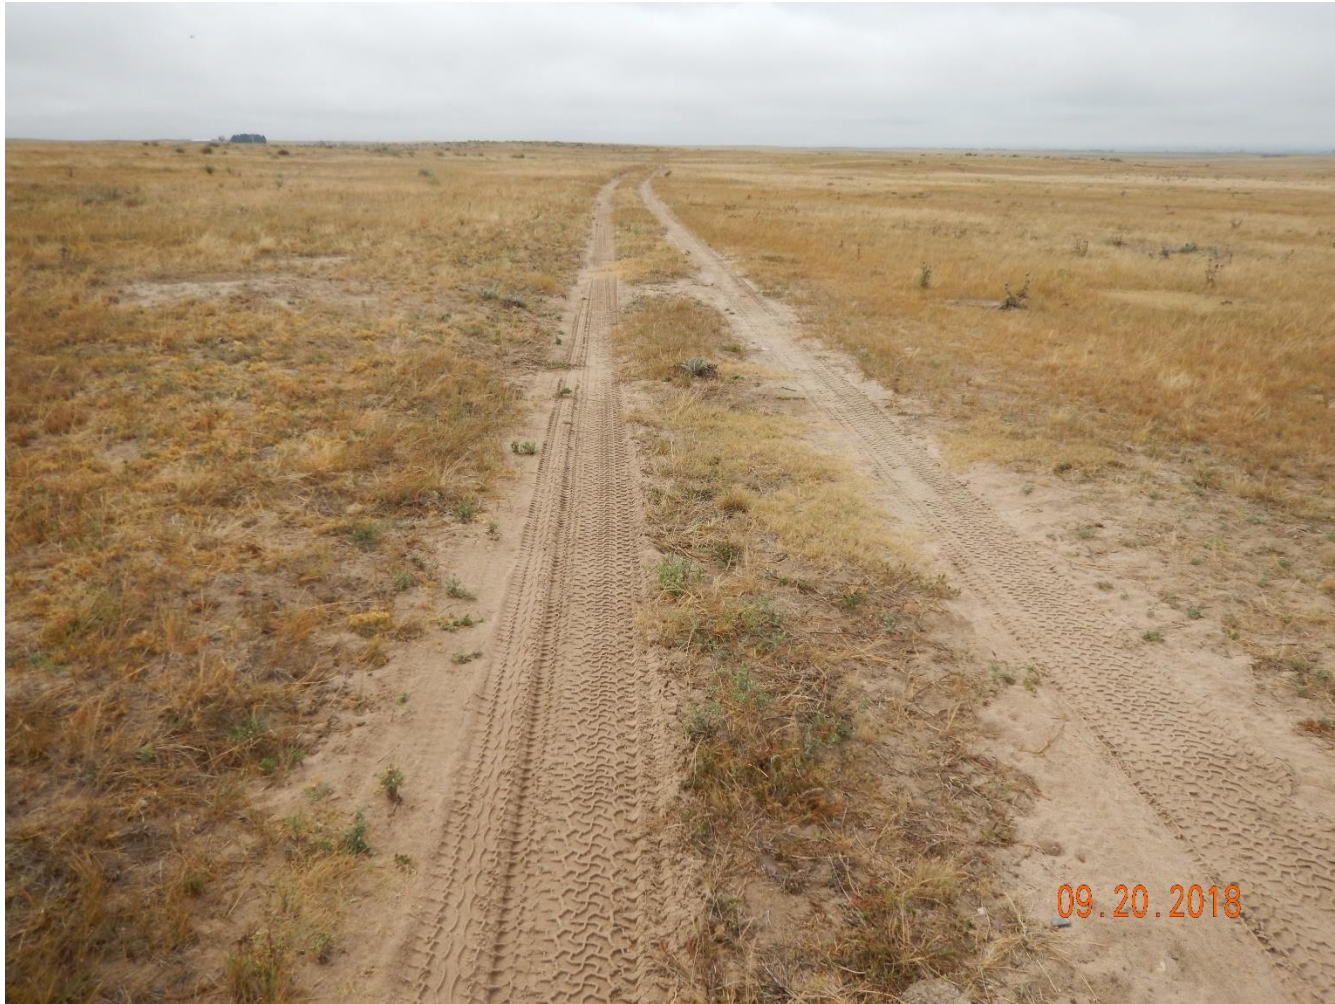
**Photo 30:** Photo taken from the access road, south of the location. Photo shows access road has not been reclaimed or maintained.

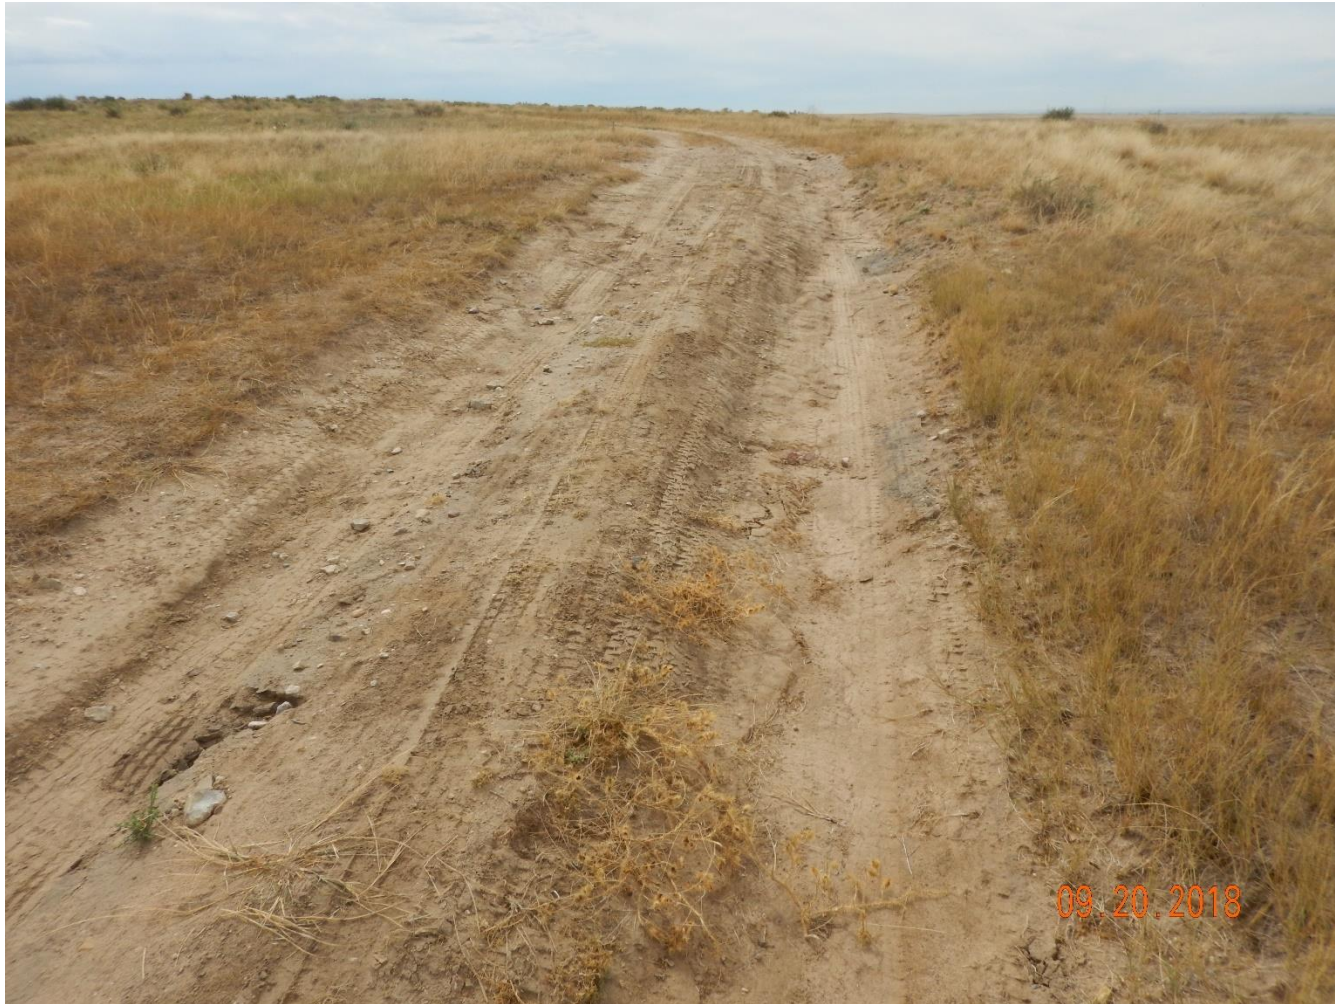
**Photo 31:** Photo taken from the access road, south of the location. Photo shows access road has not been reclaimed or maintained; erosion degradation evident.

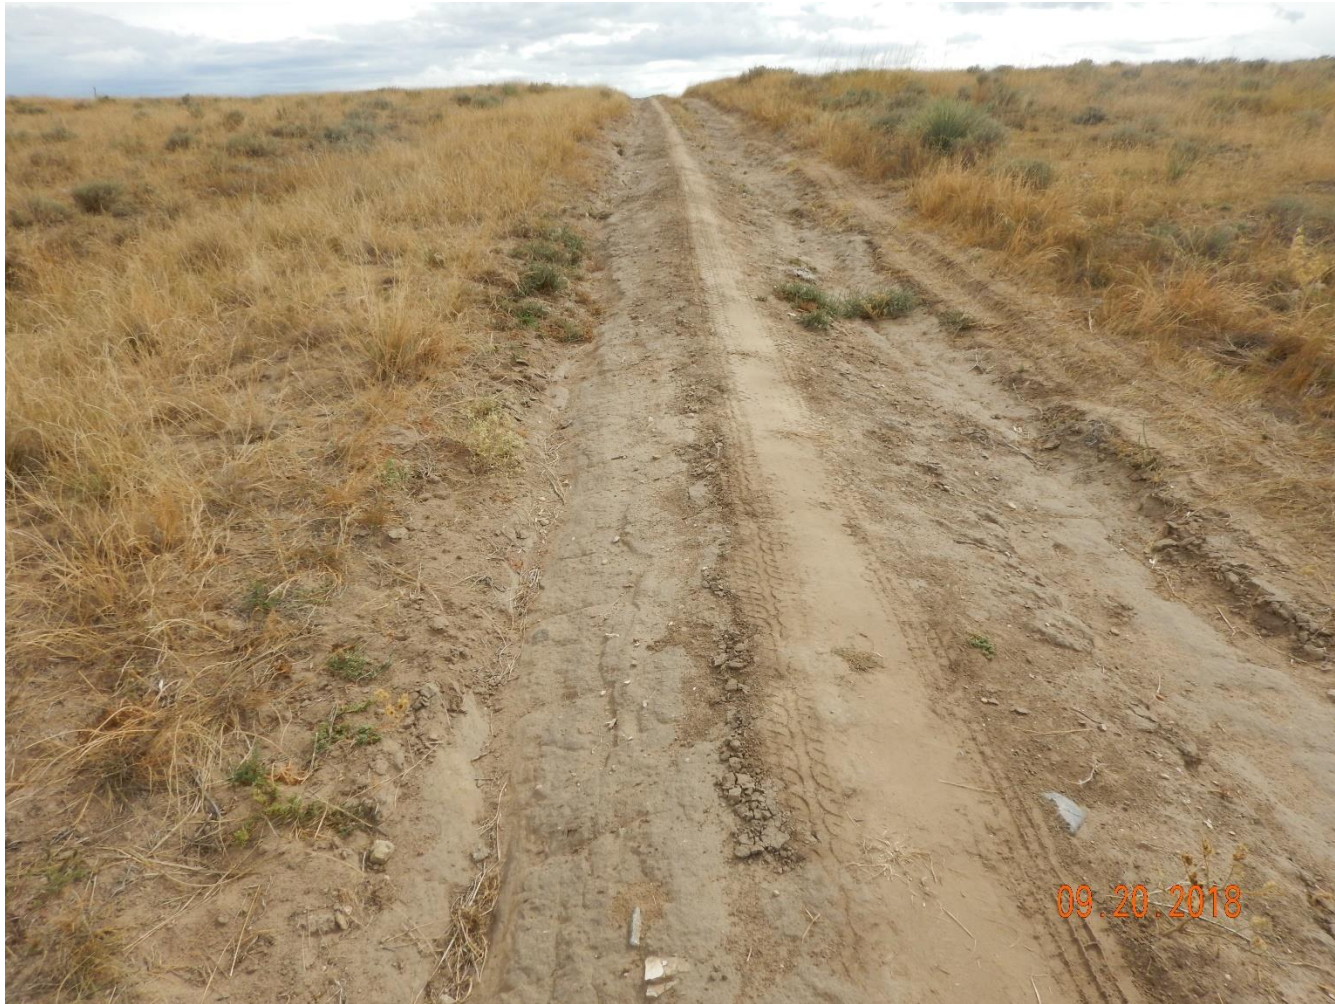
**Photo 32:** Photo taken from the access road, south of the location. Photo shows access road has not been reclaimed or maintained; erosion degradation evident.
