Inspection Photos
Location Name: USA Shaw 19
API: 05-081-60020

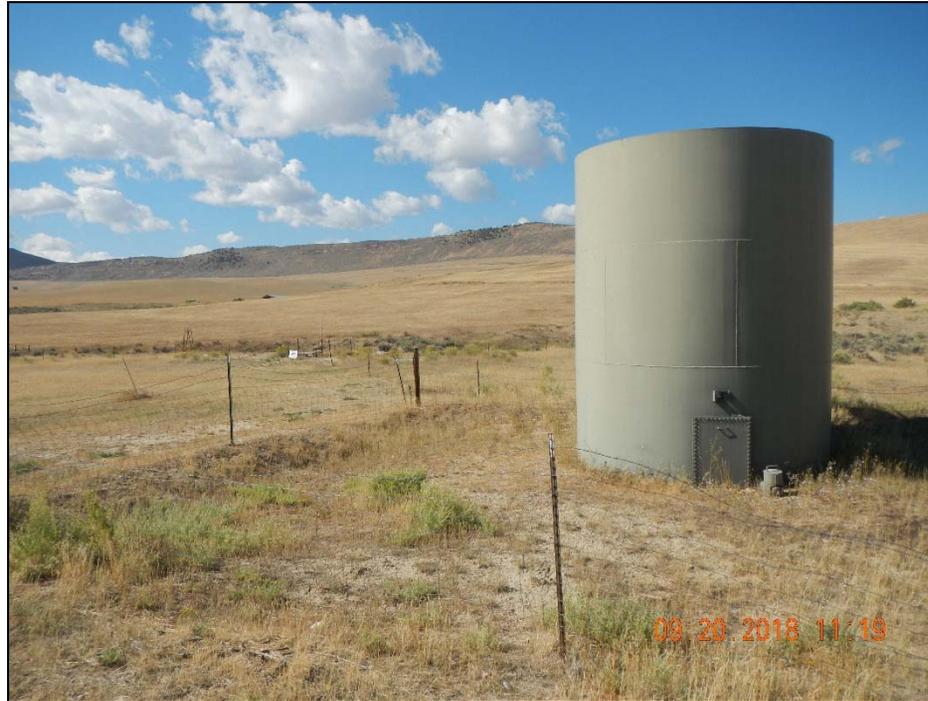
Photo 1. Overview of location taken at entrance facing southwest.

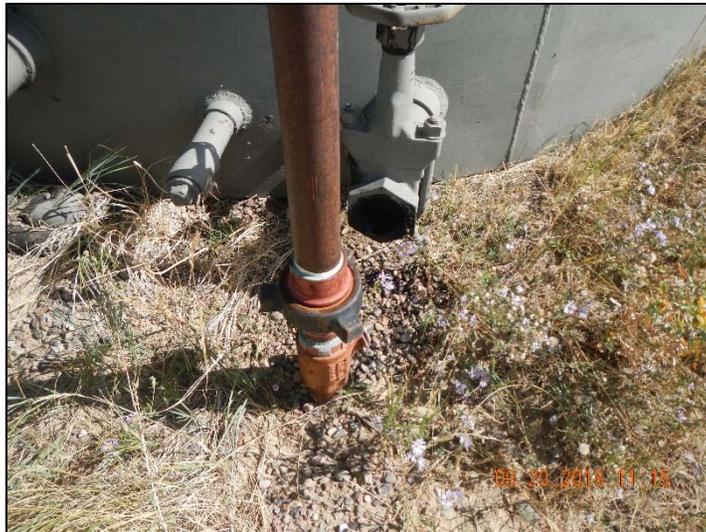
Photo 2. Stained soil at tank loadout.
9/20/2018

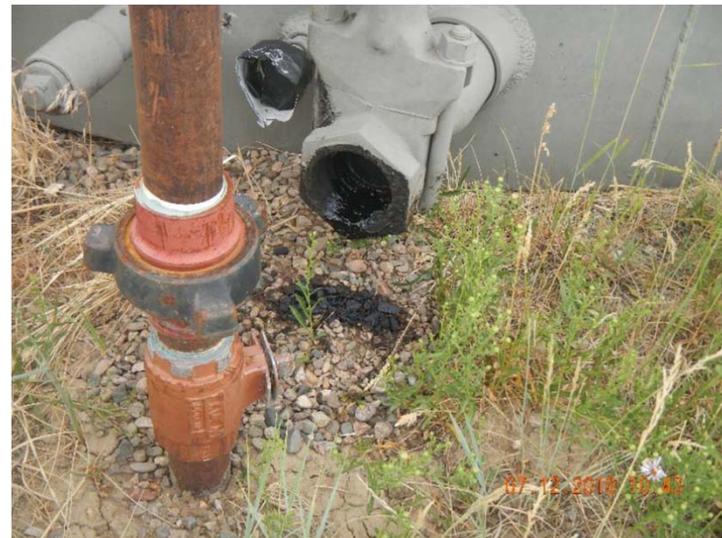
Photo 3. Stained soil at tank loadout.
7/12/2018

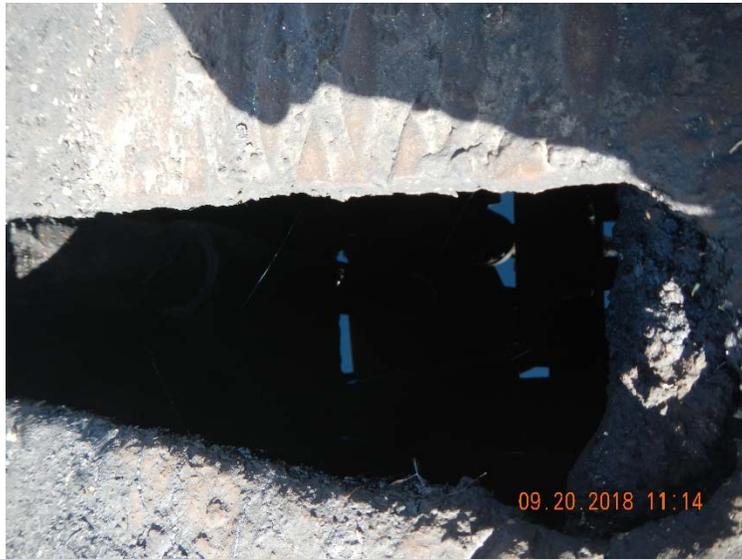
Photo 4. Fluid in cellar.
9/20/2018

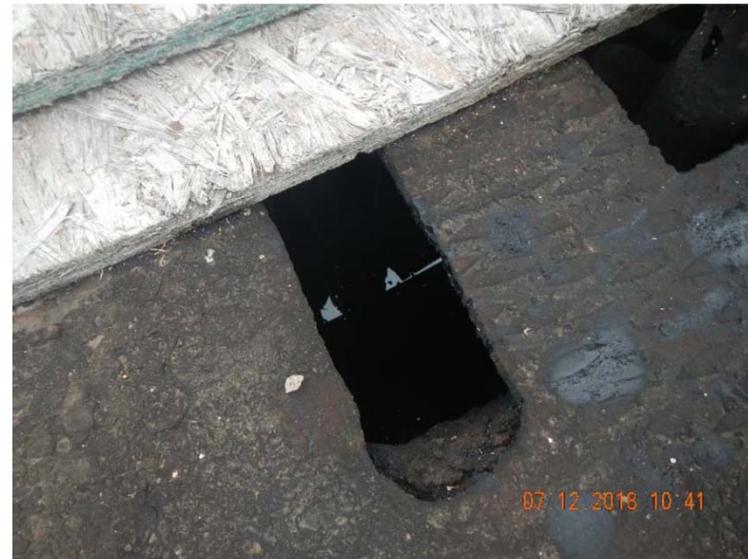
Photo 5. Fluid in cellar.
7/12/2018
