Inspection Photos

Operator: DJ Simmons Inc.

API: 05-033-06008

Date: 9/18/2018

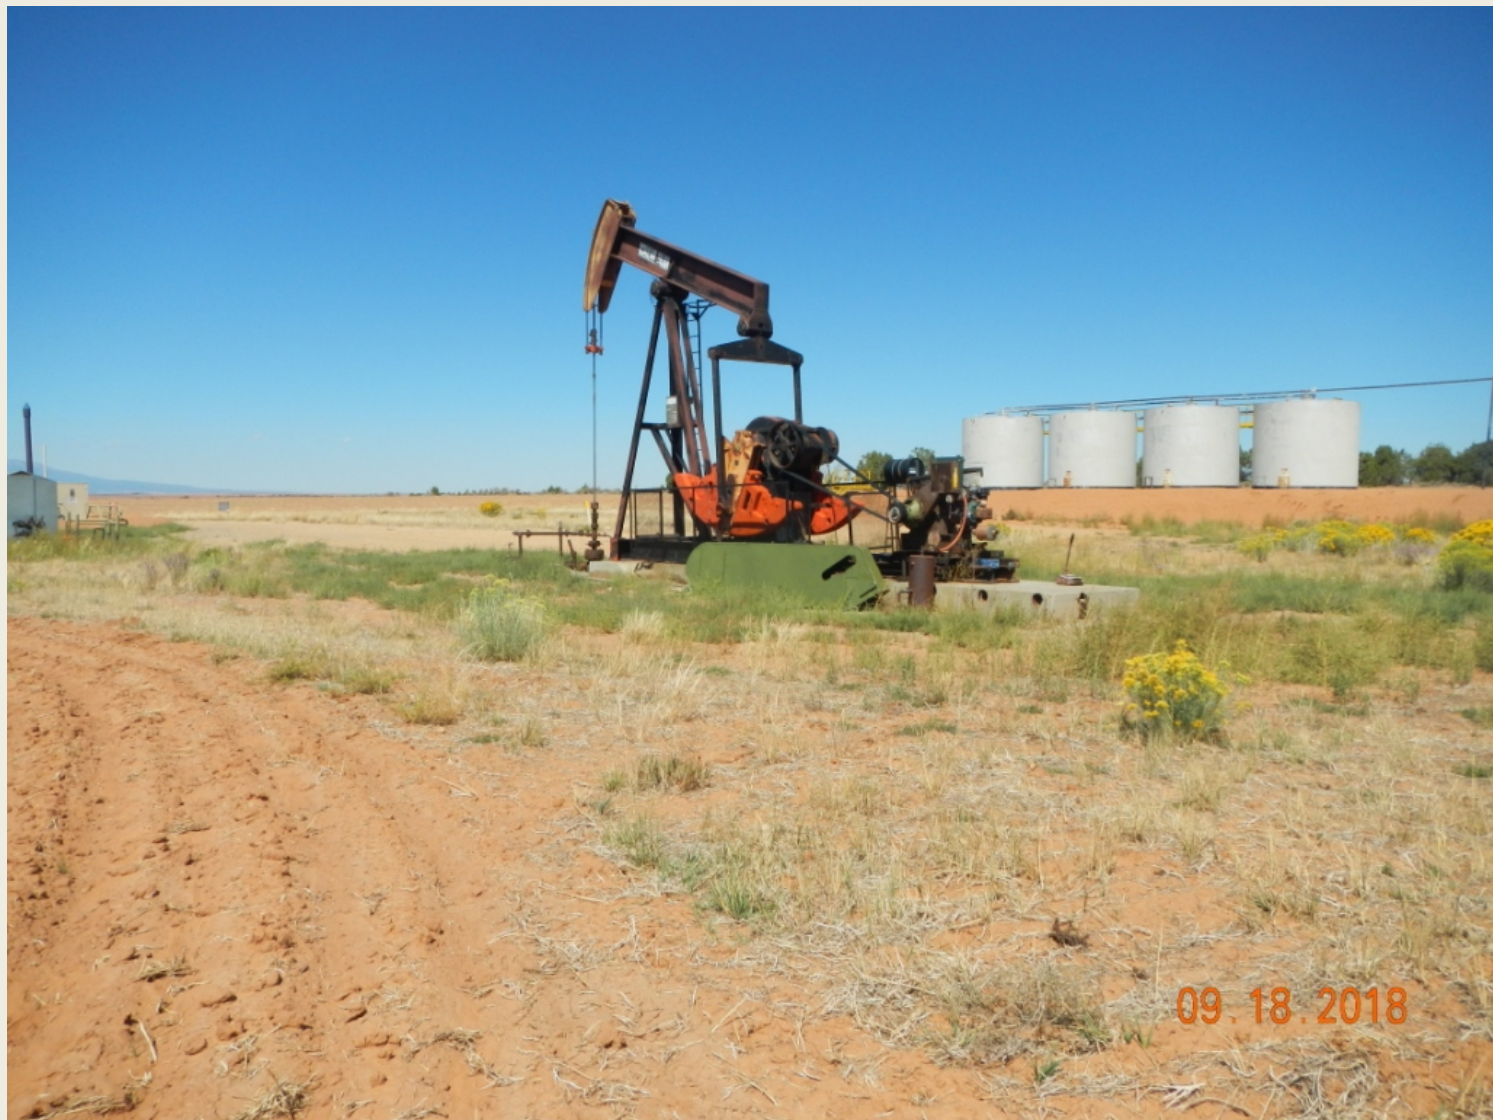
Photo 1. View of the project area from the southeastern corner facing center.

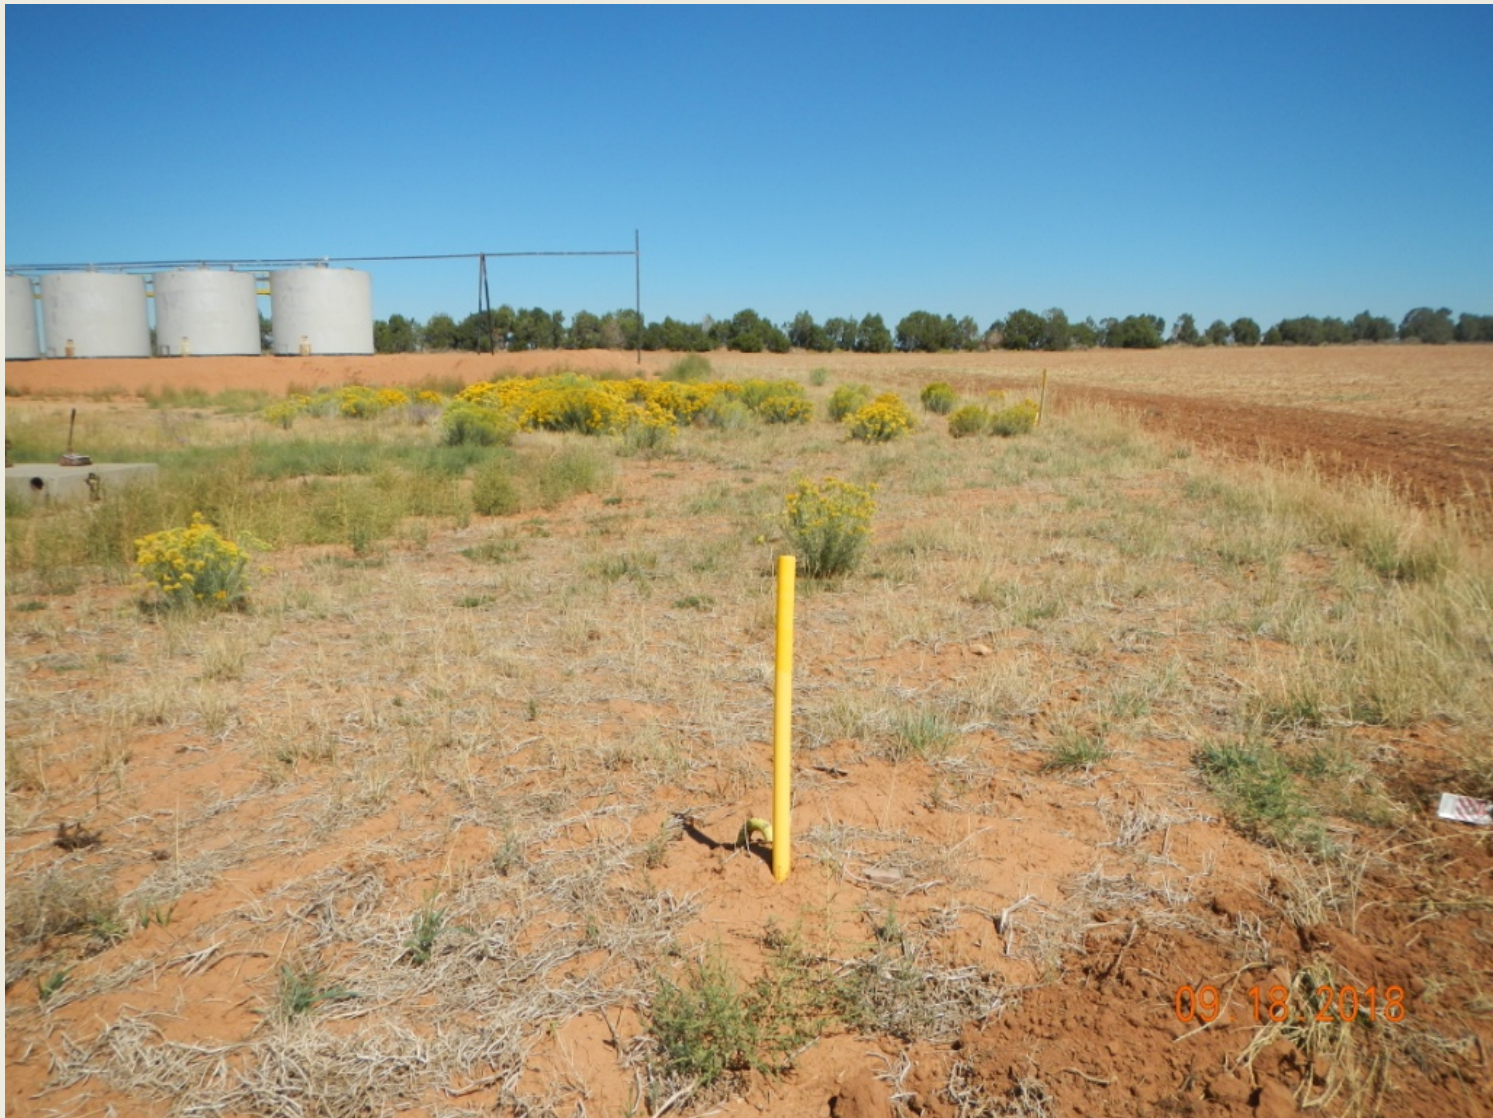
Photo 2. View of the eastern portion of the project area from the southeastern corner facing northward. Revegetation is progressing within outer reclamation areas with grass such as smooth brome (*Bromus inermis*) and shrubs such as rubber rabbitbrush (*Chrysothamnus nauseosus*).

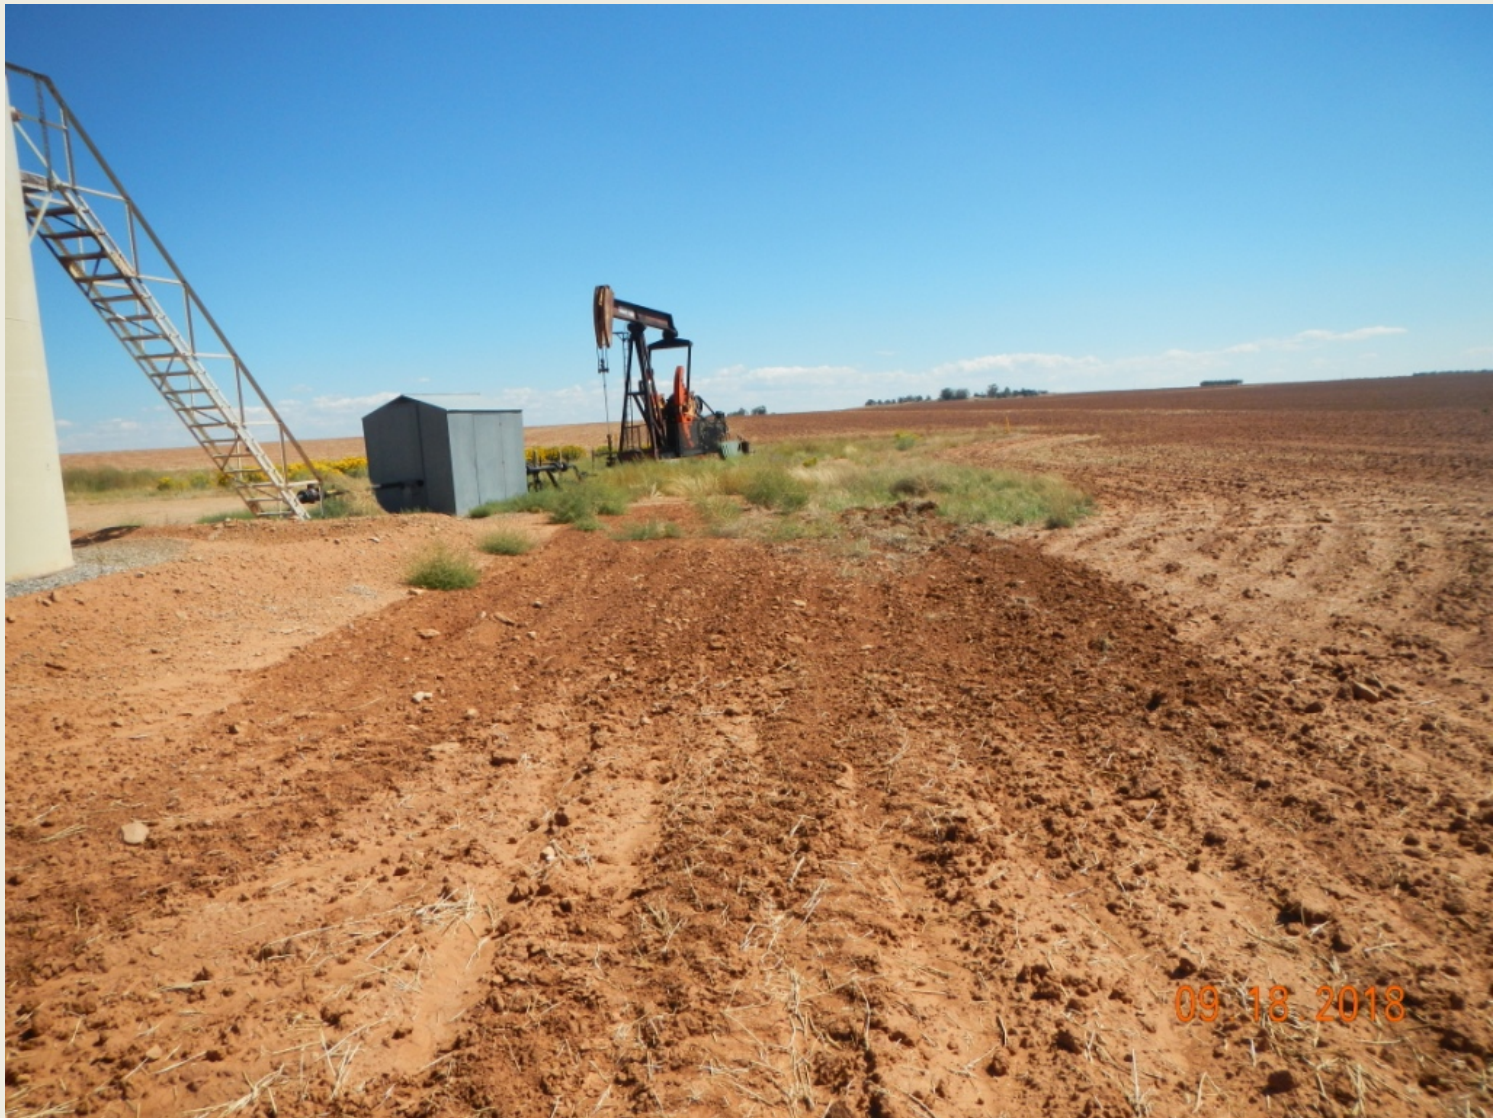
Photo 3. View of the southern portion of the project area from the southwestern edge facing eastward.

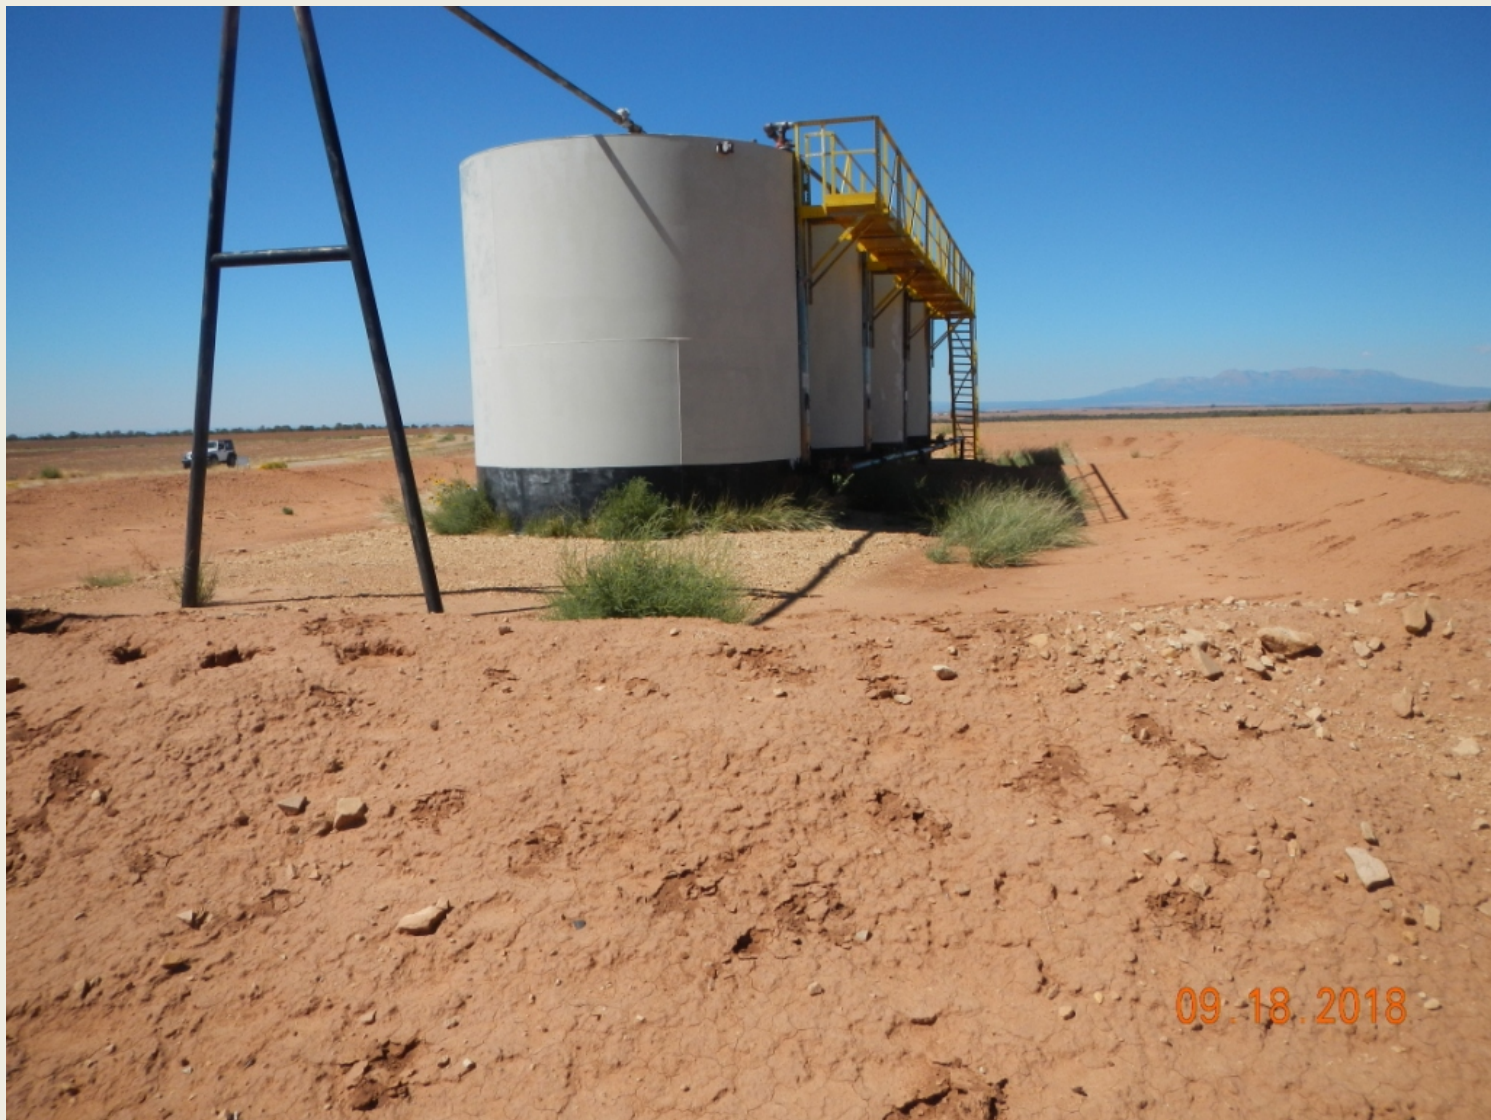
Photo 4. View of tanks in the northeastern project area.

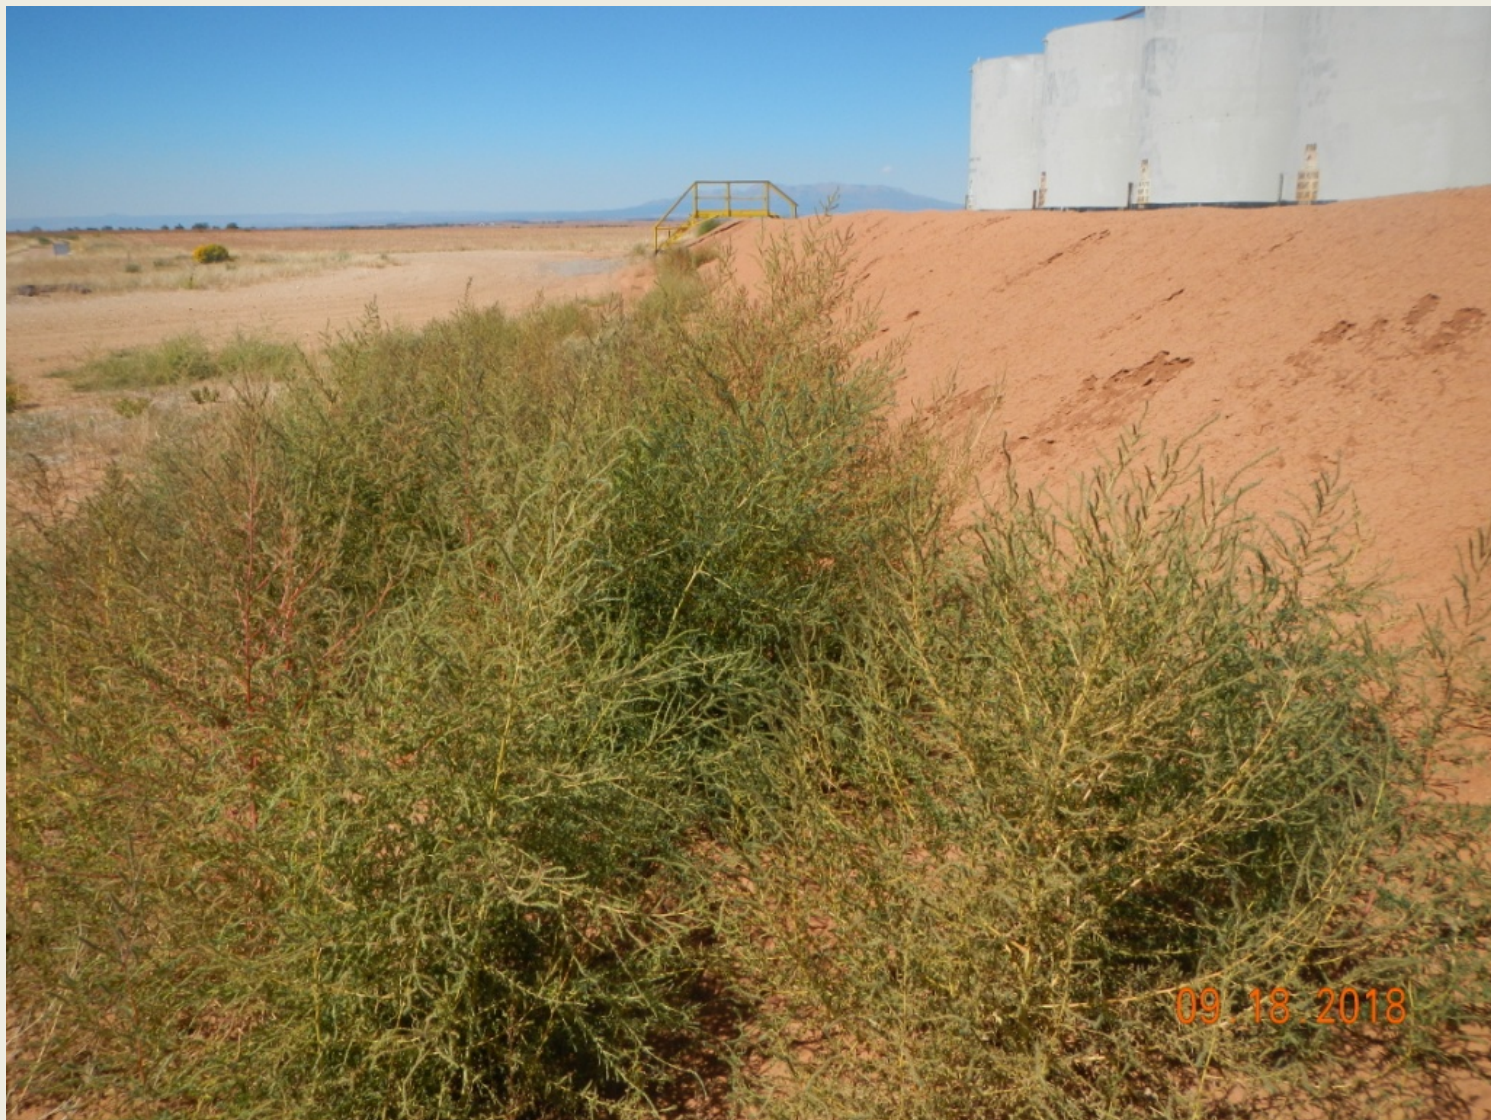
Photo 5. View of tall kochia plants (*Kochia scoparia*) in the eastern project area. These should be removed as they will dry, break off, and become debris.
