Response to September 7, 2018 Inspection

COGCC conducted an inspection of the LG 09-03 pad (Location ID 456690) on September 7, 2018 (Document 682503854). During that inspection, COGCC made the following observations:

Photo log for Response to September 7, 2018 Inspection

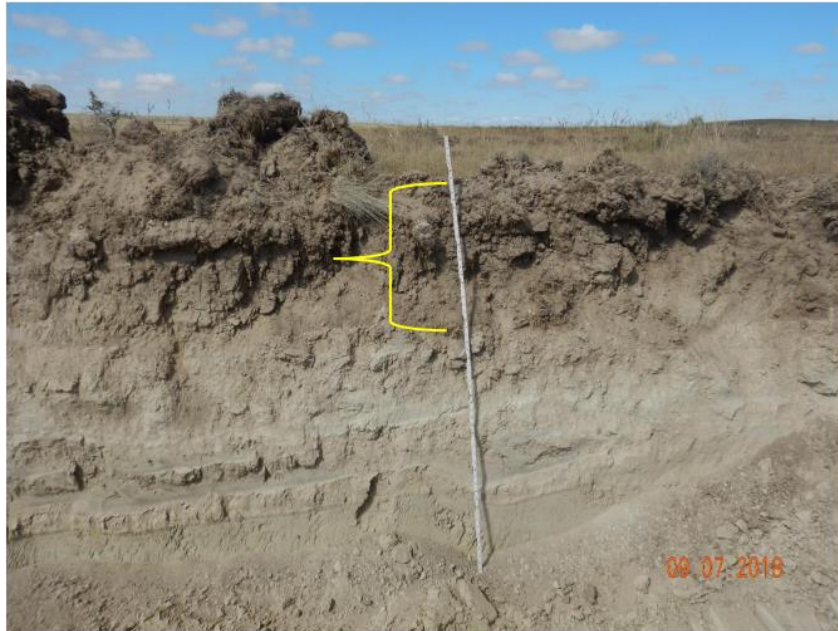
Topsoil comment 1: “It does not appear as though sufficient topsoil salvage on the location has been conducted. Contractors performing soil salvage and construction indicate that “~4-6 inches of topsoil” was salvaged and stored on the northeast end of the location. Contractor indicated that no additional topsoil salvage was planned. COGCC rule 1002.b.(2) requires that “operator shall separate and store the topsoil horizon or the top six (6) inches, whichever is deeper....”. Topsoil can still be observed on areas of surface of the the pad. A topsoil depth of ~2 feet was observed durring inspection.”

Photo 4: Photo taken from the northwest corner of the pad. Photo shows the topsoil horizon. Topsoil horizon appears to be ~2 feet in depth. 6 foot measuring stick for reference.

Response 1: Noble assessed the depth of topsoil on the LG 09-03 pad by potholing in the north, south, east, and west (See photos NBL1 through NBL4). The average depth of topsoil based on Noble’s four measurements was approximately 15.5 inches. The size of the pad area where Noble removed topsoil is approximately 400 feet by 500 feet. Noble measured the topsoil pile and estimates it contains approximately 162,000 cubic feet of topsoil. In addition, Noble is implementing enhanced procedures for evaluating topsoil depths and adequately segregating topsoil.

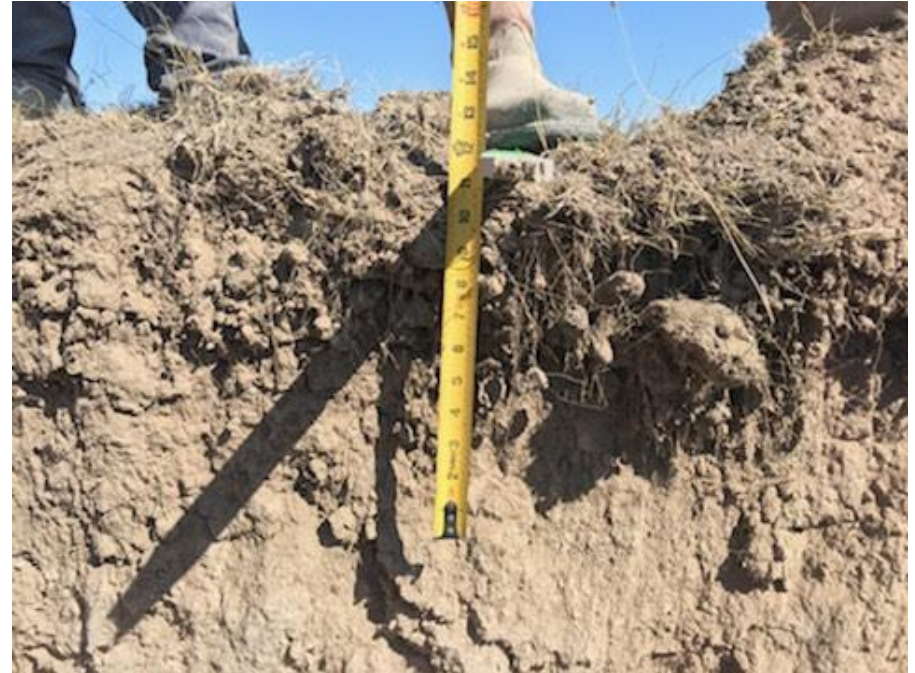
Photo NBL1. Southern pothole, showing topsoil depth

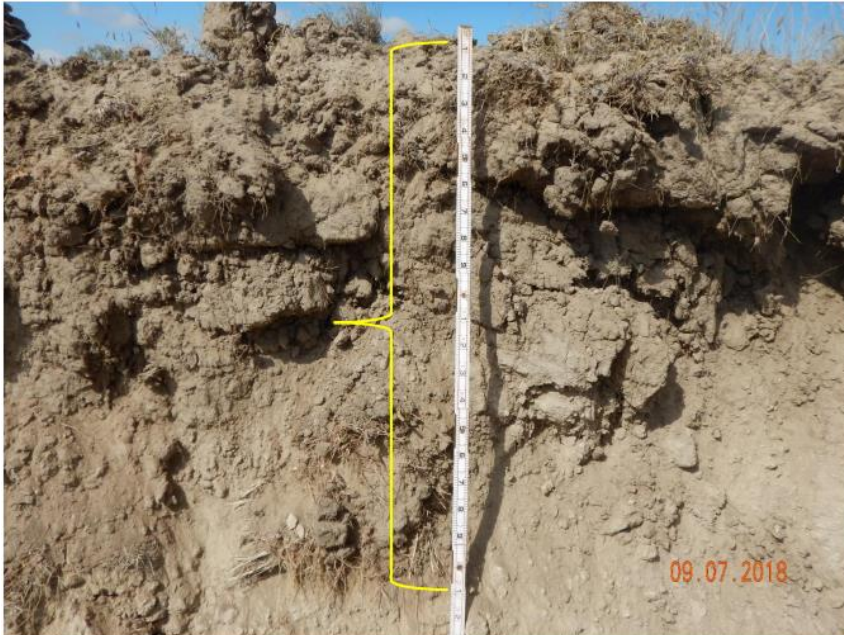
Photo 5: Continued from photo 4. Photo shows the topsoil horizon. Topsoil horizon appears to be ~2 feet in depth. 6 foot measuring stick for reference.

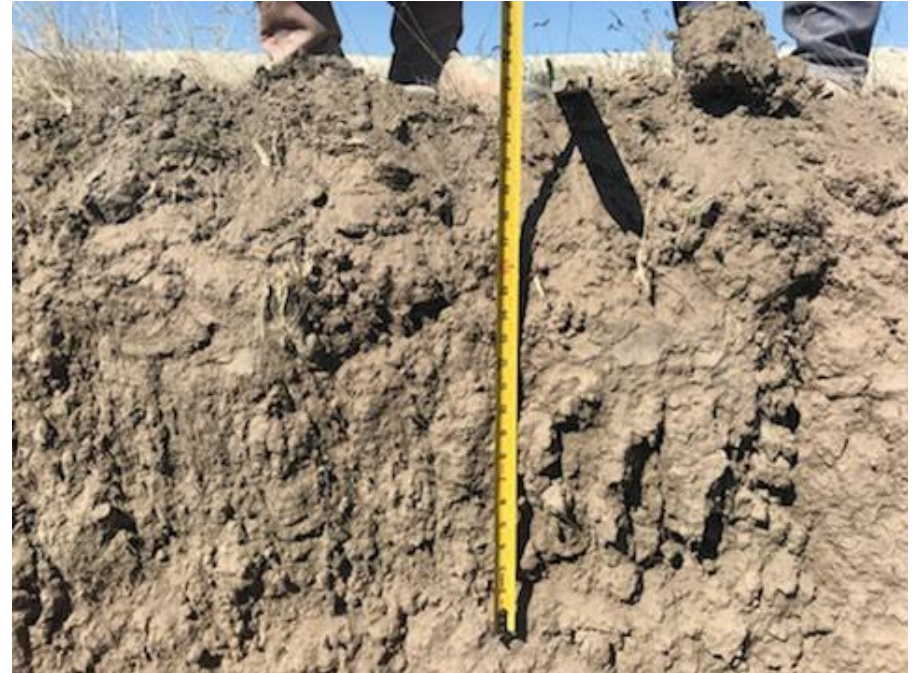
Photo NBL2. Western pothole, showing topsoil depth

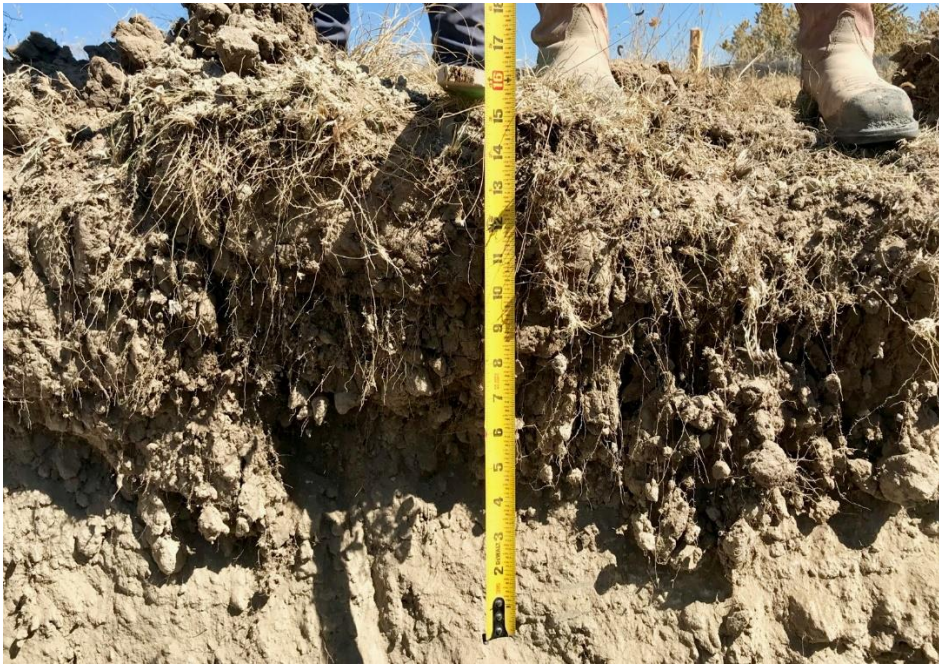
Photo NBL3. Eastern pothole, showing topsoil depth

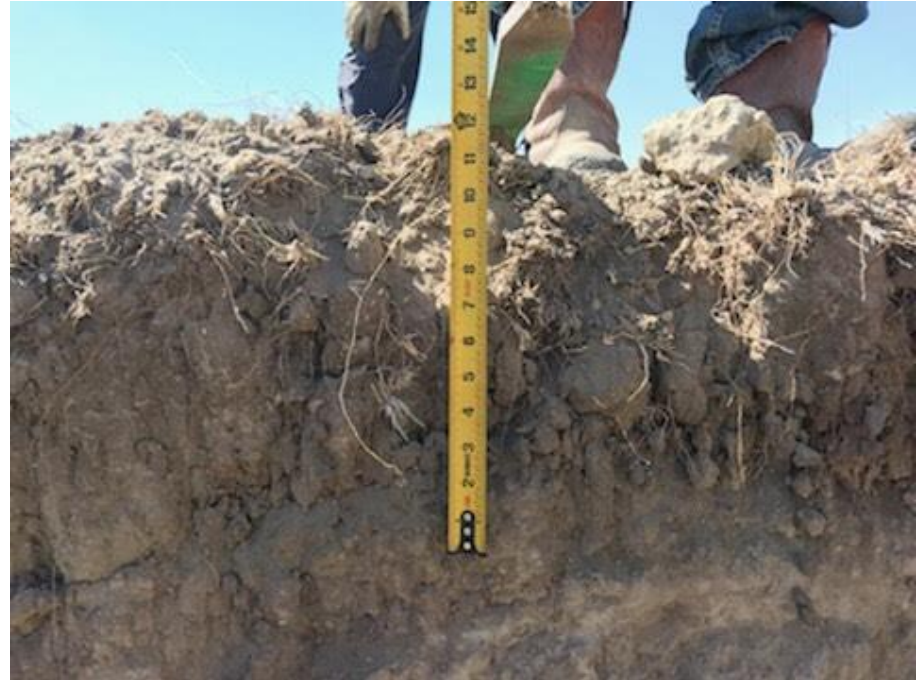
Photo NBL4. Northern topsoil pothole, showing topsoil depth

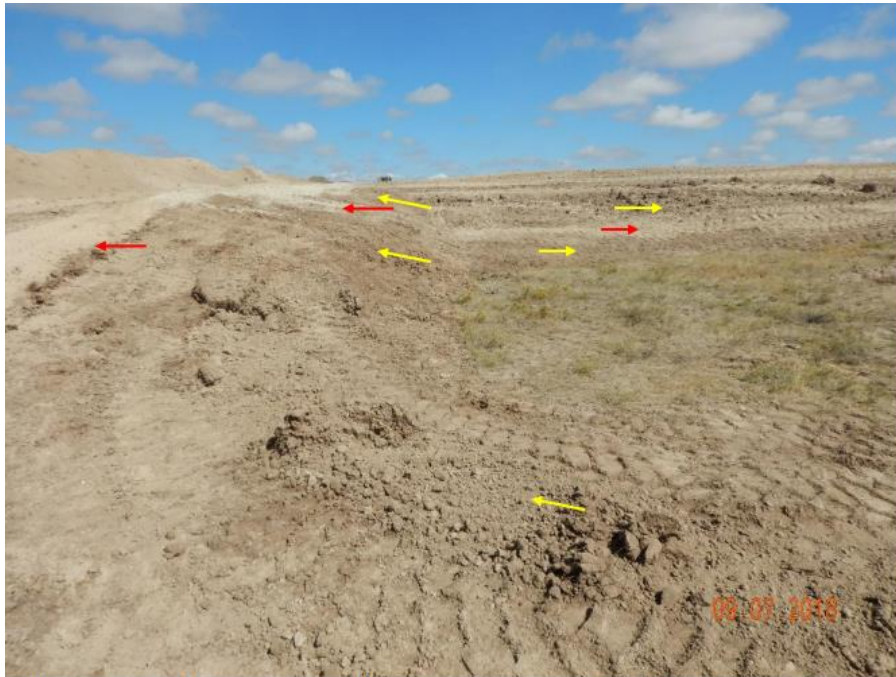
Topsoil comment 2: “It does not appear as though topsoil has been salvaged from the fill areas on the south, southwest ends of the location. It does not appear as though soils are being separated. Topsoil appears to be mixing w/subsoils on the fill areas of the pad. Additionally, it also appears as though topsoil is being used and incorporated as fill material. See photo 10 in the attached photo document.”

Topsoil comment 3: “It does not appear as though soils are being separated. Topsoil appears to be mixing w/subsoils on the fill areas of the pad. Additionally, it also appears as though topsoil is being used and incorporated as fill material. See photo 10 in the attached photo document.”

Photo 10: Photo taken from the southwest end of the pad. Photo shows construction in process. It does not appear as though soil salvage has been conducted on this section of the location. Additionally, it is unclear how the horizons are being separated as topsoil (dark soils, yellow arrow) appears to be mixing with subsoils (Light, red arrow). TOPSOIL APPEARS TO BE BEING USED AND INCORPORATED AS FILL MATERIAL.

Response 2: The area shown in Photo 10 is not a part of the pad, but is an area adjacent to the pad where a temporary ramp was built. The ramp provided access to the southwest portion of the pad so that topsoil could be removed and stored. Imported fill was used to build the ramp; topsoil was not used to construct the ramp. Fill was placed on top of the existing topsoil. Topsoil was not removed from this area because Noble believed that removal of the topsoil and disturbance of the surrounding vegetation and topsoil would cause more damage than placing and removing fill material for the short duration that the ramp was needed. Noble has since removed the ramp. Photo NBL5 provides annotations showing the layout of the ramp, pad, and undisturbed area.

Response 3: As in Response 2, imported fill material was used to construct a ramp so that topsoil could be removed from the pad footprint. The fill material was not mixed into the topsoil and was later removed once the ramp was no longer necessary.

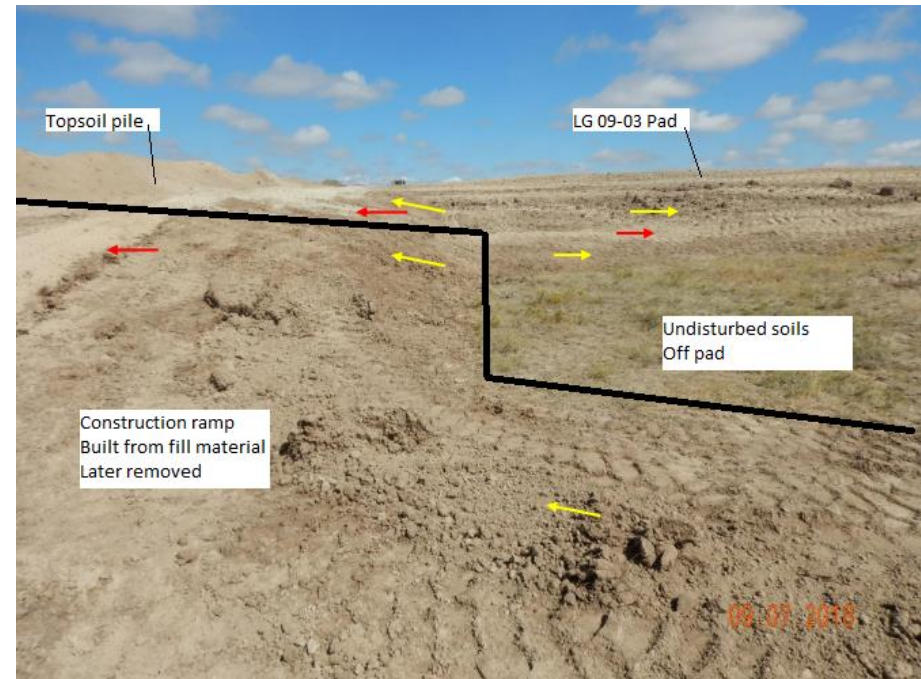
Photo NBL5. A temporary ramp was constructed from fill material to allow access to the pad for topsoil removal and segregation. Once complete, the fill material was removed. It was not incorporated into the topsoil.

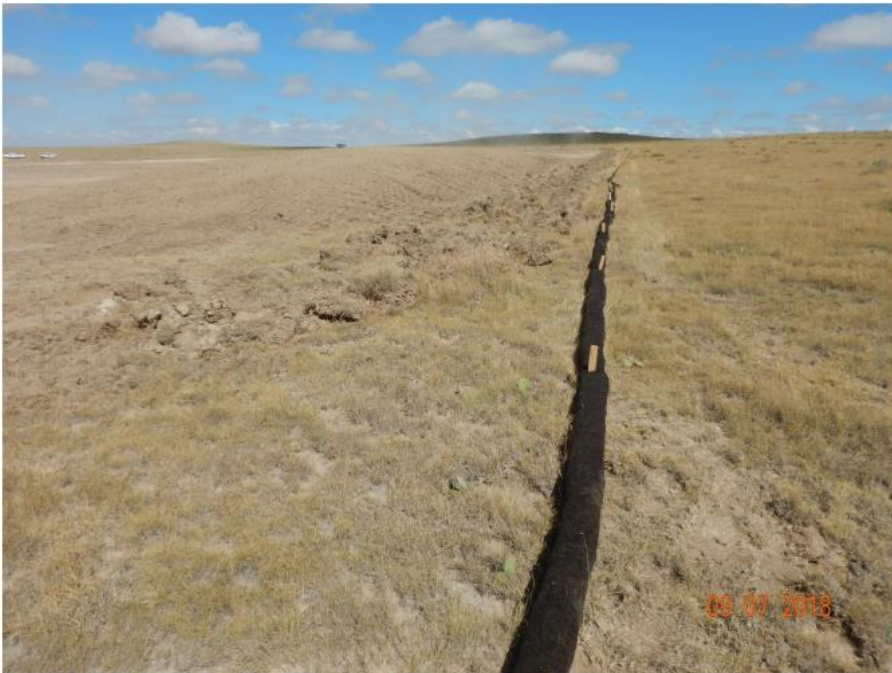
Photo 12: Photo taken from the northeast corner of the location, facing north. Photo shows topsoil stockpile for the location. Contractors performing soil salvage and construction indicate that "~4-6 inches of topsoil" was salvaged and stored on the southeast end of the location. It does not appear as though sufficient topsoil salvage has been conducted on the location.

COGCC was on-site during topsoil removal. Topsoil removal was not complete at the time the COGCC Inspector was on-site. As shown below, the topsoil pile is significantly larger than documented in COGCC Photo 12, and additional topsoil was removed from the area documented in COGCC Photo 13.

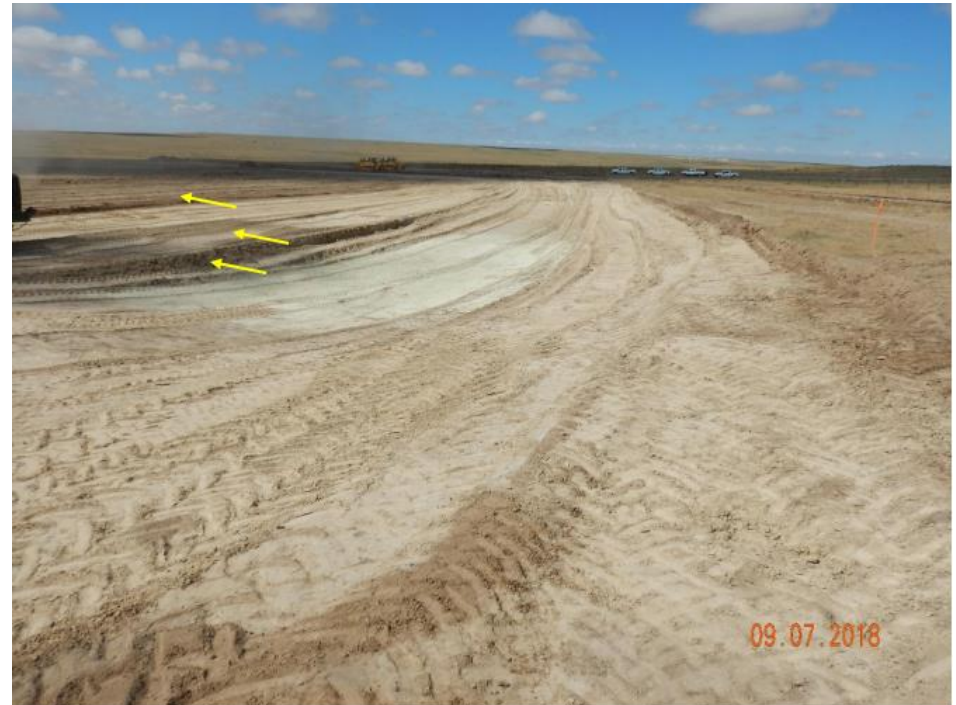
Photo 13: Photo taken from the southeast corner of the pad, facing west. Photo shows unsalvaged topsoil appears to remain on the pad.

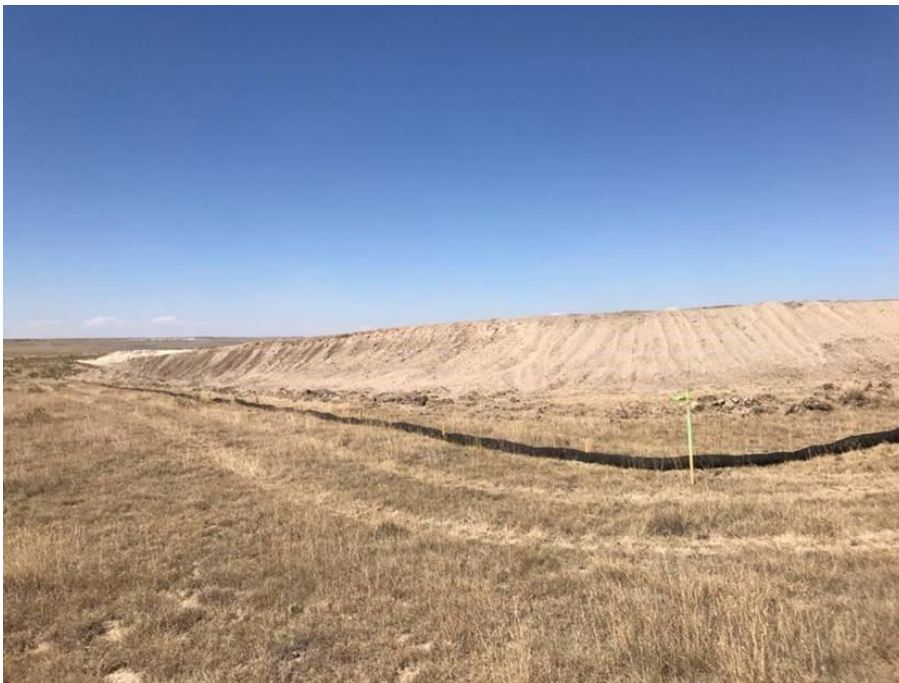
Photo NBL5. Topsoil stockpile in the southwest corner of the pad.

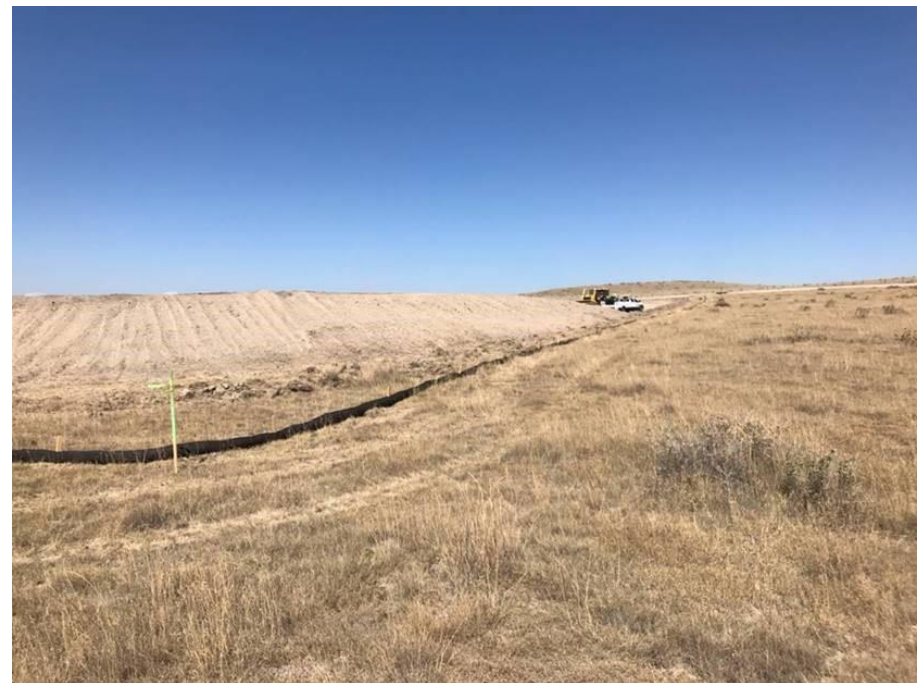
Photo NBL6. Topsoil stockpile in the southwest corner of the pad.

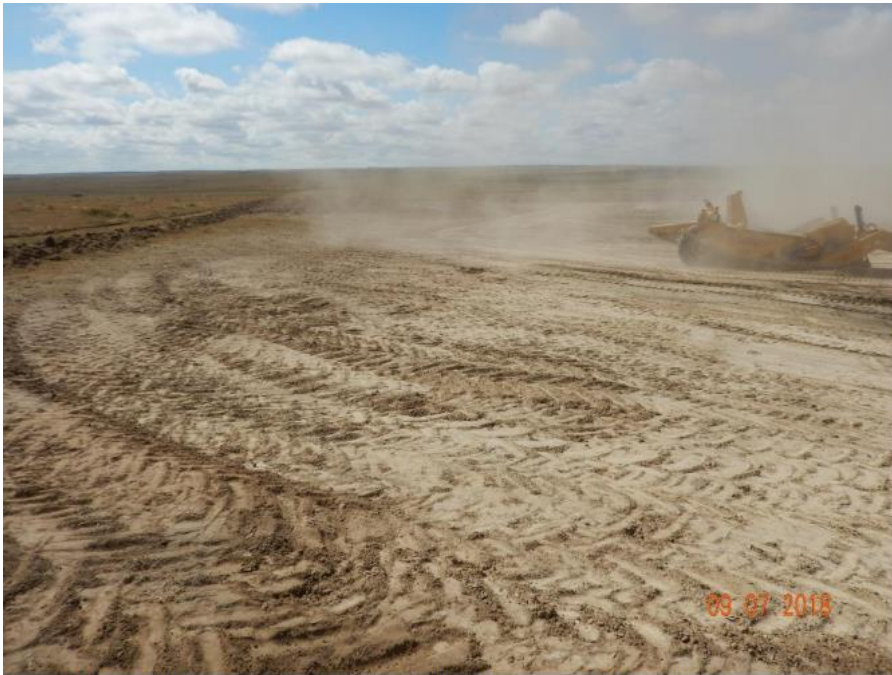
Photo 14: Photo taken from the southeast corner of the pad, facing south. Photo shows contractor scraping soil. Un-salvaged topsoil appears to remain on the pad. Upon contacting contractor operator scraper, inspector was told that topsoil salvage activities have been completed, and that no additional topsoil salvage was planned. Contractor was currently scraping soils to be used as fill material; IT APPEARS AS THOUGH TOPSOIL IS BEING USED AND INCORPORATED AS FILL MATERIAL. SEE PHOTO 10

Response (no photos): Noble was actively using scrapers to remove and segregate topsoil while the COGCC inspector was on-site (COGCC Photos 14 and 15). Topsoil was piled in the southeast corner of the pad, as COGCC observed. The pile was then recontoured to facilitate future maintenance, such as seeding, mulching, and mowing.

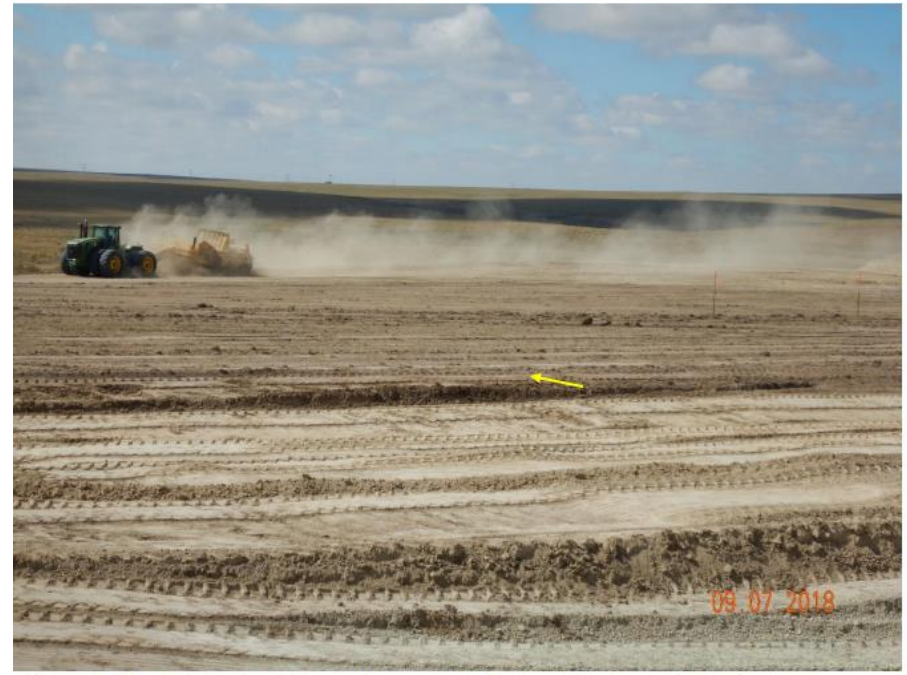
Photo 15: Photo taken from the northern area of the pad, facing south. Photo shows unsalvaged topsoil appears to remain on the pad.. It was observed that the scraper collected soils (photo 14) from areas of the pad for fill material on the southern end of the location; it appears as though topsoil is being incorporated with subsoils as fill material. See comments under photo 13 and 14
