Inspection Photos

Location Name: GMU-66S93W 26NENW Pad

Location ID: #335163

Inspection Date: September 25, 2018

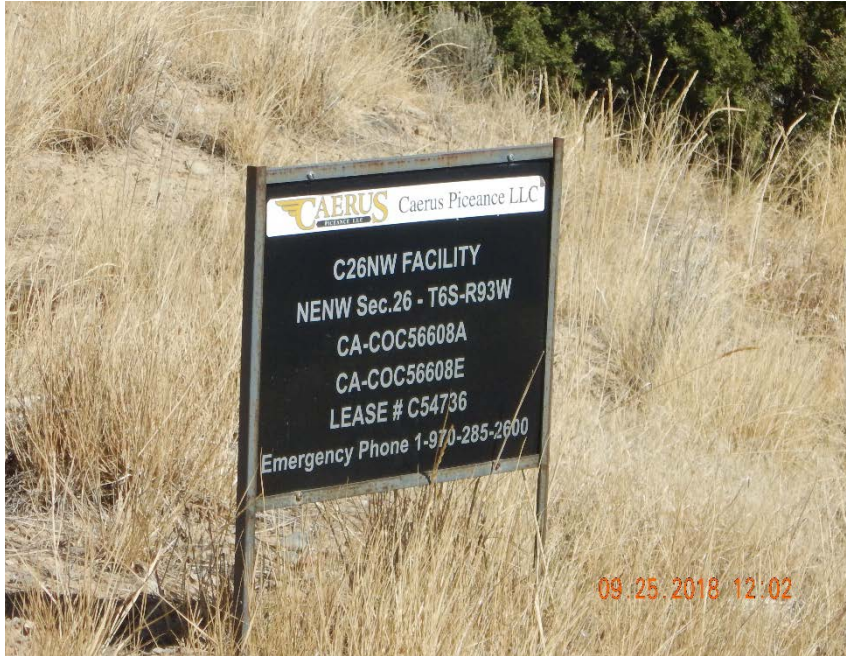
Photo #1 – Lease sign located at NE corner of pad.

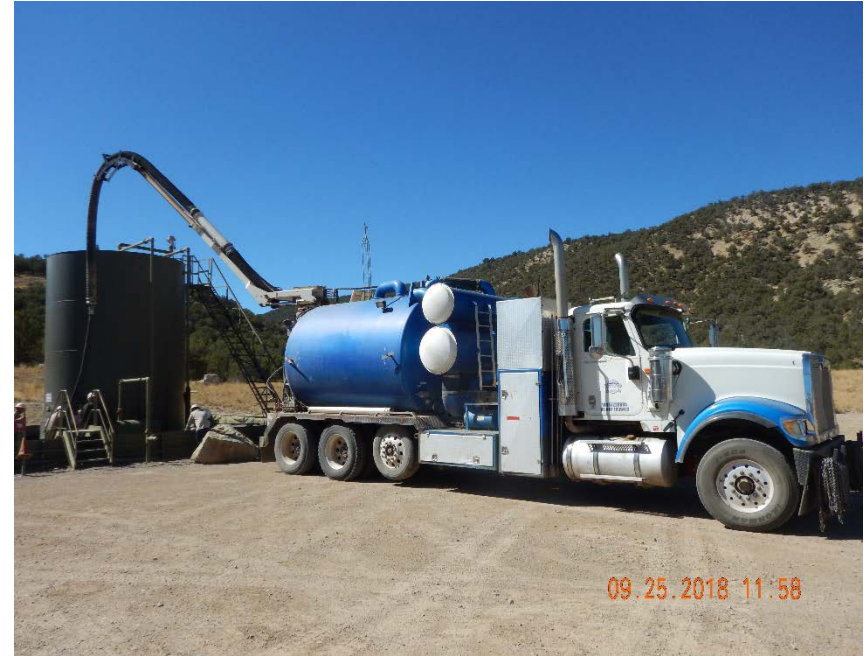
Photo #2 – Operator had vac truck on location during inspection.

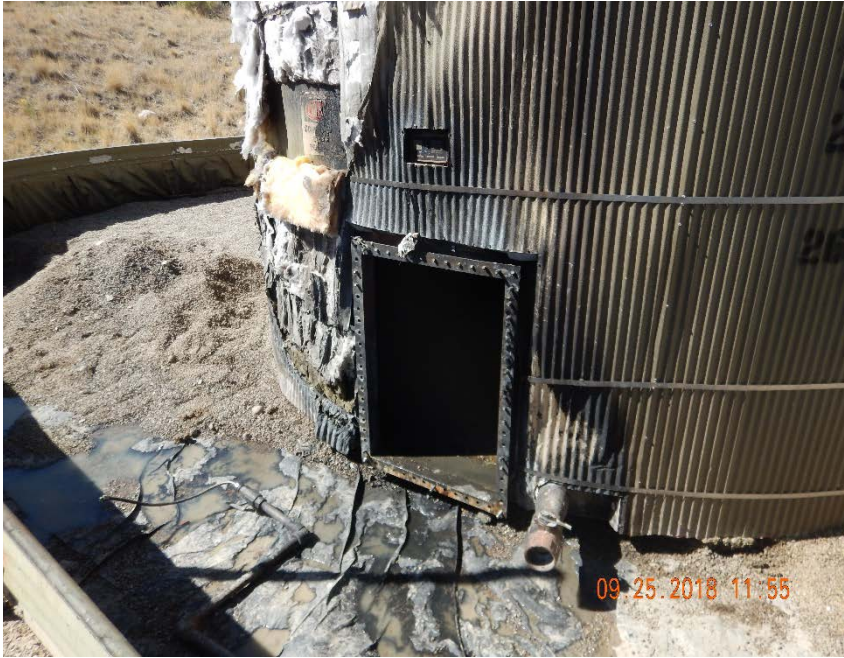
Photo #3 – View of impacted tank from NE corner.

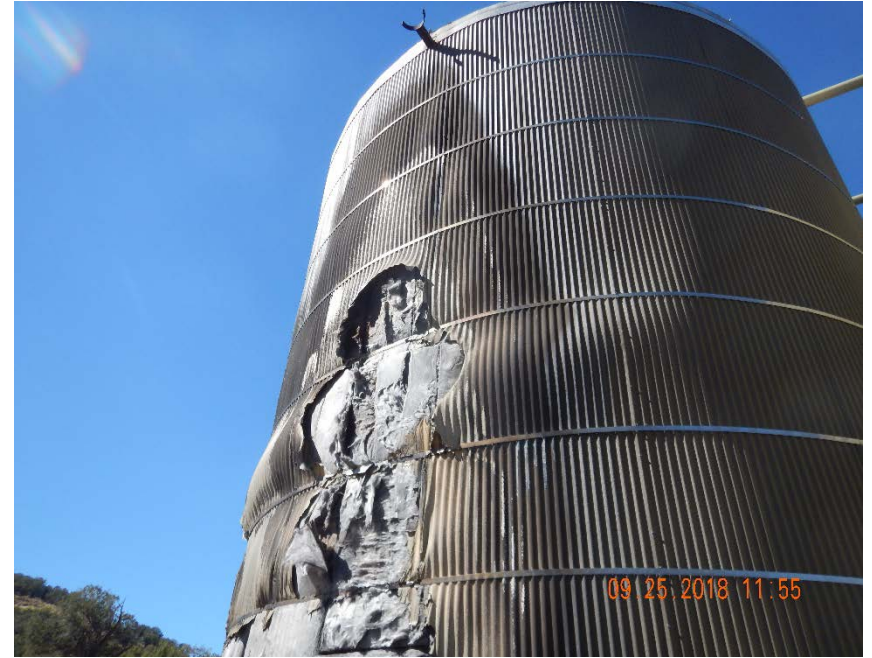
Photo #4 – Fire damage extending up the side of the impacted tank.

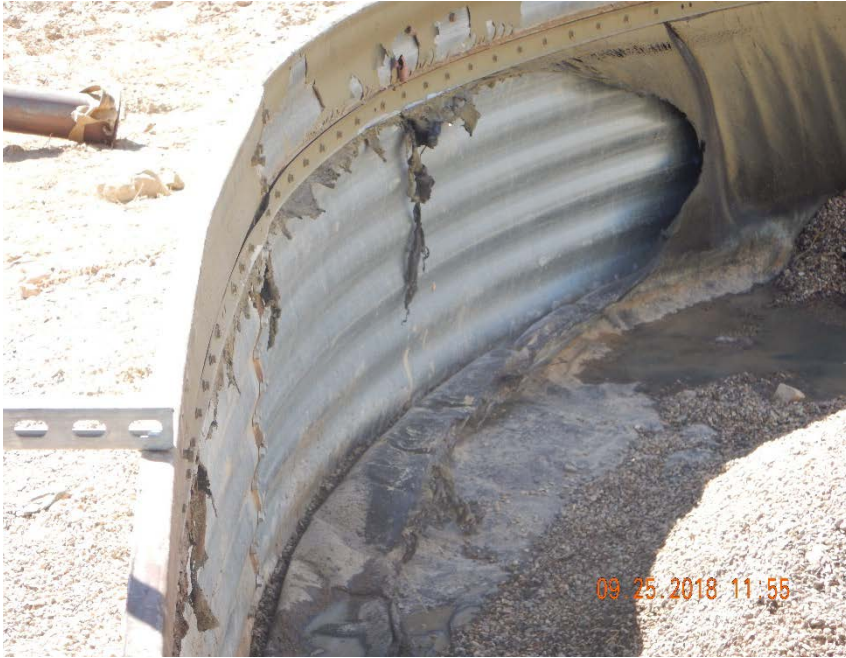
Photo #5 – Tank battery liner was compromised at SE corner due to fire damage.

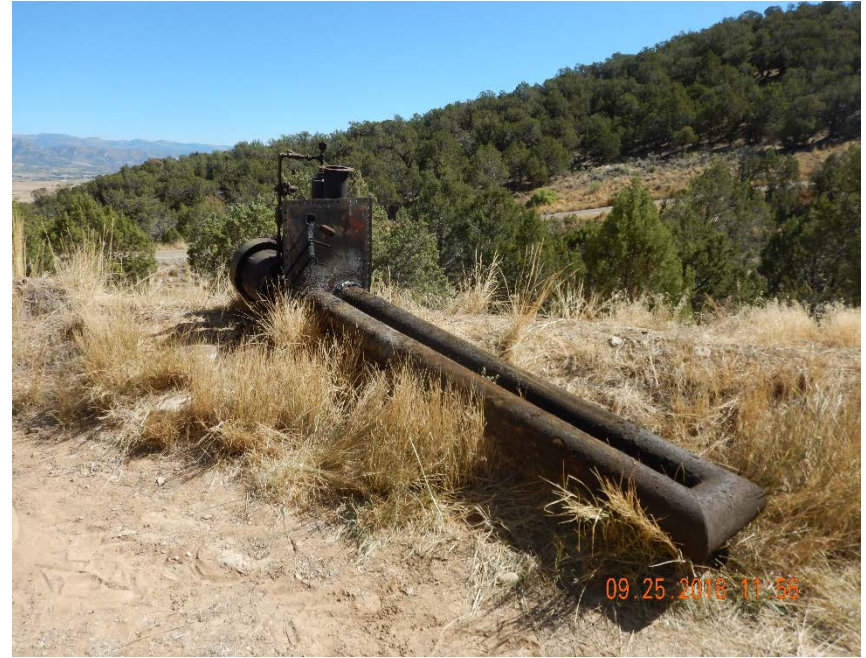
Photo #6 – Tank heater was pulled out of tank and being stored outside of tank battery berm on inspection date.
