Inspection Photos
Location Name: TEP 335123
9/19/2018

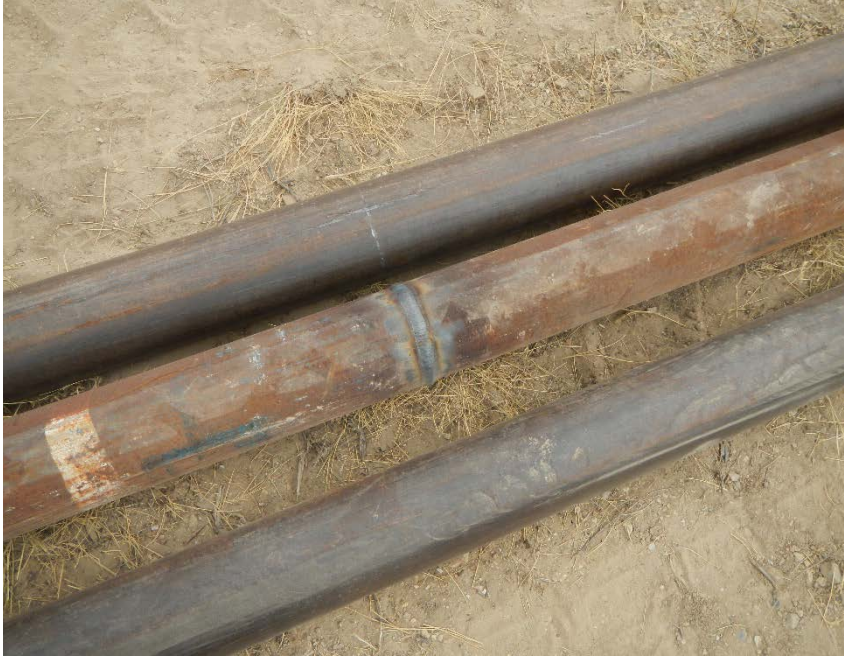
New welded pipeline segment

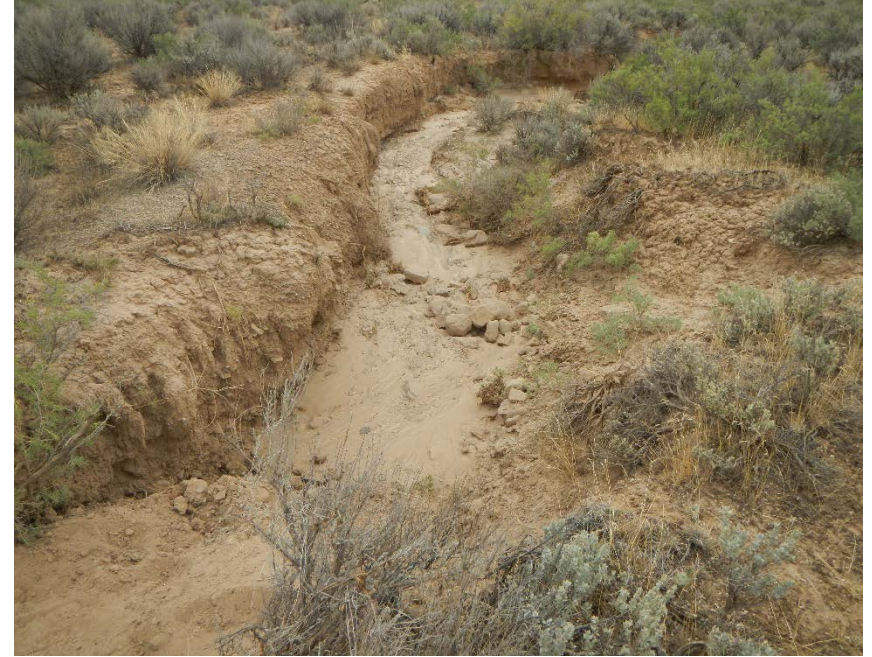
Dry soil below check dam looking SE

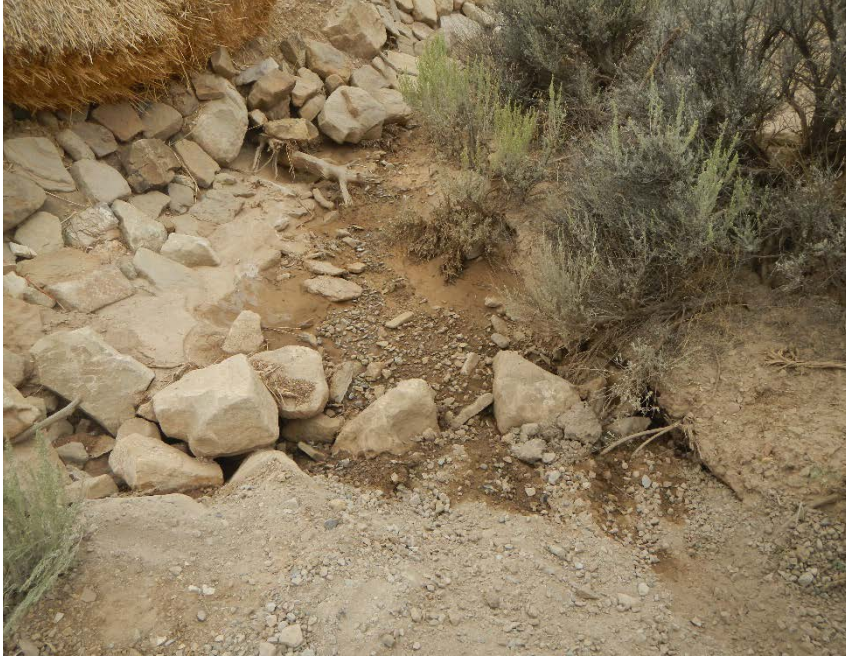
Wet soil above check dam looking NW

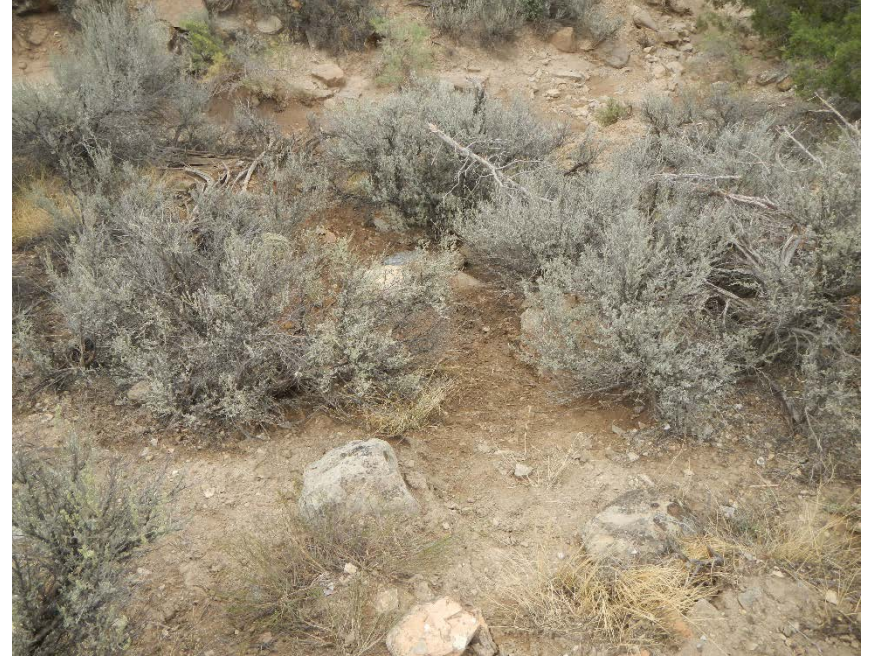
Release area to ditch looking NW
