**Inspection Photos**  
**Location Name: Champlin 367 Amoco 1**  
**Location ID: 318431**

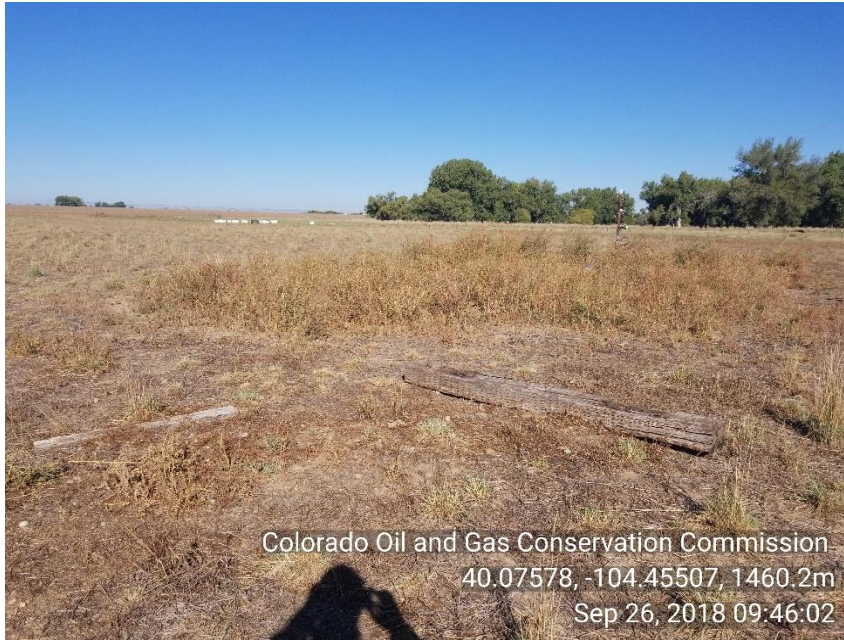
**Photo 3 old seals on loc**

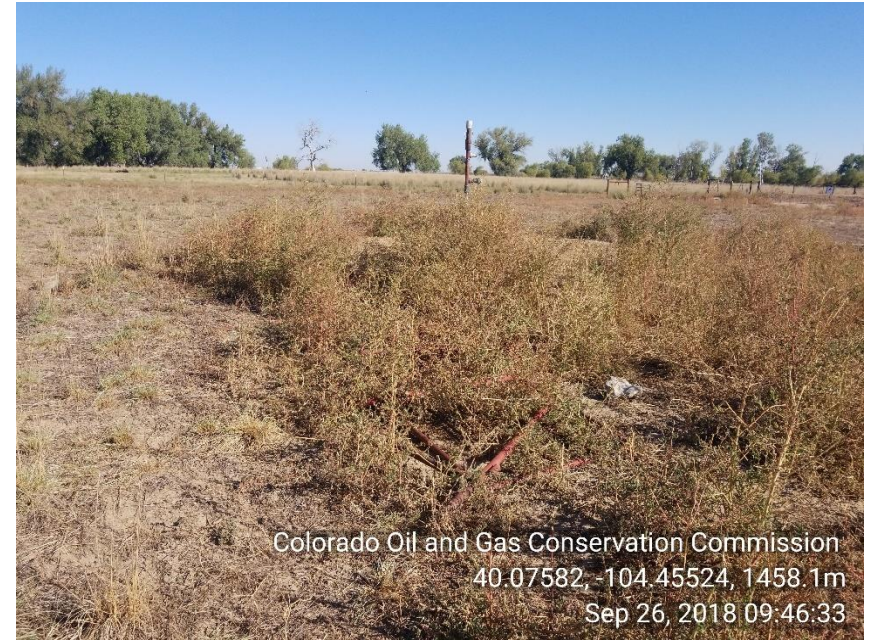
**Photo 4 old metal panels on loc**
