# Inspection Photos

Operator: Mobil Oil Corporation

API: 05-033-06101

Date: 9/18/2018

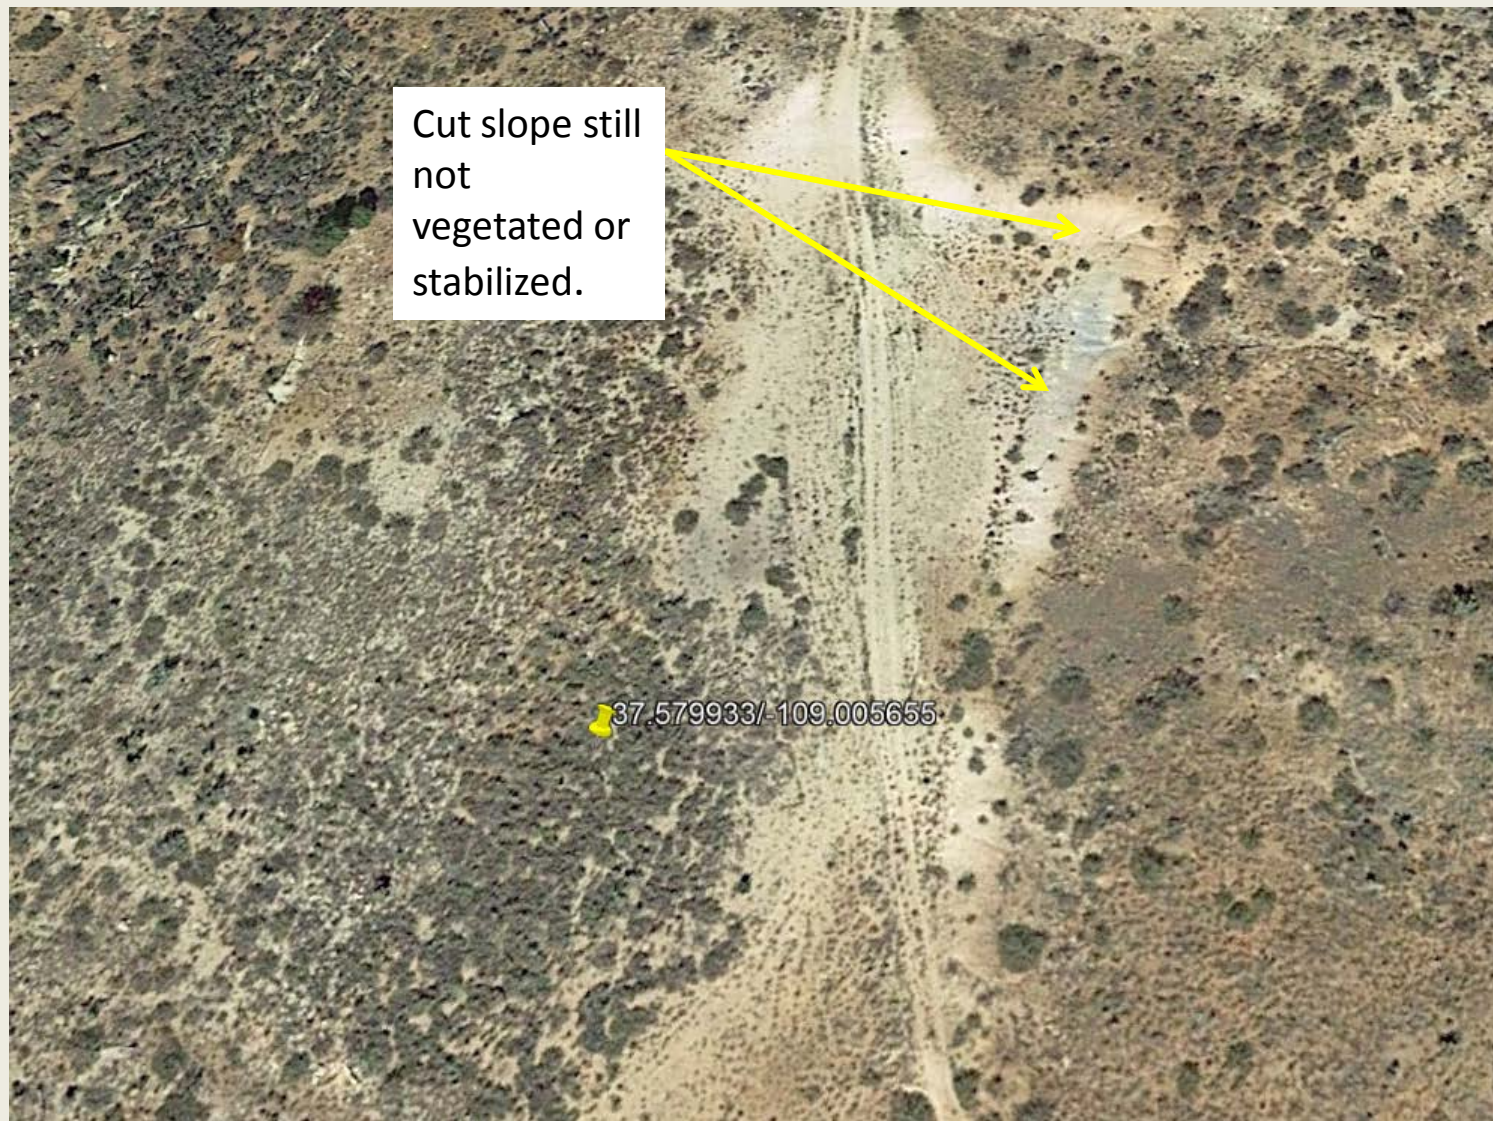
**Photo 1. Google Earth 2017 aerial view of the project area. Cut slopes are not stabilized or vegetated. Additional stabilization is needed before location can pass final reclamation.**

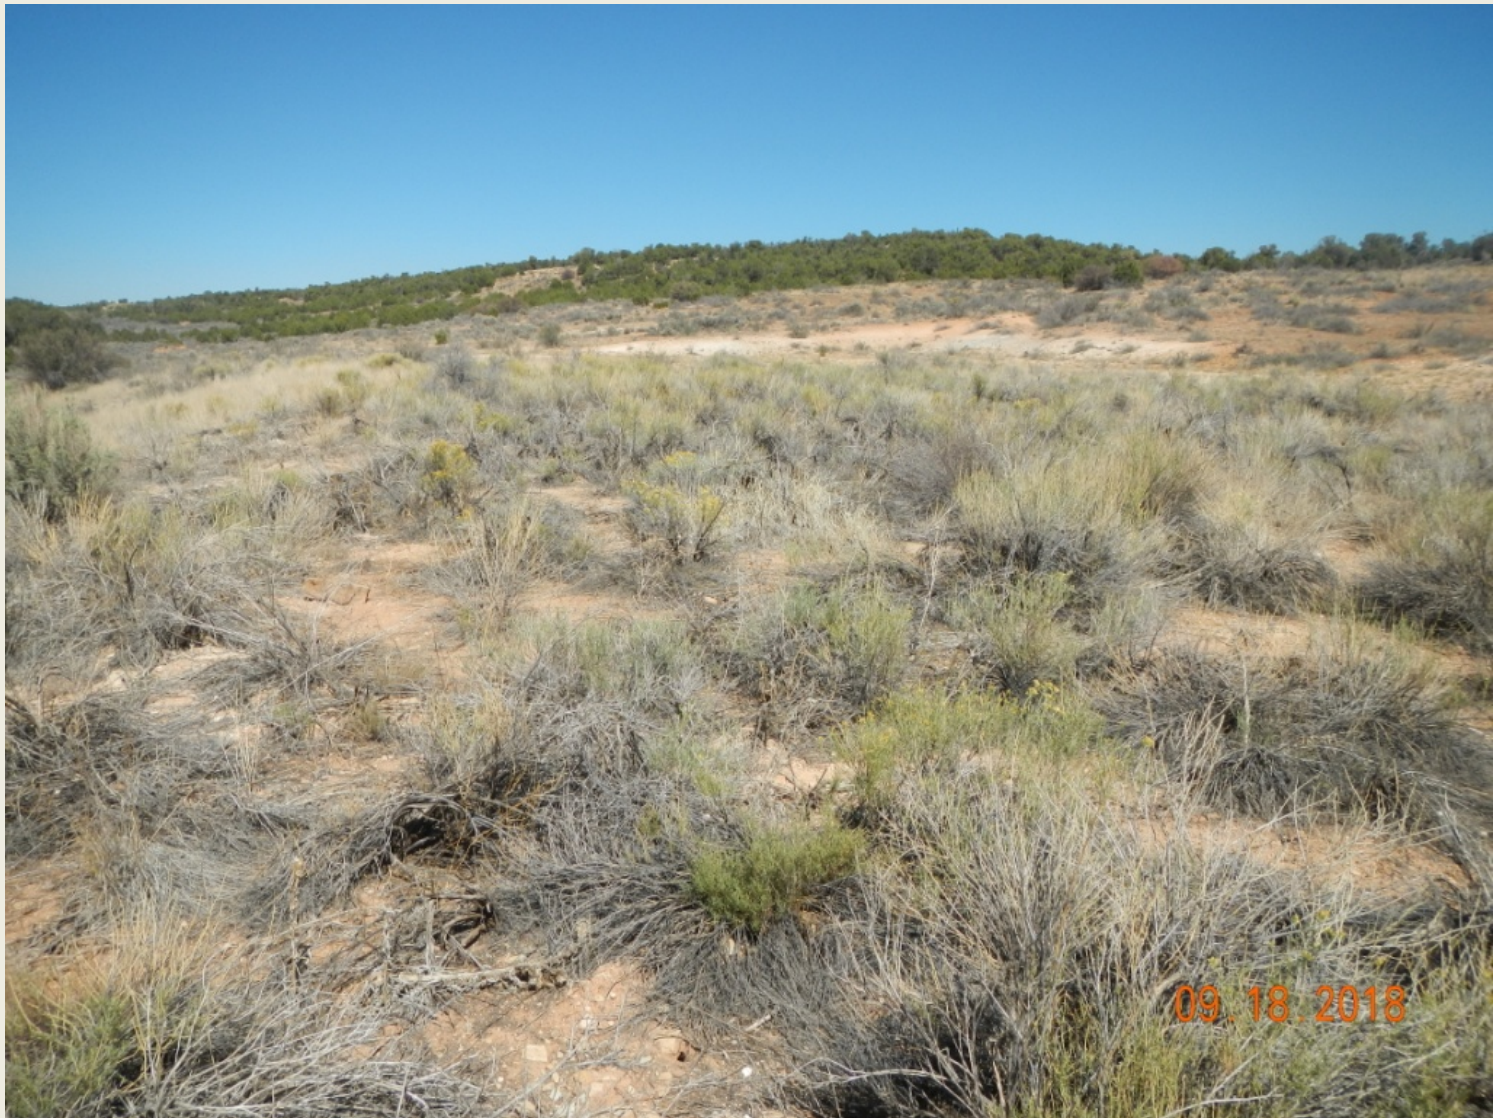
**Photo 2. View of the project area from the southwestern corner facing center. Revegetation is progressing with dense rabbitbrush (*Chrysothamnus nauseosus*) and sand dropseed (*Sporobolus cryptandrus*).**

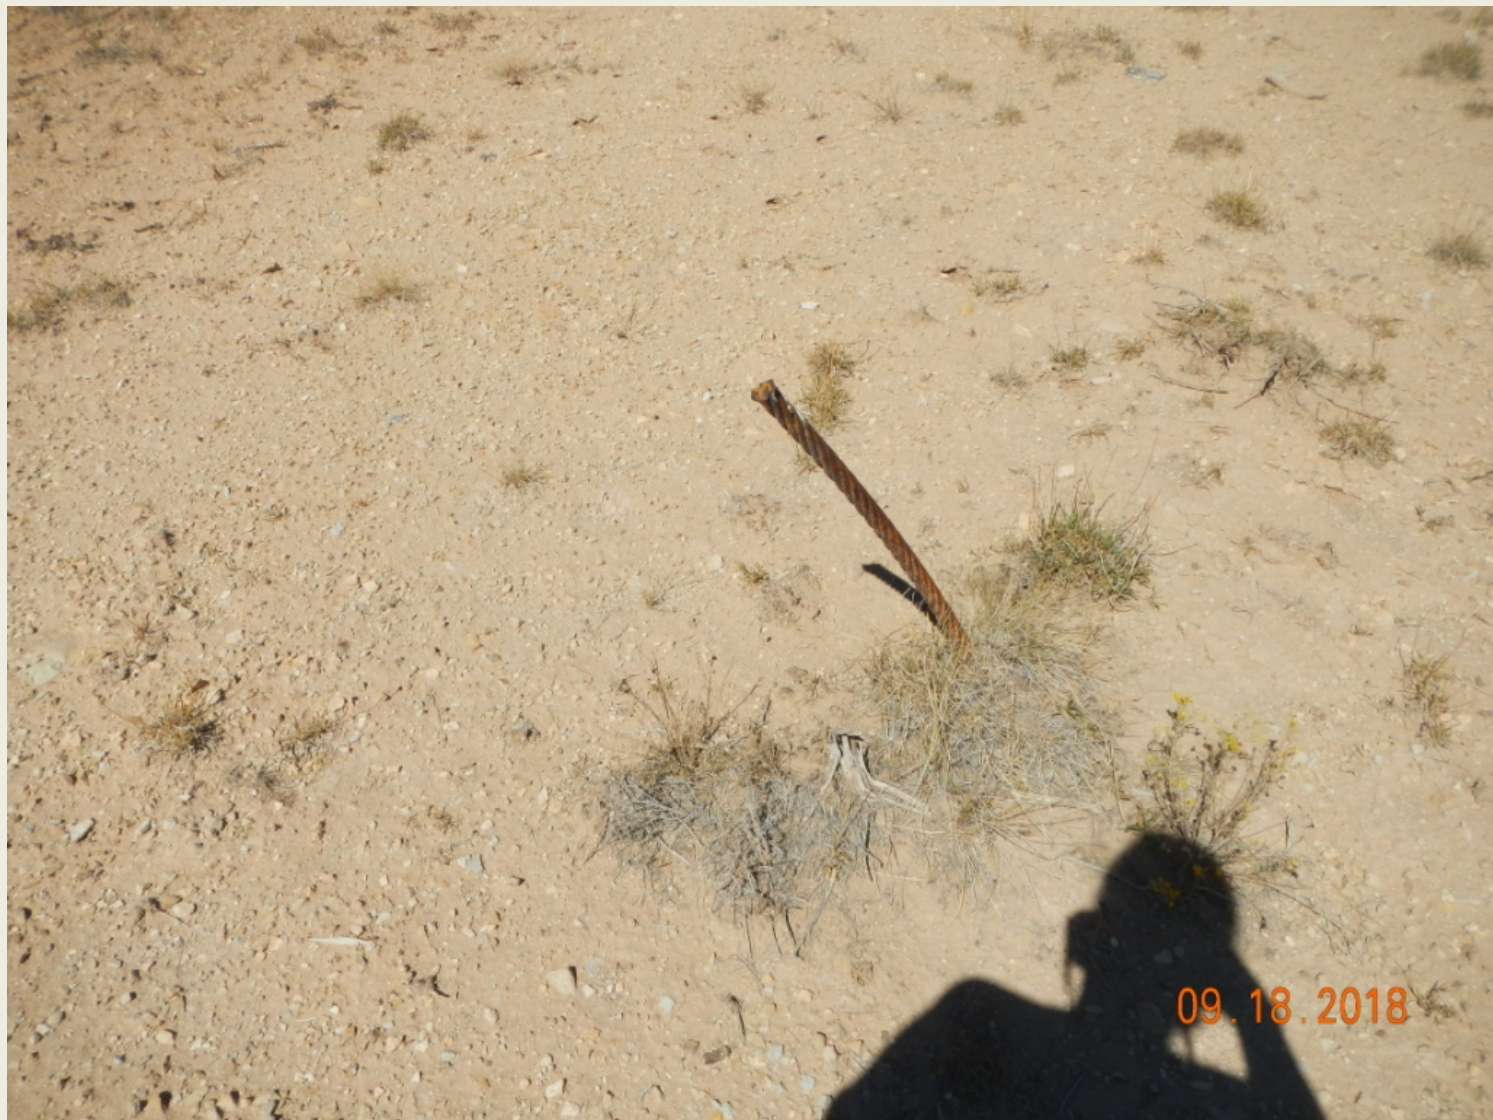
**Photo 5. View of anchor cable still in place. Two of these observed within the project area. Others may be present. These need to be removed along with anchors if still in place.**

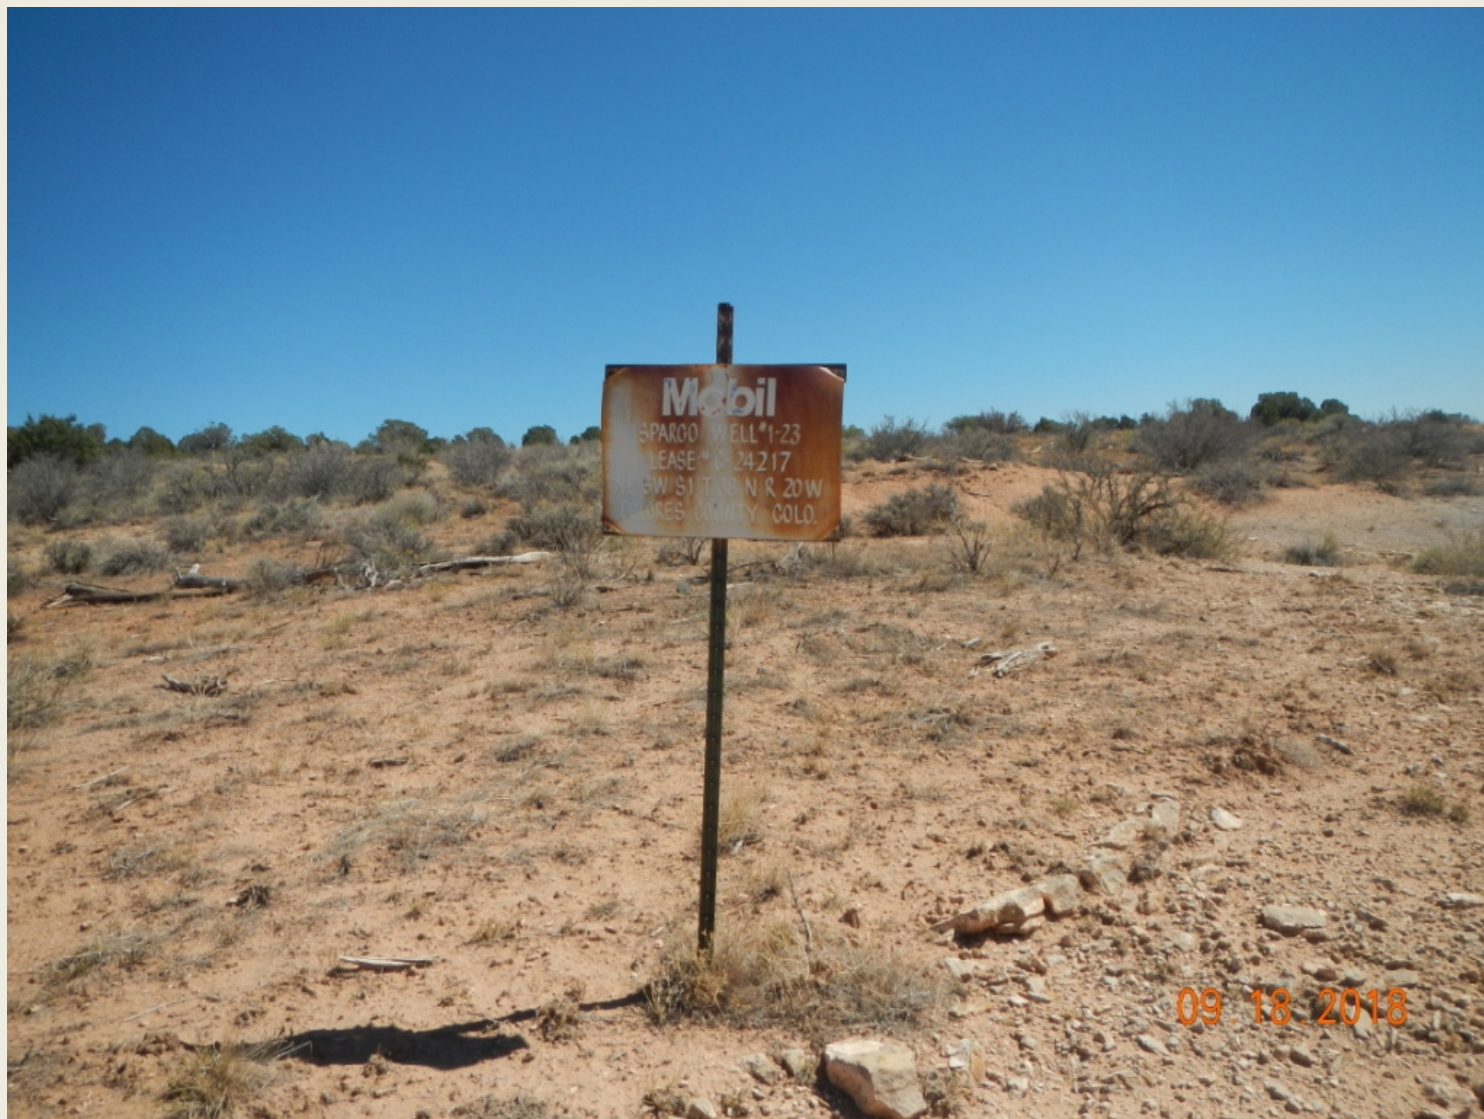
Photo 6. View of sign at the entrance of the well pad needs to be removed.

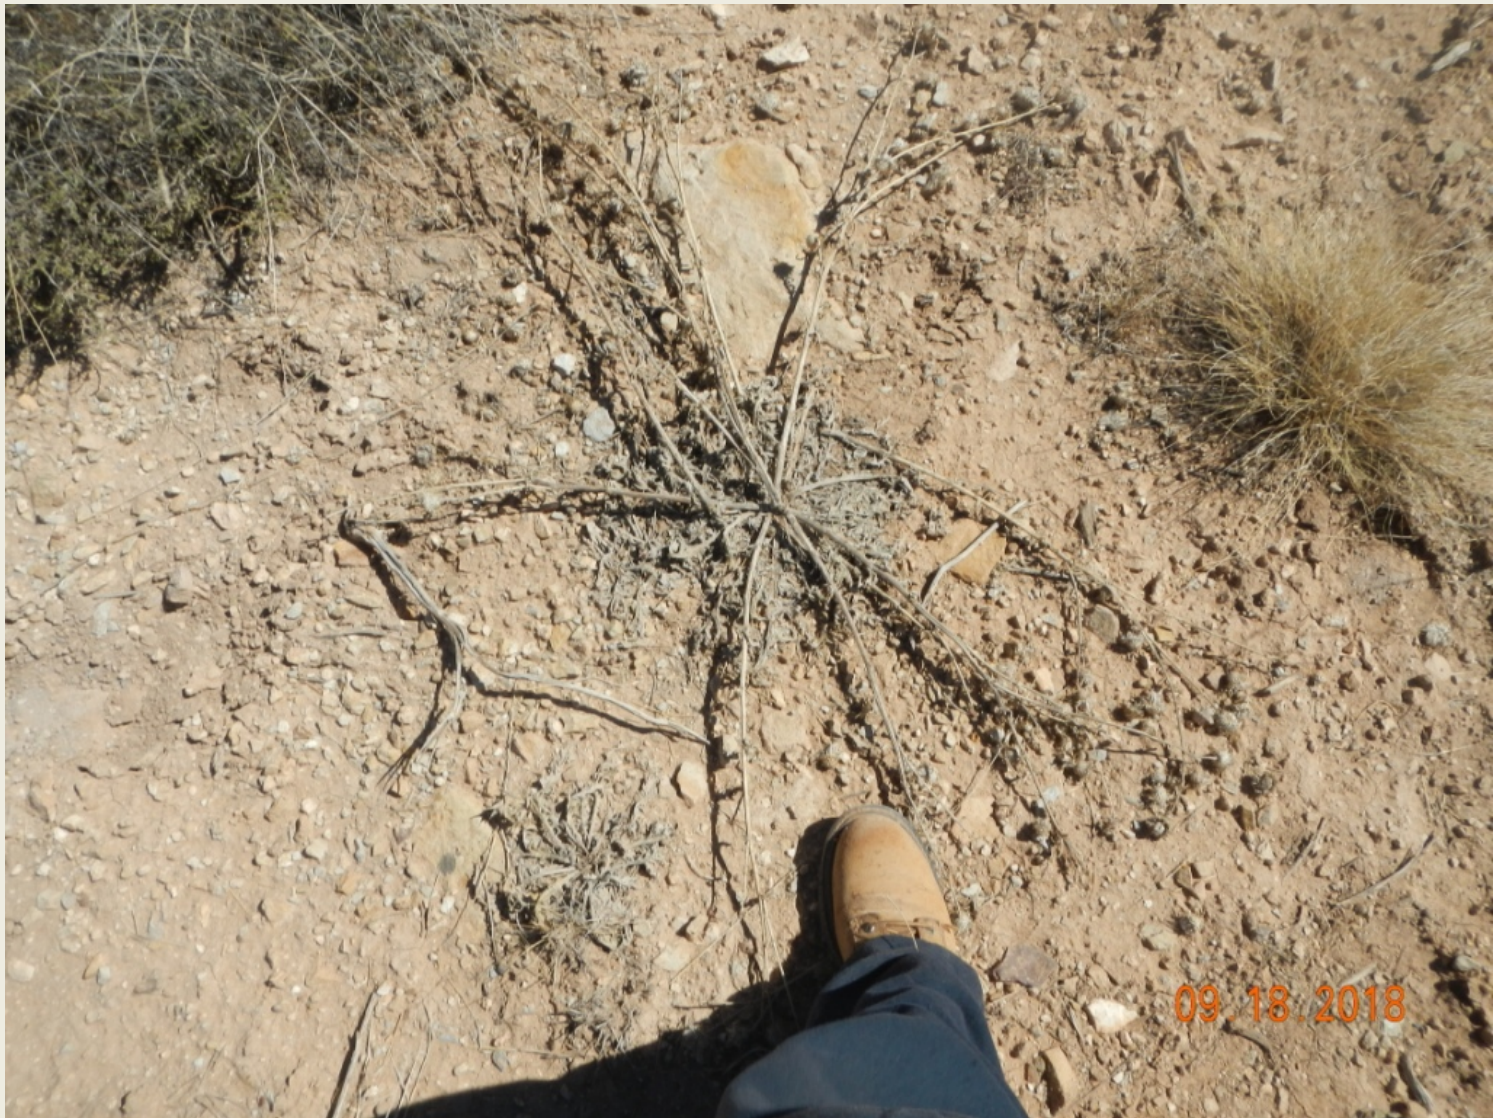
**Photo 7. View of what appears to be treated thistle within the project area.**
