# Construction and Stormwater Inspection

September 26, 2018

Operator: CCRP OPERATING INC- 10665

Location Name: True Ranch Fee /2326 East

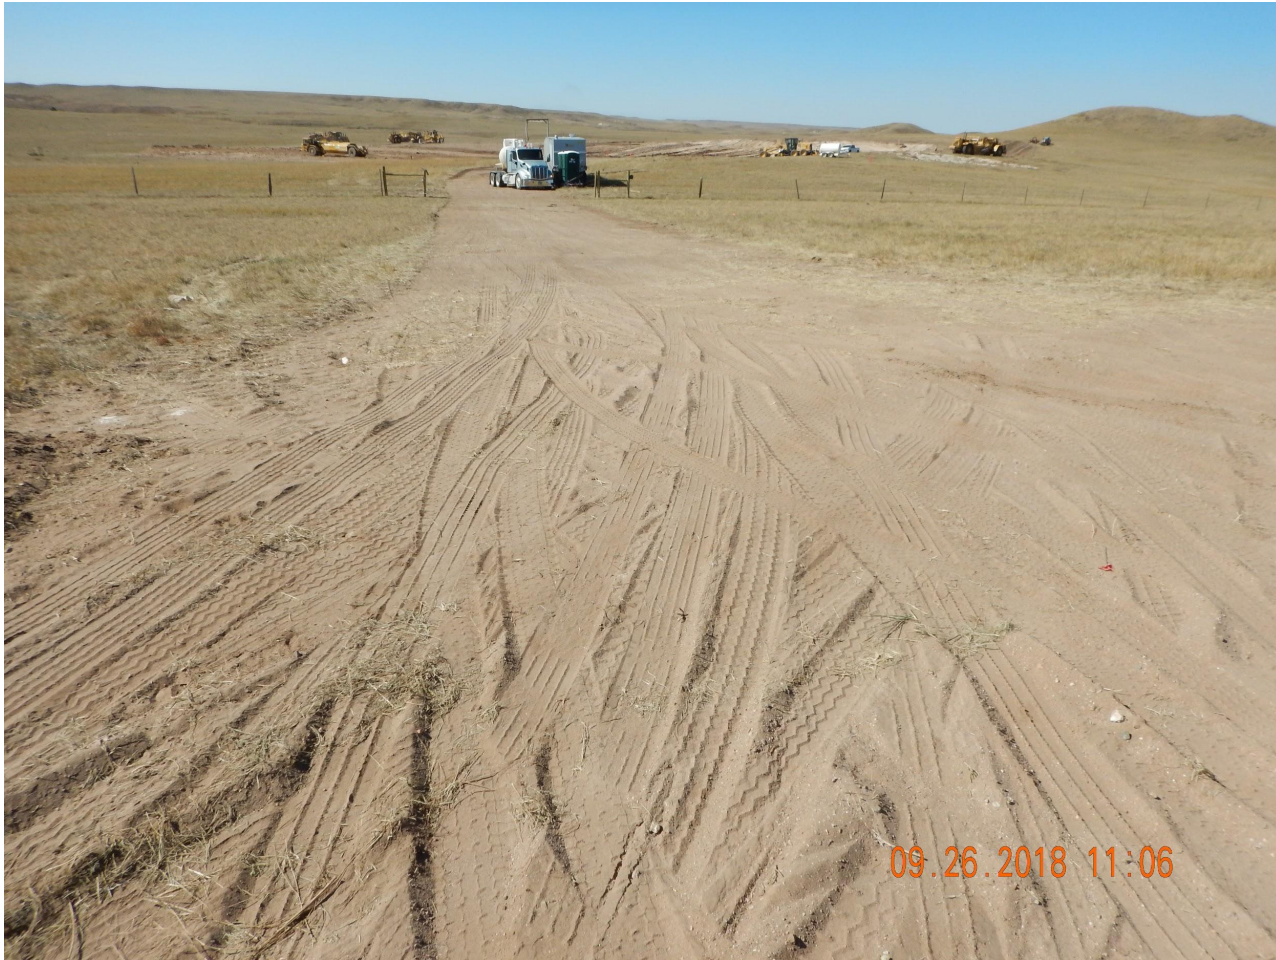
**Photo 1.** Photo taken from the entrance of the location, facing West. Operator plans to gravel the entrance to the well location to control for vehicle track out.

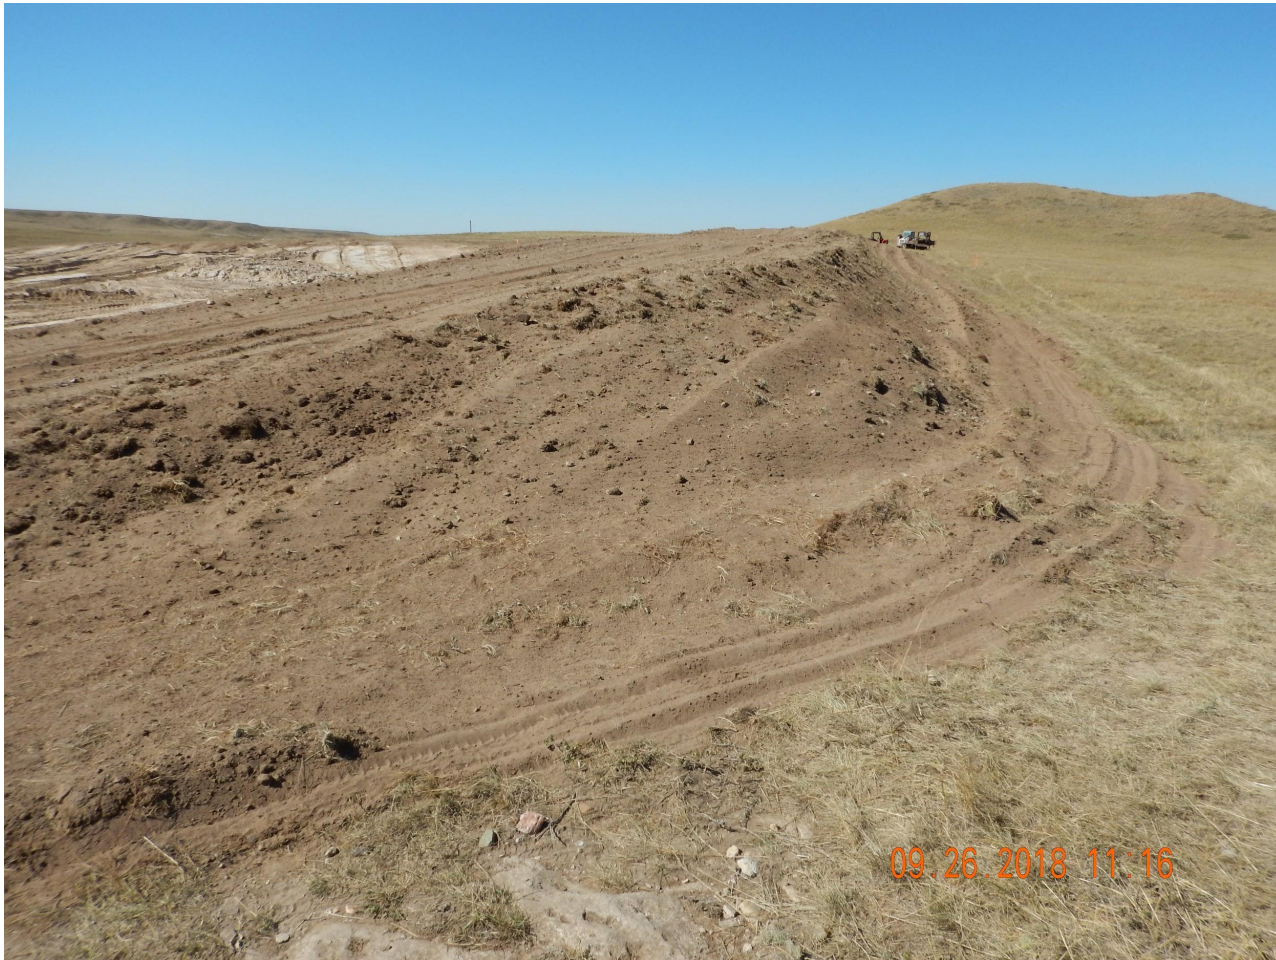
**Photo 2.** Photo taken from the northeastern perimeter of the location, facing West. Operator has salvaged and stored the topsoil along the northern perimeter. Operator plans to seed and mulch topsoil.

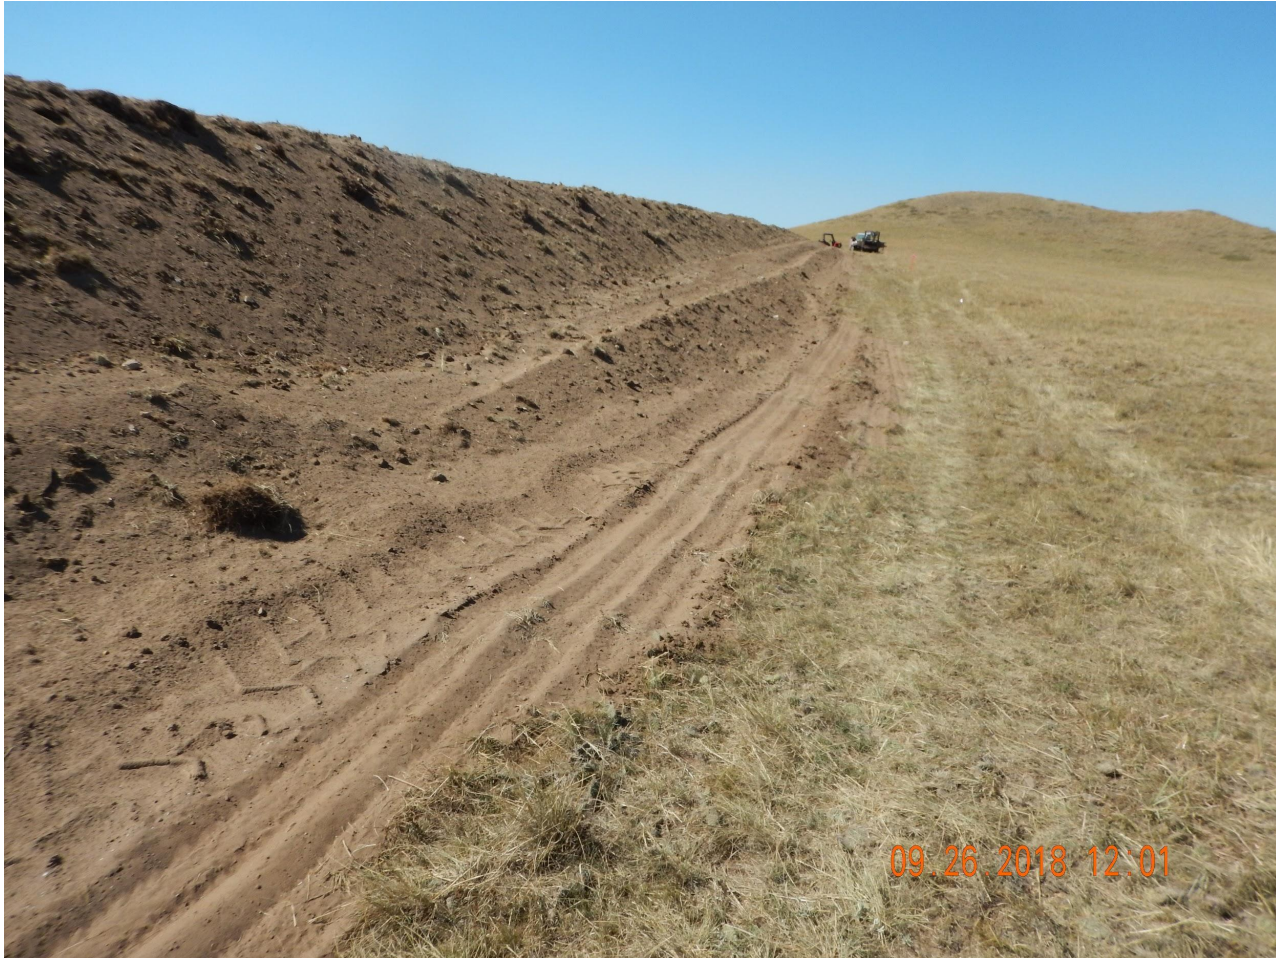
**Photo 3.** Photo taken from the northern location, facing West. Operator plans to install a perimeter BMP around the topsoil.

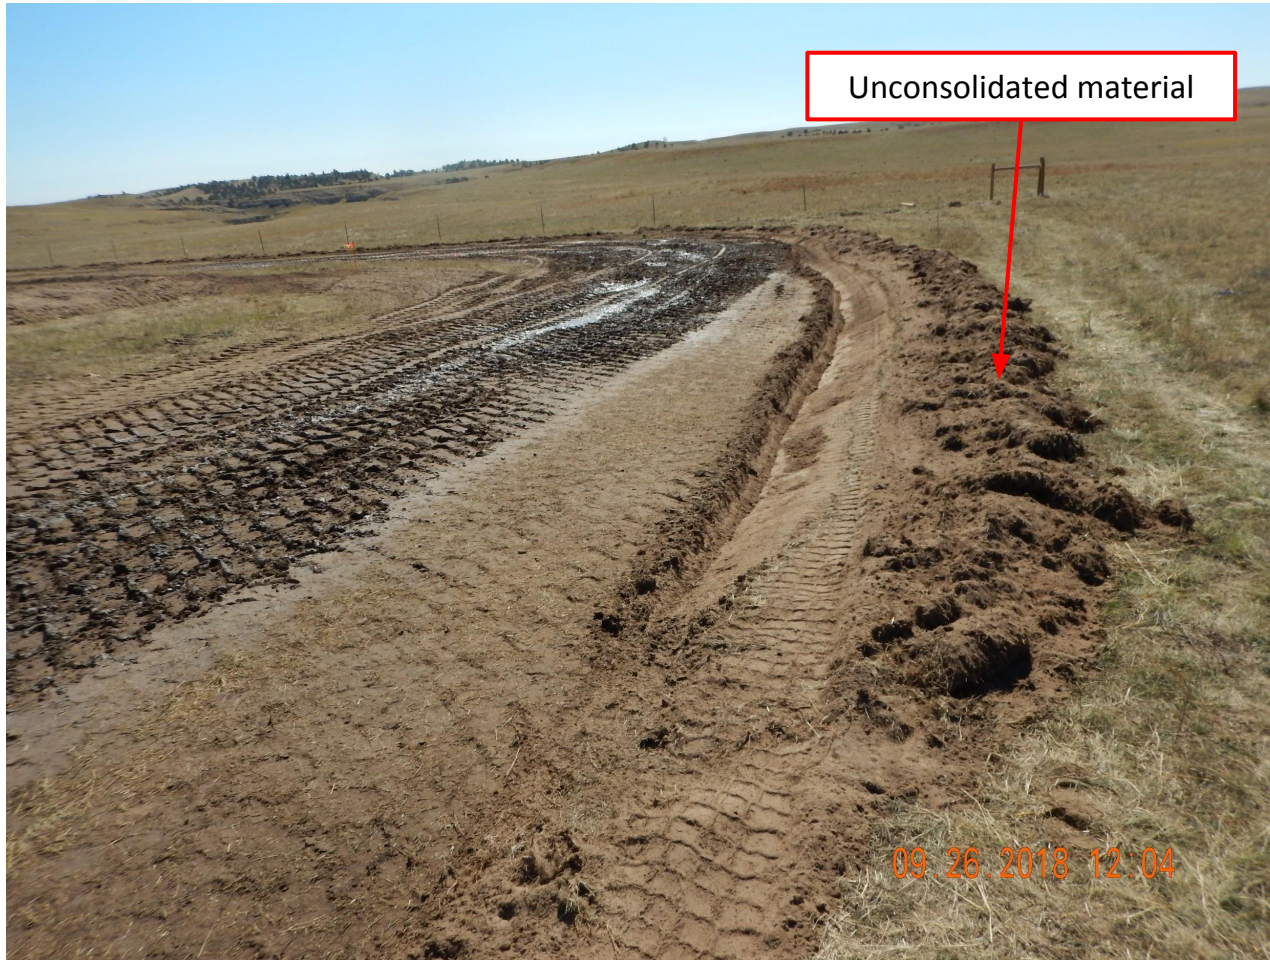
**Photo 4.** Photo taken from the southwestern perimeter of the location, facing South. Operator failed to install stormwater BMPs prior to, or at, the start of construction. Operator installed the temporary stormwater BMP (ditch) during my inspection. This would not be considered a proper functioning BMP because unconsolidated material has not been properly stabilized. Unconsolidated material becomes a source of potential pollution itself. Operator plans to install silt fence as a permanent BMP.

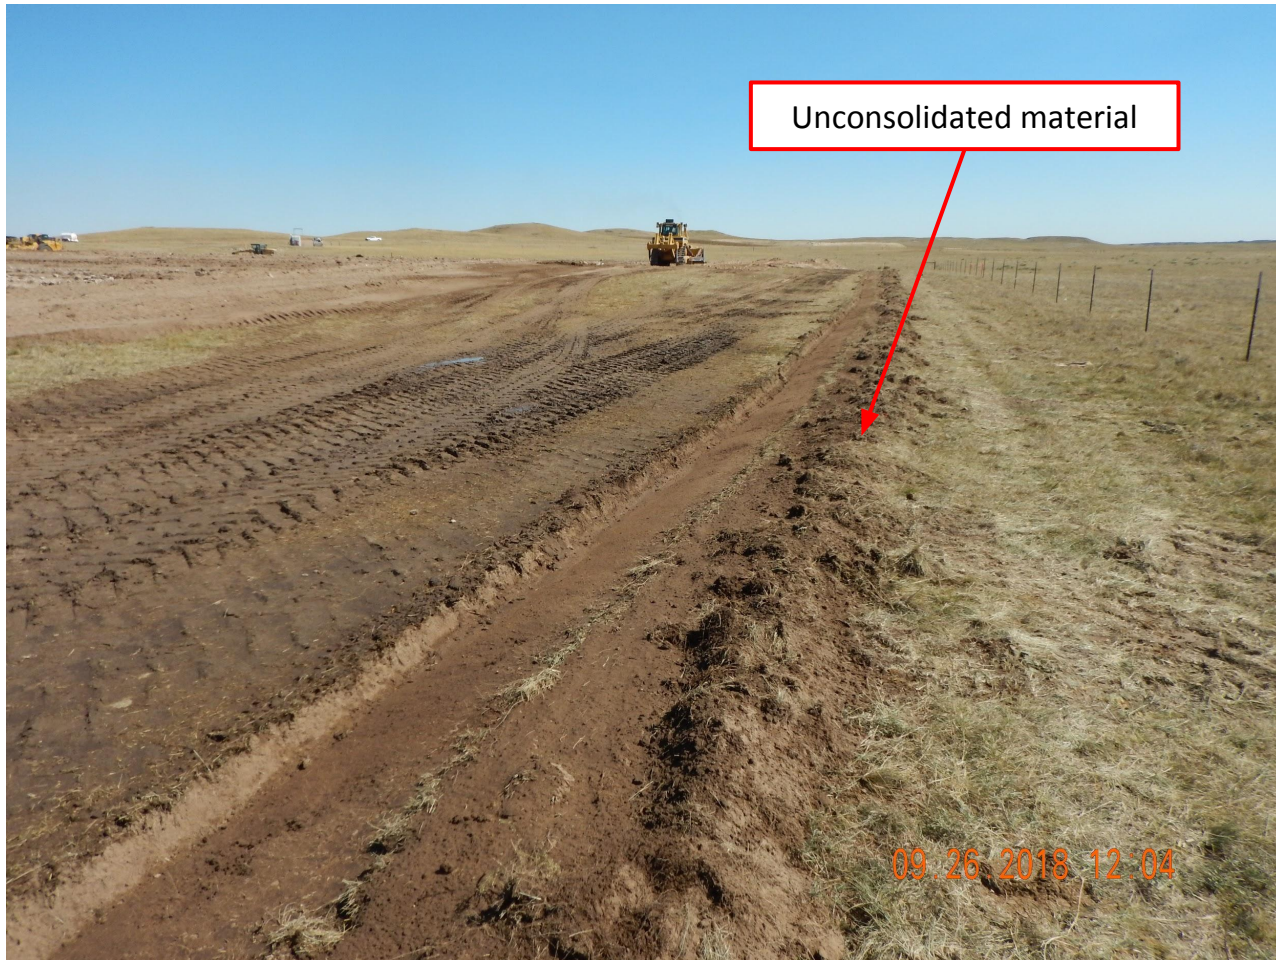
**Photo 5.** Photo taken from the southwestern perimeter of the location, facing East. See comments under Photo 4.

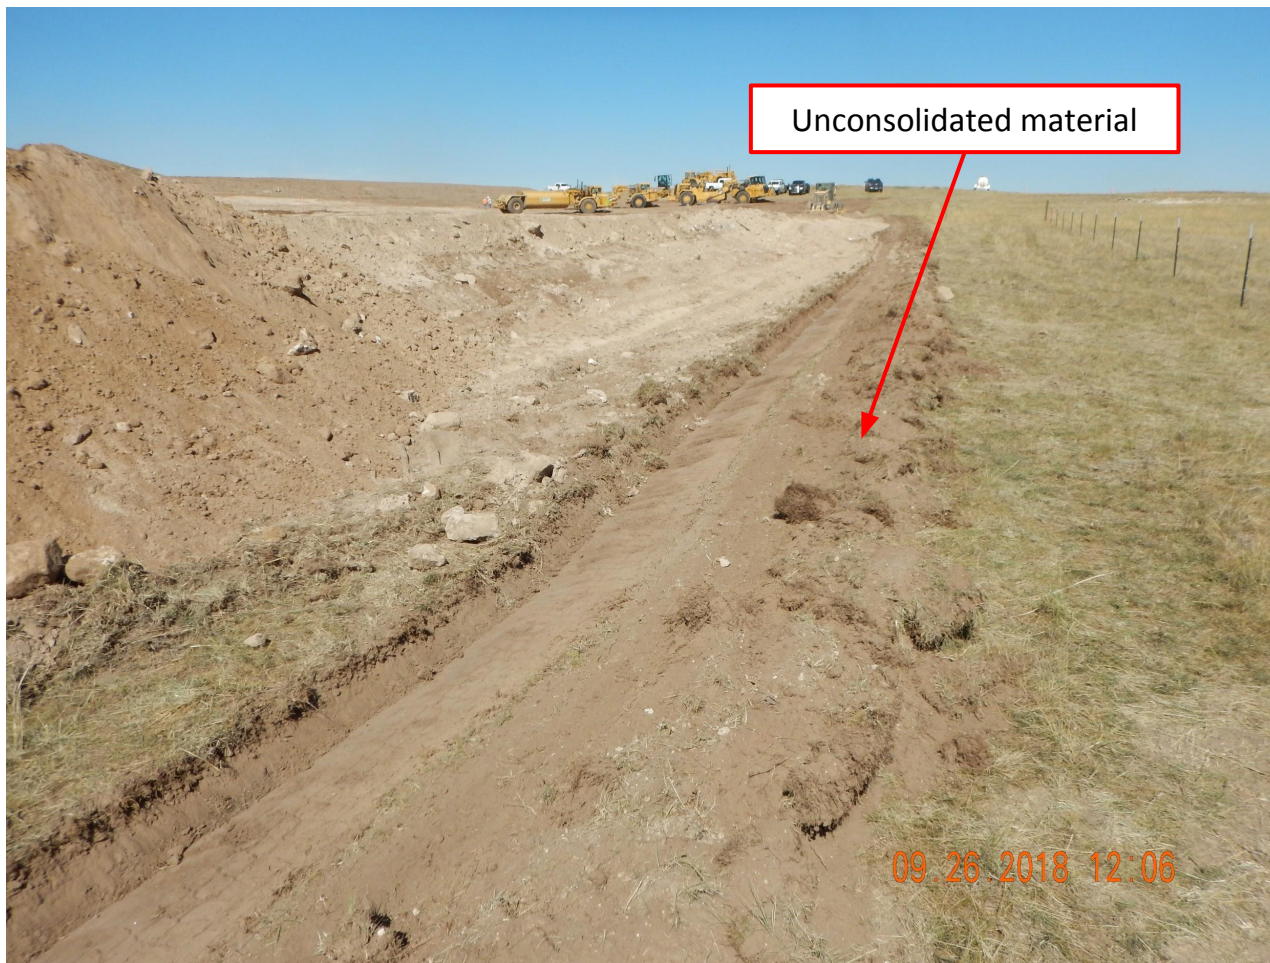
**Photo 6.** Photo taken from the southeastern perimeter of the location, facing North.  
See comments under Photo 4.
