Inspection Photos  
Location Name: Amoco-Federal 21-1  
API: 05-081-06439

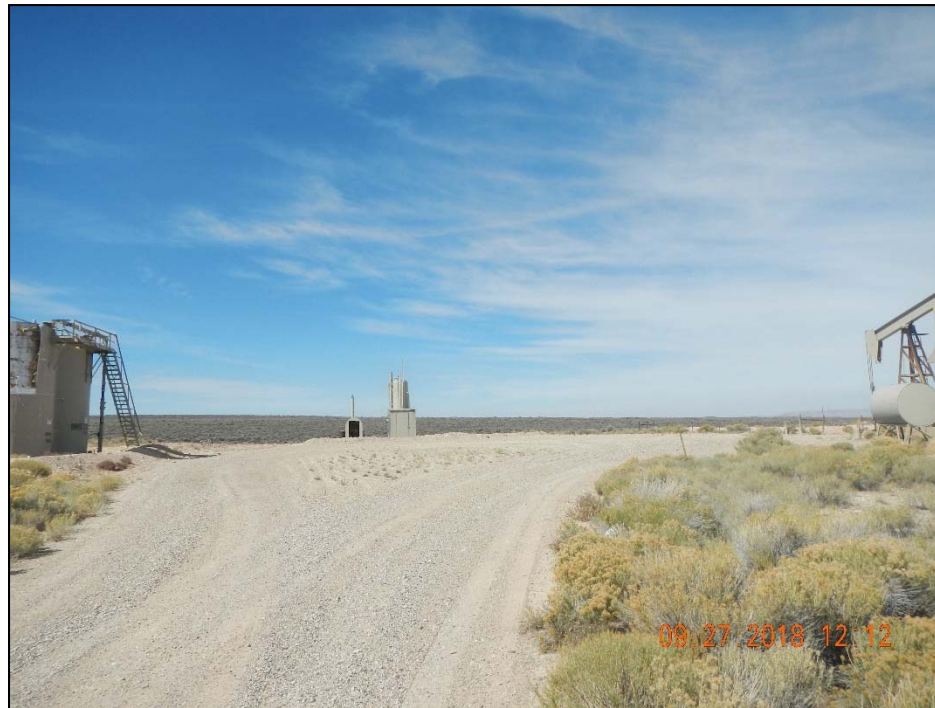
**Photo 1. Overview of location taken at entrance facing west.**

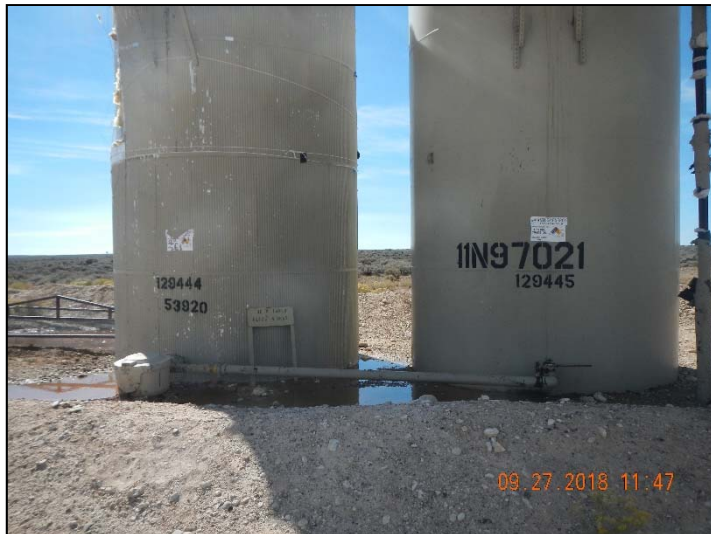
Photo 2. Label falling off left hand tank.

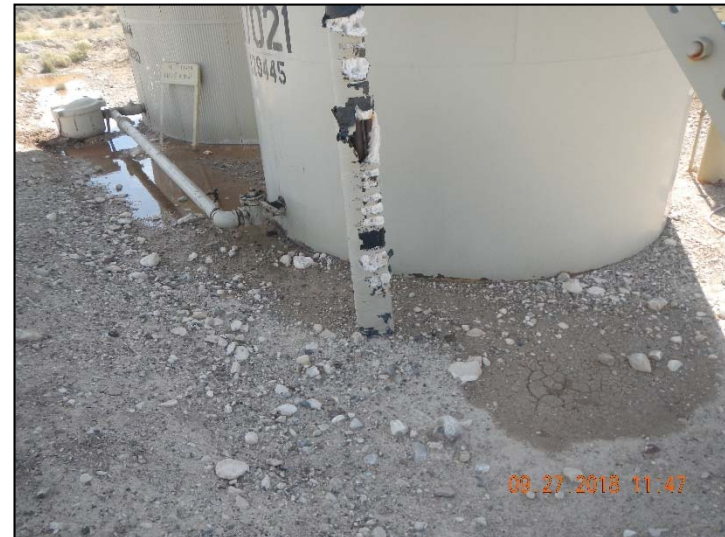
Photo 3. Spill photo 1 of 6. Standing at western edge of tank berm.

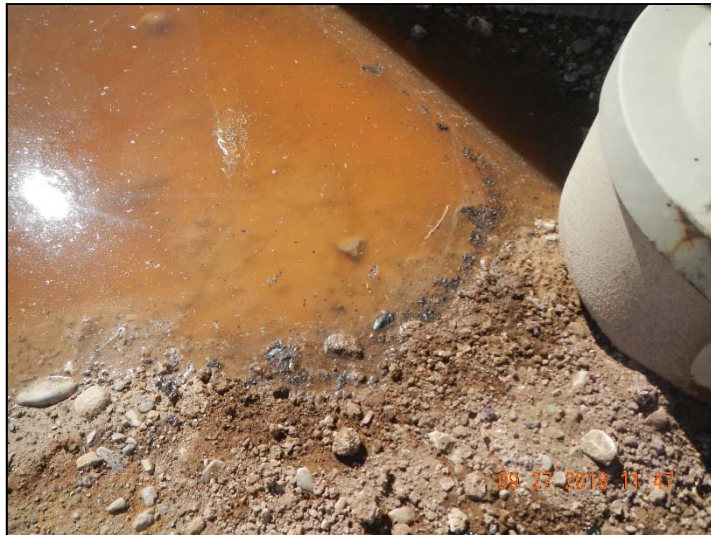
Photo 6. Spill photo 4 of 6. Sheen visible on water.

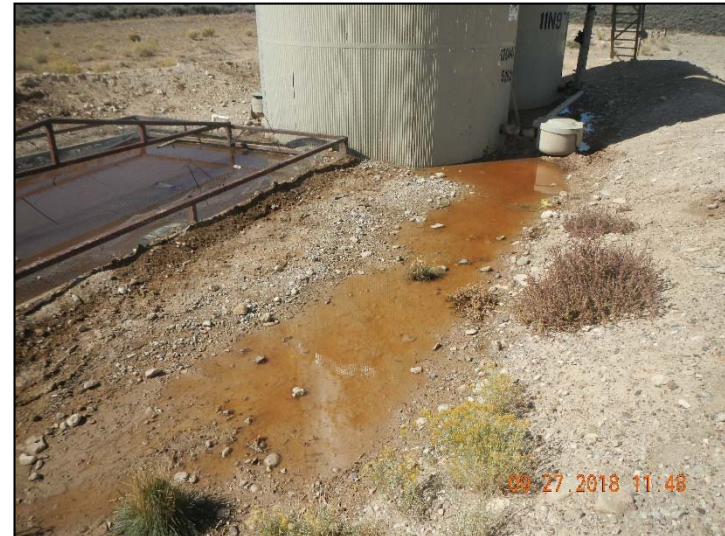
Photo 7. Spill photo 5 of 6. Standing on eastern edge of tank berm looking west.

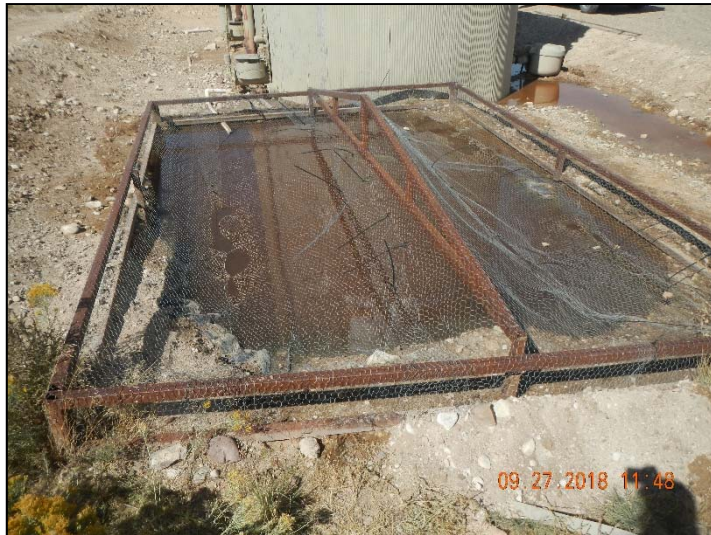
**Photo 8. Spill photo 6 of 6. Not 2 feet of freeboard, netting sagging into contents.**

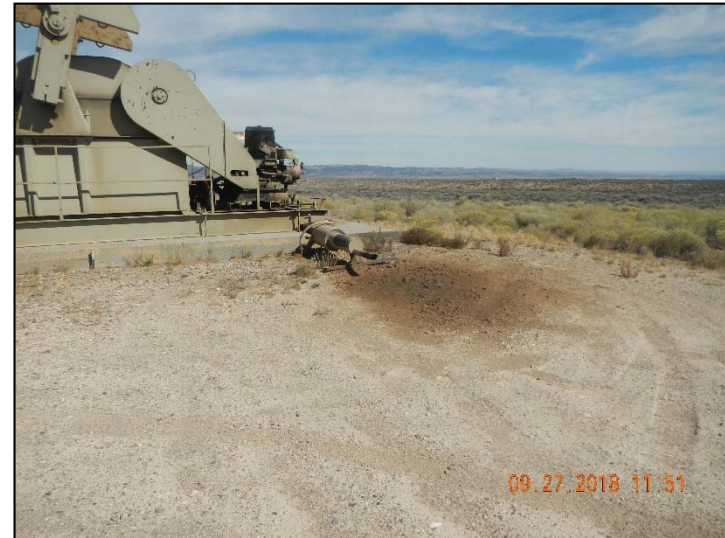
**Photo 9. Stained soil at pump jack exhaust.**

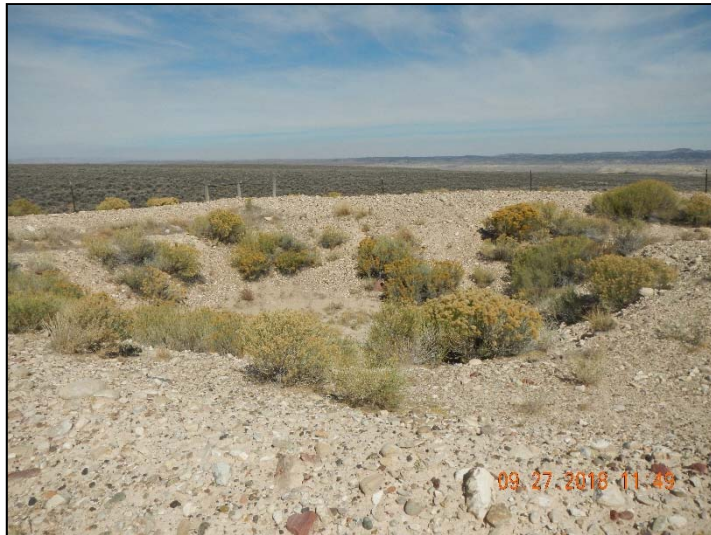
**Photo 10. Second pit on location.**

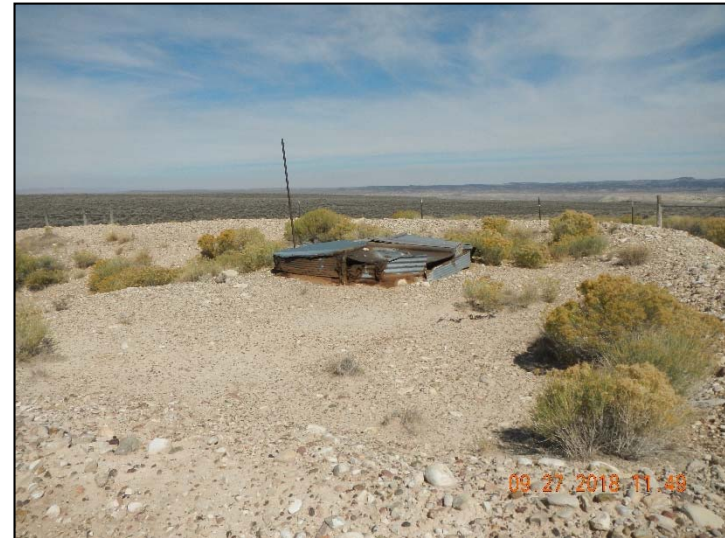
**Photo 11. Partially buried tank in fenced area with pit.**
