Inspection Photos

Operator: BP America

API: 05-067-08898

Date: 9/25/2018

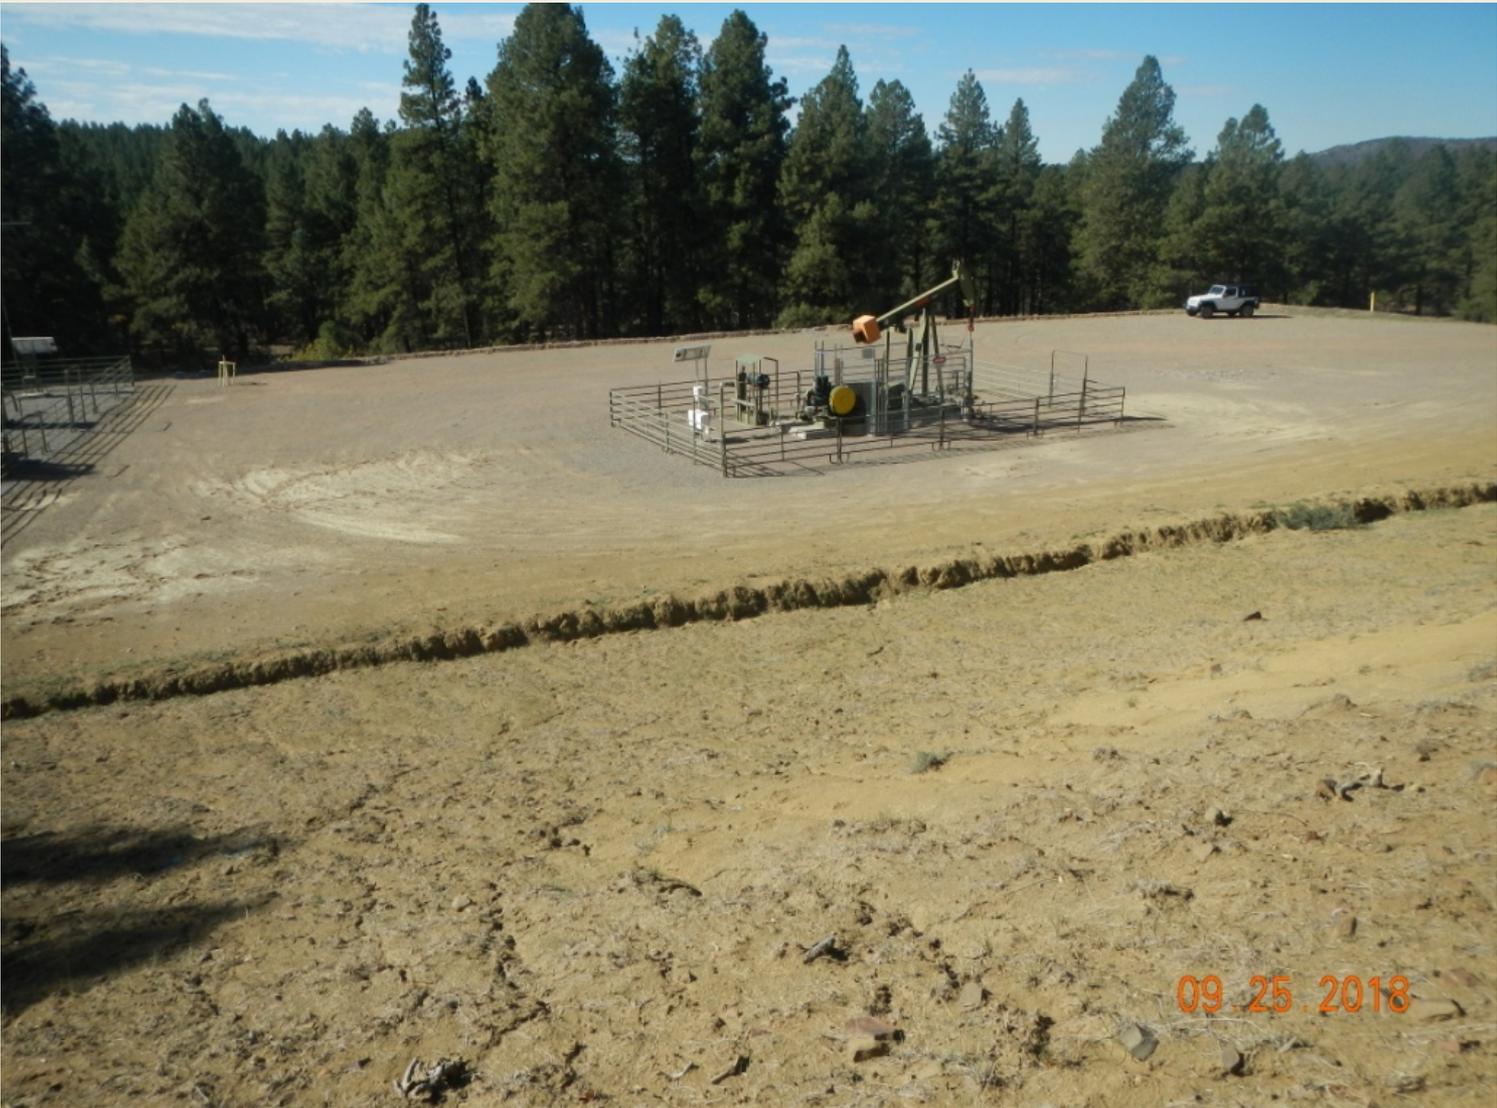
Photo 1. View of the project area from the northeastern corner facing center.

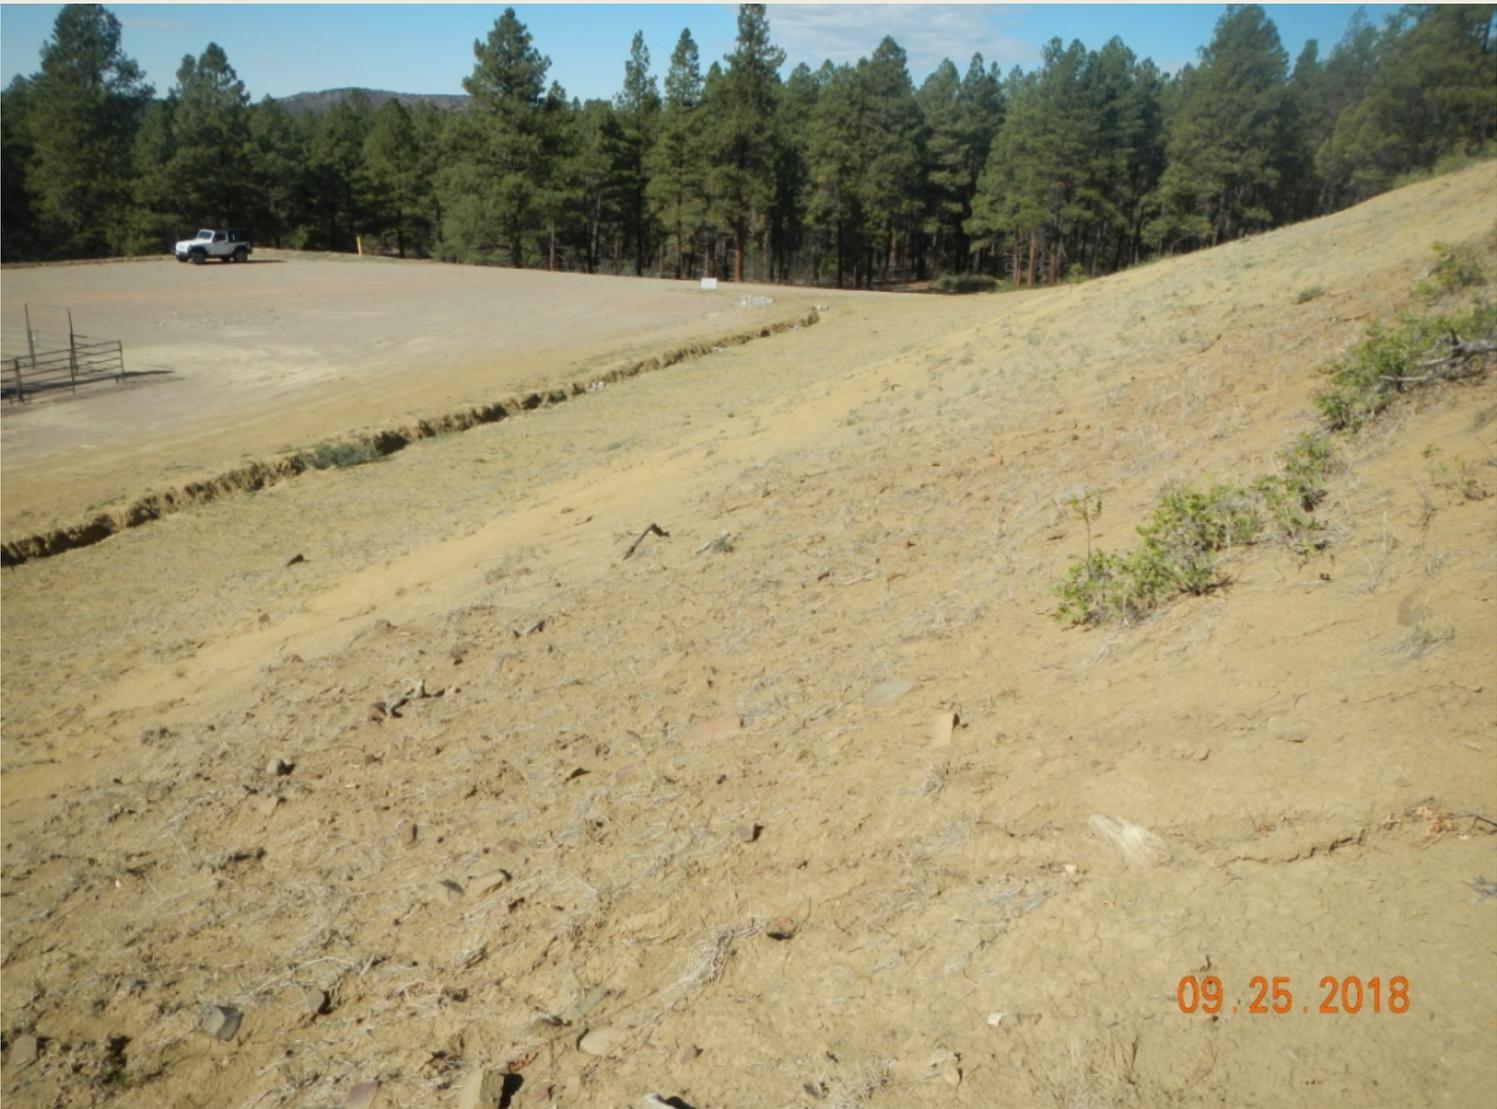
Photo 2. View of the northern project area from the northeastern corner facing westward.

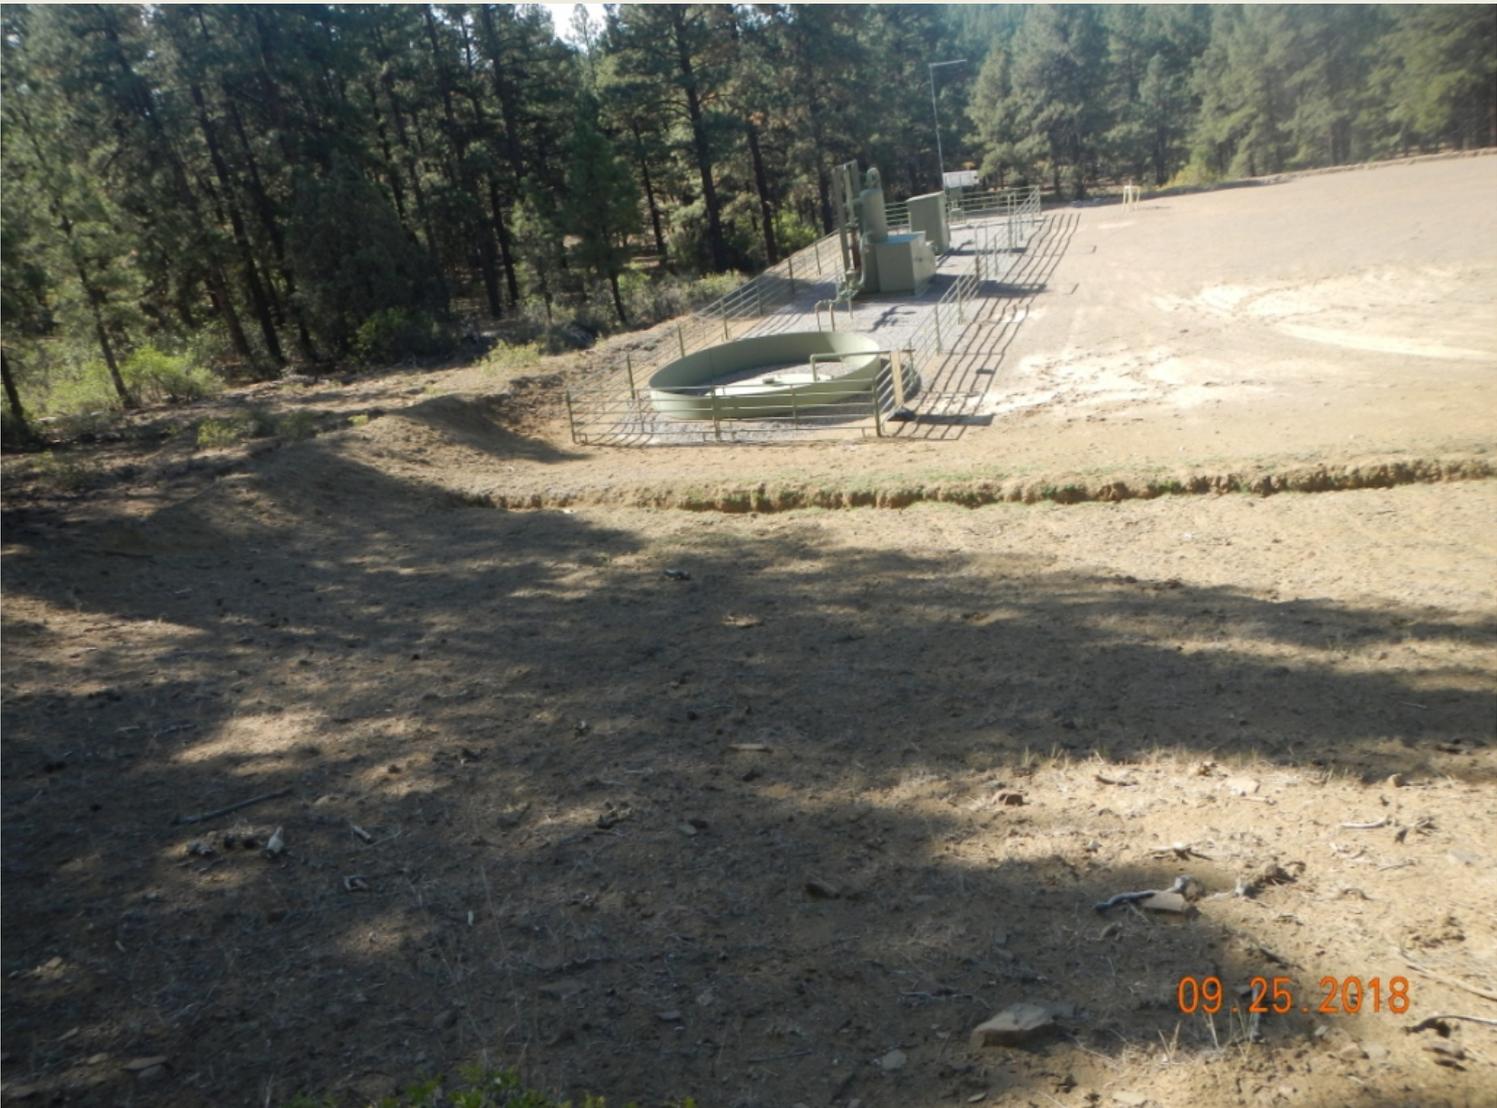
Photo 3. View of the eastern project area from the northeastern corner facing southward.

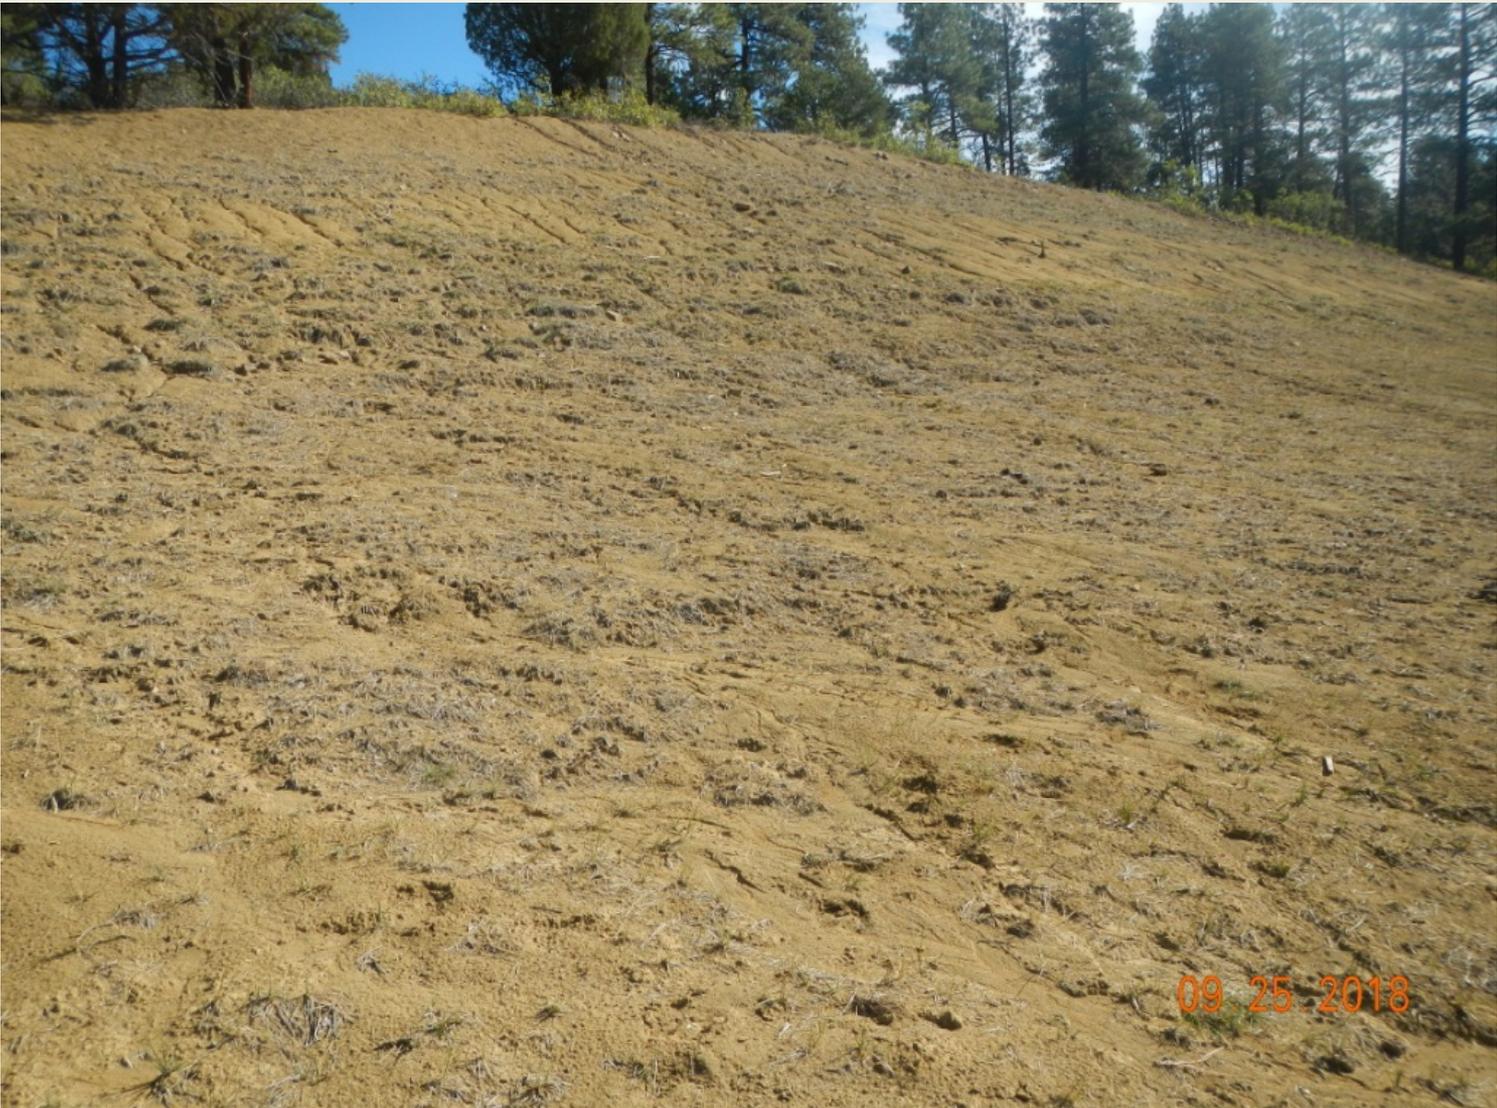
Photo 4. View of the northern cut slope from the central toe of slope facing up-slope. Vegetation is sparse and significant rilling/run-on is occurring.

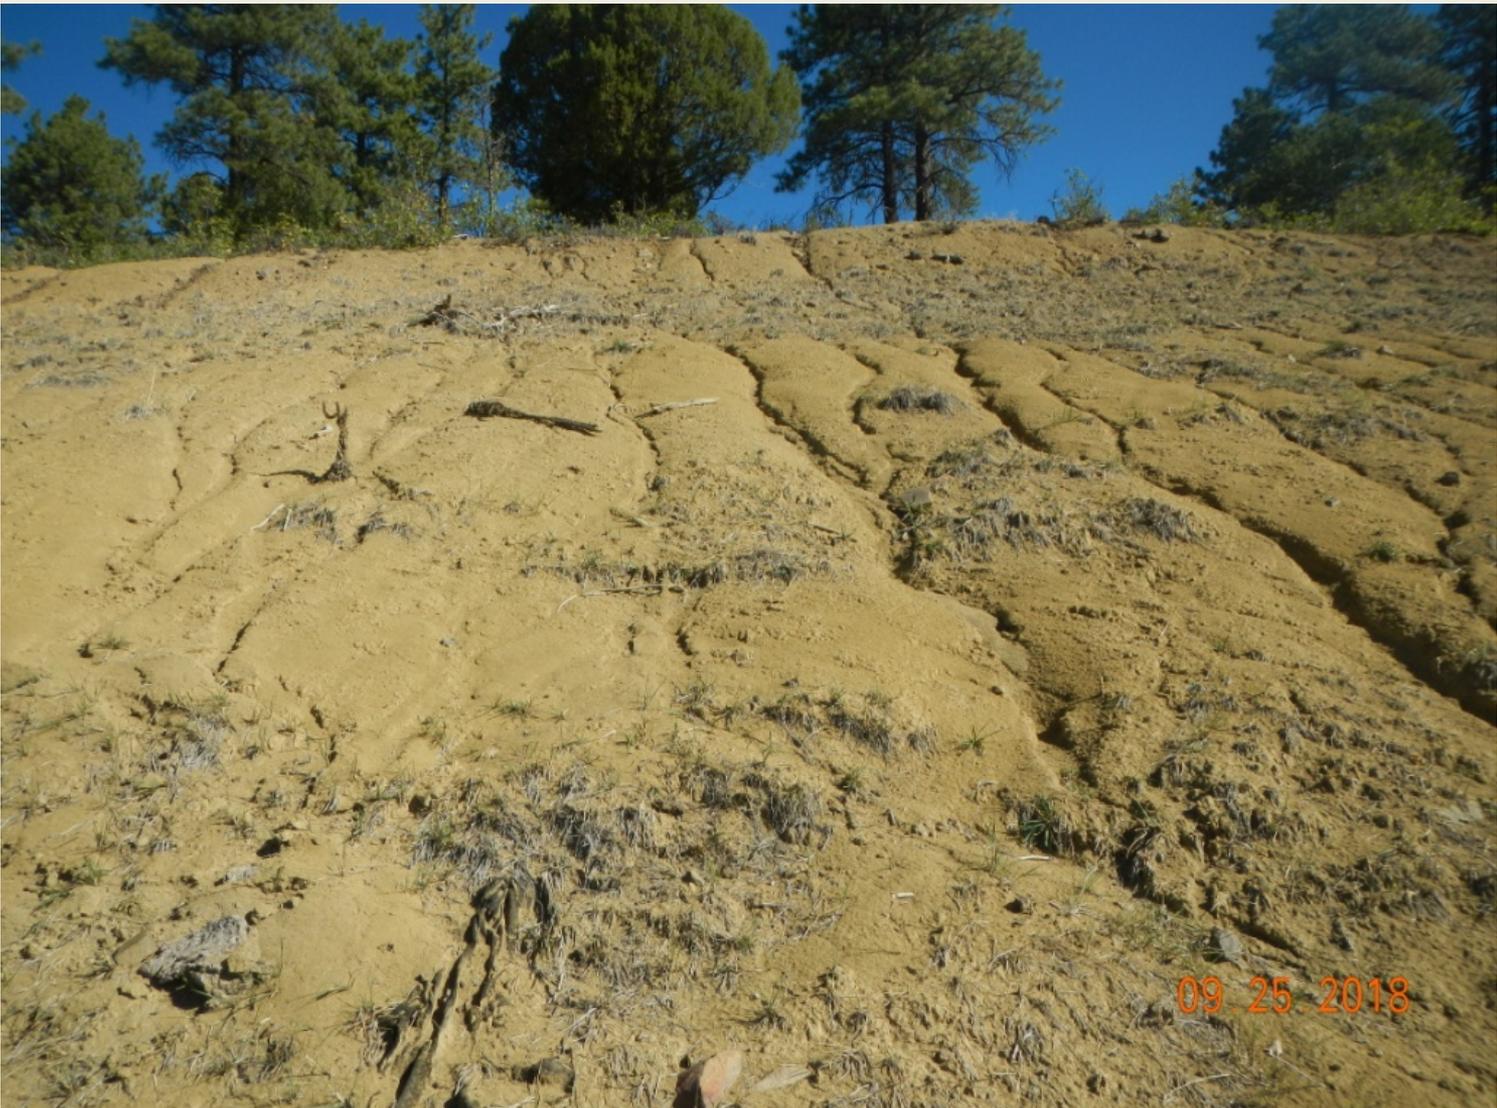
Photo 4. Closeup view of rilling on the northern cut-slope up to 10 inches wide and deep. Run-on controls, erosion controls such as erosion blankets, and cattle exclusion are likely needed to stabilize slope. Seeding is needed where vegetation is not becoming established.

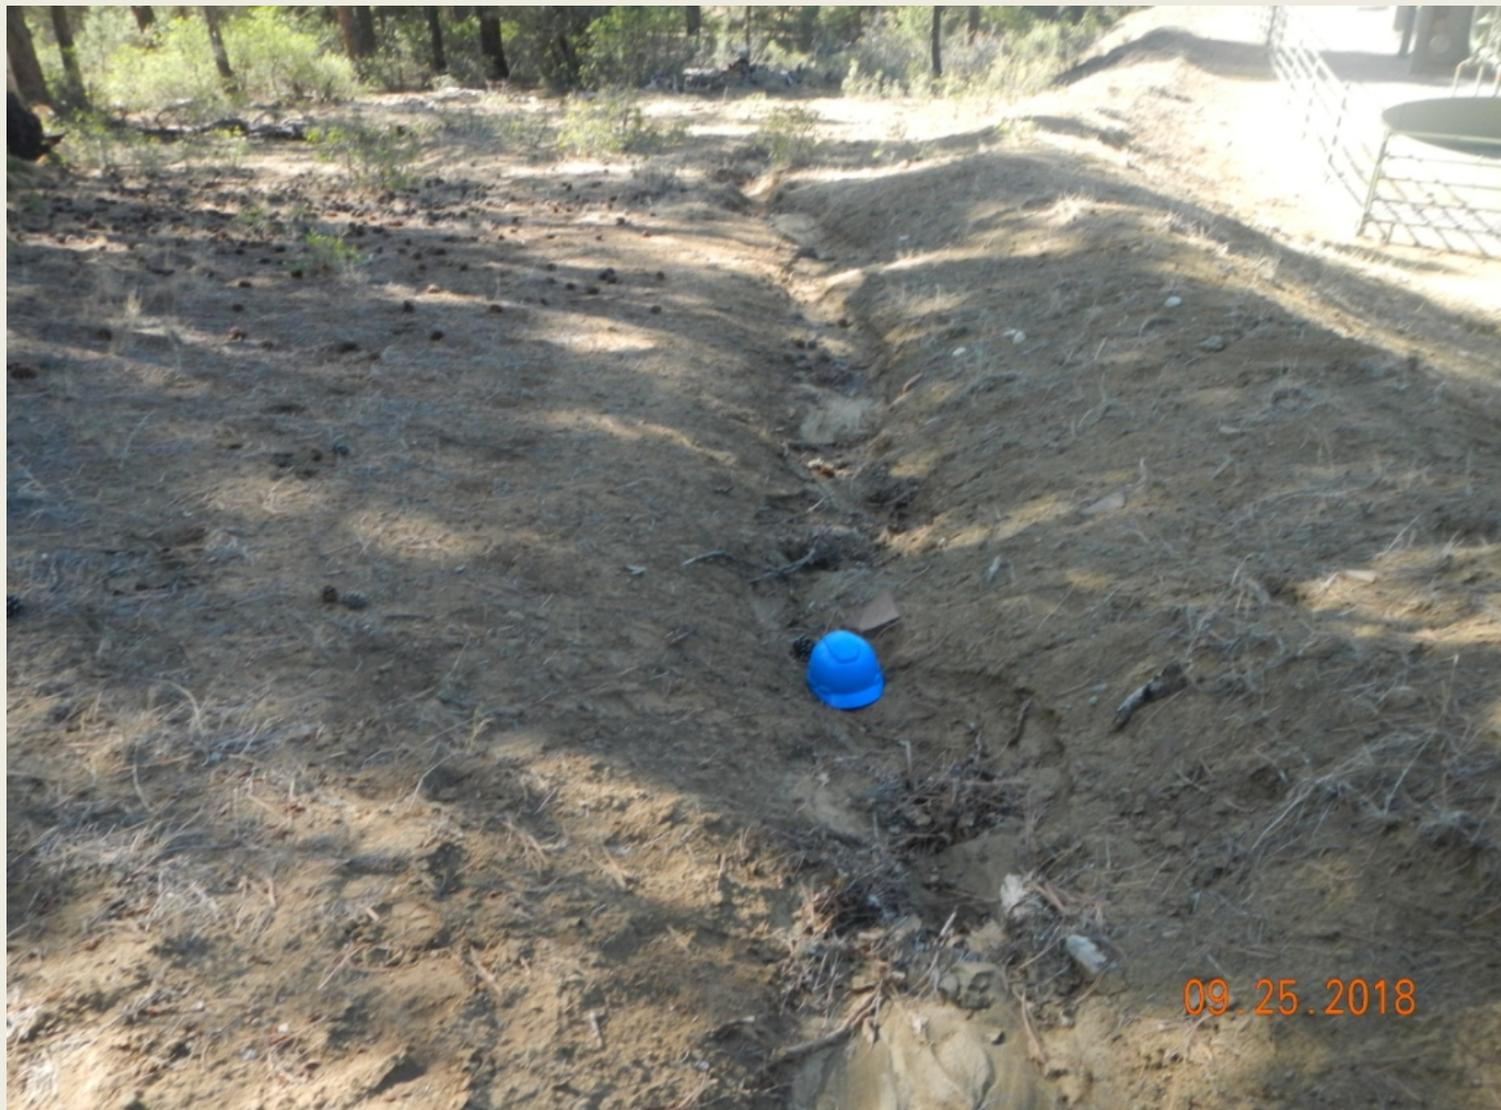
Photo 6. View of erosional channel approximately 1.5 feet wide and deep, in the northeastern project area where a drainage flows along the eastern edge of the project area and is resulting in erosional downcutting.

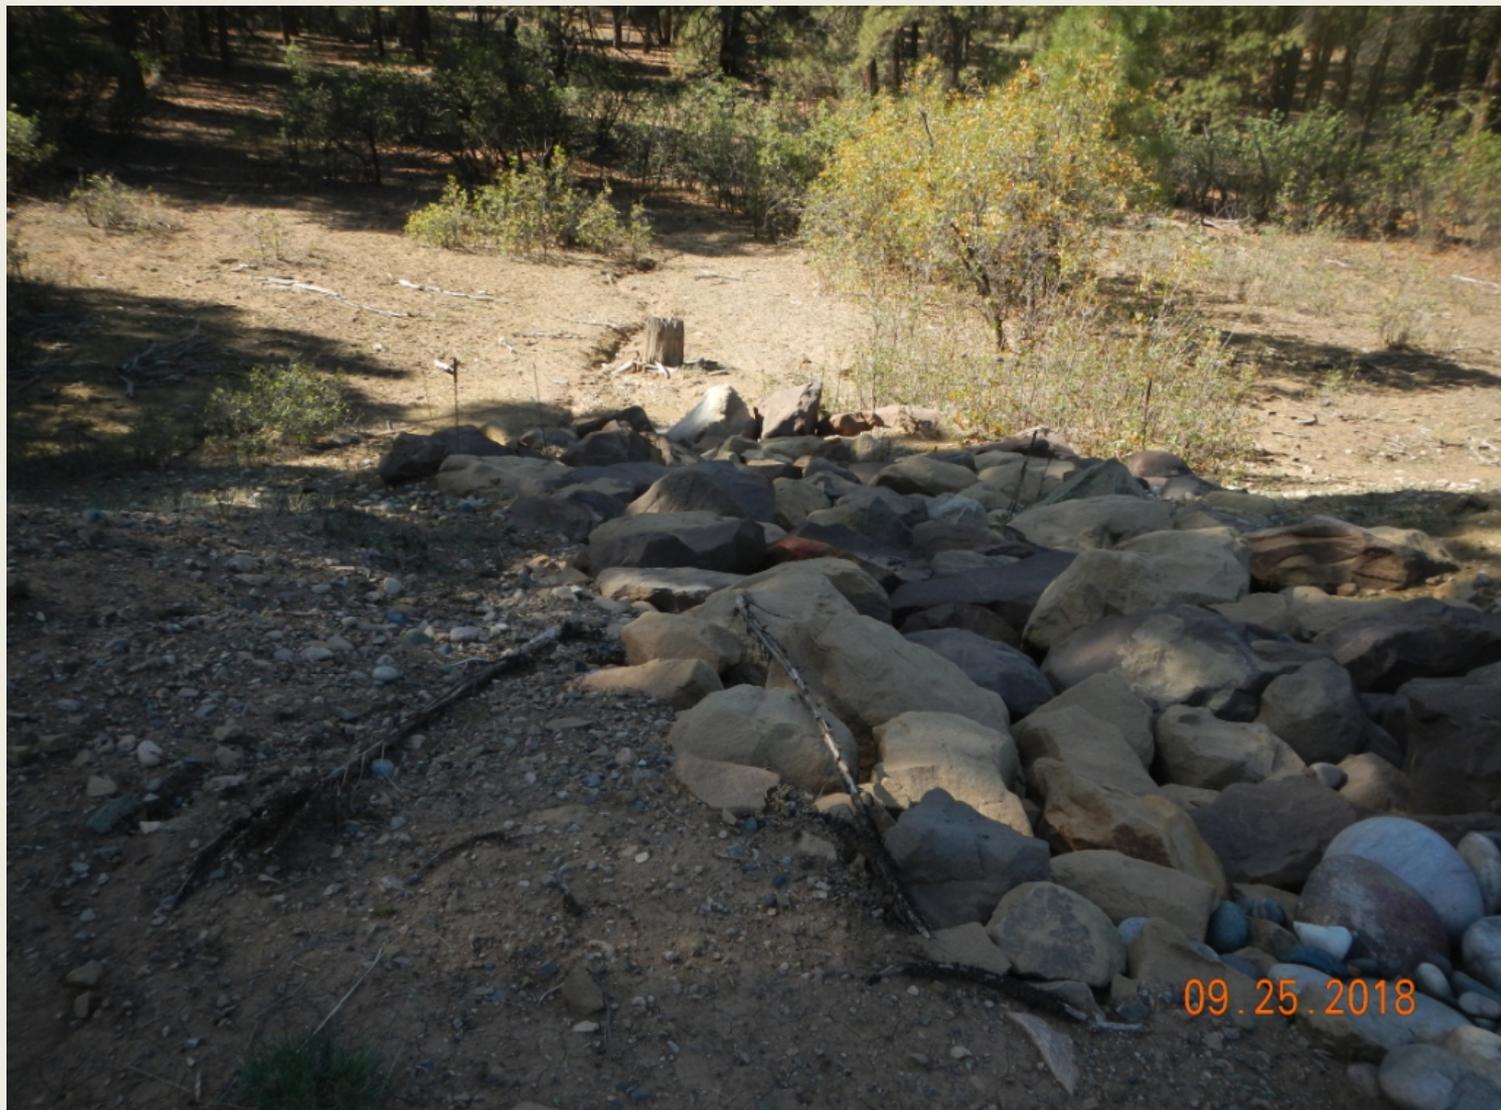
Photo 7. View of rock run-down in the southern project area.

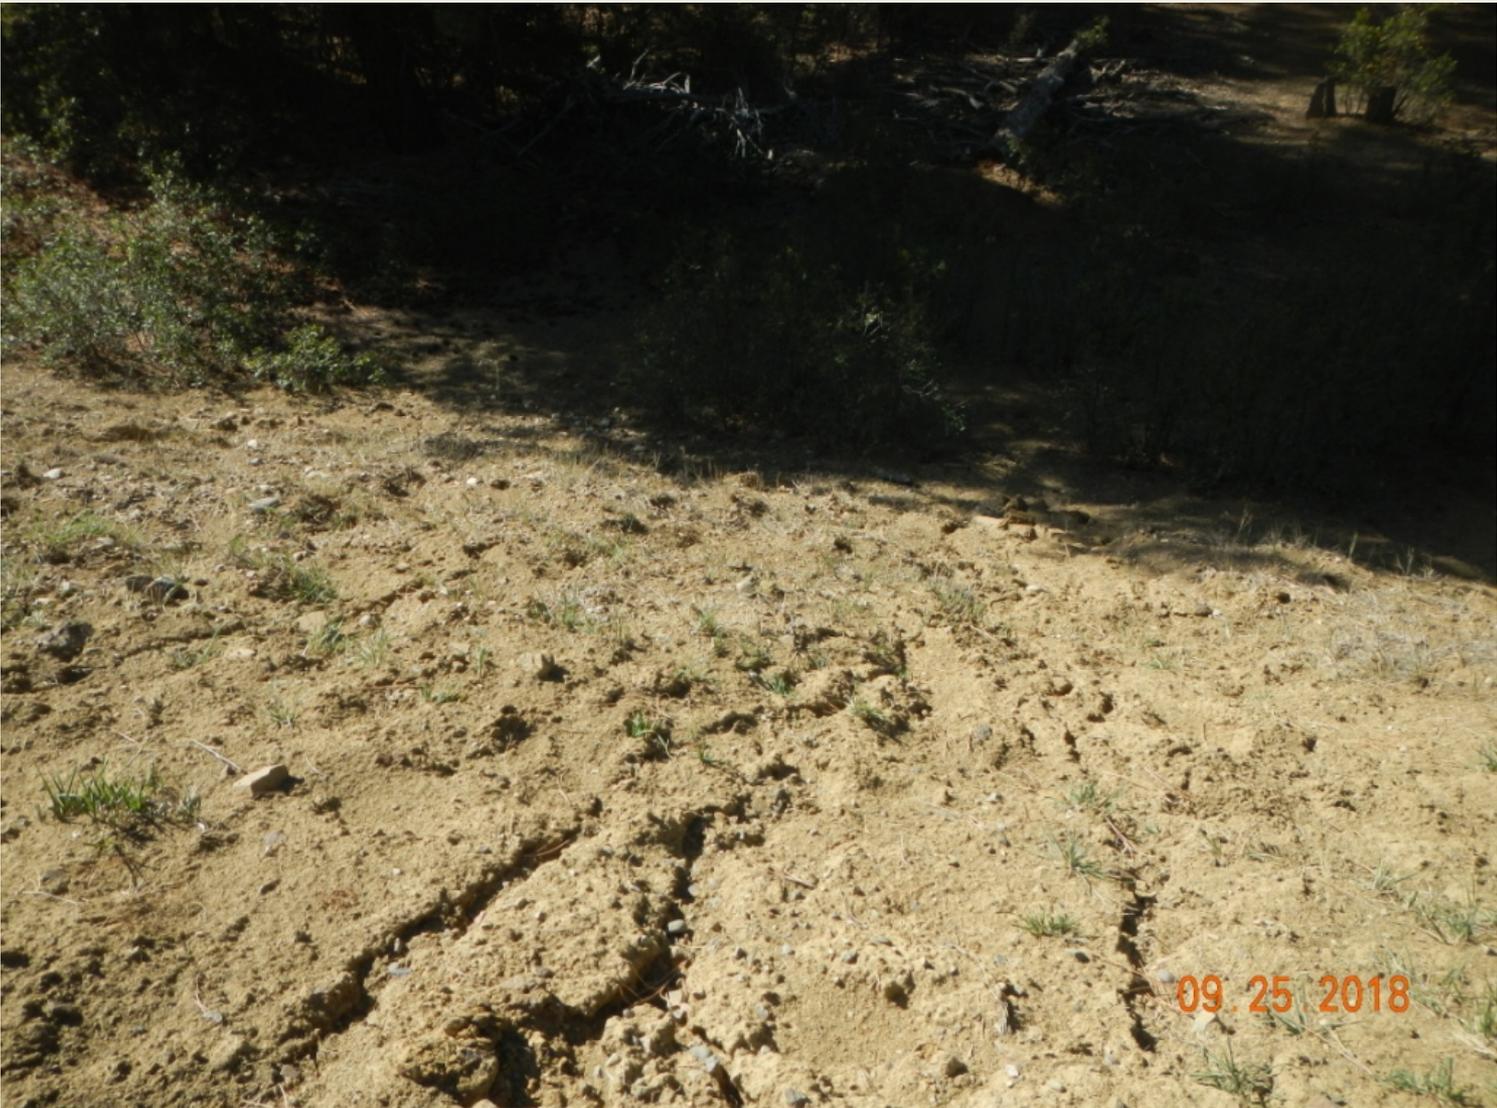
Photo 8. View of rilling in the southern cut-slope, facing down-slope.

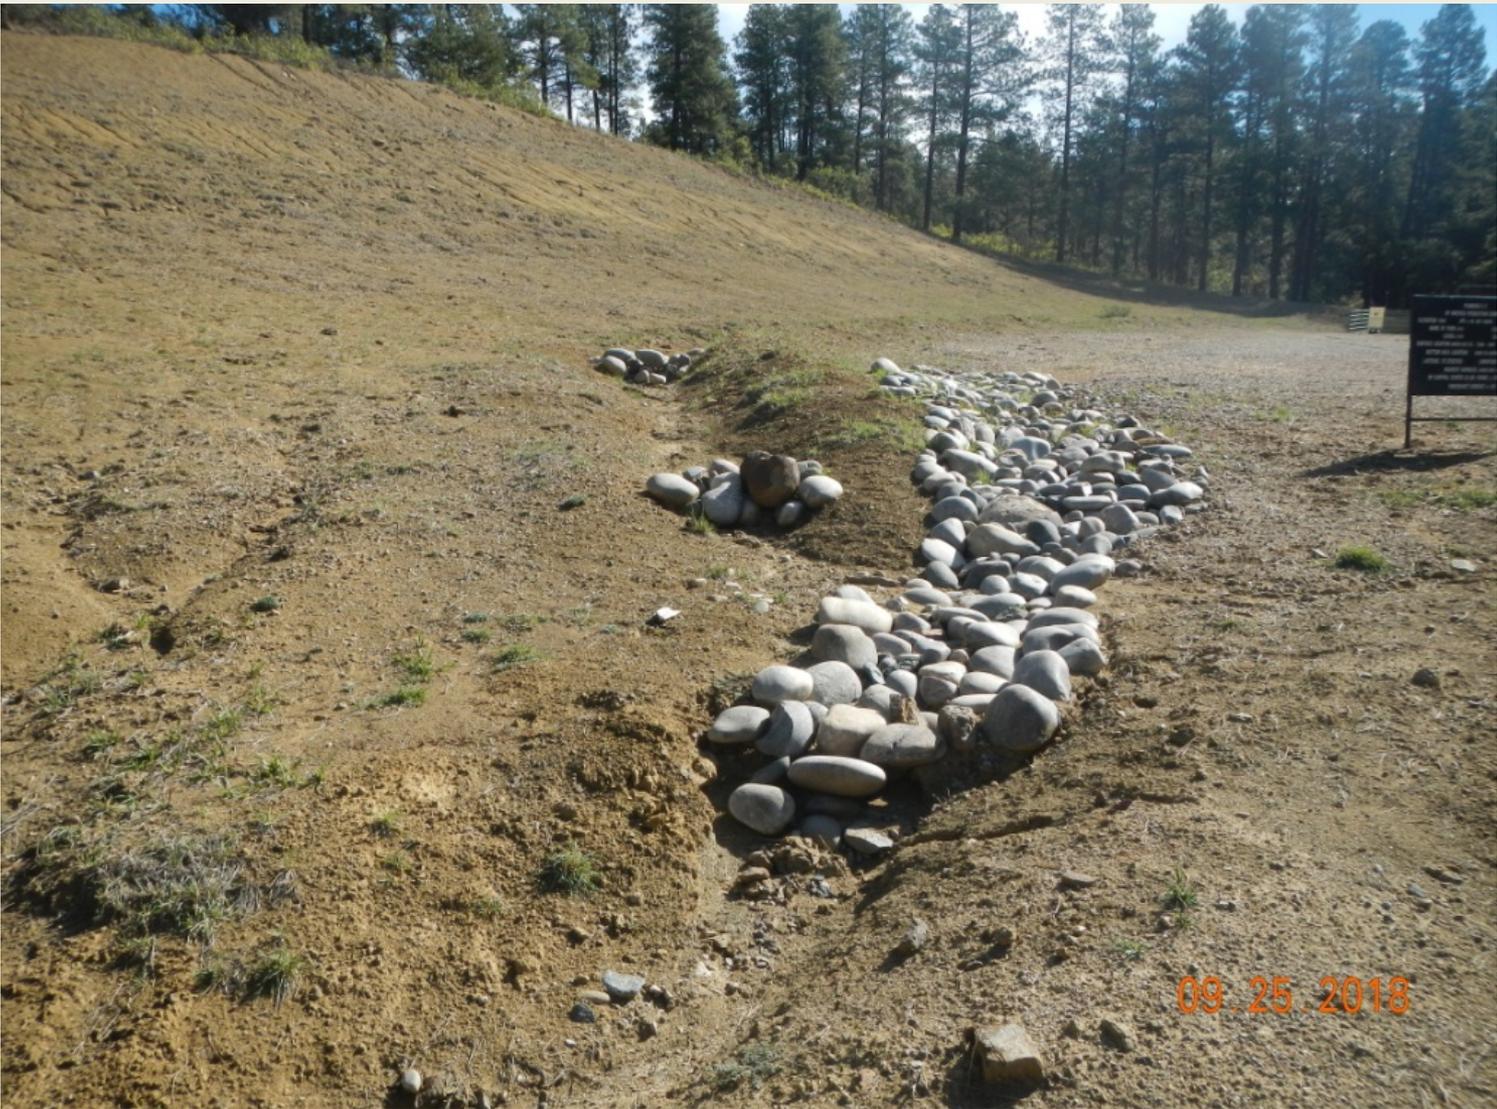
Photo 9. View of cobble armoring in the northwestern corner of the working area where stormwater is diverted off of the northern project area.
