Inspection Photos

Operator: BP America

API: 05-067-08897

Date: 9/25/2018

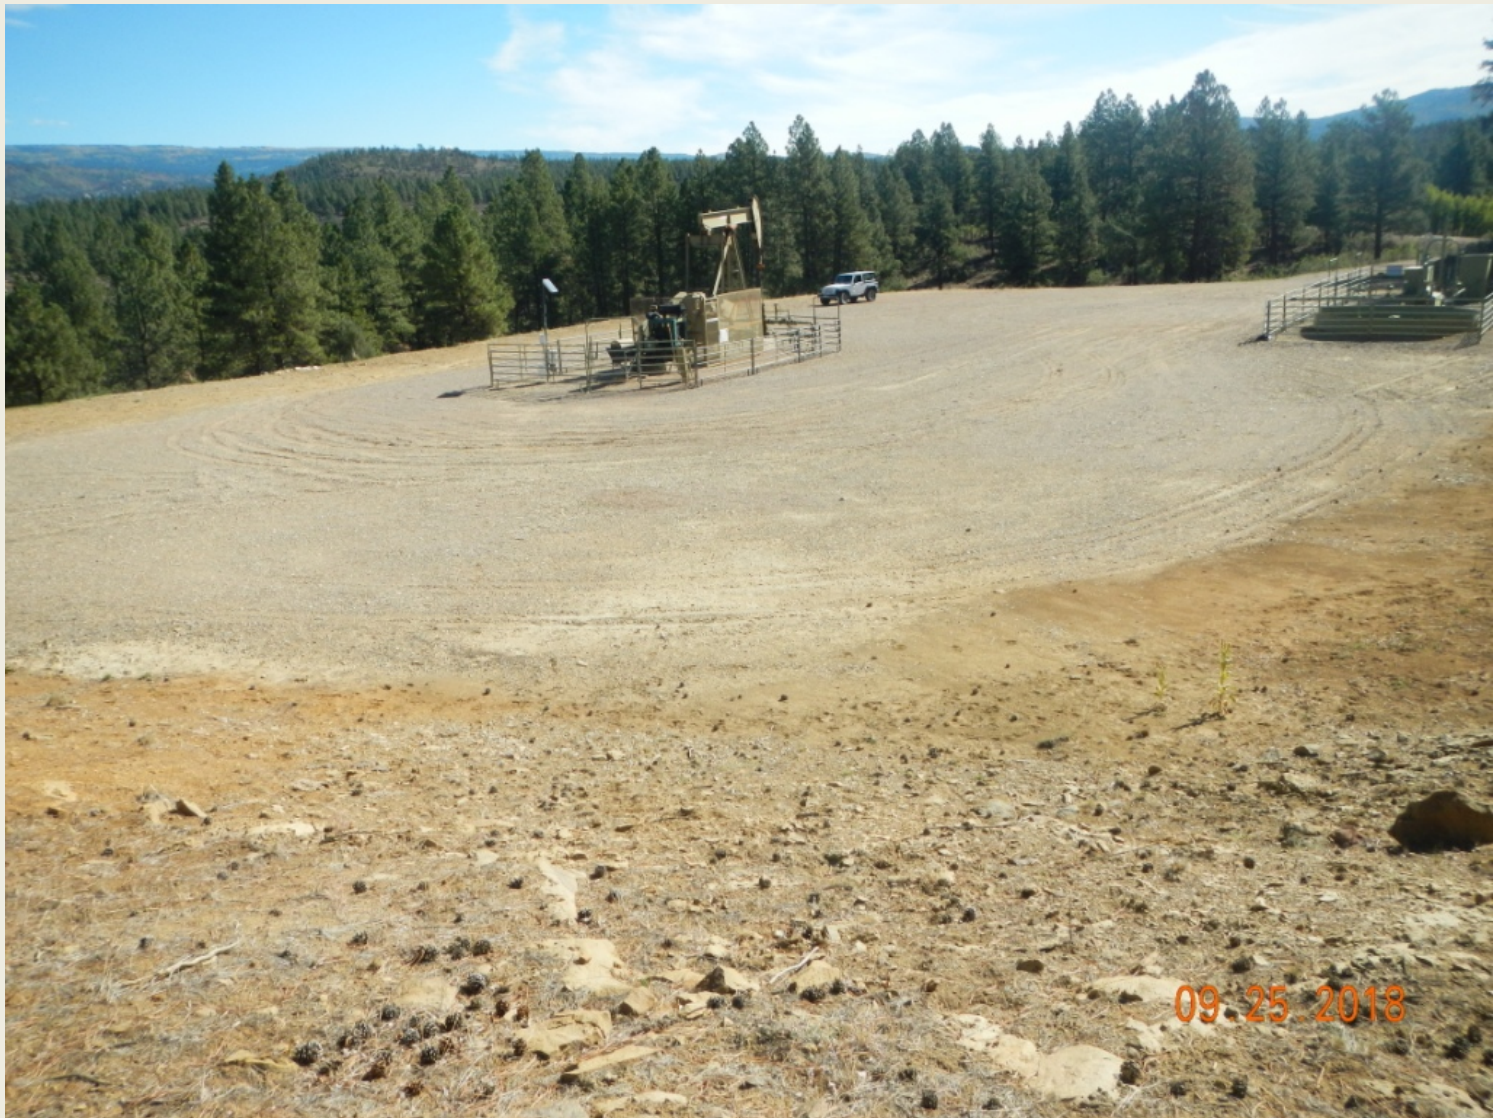
Photo 1. View of the project area from the southwestern corner facing center.

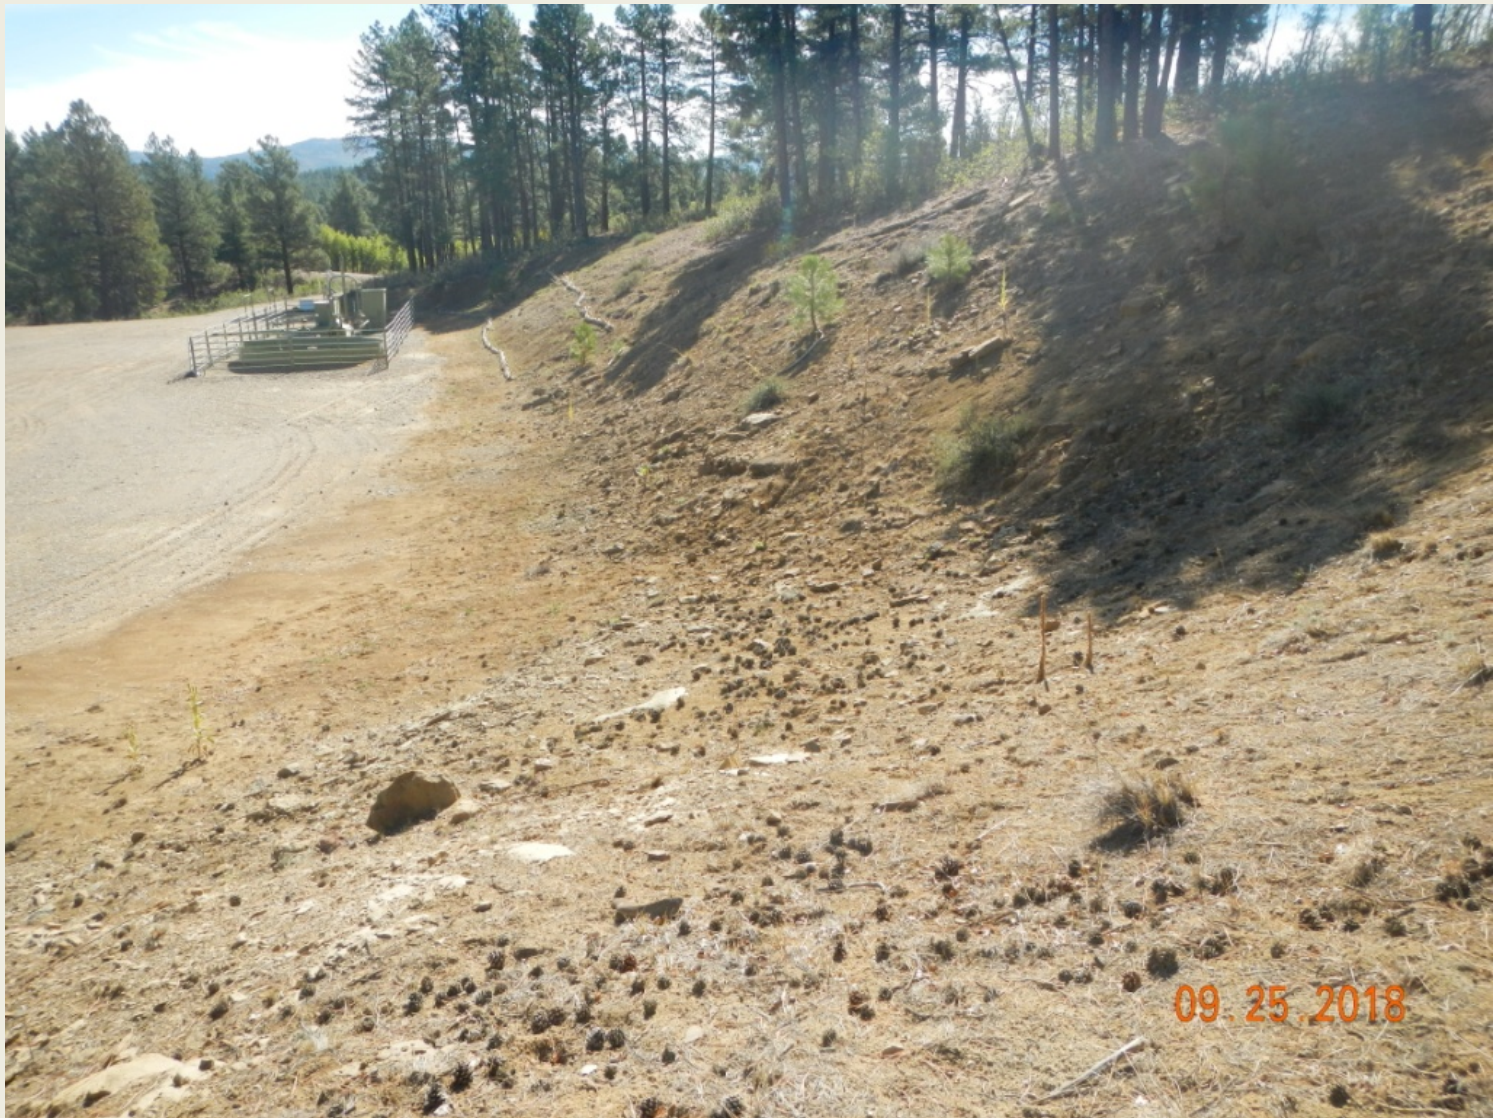
Photo 2. View of the southern project area from the southwestern corner facing eastward.

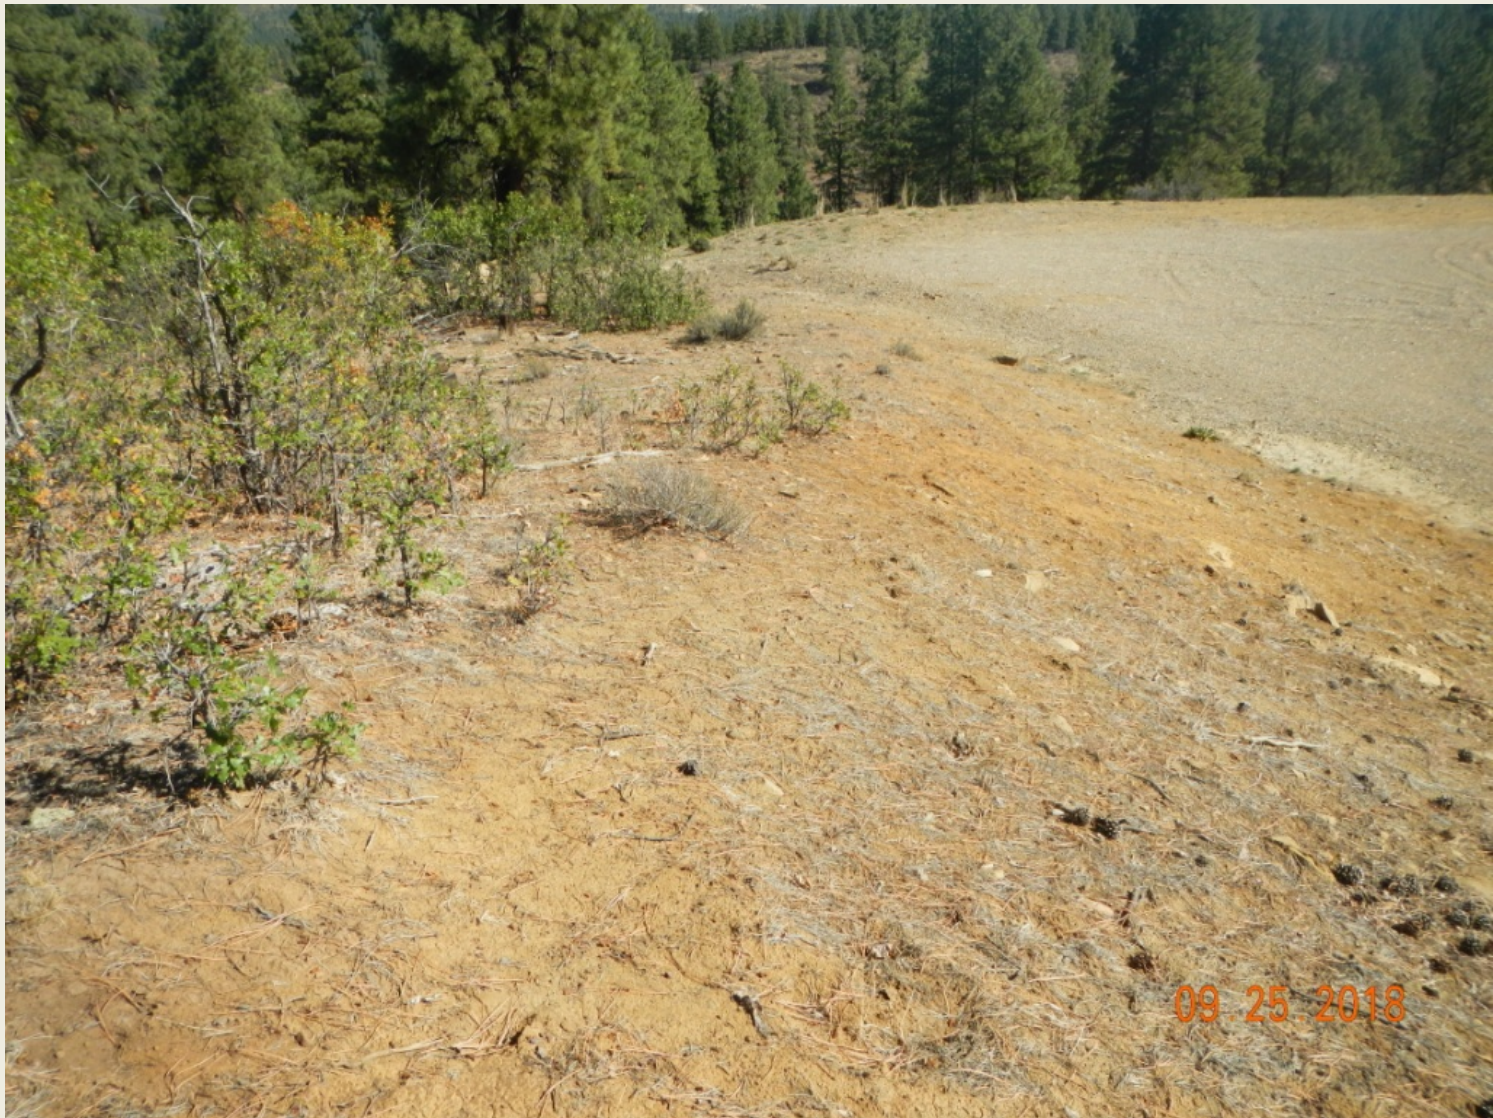
Photo 3. View of the western project area from the southwestern corner facing northward.

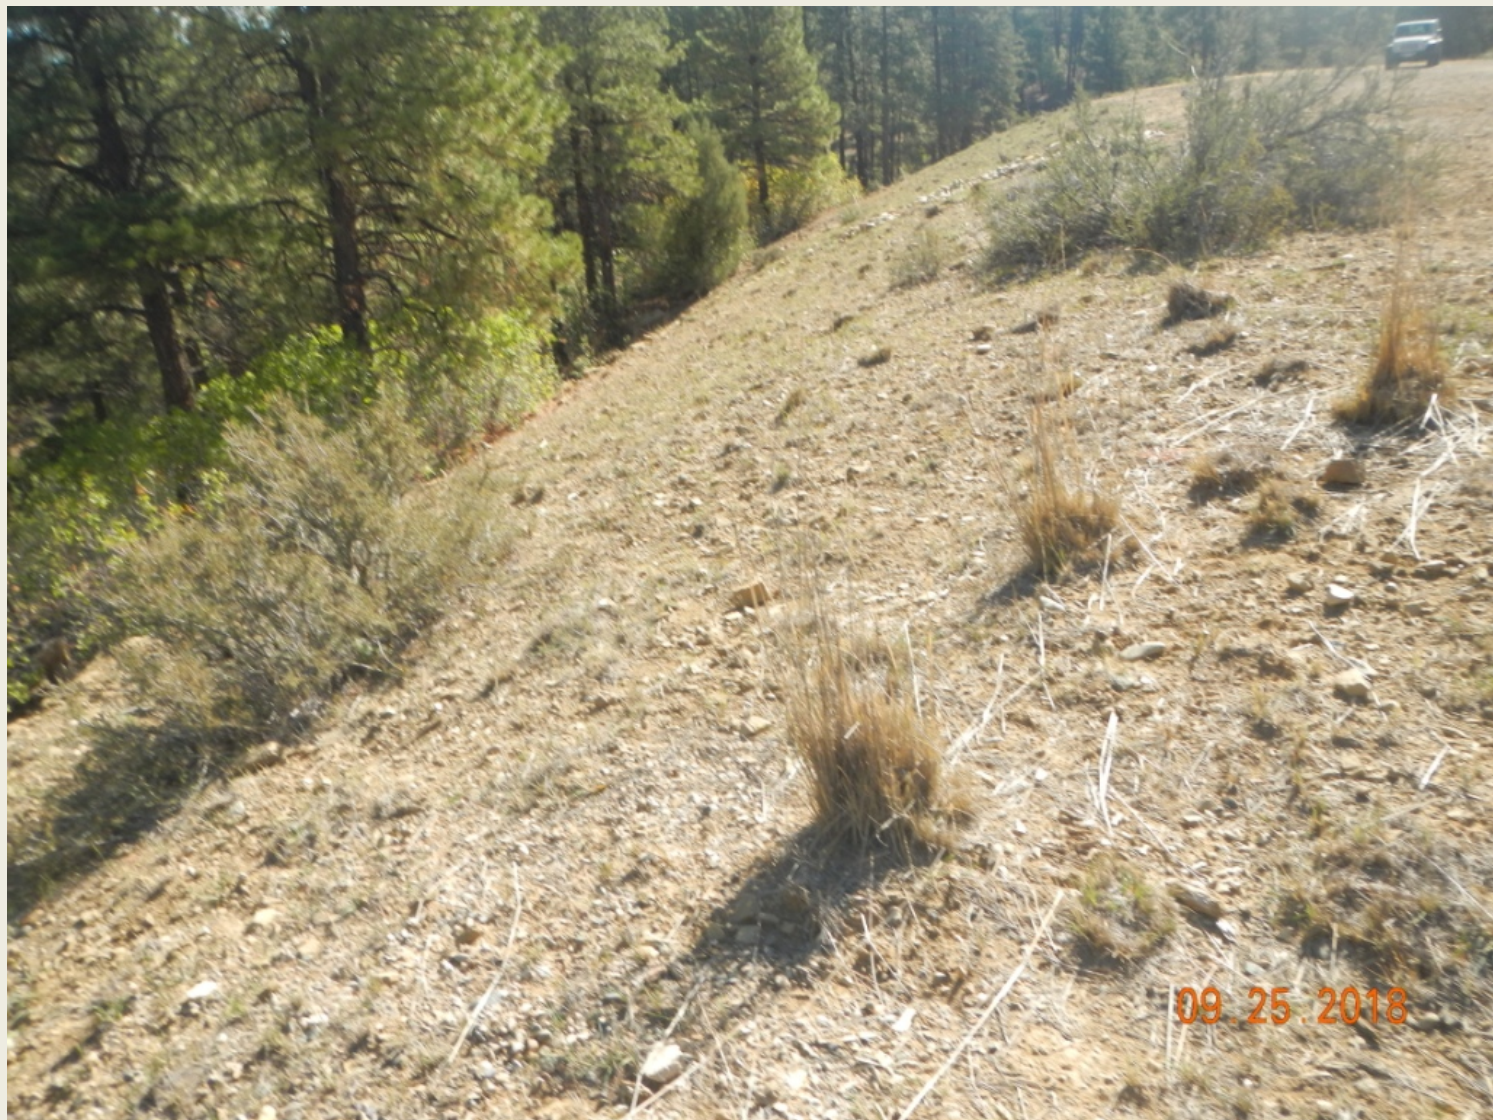
Photo 4. View of the northern project area from the northwestern corner facing eastward. Revegetation is largely grazed, and comprised with grasses such as intermediate wheatgrass (*Thinopyron intermedium*) and western wheatgrass (*Pascopyrum smithii*), as well as shrubs such as antelope bitterbrush (*Purshia tridentata*).

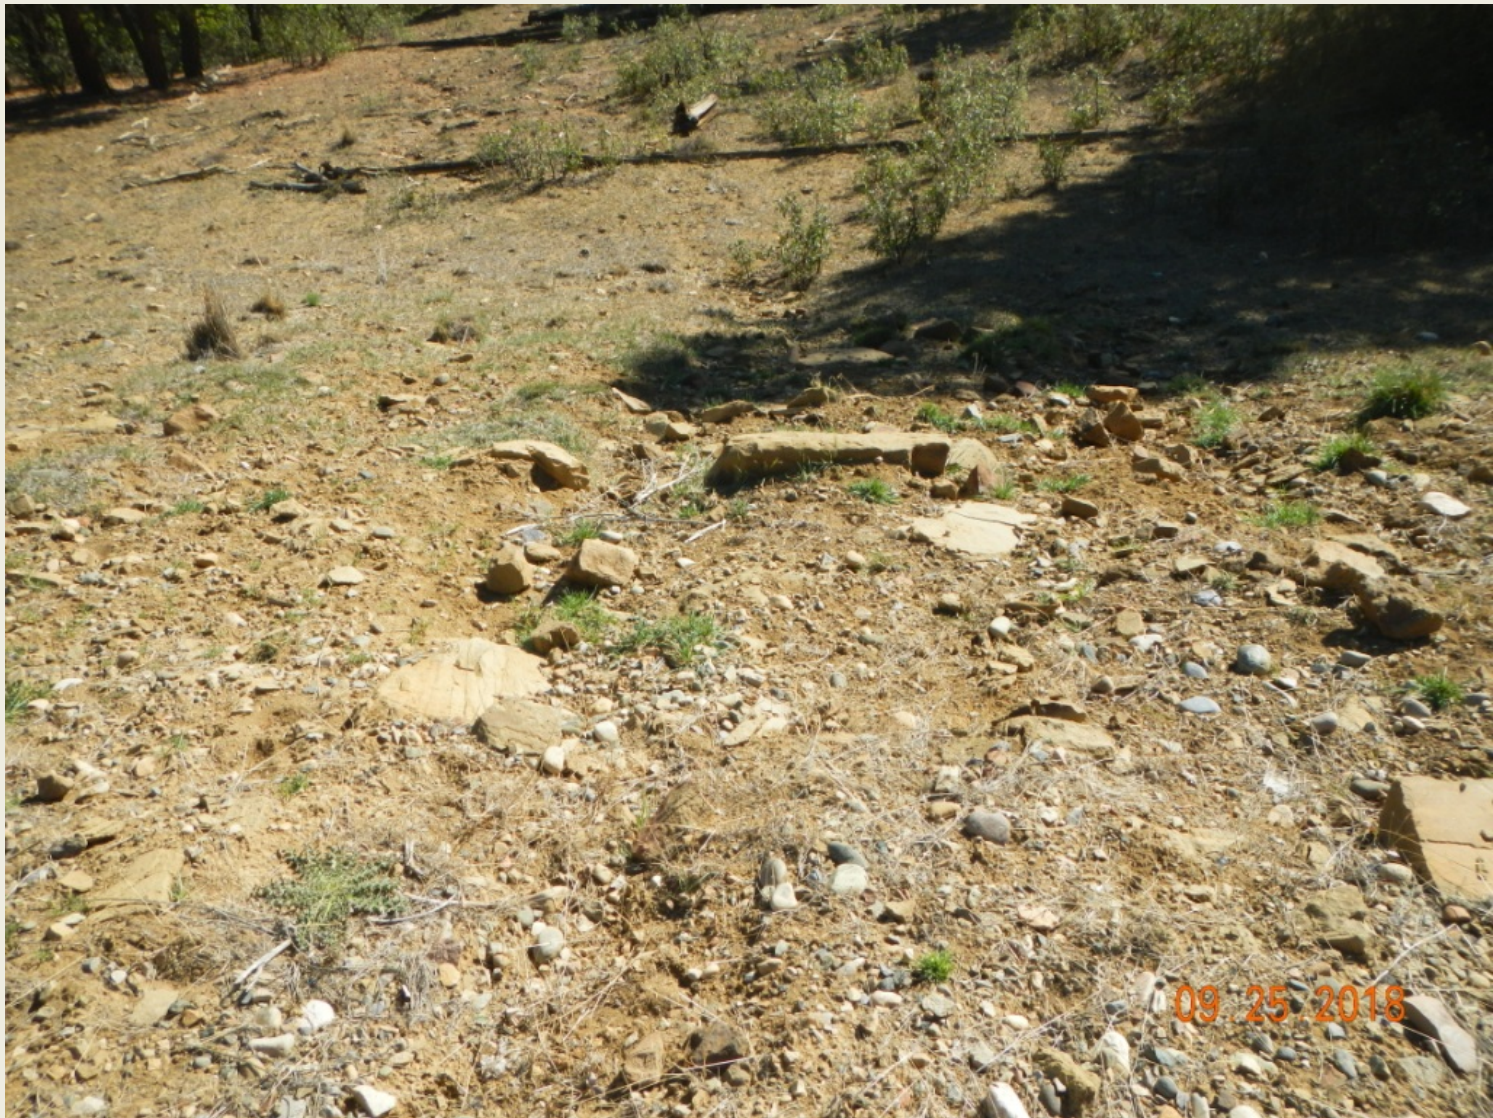
Photo 5. View of erosional rilling in the northeastern project area. It is not apparent whether area is actively eroding and needs to be monitored.
