API# 121-05603
Loc# 316965
Doc# 2303008
Date: 09/20/18

State 3 (API 121-05603, Loc ID 316965)

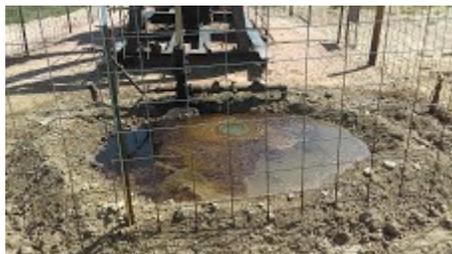
Ward & Son - State 3 121-05603.jpg
3183K

In follow up to our conversation today, please submit a Form 4 to complete the down hole work that you indicated (cemented 4-1/2" liner). Additionally, based on the photos provided by Steve Freese at SLB, and your description that fluid keeps flowing into the hole despite a downhole packer, in accordance with Rule 906, this spill should be reported on a Form 19; please submit as soon as possible--it should have been reported as a spill as soon as the volume reached 1 bbl. COGCC wants to make sure the source is identified and stopped and that any impacts are fully delineated and cleaned up in accordance with the 900-Series Rules.
