Inspection Photos

Operator: BP America

API: 05-067-08880

Date: 9/25/2018

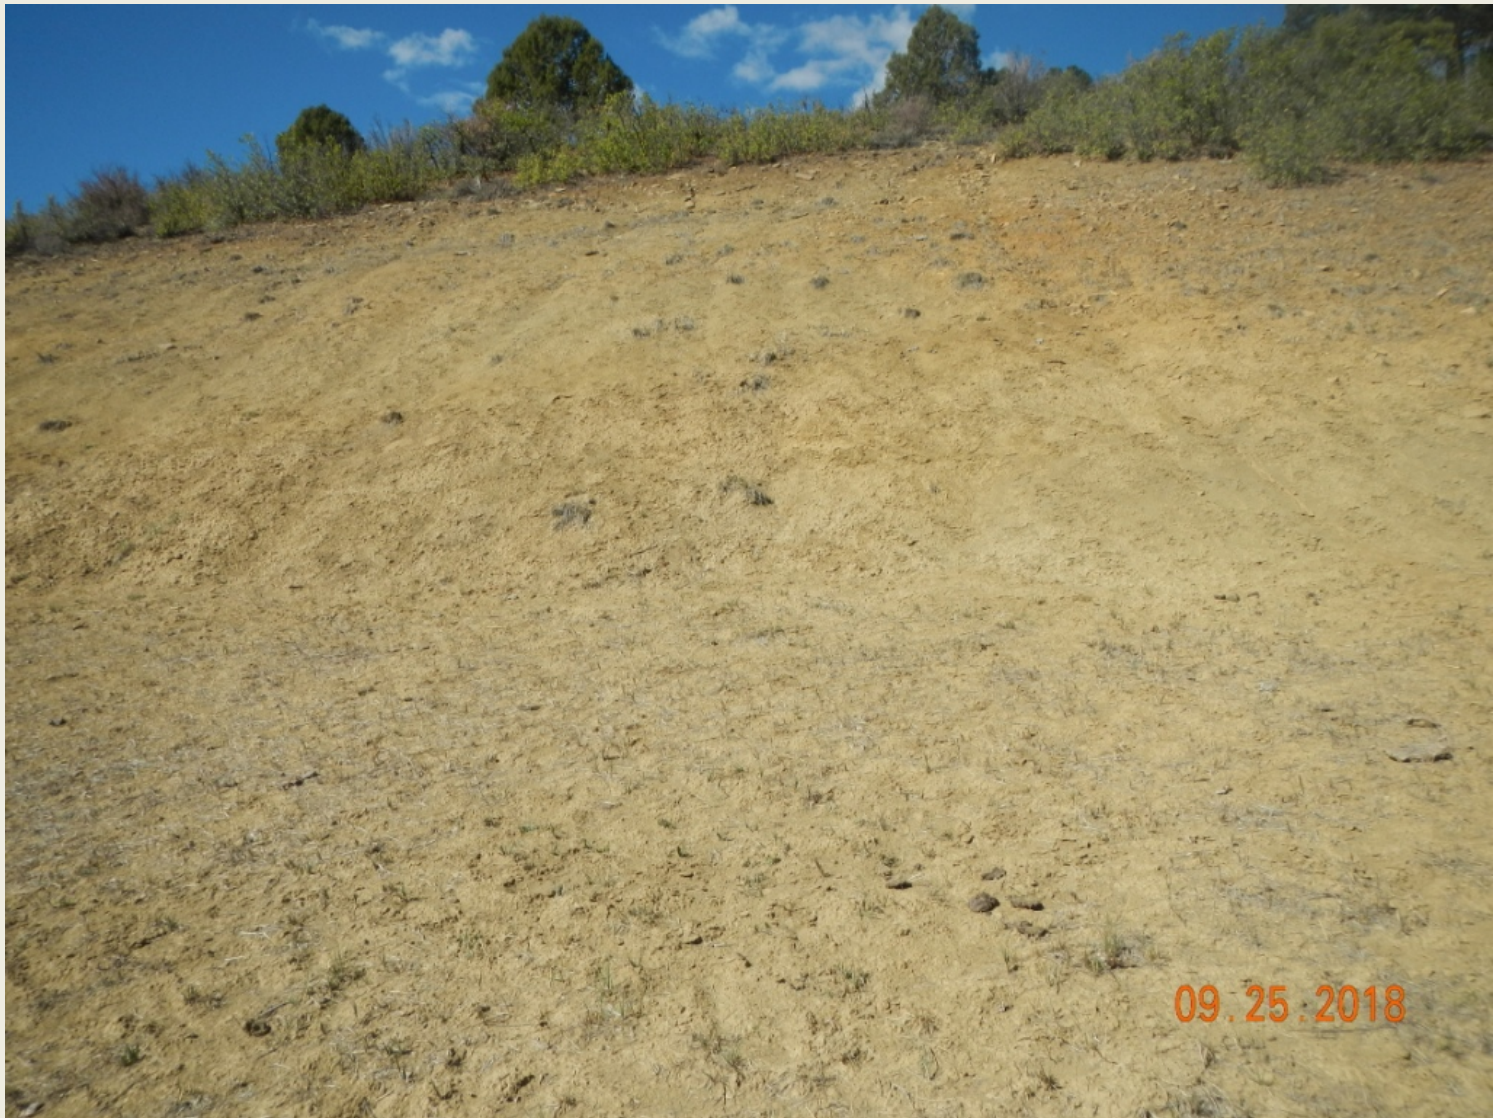
Photo 4. View of area on the western cut-slope with poor revegetation. This needs to be monitored and if revegetation is not progressing , the further seeding and reclamation efforts will be required.

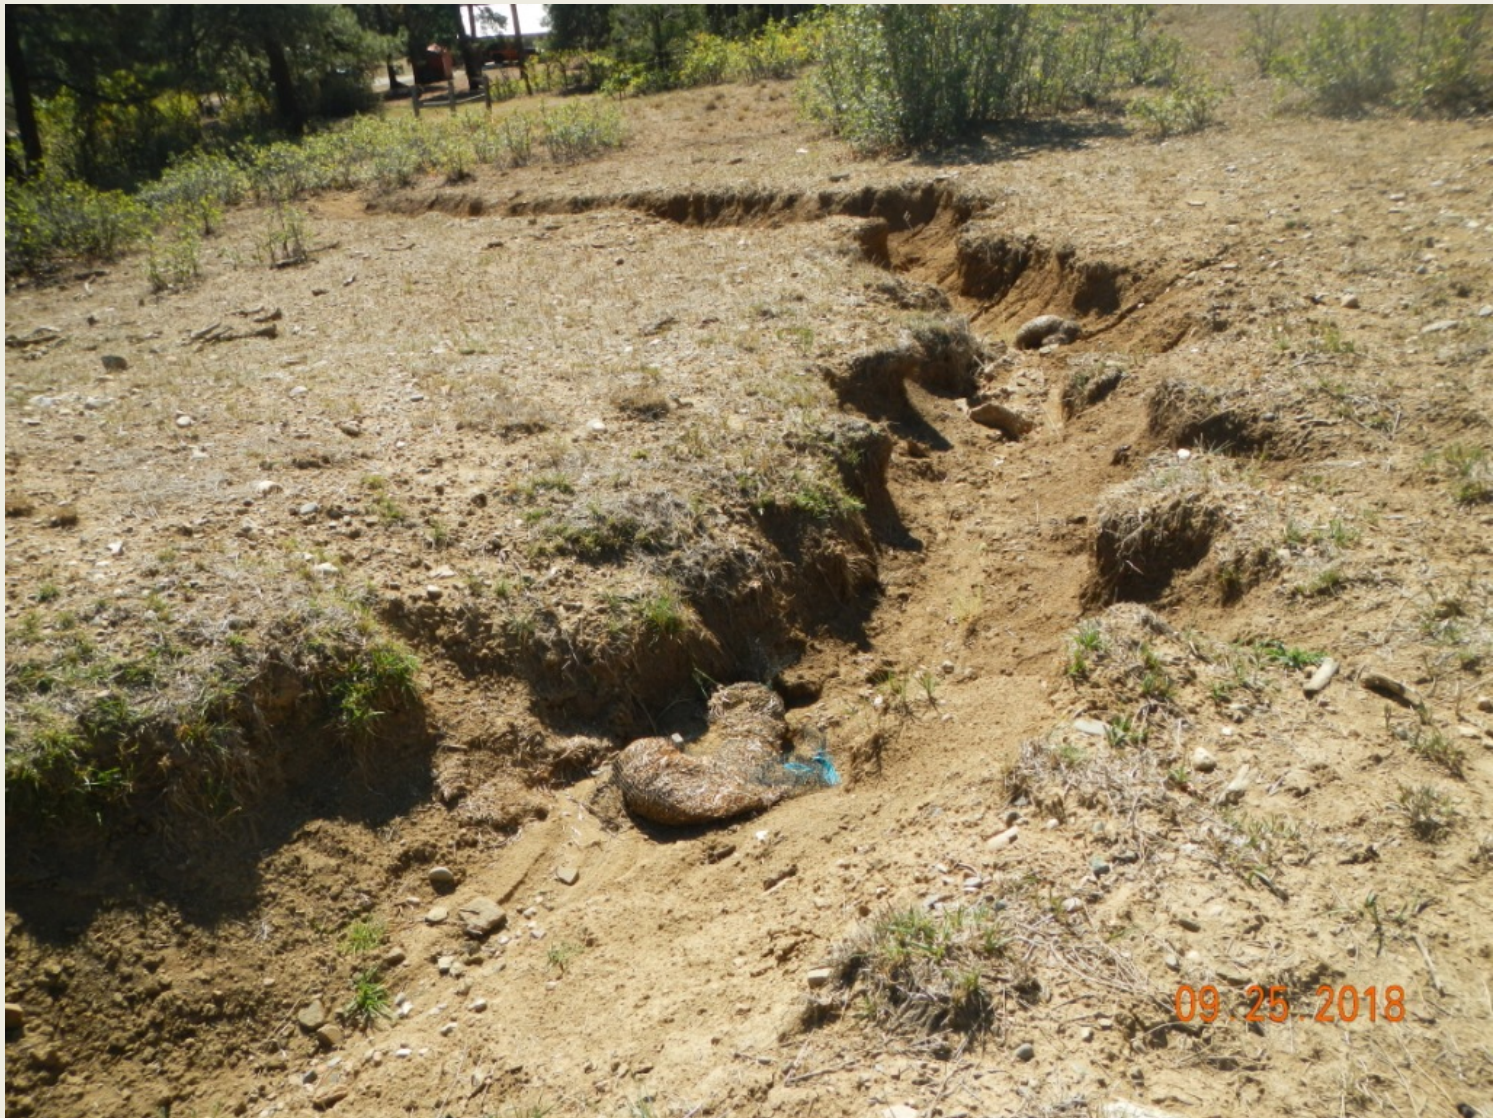
Photo 5. View of erosional channel up to 3 feet deep and 4 feet wide, in the southwestern project area. Wattles are not sufficient for stabilizing this portion of the project area.
