Inspection Photos
Location Name: Shock-Federal 1
API: 05-057-06351

8/25/2017 Inspection document number 689800233

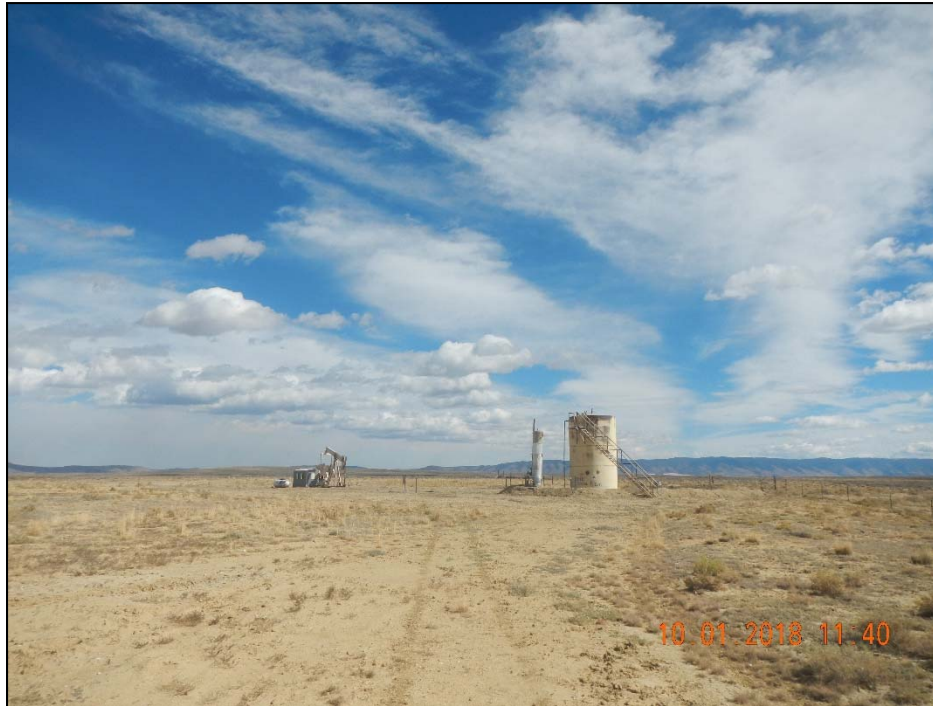
Photo 1. Overview of location taken at entrance facing northeast.

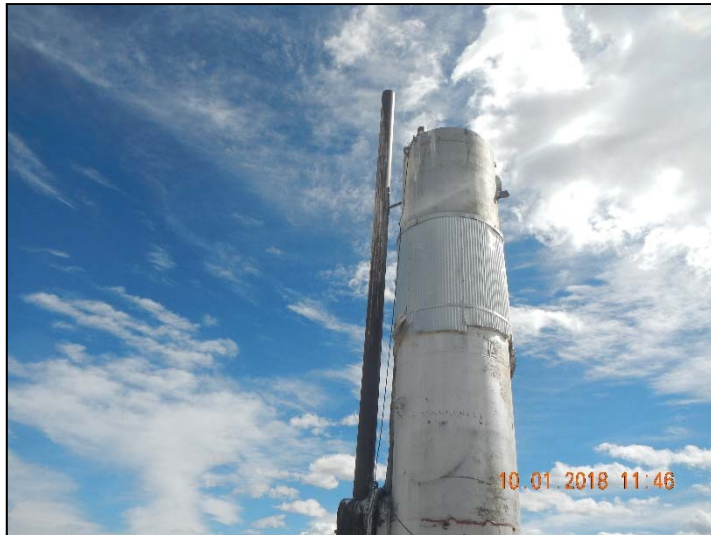
Photo 2. No wildlife protection on separator exhaust.

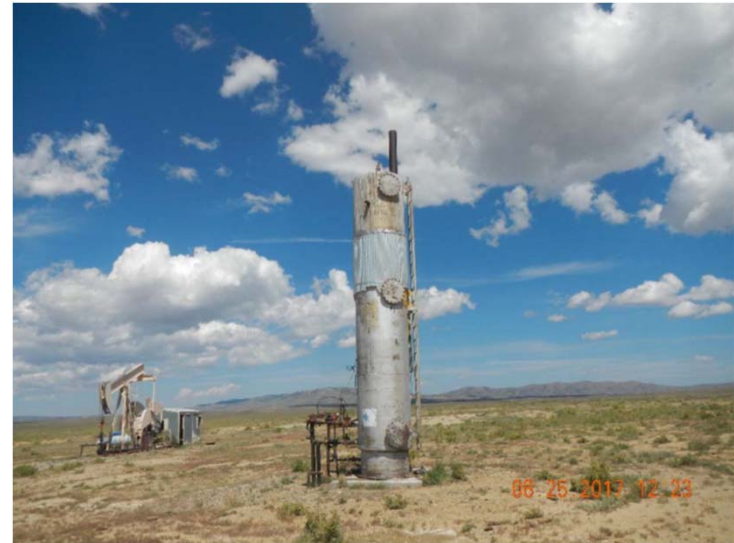
**Photo 3. No wildlife protection on separator exhaust.
8/25/2017 Inspection document number 689800233**

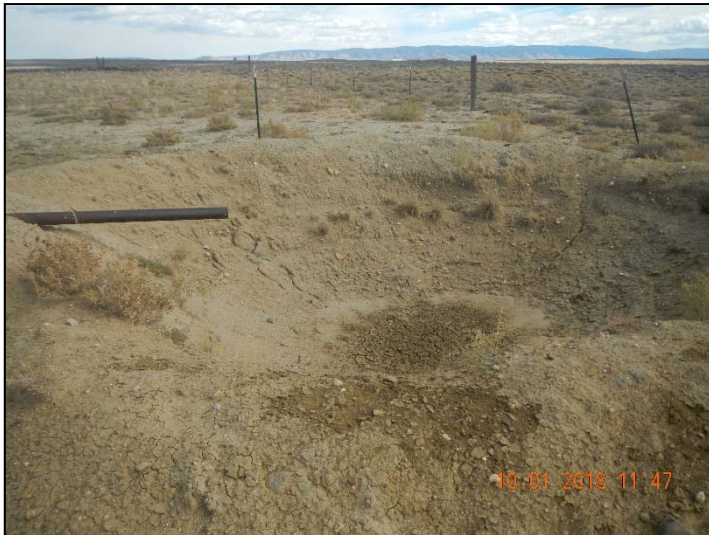
Photo 4. Pit.

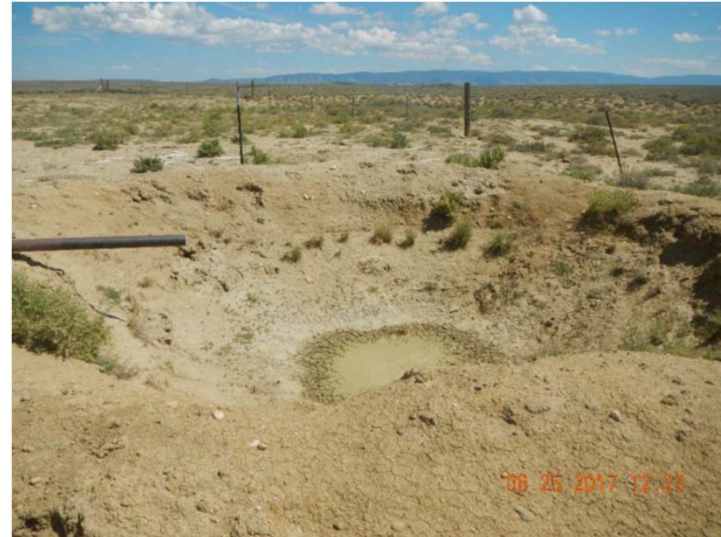
Photo 5. Pit.

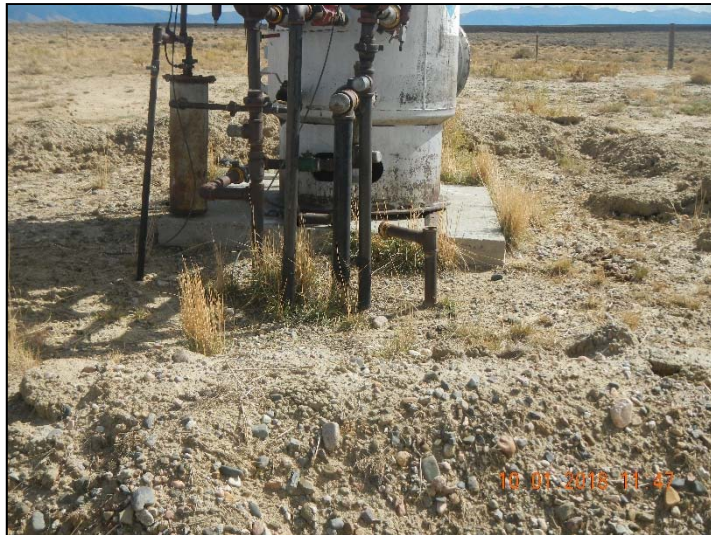
Photo 6. 2" steel riser.

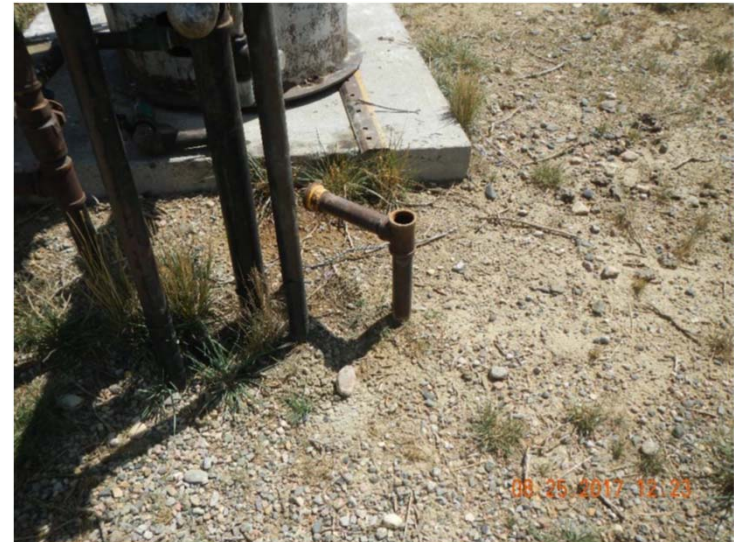
Photo 7. 2" steel riser.

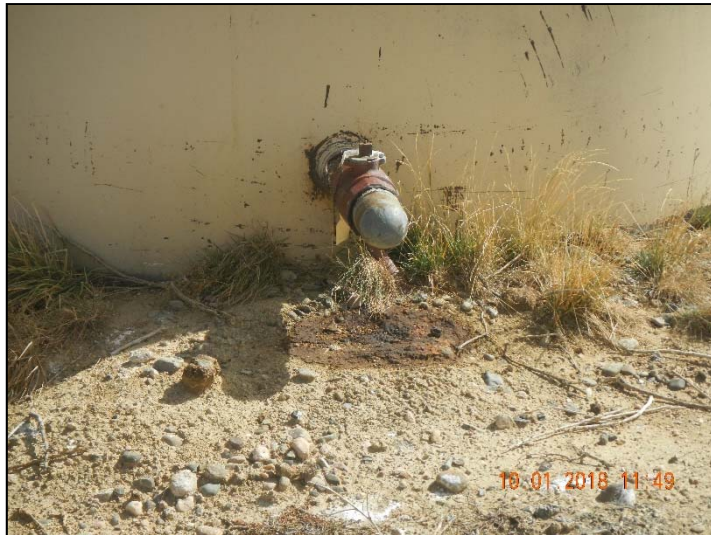
Photo 8. Stained soil at loadout.

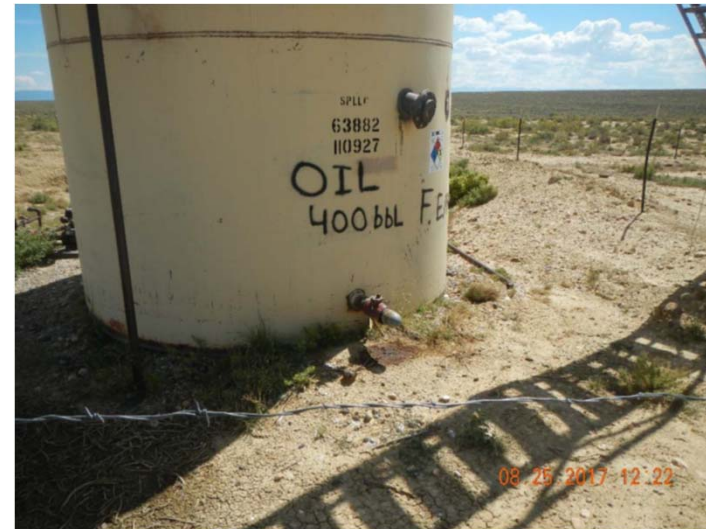
**Photo 9. Stained soil at loadout.
8/25/2017 Inspection document number 689800233**
