Inspection Photos

Operator: BP America

API: 05-067-07069

Date: 9/25/2018

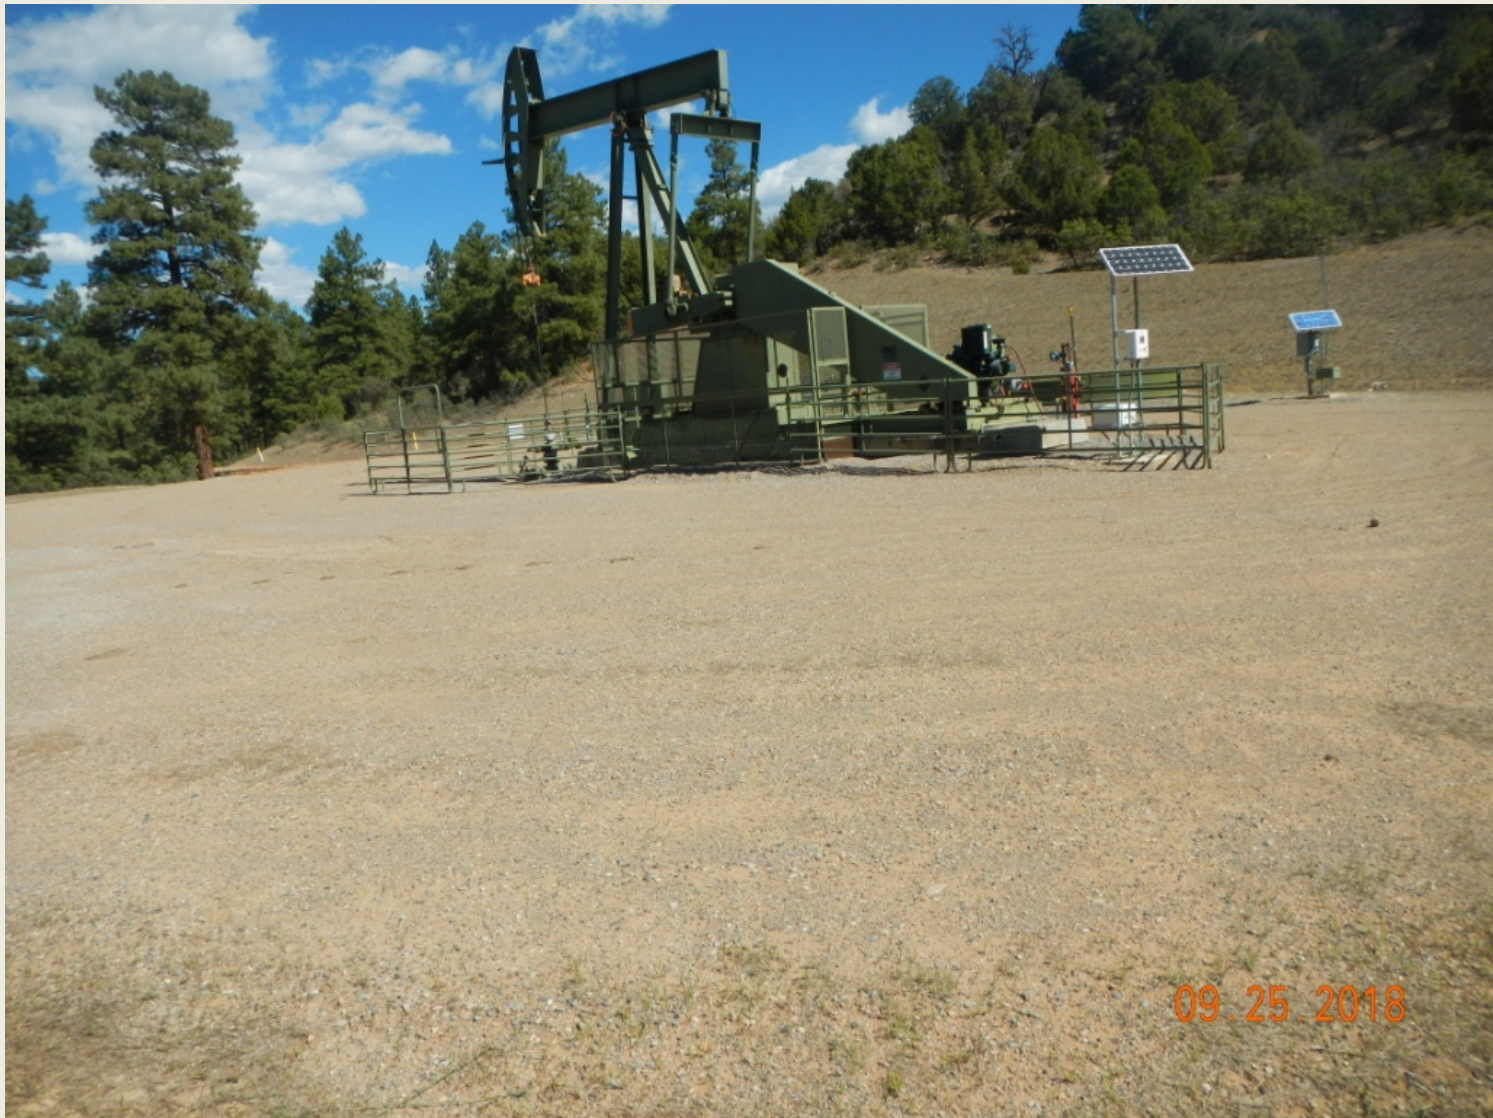
Photo 1. View of the project area from the southwestern corner facing center.

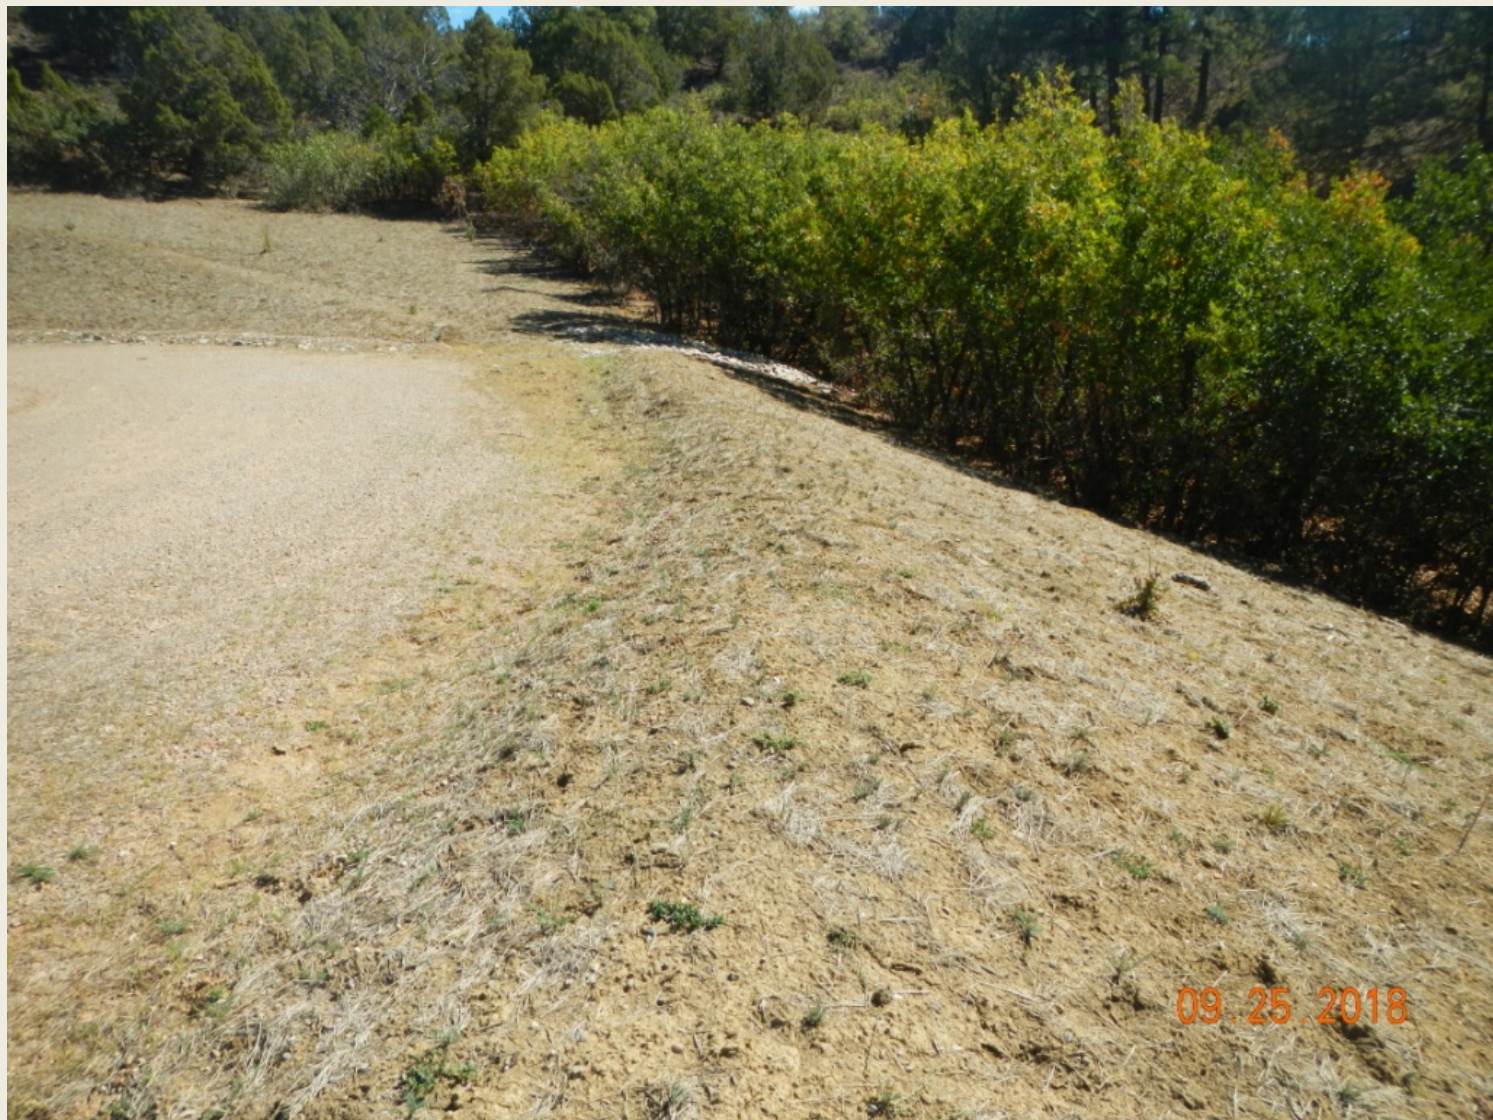
Photo 2. View of the southern project area from the southwestern corner facing eastward.

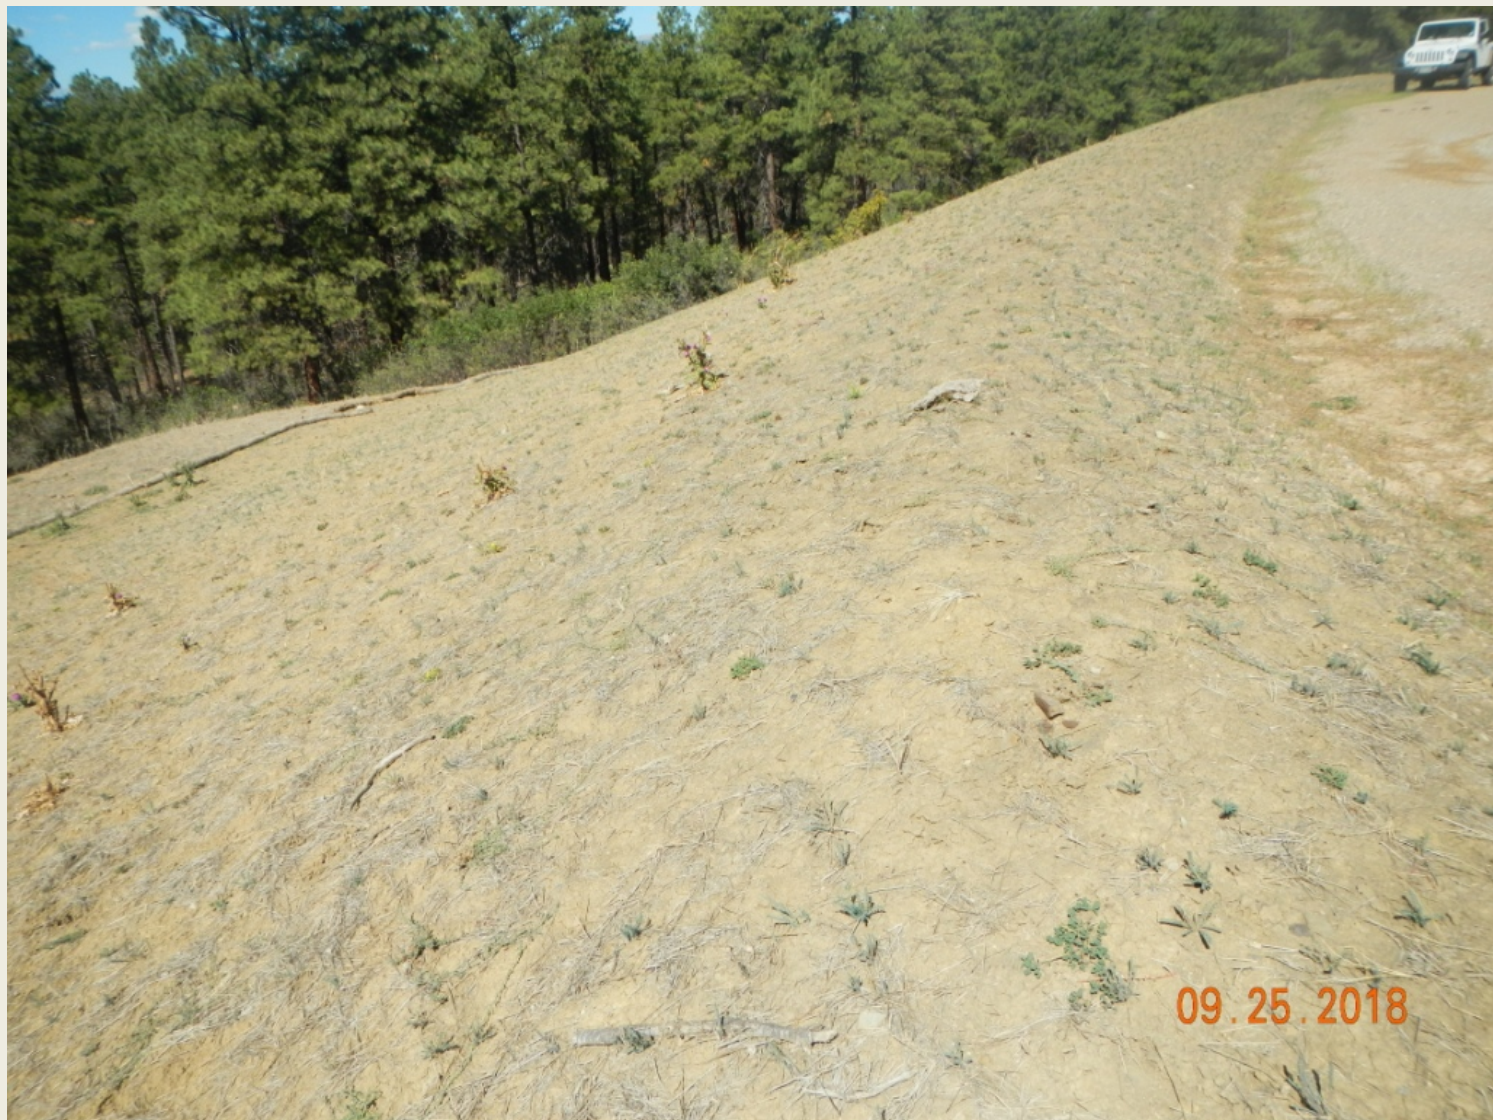
Photo 3. View of the western project area from the southwestern corner facing northward. Interim reclamation areas appear to be recently reclaimed. Grasses and forbs such as western wheatgrass (*Pascopyrum smithii*) and blue flax (*Linum lewisii*) are becoming established. Straw mulch is still in place.

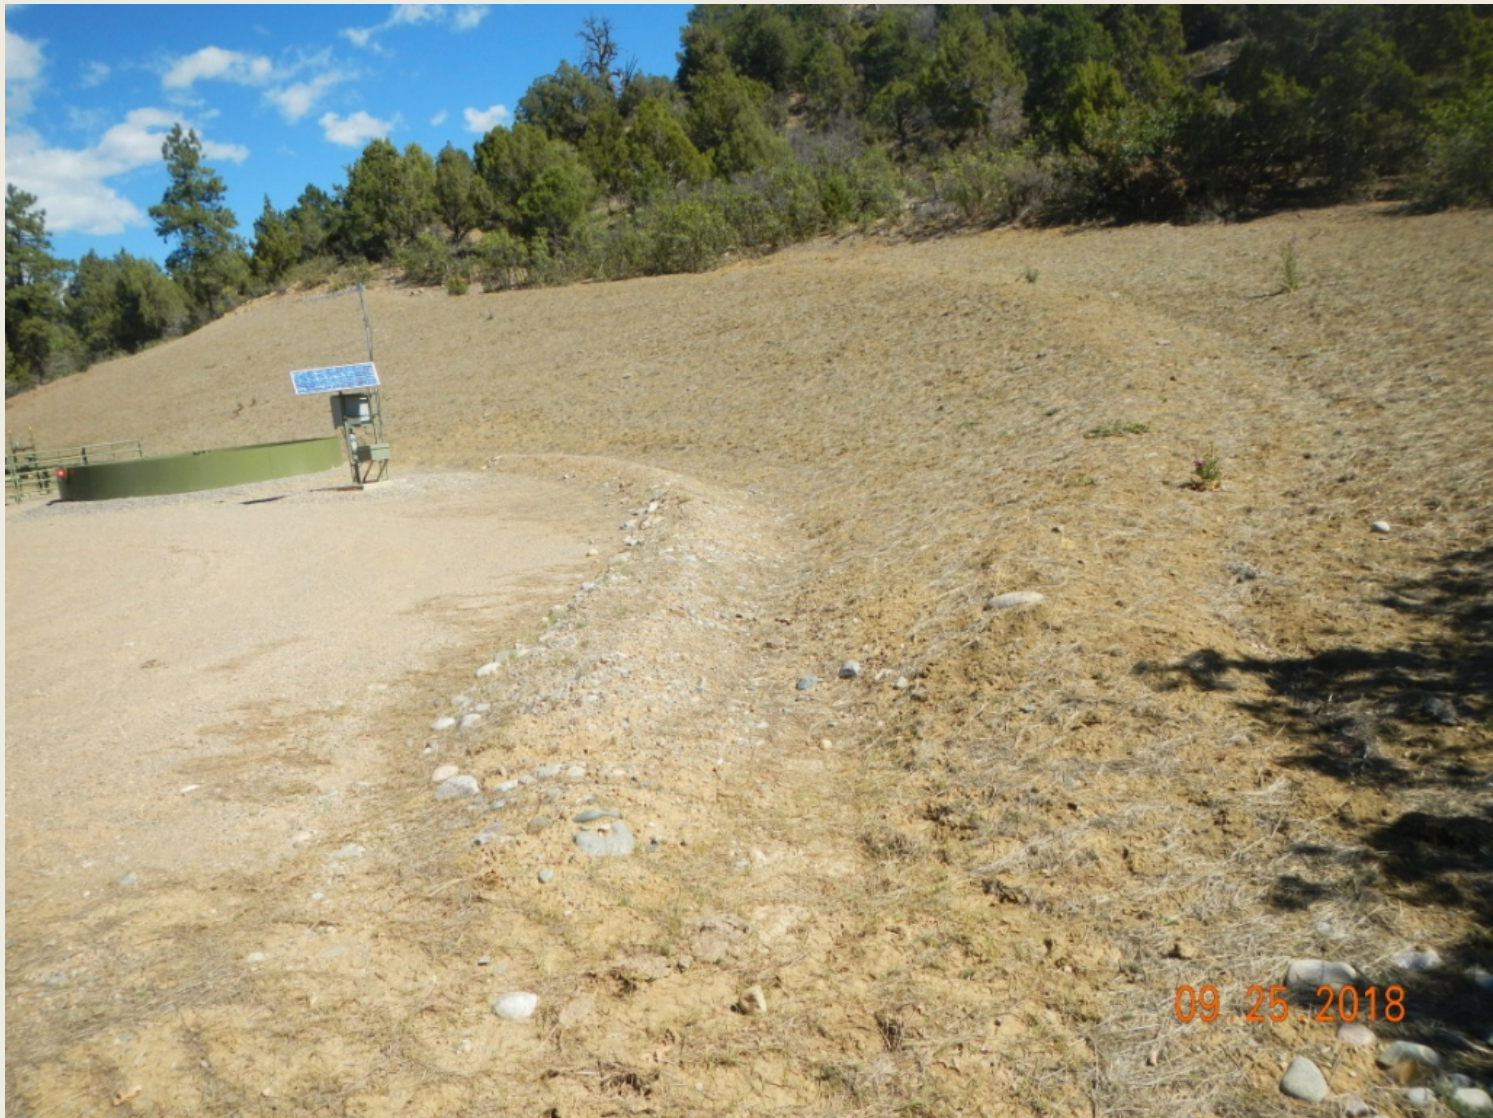
Photo 4. View of the eastern project area from the southeastern project area facing northward.

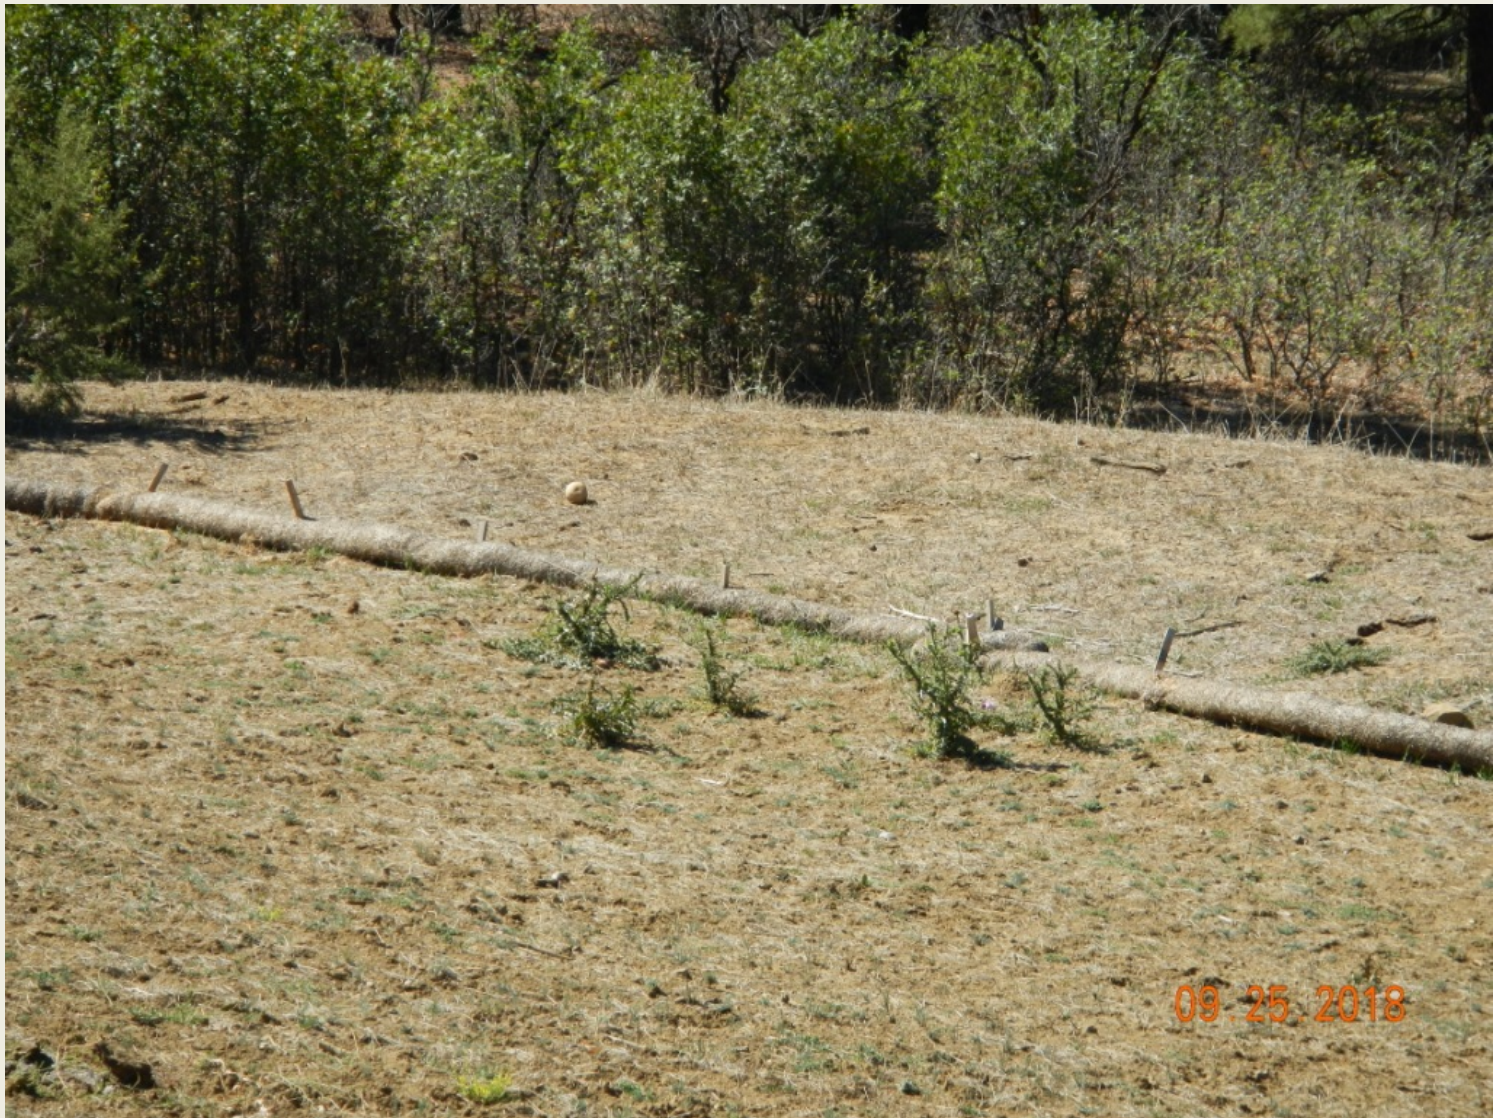
Photo 5. View musk thistles (*Carduus nutans*) within the project area. Approximately 150 individuals observed.

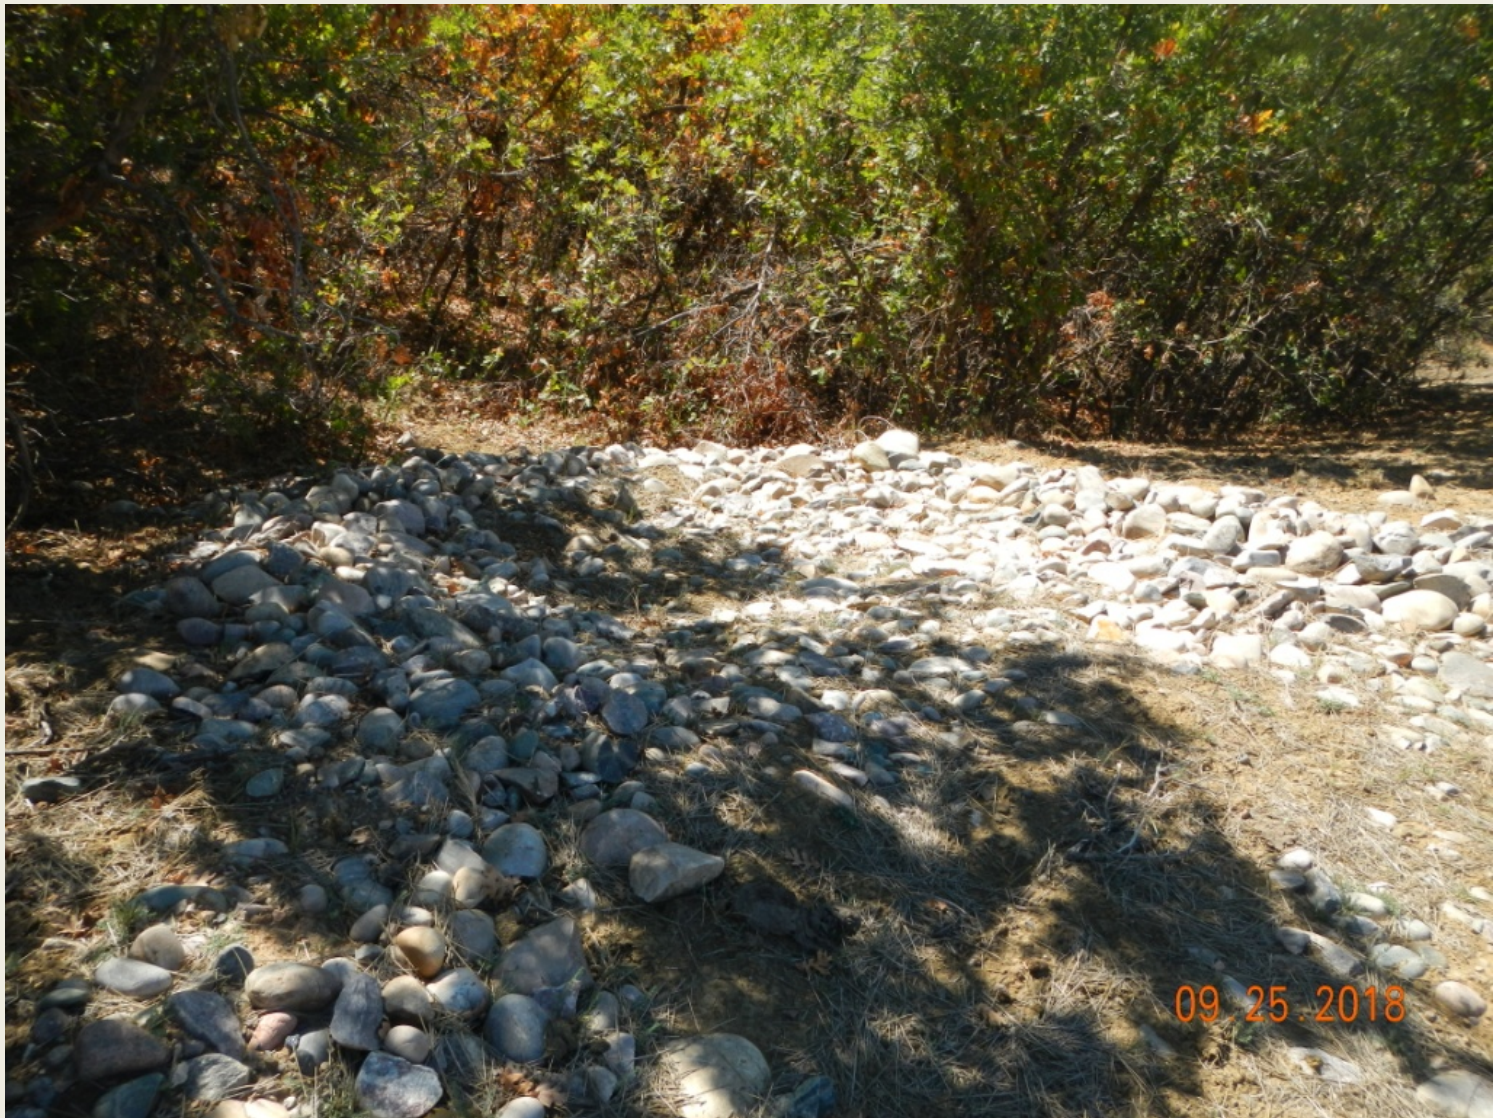
Photo 6. View of cobble run-down in the southeastern project area, appears to be functioning at this time.
