Interim Reclamation and Stormwater Inspection

Operator: LONGS PEAK RESOURCES LLC- #10611

Location ID: 438066

Inspection Document #: 682404010

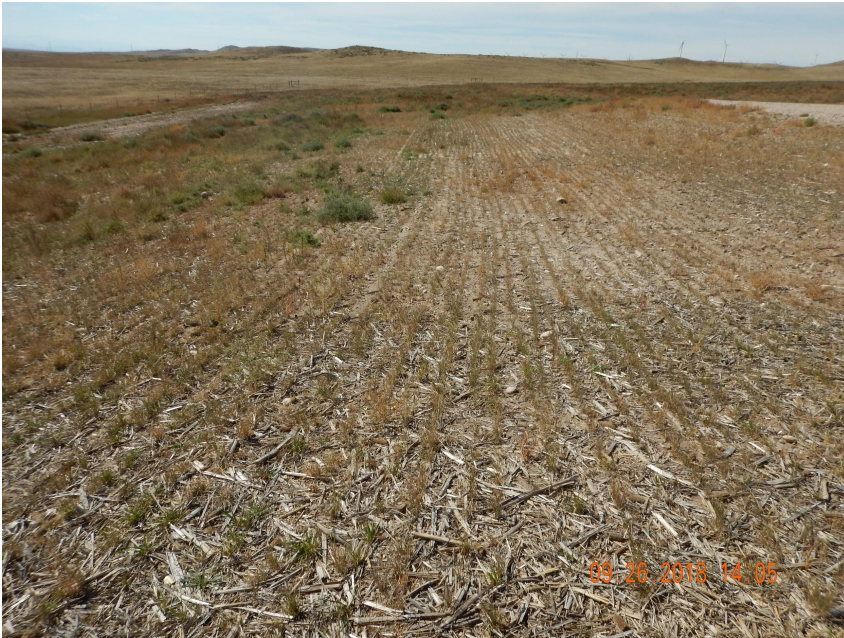
Photo 1. Photo taken from the southern location, facing West. Germination of desirable species was observed. At a minimum, the Operator needs to control the weedy, annual vegetation (Russian thistle) per Rule 603.f. Some areas were observed with little to no germination which may require additional work if no progress is observed.

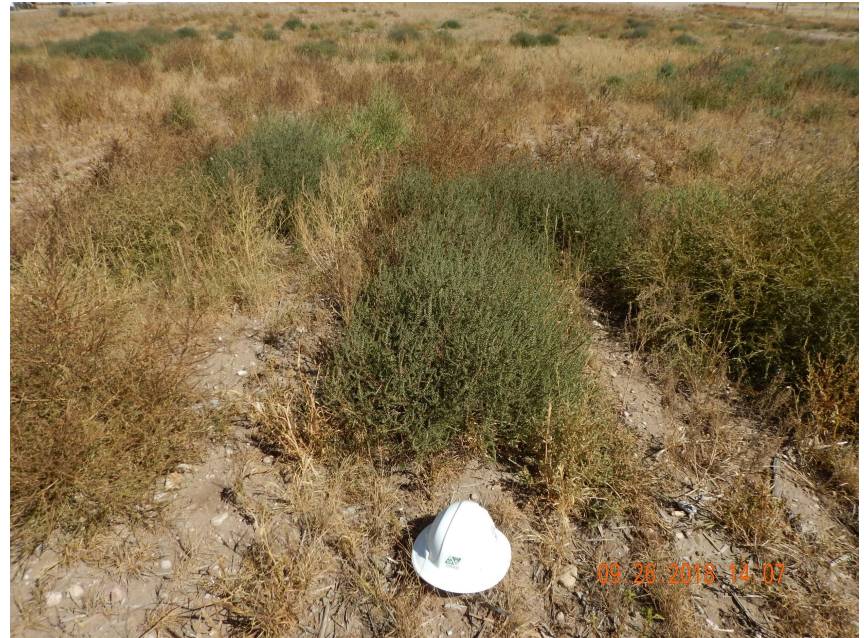
Photo 2. Photo taken from the southwestern location, facing East. Photo illustrates weedy, annual vegetation (Russian thistle). See comments under Photo 1.

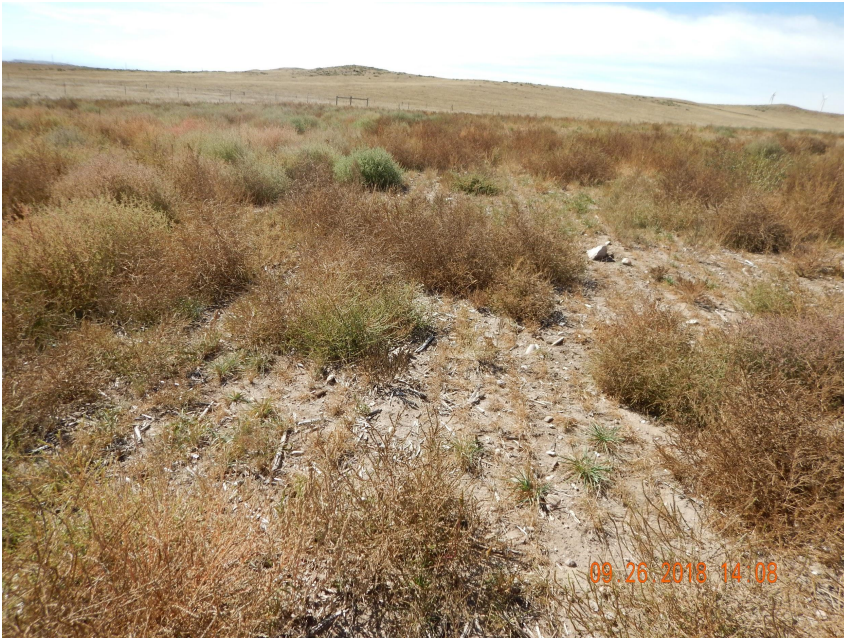
Photo 3. Photo taken from the southwestern location, facing West. See comments under Photo 1.

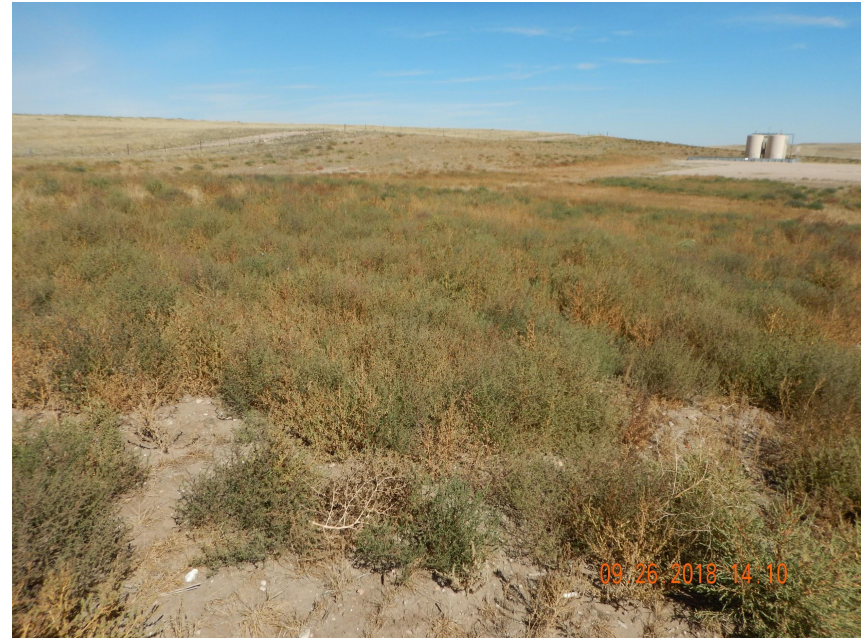
Photo 4. Photo taken from the western location, facing East. See comments under Photo 1.

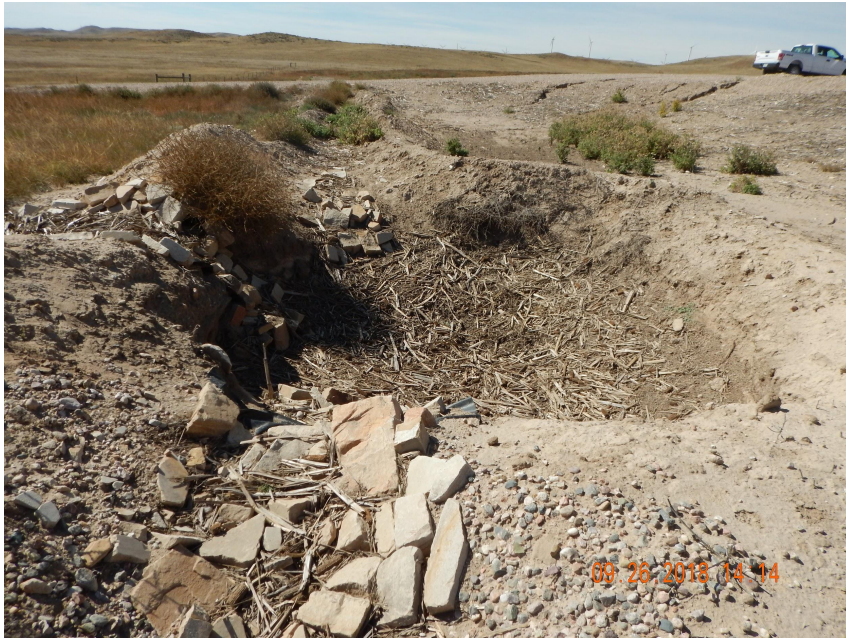
Photo 5. Photo taken from the southern location, facing West. Stormwater BMP maintenance is required as the sediment trap is not in proper functioning condition.

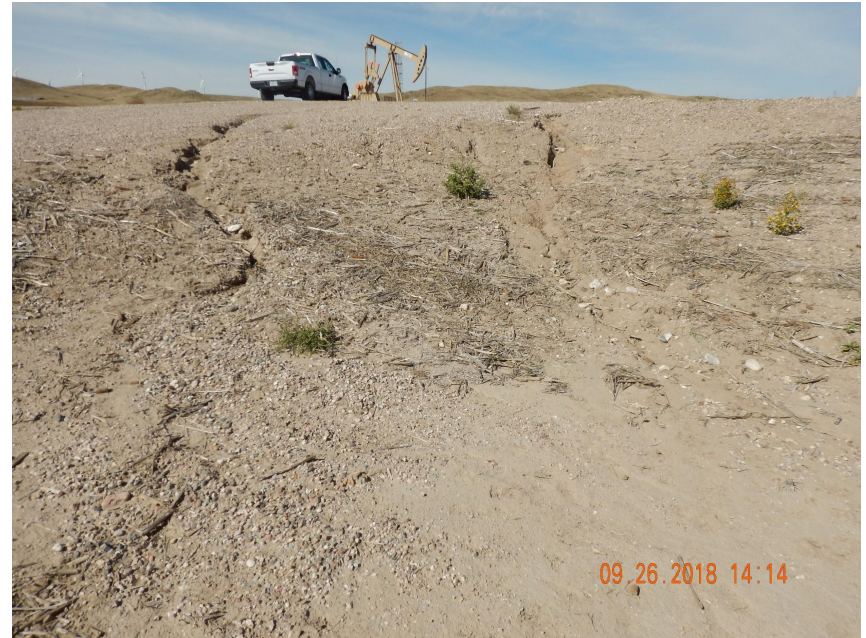
Photo 6. Photo taken from the southern location, facing North. Rill erosion forming along the southern fill slope. Stormwater repairs are required.
