Inspection Photos

Operator: BP America

API: 05-067-06904

Date: 9/25/2018

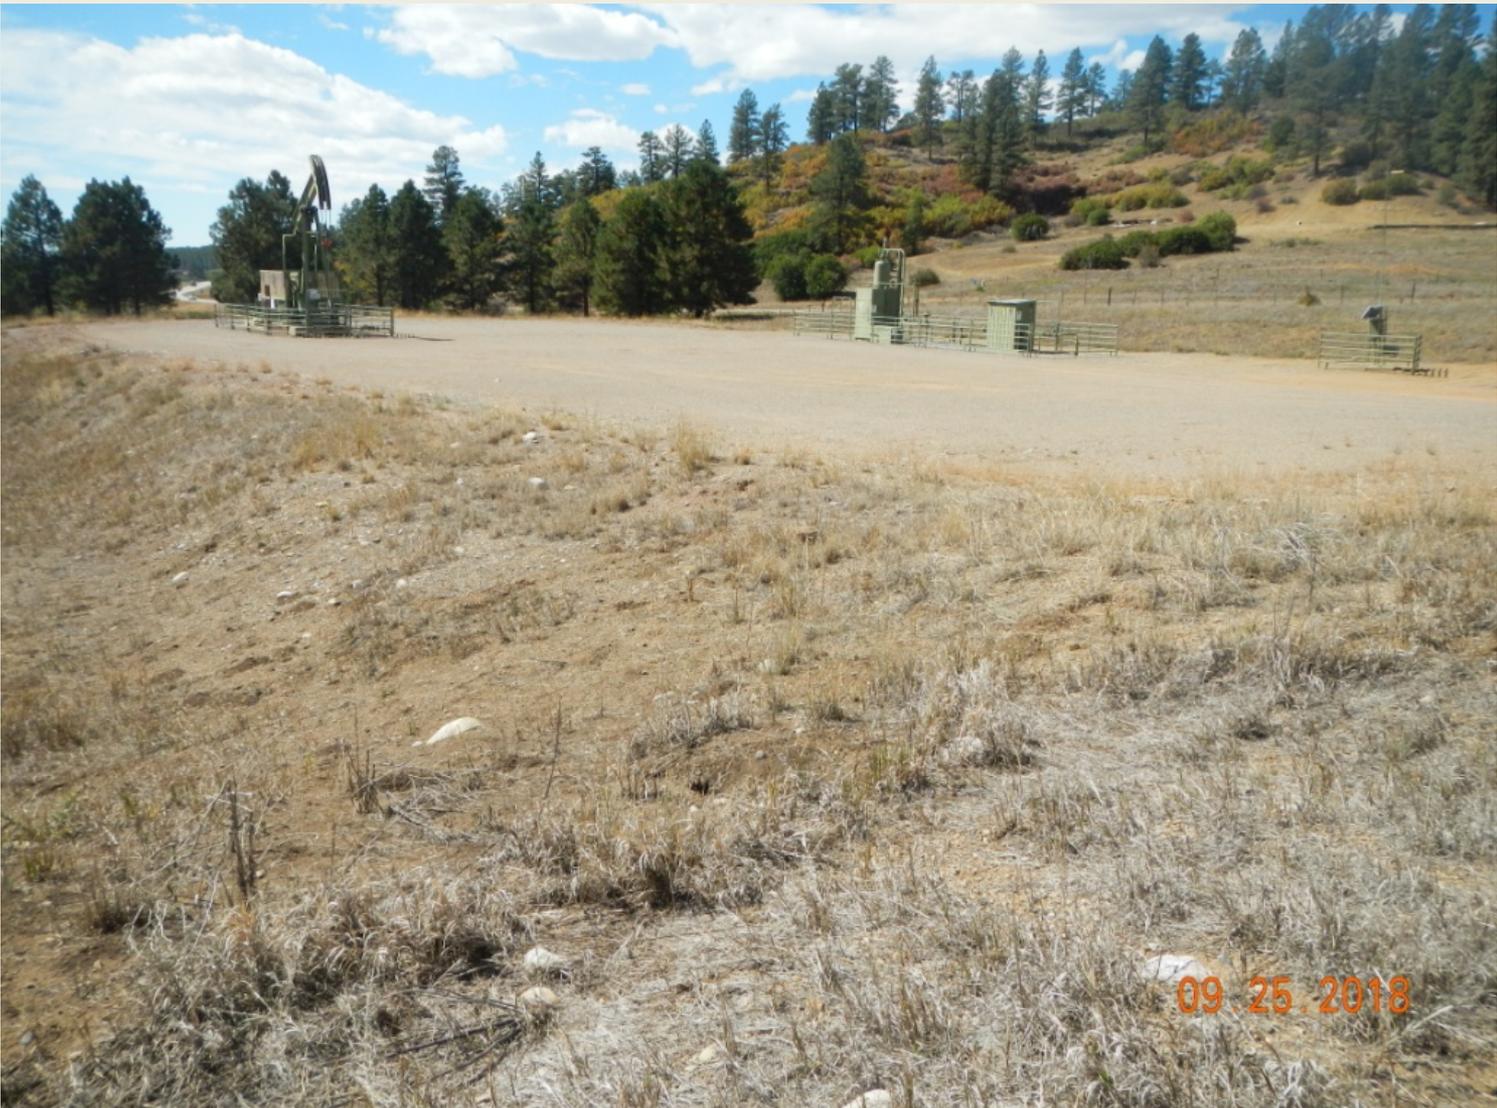
Photo 1. View of the project area from the northeastern corner facing center.

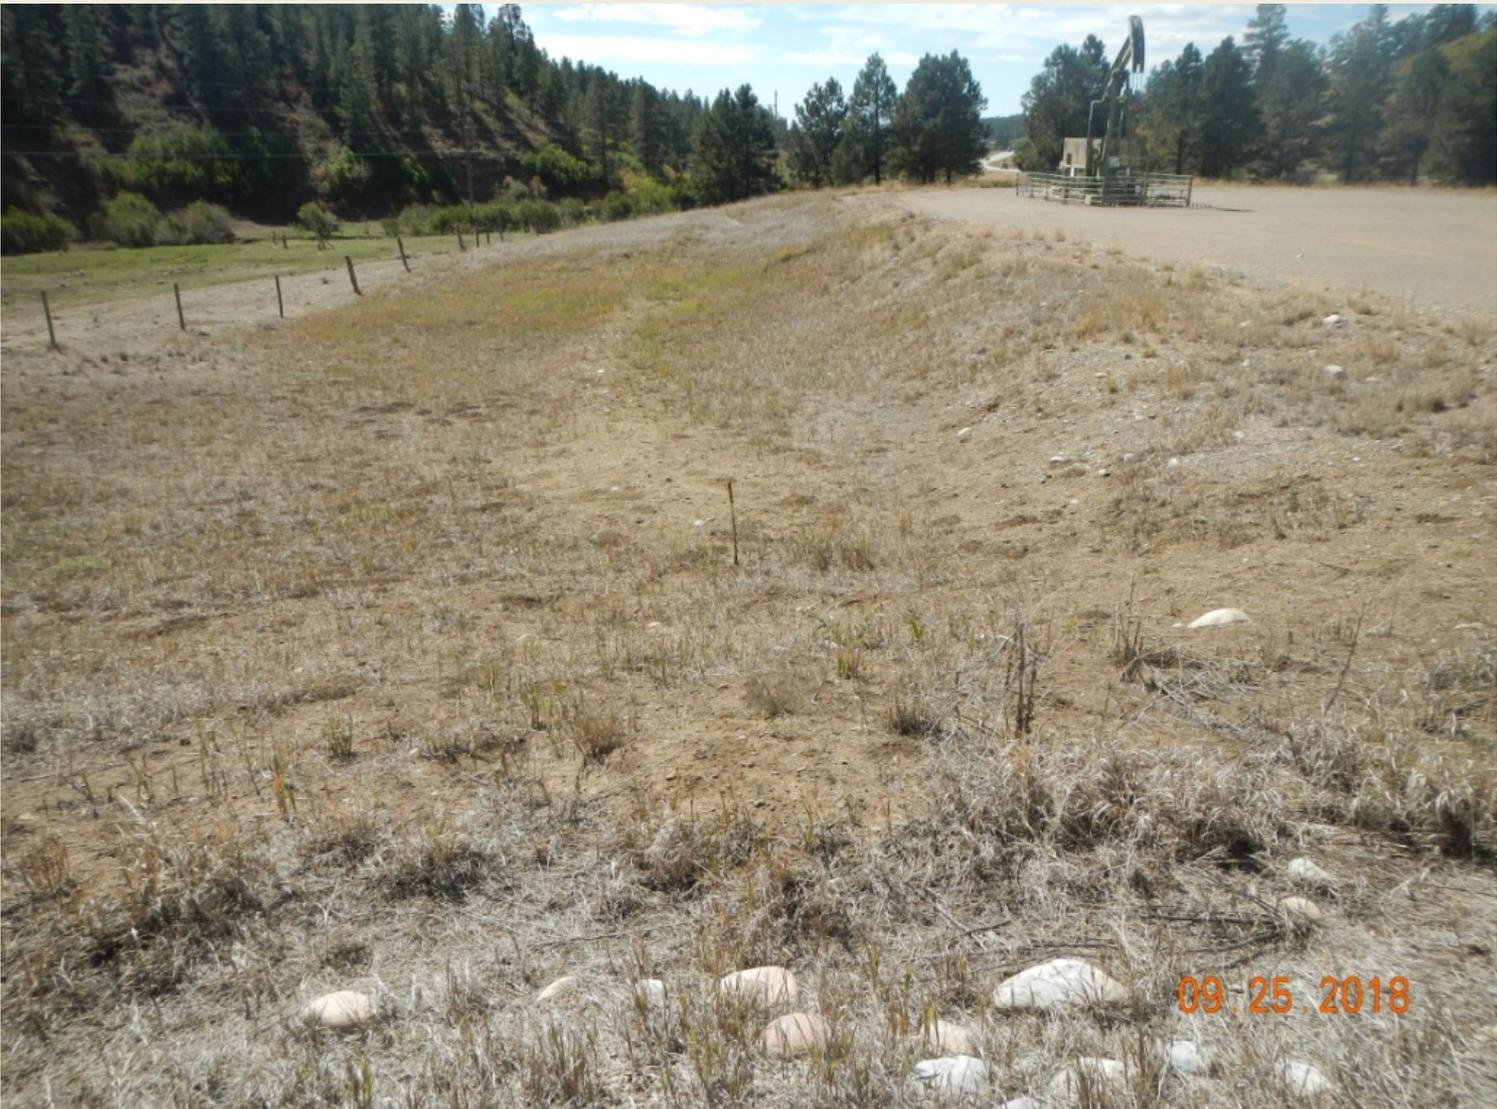
Photo 2. View of the eastern project area from the northeastern corner facing southward. Revegetation is progressing, largely with grasses such as smooth brome (*Bromus inermis*).

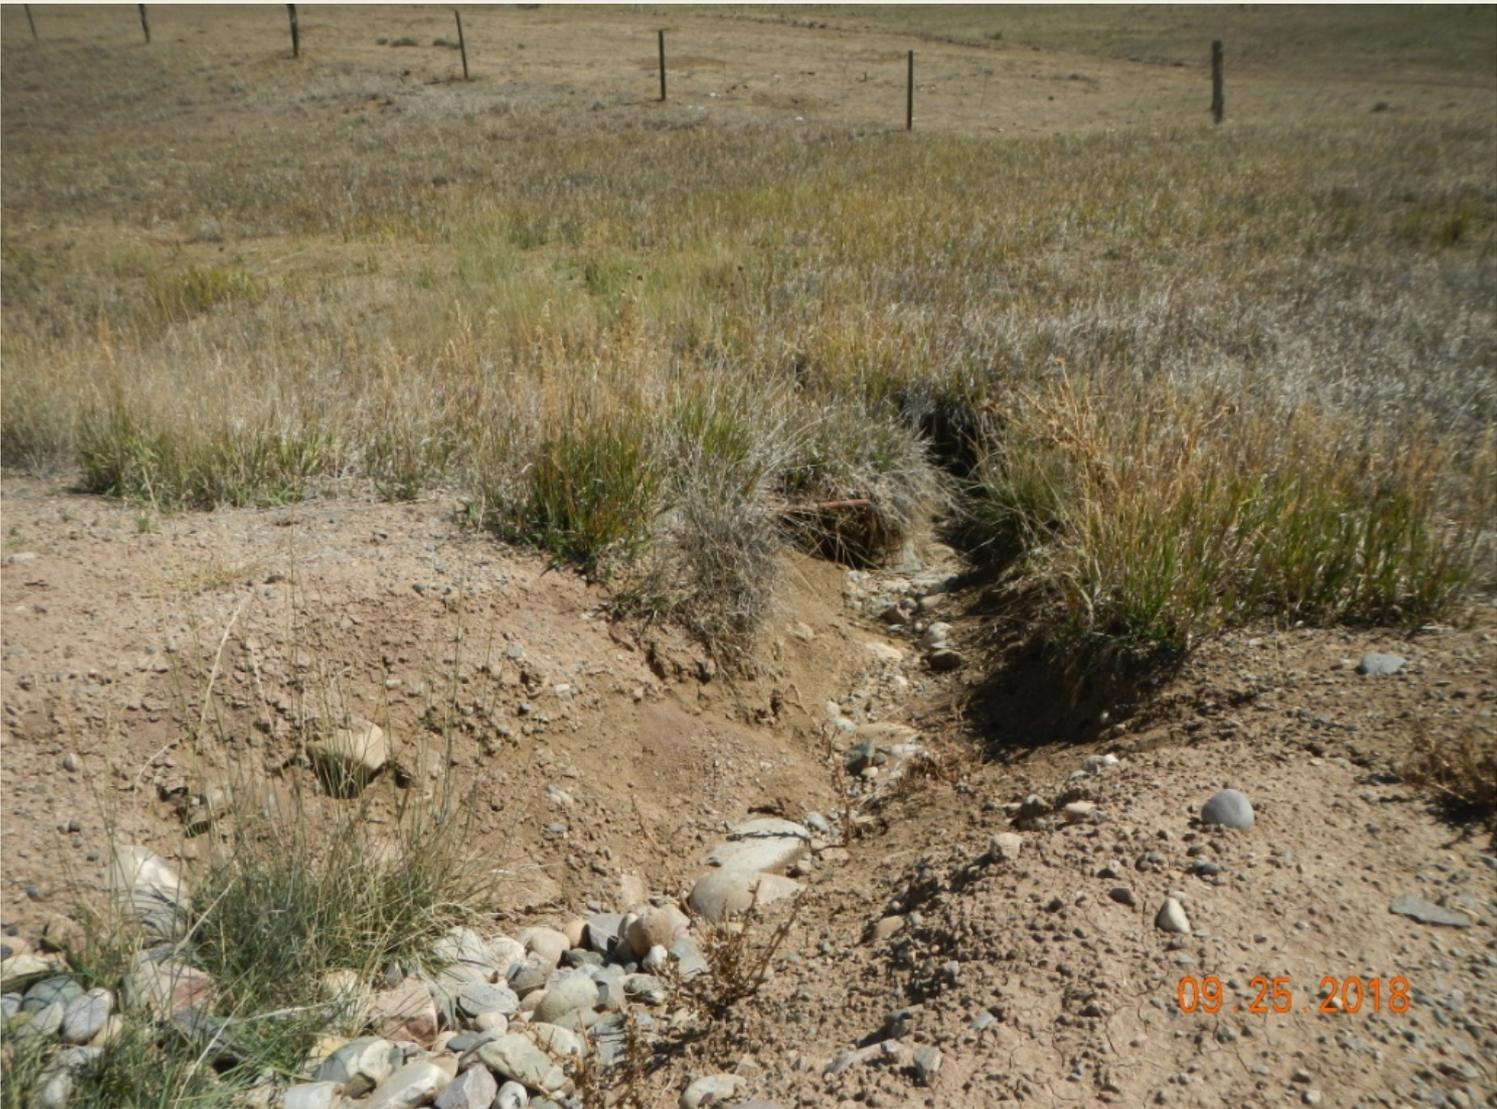
Photo 3. View of erosional channel in the eastern fill slope, appears to be partially stabilized with cobble. This needs to be monitored and additional erosion controls applied if active erosion is occurring.

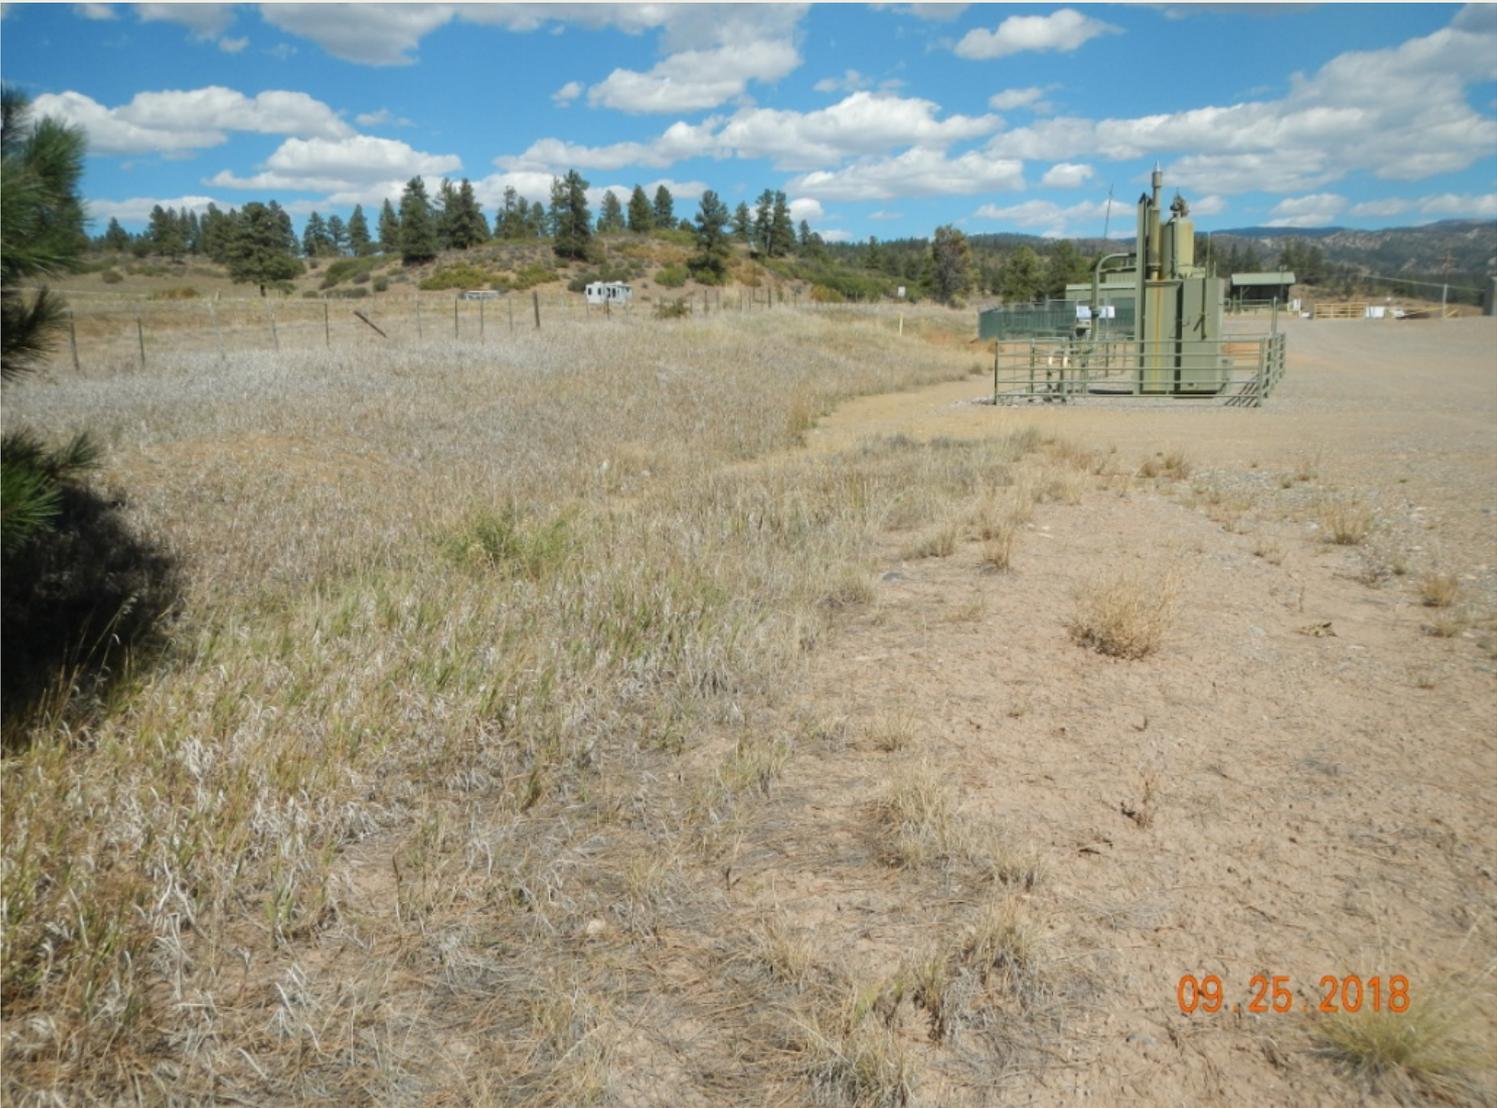
Photo 4. View of the western project area from the southwestern corner facing northward.
