**Inspection Photo
Clough RWF 43-15
API # 045-11180
Inspection # 689302056**

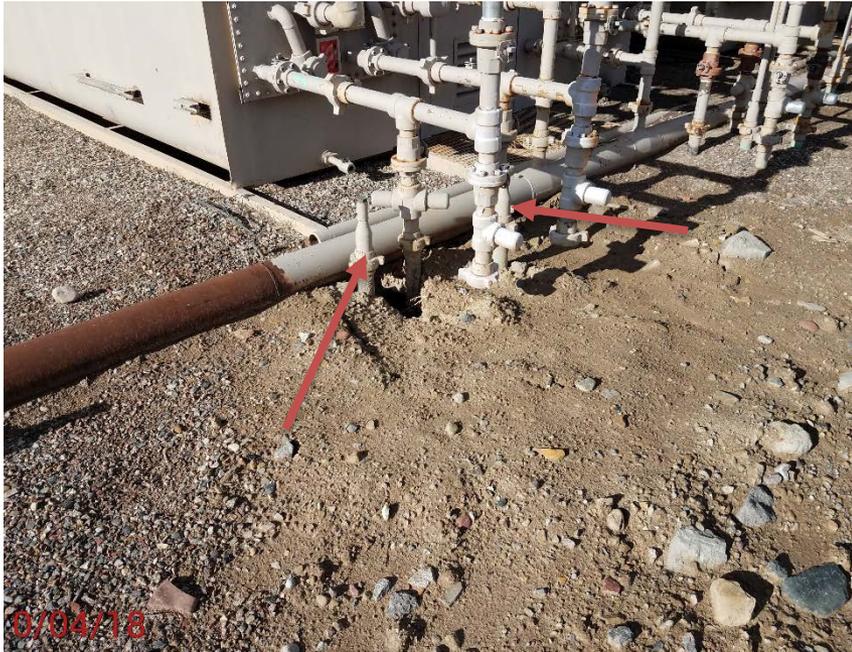
Location Photo #3, 2 unmarked/unused flow line risers

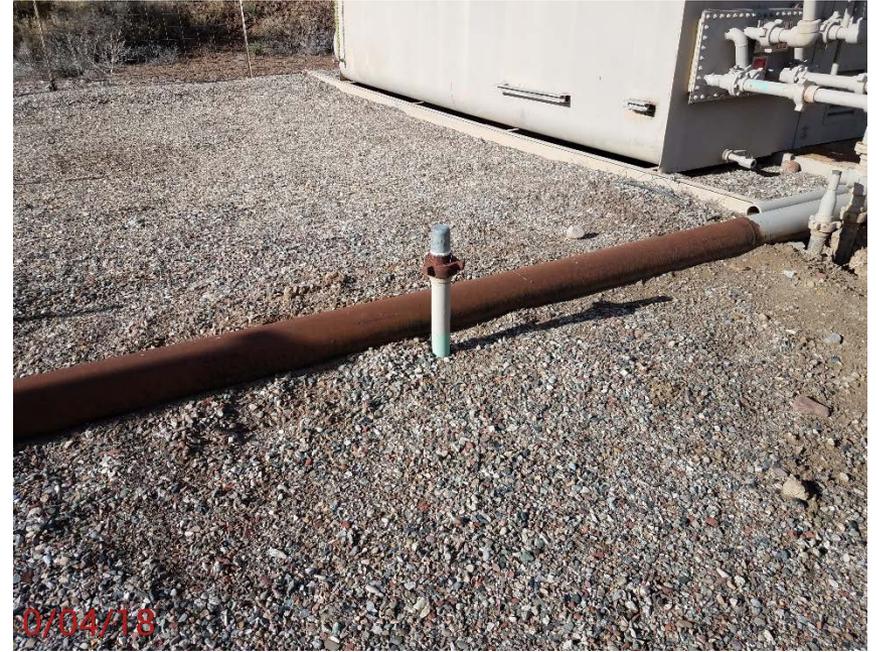
Location Photo #4, unmarked/unused flow line riser

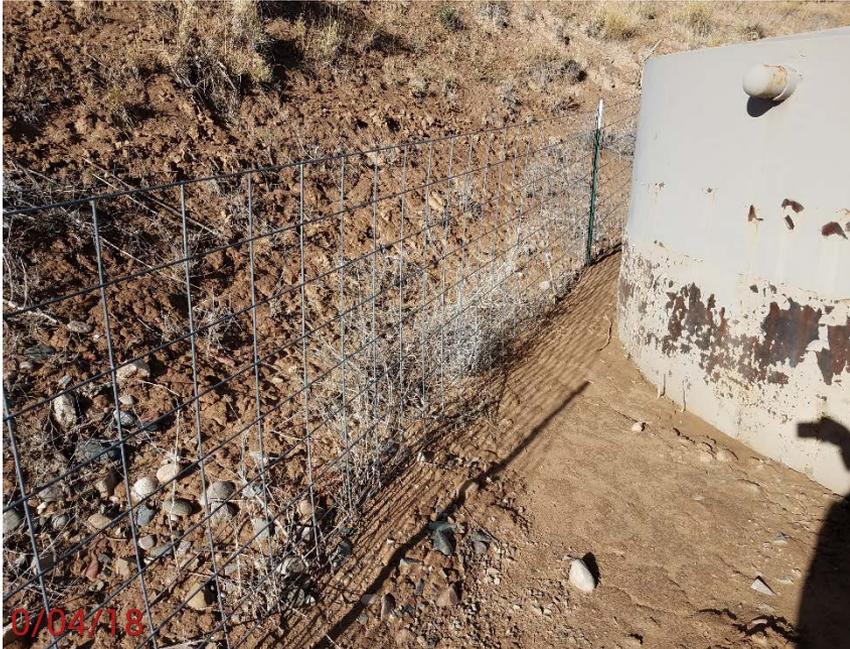
Location Photo #5, Sediment moving onto location

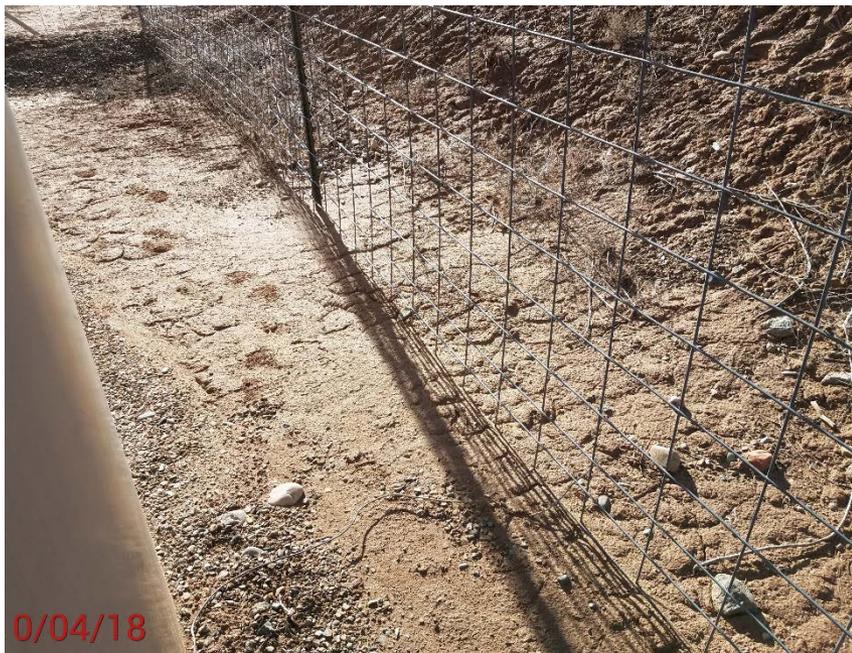
Location Photo #7, sediment being moved onto location.

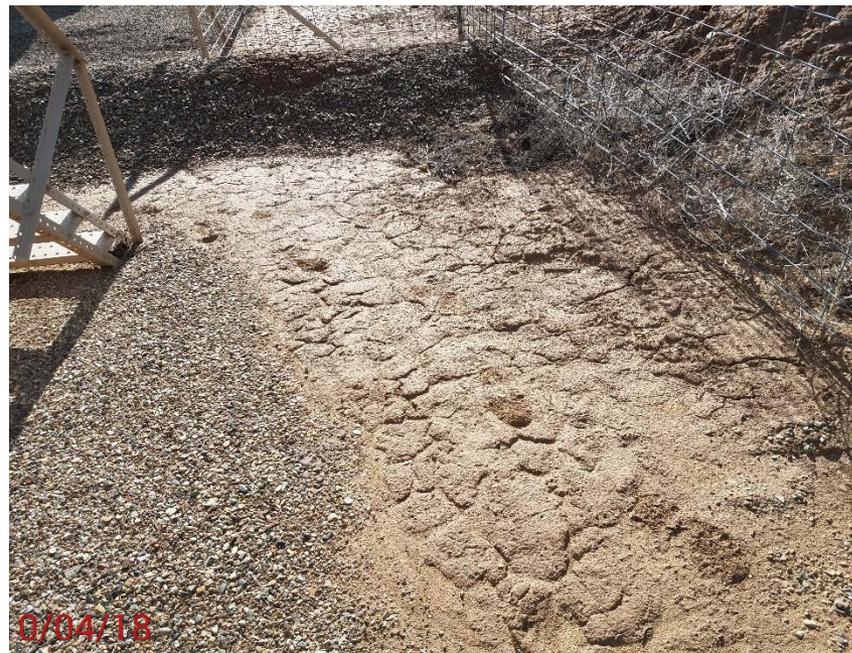
Location Photo #8, sediment being moved onto location.

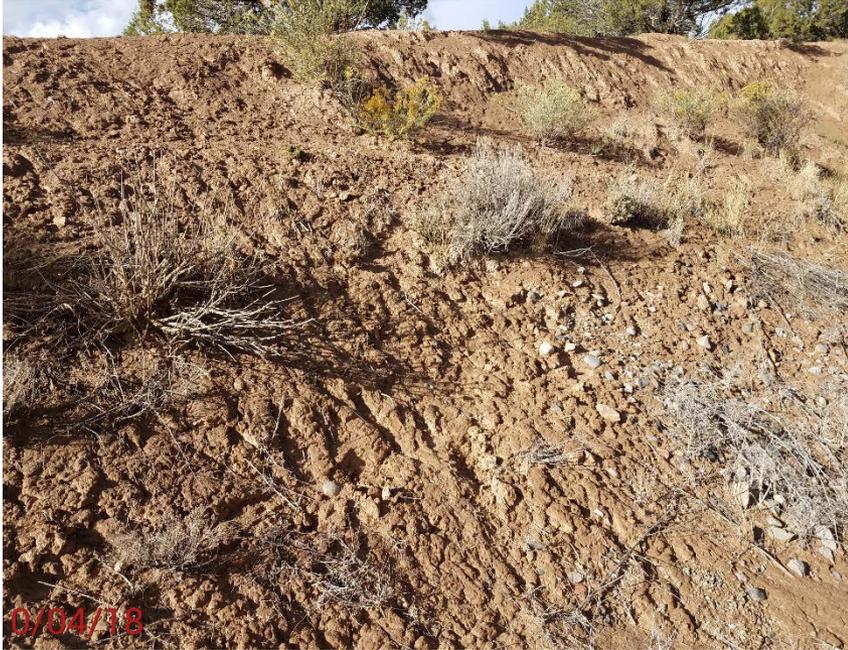
Location Photo #9, non stabilized slope near south side of battery.
