**GM 42-27**  
**Api# 045-07593**  
**Inspection # 689701882**

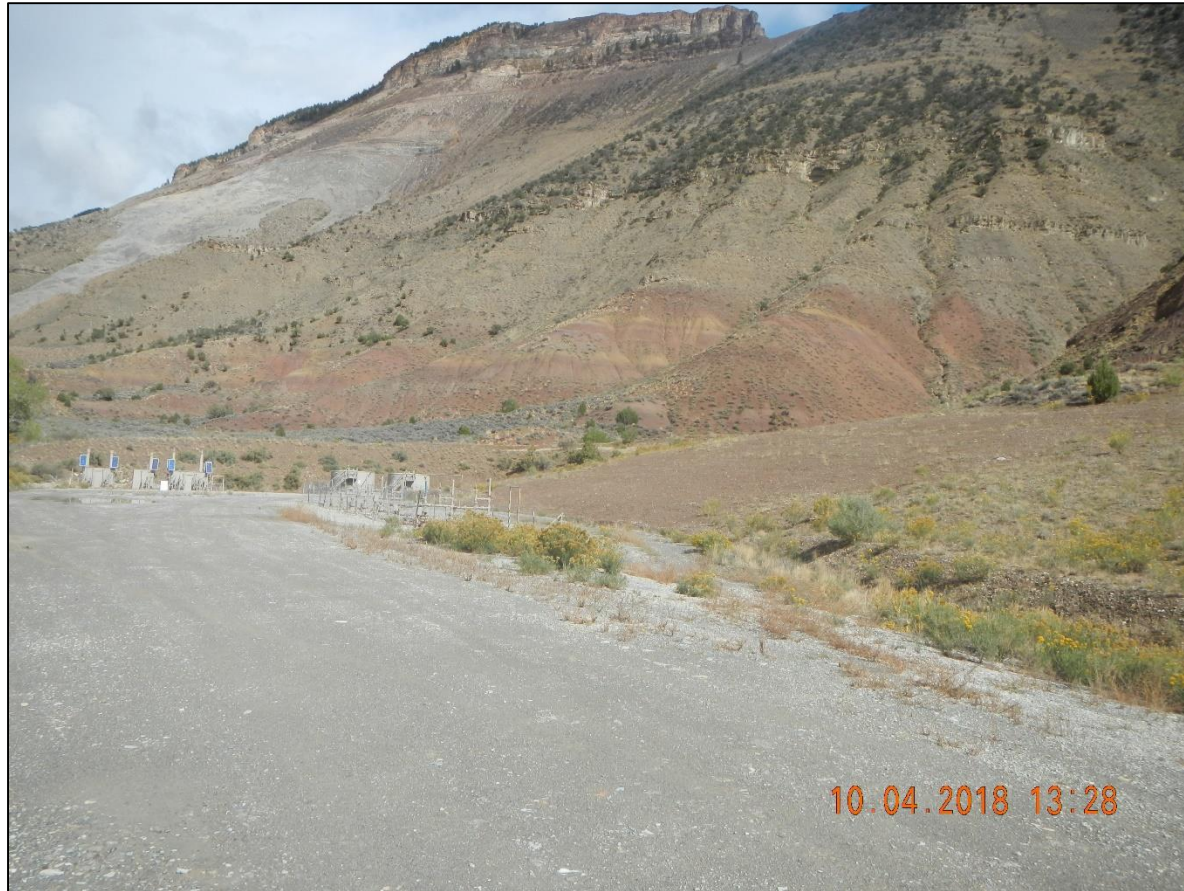
**Weeds**

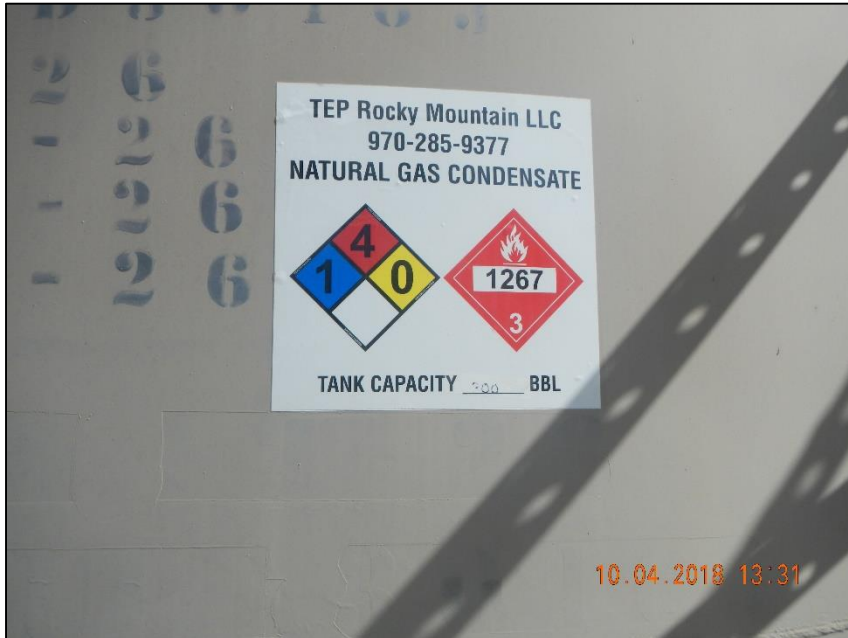
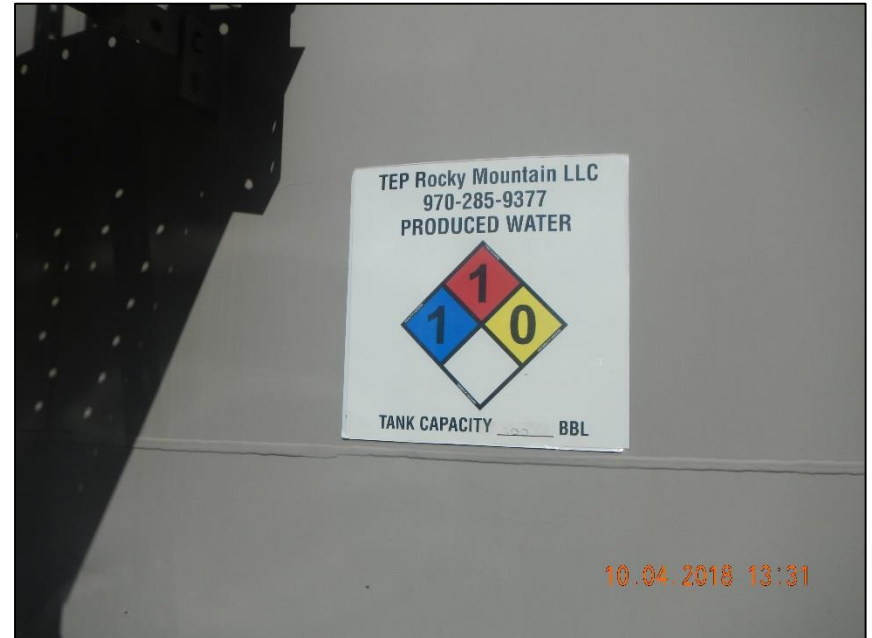
**Volumes need fixed.**

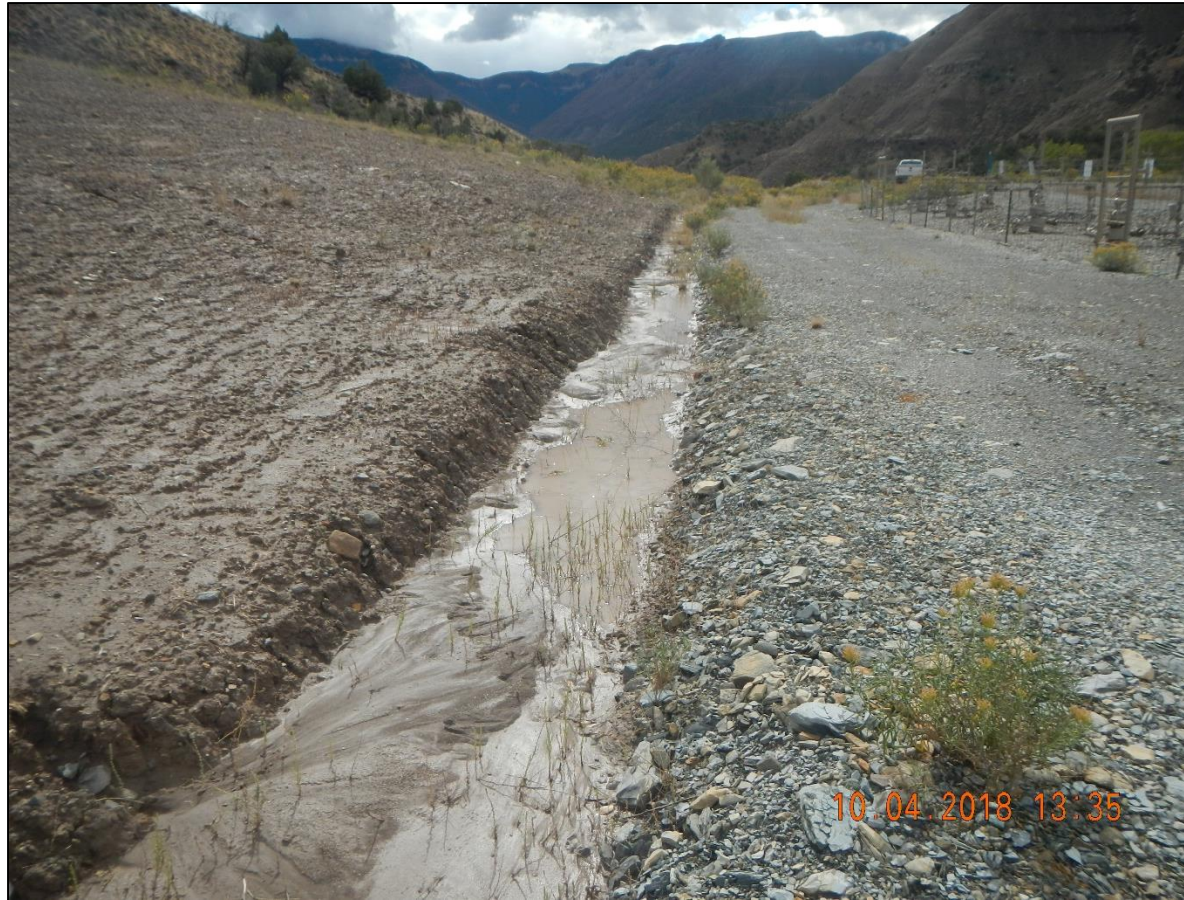
**Sediment in ditch along cut slope.**

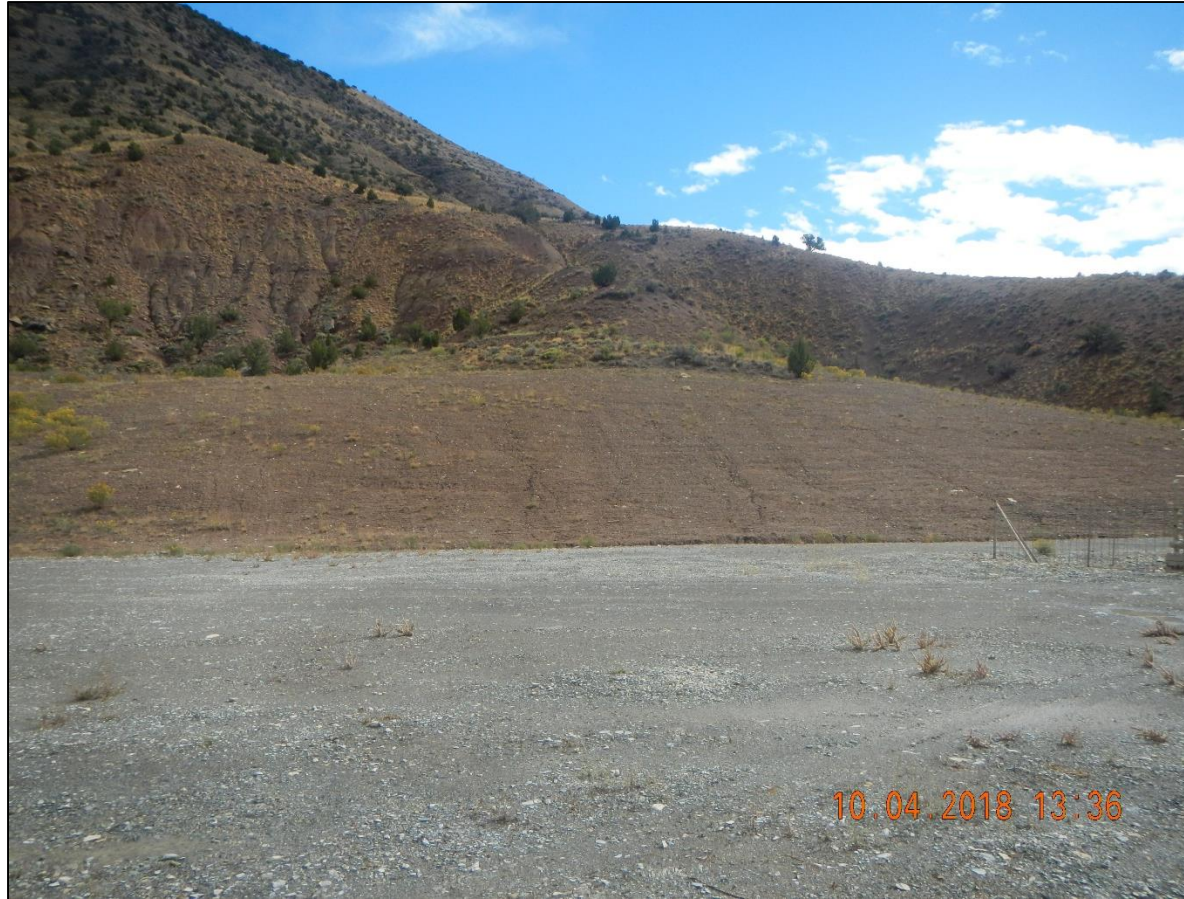
**Seeding needed on sut slope.**

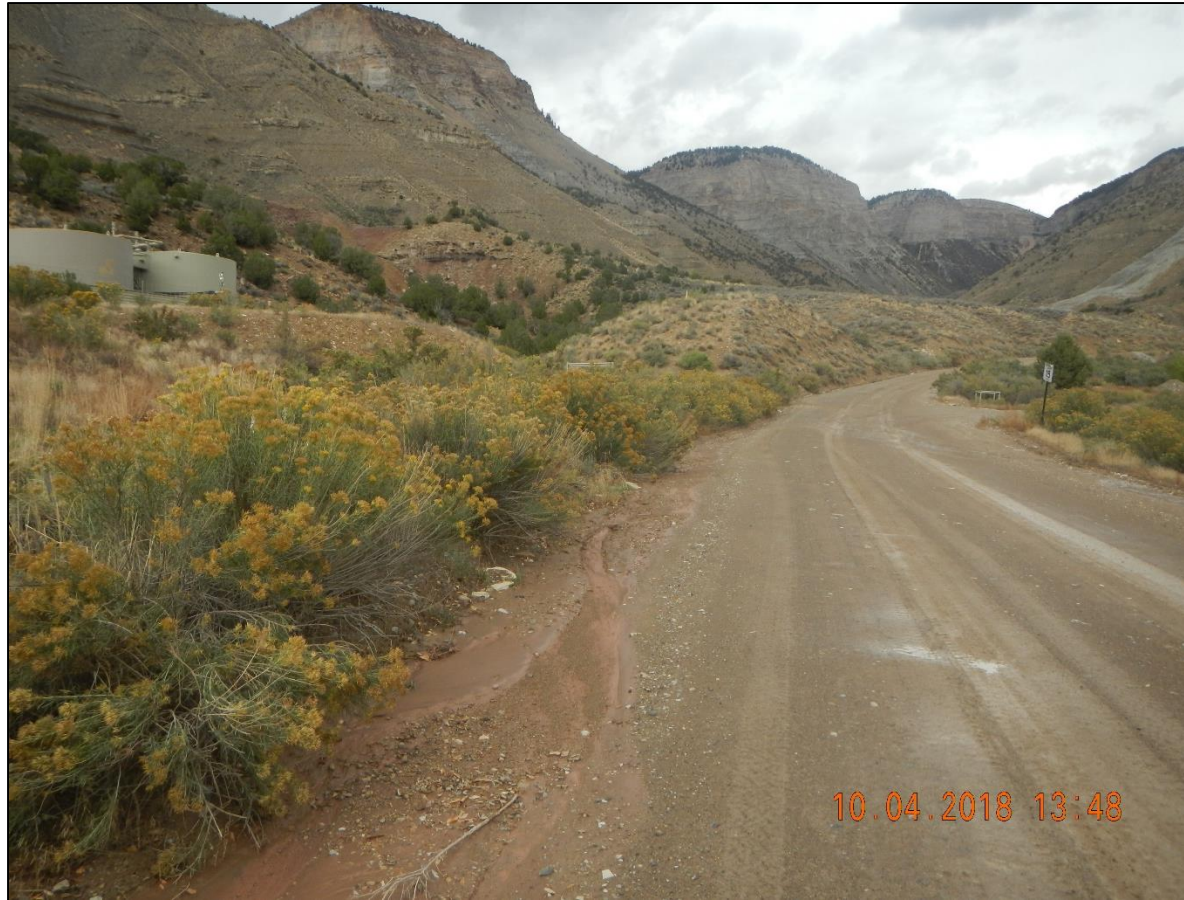
**Sediment in ditch.**

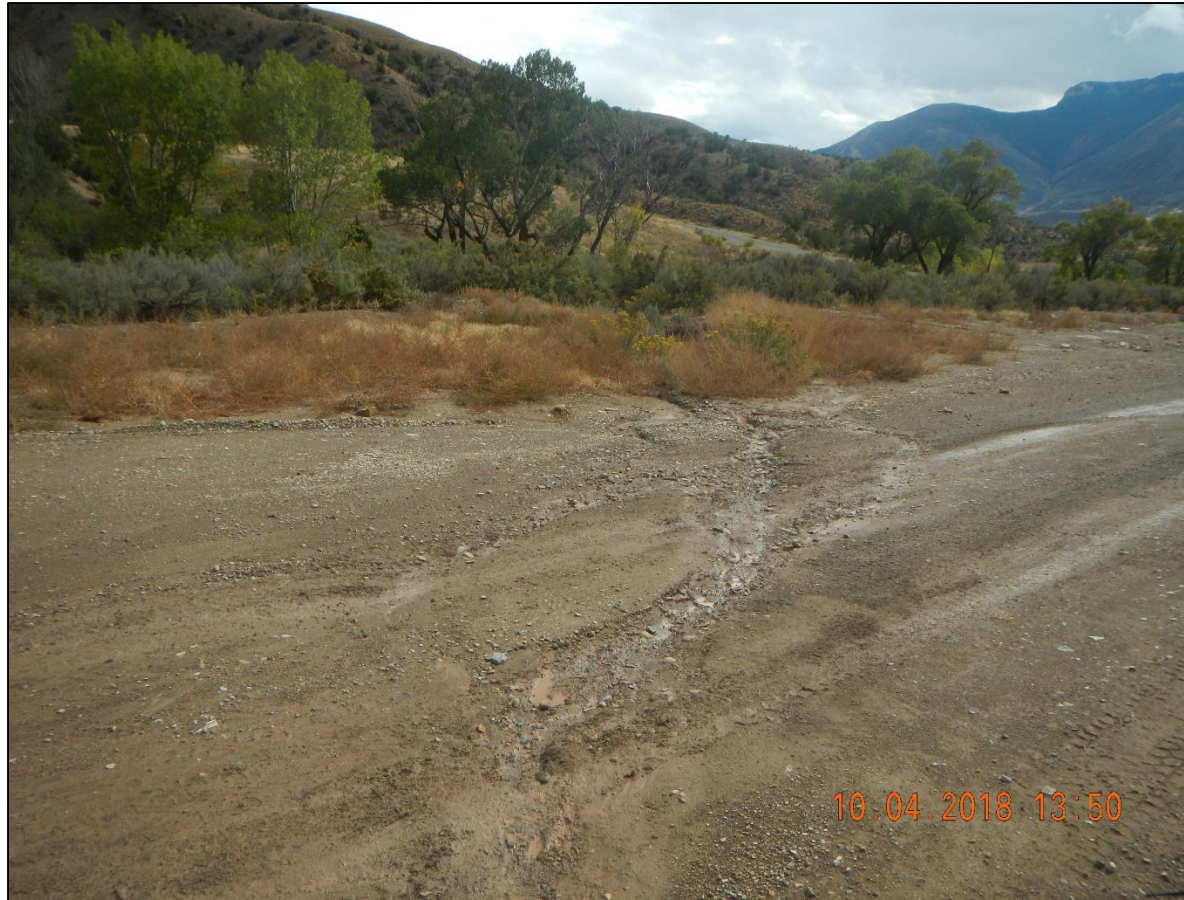
**Washing across road into check dam.**

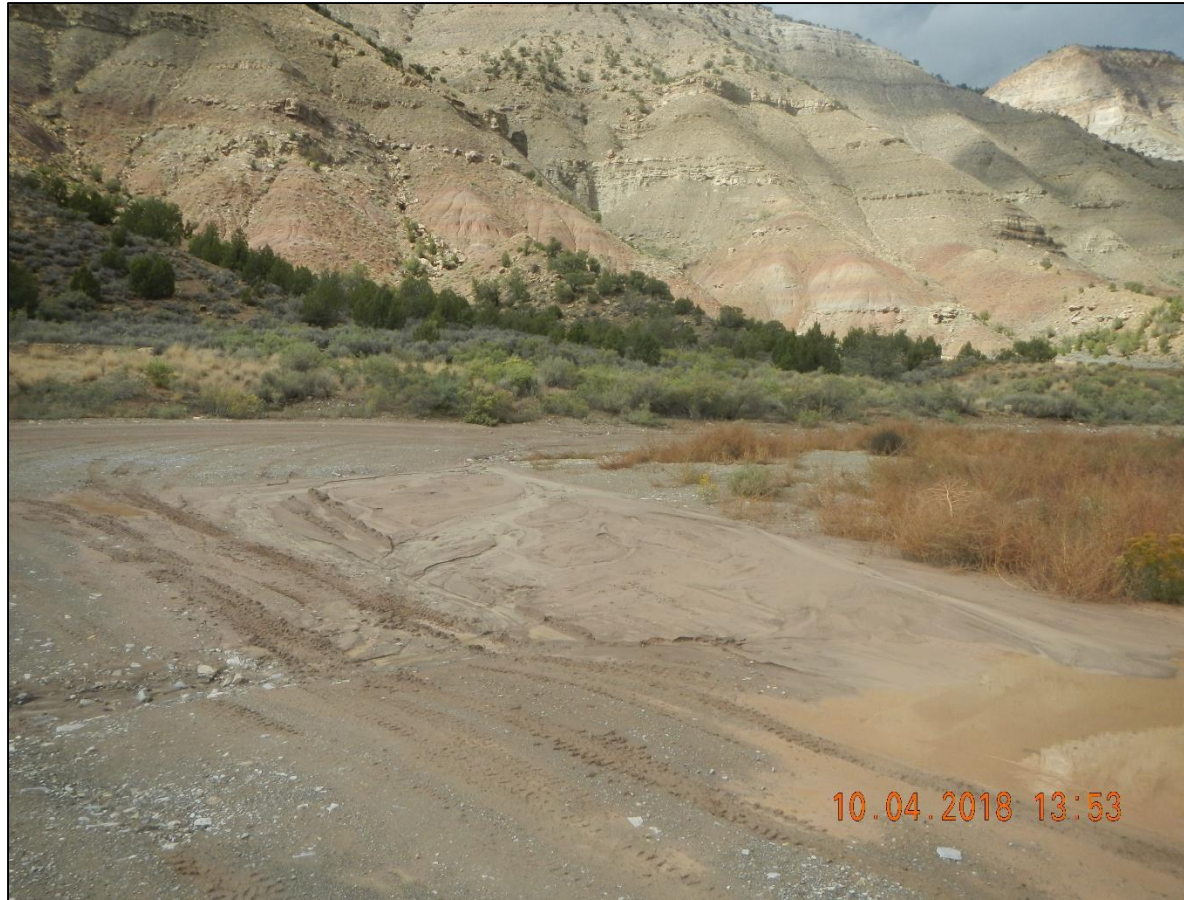
**Sediment and water build up on main road and entrance road to MV 29-27 pad**
