# Construction and Stormwater Inspection

Operator: BAYSWATER EXPLORATION AND PRODUCTION LLC - #10261

Location ID: 456151

**Inspection Photos**  
**Location Name: Hester Farms II /31-H Pad**  
**Location ID: 456151**

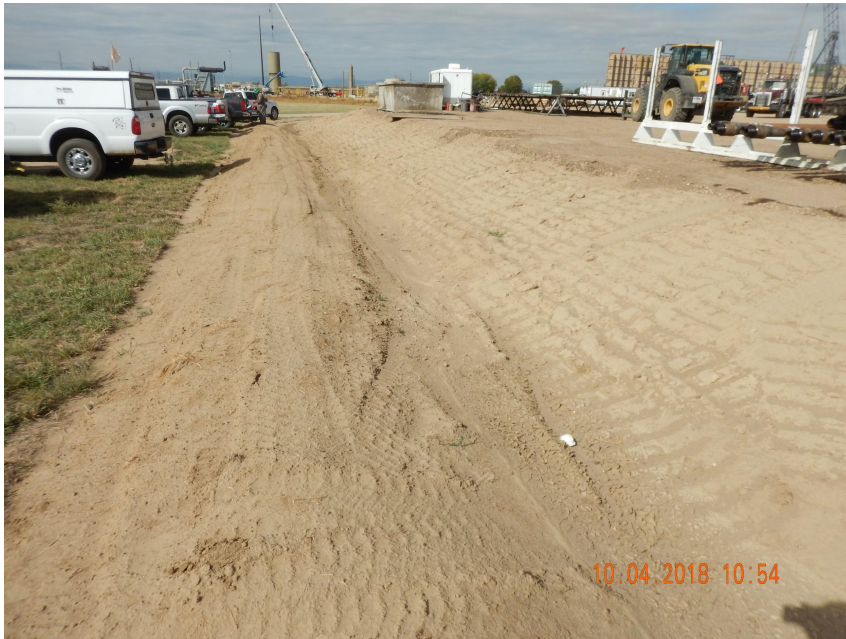
**Photo 1.** Photo taken from the southeast perimeter of the location, facing West. Ditch and berm BMP has been installed around the entire perimeter of the location. Rill erosion was observed along the southern, eastern and western fill slope areas, but did not discharge off location.

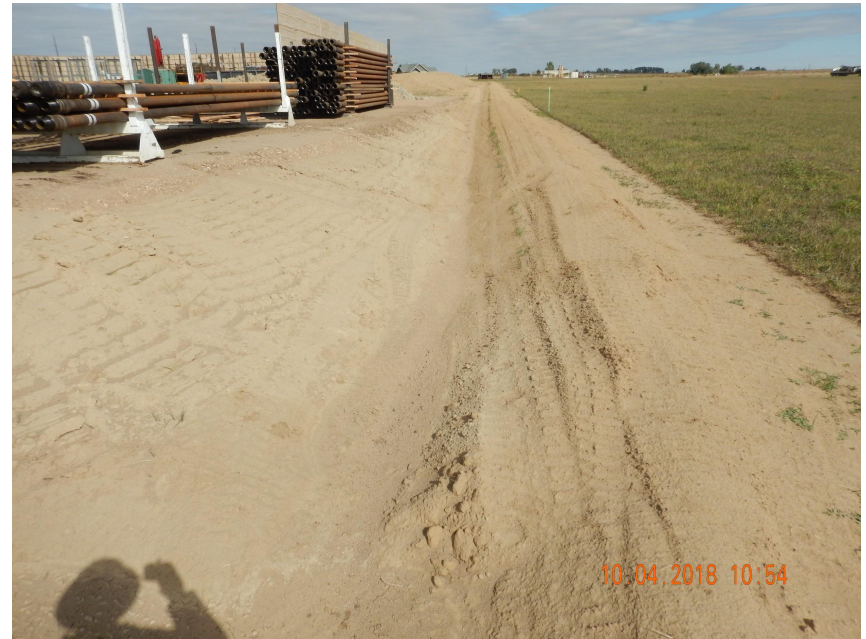
**Photo 2.** Photo taken from the southeast perimeter of the location, facing North. See comments under Photo 1.

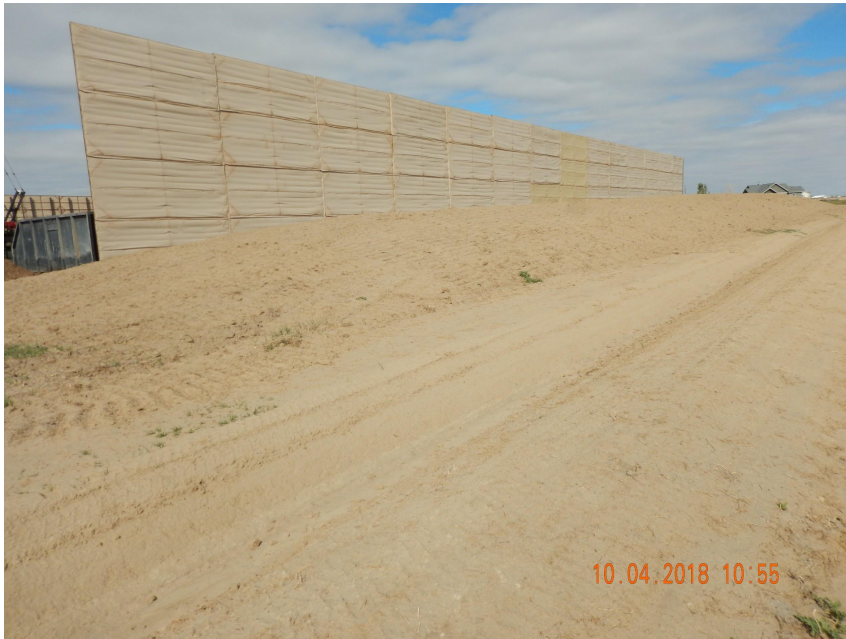
**Photo 3.** Photo taken from the eastern location, facing North. Operator has salvaged and stored topsoil along the eastern perimeter of the location. Topsoil has been temporarily stabilized with equipment tracking.

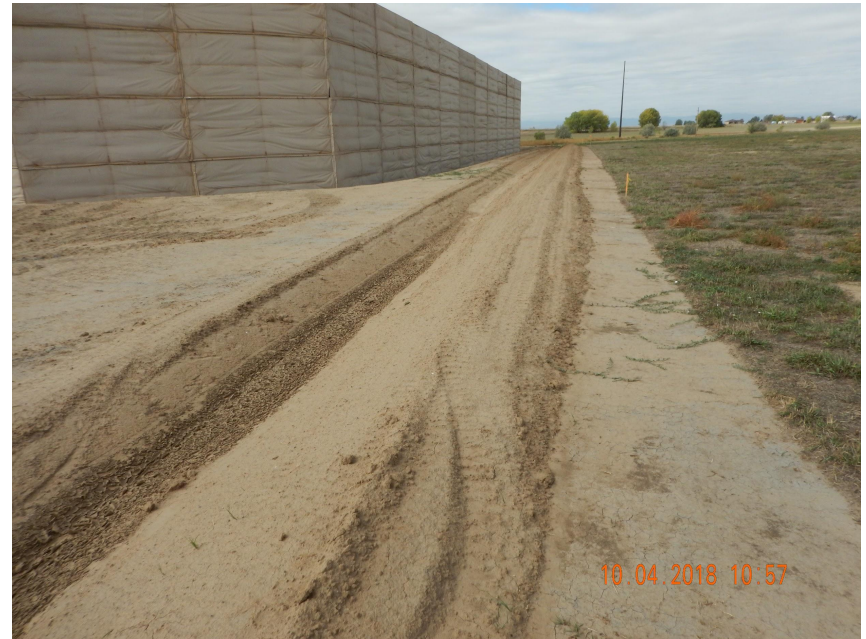
**Photo 4.** Photo taken from the northeast perimeter of the location, facing West. See comments under Photo 1.

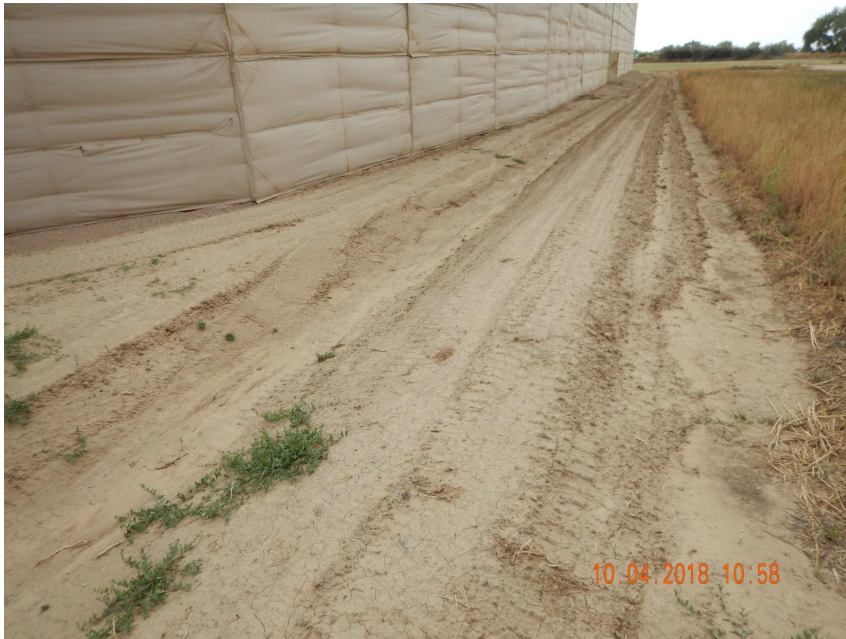
**Photo 5.** Photo taken from the northwest perimeter of the location, facing South. See comments under Photo 1.

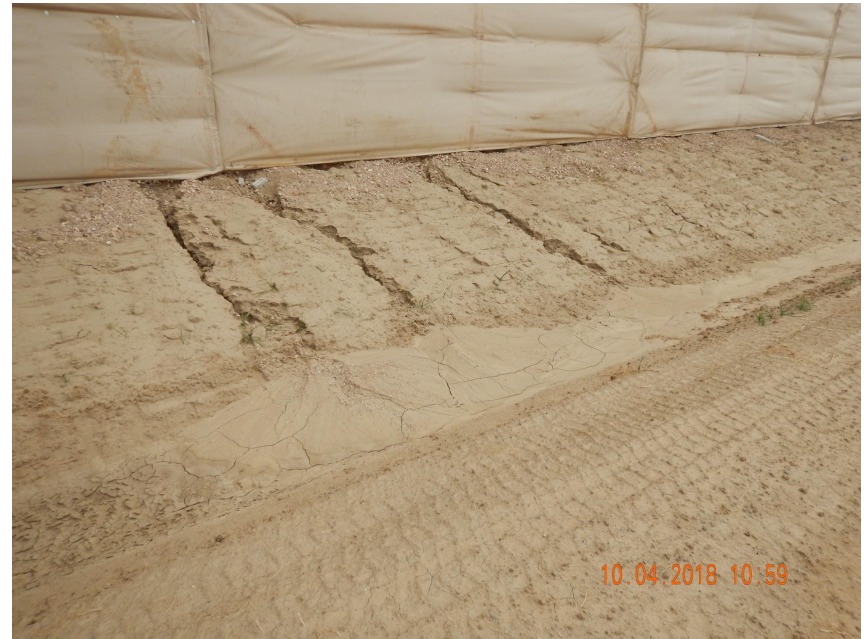
**Photo 6.** Photo taken from the western location. Photo illustrates rill erosion.

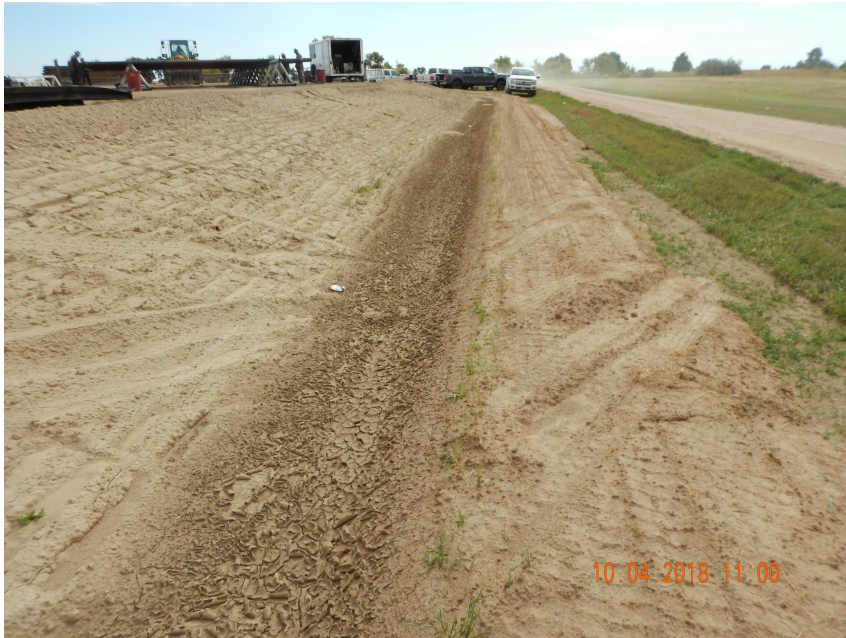
**Photo 7.** Photo taken from the southern perimeter of the location, facing East. See comments under Photo 1. Note: Vehicle traffic should remain off BMPs as this could cause damage to the BMPs.
