Inspection Photos

10/04/2018

Operator: WESTERN OPERATING COMPANY #
95620

Location ID: 312292

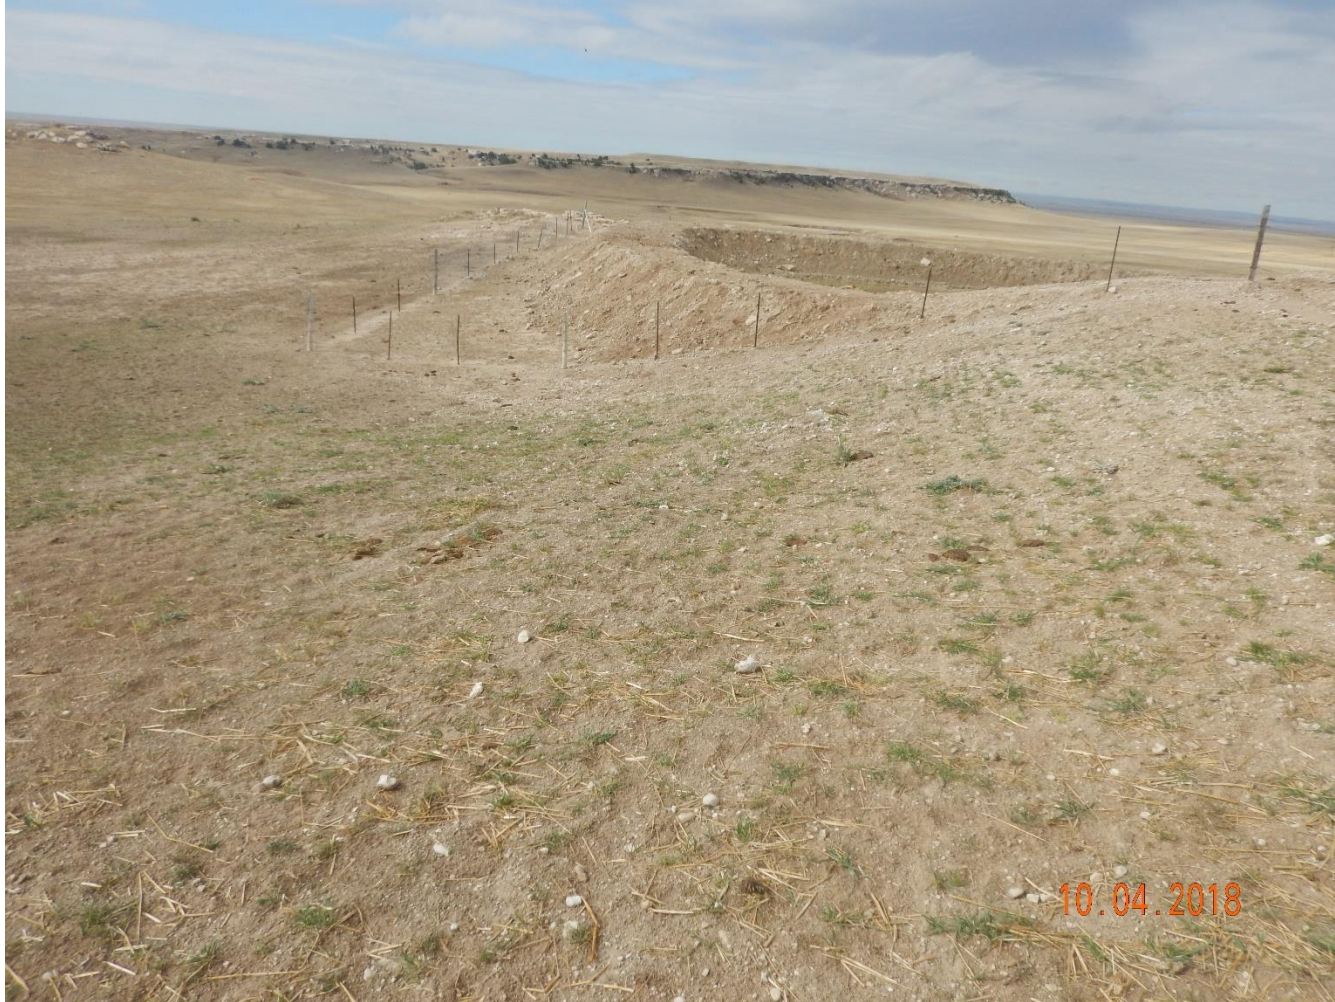
Photo 1: Photo taken from the south end of the location, facing west. Photo 1-2 provides overview of the area of degradation to the south of the pits.

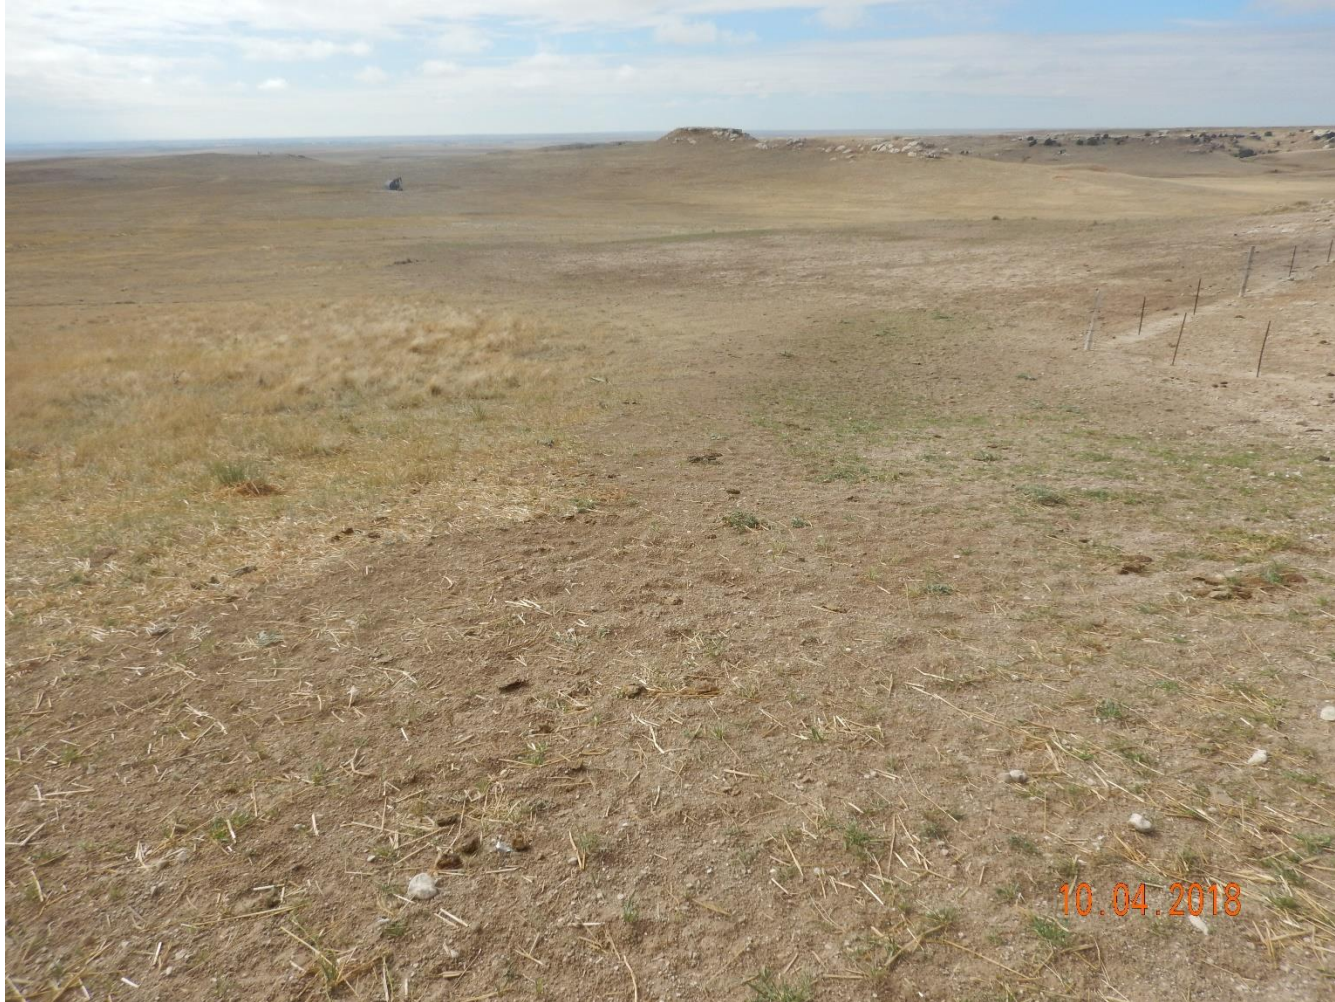
Photo 2: : Photo taken from the south end of the location, facing south

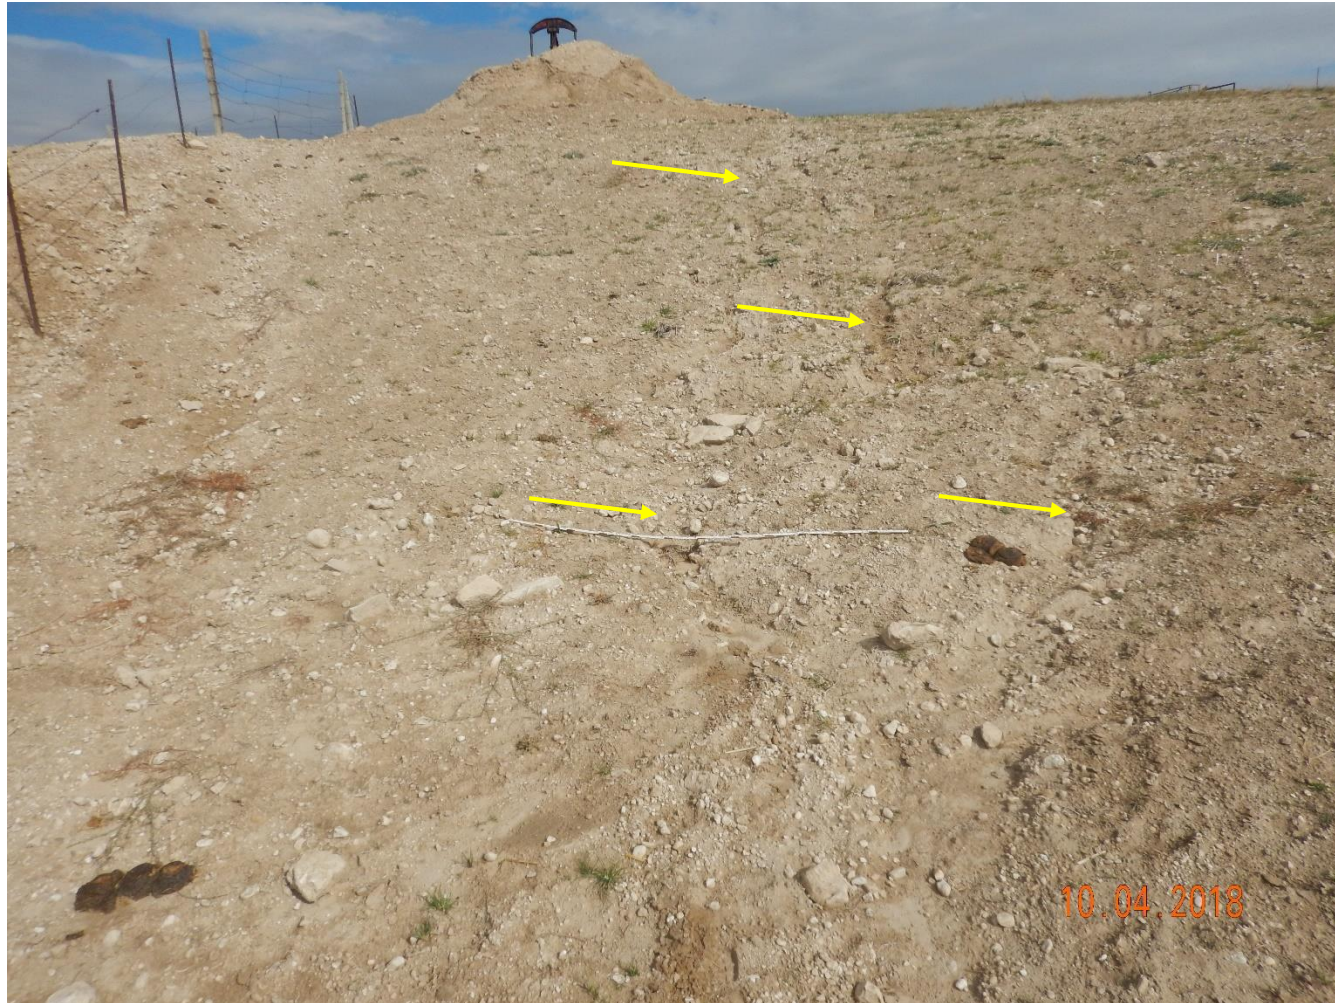
Photo 3: Photo taken from the southeast end of the pit, facing north towards the well. Photo shows areas of the interim that operator previously regraded and seeded. Operator failed to implement required stabilization or stormwater and erosion control BMPs per CAs. Photo shows erosion degradation has been allowed to continue. 6 foot measuring stick for reference

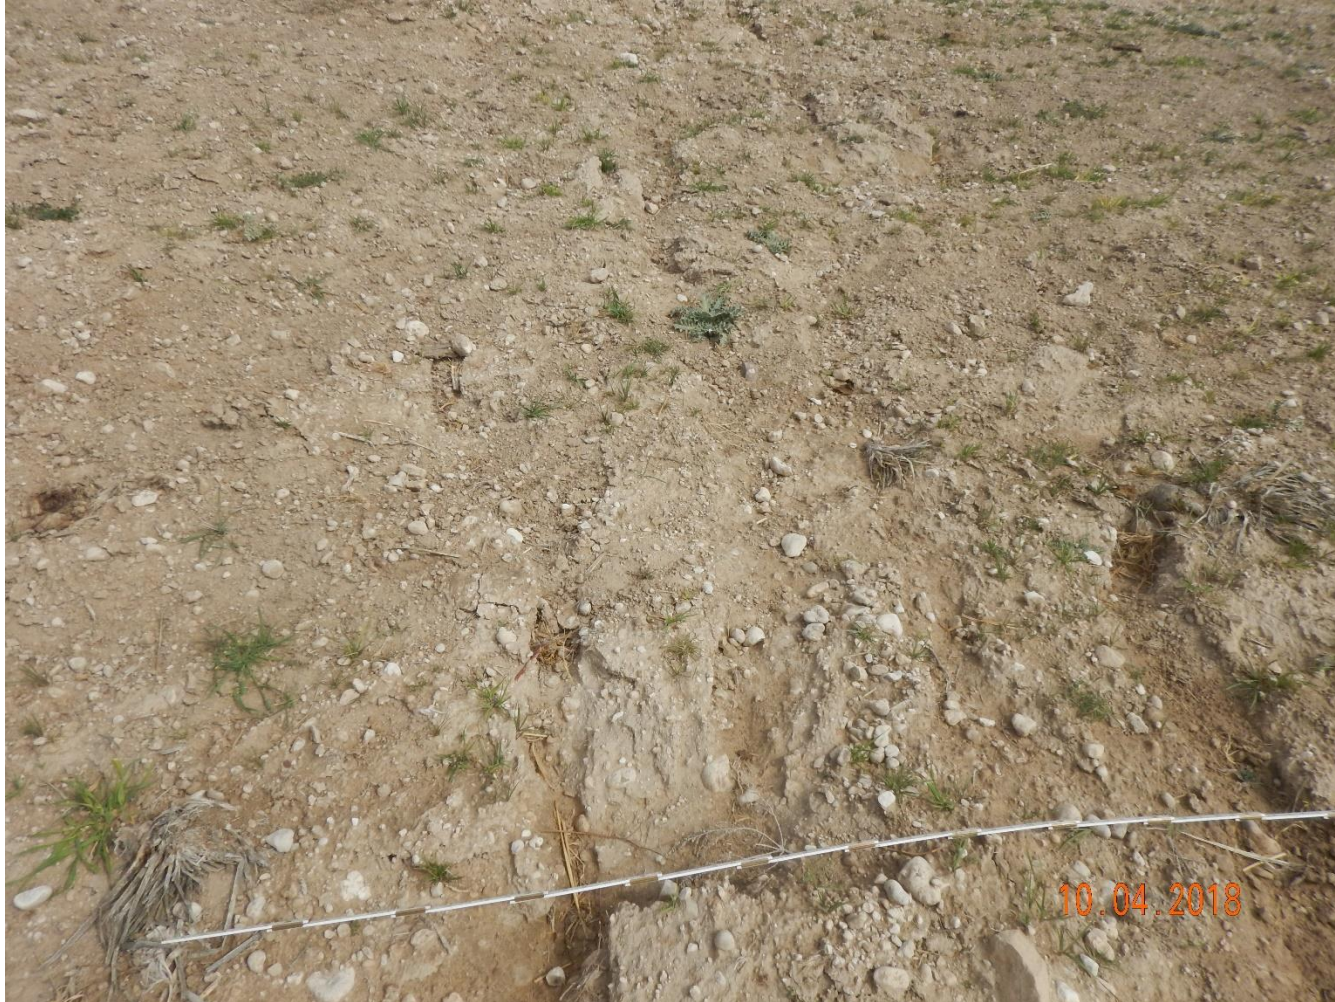
Photo 4: Photo taken from the southeast end of the pit, facing north towards the well. Photo shows areas of the interim that operator previously regraded and seeded. Photo shows Operator has failed to implement required stabilization, stormwater and erosion control BMPs per Cas; erosion degradation has been allowed to continue. 6 foot measuring stick for reference.

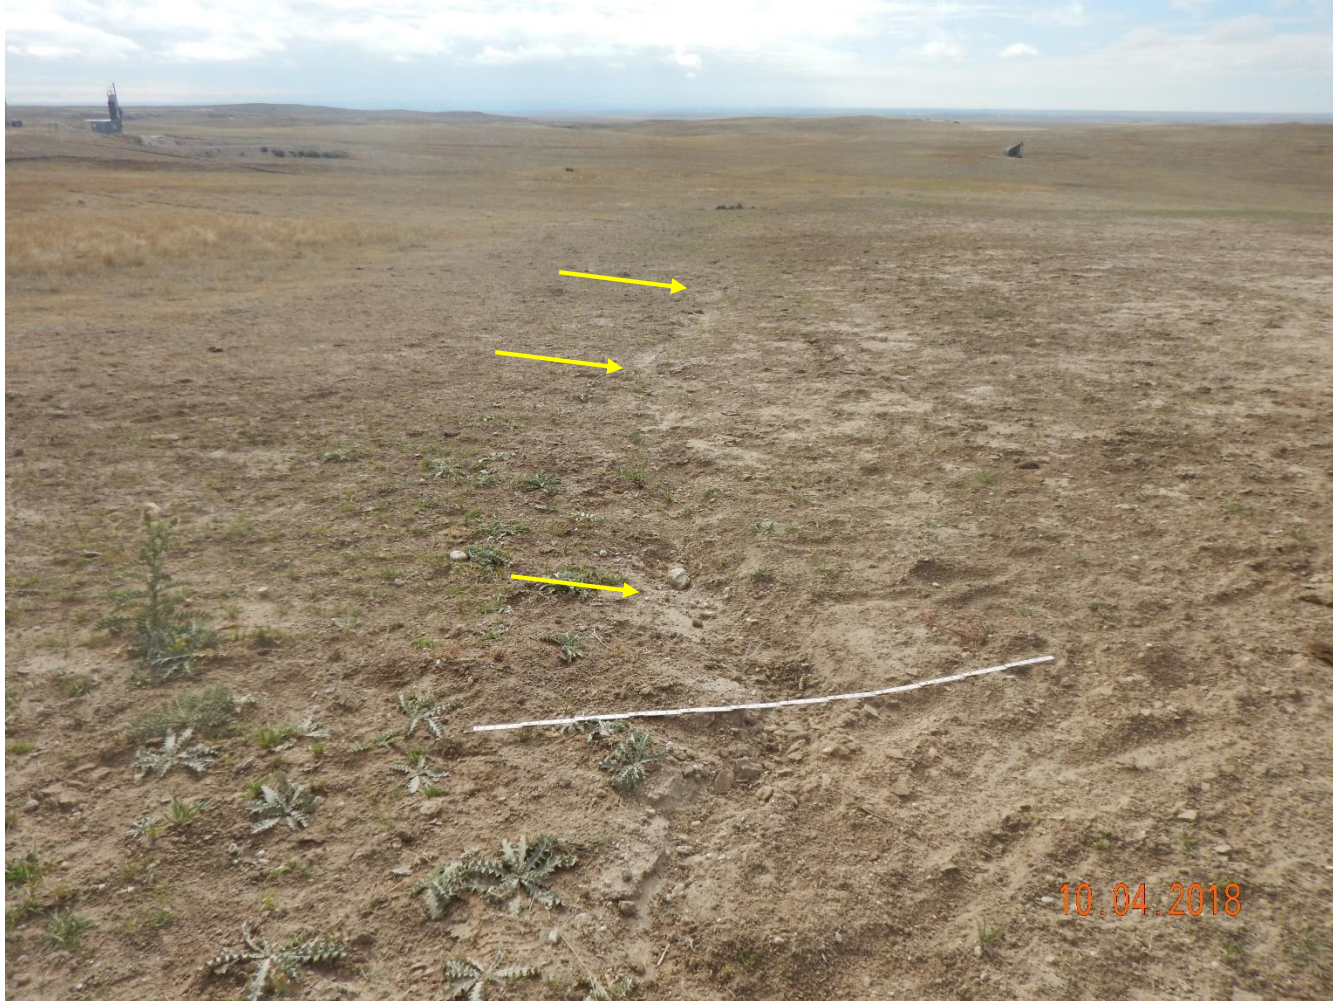
Photo 5: Photo taken from the southeast corner of the pit, facing south. See comments under photo 4.

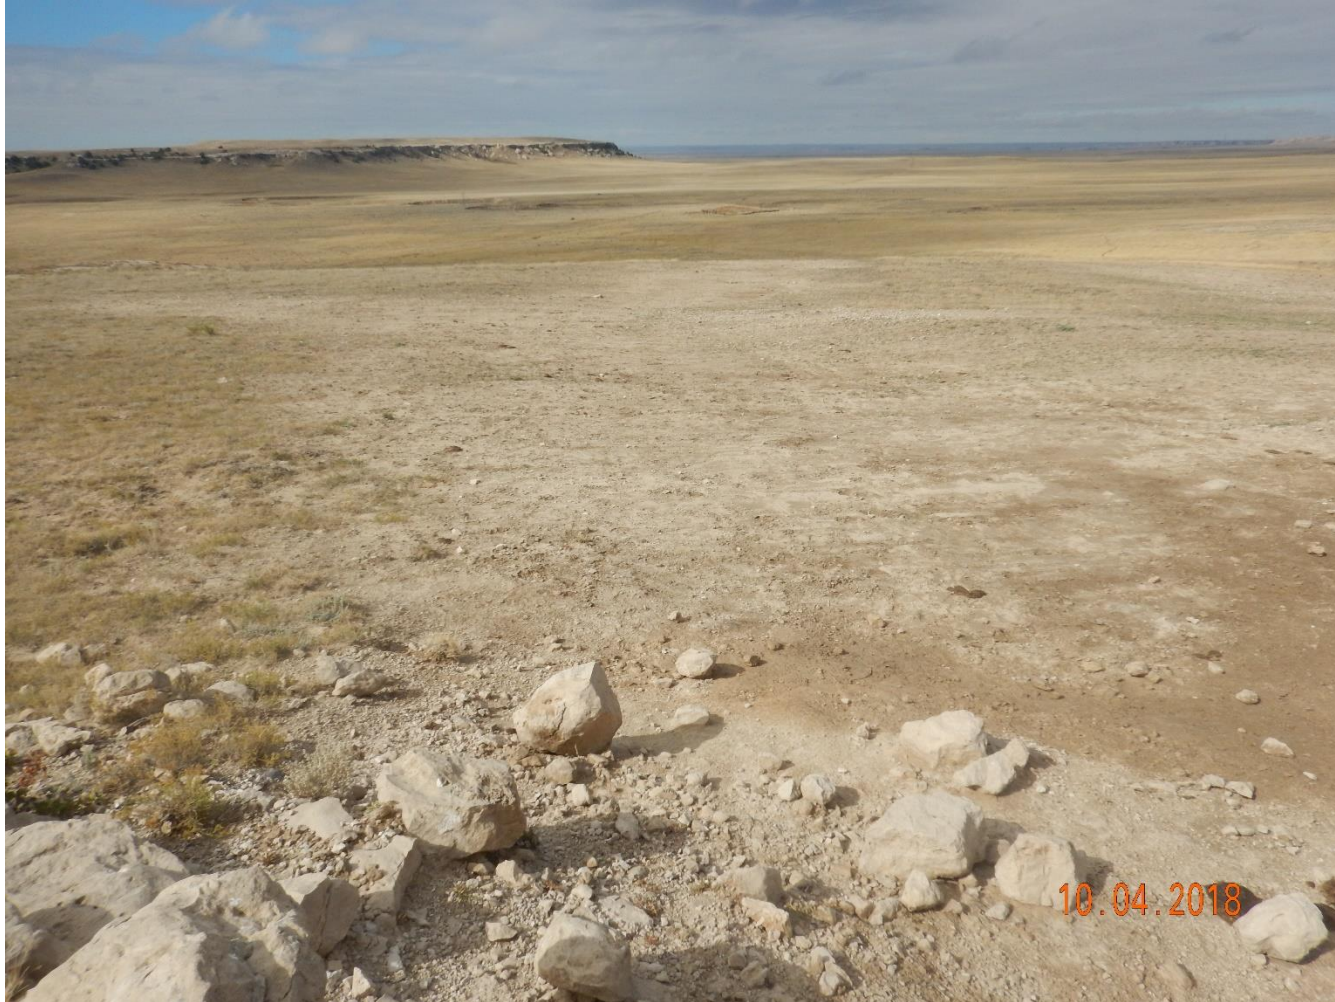
Photo 6: Photo taken from the southwest corner of the pit, facing west. See comments under photo 4

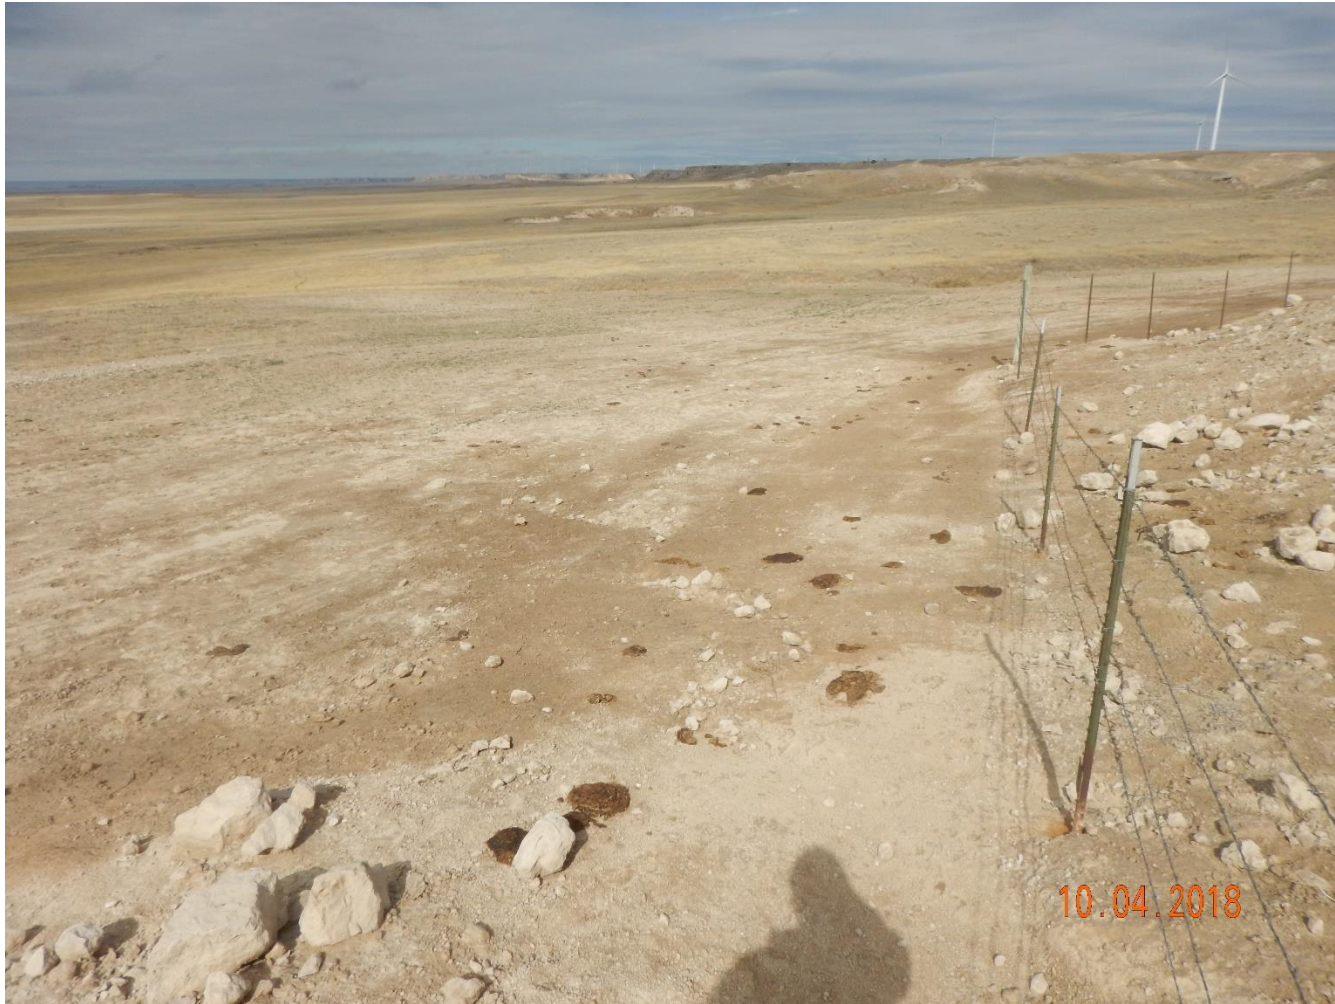
Photo 7: Photo taken from the southwest corner of the pit, facing northwest. See comments under photo 4

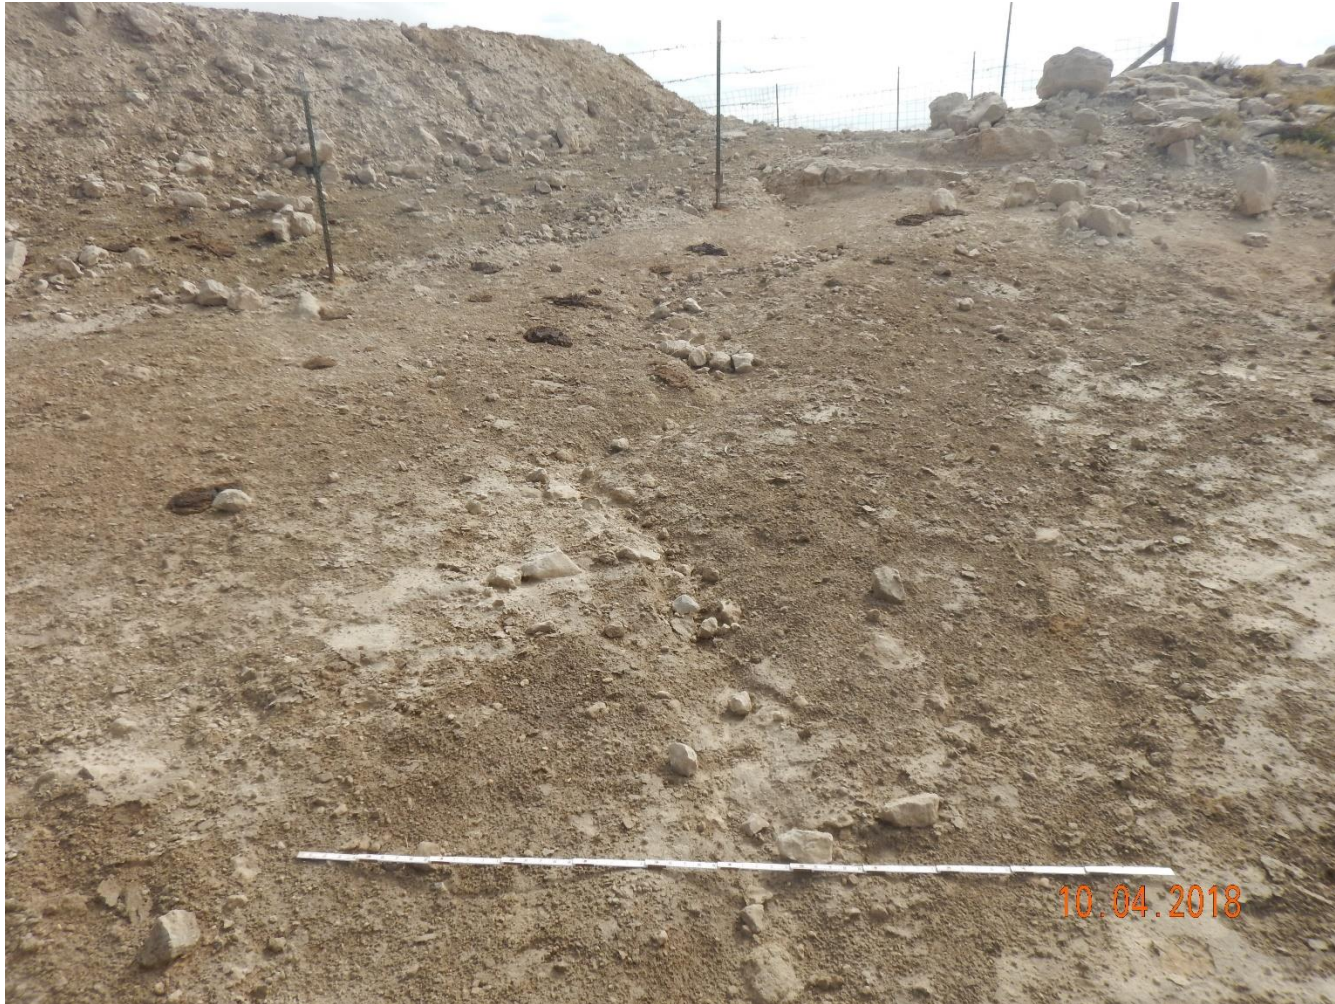
Photo 8: Photo taken from the southwest corner of the pit, facing southeast. See comments under photo 4

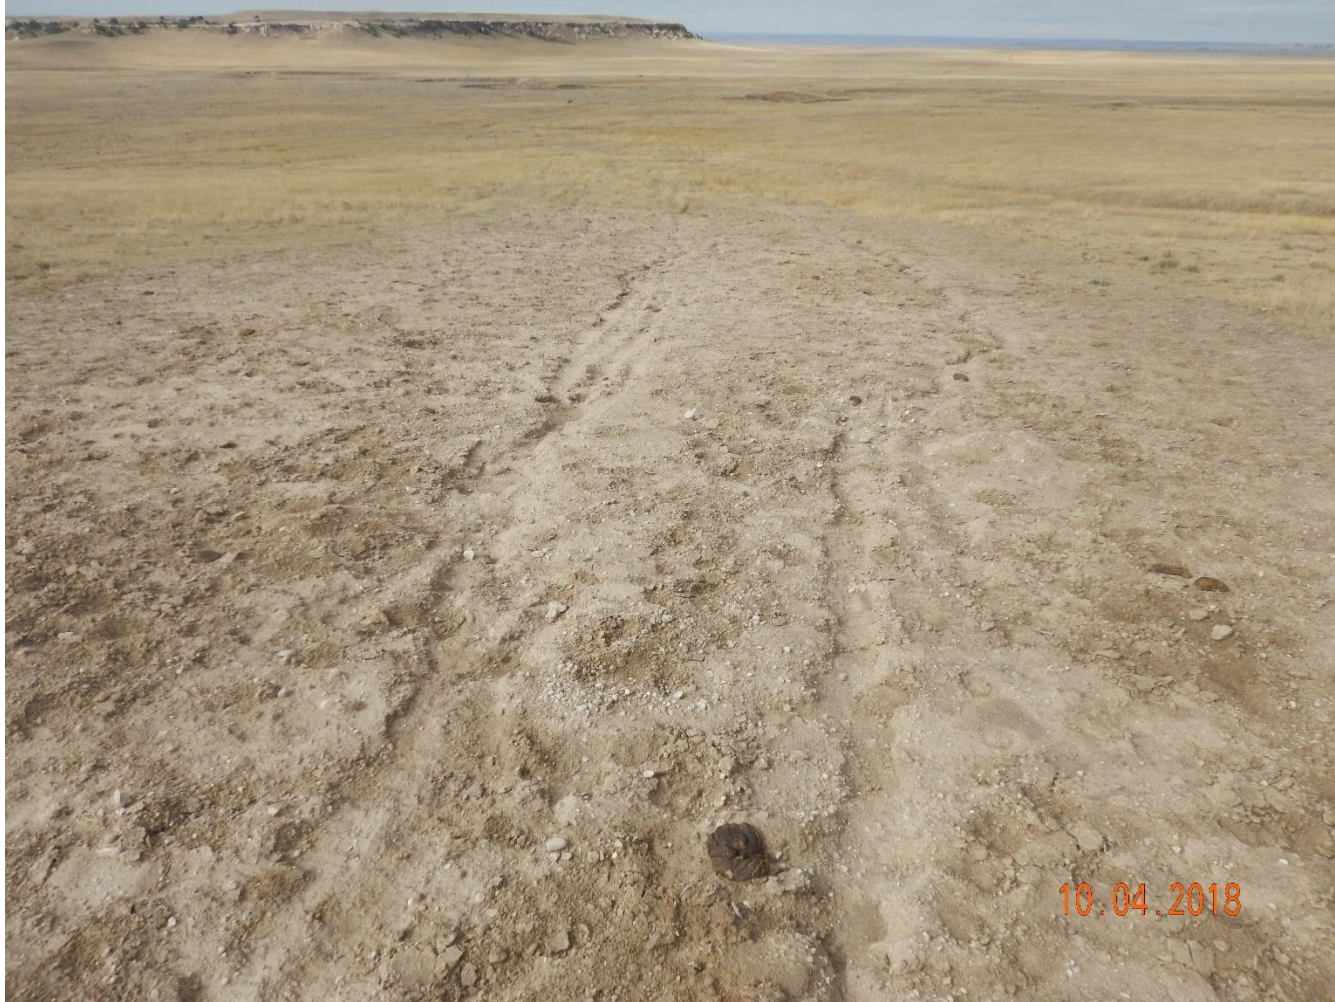
Photo 9: Photo taken from the west of the pit, facing west. See comments under photo 4

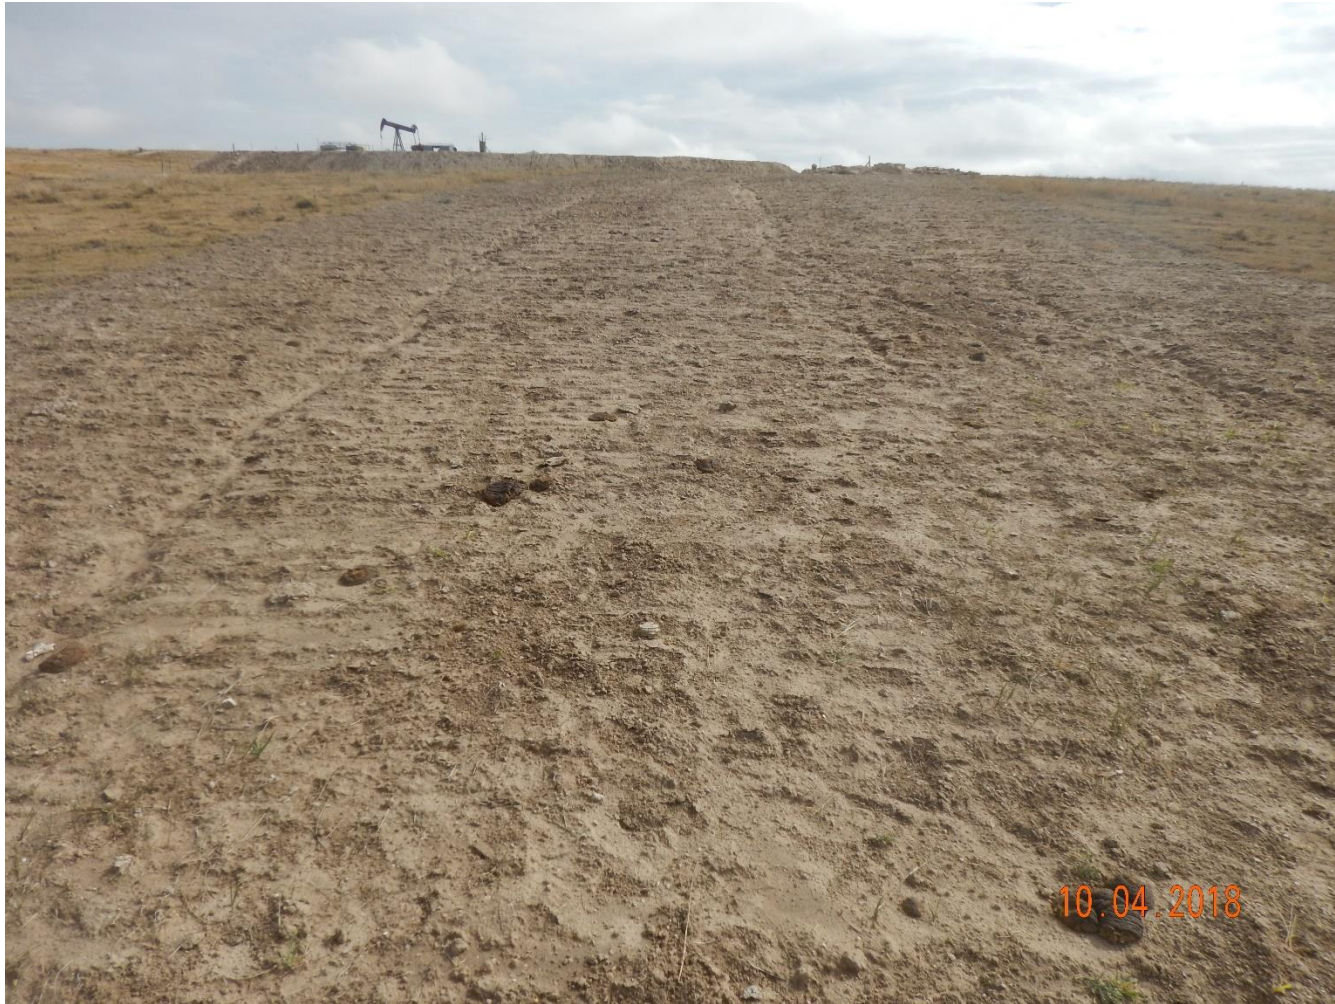
Photo 10: Photo taken from the west of the pit, facing east. See comments under photo 4

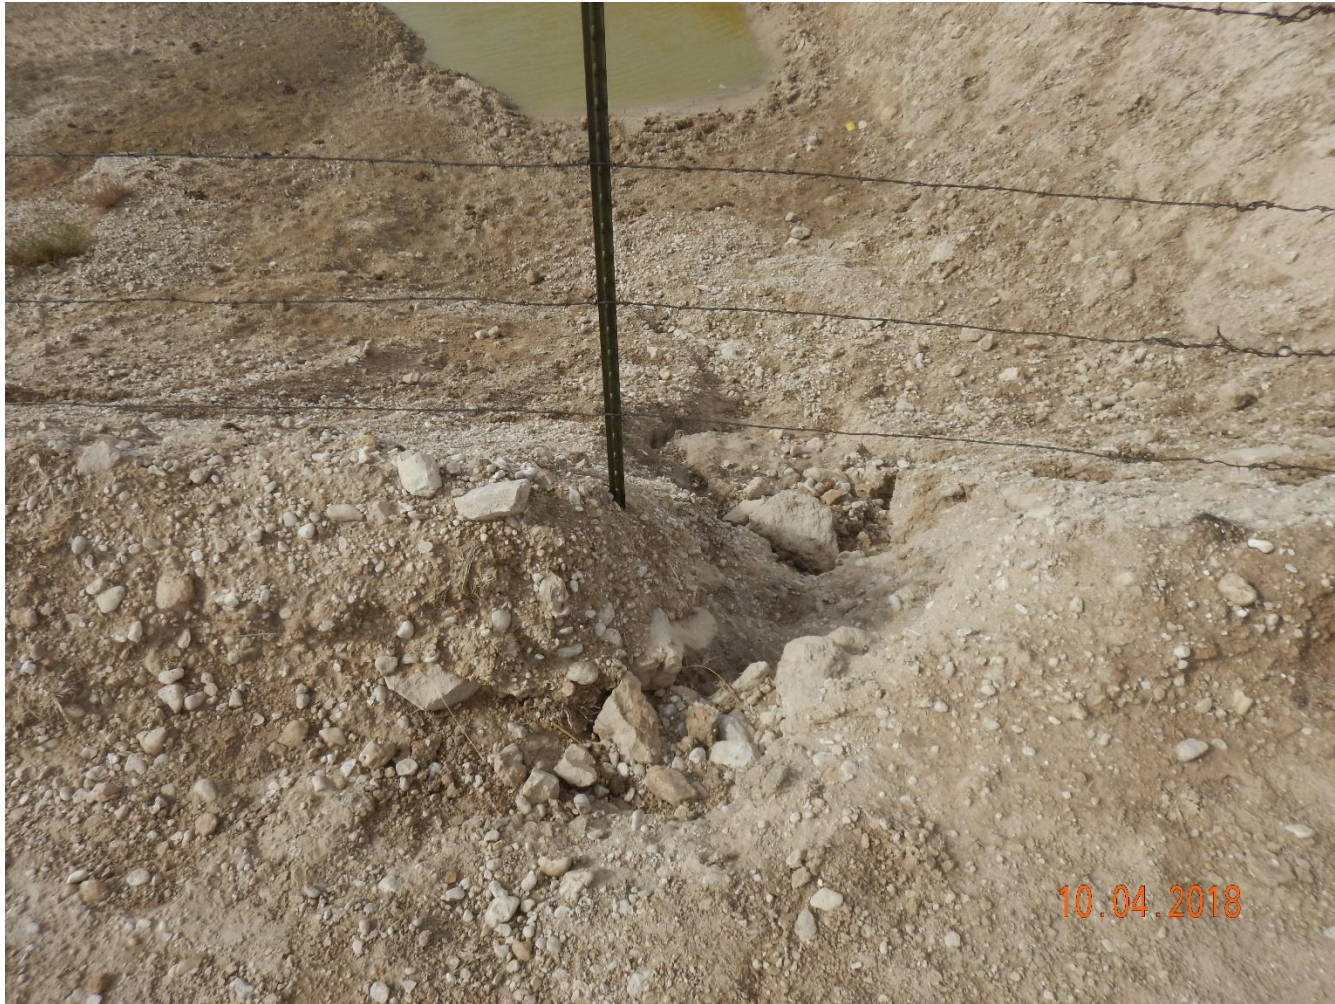
Photo 11: Photo taken from the east end of the pit, facing west. Photo shows erosion degradation (gully) has reformed. Production areas have not been sufficiently stabilized.

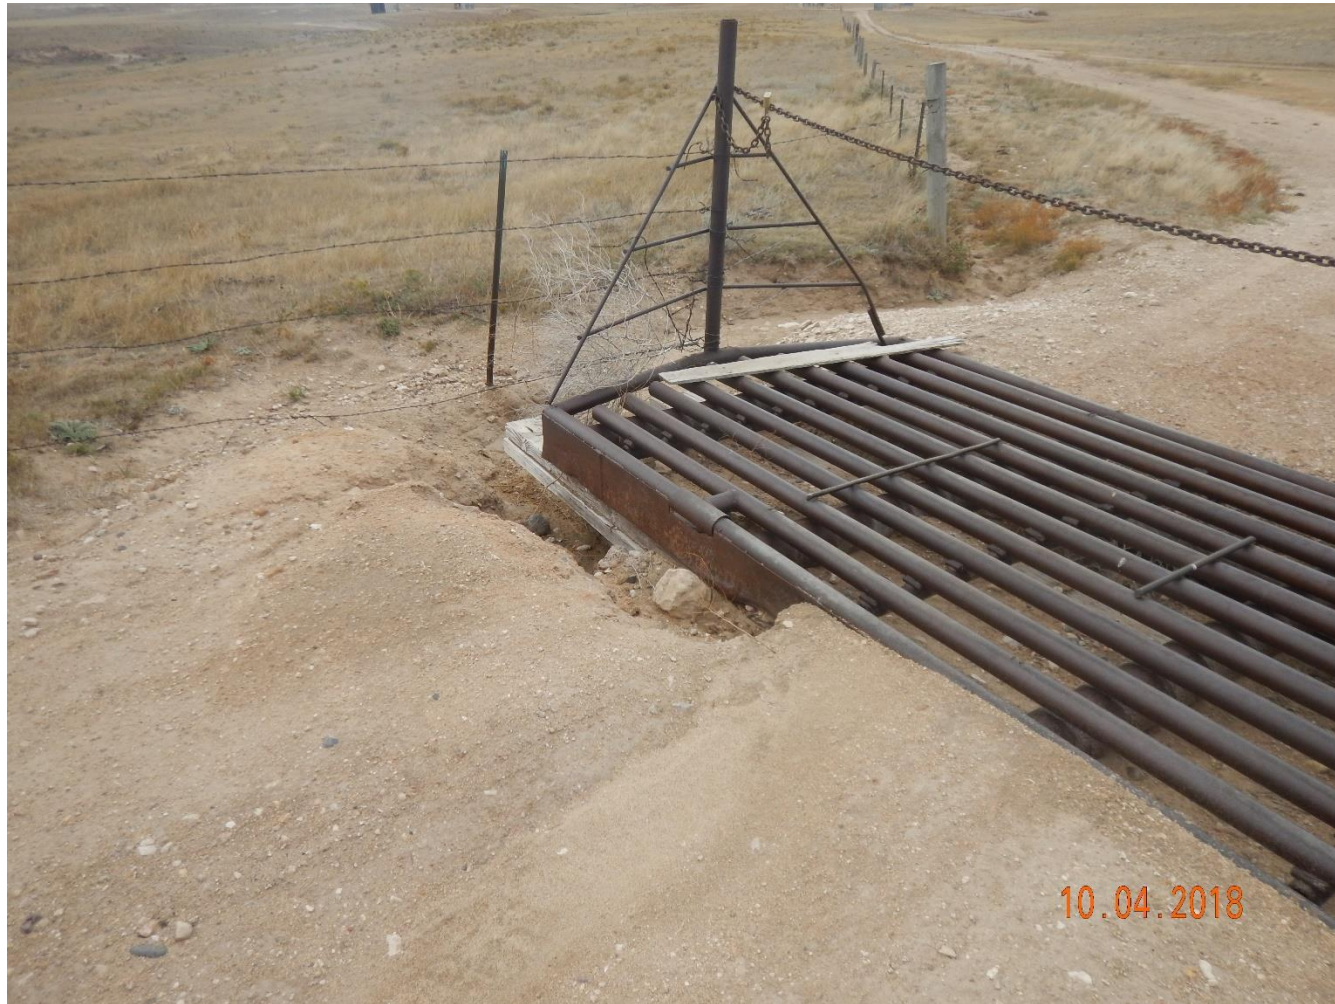
Photo 12: Photo taken from the cattle guard at the access road entrance. Photo shows erosion degradation has not been repaired; stormwater erosion has cut underneath the cattle guard.

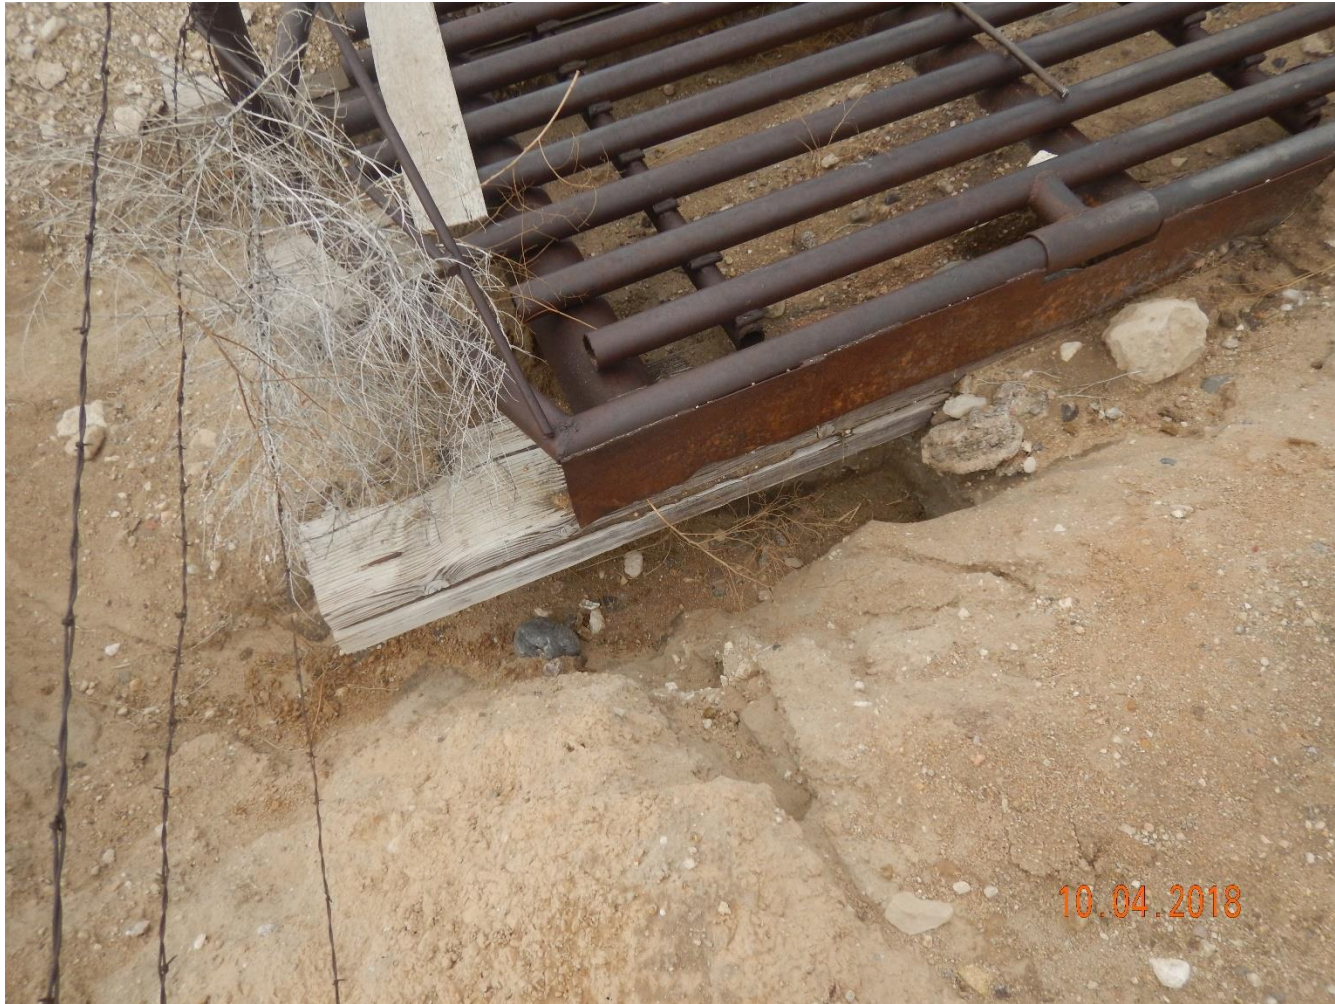
Photo 13: Photo taken from the cattle guard at the access road entrance. Photo shows erosion degradation has not been repaired; stormwater erosion has cut underneath the cattle guard.
