Inspection Photos 09/28/18
Location: KP Kauffman Amoco-Charter-Schneider Facility
Location ID #405998

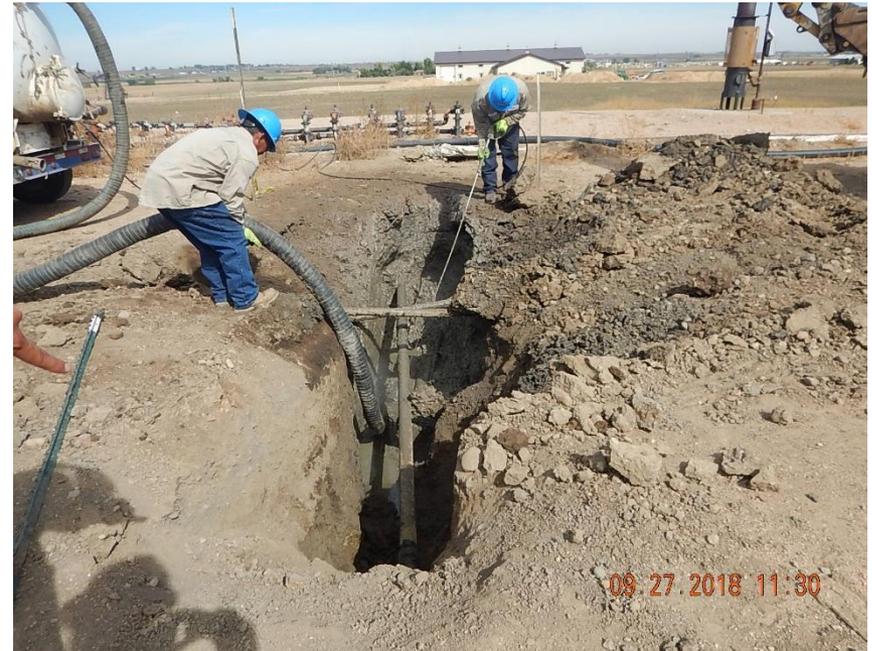
Hydro – excavation work being completed to expose flowlines in the area of release (view North)

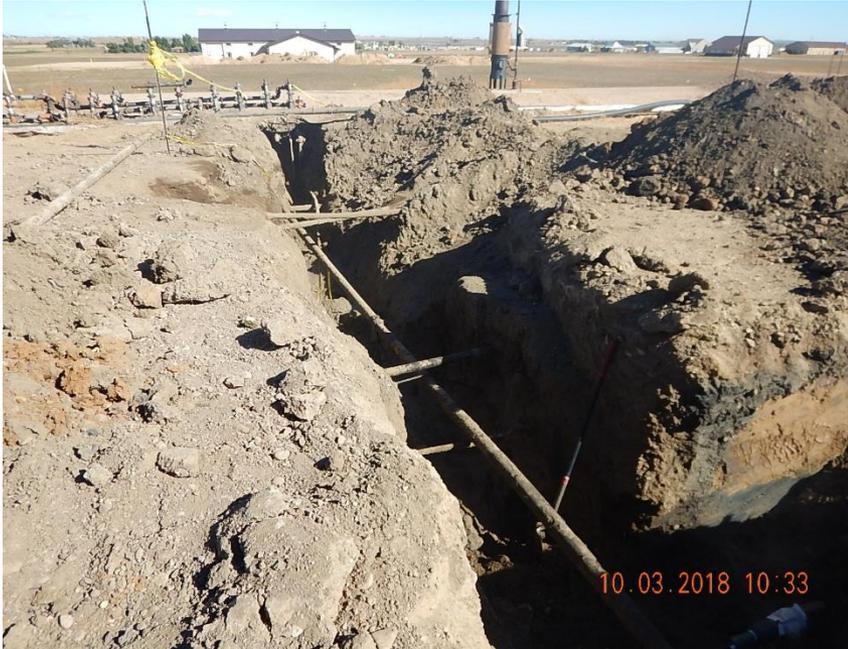
Excavation work exposed numerous flowlines in the area of release south of the flowline manifold (pictured at top).

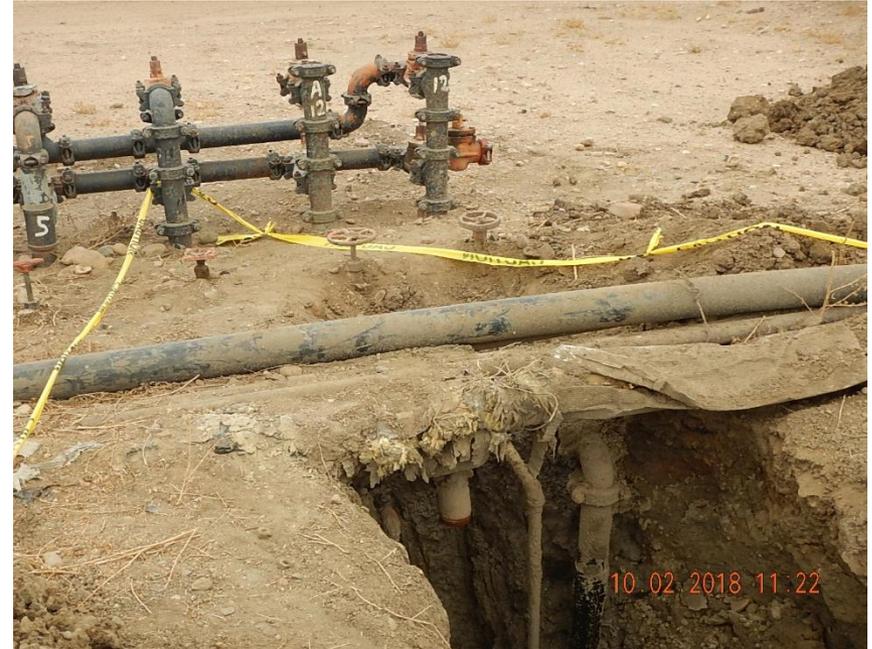
An external corrosion hole was found on the 3" un-coated carbon steel flowline associated with the Amoco-Charter-Schneider 12A well (API 123-09038); a section of this flowline was removed.

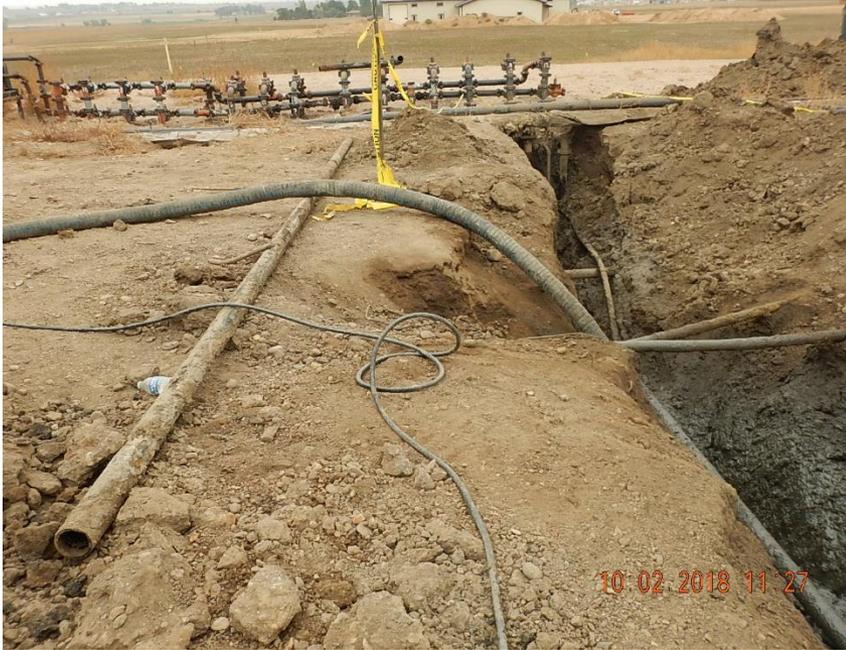
Approximately 20' of 3" flowline was cut out and removed from the excavation (shown on left side of photo)

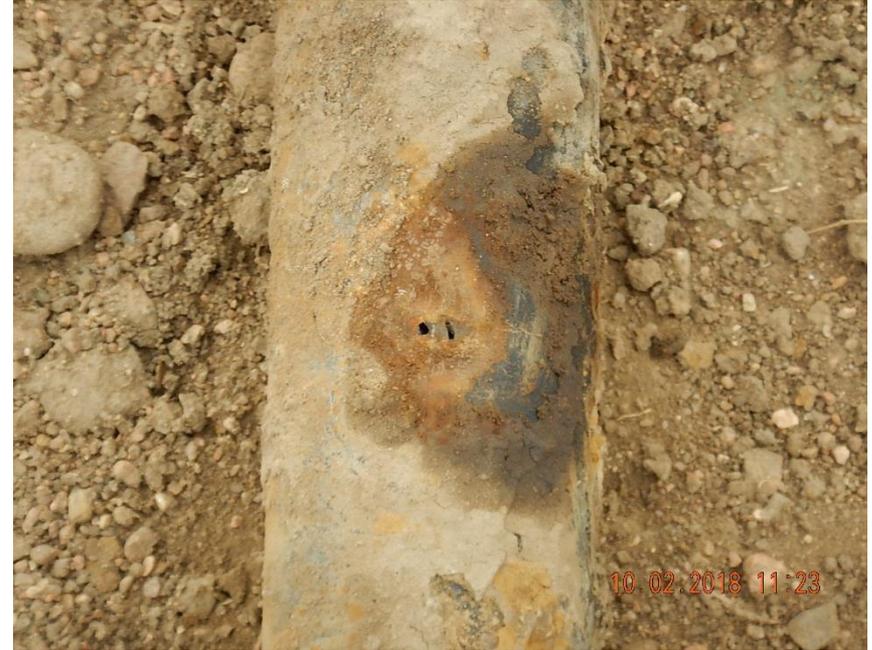
Close up view of a corrosion hole found on the failed section of flowline associated with the Amoco-Charter-Schneider 12A well (API 123-09038)
