Inspection Photos

Location Name: Roan Creek Evaporation Pit

Facility ID: #433509 Pit ID: #116525

Inspection Date: September 27, 2018

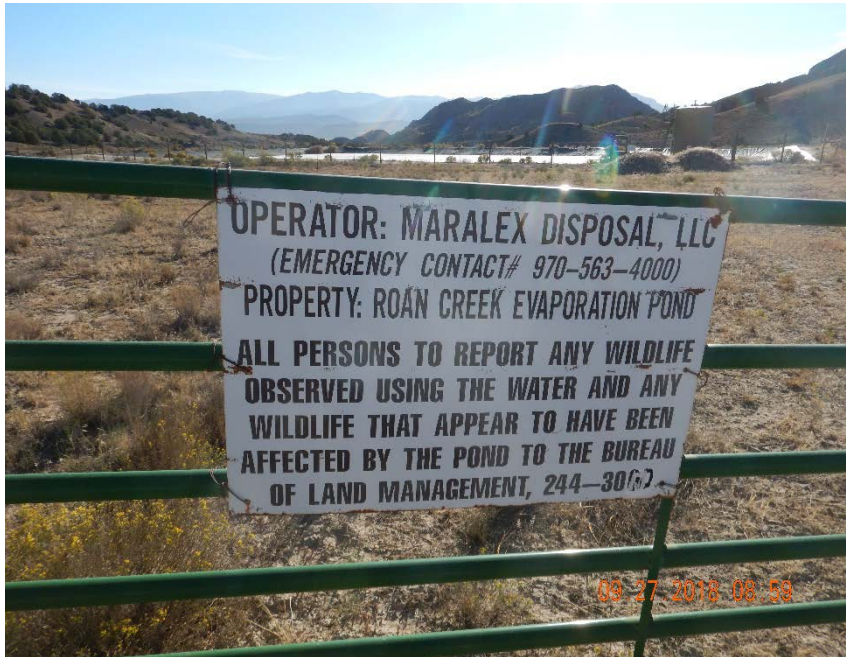
Photo #1 – Facility sign attached to gate on access road.

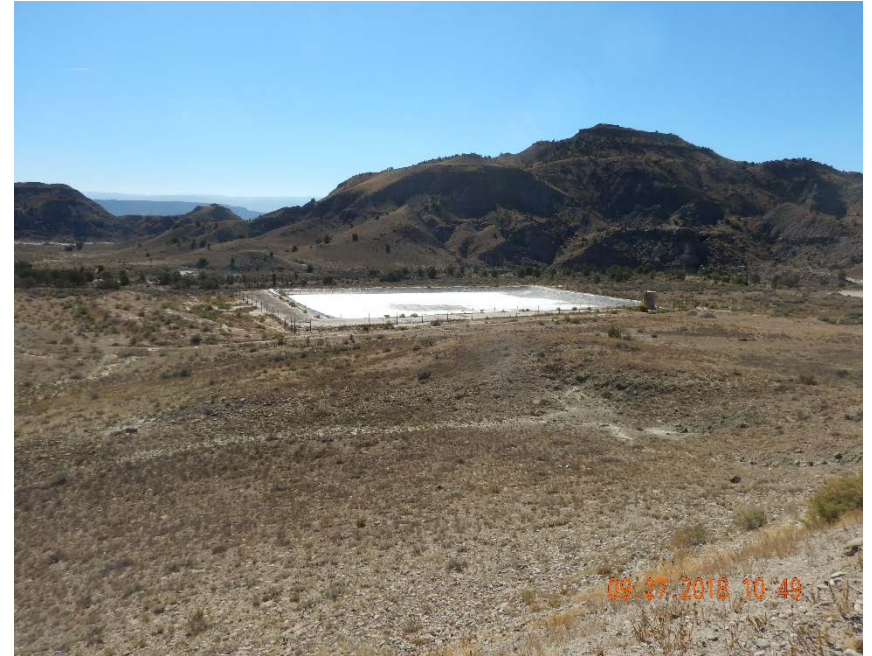
Photo #2 – View overlooking facility from NW.

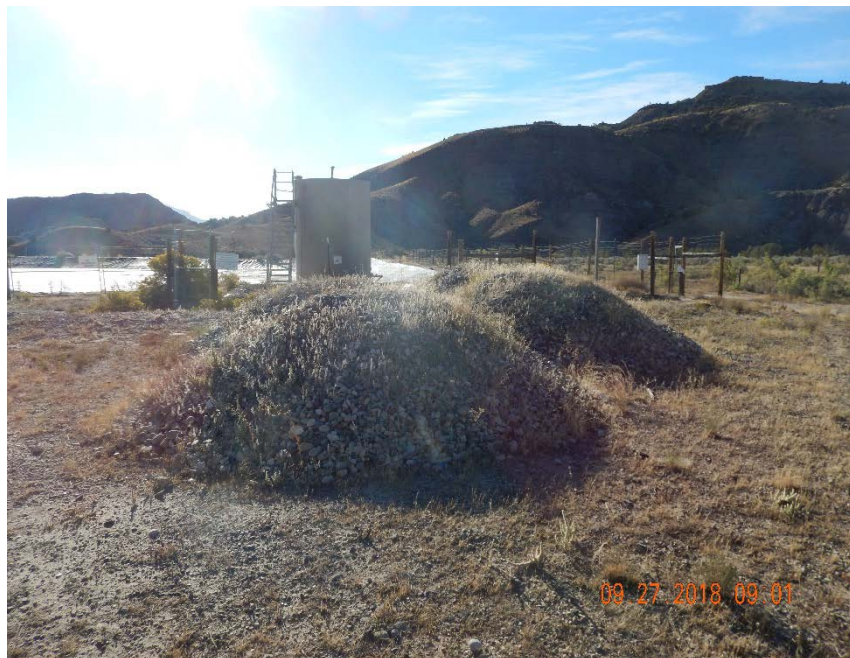
Photo #3 – Vegetated stockpiles of unidentified soil with gravel, located at SW corner of facility.

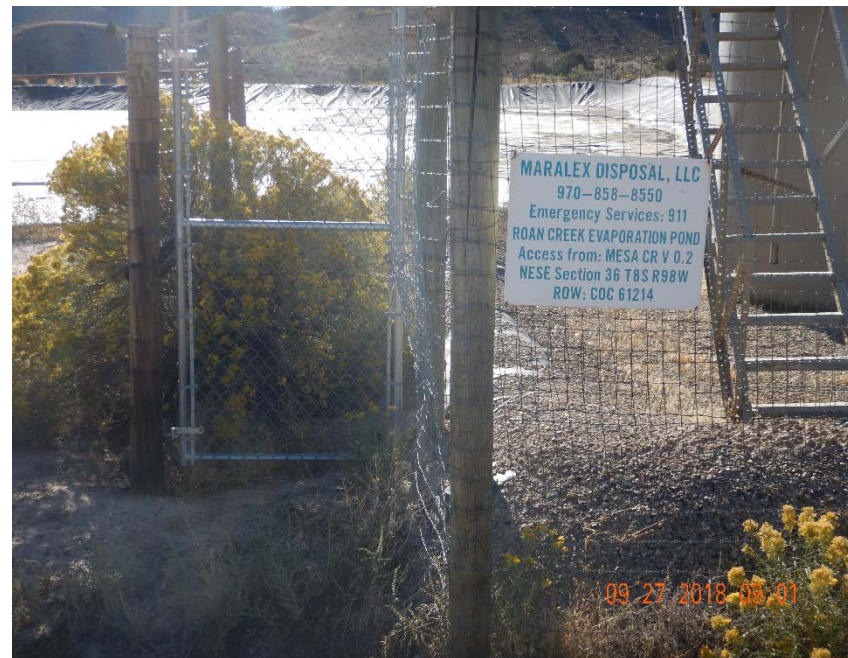
Photo #4 – Pit facility sign located at SW corner of pit fence.

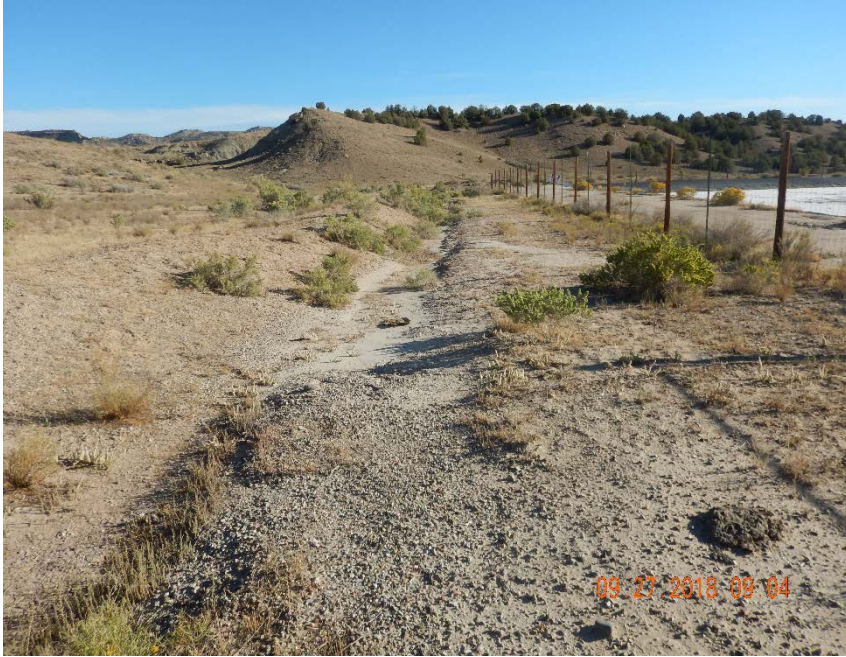
Photo #5 – Stormwater channel on west side of pit, looking NE.

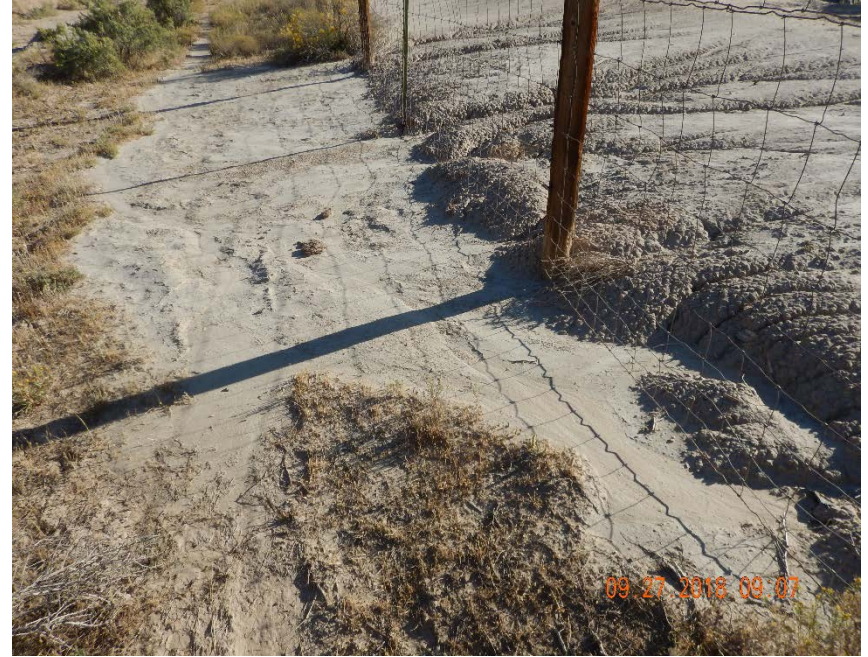
Photo #6 – Erosion of western pit berm and off-site sediment transport into stormwater channel.

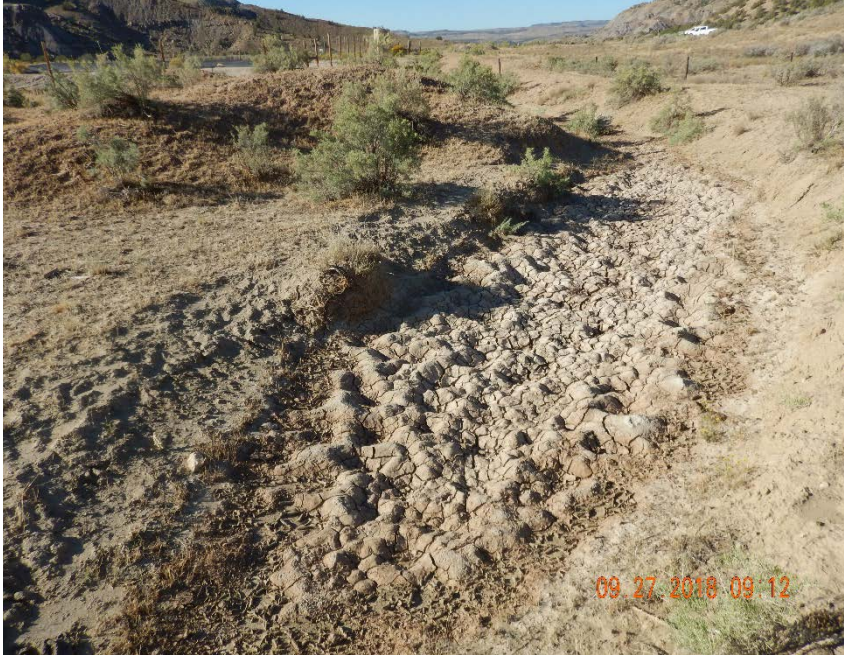
Photo #7 – Apparent sediment pond located at terminus of stormwater channel, located northwest of pit.

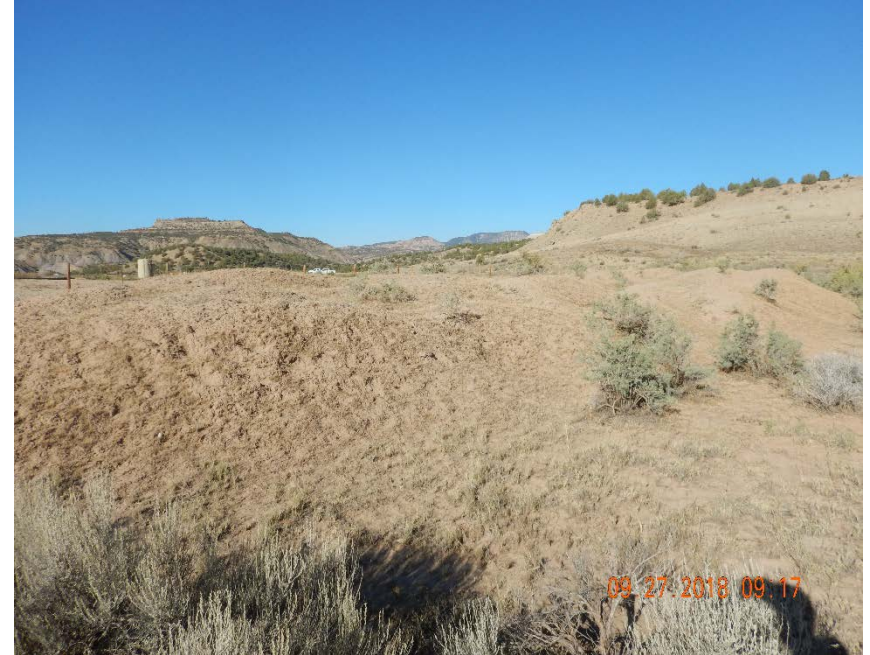
Photo #8 – Vegetated soil stockpile located north of pit, view looking SW.

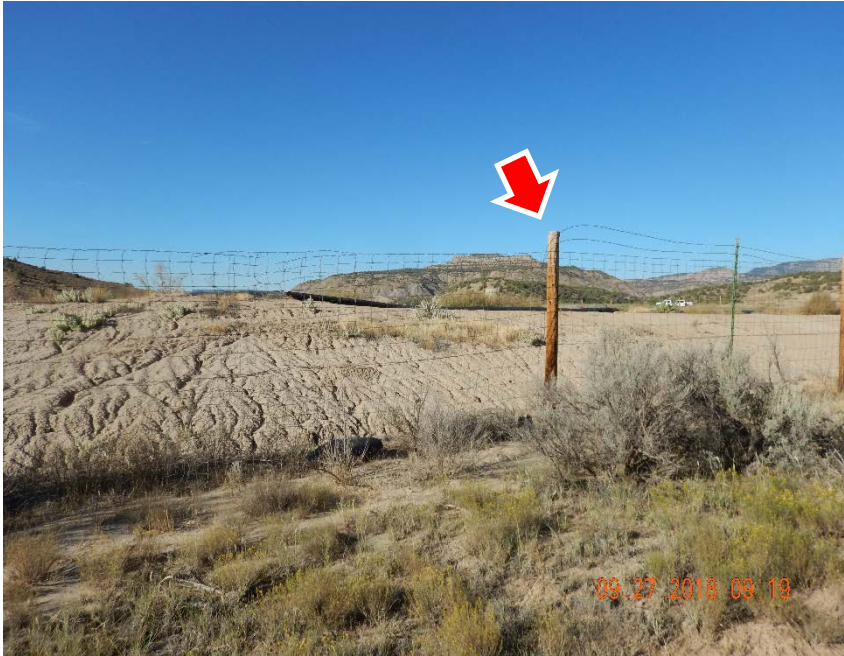
Photo #9 – Damaged/patched section of fence at NE corner of pit. Note that barbed wire has not been repaired or replaced (red arrow).

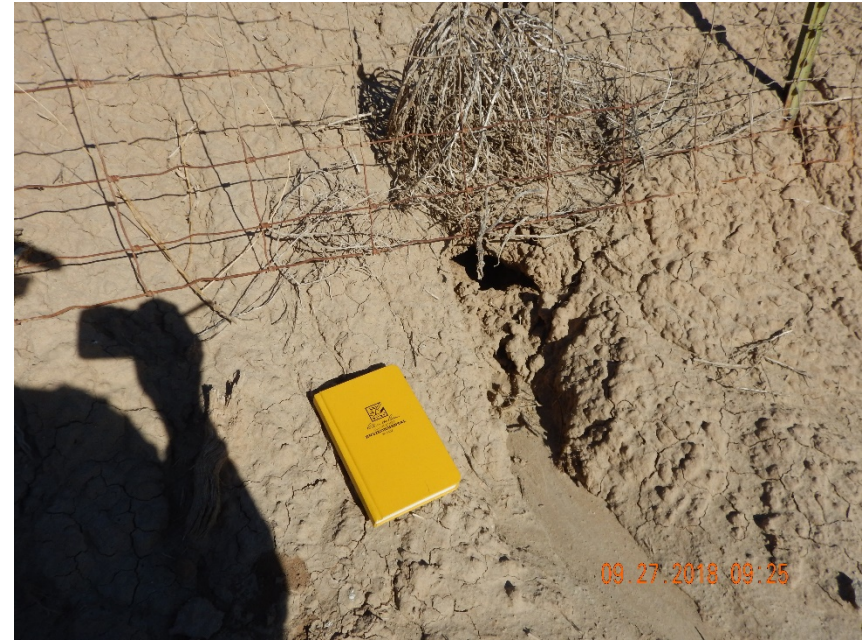
Photo #10 –Evidence of erosion (and apparent subsurface soil piping) observed in east pit berm.

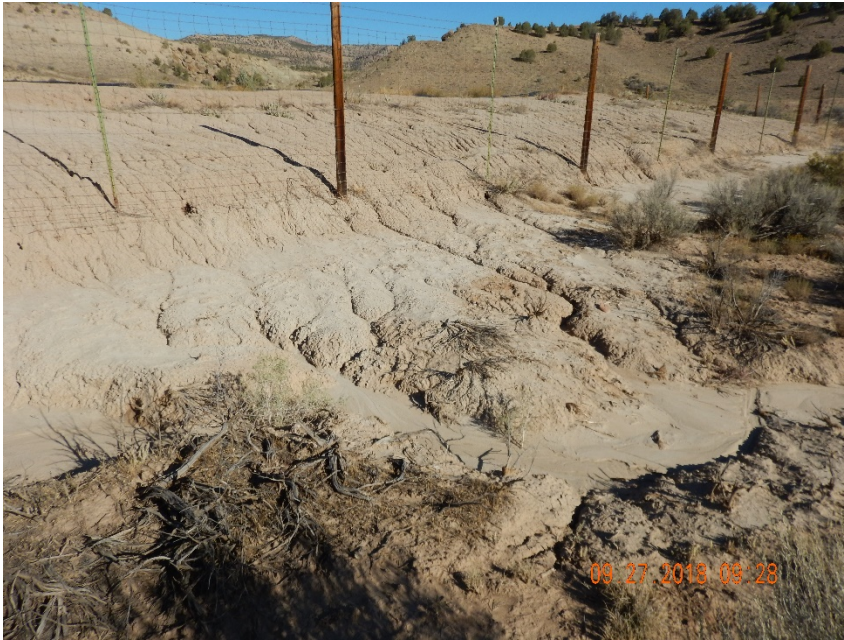
Photo #11 – Berm erosion and off-site sediment transport to east of pit. Stormwater and sediment flow toward mapped surface water feature, Coon Hollow, located approximately 200' east of pit.

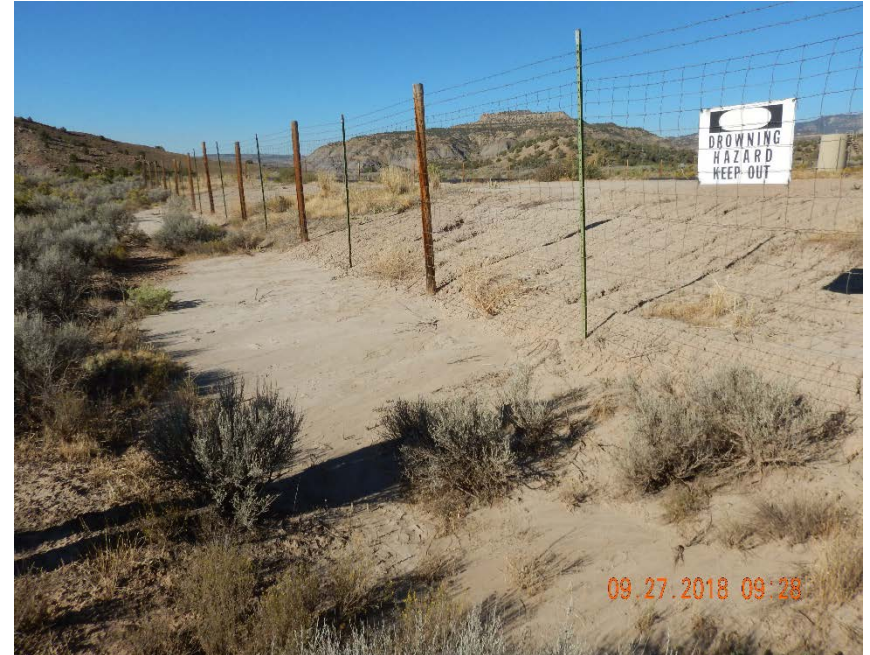
Photo #12 – Additional erosion and off-site sediment transport from east pit berm.

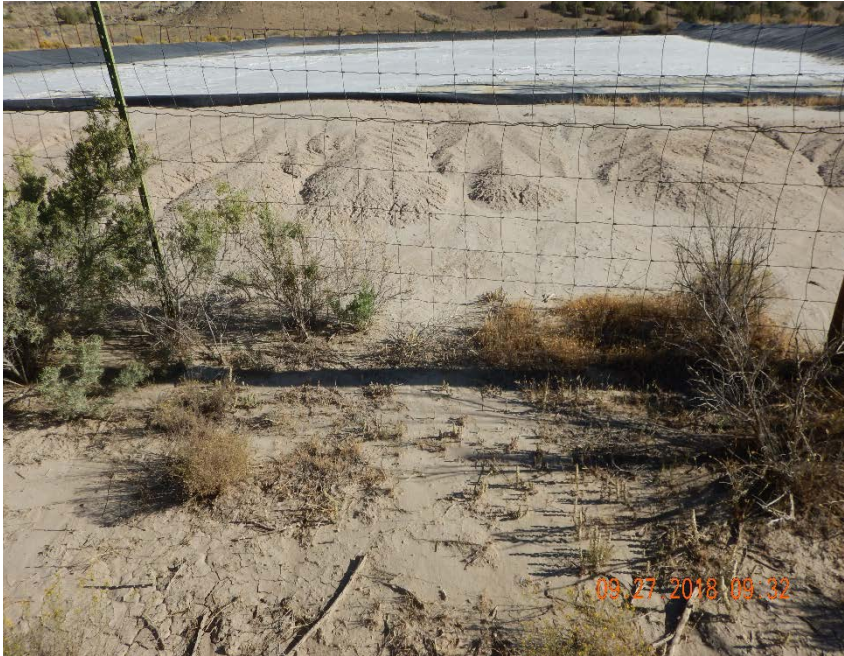
Photo #13 – Erosion and off-site sediment transport from south pit berm.

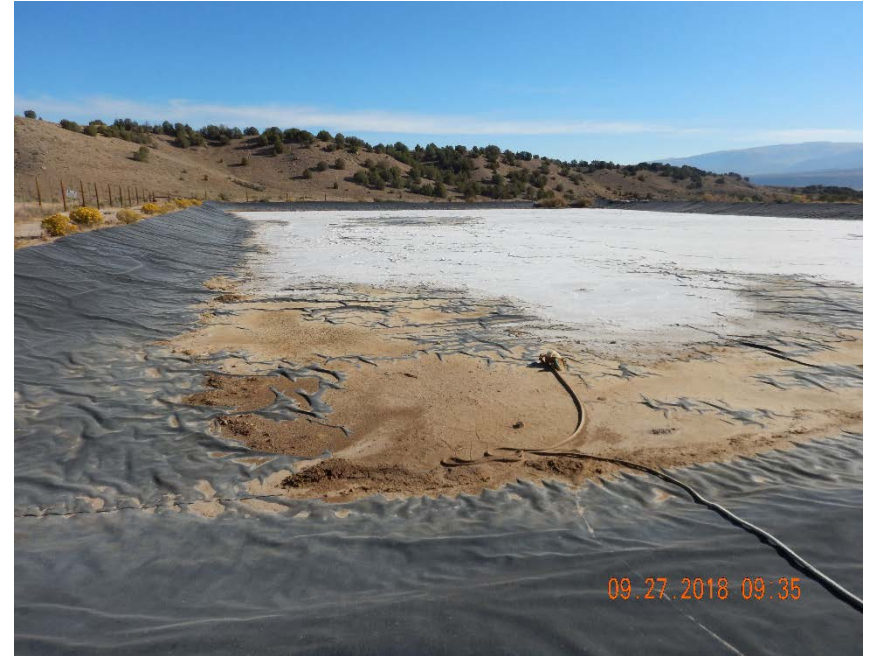
Photo #14 – Pit liner was covered in salt deposits and stained sediment on inspection date. Composite samples of sediment inside of pit exceeded COGCC Table 910-1 for multiple constituents, including DRO (doc #2144696).

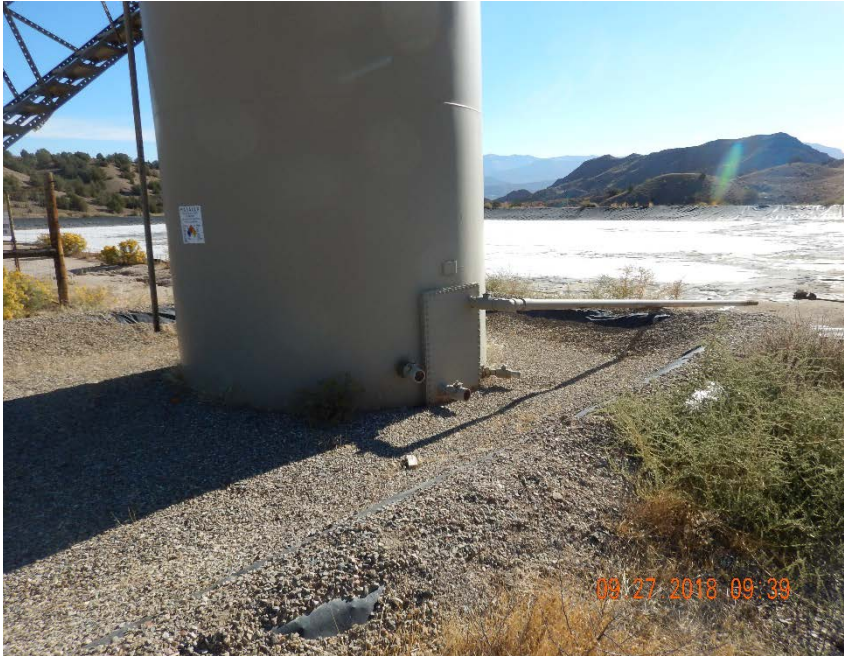
Photo #15 – Tank berm at SW corner of pit is shallow and eroded. Note produced water tank lacked truck loadout assembly on inspection date.

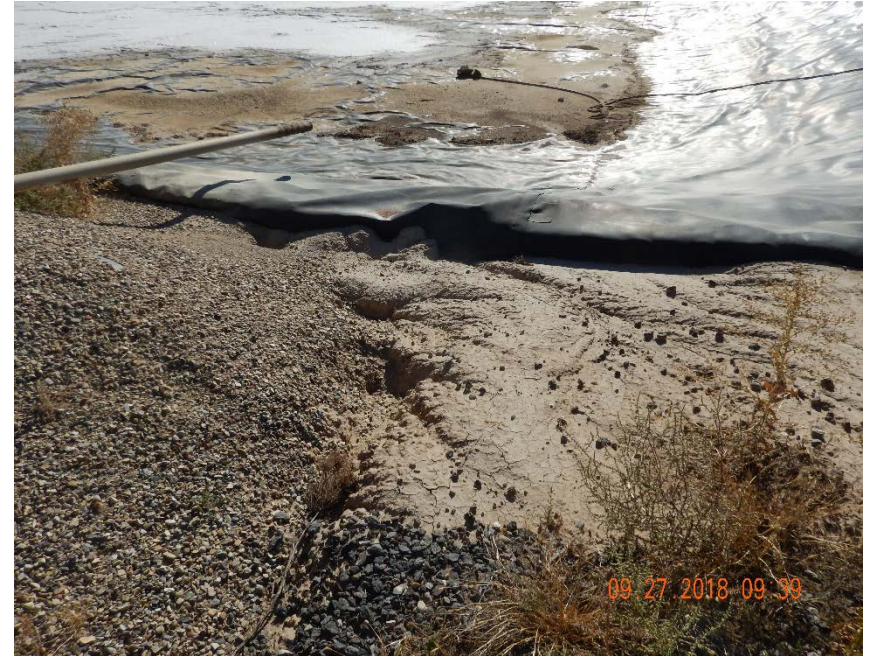
Photo #16 – Evidence of berm erosion, stormwater flow into anchor trench/beneath liner located at SW corner of pit near inlet from produced water tank.

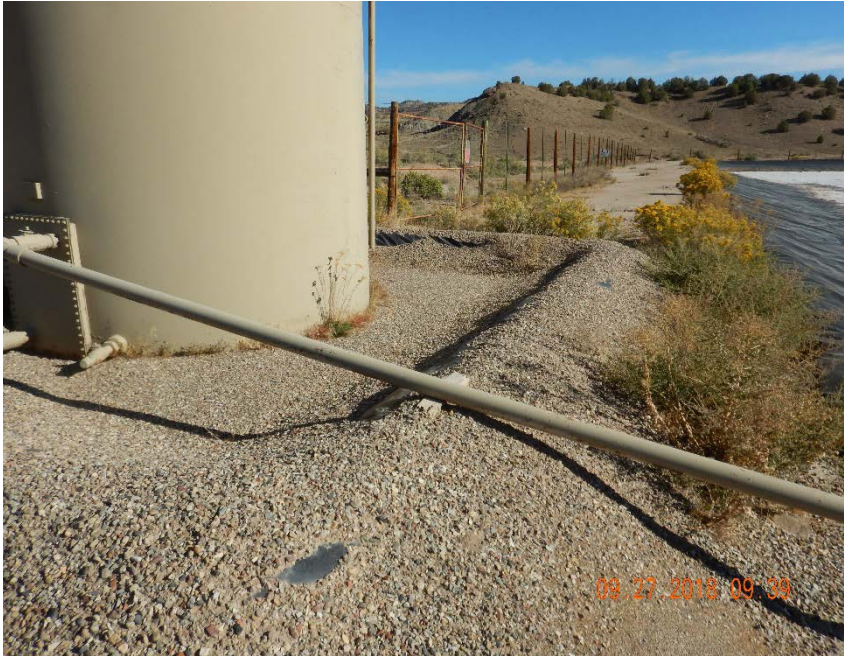
Photo #17 –Vegetation growth along anchor trench, pictured on west side of pit, was present along all sides of pit on inspection date.

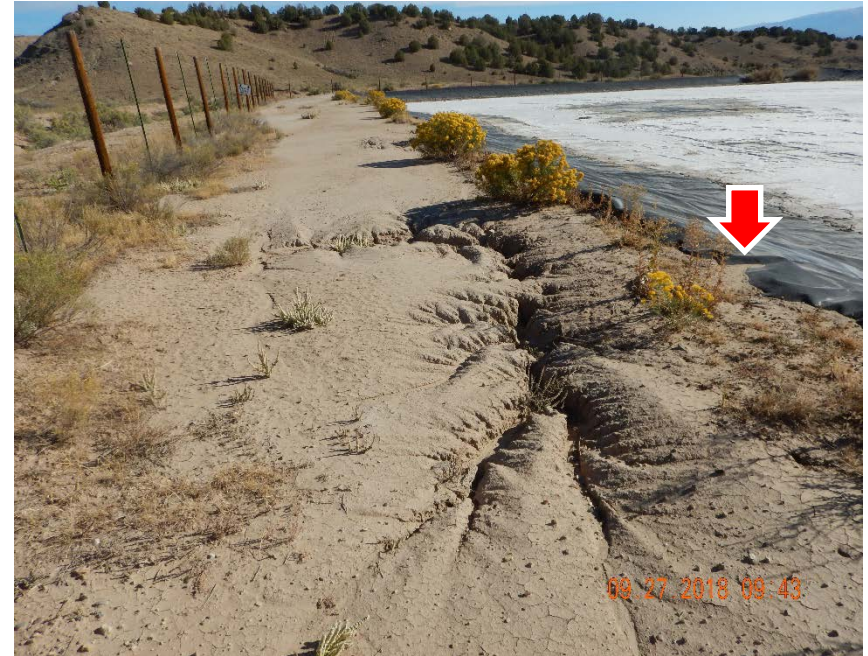
Photo #18 – Erosion rill on west pit berm resulting from apparent subsurface soil piping and stormwater flow. Note evidence of sediment transport into pit (red arrow).

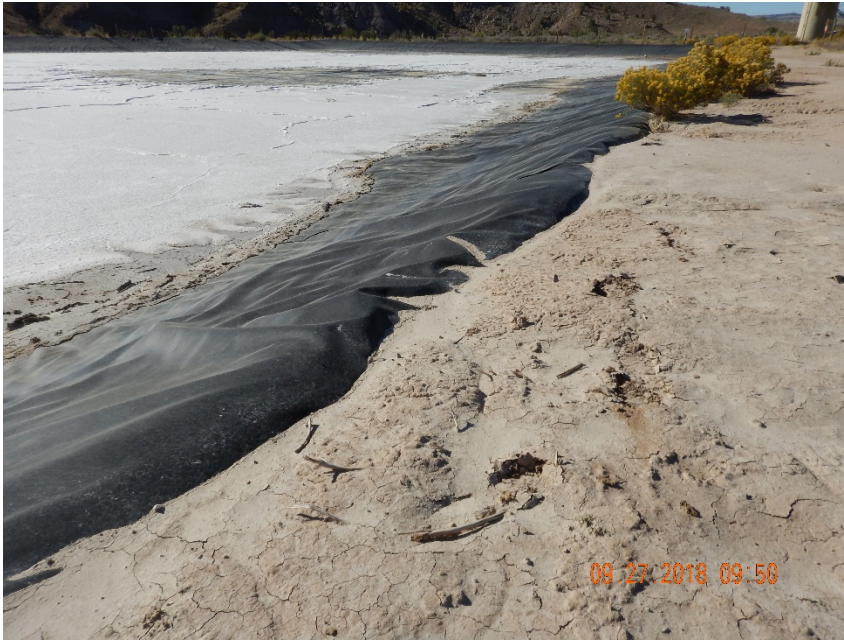
Photo #19 – Evidence of sediment transport into pit and mud cracks resulting from apparent pooling of storm water in shallow area at NW corner of pit berm.

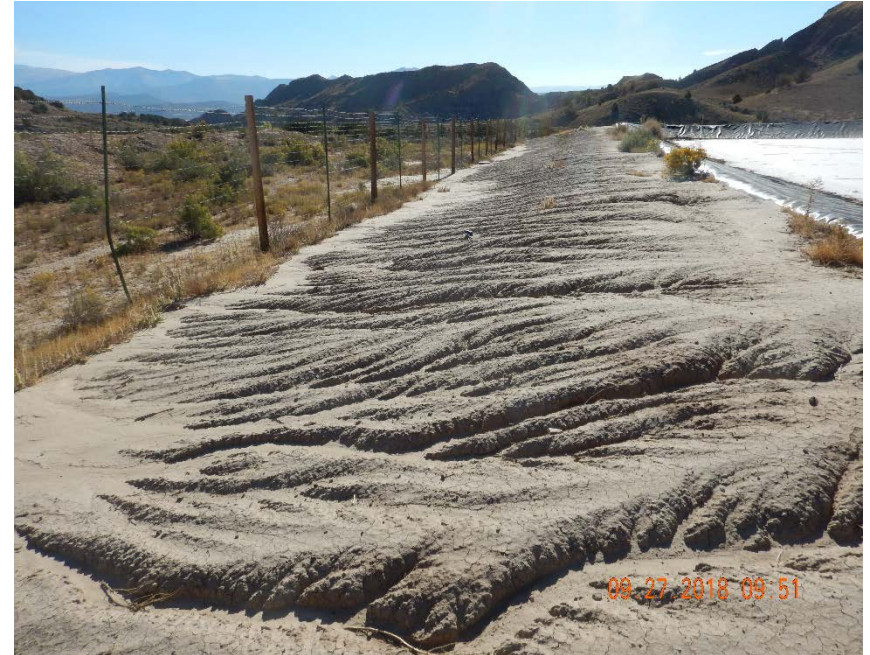
Photo #20 – Erosion rills along north pit berm resulting in off-site sediment transport north of pit.

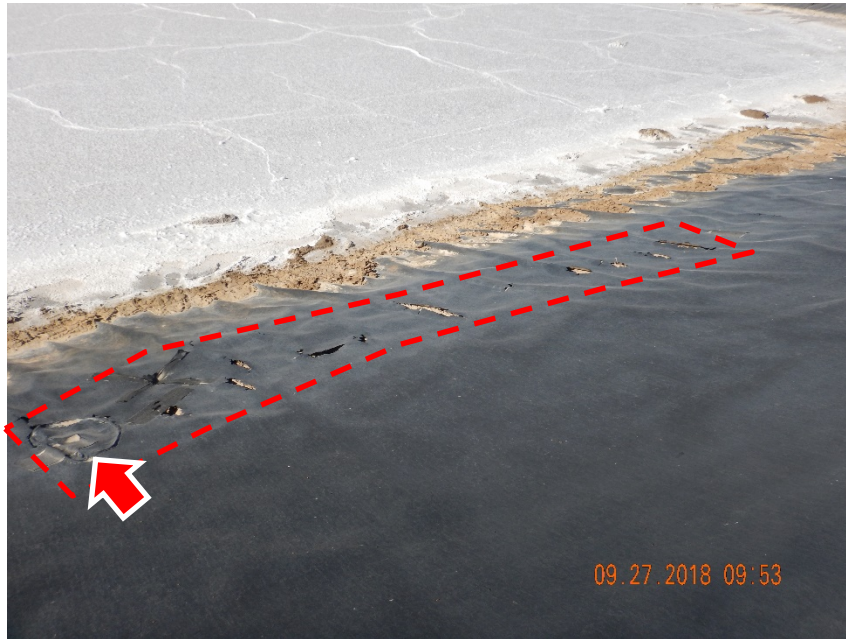
Photo #21 – Examples of holes observed in pit liner (outlined in red), primarily along north side of pit. Over sixty (60) holes were observed in visible portion of pit liner on inspection date, some of which had been previously patched by operator (red arrow).

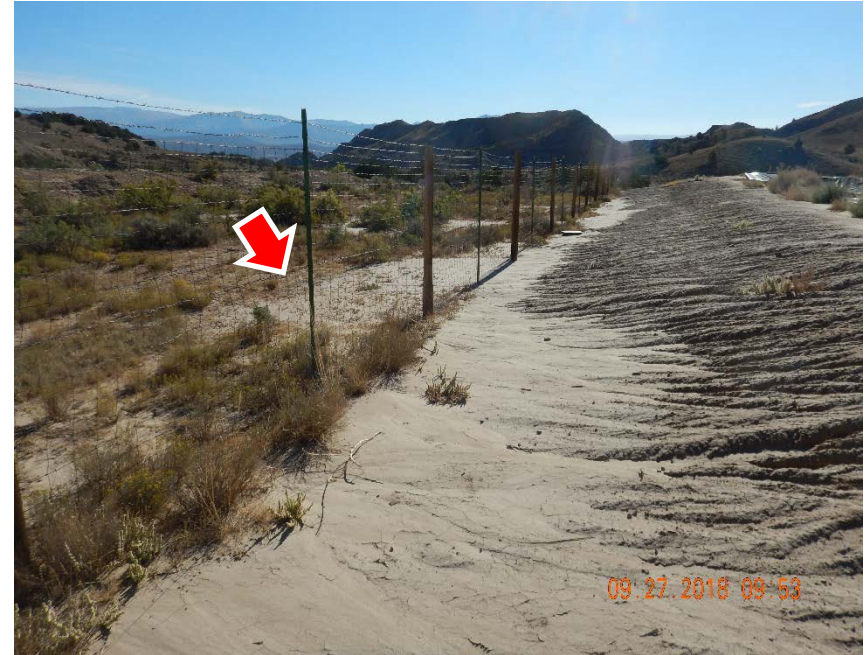
Photo #22 – Off-site sediment transport to north of pit (red arrow).

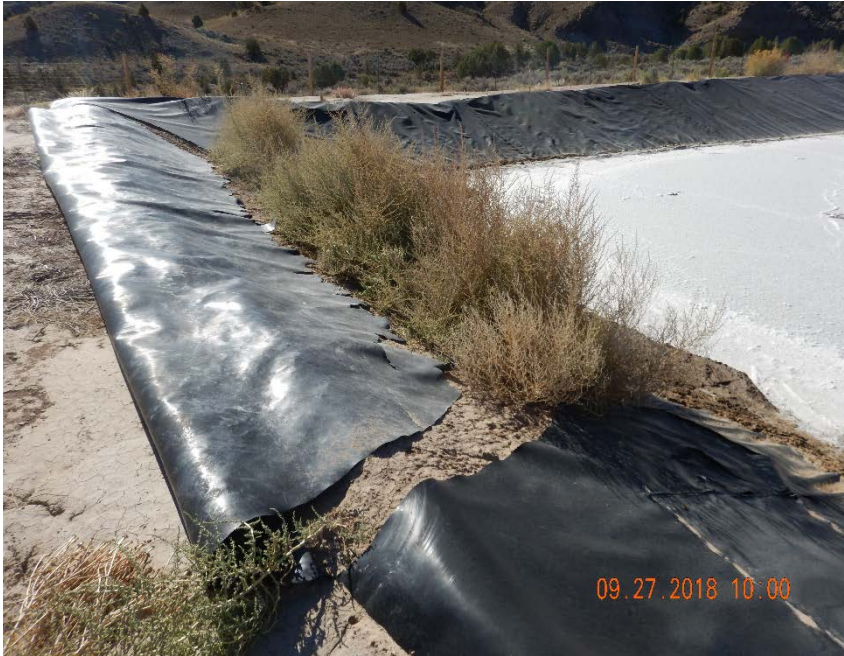
Photo #23 – Approximately 30’ section of pit liner has been completely separated from pit and was rolled back into place without being sealed or repaired. Note that area of berm formerly underlying pit liner now supports vegetation.

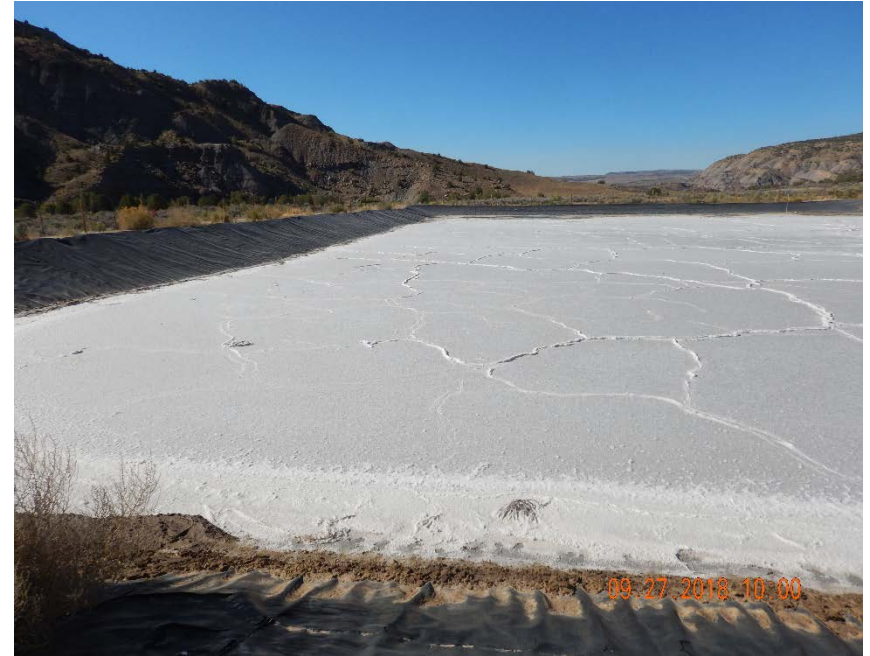
Photo #24 – View of salt and sediment covering lined pit bottom. Liner beneath salt and sediment could not be visibly inspected for integrity issues. Liner integrity issues along pit bottom have been documented under Remediation Project #8494 and Spill/Release ID #443917.

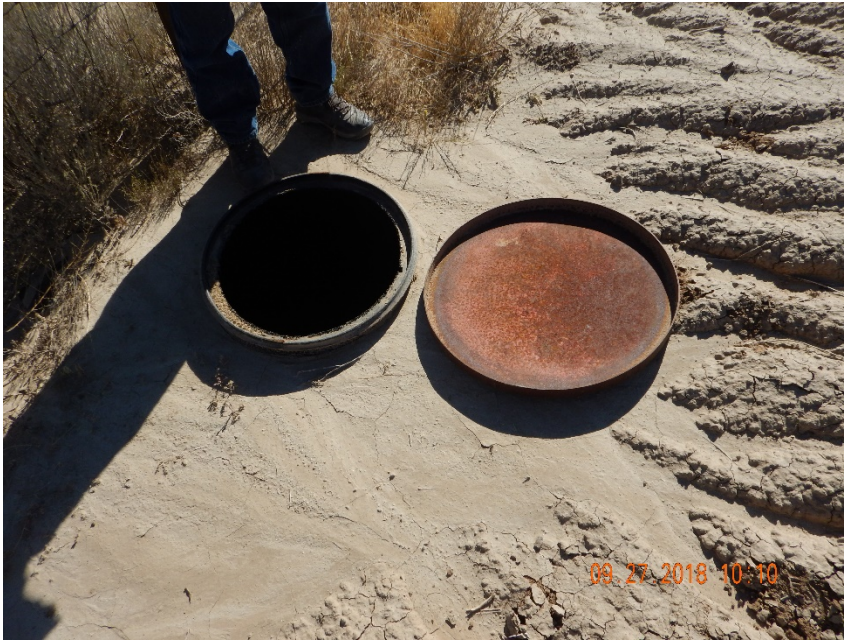
Photo #25 – Leak detection system located at north end of pit.

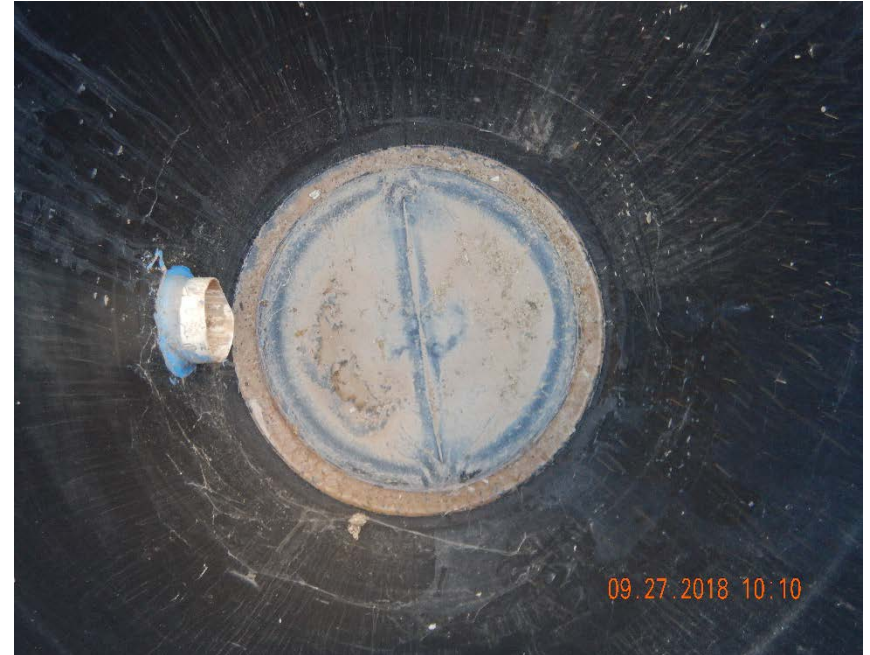
Photo #26 – Leak detection system was dry on date of inspection.

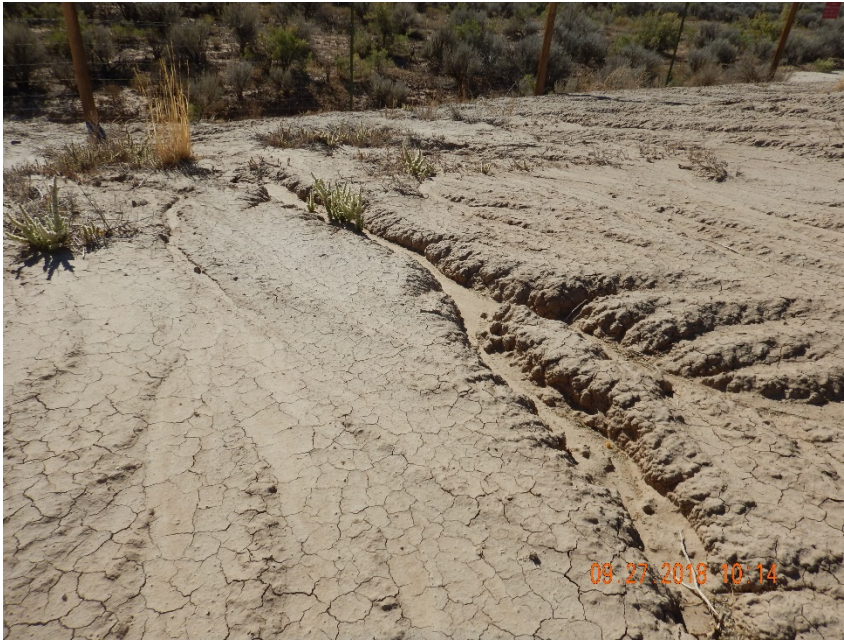
Photo #27 – Erosion rills along east berm of pit suggest apparent subsurface soil piping within berm.

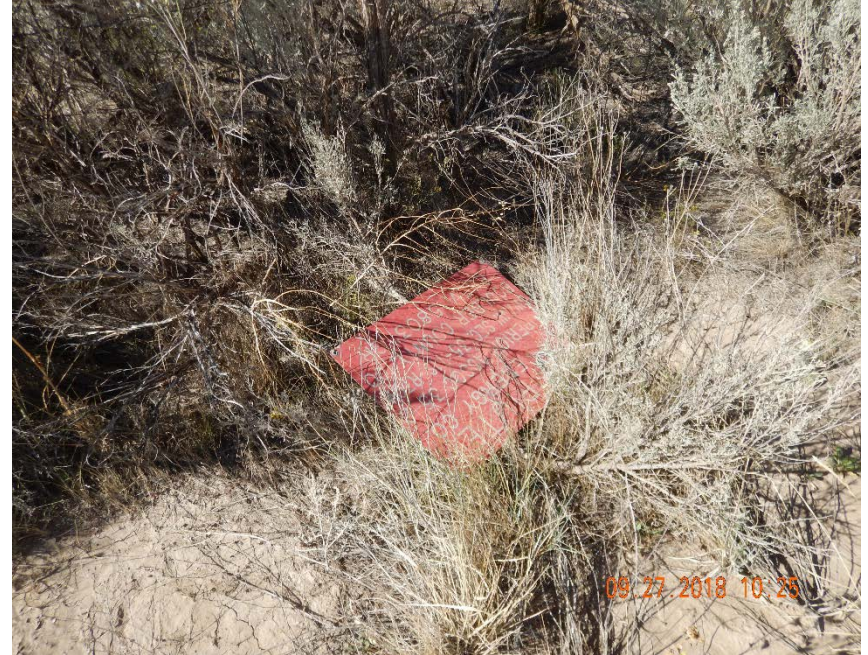
Photo #28 – Unused sign located inside of southern fence line.

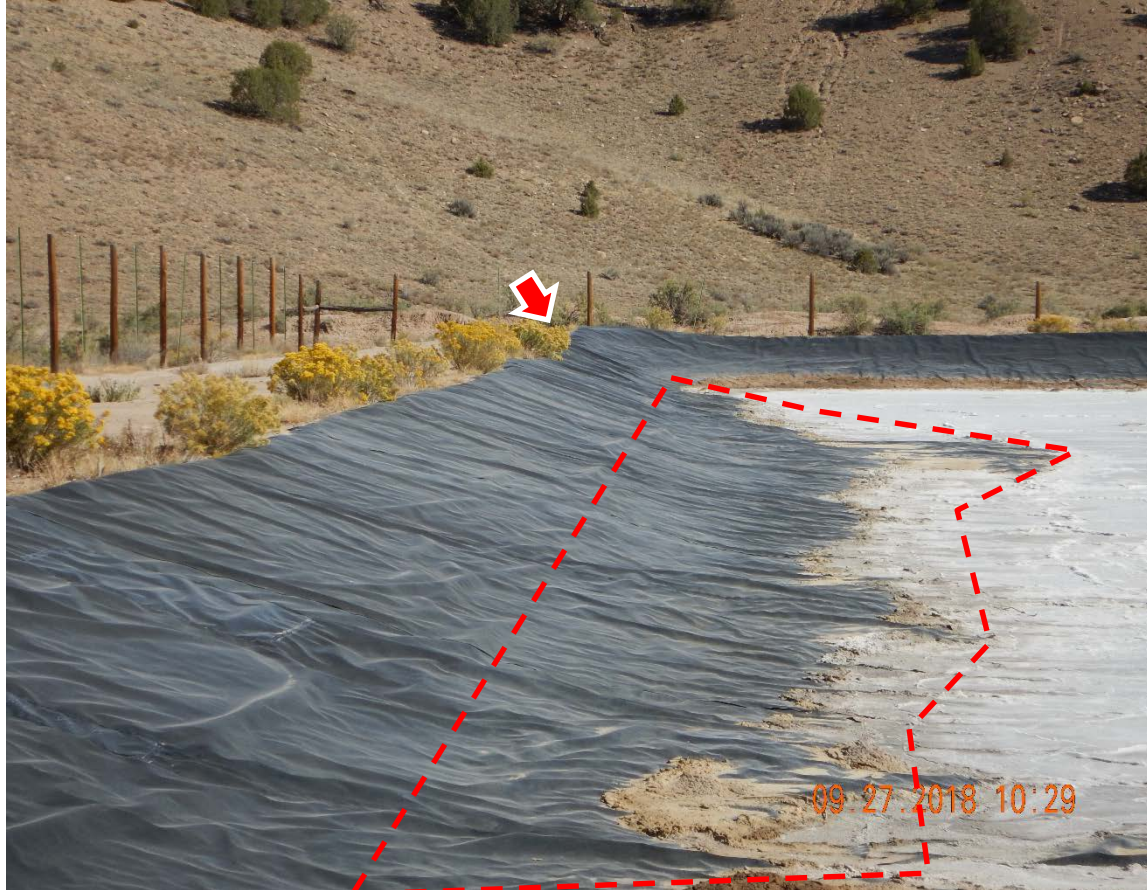
Photo #29 – View along west pit berm from SW corner of pit illustrates: 1) low area in NW corner of pit berm (red arrow) and 2) irregular surface along base of pit berm resulting from apparent sediment transport beneath pit liner (outlined in red).
