Inspection Photos

Location Name: Spill/Release Point ID #451553
REM #10395

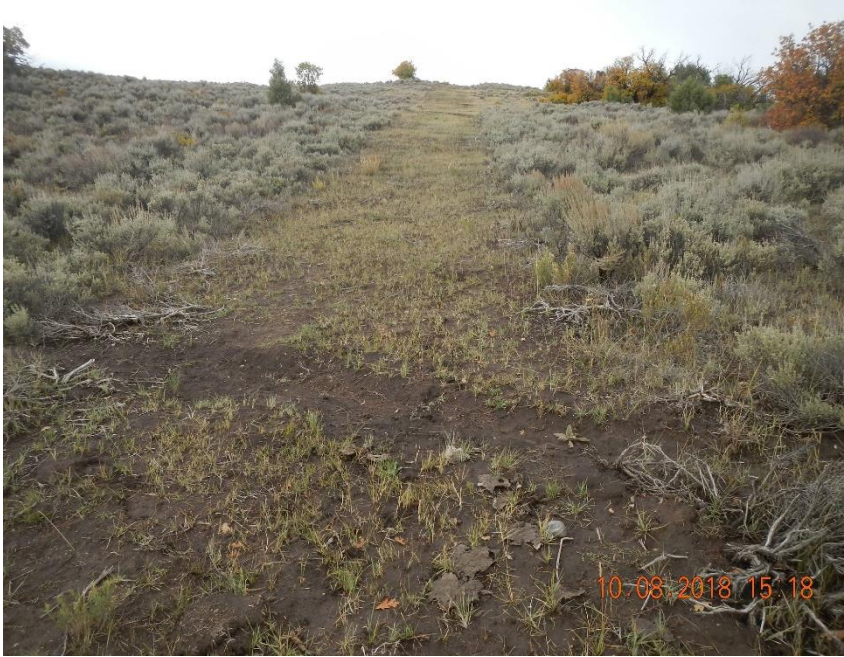
Gathering line ROW south of project area.

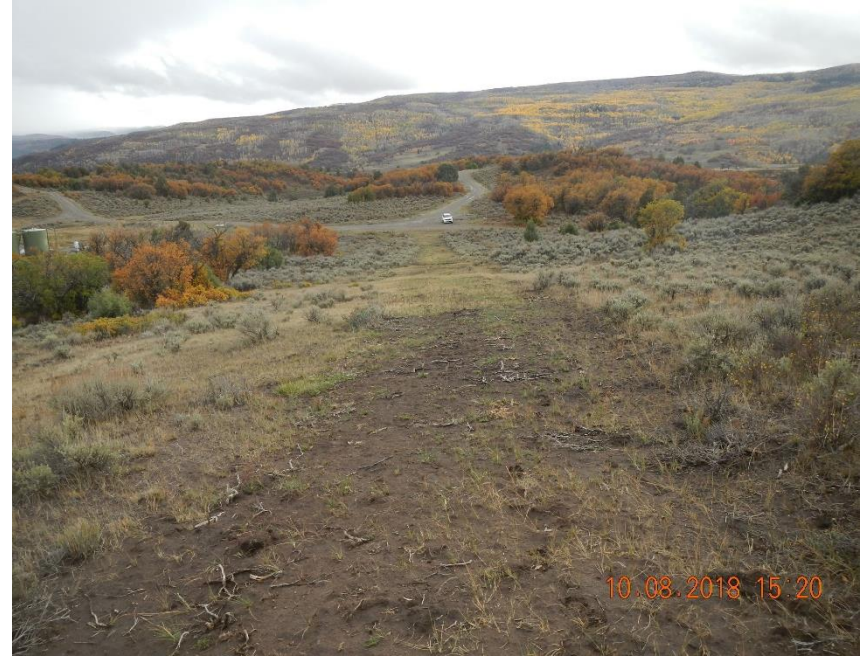
View of ROW from near Spill/Release Point ID #451553.

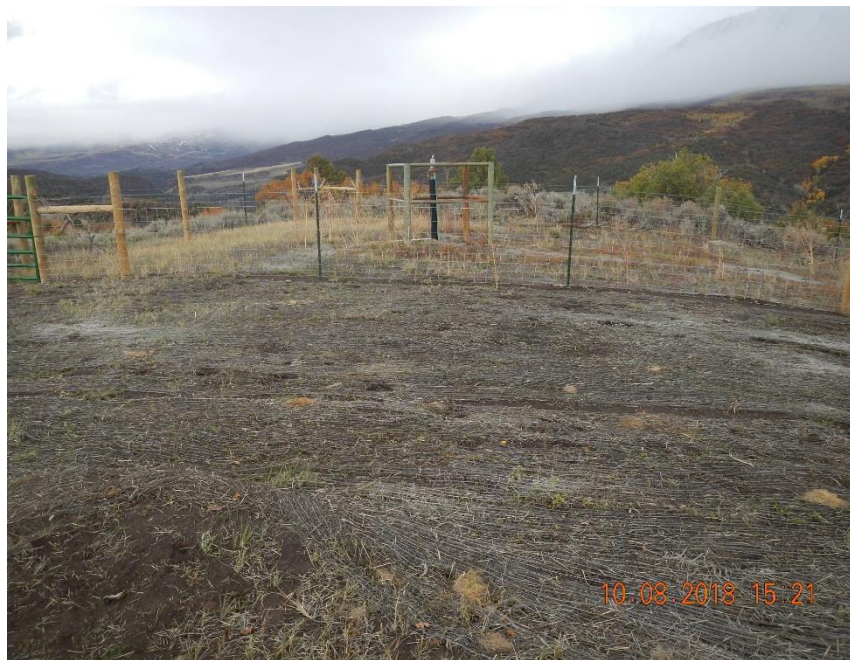
Spill/Release Point ID #451553.

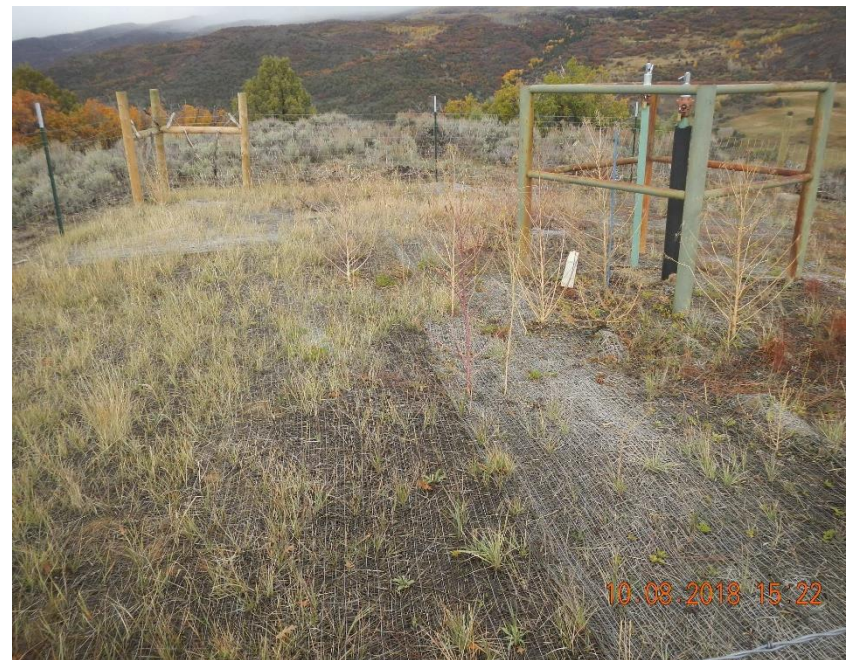
View of revegetation in progress within project area.

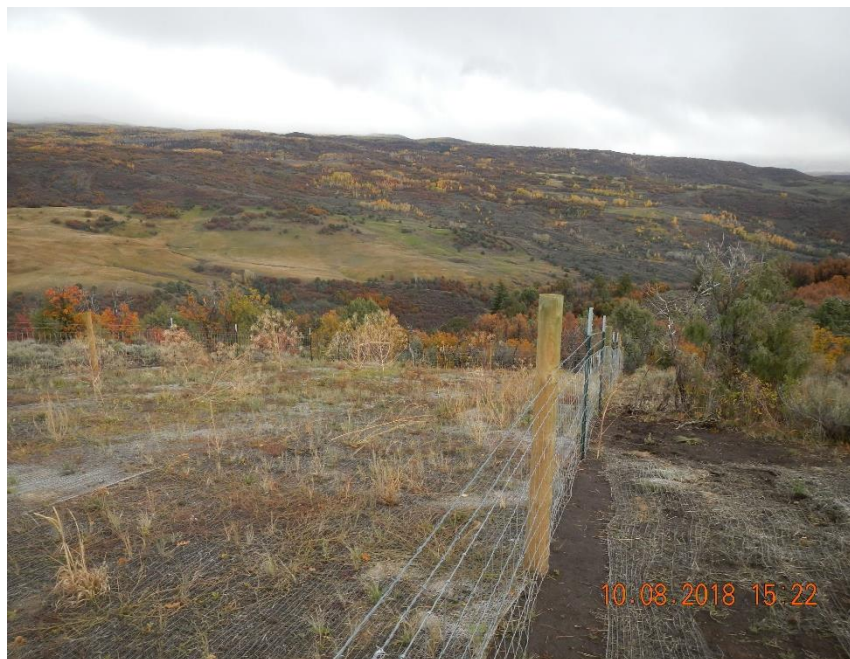
View along southern edge of perimeter fencing, facing east.

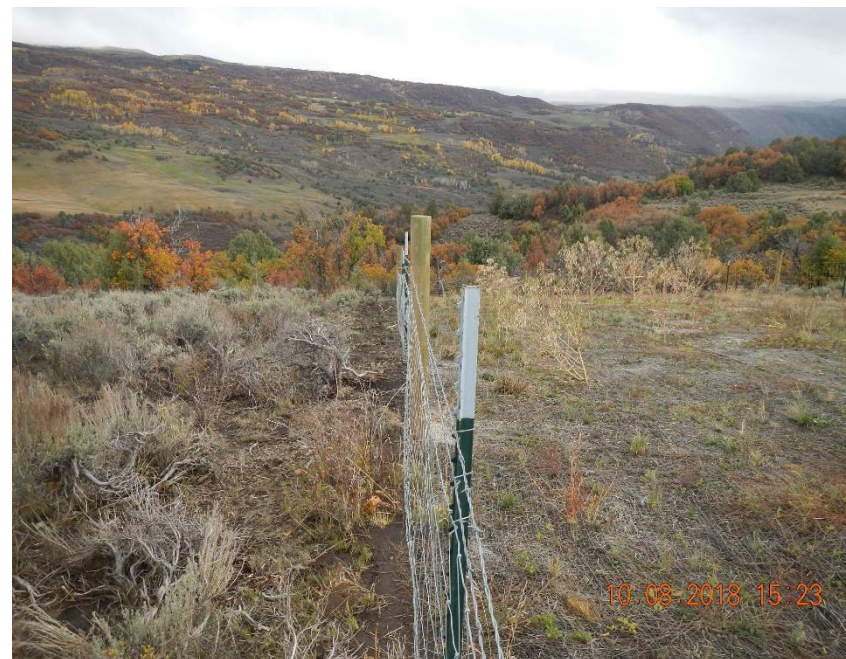
View along northern edge of perimeter fencing, facing east.

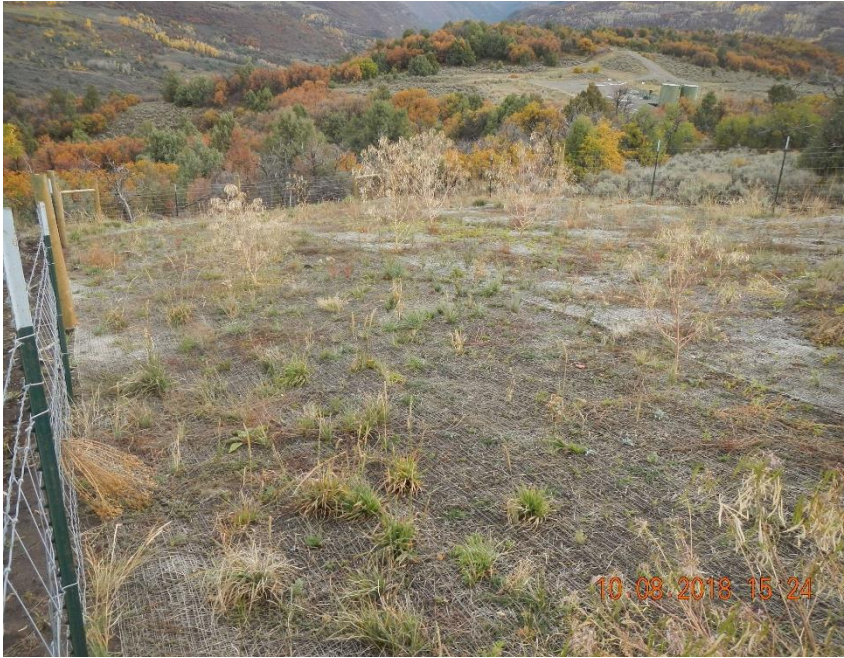
Revegetation along slope east of release point.

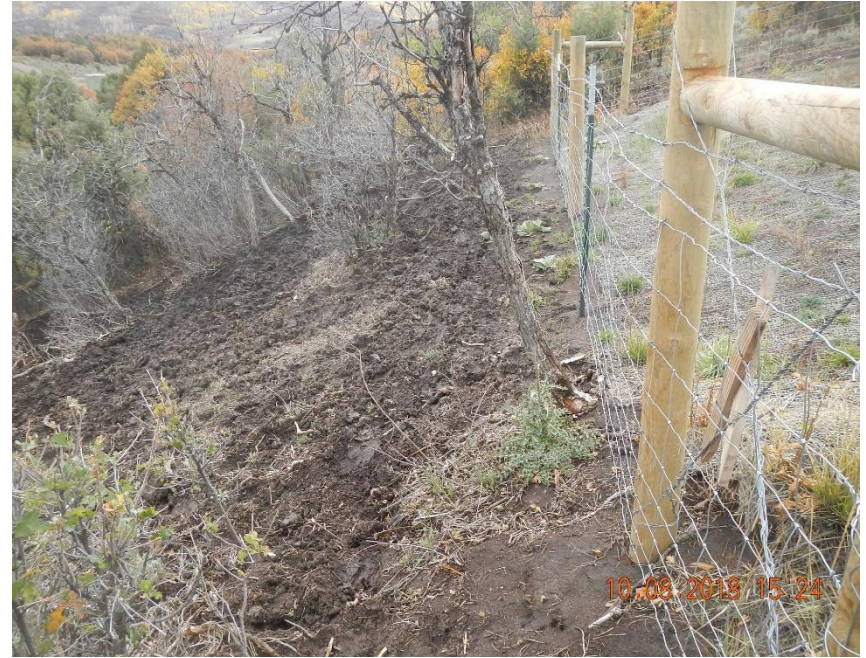
Eastern extent of perimeter fencing. Evidence of significant livestock traffic noted across the region.

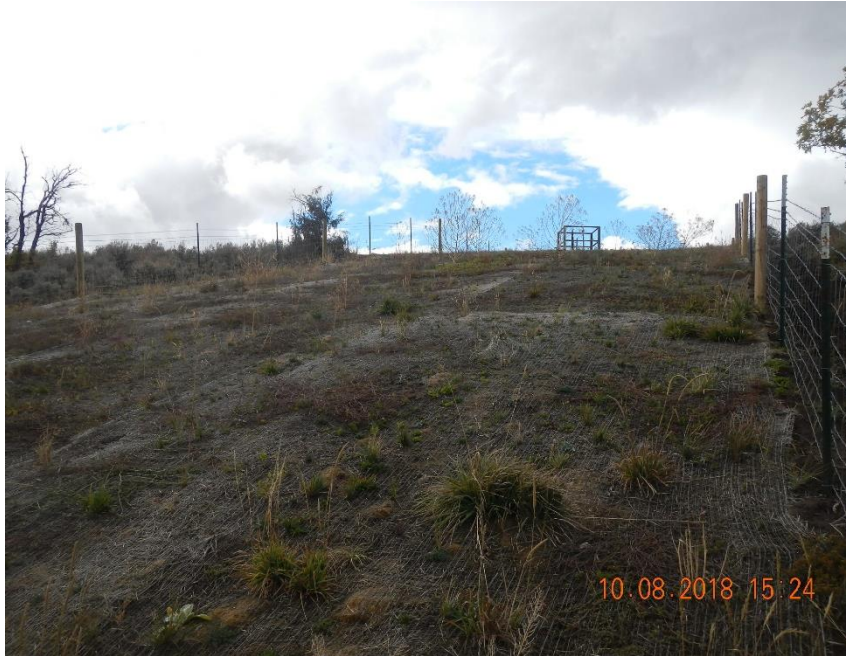
View of interior of project area from the eastern edge facing west.

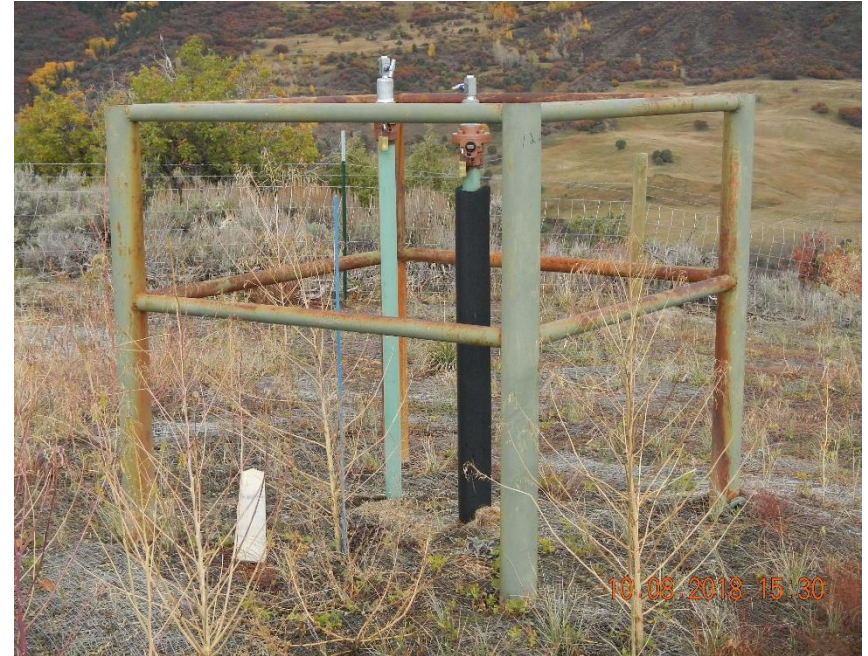
Both 2" valves are locked out in the closed position.
